CHOLLA POWER PLANT Fly Ash Dam, Bottom Ash Dam, and Bottom Ash Monofill

Annual CCR Impoundment and Landfill Inspection Report 2021

GENERATION ENGINEERING
Design Engineering
P.O. BOX 53999
PHOENIX, ARIZONA 85072

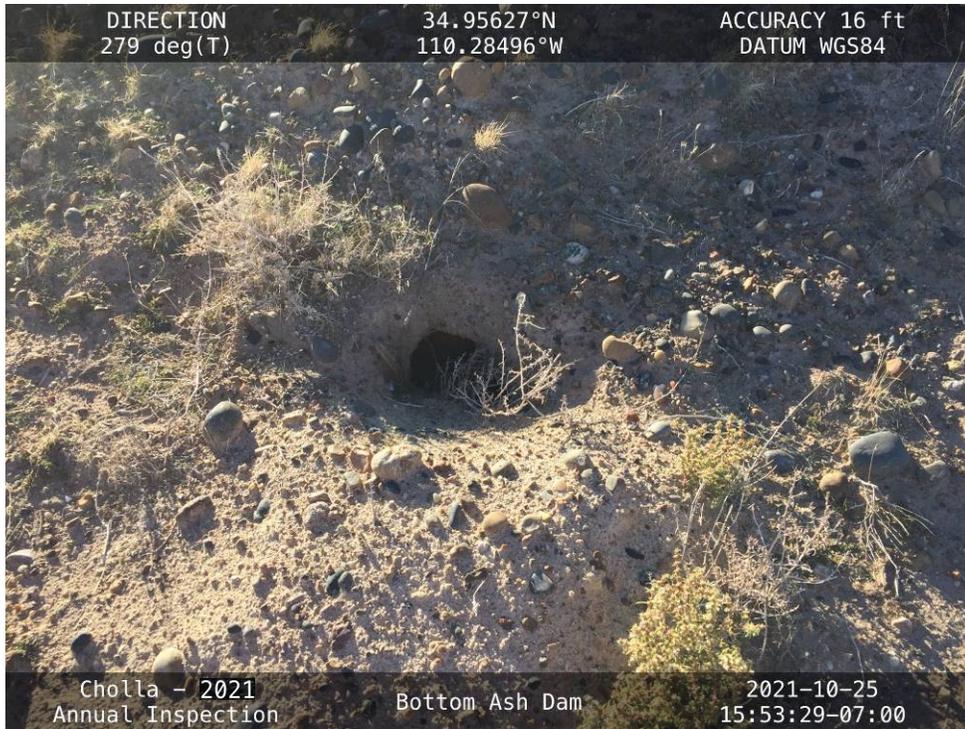
20211025-IMG_7117

An animal burrow near the access road along the downstream slope of the East Embankment.

2) Monitor the erosion gullies at the downstream slope of the East Embankment.	Repair erosion since it has exceeded 1 foot in depth.
3) Continue identifying and remediating scattered animal burrows and ant hills.	1) Mark ant hills and animal burrows identified during weekly inspections. 2) Continue remediating identified ant hills and animal burrows. NOTE: This will always be an ongoing maintenance activity.

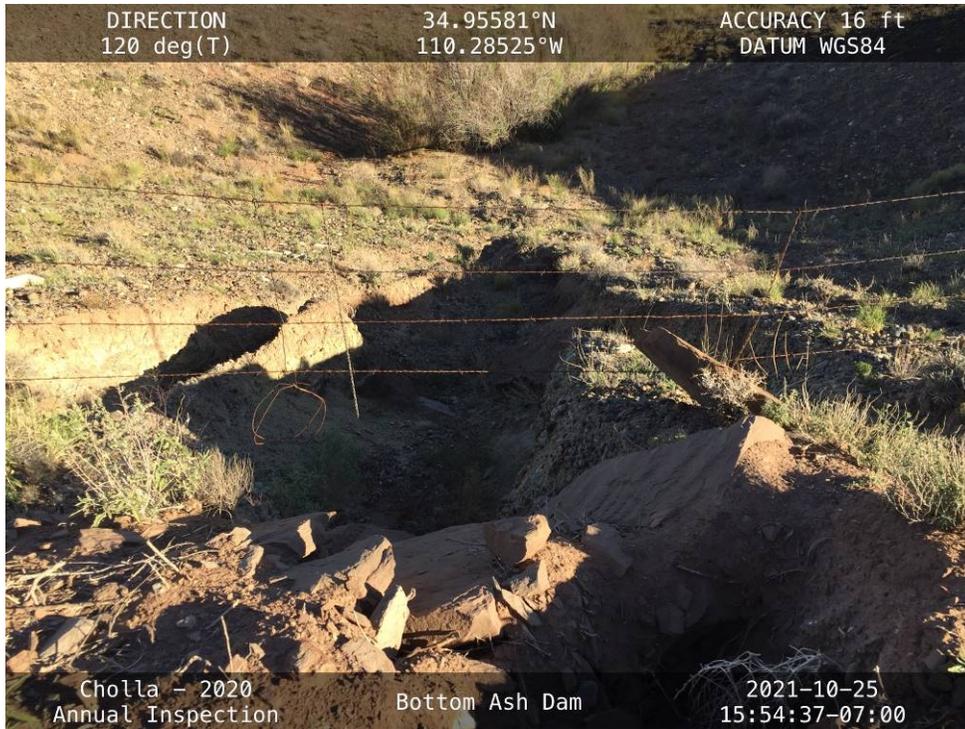
20211025-IMG_7120

An erosion gully on the downstream slope along the northern half of the East Embankment.

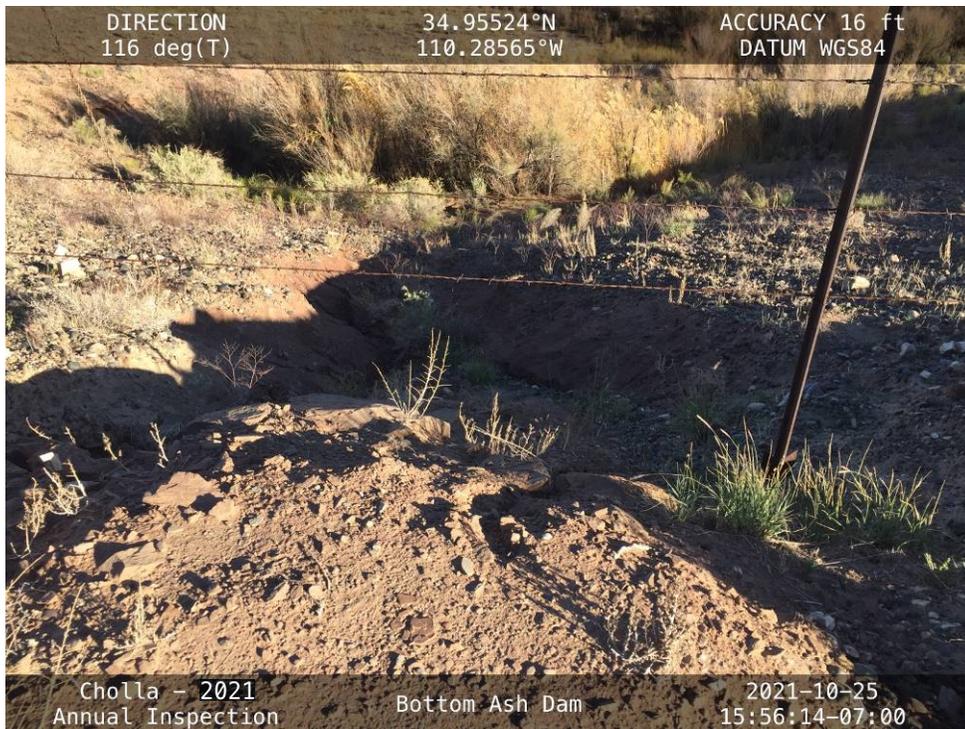
20211025-IMG_7127

An erosion gully on the downstream slope along the northern half of the East Embankment.

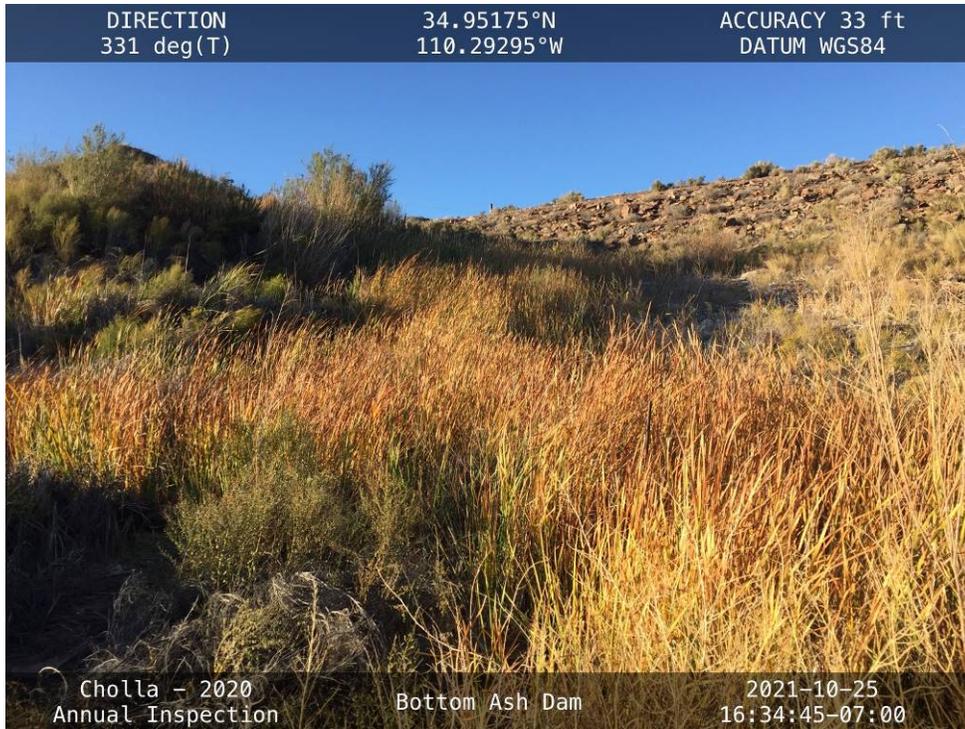
20211025-IMG_7173

Grassy vegetation growing in the area near the West Abutment Weir.

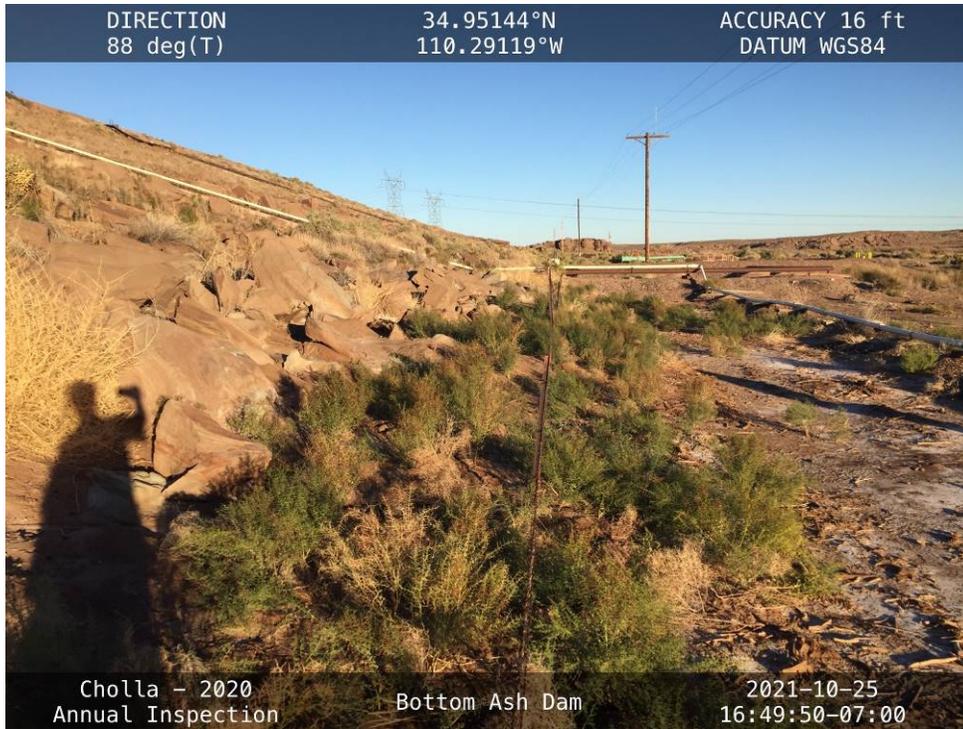
20211025-IMG_7191

Riprap deterioration along the South Embankment toe.

5) Continue monitoring the riprap for additional signs of deterioration.	Replace riprap as needed.
6) Continue to monitor seepage through the embankment.	Sumps should be clear of algae and other obstructions to facilitate observations of clear or cloudy seepage. NOTE: This will always be an ongoing maintenance activity.

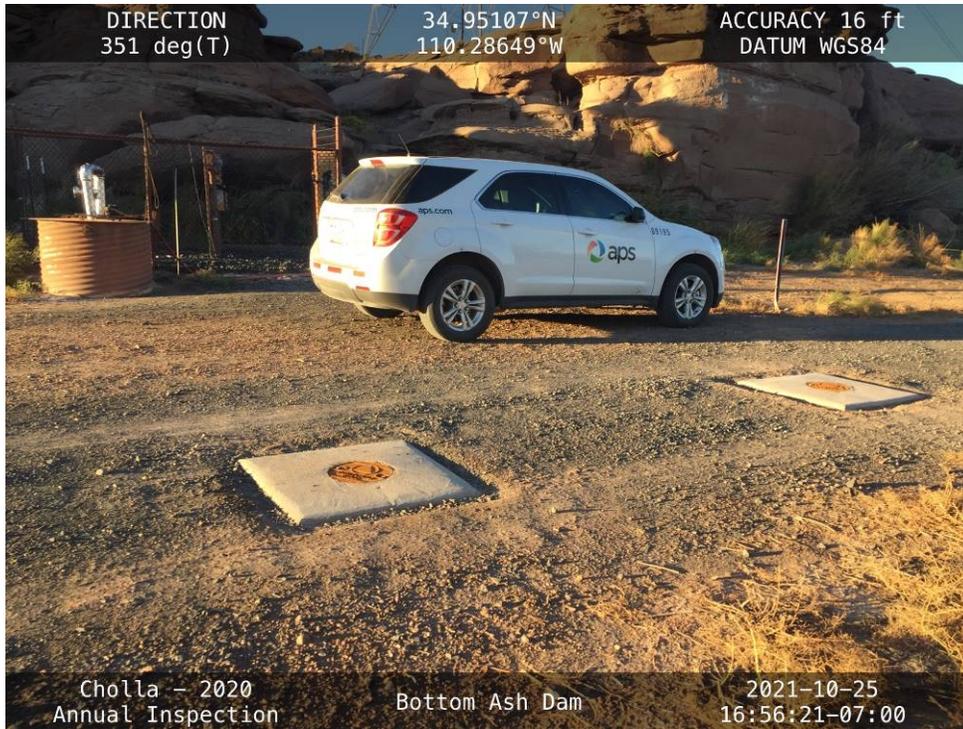
20211025-IMG_7195
 Two new monitoring wells installed near the Petroglyph Seep.

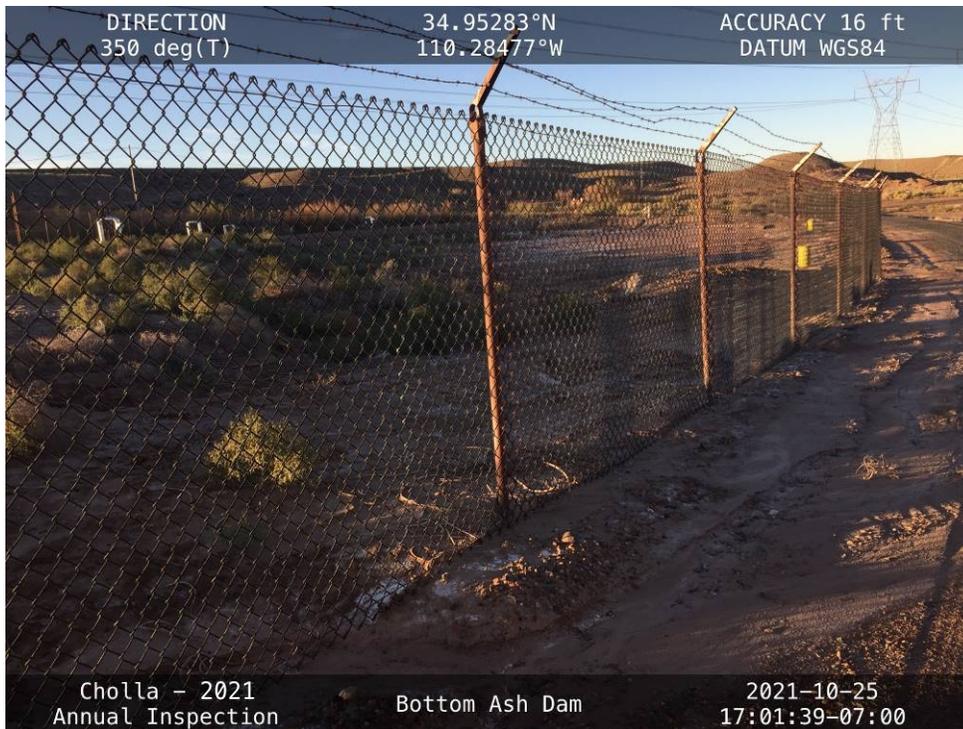
20211025-IMG_7206
 The P-232 seepage intercept area with two new wells installed (yellow monuments).

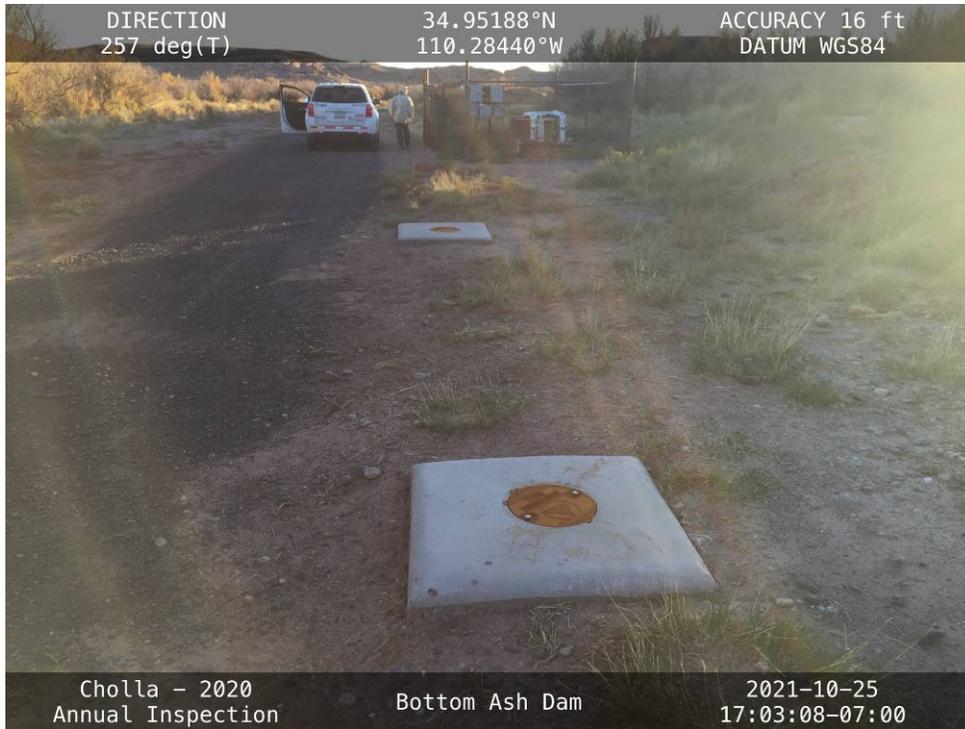
20211025-IMG_7208

Two new monitoring wells installed near the Tanner Wash Seep.

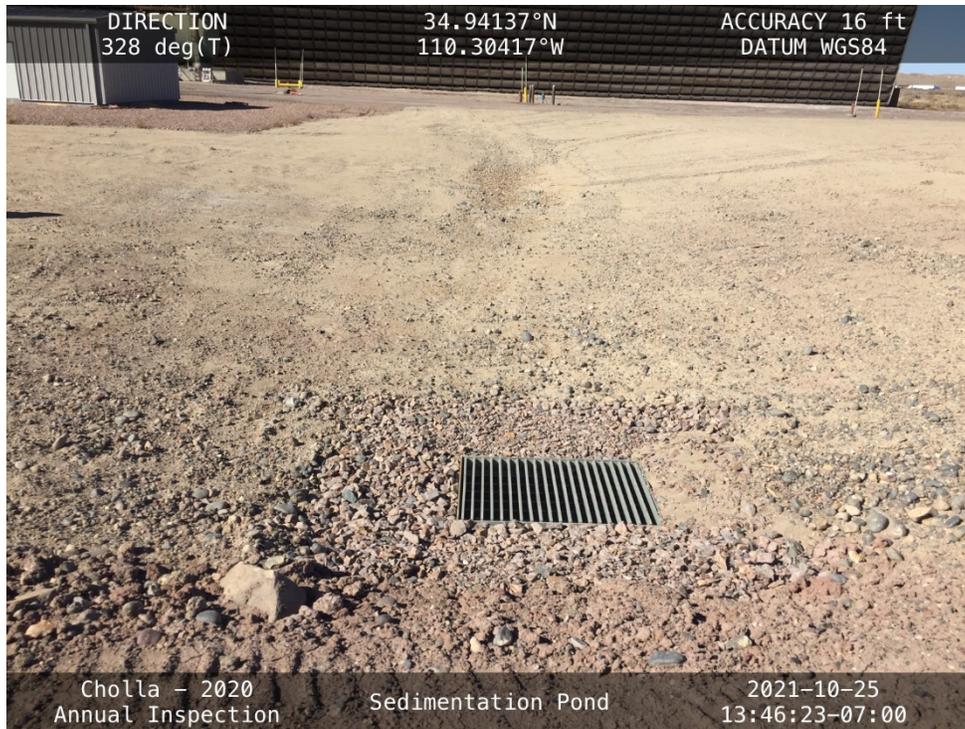
20211025 – IMG_6933

The earthen swale and catch basin grate installed to drain surface flows, facing northwest.

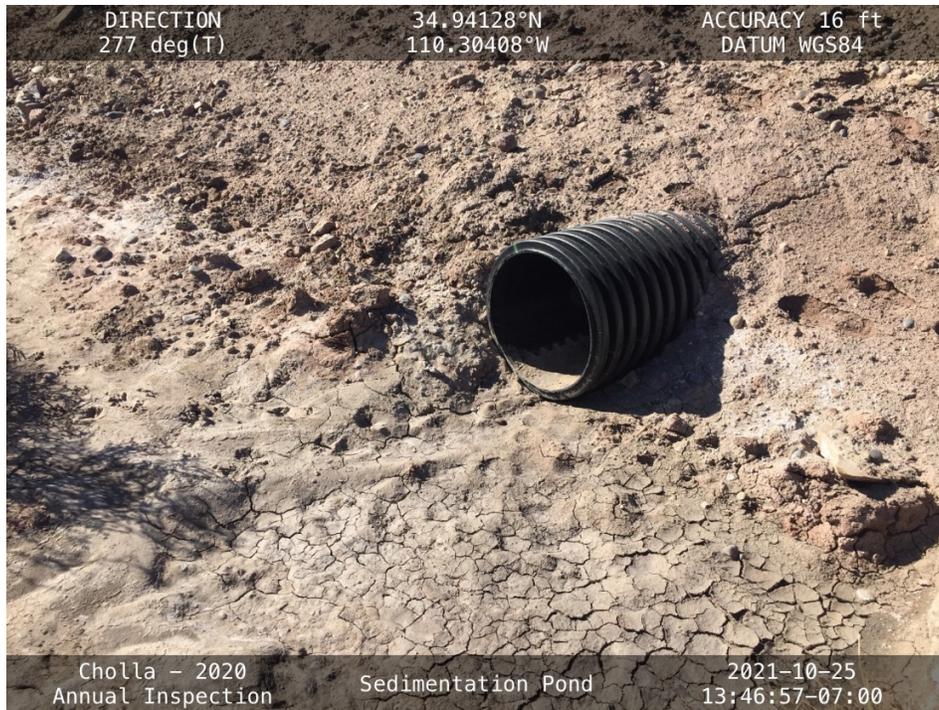
20211025 – IMG_6937

The downstream side of the 18-inch HDPE drain pipe installed to drain surface flows from the catch basin.

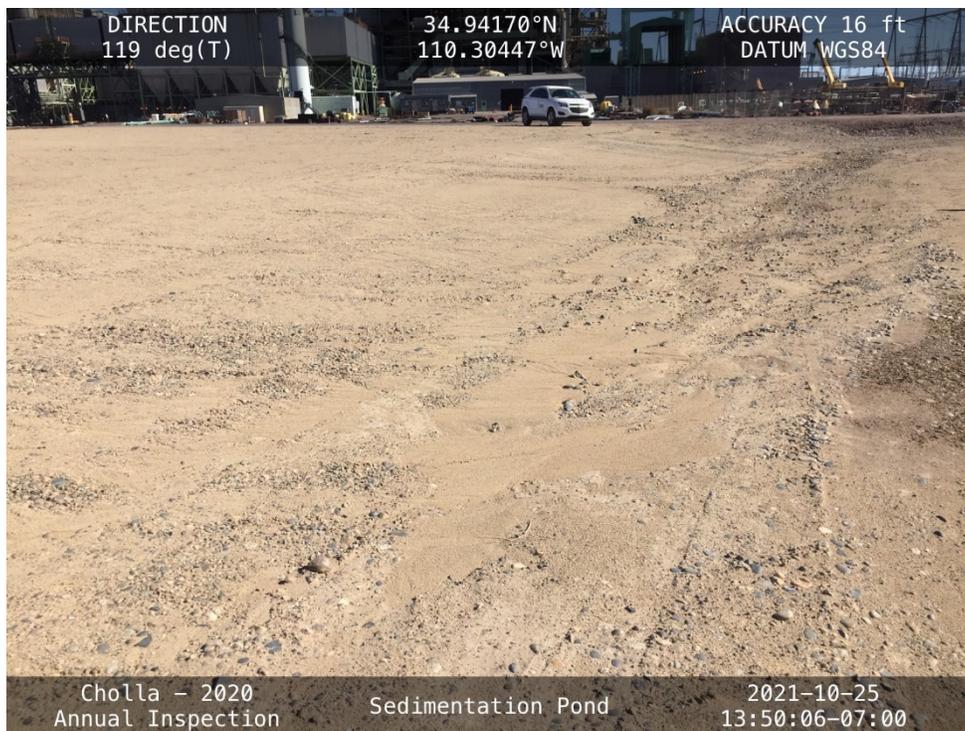
20211025 – IMG_6960

The earthen swale installed to drain surface flows, facing southeast.

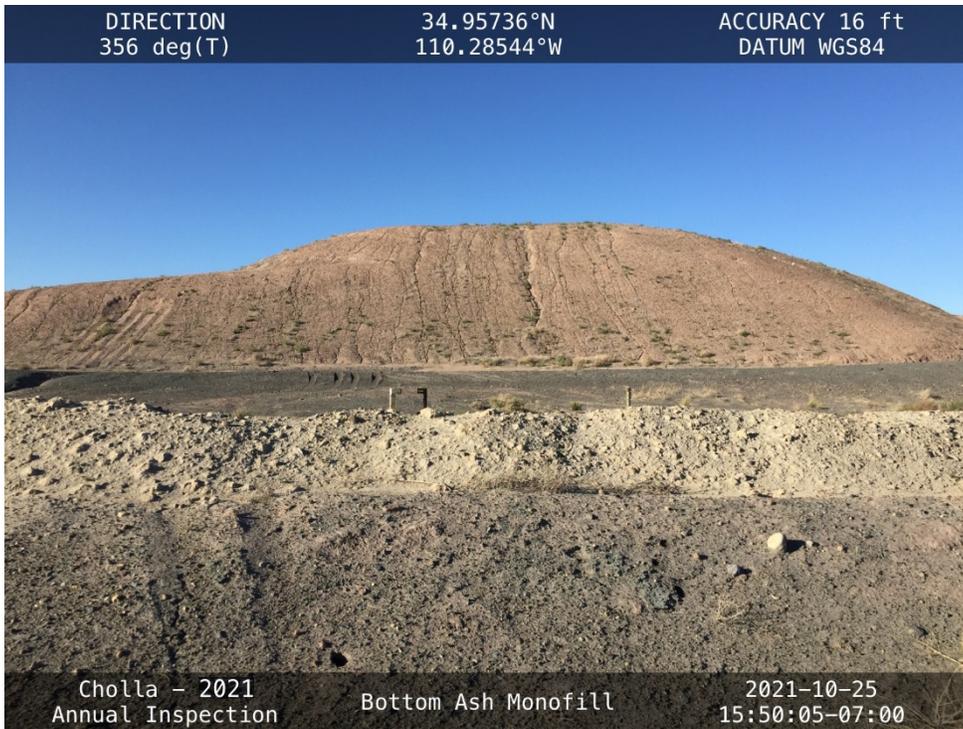
20211025-IMG_7107

The south end of the BAM, facing north from the Bottom Ash Dam.

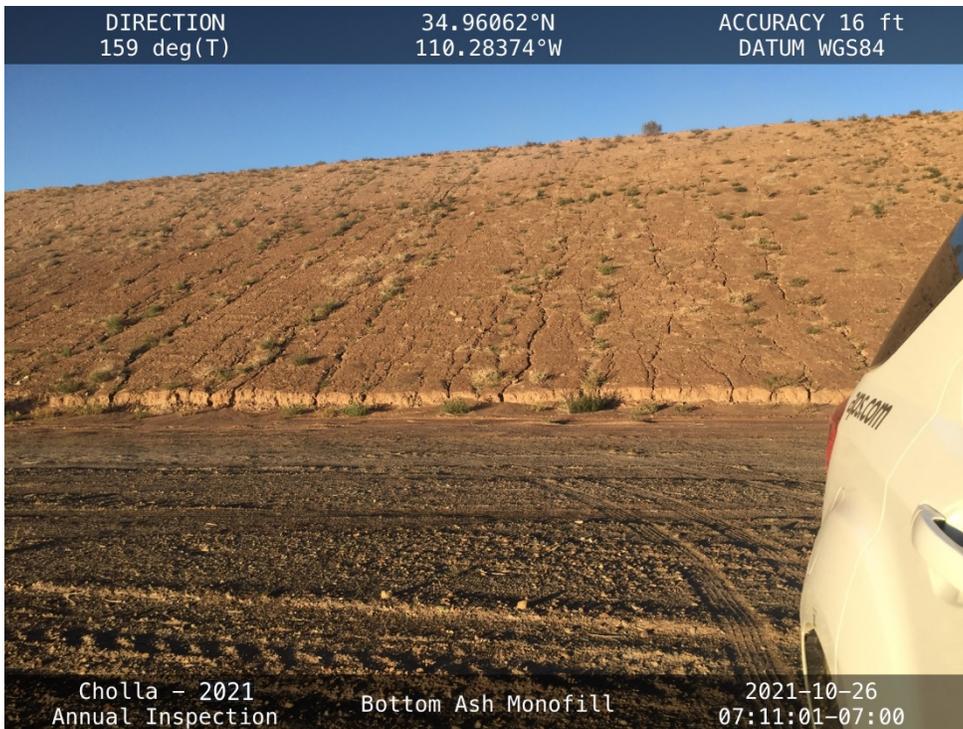
20211026-IMG_7216

Shallow erosion gullies along the eastern slope of the BAM, facing west.

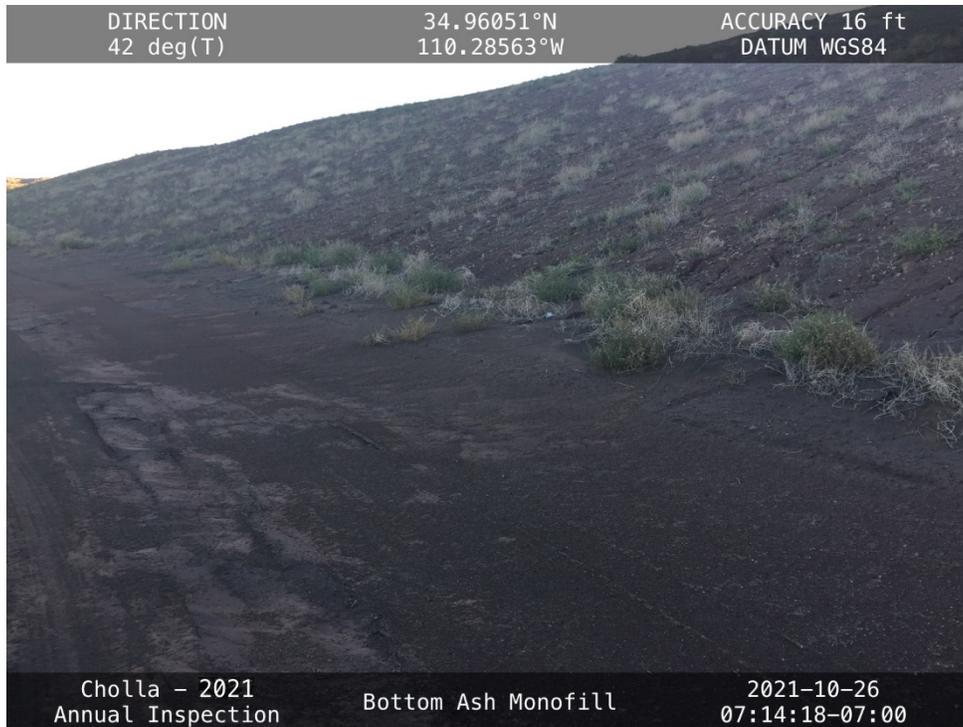
20211026-IMG_7218

The western toe of the BAM, facing north from the road near the middle of the slope.

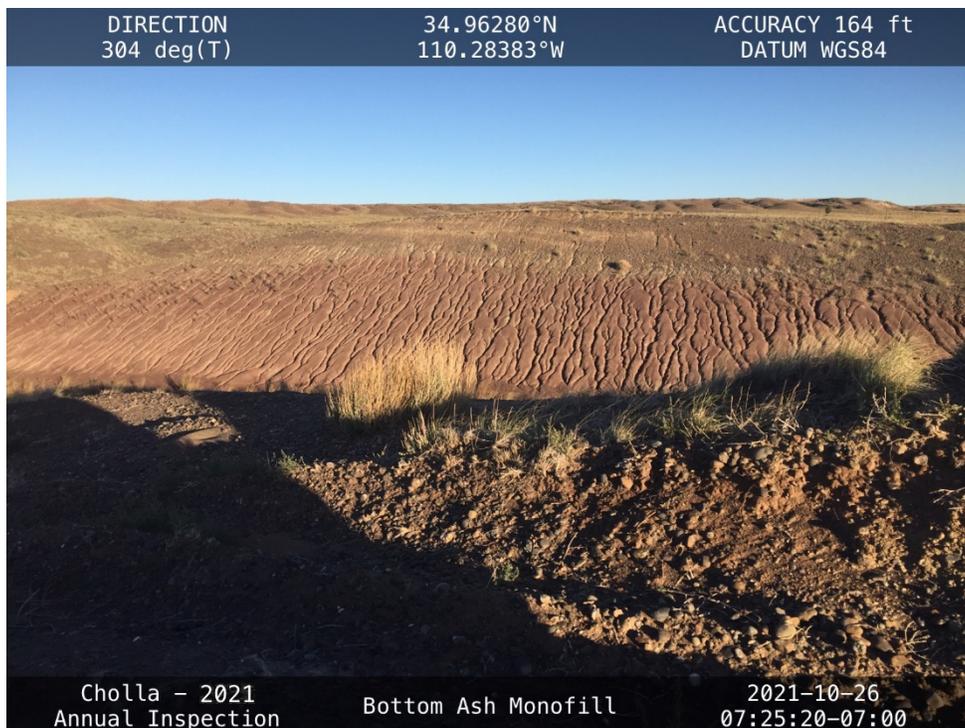
20211026-IMG_7234

Erosion rills along the slope of the stormwater diversion ditch on the north side of the BAM.

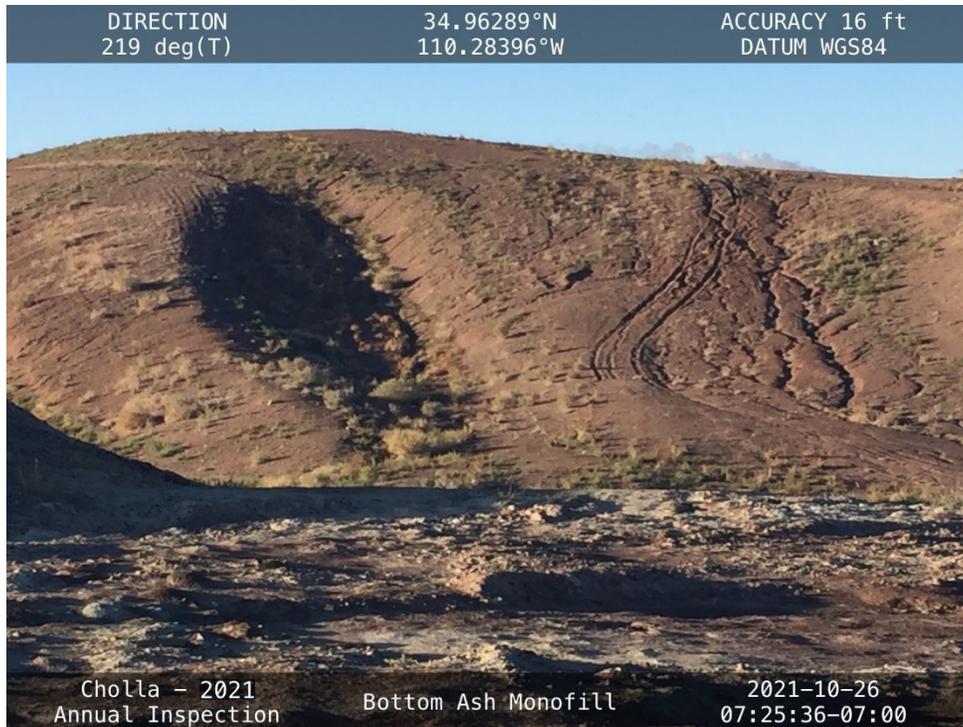
20211026-IMG_7236
The north side of the BAM.

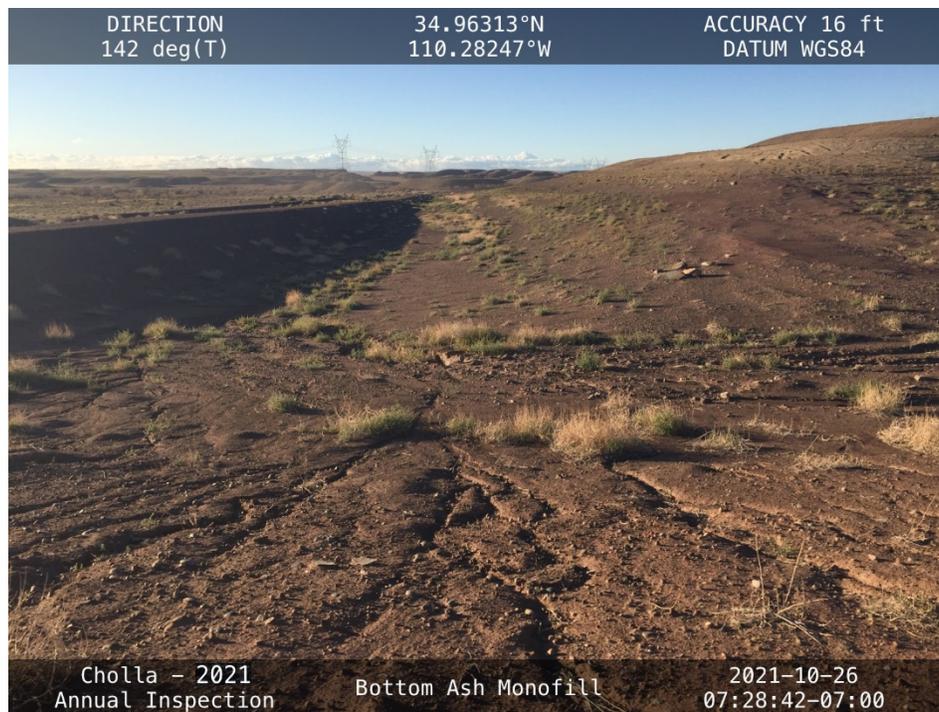
20211026-IMG_7239
The stormwater diversion ditch on the east side of the BAM, facing south from the north end.

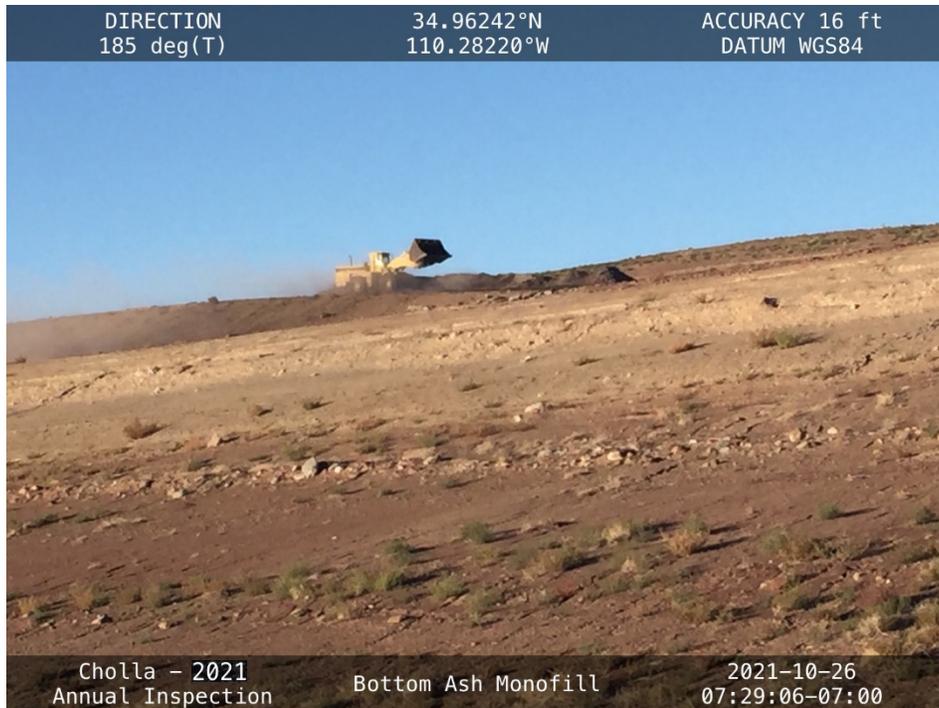
20211026-IMG_7241

A loader placing waste coal in the BAM and generating dust. Dust generation should be minimized during material placement.

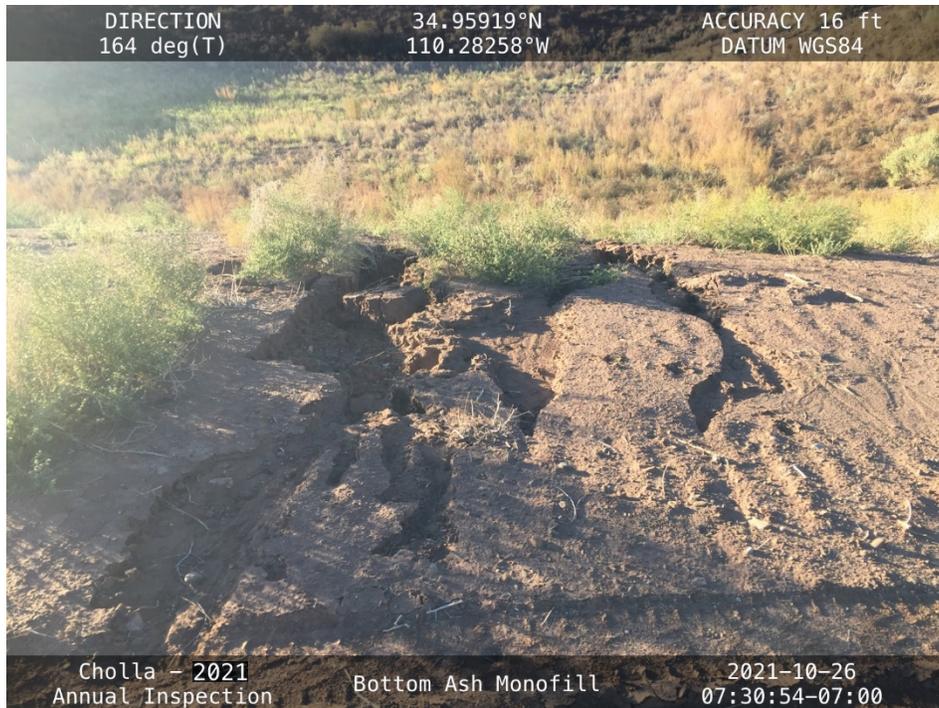
20211026-IMG_7248

Erosion gullies forming on the north side of the Stormwater Detention Basin.

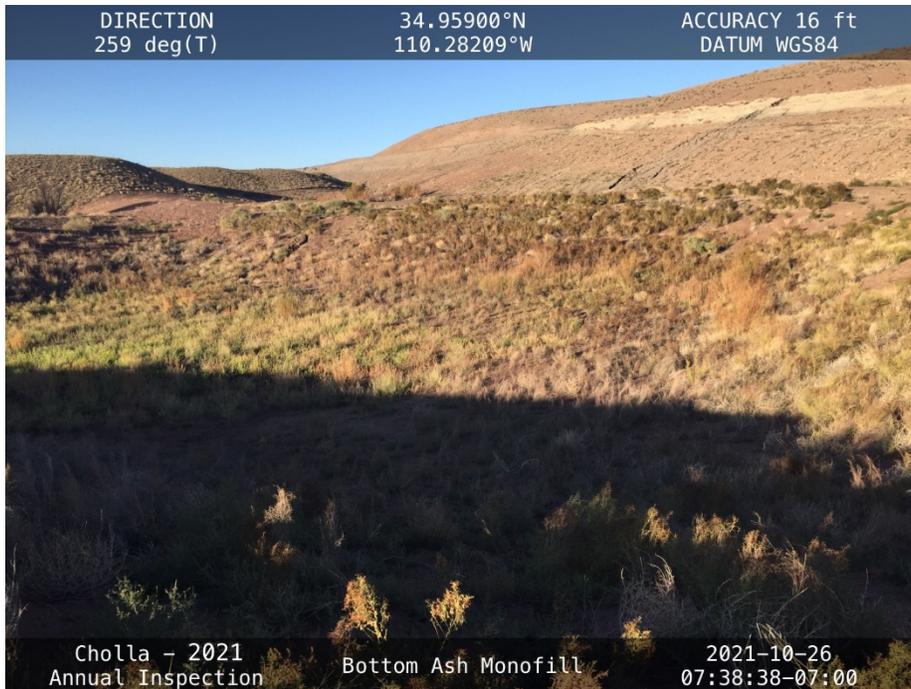
20211026-IMG_7265

The west side of the Stormwater Detention Basin and the southern end of the BAM, facing west from the east side of the Stormwater Detention Basin.

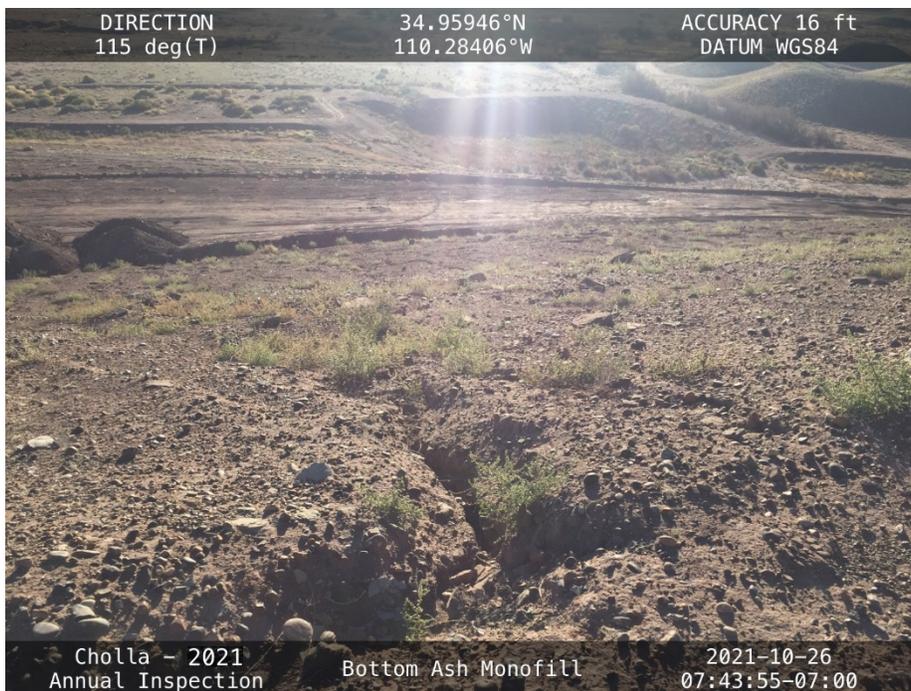
20211026-IMG_7267

An erosion rill on the eastern slope near the top of the Bottom Ash Monofill, facing east from the top of the BAM toward the Stormwater Detention Pond.

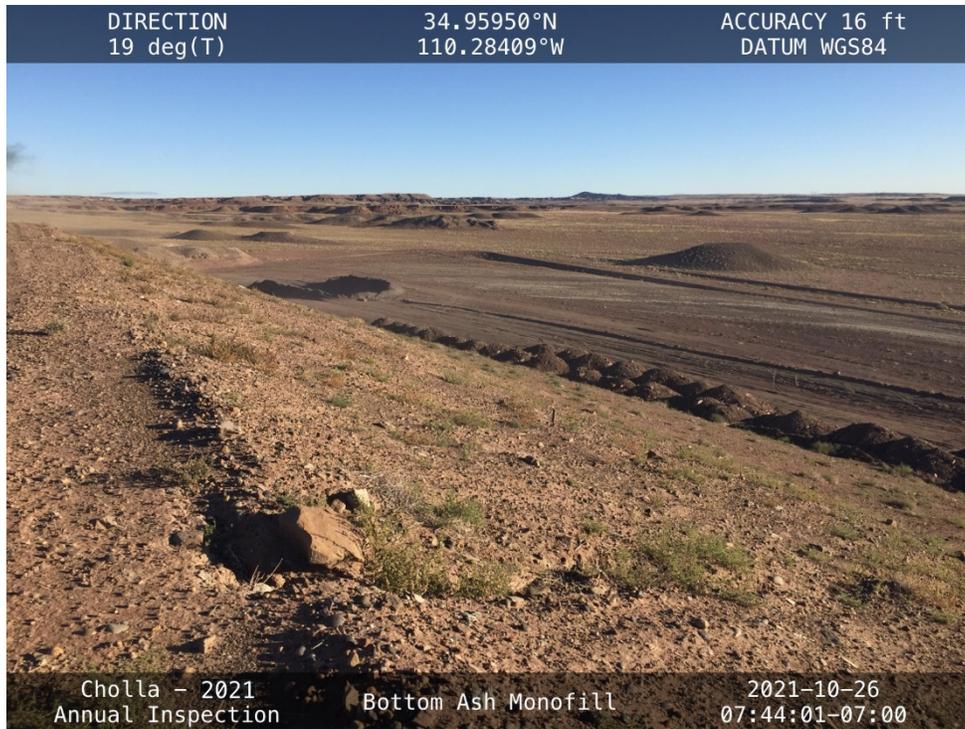
20211026-IMG_7268

The eastern portion of the Bottom Ash Monofill, facing north from the top of the Monofill.

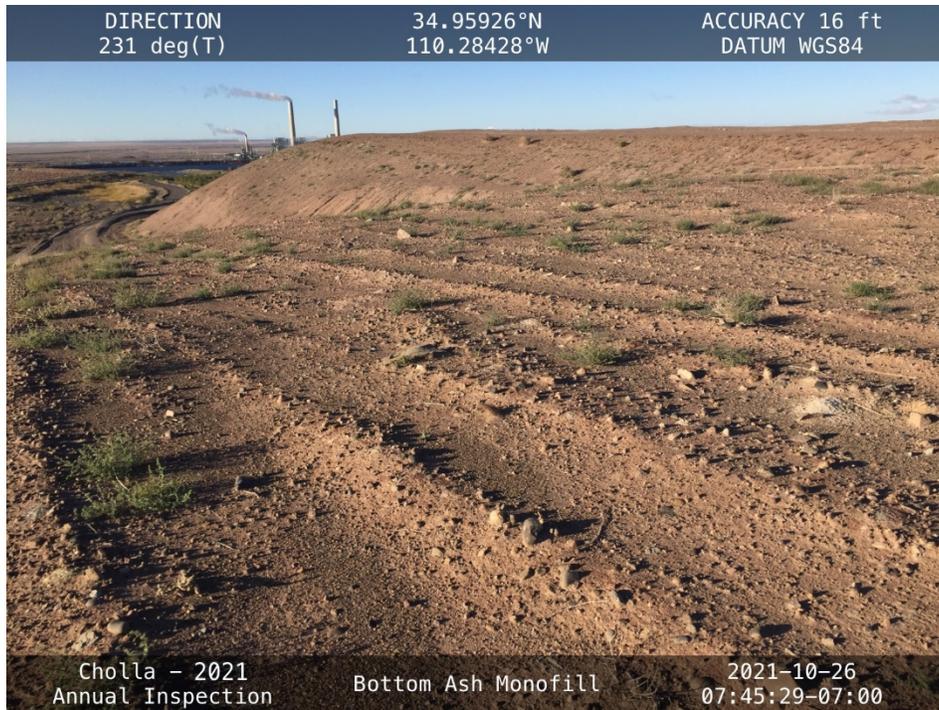
20211026-IMG_7275

Cover soil on the surface of the BAM, facing southwest along the top of the CCR unit.

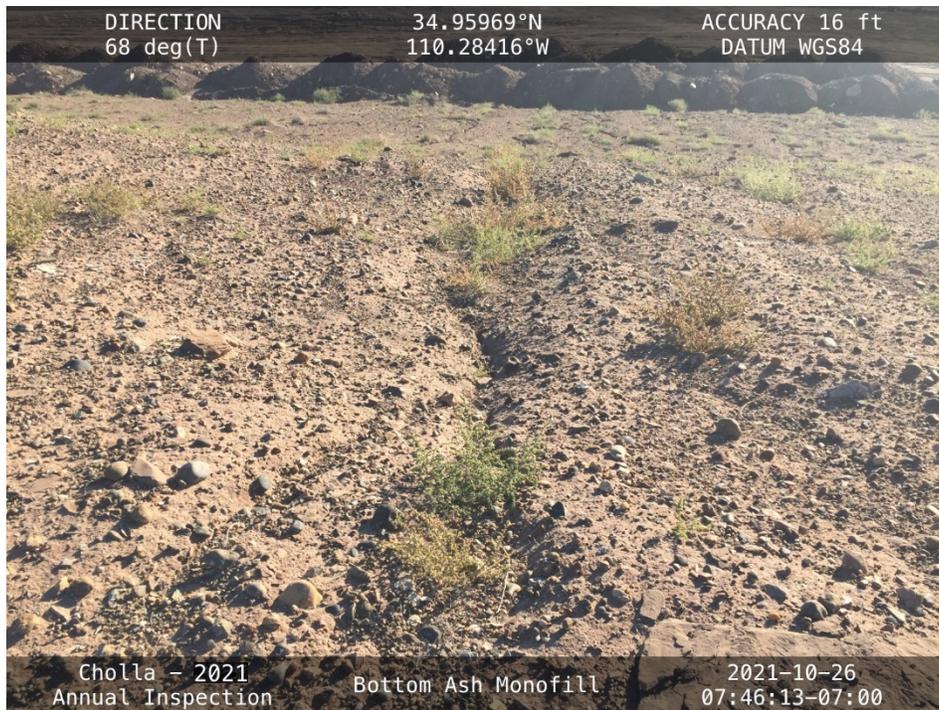
20211026-IMG_7275

An incipient erosion rill on the eastern slope near the top of the BAM, relatively unchanged since the 2020 inspection (IMG_2894).

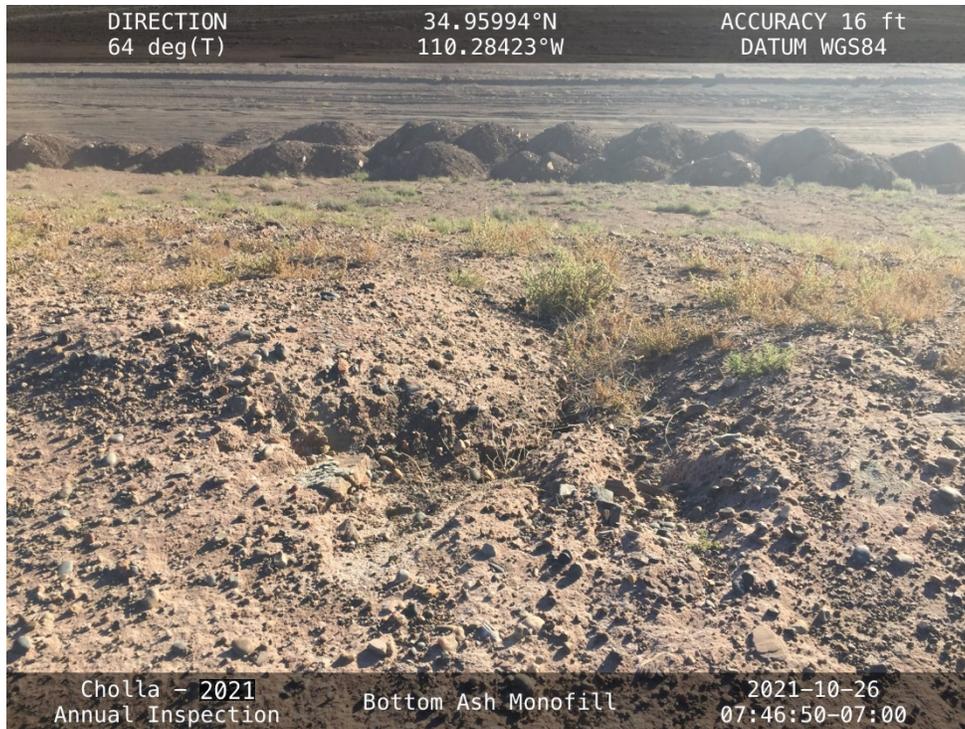
20211026-IMG_7282

An incipient erosion rill on the eastern slope near the top of the BAM.

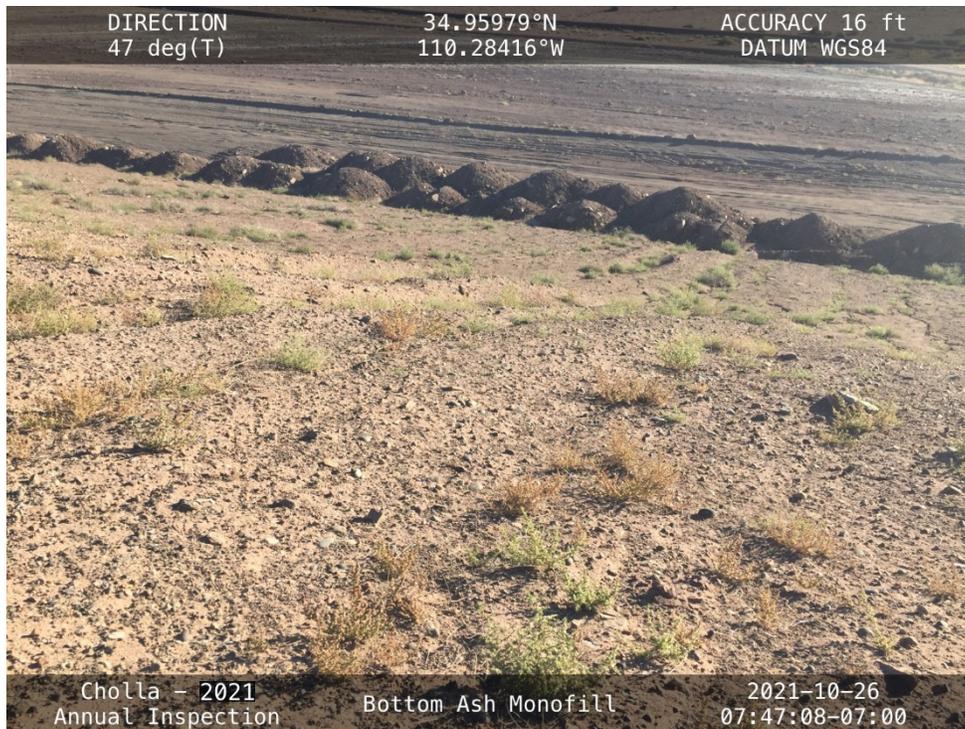
20211026-IMG_7283

An incipient erosion rill on the eastern slope near the top of the BAM.
