CHOLLA POWER PLANT Fly Ash Dam, Bottom Ash Dam, and Bottom Ash Monofill

Annual CCR Impoundment and Landfill Inspection Report

2023

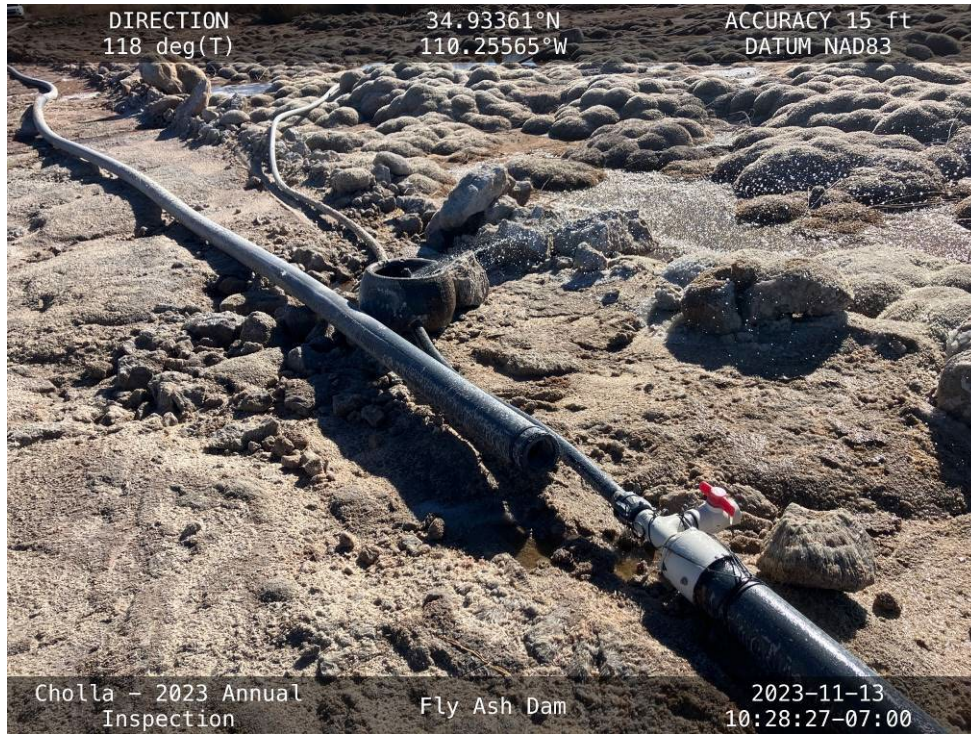
20231113 – IMG_1386

A sprinkler installed on the higher-elevation salt to accelerate water removal via evaporation.

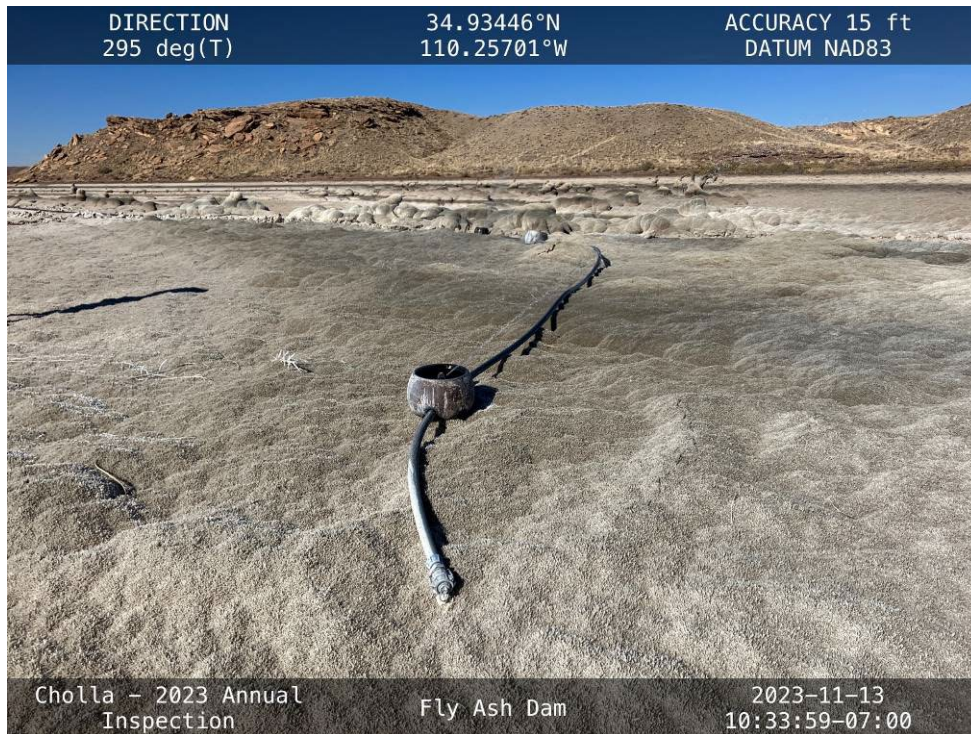
20231113 – IMG_1391

A sprinkler installed on the higher-elevation salt to accelerate water removal via evaporation.

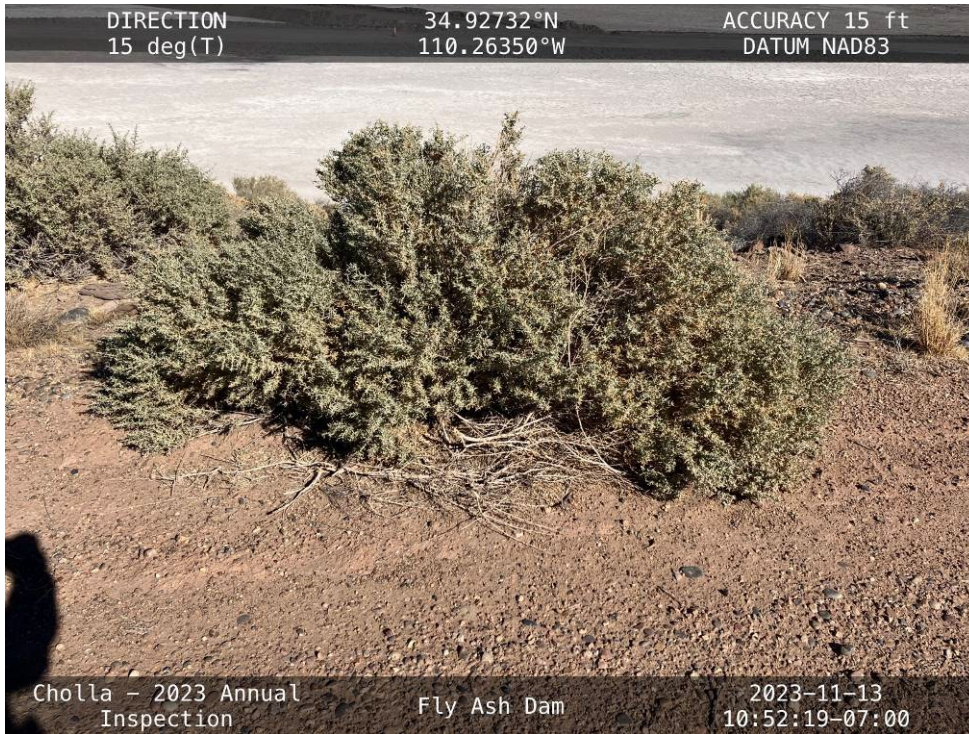
20231113 – IMG_1397

Vegetation to be removed from the upstream shoulder of the South Embankment crest.

- viii. Continue removing excessive natural vegetation in accordance with APS’s preferred protocol, the NMOSE “*Vegetation Management on Dams*” (2011) document.
- ix. The weekly inspection reports for the period between October 1, 2022, and September 30, 2023, were reviewed and indicate the following:
 - a. Erosion on the dam crest was noted as requiring repair starting with the 6/1/2023 weekly inspection. APS scheduled an earthwork contractor to complete the repair.
 - b. Animal burrows on the downstream slope were noted as requiring monitoring starting with the 6/1/2023 weekly inspection.

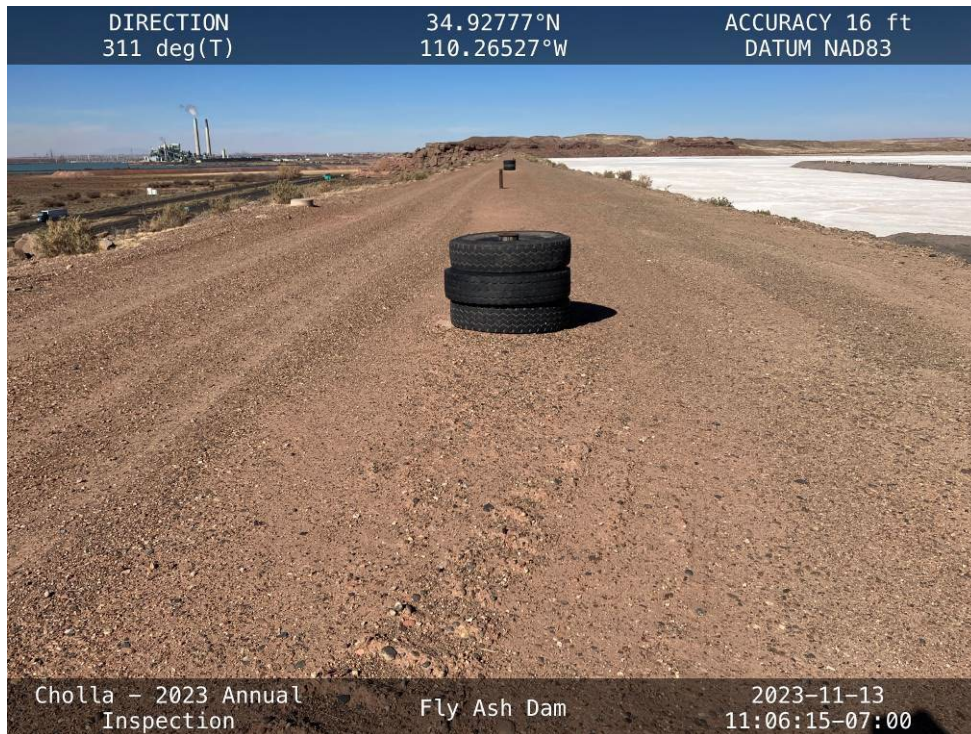
20231113 – IMG_1411

The crest of the West Embankment, facing northwest. Tires placed around the piezometer for protection.

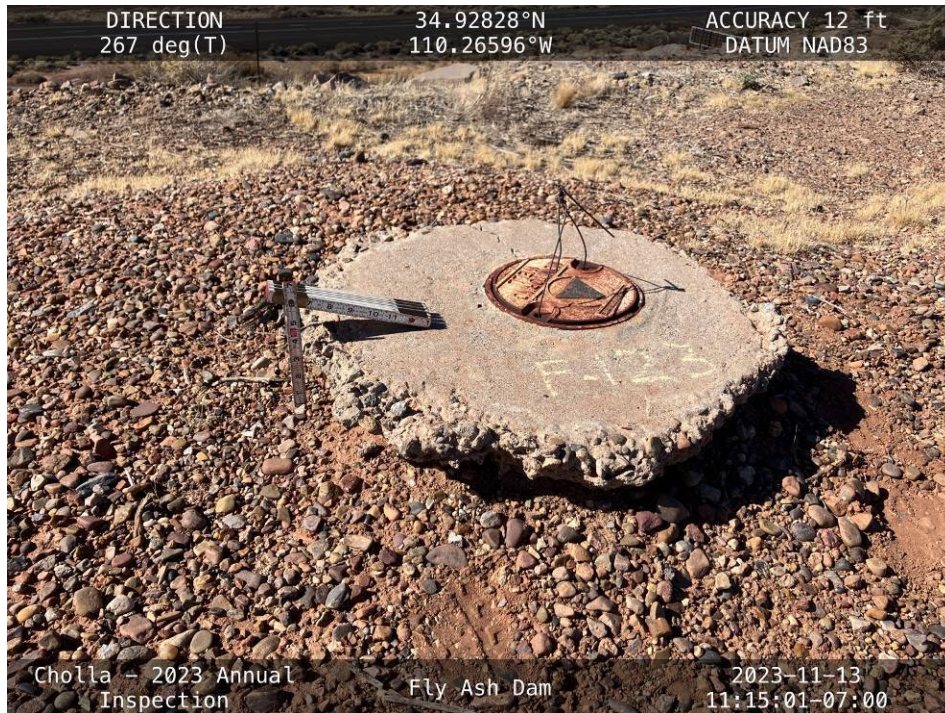
20231113 – IMG_1430

Erosion around piezometer F-123 on the downstream shoulder of the West Embankment crest.

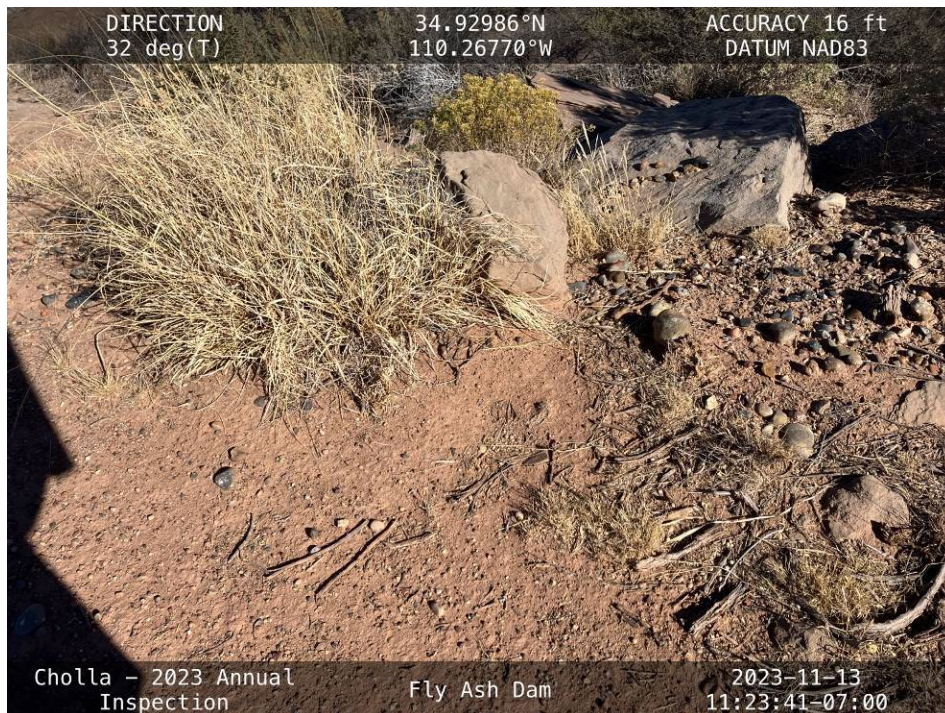
20231113 – IMG_1442

The area with a 3.5-inch-deep erosion hole observed during the 2022 inspection. No hole observed during this inspection.

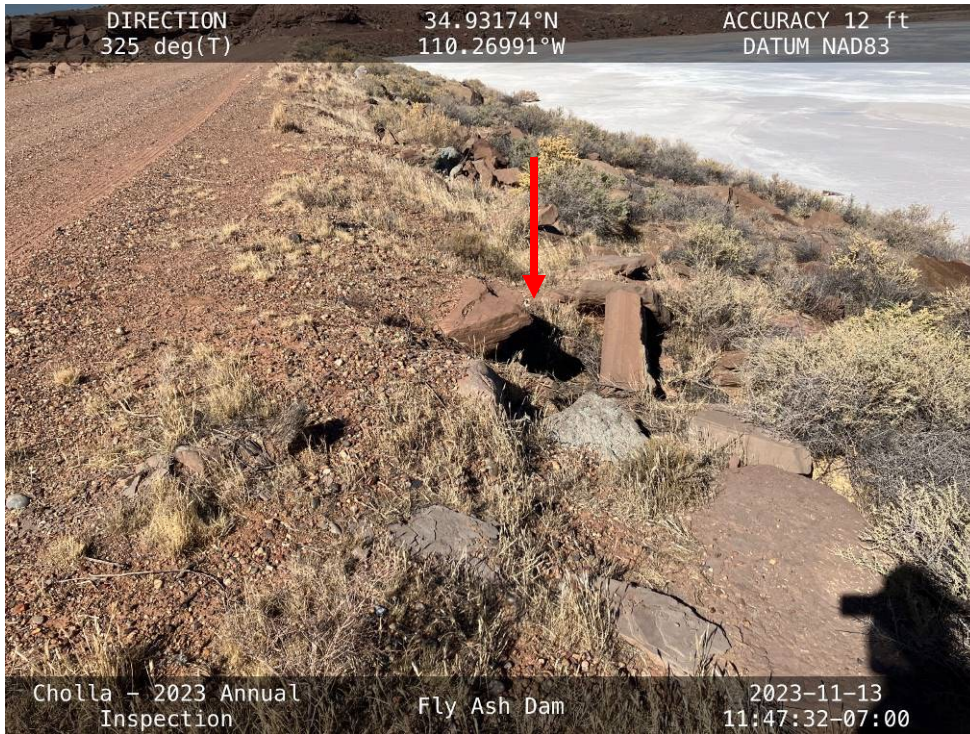
20231113 – IMG_1472

Riprap overhanging the gap shown in IMG_1469, as seen from the upstream shoulder.

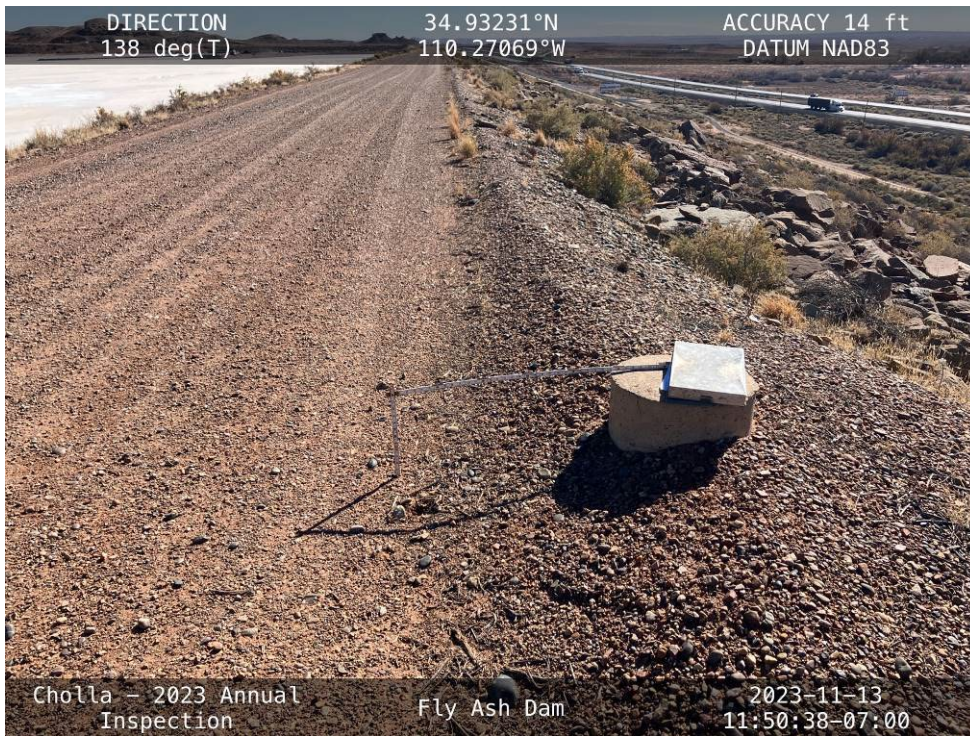
20231113 – IMG_1474

Settlement monument M-2 on the crest of the West Embankment.

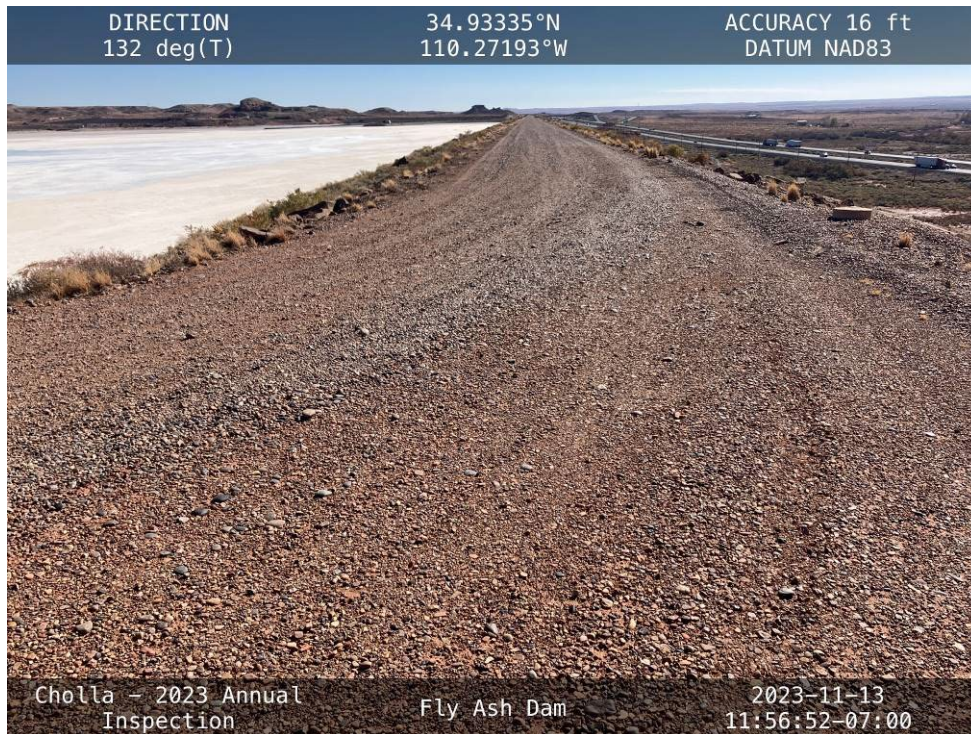
20231113 – IMG_1477

The crest of the Fly Ash Dam, facing southeast from the Right Abutment.

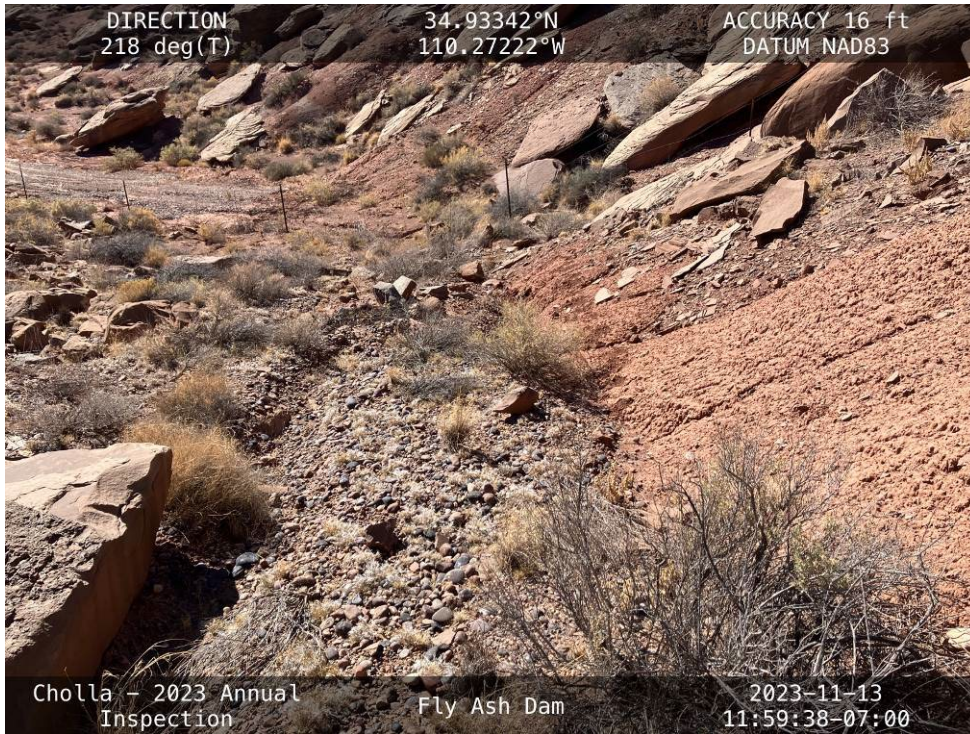
20231113 – IMG_1485

Erosion on the downstream side of the Right Abutment contact.

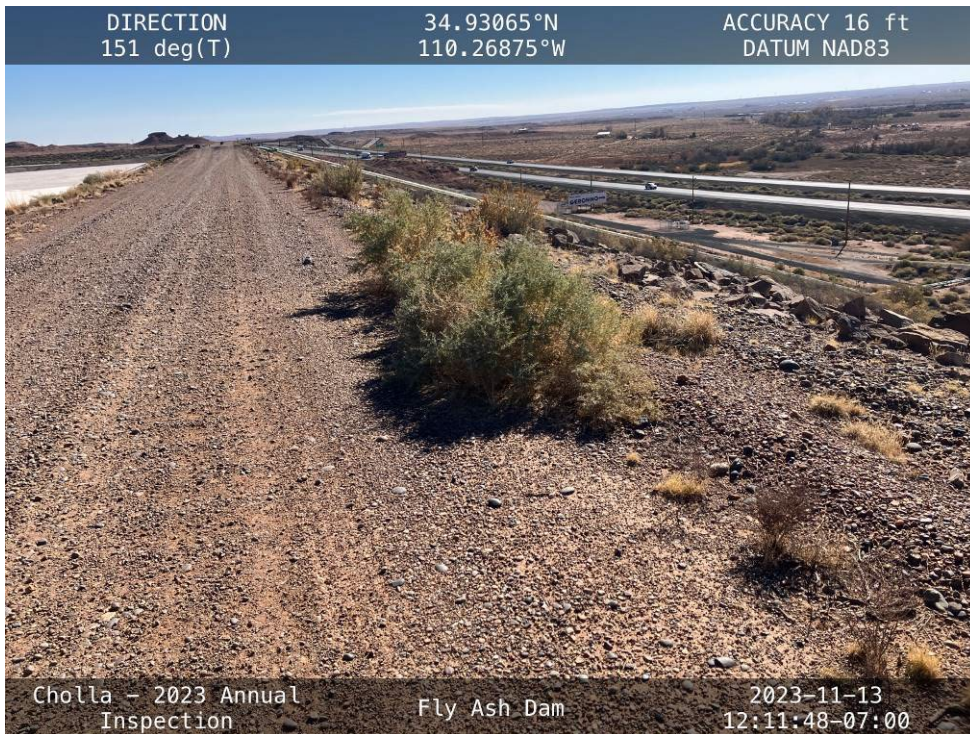
20231113 – IMG_1490

Vegetation to be removed from the West Embankment downstream shoulder.

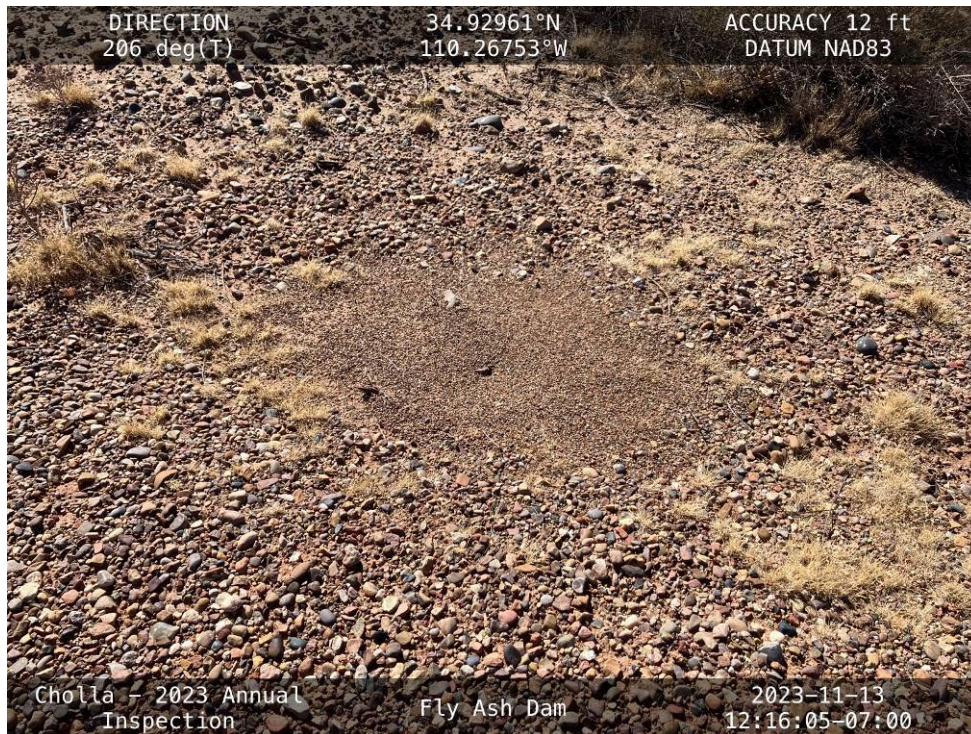
20231113 – IMG_1496

An ant hill on the West Embankment downstream shoulder.

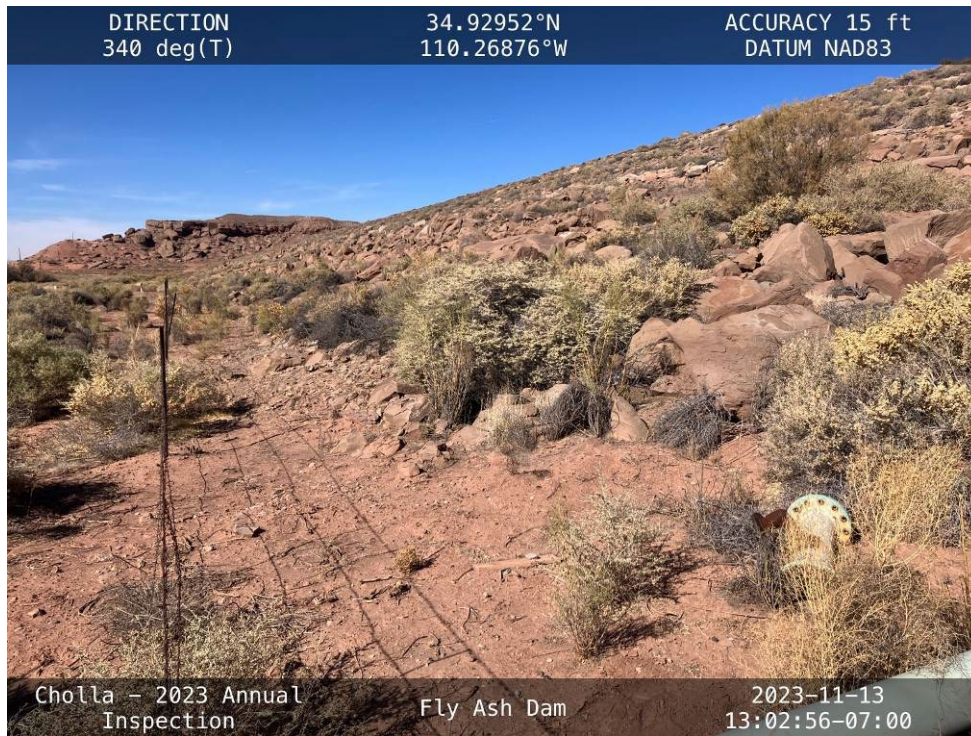
20231113 – IMG_1575
Missing pipe supports along the inlet lines.

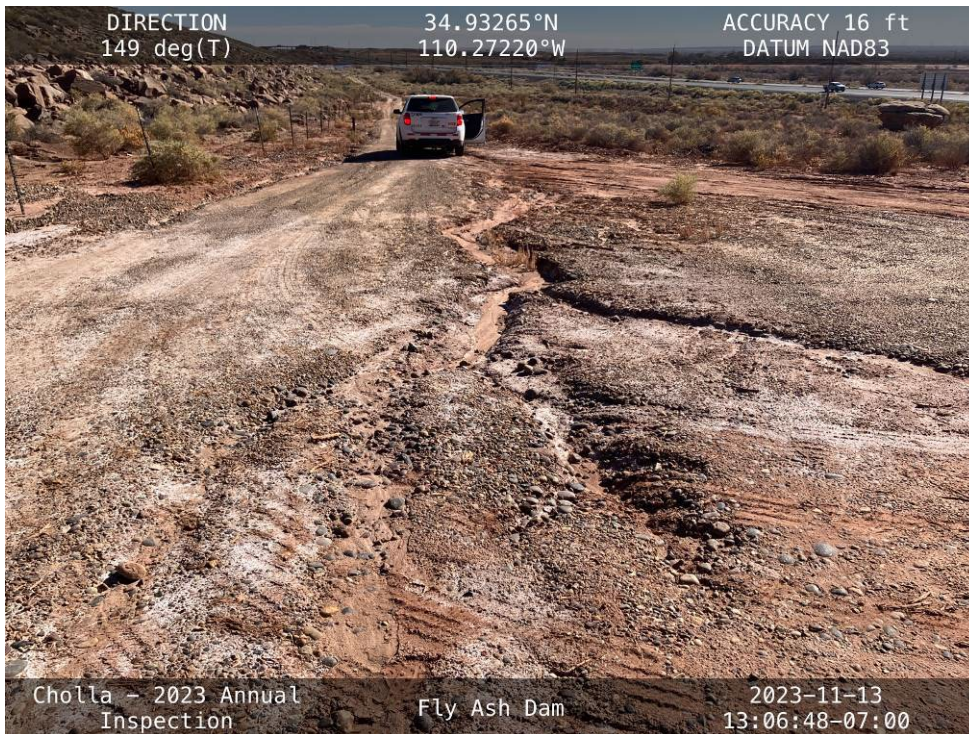
20231113 – IMG_1589

Erosion on the slope coming down from the Right Abutment groin.

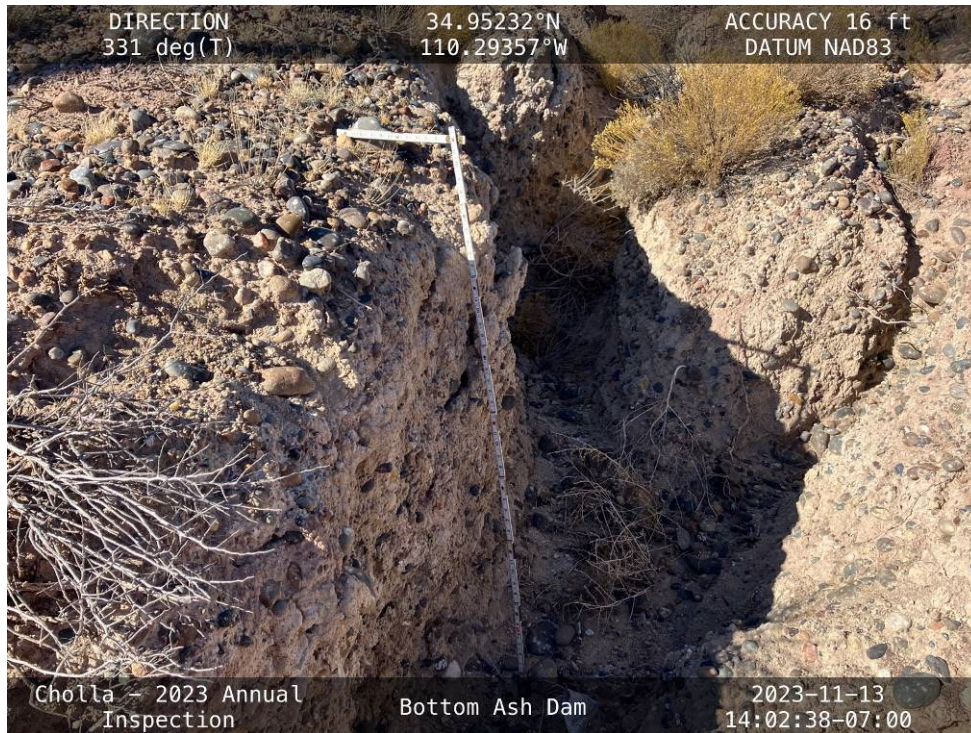
20231113 – IMG_1604

4 feet of erosion in the downstream groin of the Right Abutment.

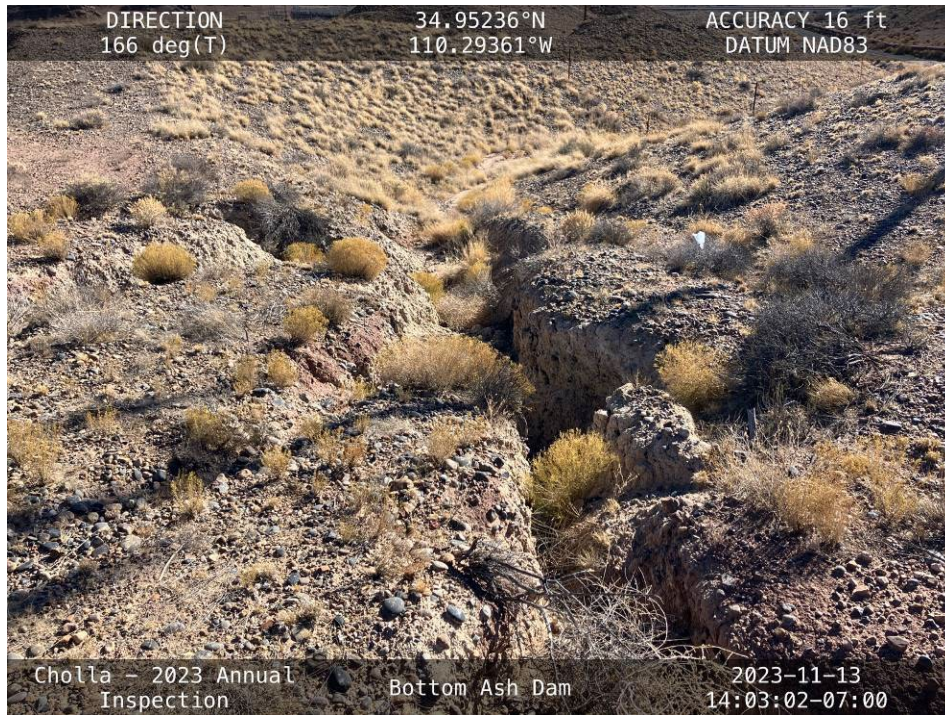
20231113 – IMG_1605

Erosion in the downstream groin of the Right Abutment, facing south from the abutment contact, more extensive than during the 2022 inspection.

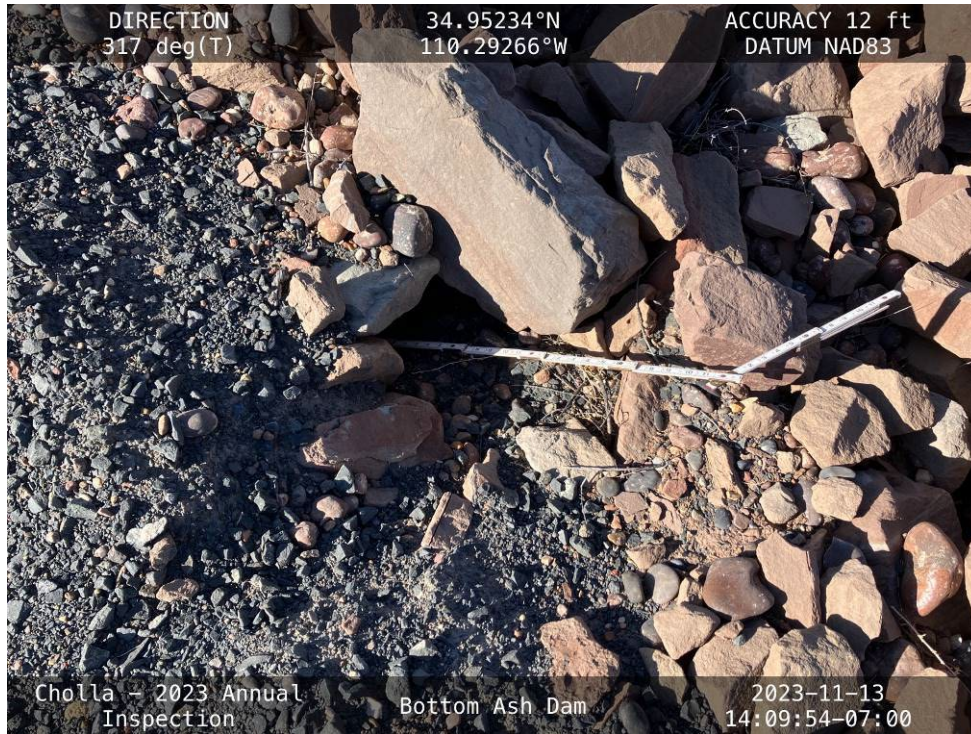
20231113 – IMG_1612

10 inches of erosion on the upstream side of the South Embankment shoulder.

10) Continue to monitor the erosion around the siphon line encasements and on the shoulder of the crest.	Repair erosion if the eroded depth exceeds 1 foot.

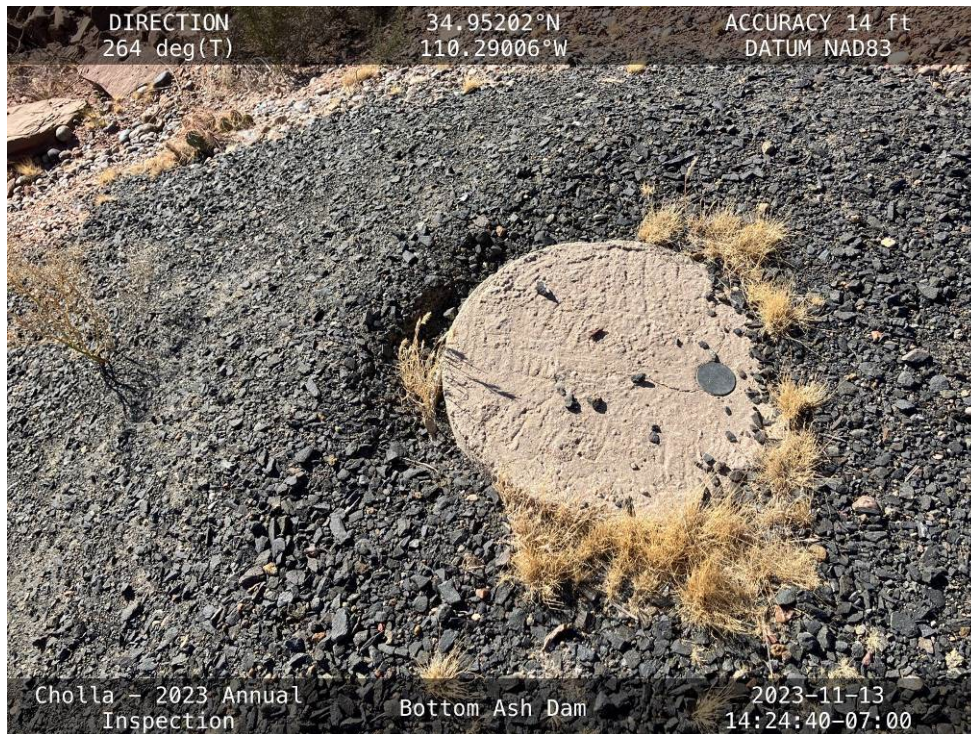
20231113 – IMG_1628

The support material on the downstream side of M-13 separating from the concrete.

12) The downstream section of support material is separating from the concrete at Settlement Monument M-13.	Monitor M-13 and repair the section of support material that is separating from the concrete only if a series of deviant readings are recorded for the horizontal or vertical measurements. Record the position of M-13 via GPS immediately before and after any repairs.

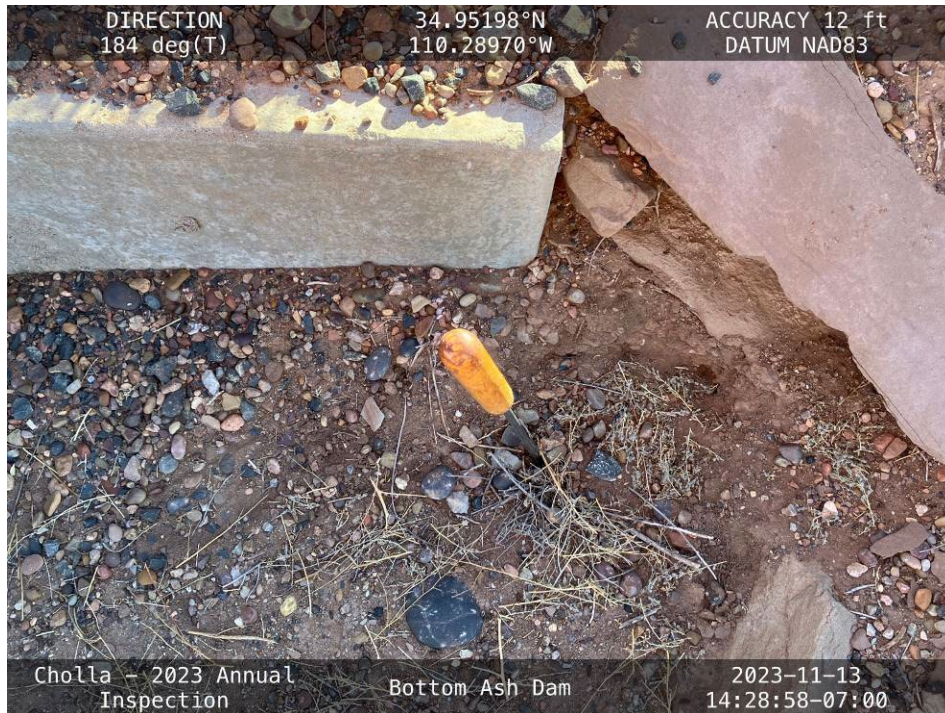
20231113 – IMG_1644

A hole adjacent to the concrete on the west side of the central siphon line, filled in since the 2022 inspection, on the upstream slope.

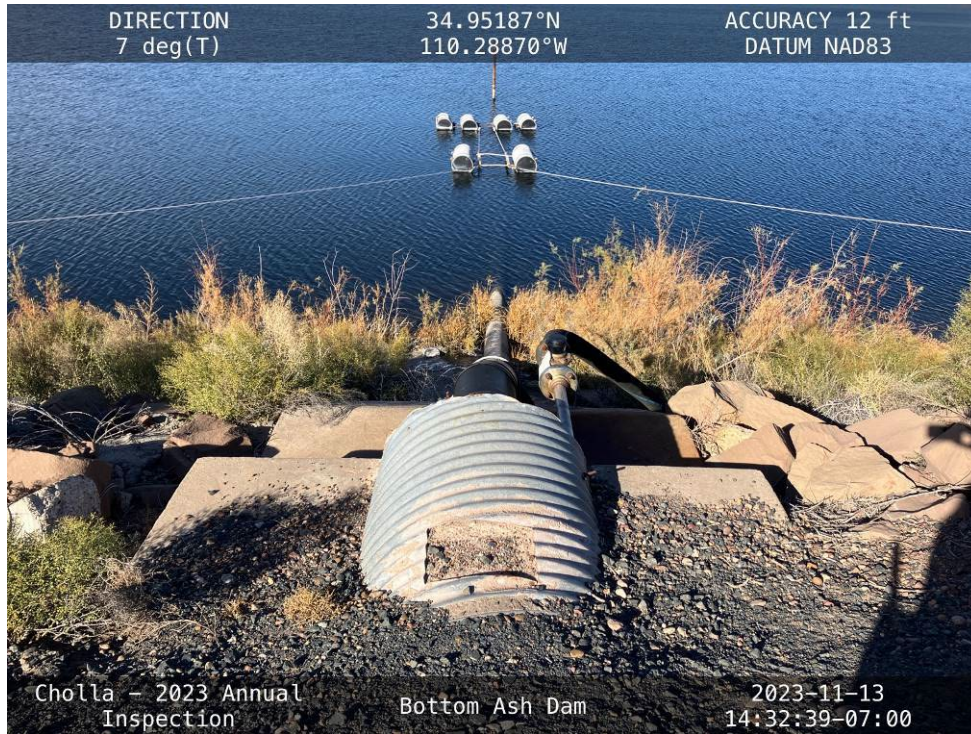
20231113 – IMG_1645

The upstream slope and crest along the eastern half of the South Embankment, with vegetation to be removed.

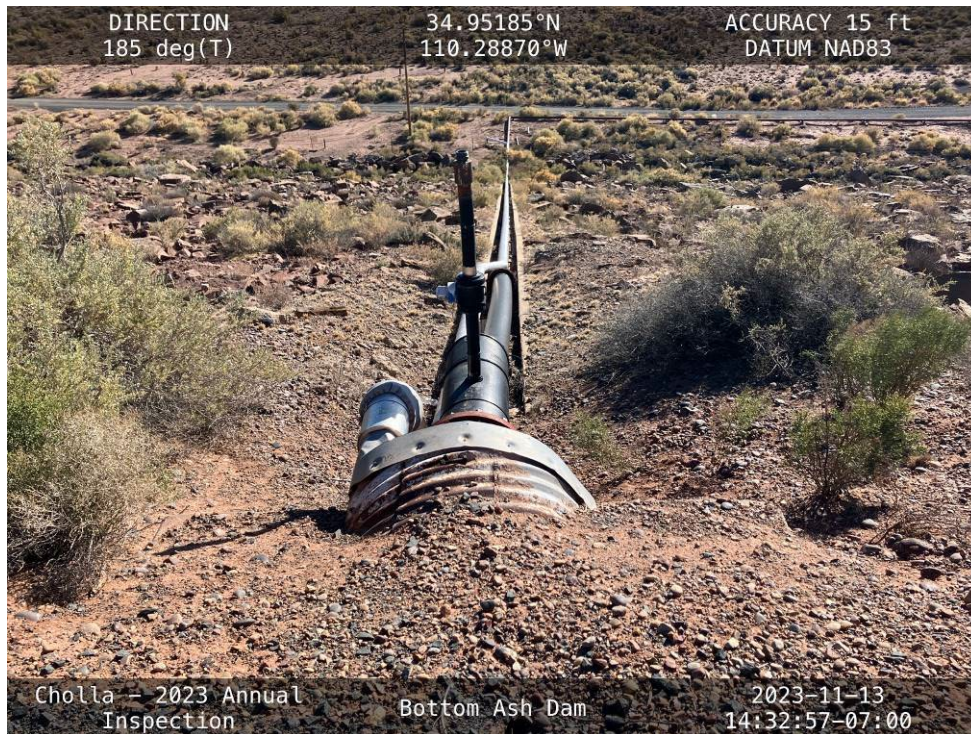
20231113 – IMG_1647

The eastern siphon line along the upstream slope of the South Embankment.

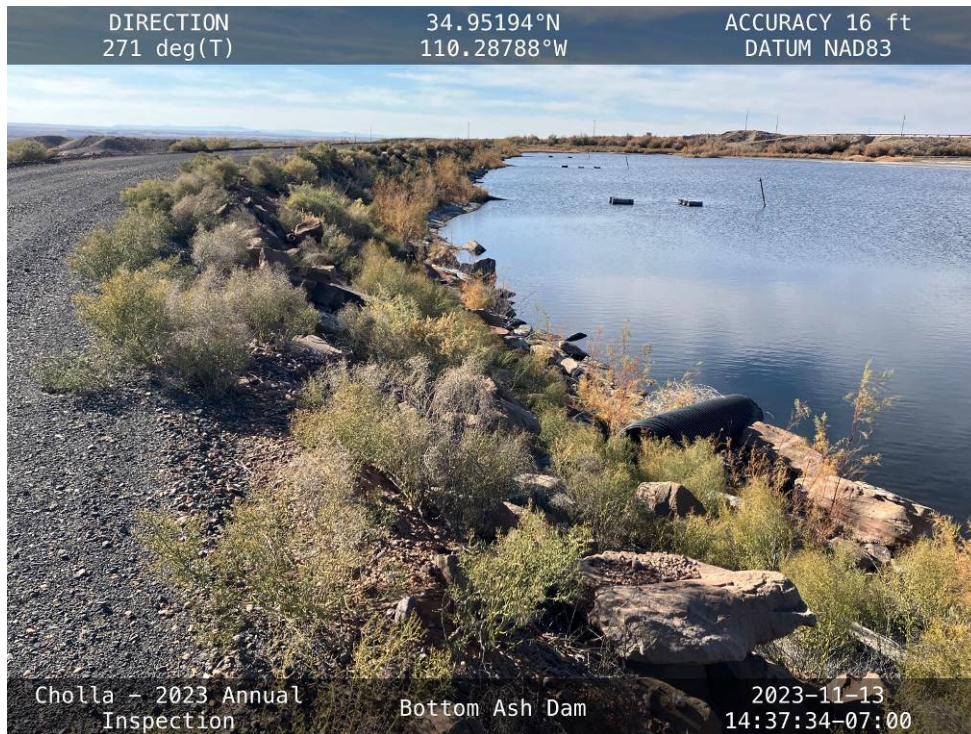
20231113 – IMG_1661

The upstream slope at the southern end of the East Embankment, facing north.

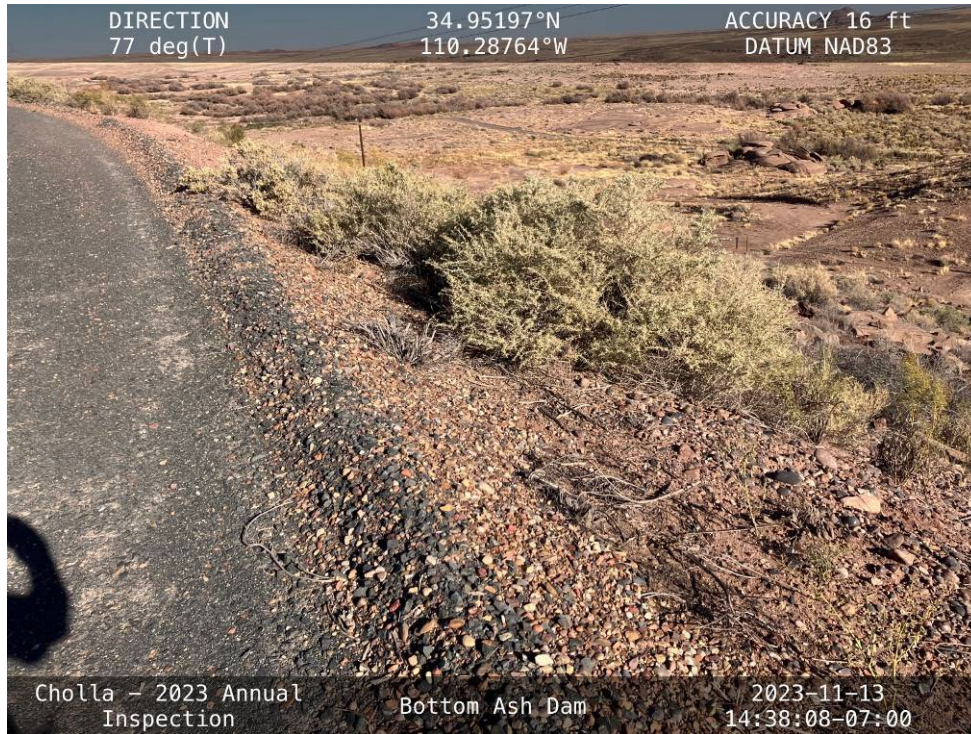
20231113 – IMG_1663

The upstream slope of the South Embankment, facing west.

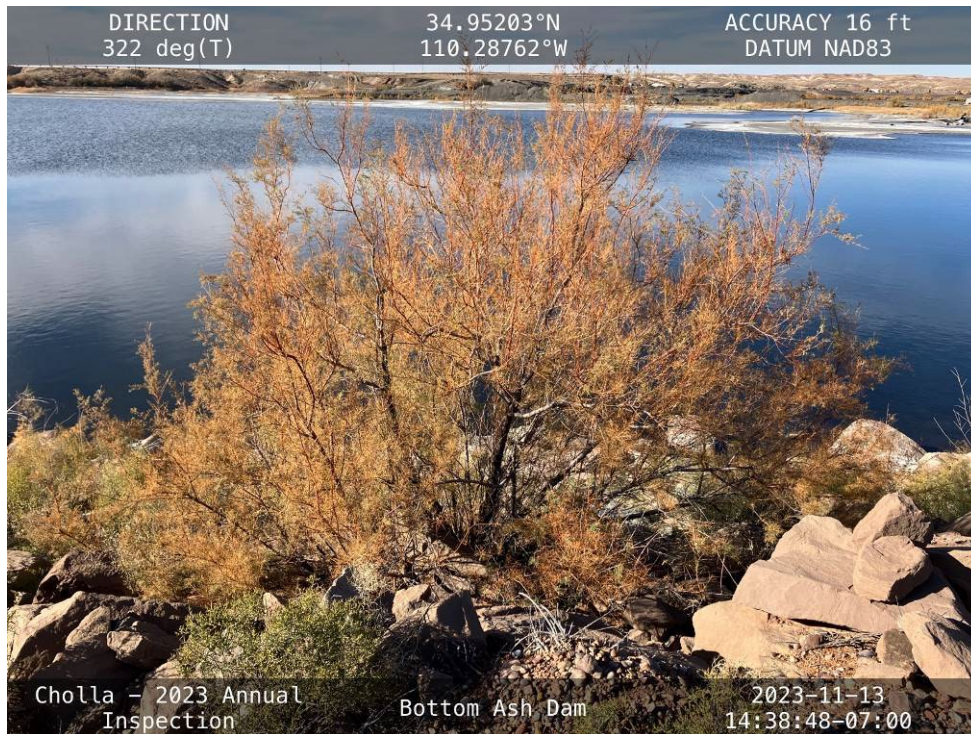
20231113 – IMG_1664

Vegetation to be removed along the downstream slope of the South Embankment.

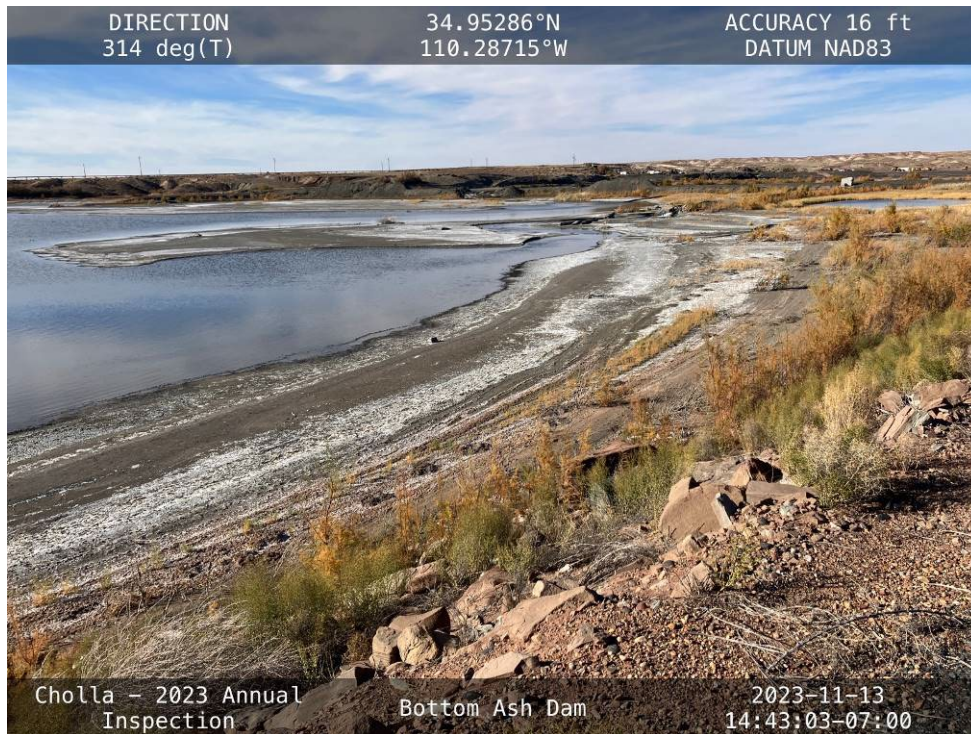
20231113 – IMG_1675

The downstream slope of the East Embankment, facing north from the southern end.

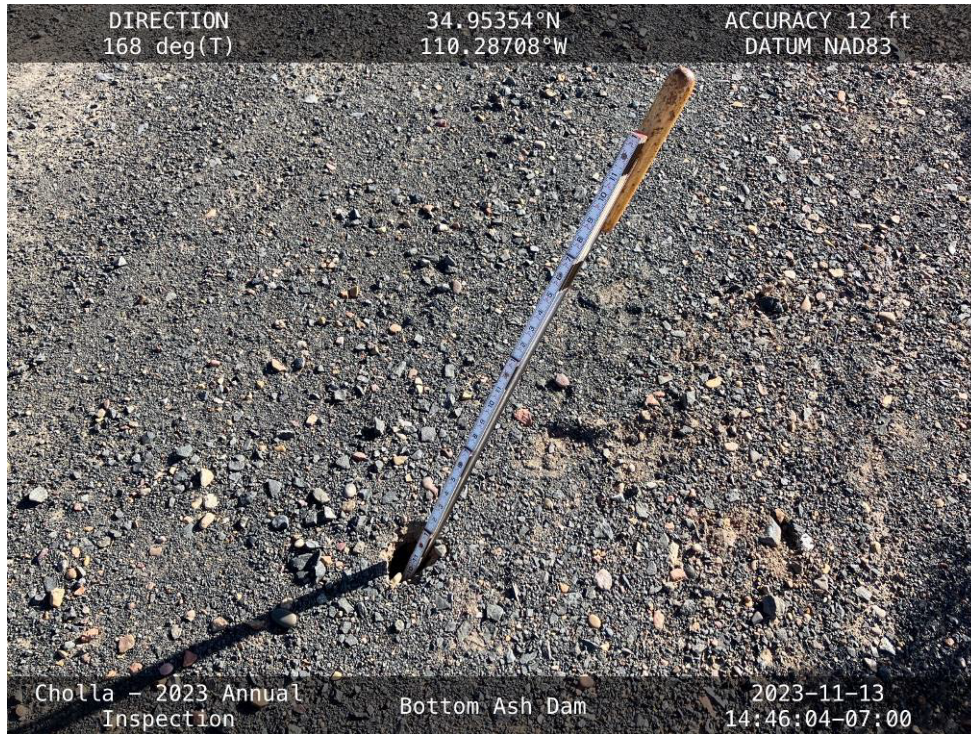
20231113 – IMG_1677

The Divider Dike in the reservoir and vegetation on the upstream side of the East Embankment.

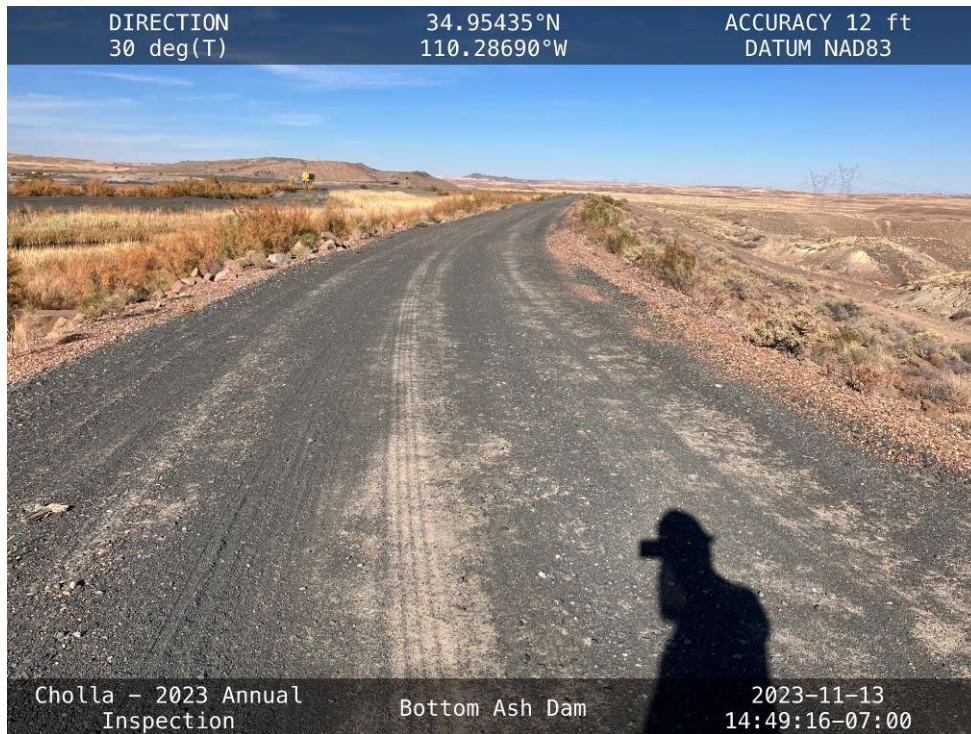
20231113 – IMG_1679

A hole in the crest of the East Embankment, approximately 13 inches deep.

Action Item	Action Status
<p>1) Monitor the crest for erosion holes during weekly inspections. Record the location and sizes of erosion holes during the weekly inspections.</p> <p>There is a 21-inch-deep hole adjacent to the concrete on the west side of the central siphon line.</p>	<p>Establish a regular schedule (e.g., semi-annually) to remediate holes identified in the crest. Establish a procedure to track the appearance of new holes and the disappearance of old holes. NOTE: This will always be an ongoing maintenance activity.</p> <p>Repair the 21-inch-deep hole.</p>
<p>2) Repair the 4-foot-deep erosion in the downstream groin of the Right Abutment.</p>	<p>The erosion should be restored with compacted, well-graded fill at the direction of the APS geotechnical engineer.</p>
<p>3) Repair the erosion gullies at the downstream slope of the East Embankment and the erosion in the downstream groin of the Right Abutment.</p>	<p>Repair erosion that has exceeded 1 foot in depth.</p>

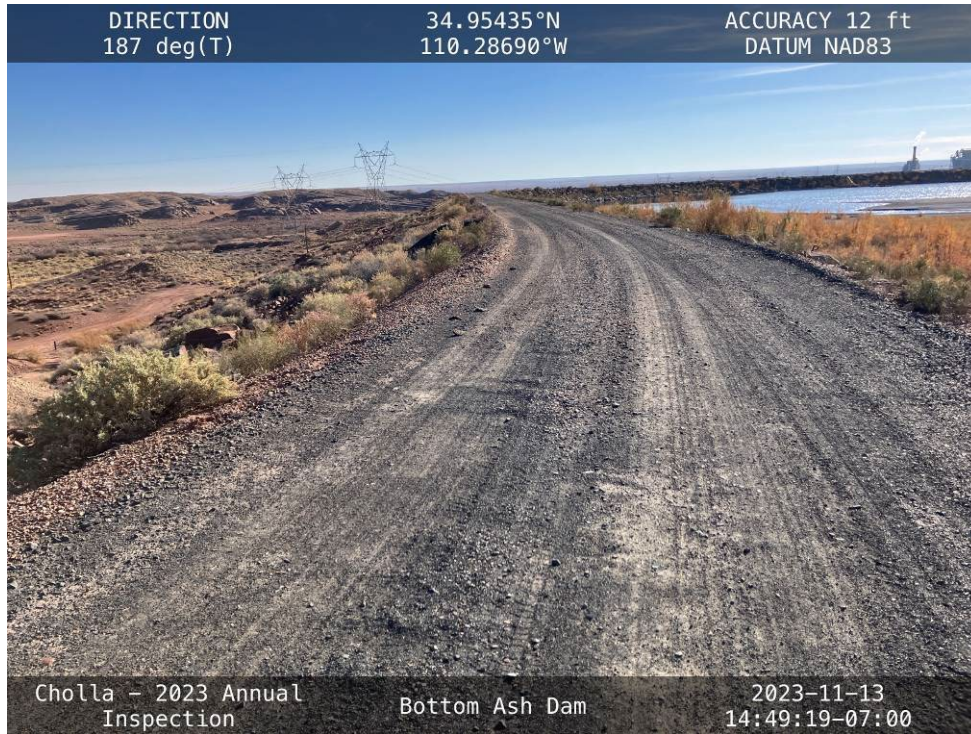
20231113 – IMG_1680

The northern half of the East Embankment crest, facing northeast.

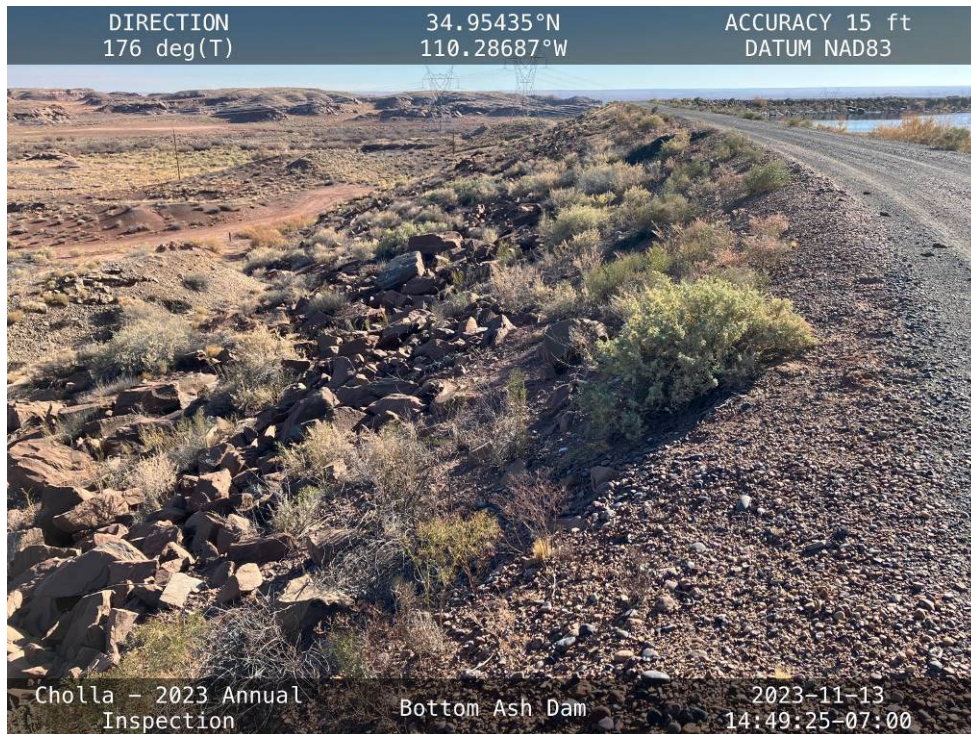
20231113 – IMG_1681

The southern half of the East Embankment crest, facing southwest.

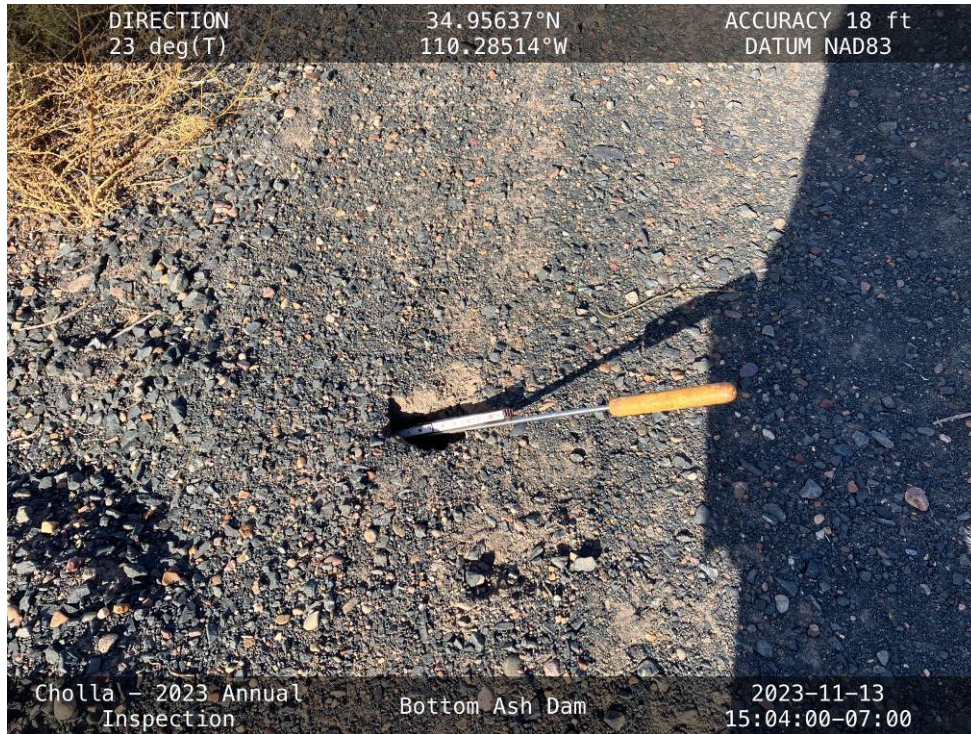
20231113 – IMG_1702

Depressions on the upstream slope of the East Embankment and vegetation to be removed. The ruler is 19 inches long.
