CHOLLA POWER PLANT Fly Ash Dam, Bottom Ash Dam, and Bottom Ash Monofill

Annual CCR Impoundment and Landfill Inspection Report

2023

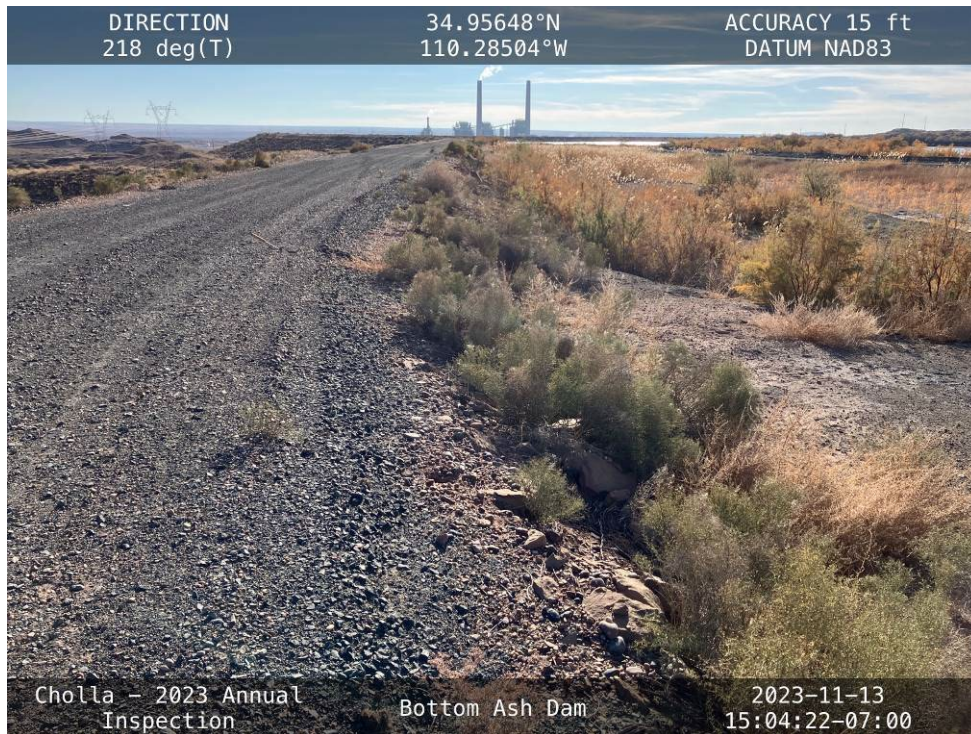
20231113 – IMG_1703

A 22-inch-long erosion hole on the upstream half of the East Embankment crest.

Action Item	Action Status
<p>1) Monitor the crest for erosion holes during weekly inspections. Record the location and sizes of erosion holes during the weekly inspections.</p> <p>There is a 21-inch-deep hole adjacent to the concrete on the west side of the central siphon line.</p>	<p>Establish a regular schedule (e.g., semi-annually) to remediate holes identified in the crest. Establish a procedure to track the appearance of new holes and the disappearance of old holes. NOTE: This will always be an ongoing maintenance activity.</p> <p>Repair the 21-inch-deep hole.</p>
<p>2) Repair the 4-foot-deep erosion in the downstream groin of the Right Abutment.</p>	<p>The erosion should be restored with compacted, well-graded fill at the direction of the APS geotechnical engineer.</p>
<p>3) Repair the erosion gullies at the downstream slope of the East Embankment and the erosion in the downstream groin of the Right Abutment.</p>	<p>Repair erosion that has exceeded 1 foot in depth.</p>

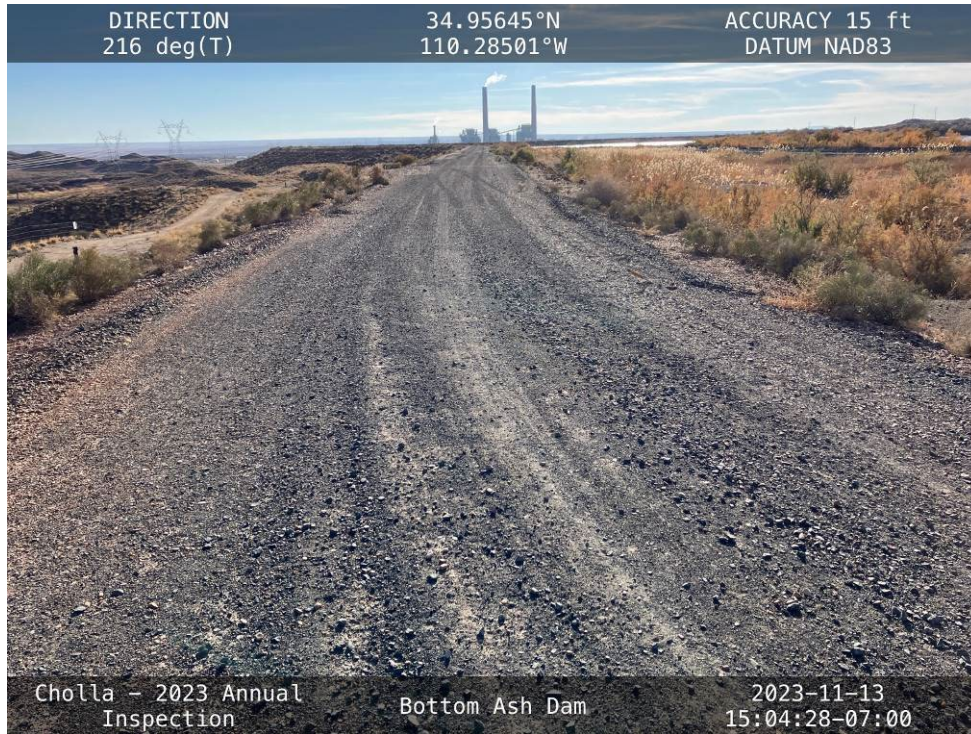
20231113 – IMG_1704

The upstream slope of the East Embankment at the Left Abutment, facing southwest.

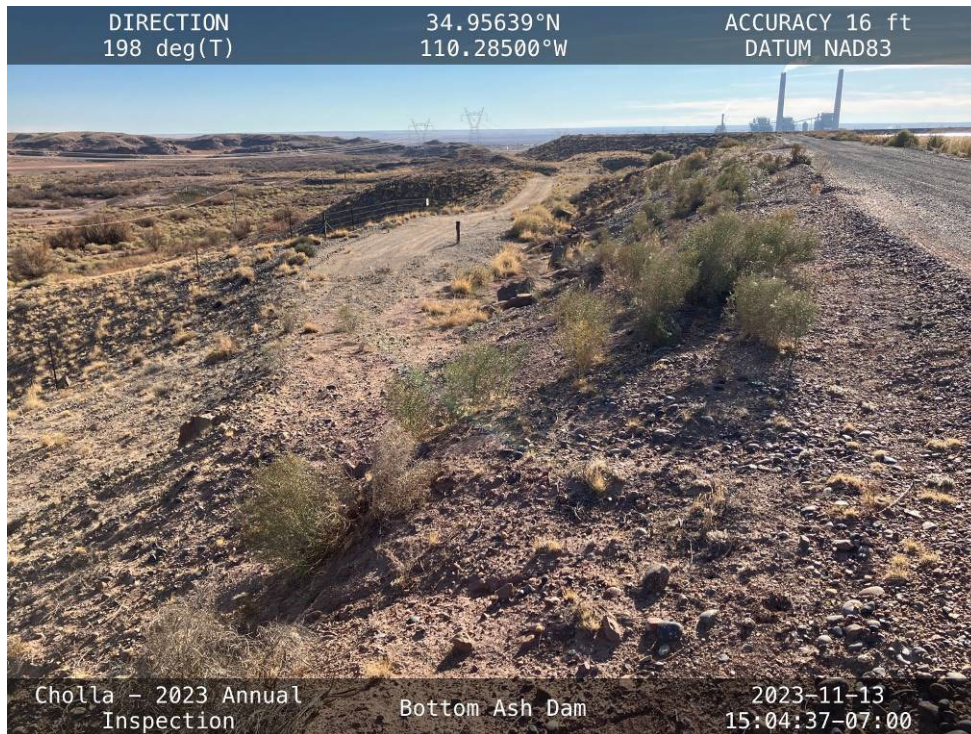
20231113 – IMG_1705

The crest of the East Embankment at the Left Abutment, facing southwest.

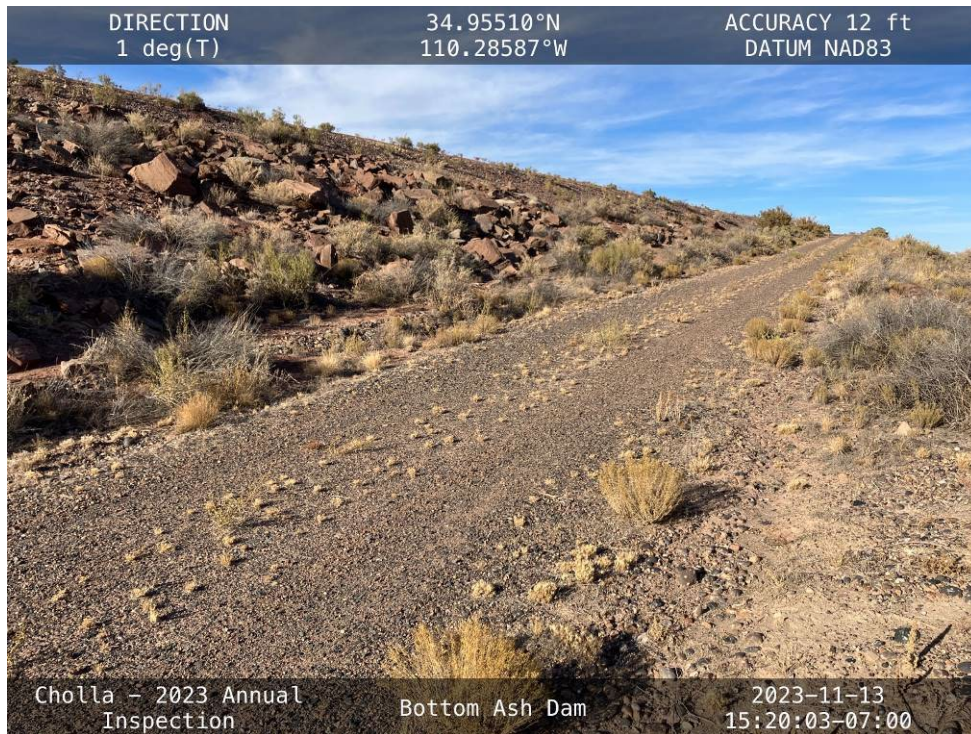
20231113 – IMG_1729

The downstream slope and toe of the East Embankment, facing southwest.

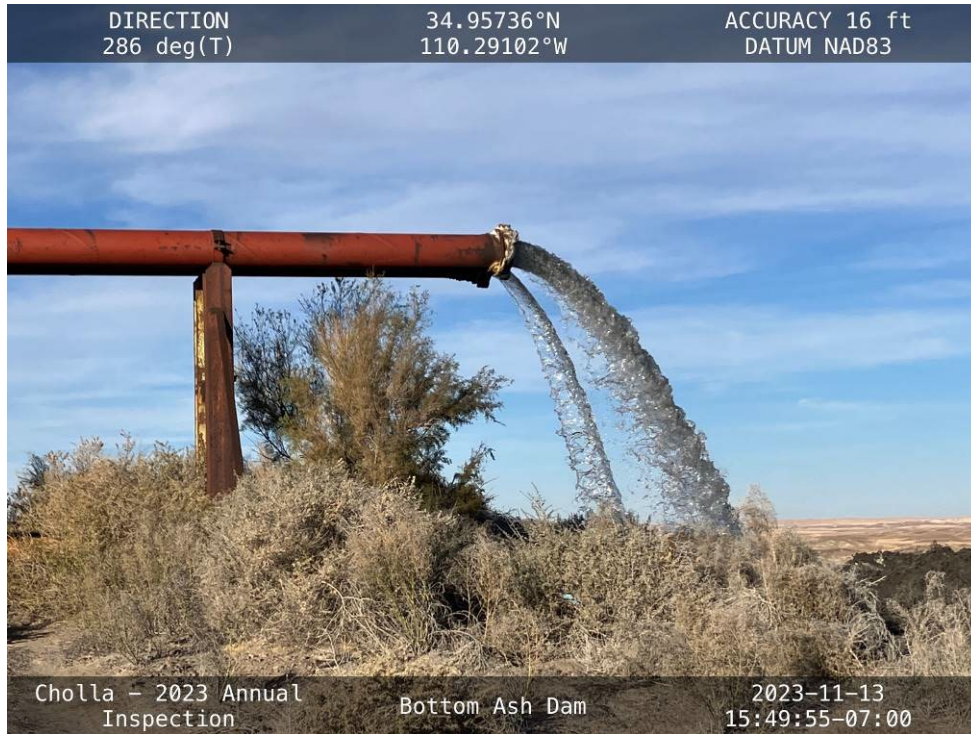
20231113 – IMG_1742

Sign identifying allowed and disallowed materials for the Bottom Ash Pond.

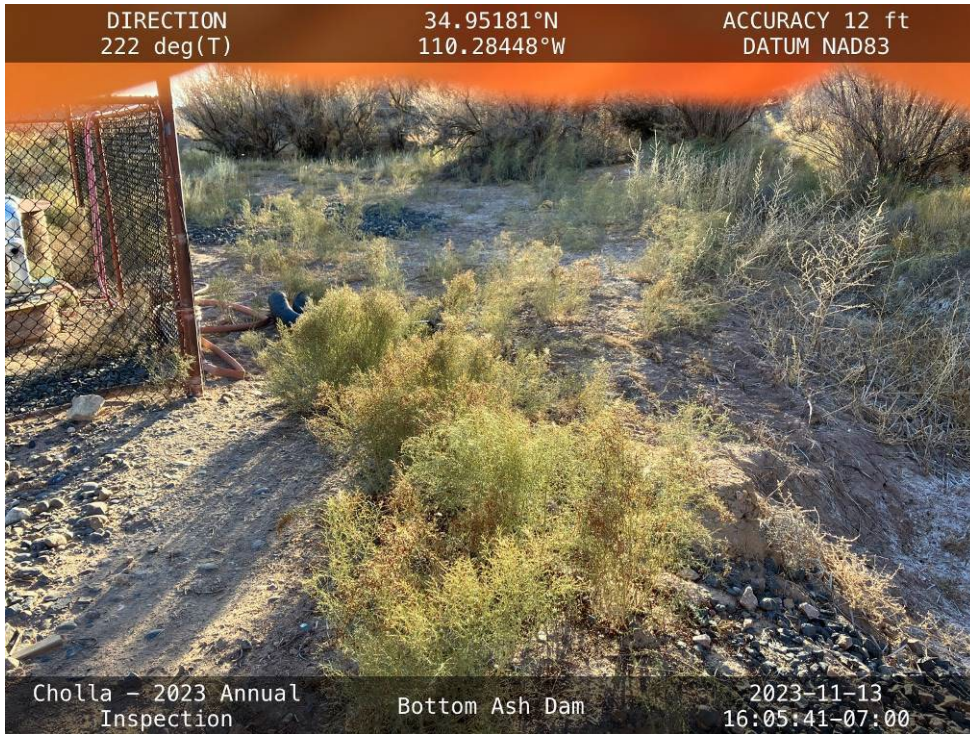
20231113 – IMG_1761
Some standing water in the ditch adjacent to the Petroglyph Seep, cleaned up since the 2022 inspection.

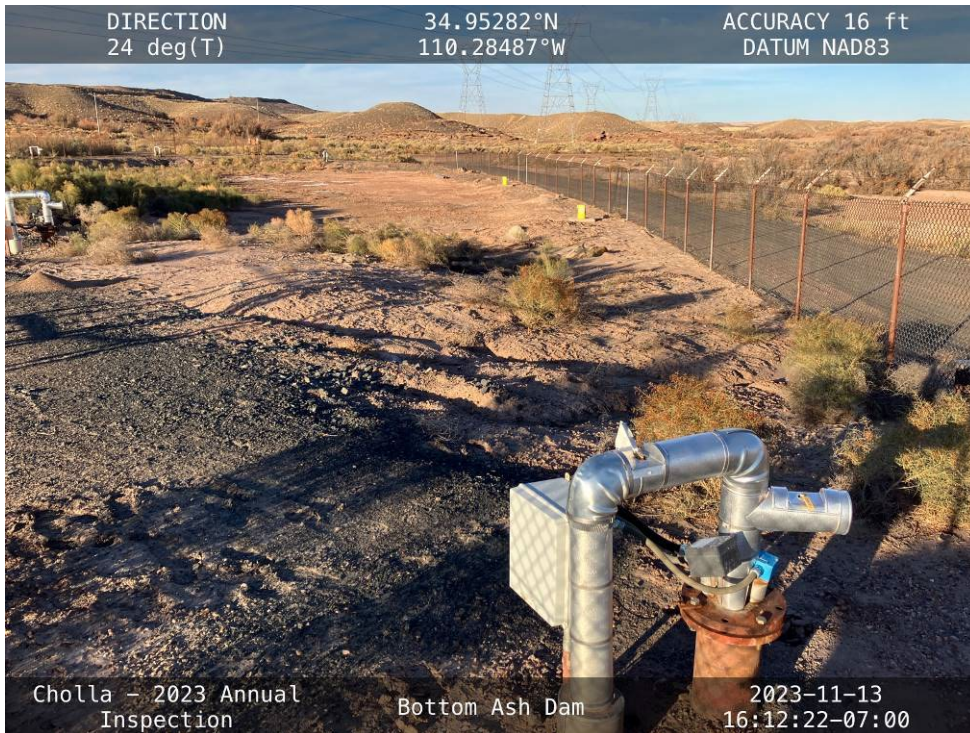
20231113 – IMG_1768

The area around the Tanner Wash Seep, cleaned up since the 2022 inspection.

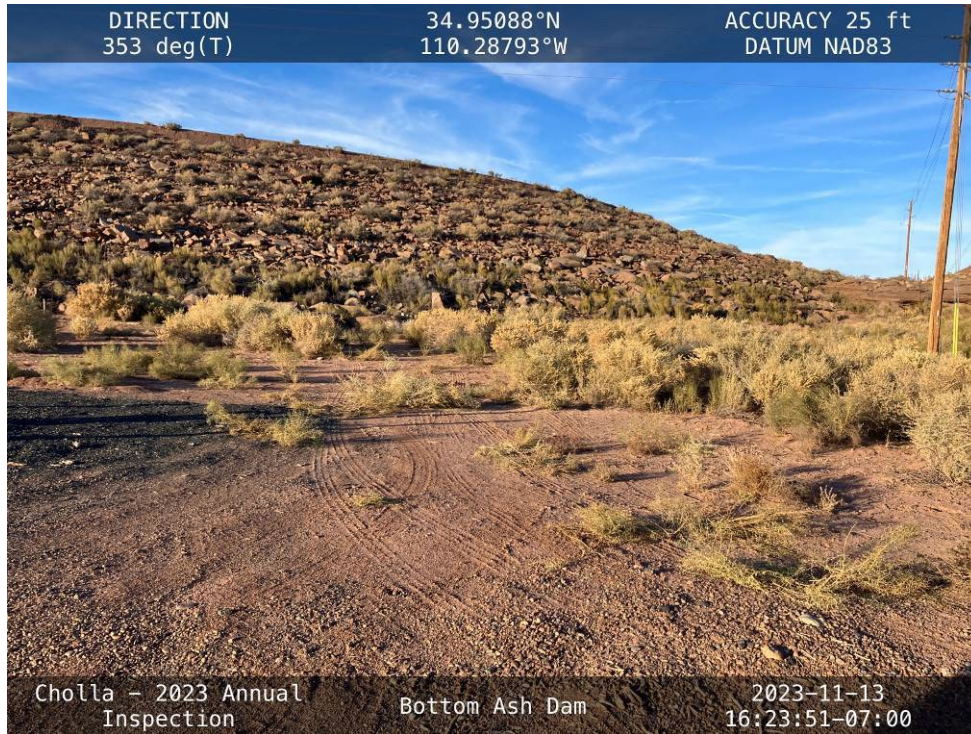
20231113 – IMG_1781

The P-226 seepage intercept area.

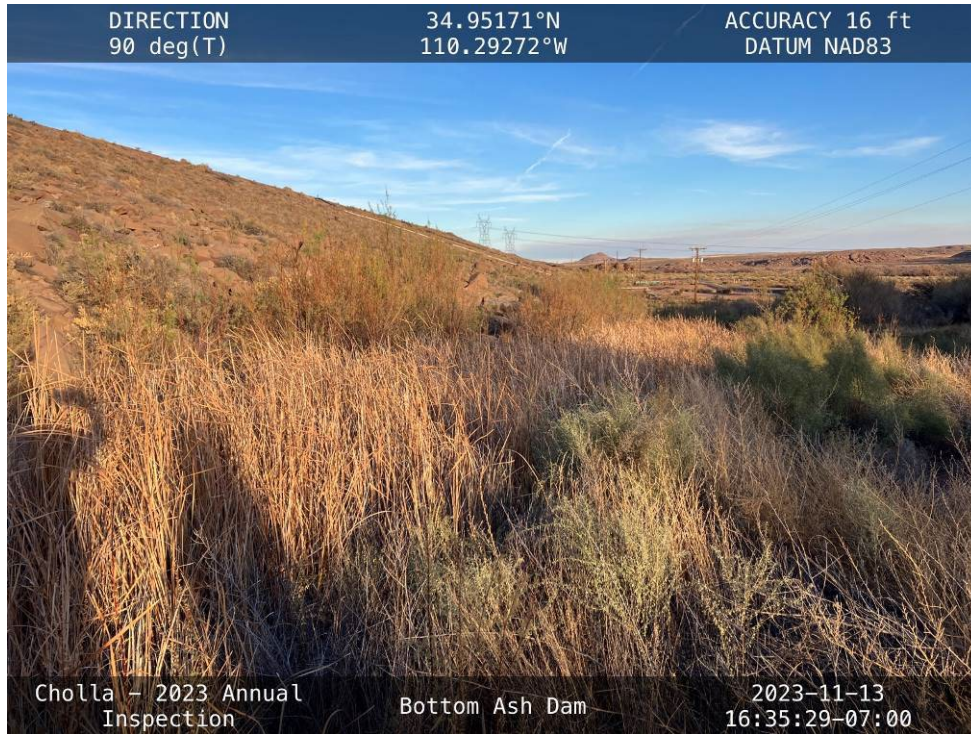
20231113 – IMG_1803
Grassy vegetation growing in the area near the West Abutment Weir.

Action Item	Action Status
8) Continue to monitor seepage areas, including the West Abutment Weir, for excessive vegetation.	Woody vegetation rooted in the embankment should be removed and the resulting disturbed area should be replaced with compacted material similar to the embankment material per NMOSE (2011).

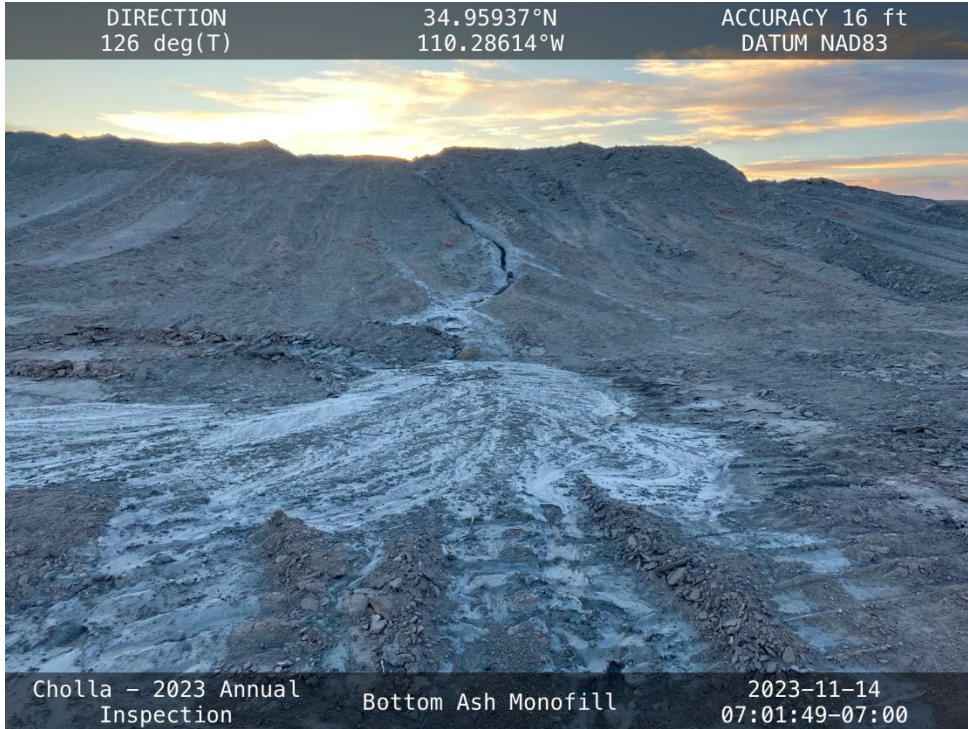
20231114 – IMG_1810

An erosion rill on the west side of the BAM, facing east.

Action Item	Action Status
1) Erosion gullies several feet deep were observed at various locations at the CCR unit. Some erosion gullies extended into the ash underlying the soil cover.	Repair the erosion once it exceeds 1 foot in depth or reaches the underlying ash. NOTE: This will always be an ongoing maintenance activity.

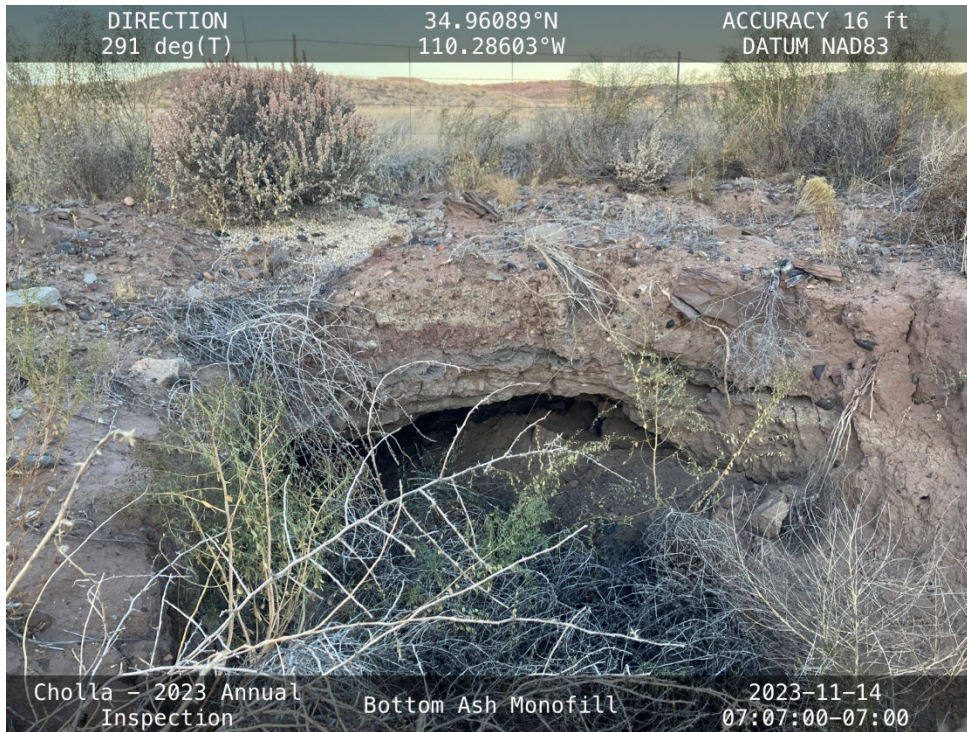
20231114 – IMG_1818

A tunnel on the west side of the western perimeter drainage channel that has formed by erosion.

4) Severe erosion on the west side of the perimeter drainage channel has resulted in a tunnel leading into the channel.	Repair the erosion and fill in the tunnel with compacted fill under the direction of the APS Geotechnical Engineer.

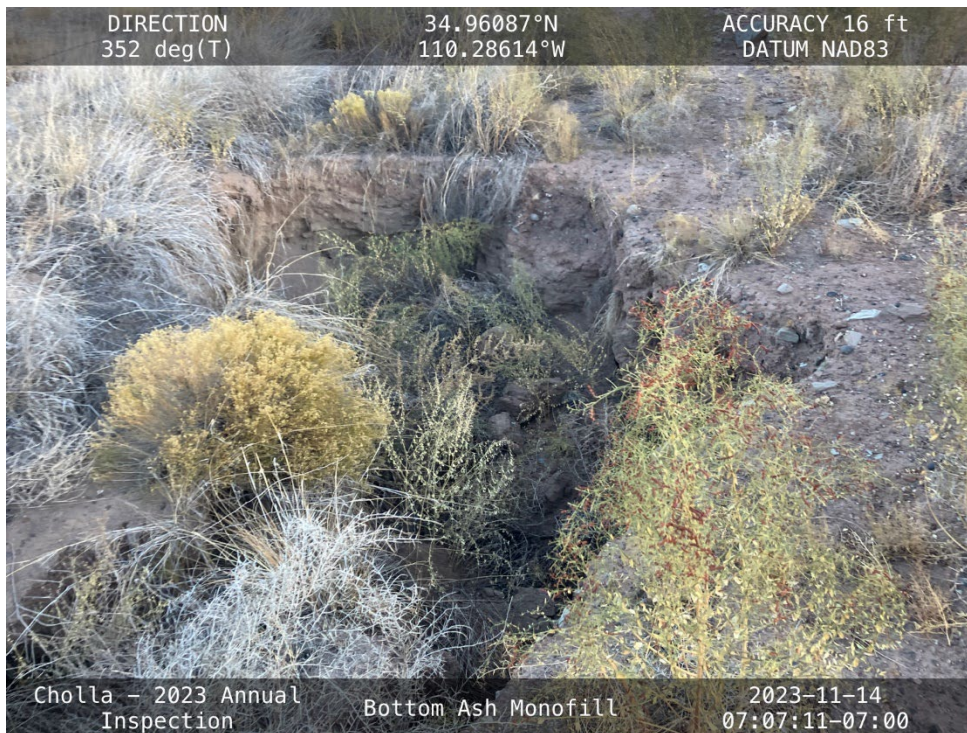
20231114 – IMG_1819

The head of the tunnel on the west side of the perimeter drainage channel that has formed by erosion.

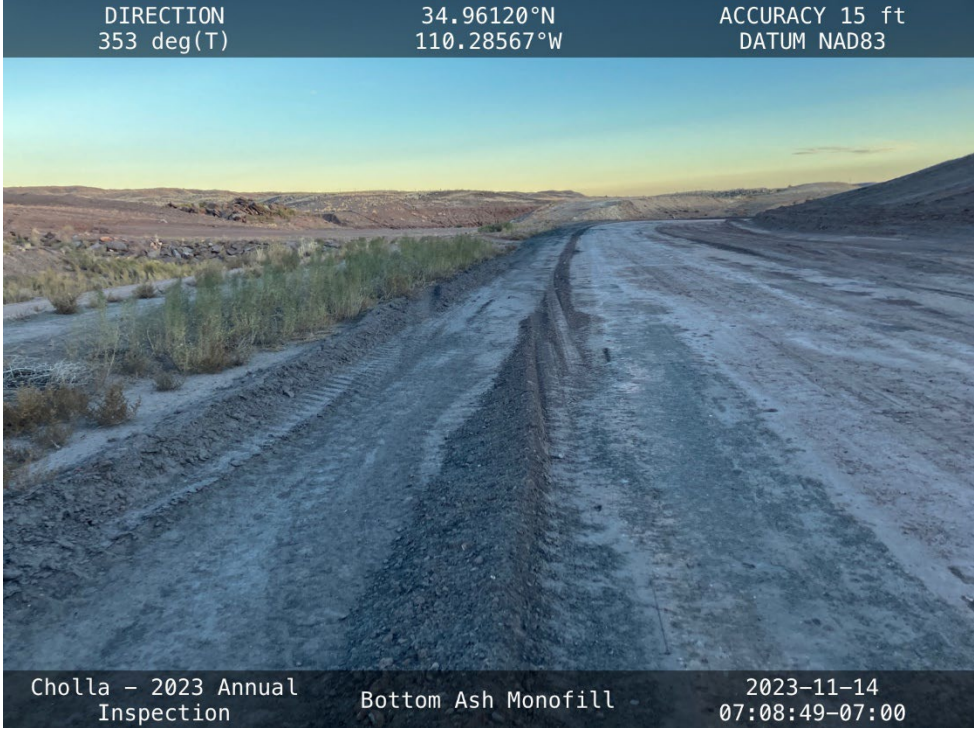
20231114 – IMG_1822

The west side of the BAM, facing north toward an area that had ponded water during the 2022 inspection.

3) Standing water was observed in the perimeter drainage channel during the 2022 inspection.	Grade the channel to drain to the Stormwater Detention Basin.

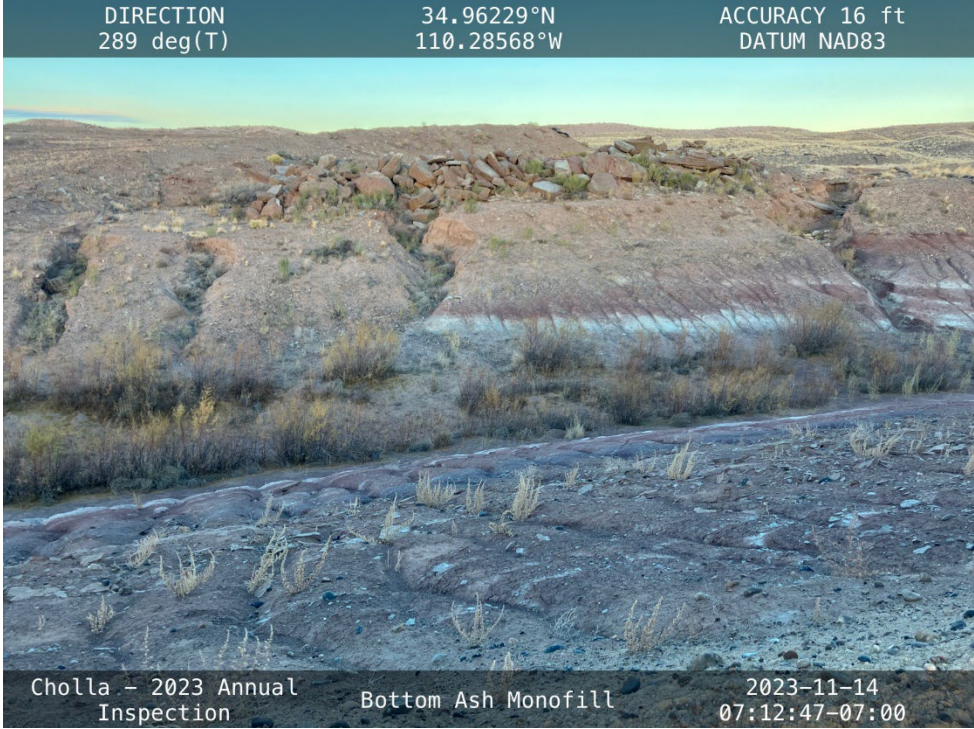
20231114 – IMG_1825

Erosion gullies on the west side of the drainage channel.

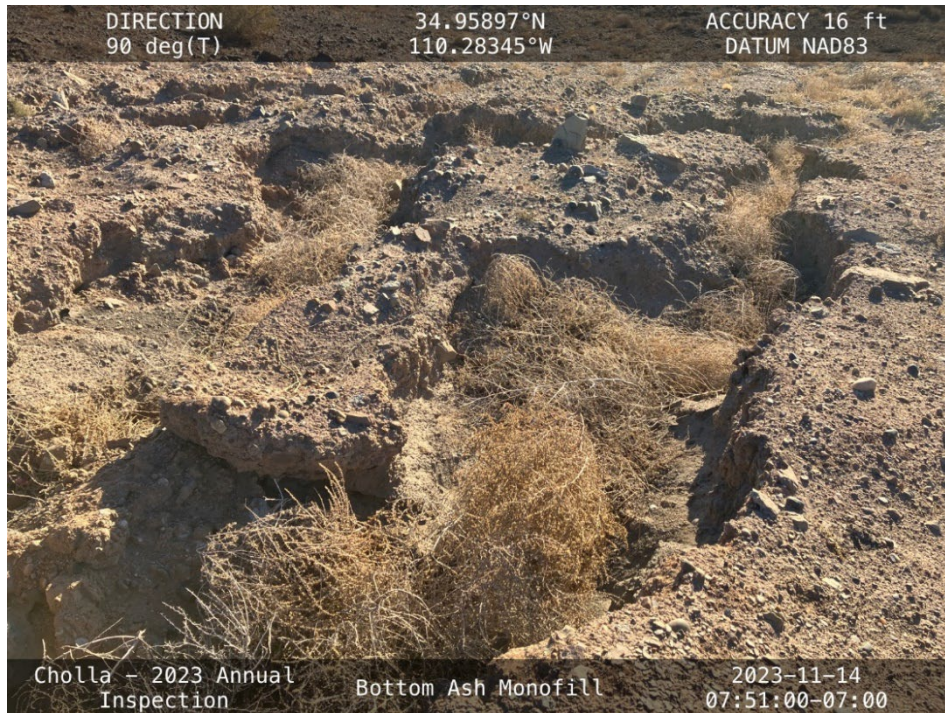
20231114 – IMG_1897

An erosion area on the lower half of the East Embankment slope, just east of the access road.

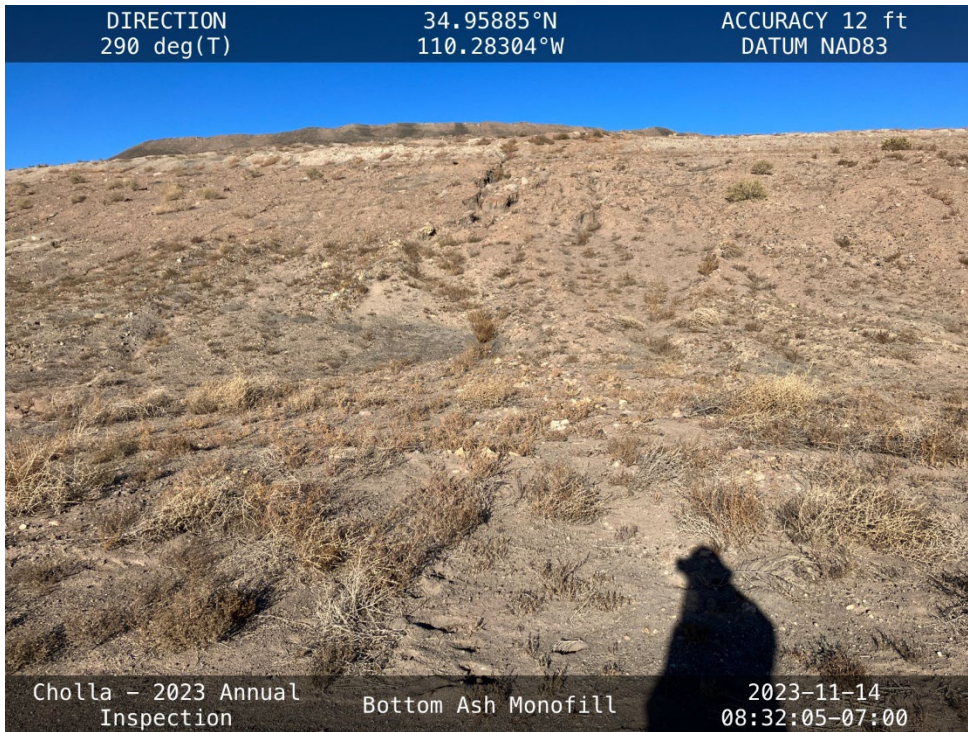
20231114 – IMG_1954

An erosion gully on the east side of the BAM, west of the Stormwater Detention Basin.
