CHOLLA POWER PLANT Fly Ash Dam, Bottom Ash Dam, Sedimentation Pond, and Bottom Ash Monofill

Annual CCR Impoundment and Landfill Inspection Report

2017

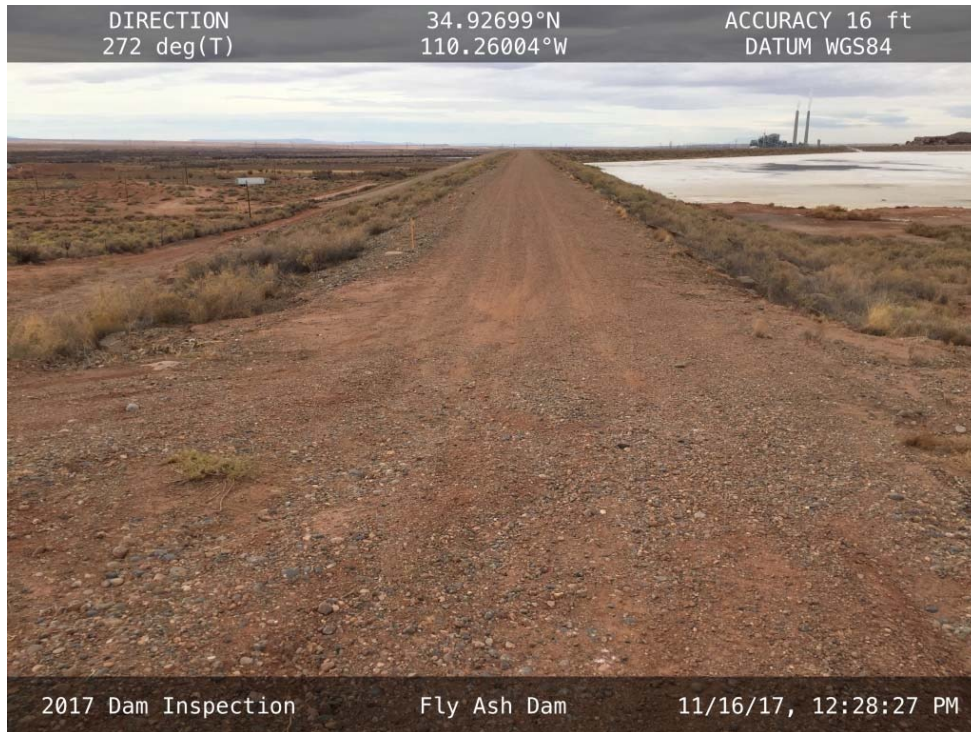
20171116 – IMG_5938

The crest of the Fly Ash Dam, facing west from the East Abutment.

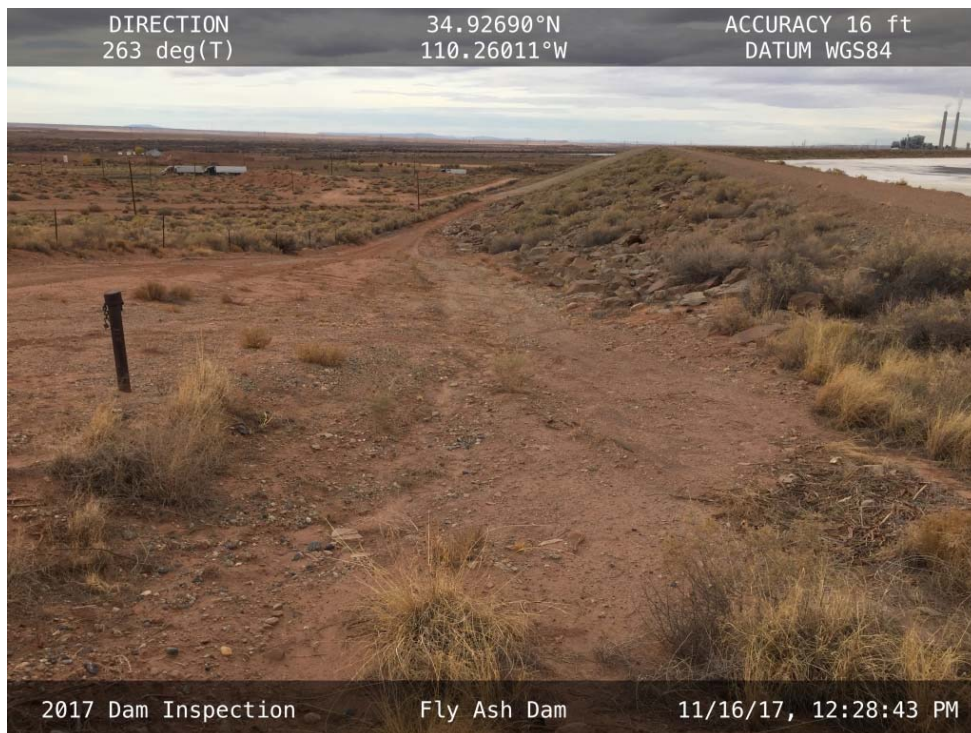
20171116 – IMG_5939

- iii. Minor stone deterioration was observed during the 2016 inspection. The stone along the downstream slope was not significantly worse during this inspection, but should be monitored as the dam ages.

The downstream slope of the Fly Ash Dam, facing west from the East Abutment.

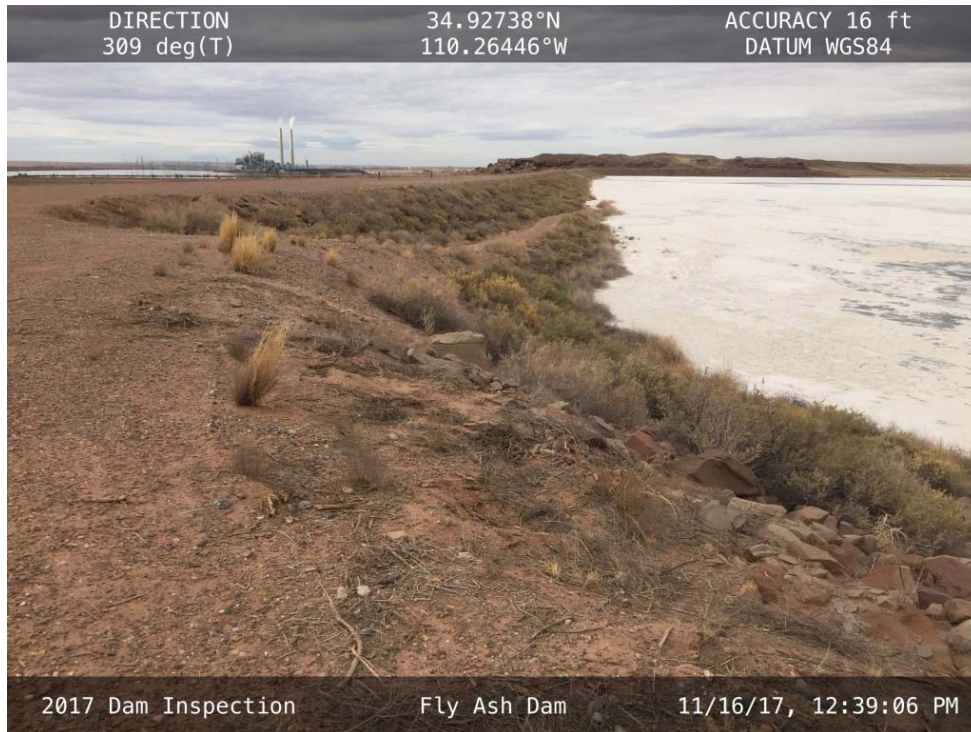
20171116 – IMG_5945

The upstream slope of the Fly Ash Dam, facing northwest from the East Embankment.

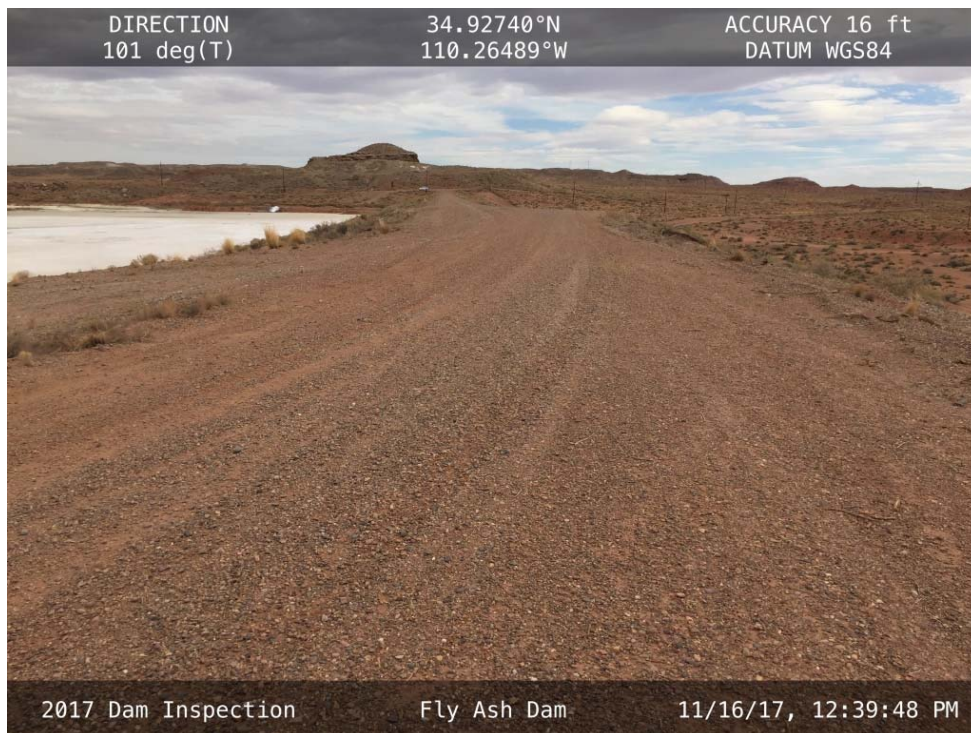
20171116 – IMG_5947

The crest of the East Embankment, facing east.

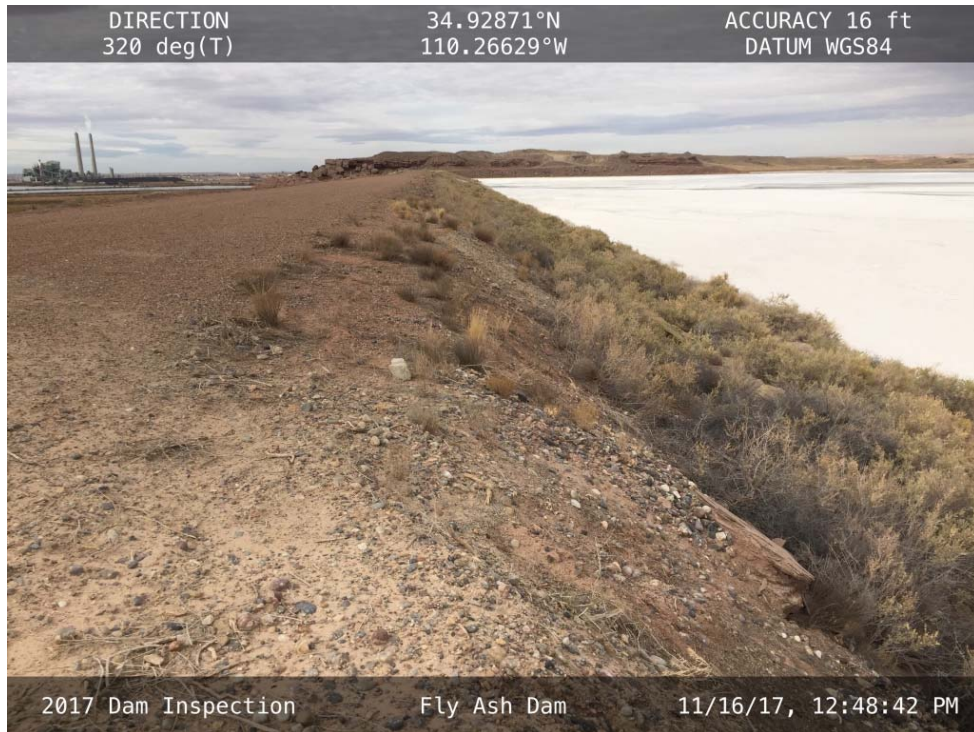
20171116 – IMG_5957
The upstream slope of the Fly Ash Dam, facing northwest.

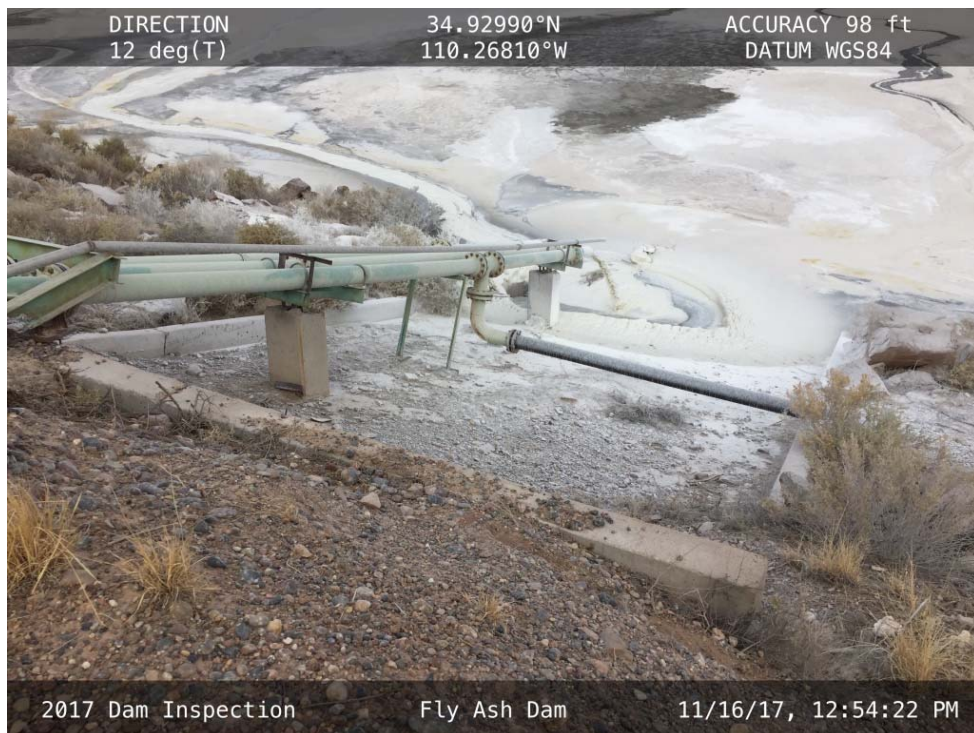
20171116 – IMG_5958
The inlet pipe depositing CCR into the impoundment.

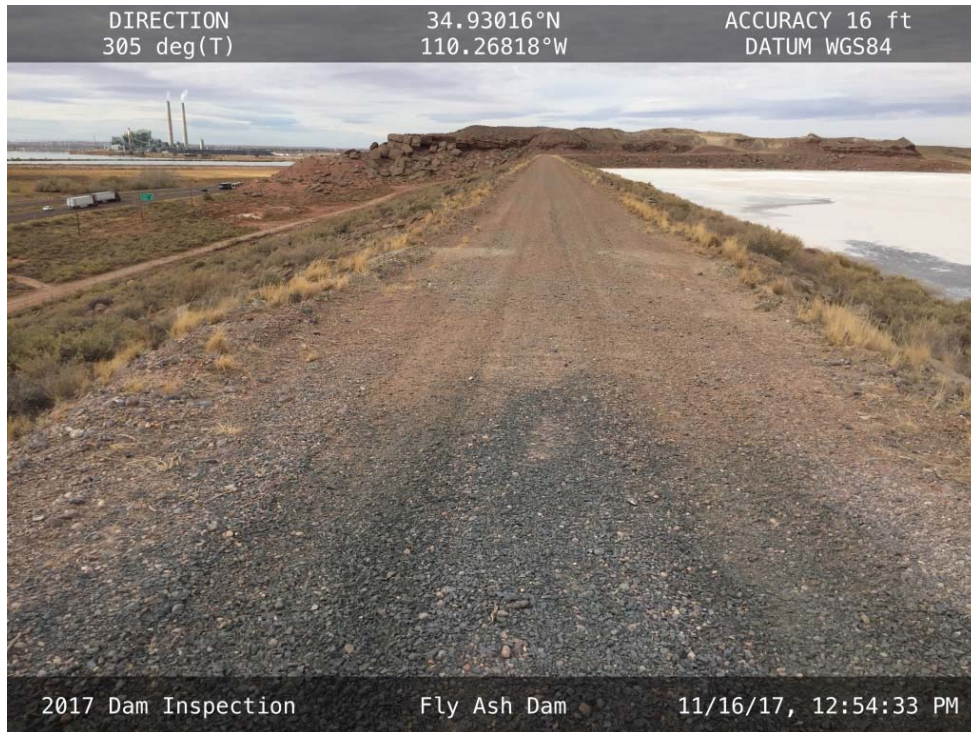
20171116 – IMG_5959

The crest of the Fly Ash Dam, facing northwest from the center of the embankment.

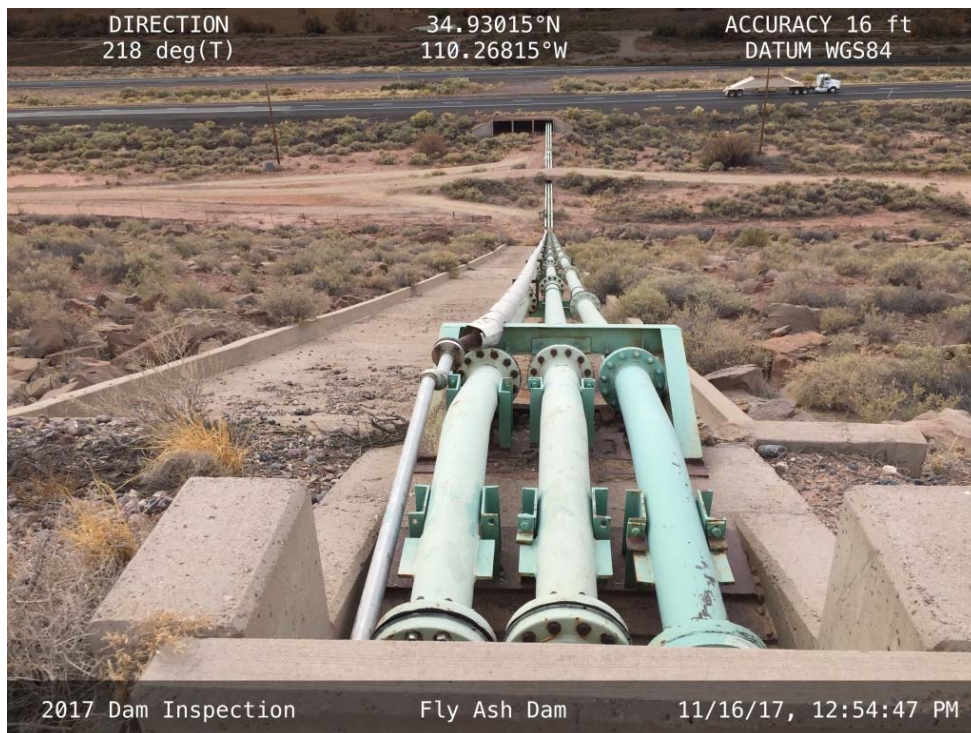
20171116 – IMG_5962

The inlet pipe system facing toward the downstream slope.

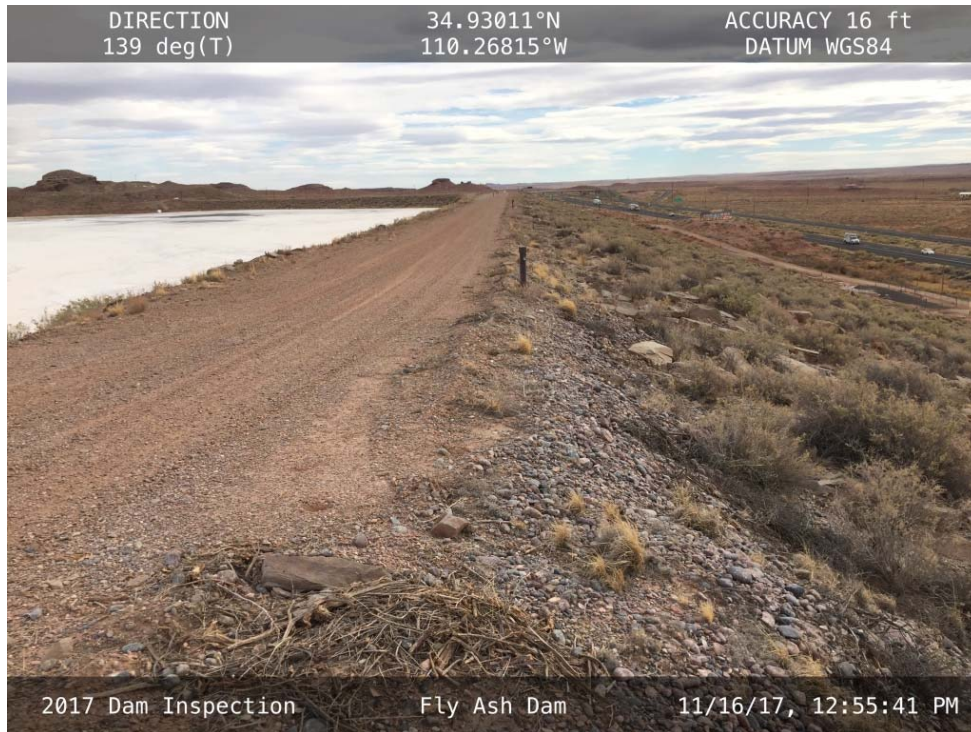
20171116 – IMG_5963

The crest and downstream slope of the Fly Ash Dam, from center, facing southwest.

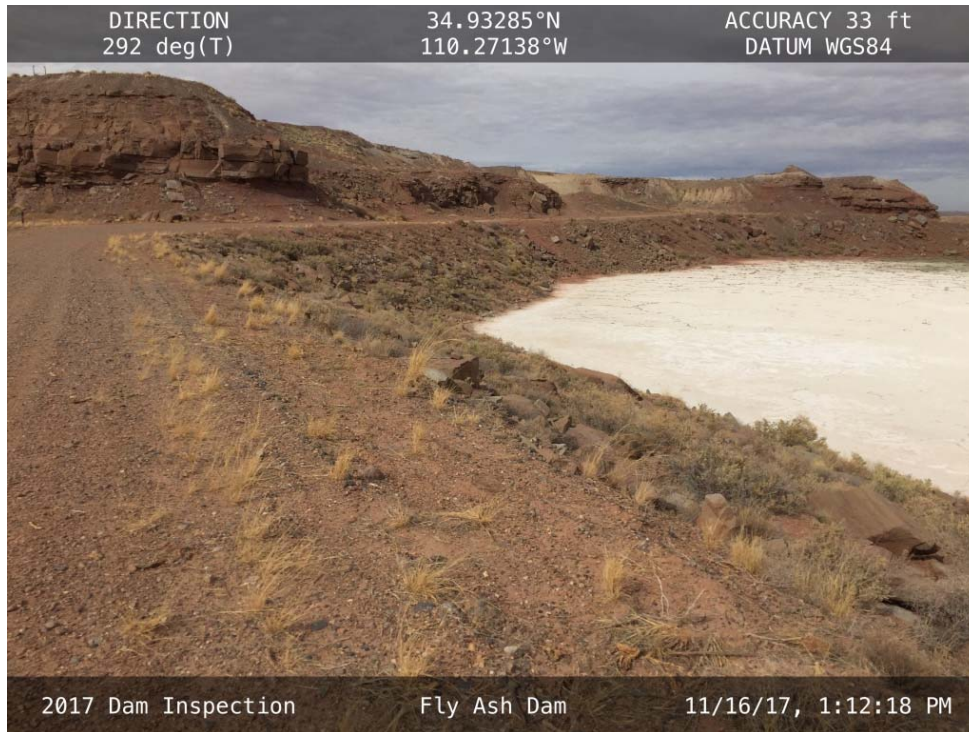
20171116 – IMG_5970

The upstream slope near the North Abutment, facing northwest.

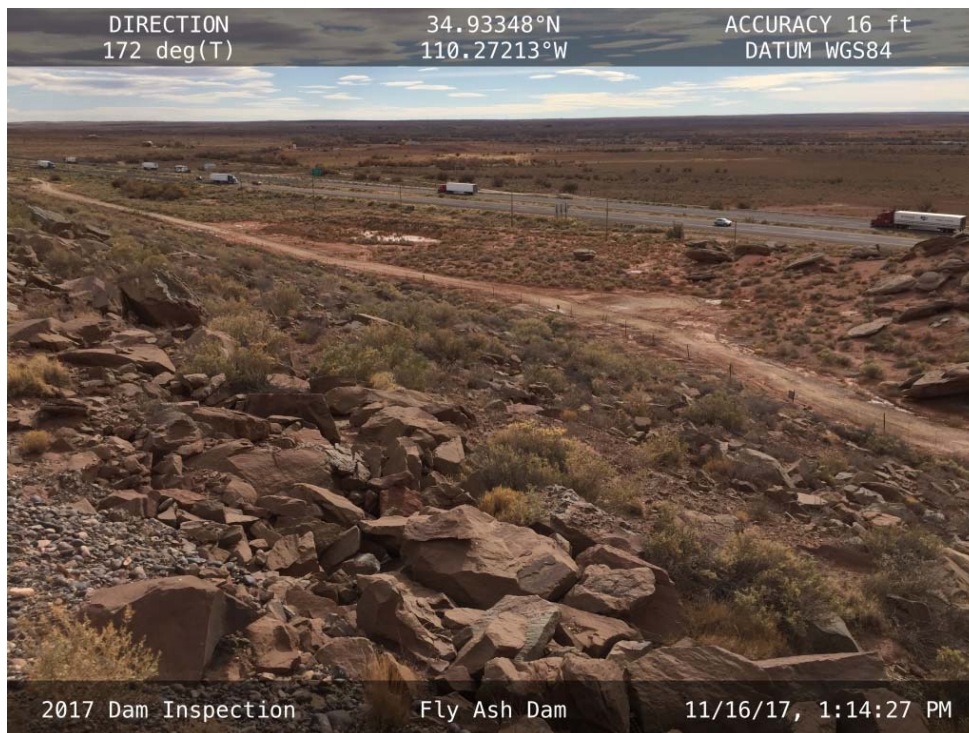
20171116 – IMG_5977

The downstream toe of the Fly Ash Dam, facing south from the North Abutment.

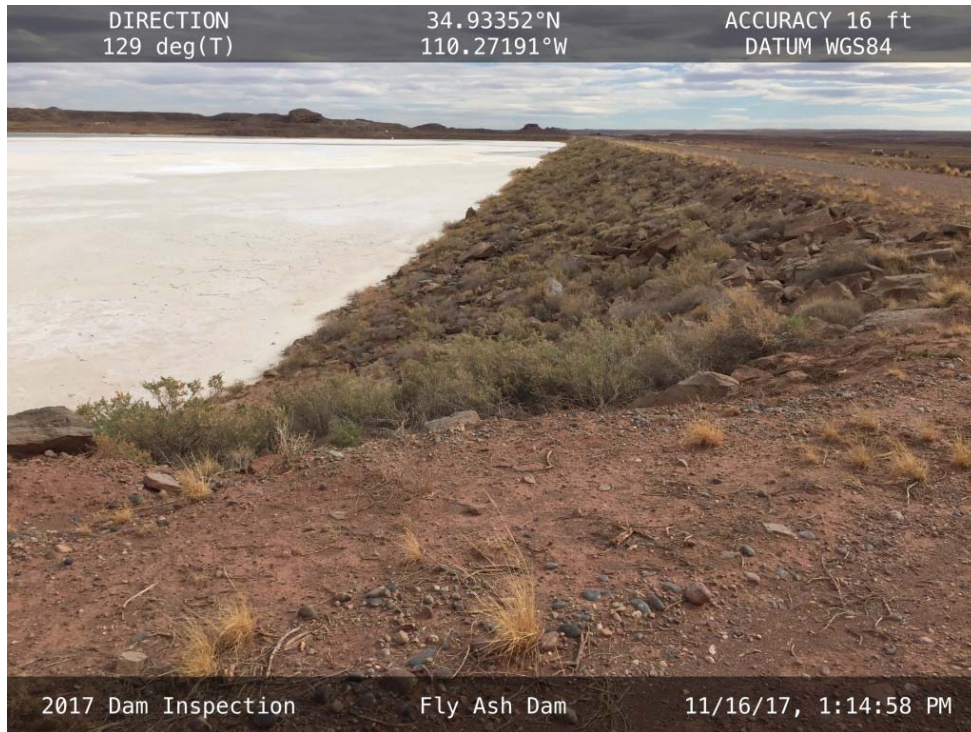
20171116 – IMG_5980
The upstream slope of the Fly Ash Dam, facing east.

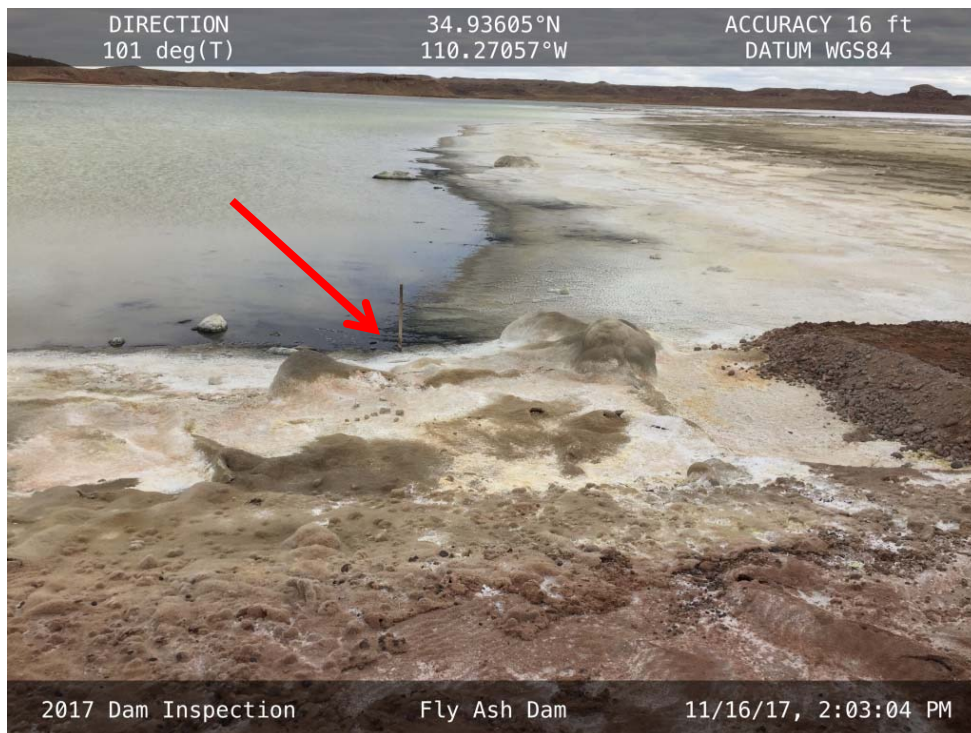
20171116 – IMG_6017
The survey location for the water level readings.

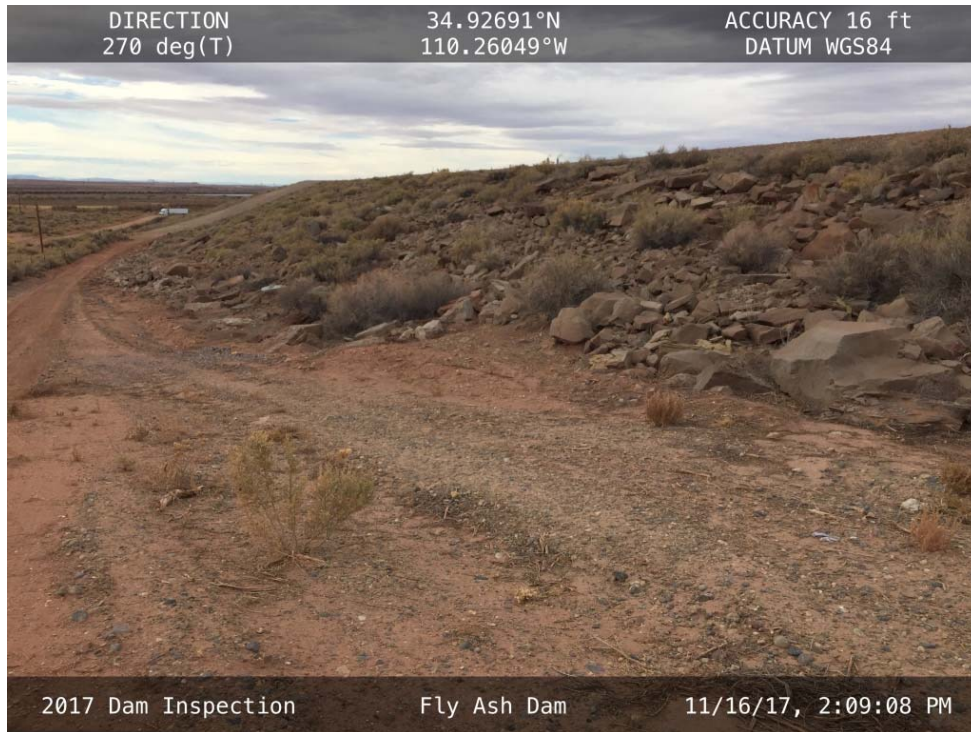
20171116 – IMG_6018

The south toe and upstream slope of the East Embankment, facing west.

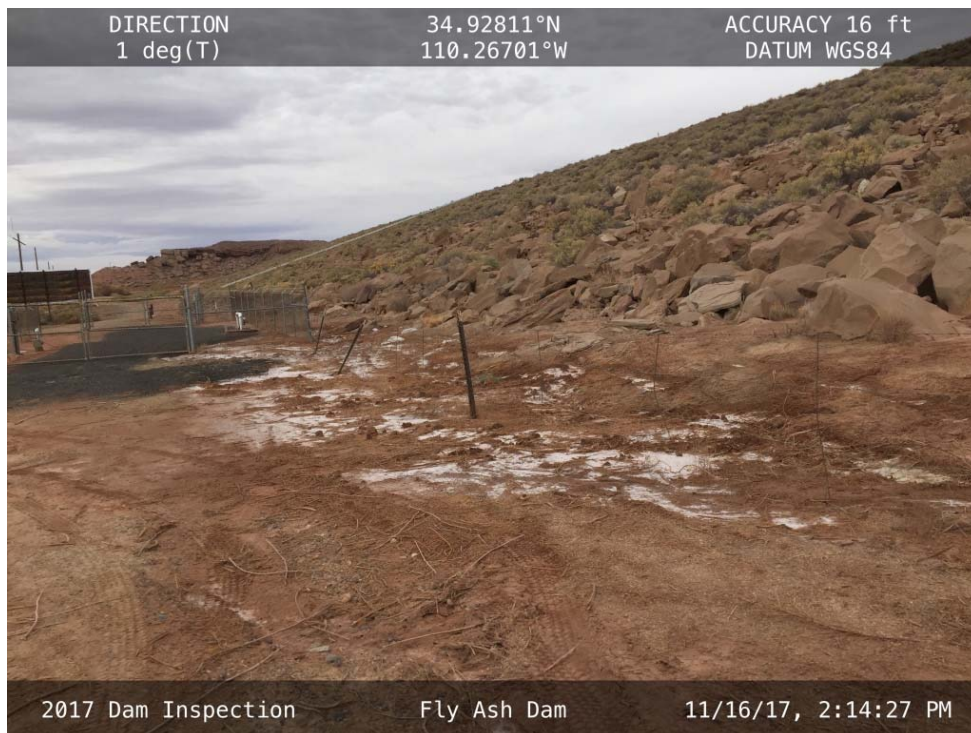
20171116 – IMG_6025

The toe of the Fly Ash Dam, facing north.

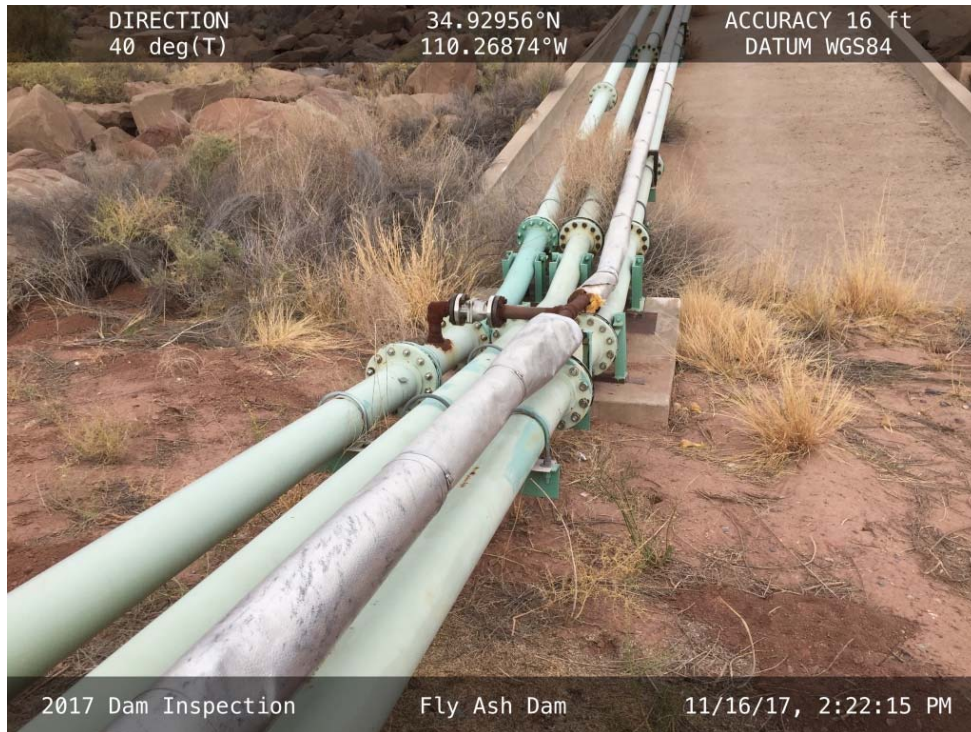
20171116 – IMG_6034
The inlet pipes reconfigured to circulate water.

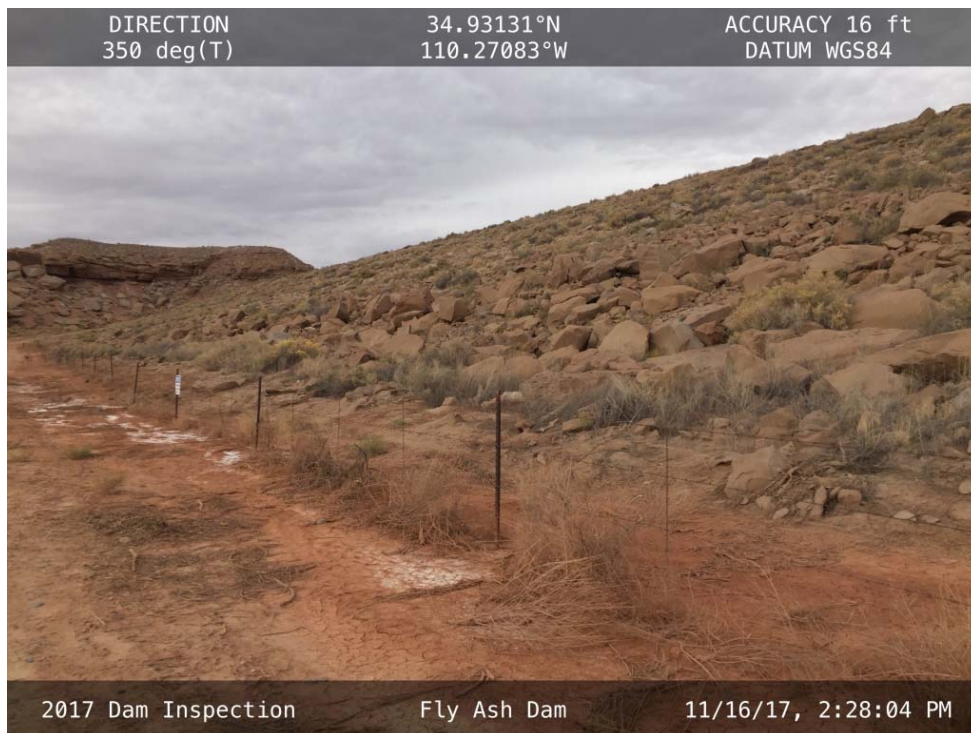
20171116 – IMG_6039
The north toe of the Fly Ash Dam, facing north.

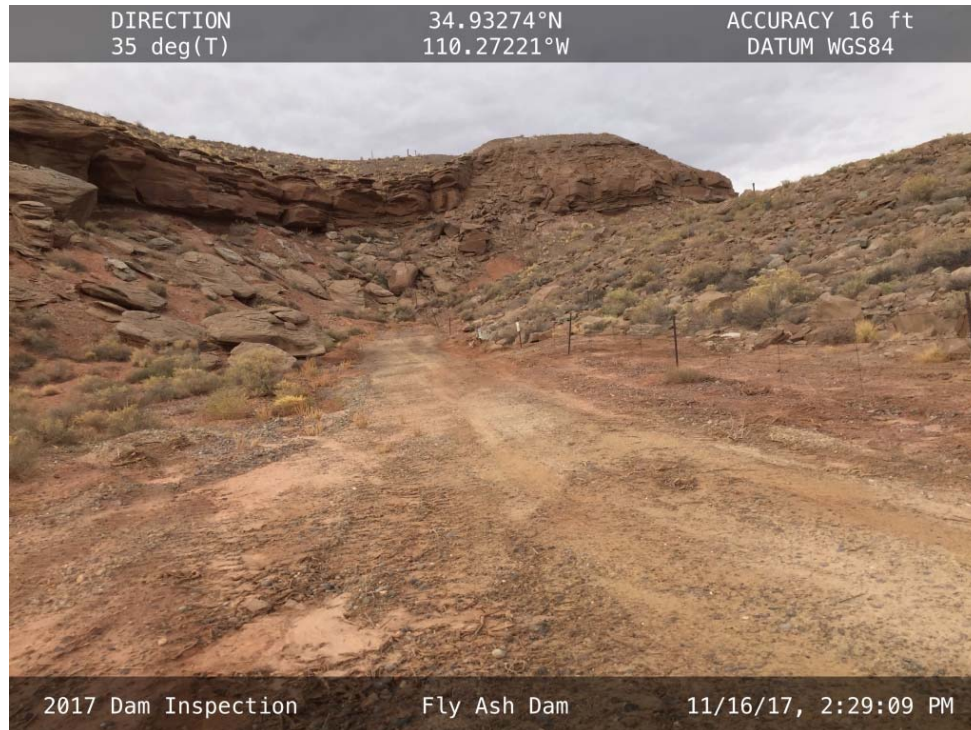
20171116 – IMG_6041

The North Abutment of the Fly Ash Dam, facing north from the toe.

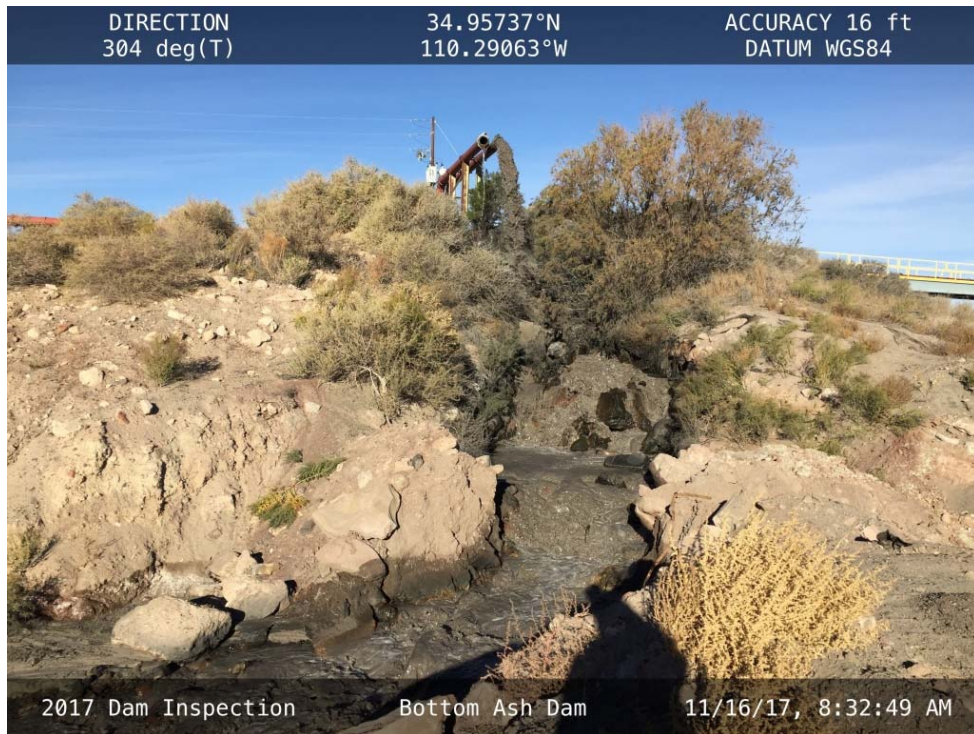
20171116 – IMG_5757
Ash and water being deposited into the Bottom Ash Pond.

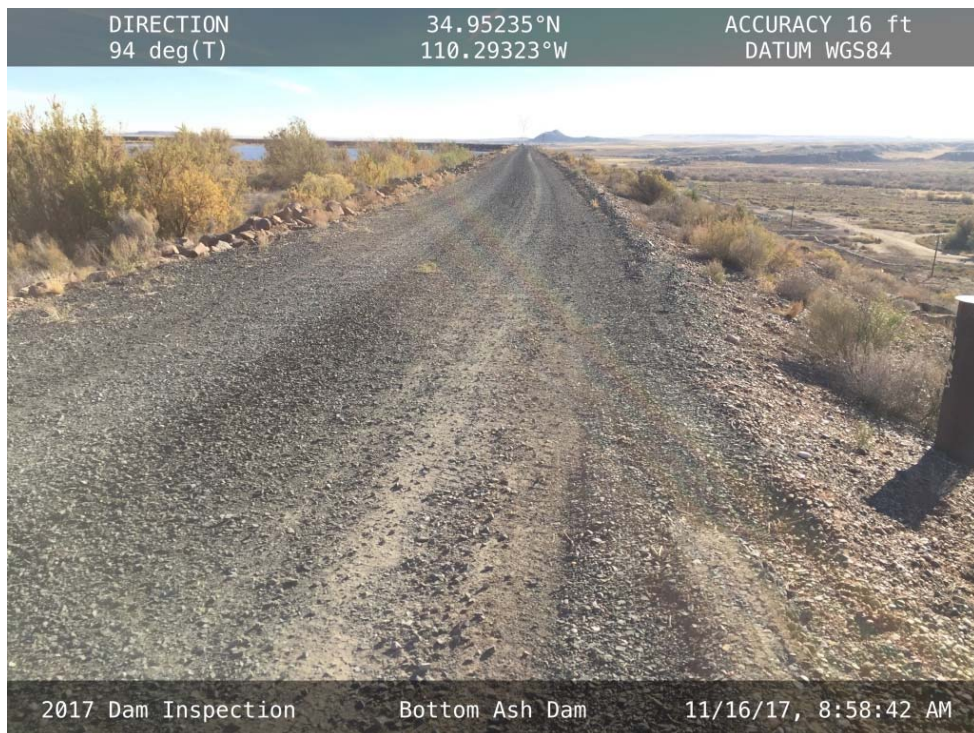
20171116 – IMG_5786
The crest of the Bottom Ash Dam, facing east.

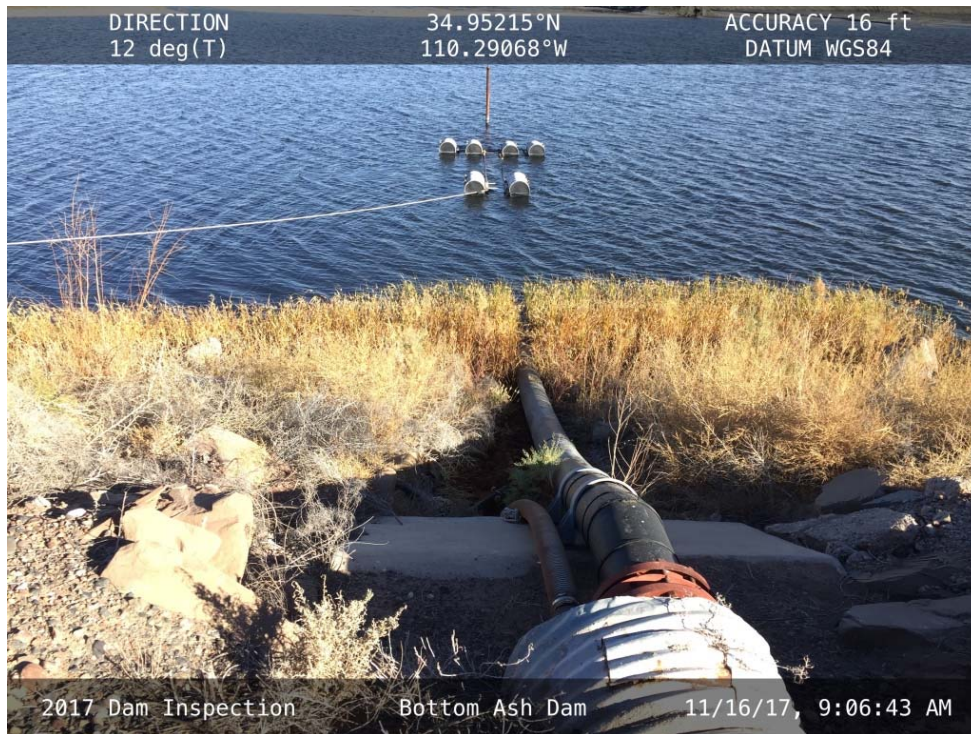
20171116 – IMG_5795

The western siphon line in the Bottom Ash Pond, facing upstream.

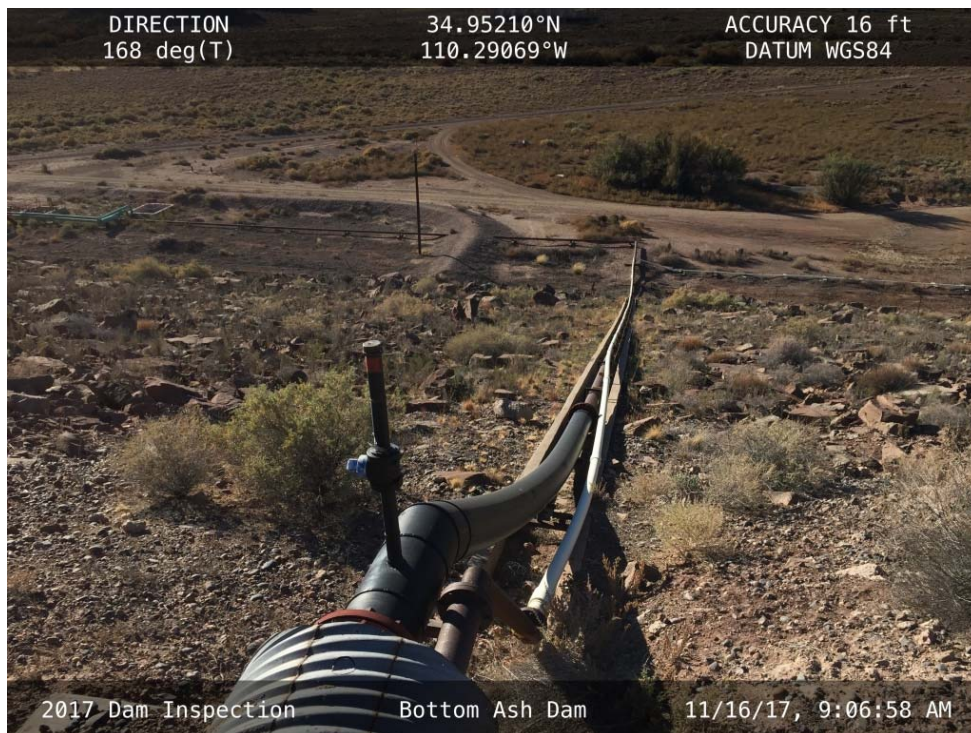
20171116 – IMG_5798

The western siphon line in the Bottom Ash Pond, facing downstream.

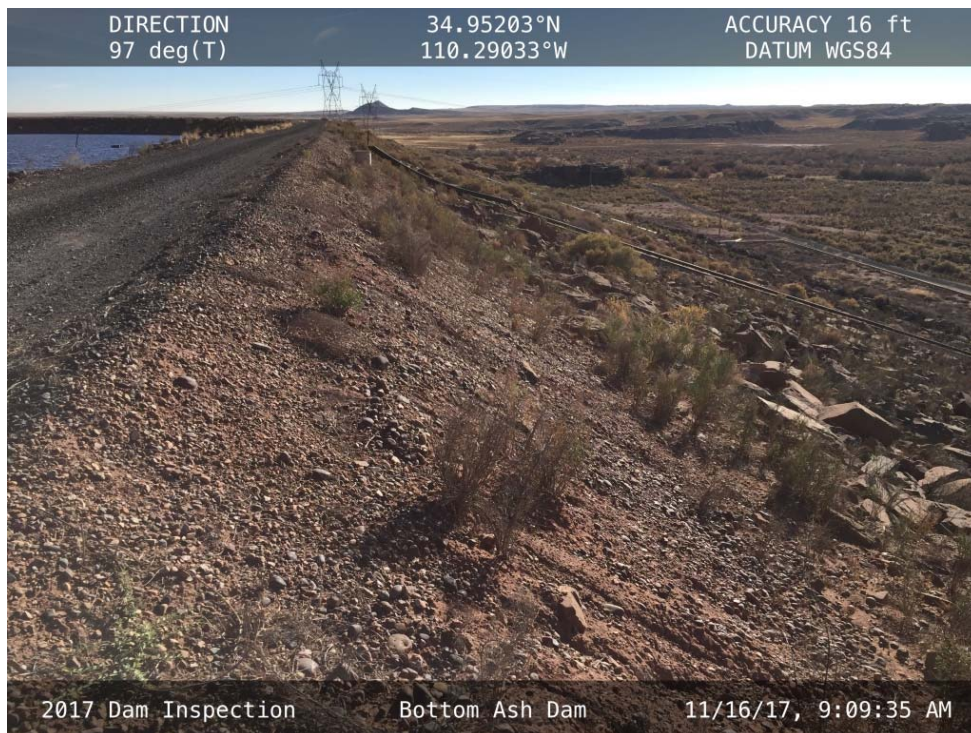
20171116 – IMG_5803

The downstream slope of the South Embankment, facing east.

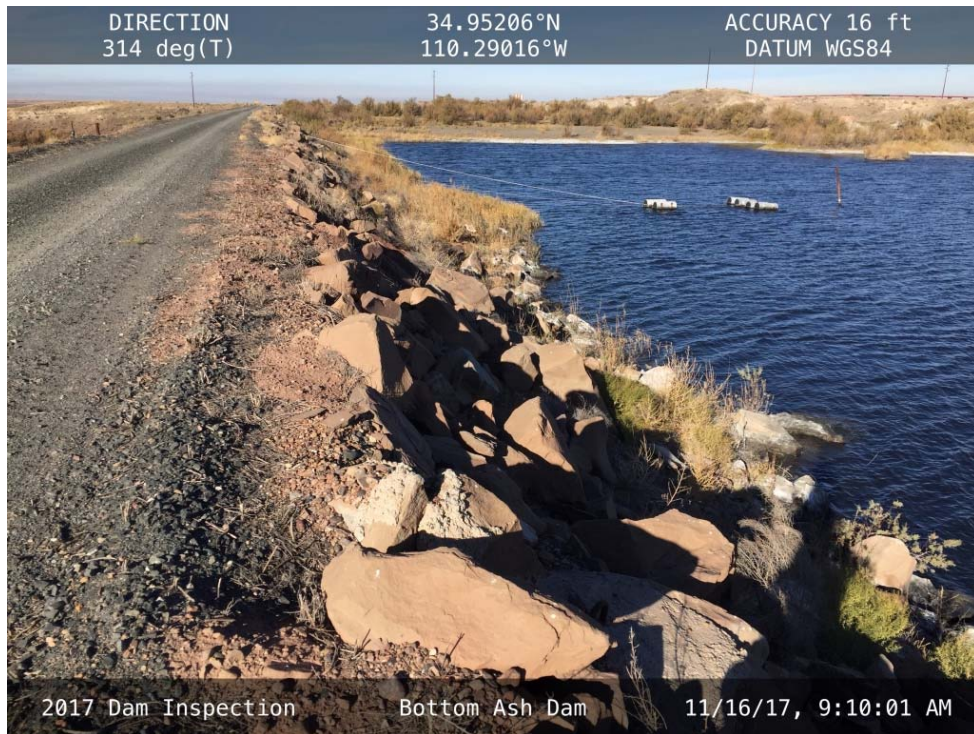
20171116 – IMG_5805

The upstream slope of the South Embankment, facing west.

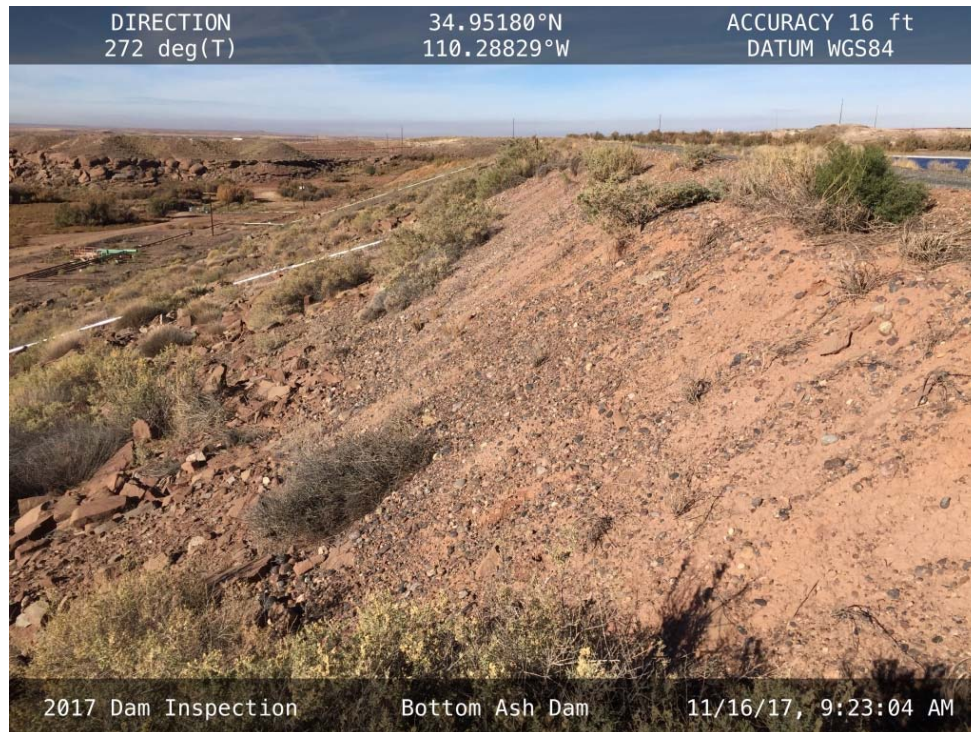
20171116 – IMG_5822
The downstream slope of the South Embankment, facing west.

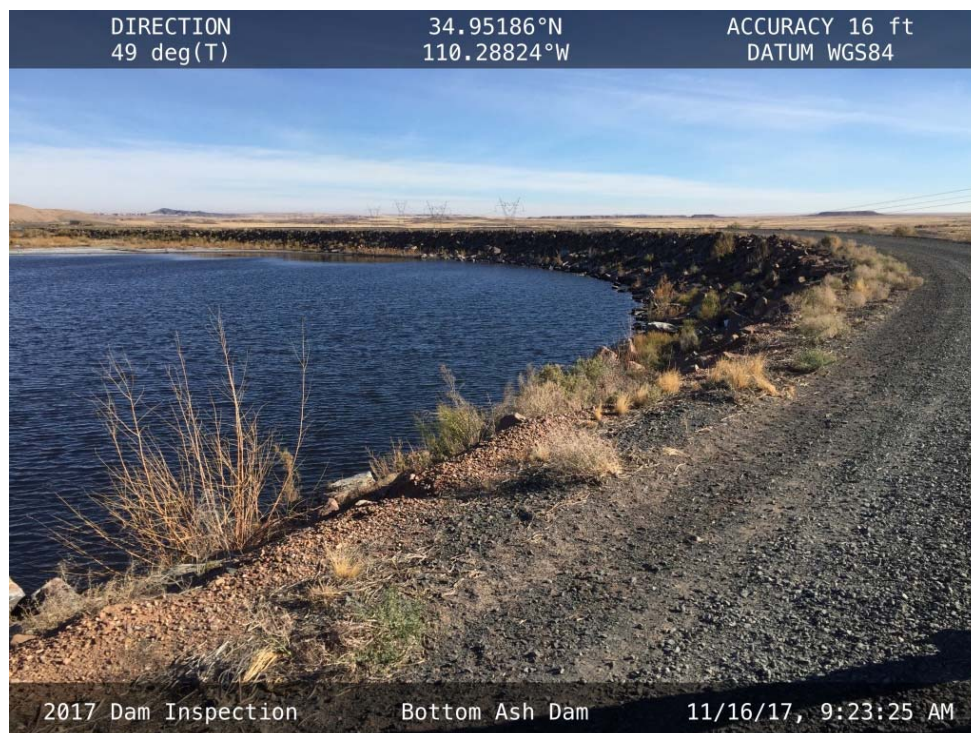
20171116 – IMG_5824
The upstream slope of the southeast corner, facing east.

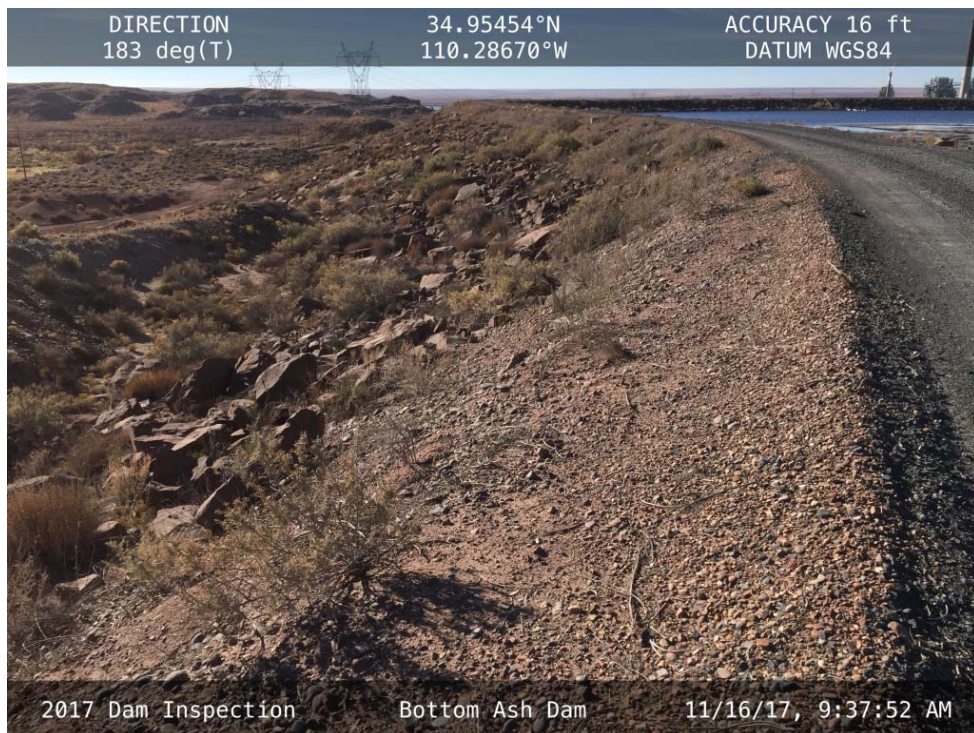
20171116 – IMG_5844

The downstream slope of the East Embankment, facing south.

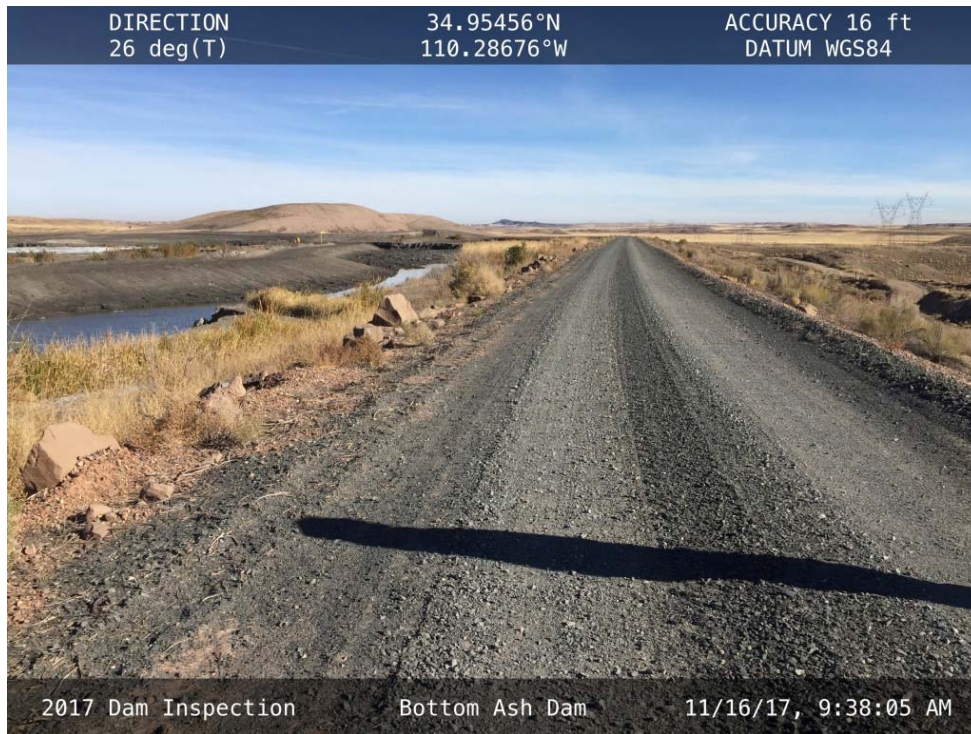
20171116 – IMG_5850
The crest of the East Embankment, facing north.

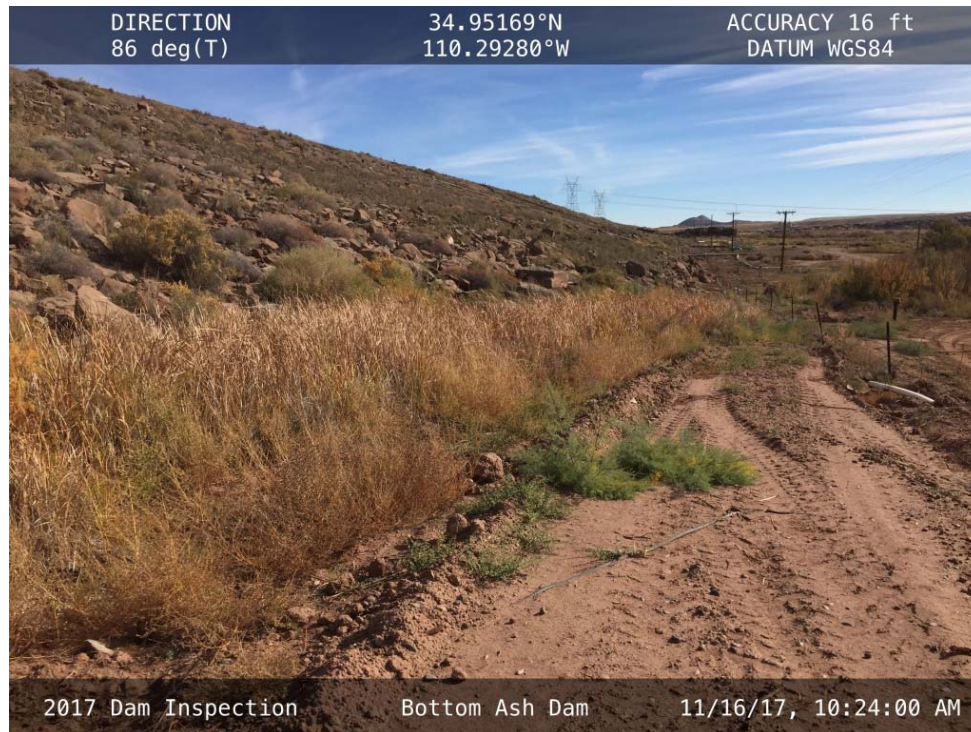
20171116 – IMG_5881
The toe of the South Embankment, facing east.

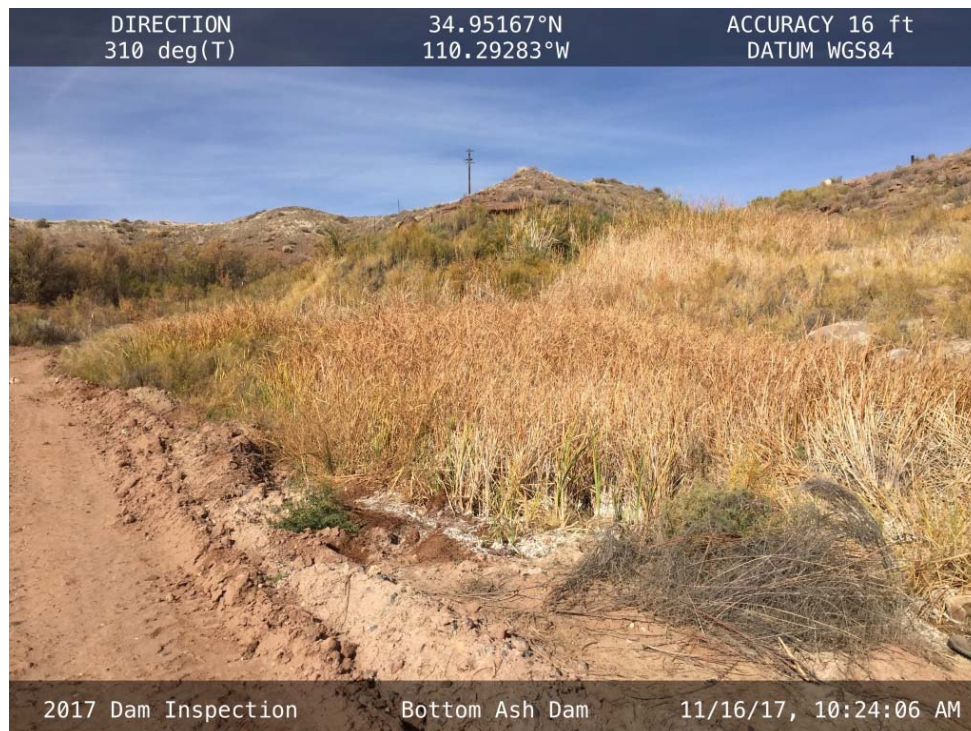
20171116 – IMG_5883
Grassy vegetation growing near the West Abutment Weir, facing west.

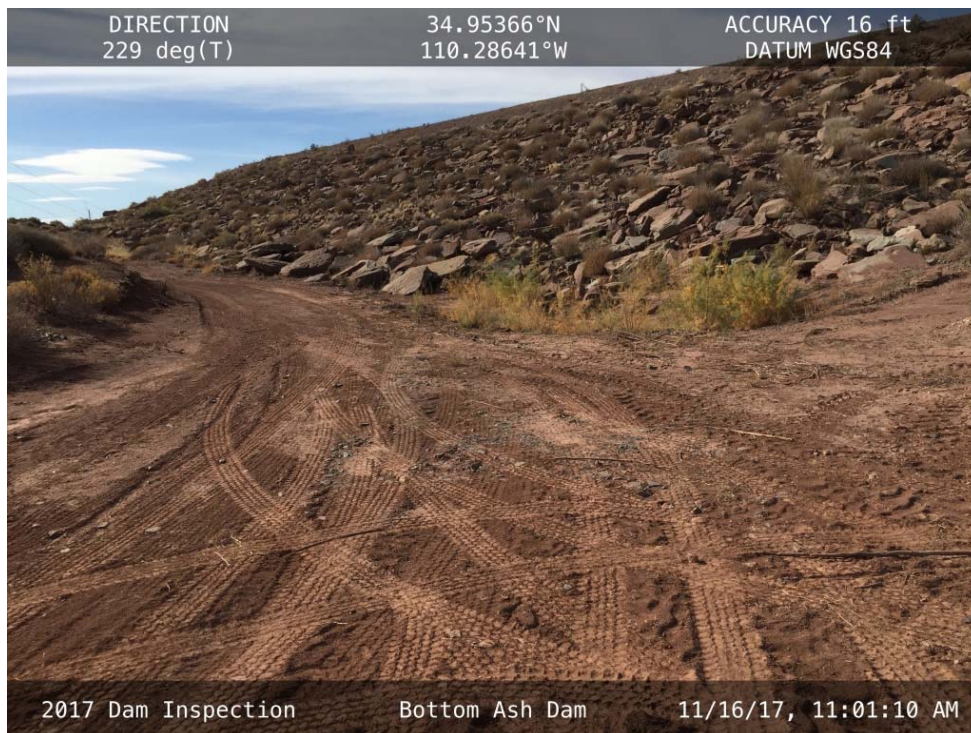
20171116 – IMG_5909
The toe of the East Embankment, facing south.
