CHOLLA POWER PLANT Fly Ash Dam, Bottom Ash Dam, Sedimentation Pond, and Bottom Ash Monofill

Annual CCR Impoundment and Landfill Inspection Report

2017

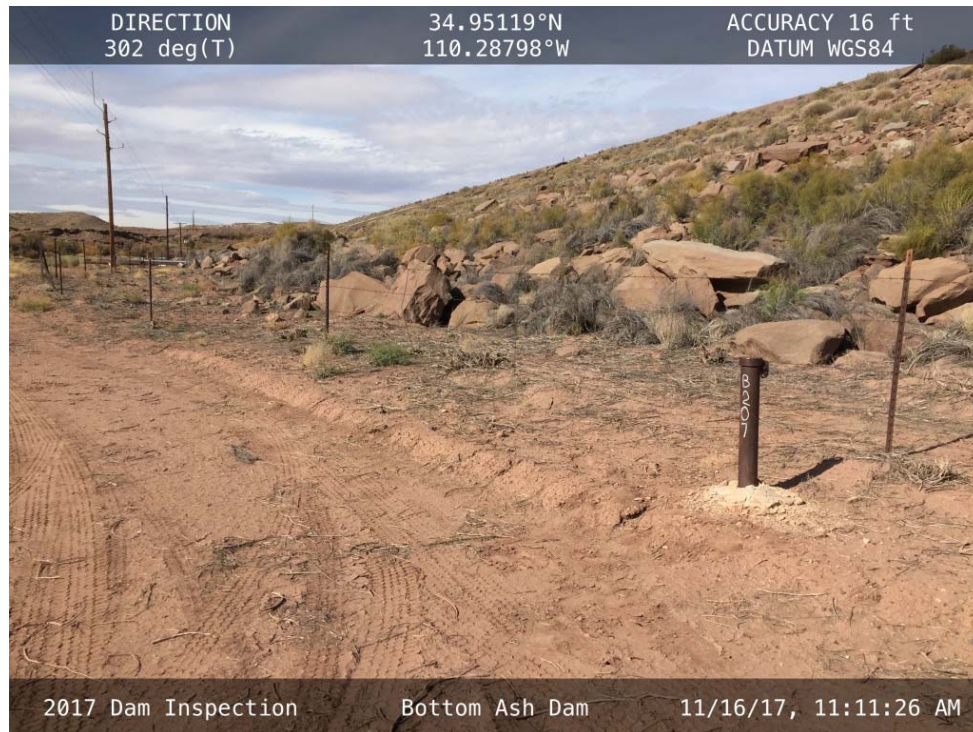
20171116 – IMG_5916

The toe of the South Embankment with most of the vegetation removed, facing west.

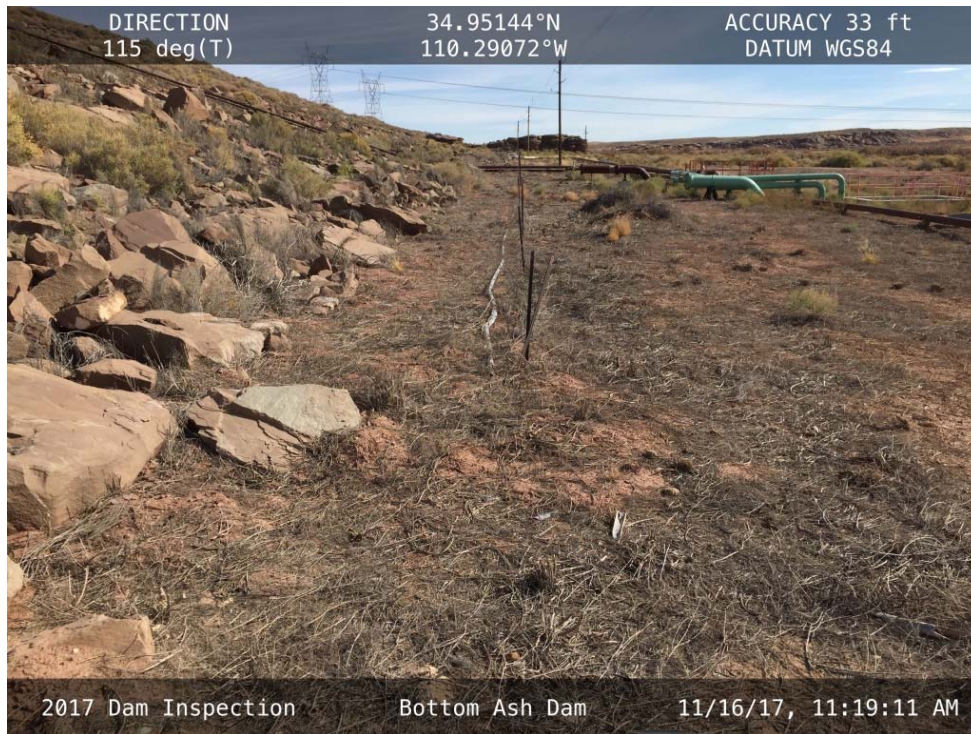
20171116 – IMG_5923

The toe of the South Embankment with most of the vegetation removed, facing east.

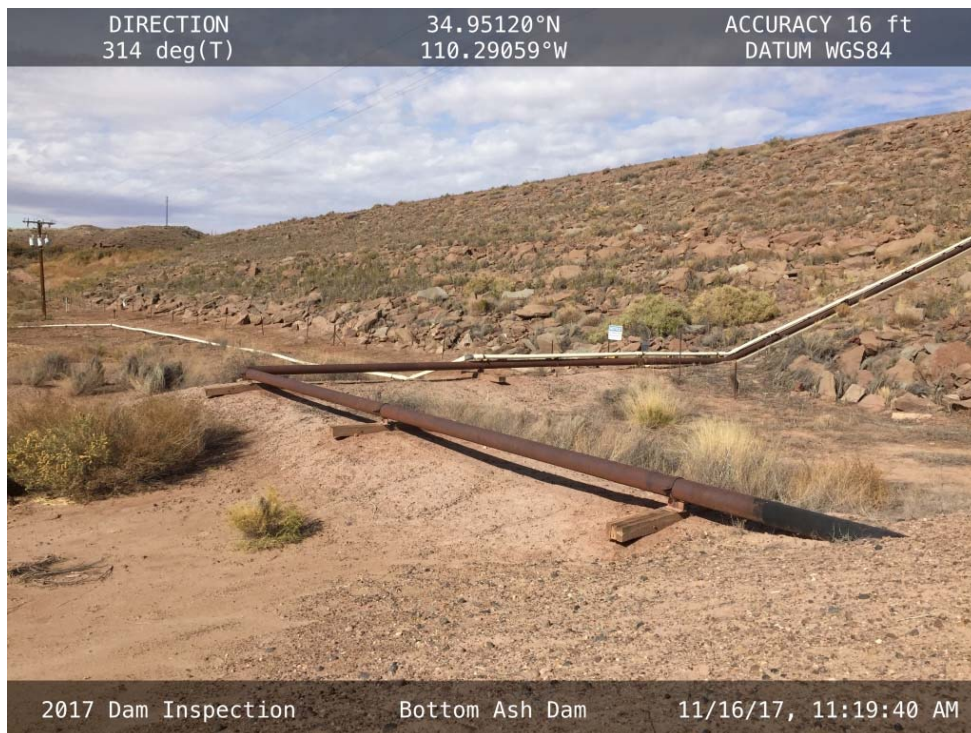
20171116 – IMG_5927

The toe of the South Embankment with most of the vegetation removed, facing west.

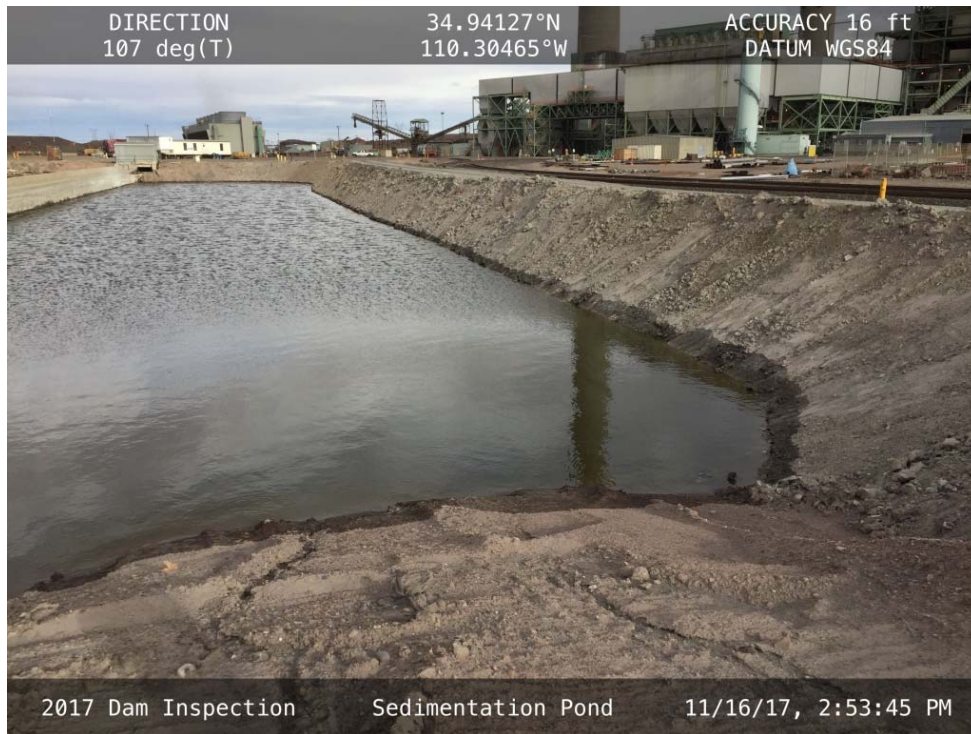
20171116 – IMG_6051

The southern slope of the southern cell, facing east.

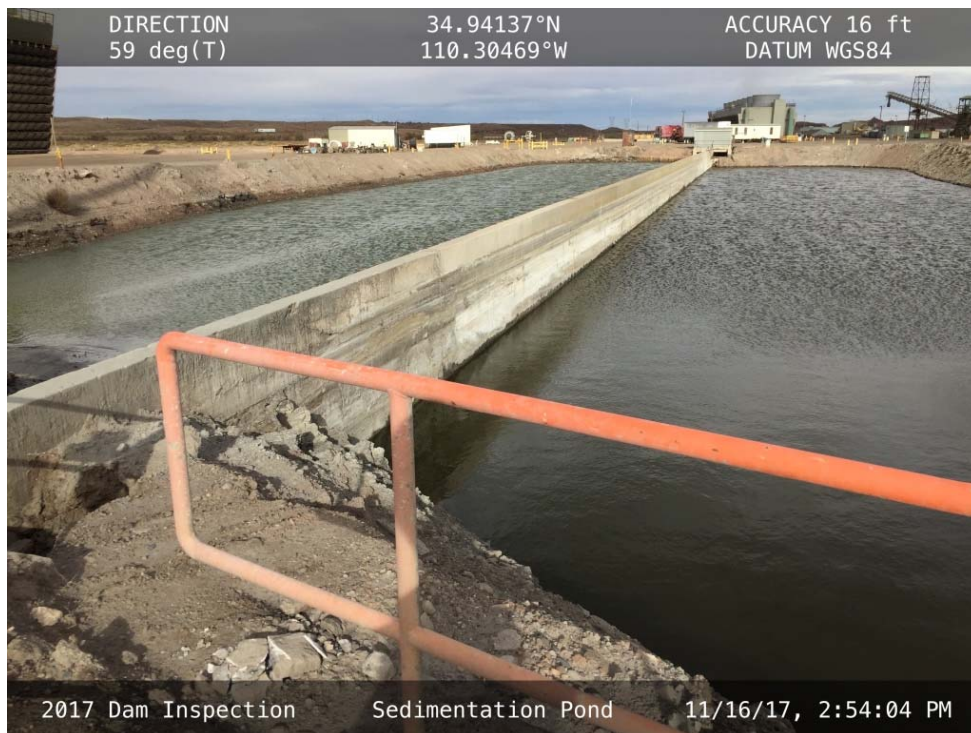
20171116 – IMG_6052

The divider wall in the Sedimentation Pond, facing northeast.

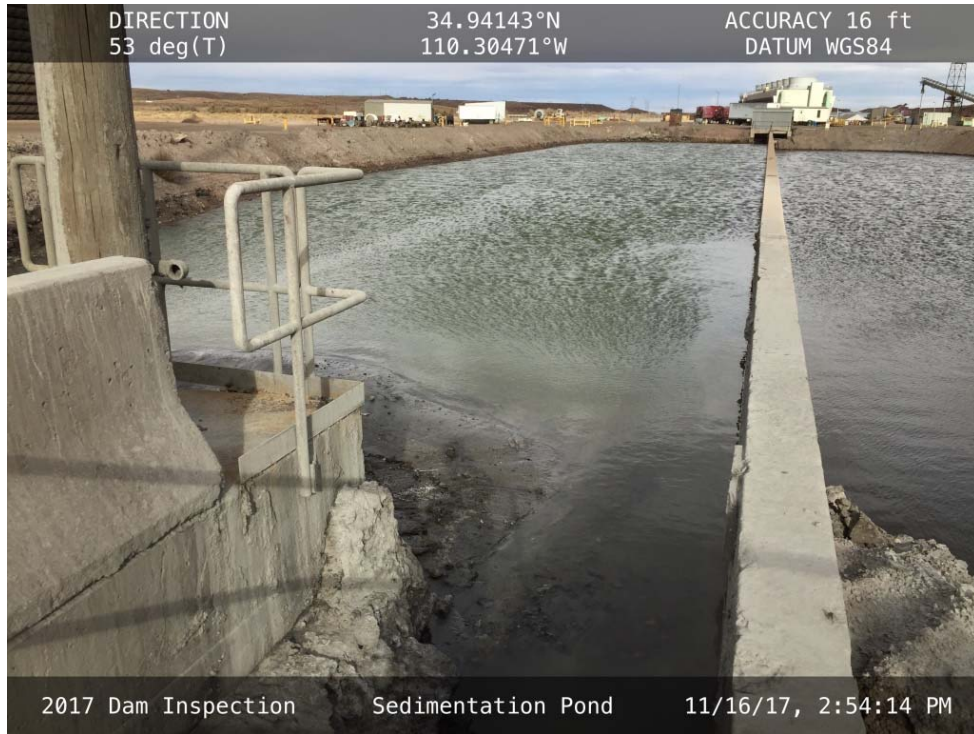
20171116 – IMG_6053

The northern cell of the Sedimentation Pond, facing northeast.

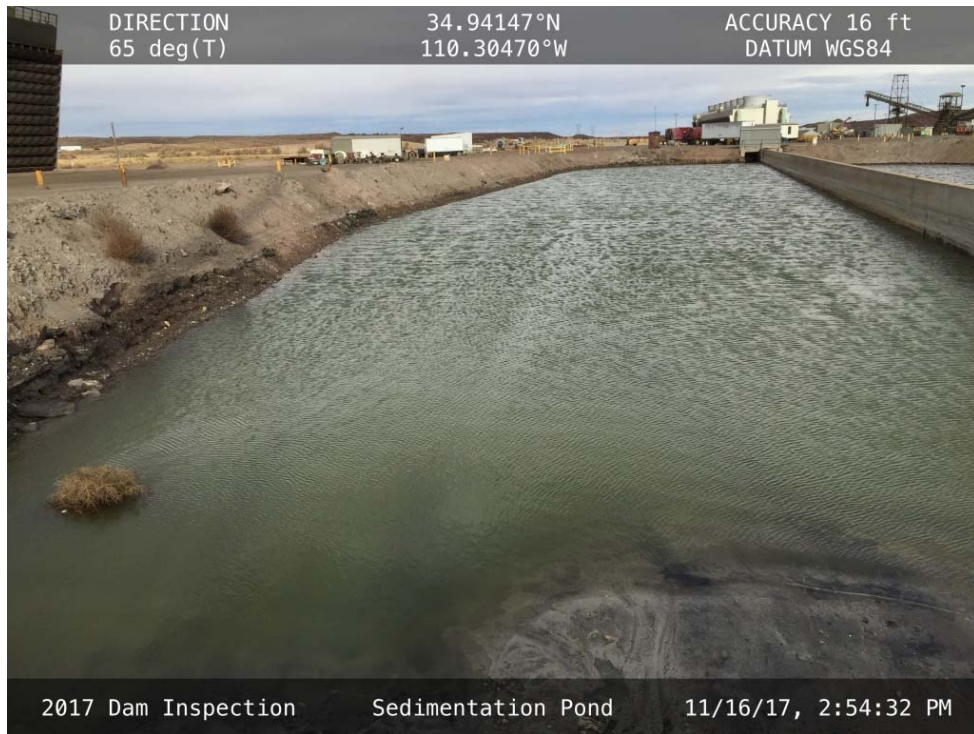
20171116 – IMG_6055

The northern cell of the Sedimentation Pond, facing northeast.

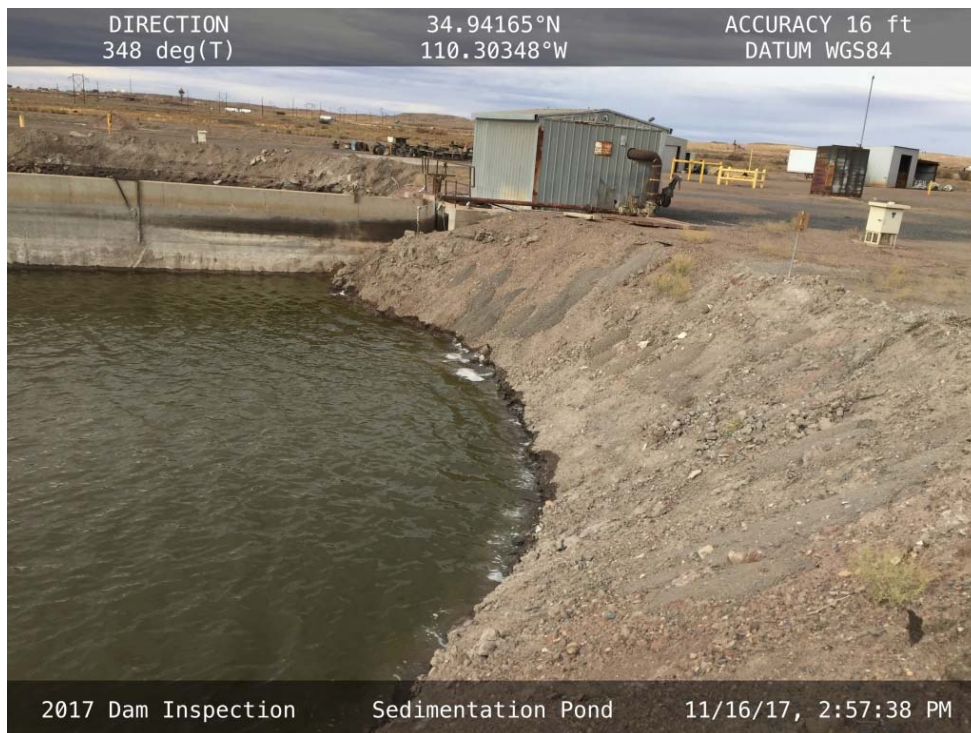
20171116 – IMG_6064

The upstream slope of the southern cell along the east side, facing north.

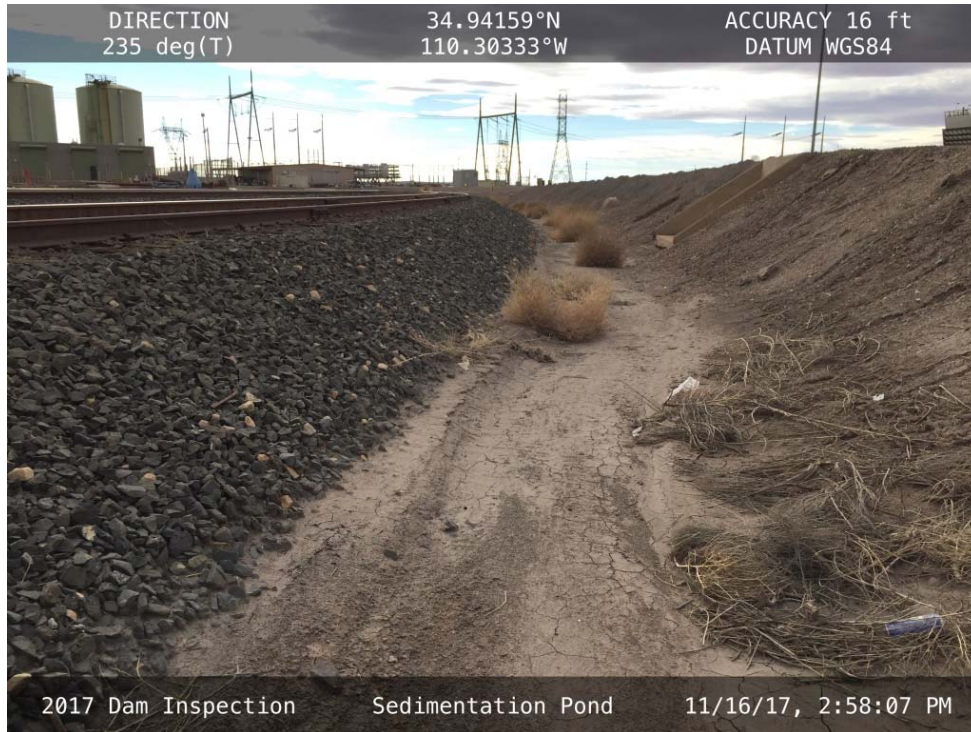
20171116 – IMG_6065

Canal between the railroad tracks (left) and the Sedimentation Pond (right), facing southwest.

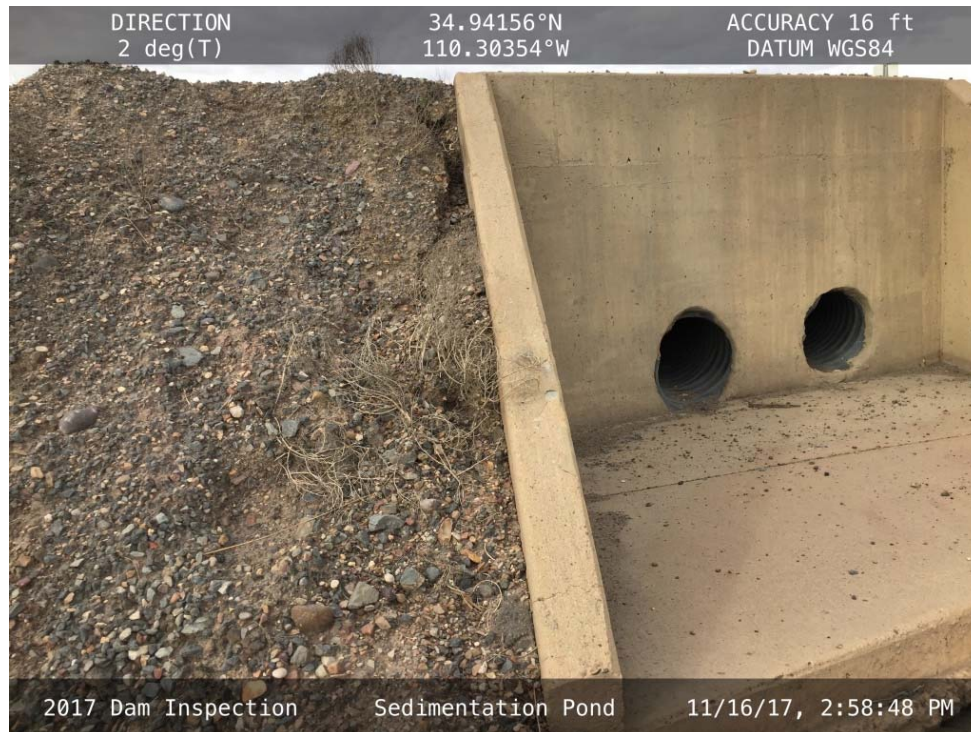
20171116 – IMG_6070

Erosion around the concrete spillway along the south embankment.

Action Item	Action Status
1) Monitor the erosion around the outfall structure and the surface of the CCR unit.	Repair as needed.

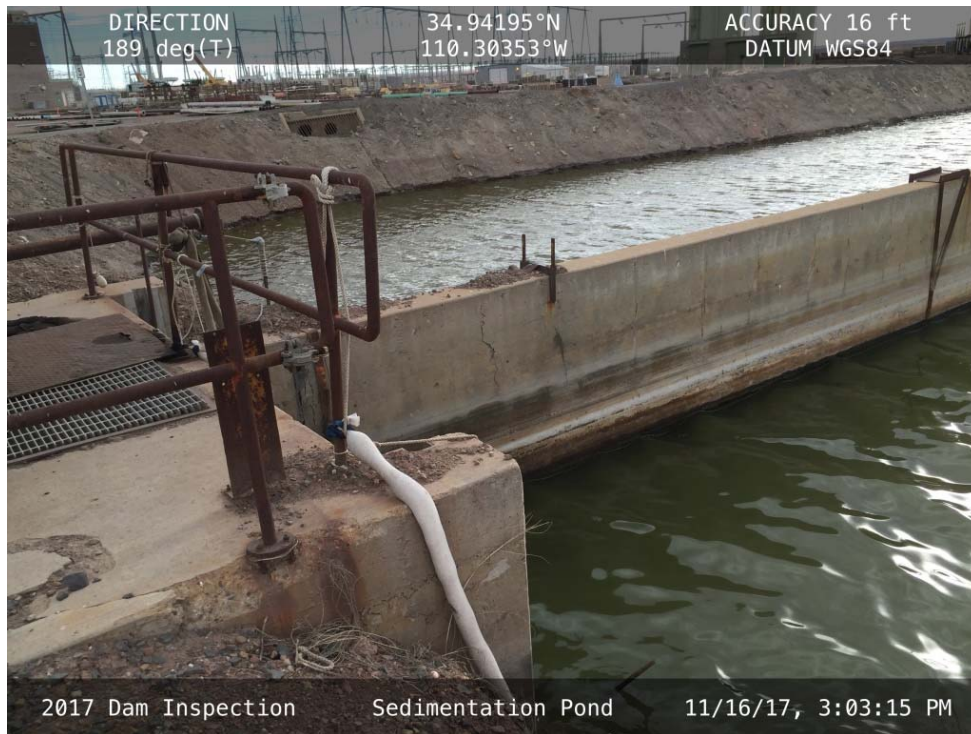
20171116 – IMG_6074

The north side of the divider wall in the Sedimentation Pond, facing south.

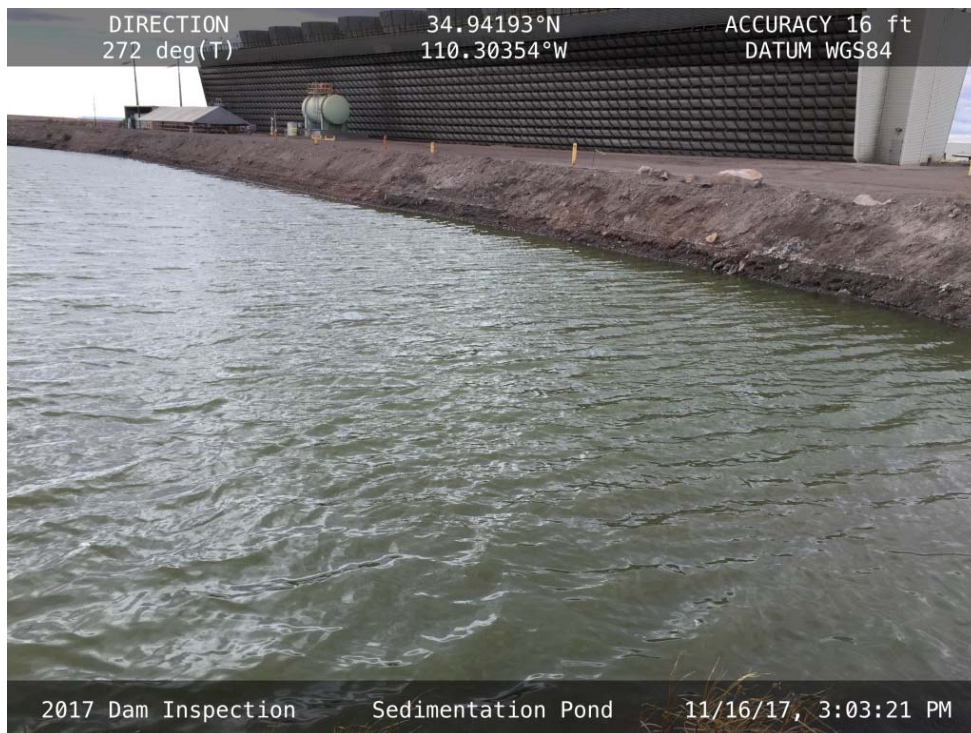
20171116 – IMG_6077

The northern cell of the Sedimentation Pond, facing west from the east embankment.

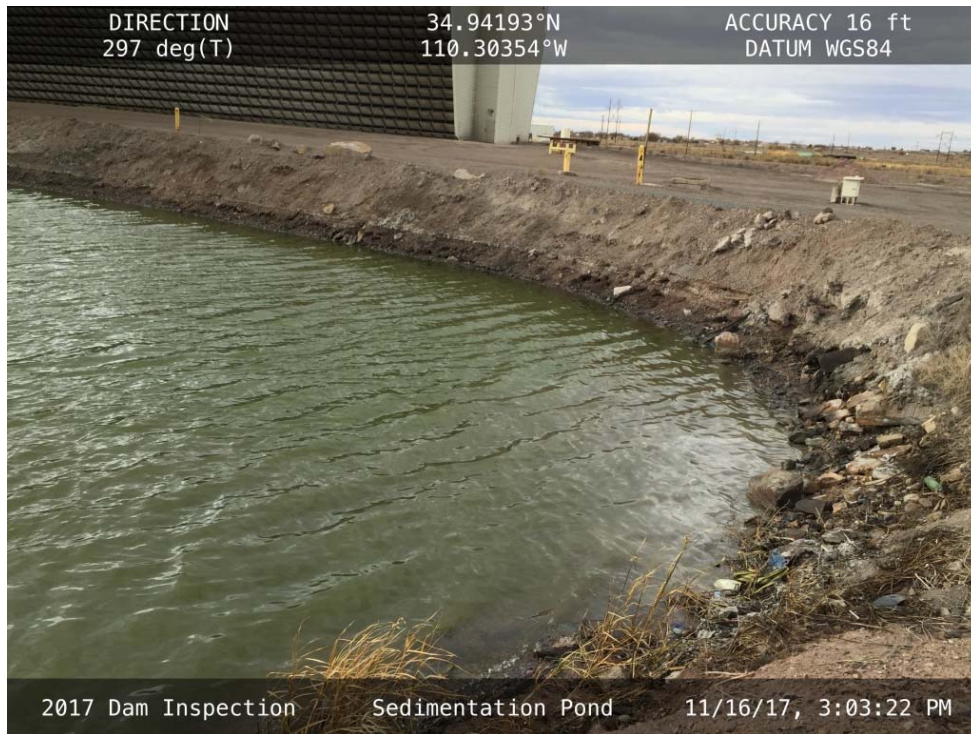
20171116 – IMG_6078

The northern portion of the Sedimentation Pond, facing west from the east embankment.

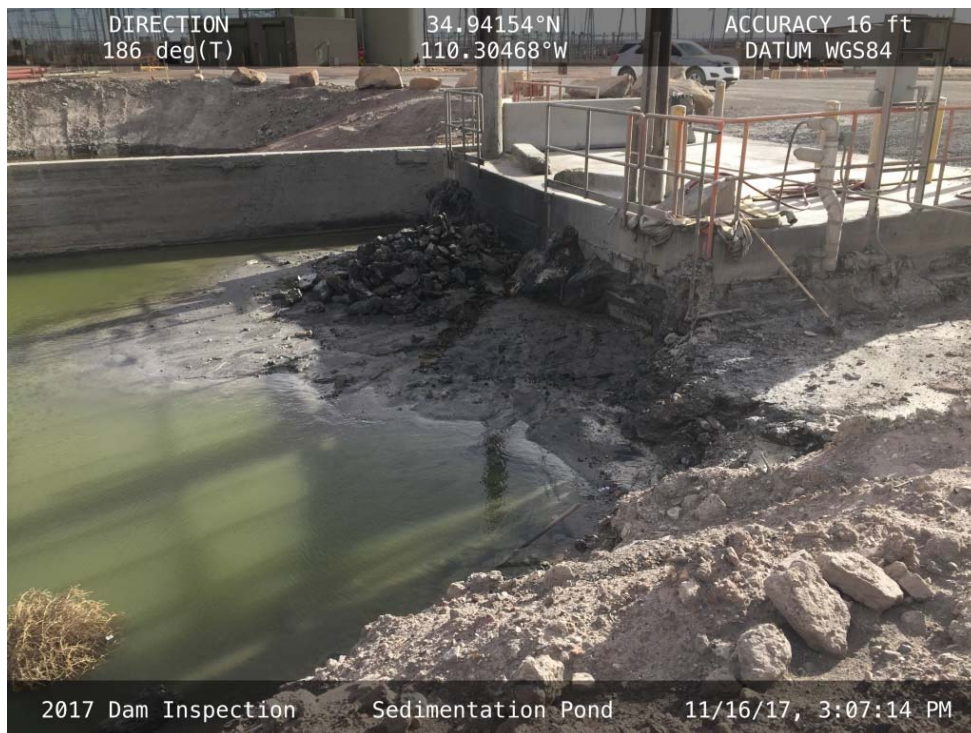
20171116 – IMG_6079

The western portion of the northern cell in the Sedimentation Pond, facing south.

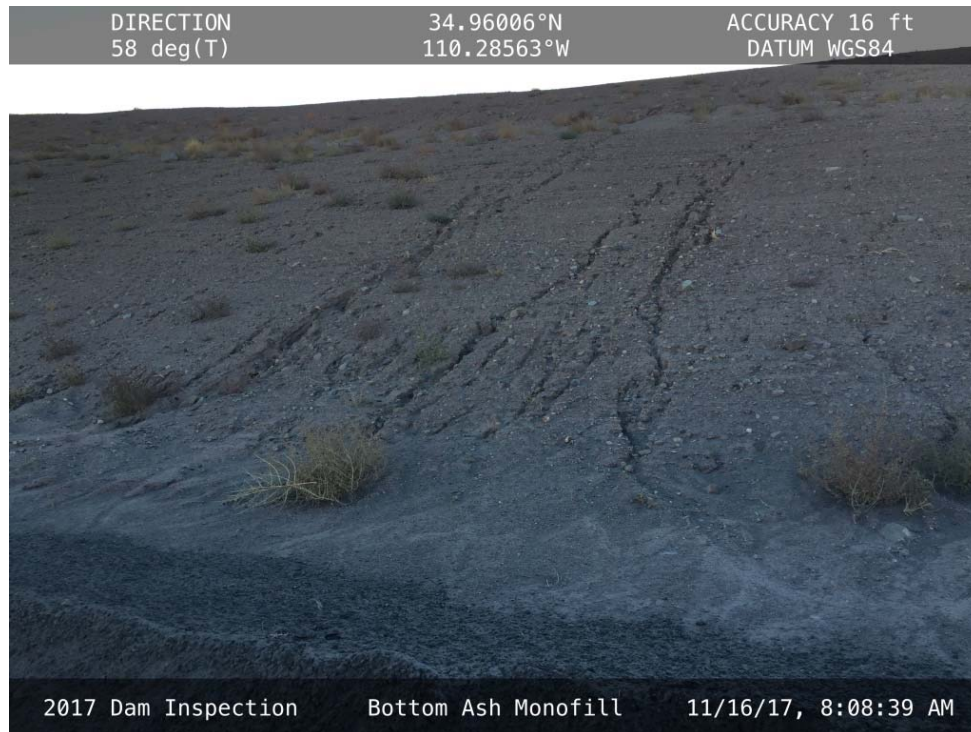
20171116 – IMG_5722

- ii. Erosion rills were observed along the western slope of the CCR unit and a shallow erosion channel was observed in the northwest corner of the CCR unit (photos IMG_5722 and IMG_5725). Monitor these areas and repair them if the erosion depth exceeds 1 foot.

Erosion rills along the western slope of the Bottom Ash Monofill, facing east.

Action Item	Action Status
1) There is evidence of head cutting in the inlet to the Stormwater Detention Basin, erosion along the west slope, and an erosion channel forming in the northwest corner of the structure.	Monitor and repair erosion as needed. NOTE: This will always be an ongoing maintenance activity.

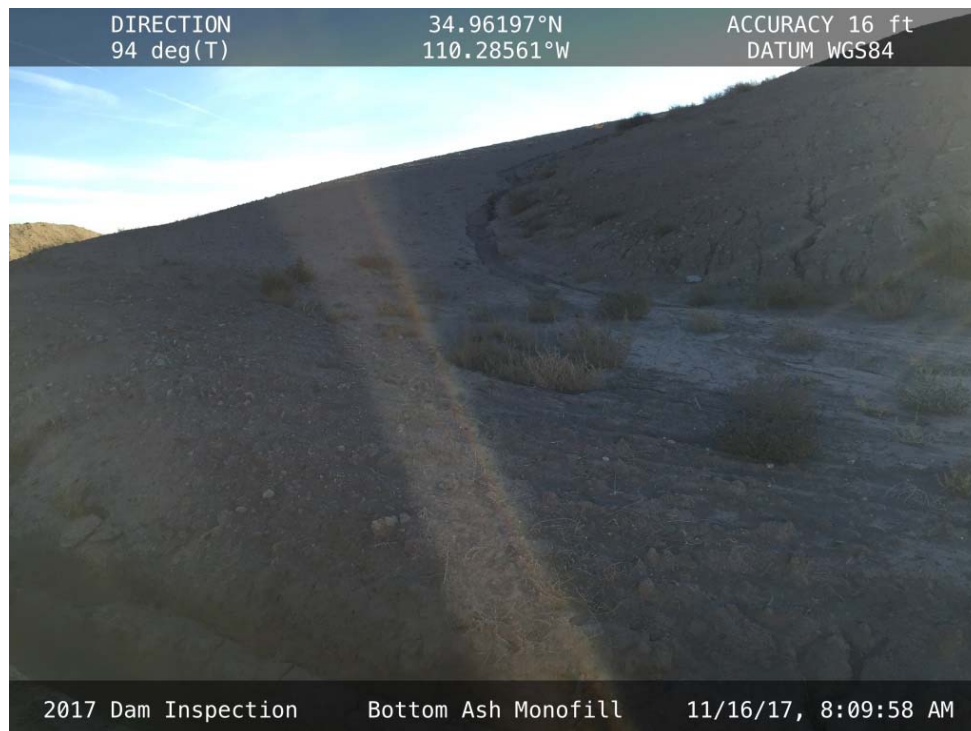
20171116 – IMG_5725

Erosion on the north side of the western slope, facing east.

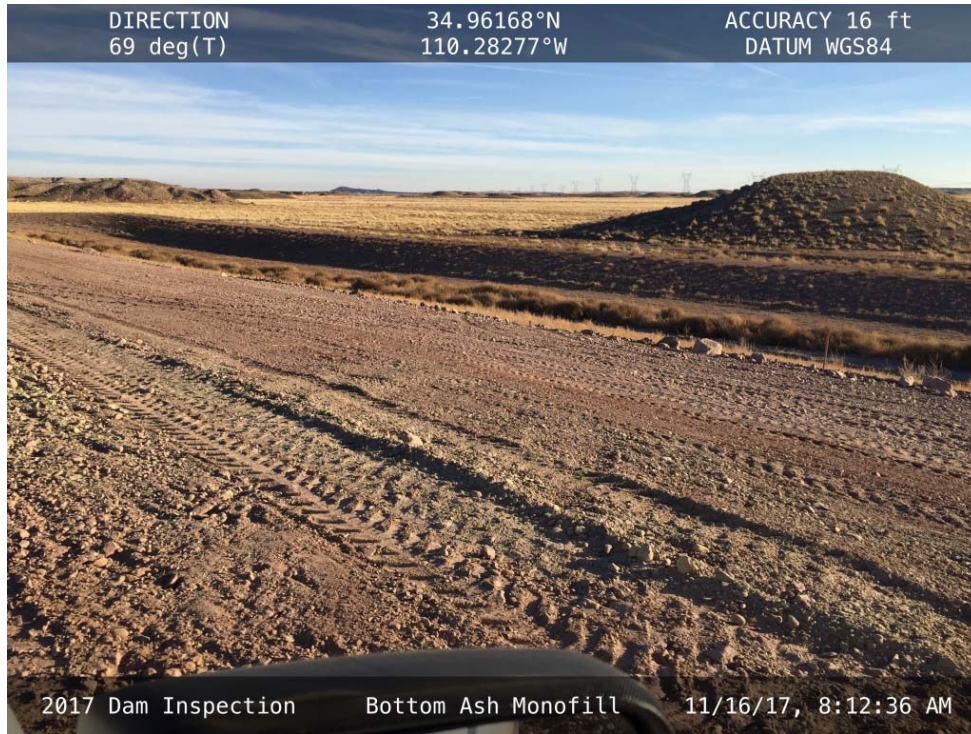
20171116 – IMG_5727

The diversion channel along the west side of the Bottom Ash Monofill, facing northeast.

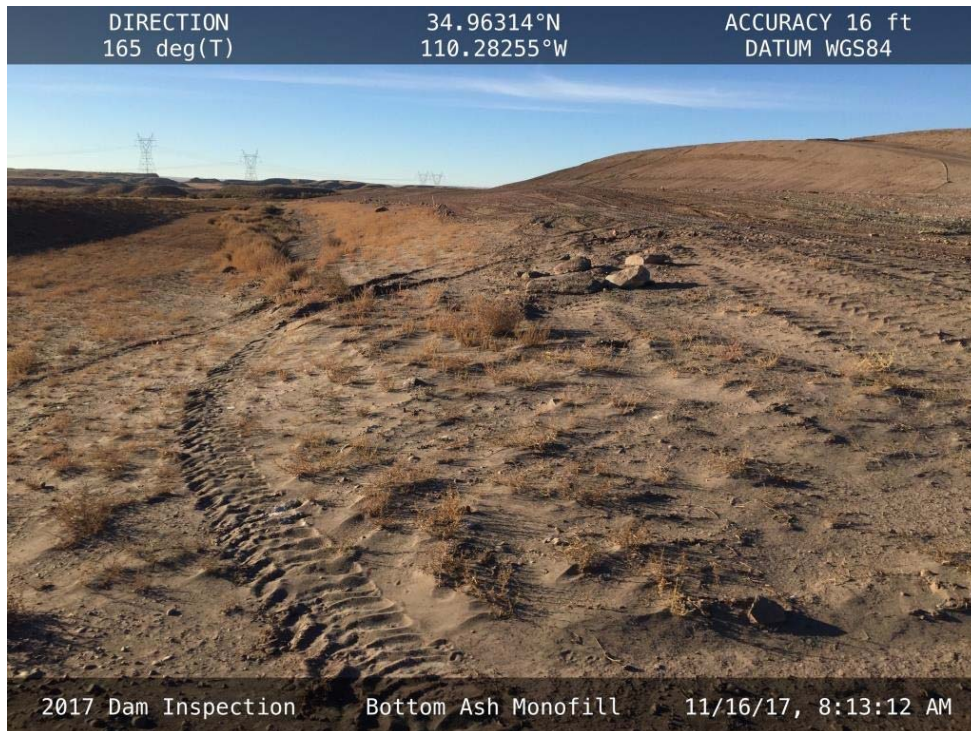
20171116 – IMG_5728

The diversion channel along the west side of the Bottom Ash Monofill, facing south.

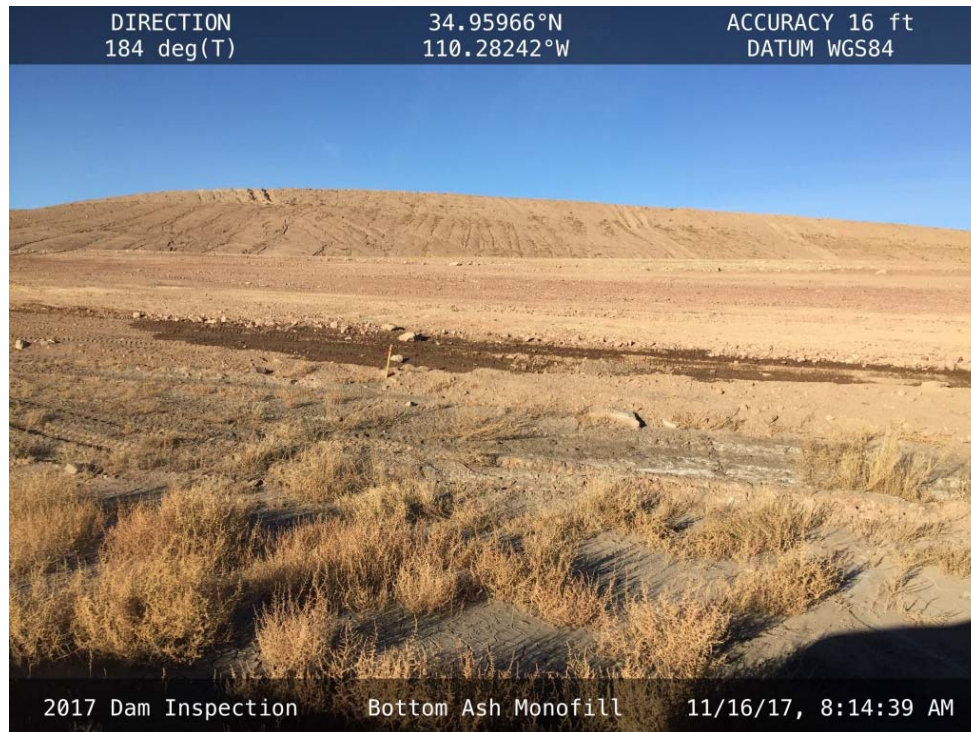
20171116 – IMG_5730

The southeast corner of the Bottom Ash Monofill, facing south.

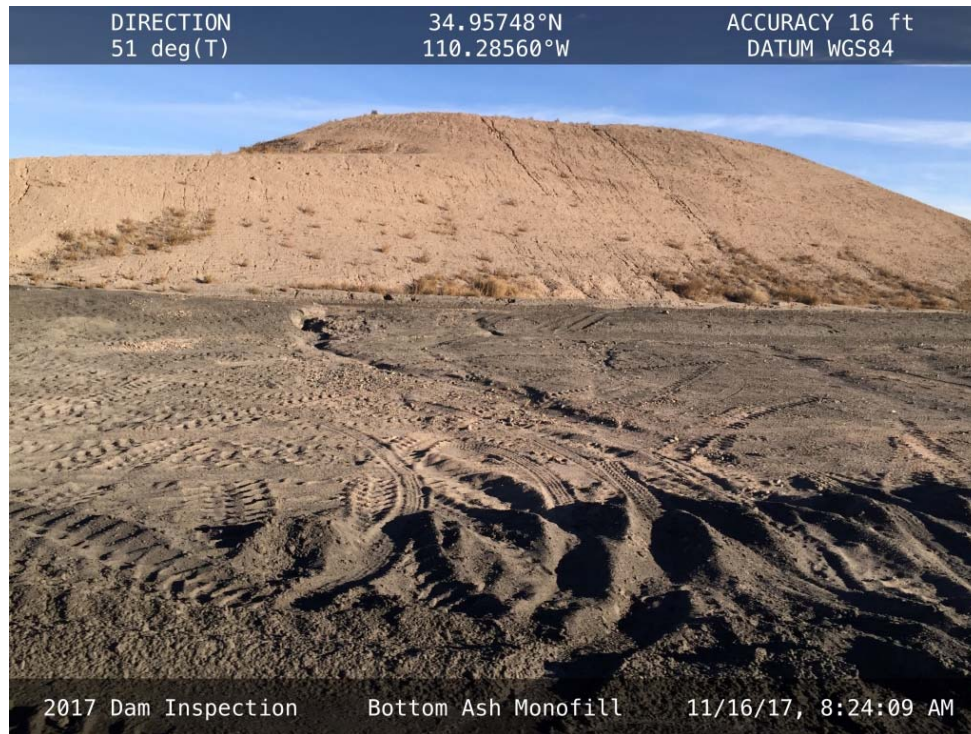
20171116 – IMG_5750
The south side of the Bottom Ash Monofill, facing northeast.
