# CHOLLA POWER PLANT Fly Ash Dam, Bottom Ash Dam, Sedimentation Pond, and Bottom Ash Monofill

## Annual CCR Impoundment and Landfill Inspection Report

2020

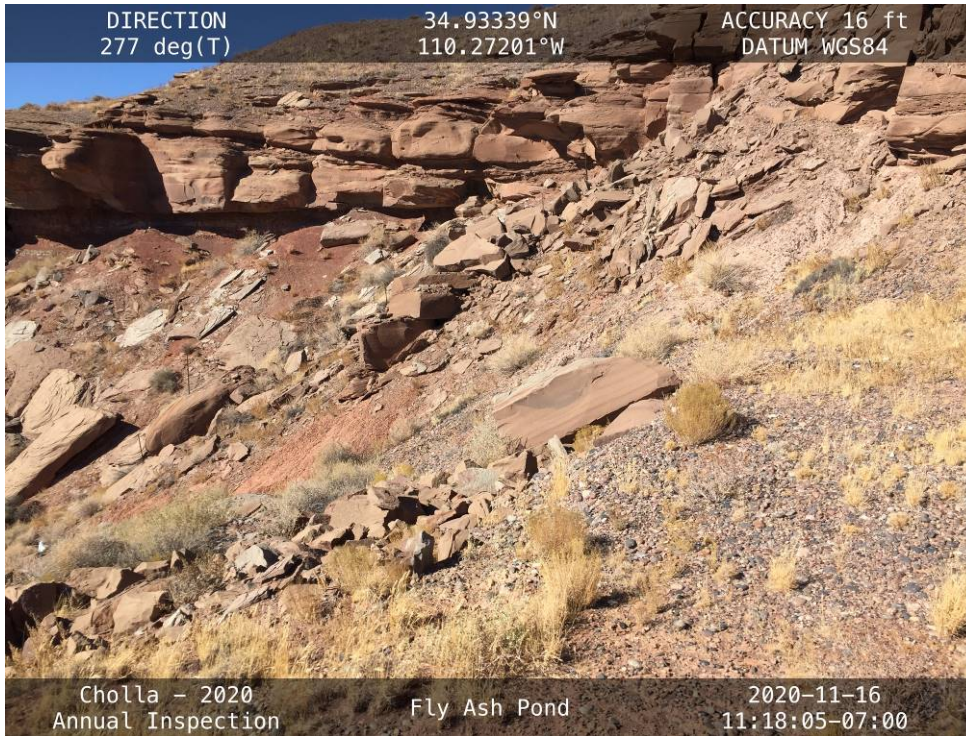
**20201116 – IMG\_2209**

e	Seepage?	Historic seepage has been observed downstream of the Northwest Abutment during previous inspections. The areas were observed to be dry during this inspection.		X		X		
f	Animal burrows?	None observed. Continue to monitor.		X		X		
<b>7</b>	<b>SEEPAGE/PIPING CONTROL DESIGN FEATURE(S)</b>							
a	Describe:	1) The Geronimo and Hunt seepage collection and pump back systems are located downstream of the dam near I-40 for fluid interception. 2) Discharge from the crest side of the reservoir creates a beach to prevent water from being stored against the upstream face.						
b	Internal drains flowing?				X	X		
c	Seepage at or beyond toe?	See comment v.			X	X		
d	If so, does seepage contain fines?	No water was observed in the sumps.		X				
e	Evidence of sand boils at or beyond toe?			X

The downstream side of the Northwest Abutment contact.

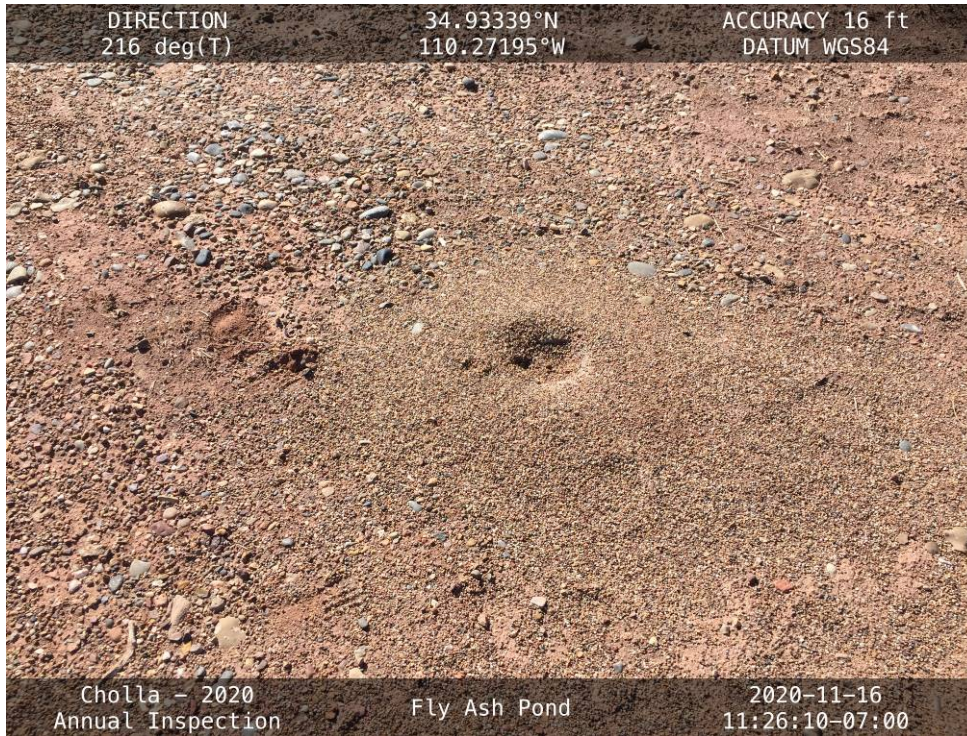
**20201116 – IMG\_2233**

<b>DAM EMBANKMENT CHECKLIST</b>											
<b>3</b>	<b>DAM CREST</b>										
a	Settlements, slides, depressions?										
b	Misalignment?										
c	Longitudinal/Transverse cracking? <b>See comment ii.</b>				X	X					
d	Animal burrows? <b>Ant hills were observed at various locations across the crest (Photos IMG 2233 and IMG 2273).</b>					X	X				
e	Adverse vegetation?										
f	Erosion?										
<b>4</b>	<b>UPSTREAM SLOPE</b>										
a	Erosion? <b>Minor erosion and soil wasting observed along the upstream slope. See comment iii.</b>					X	X				
b	Inadequate ground cover?										
c	Adverse vegetation? <b>None observed. Continue to monitor vegetation.</b>				X		X				
d	Longitudinal/Transverse cracking?										
e	Inadequate riprap?										
f	Stone deterioration? <b>Minor wasting observed. See comment iv.</b>					X	X				
g	Settlements, slides, depressions, bulges?										
h	Animal burrows? <b>None observed. Continue to monitor.</b>				X		X

An ant hill in the crest of the embankment near the Northwest Abutment.

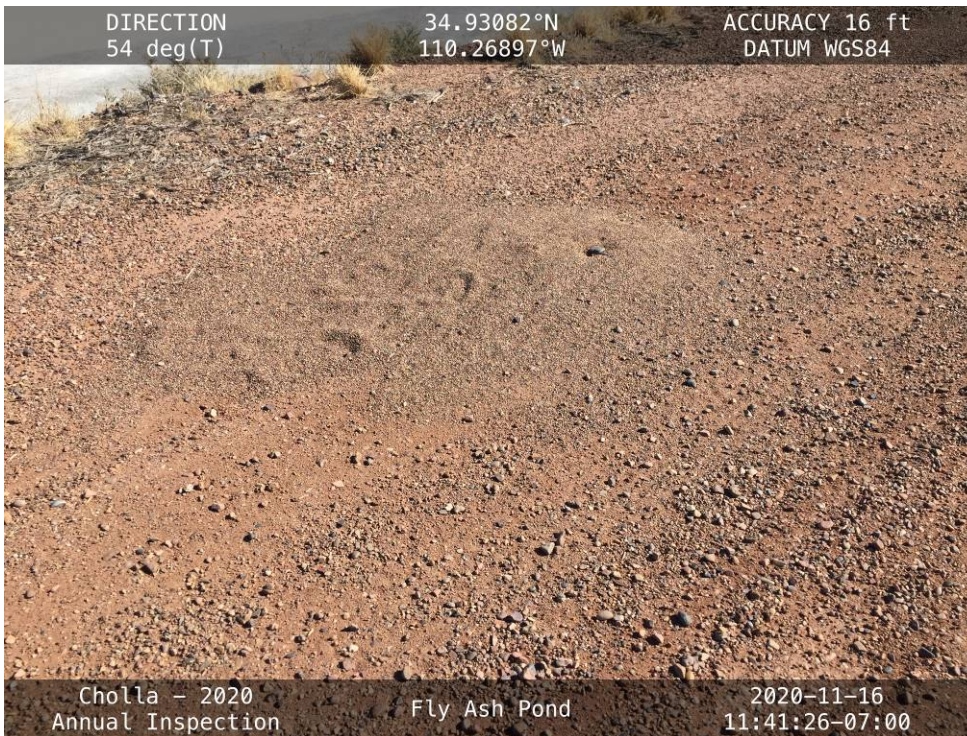
**20201116 – IMG\_2273**

An ant hill in the crest of the embankment along the West Embankment.

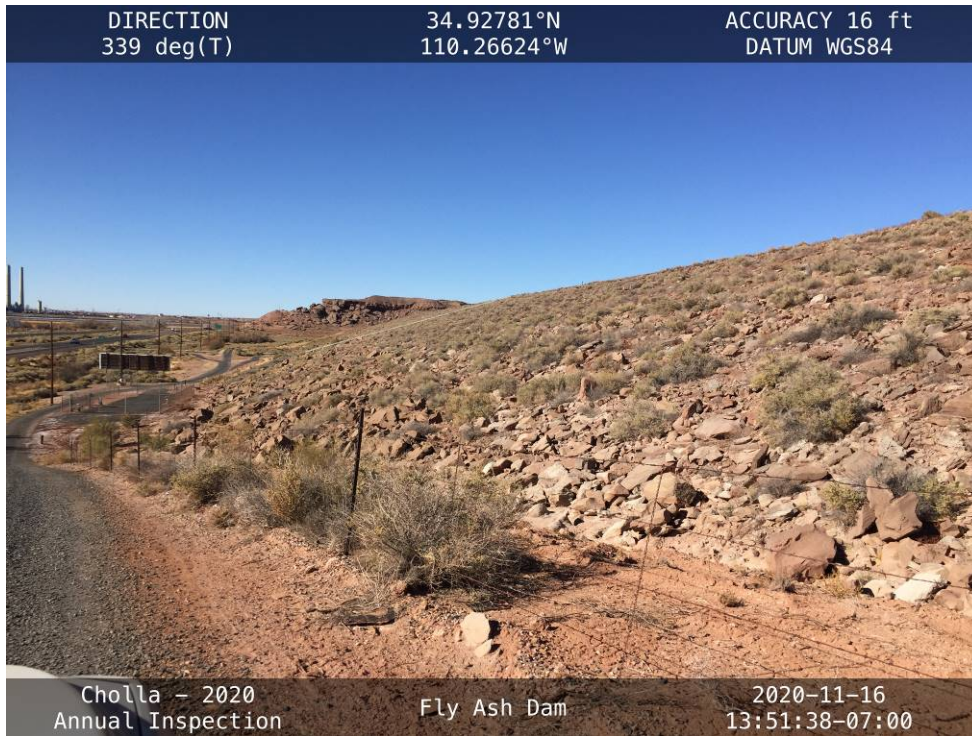
**20201116 – IMG\_2518**

Area of historic erosion along the downstream toe of the West Embankment.

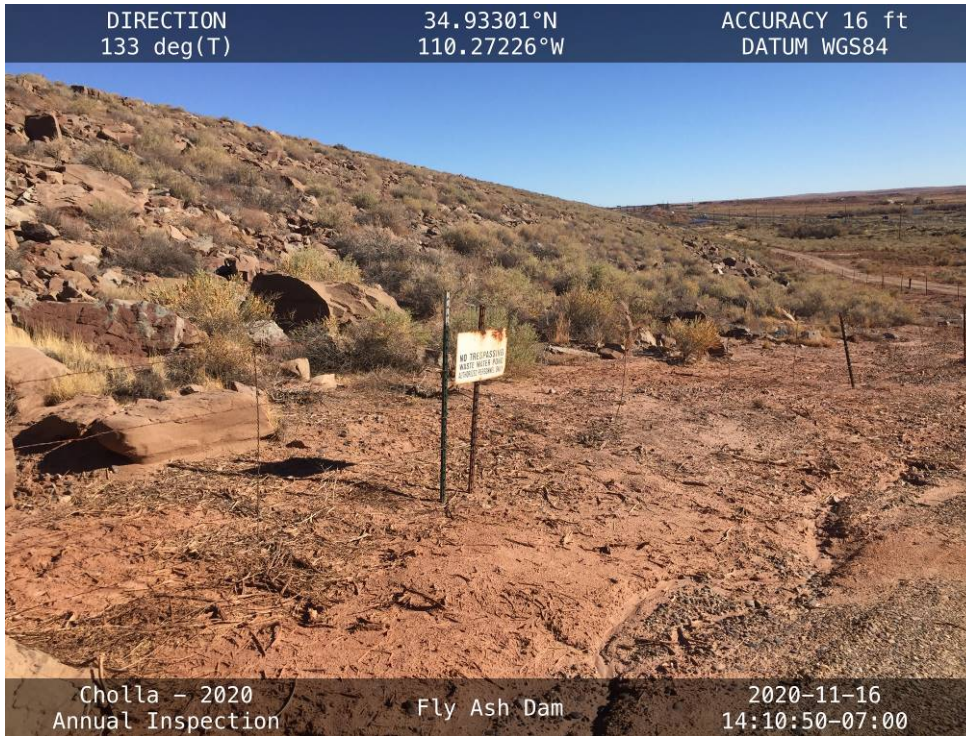
**20201116 – IMG\_2568**

The downstream toe of the West Embankment and historic erosion near the Northwest Abutment.

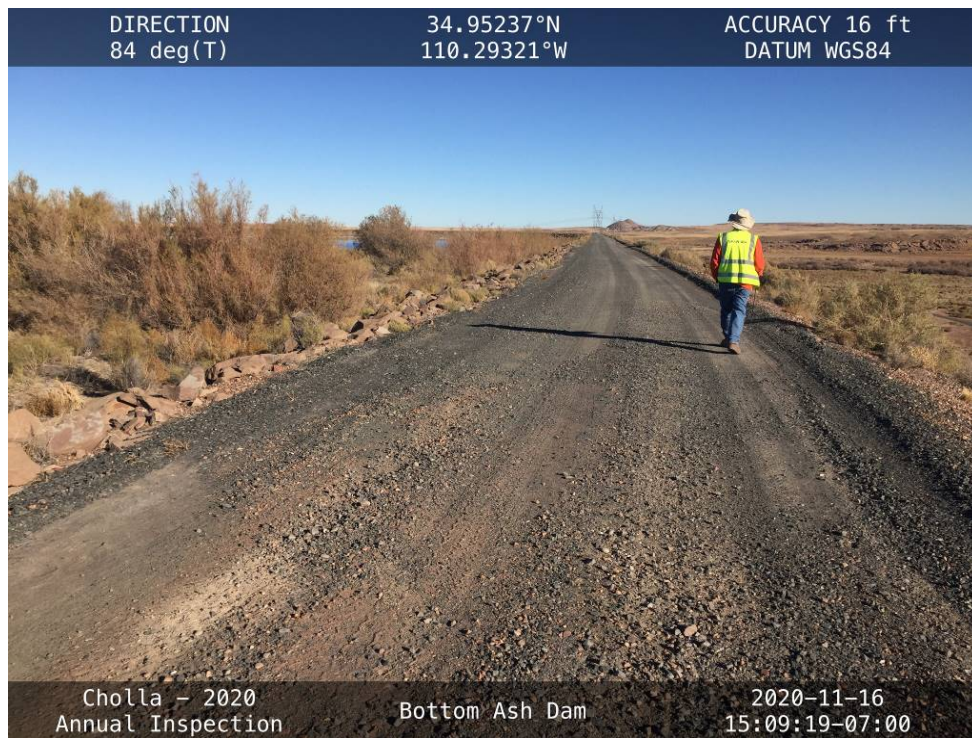
**20201116 – IMG\_2594**

The South Embankment crest, facing east from the West Abutment.

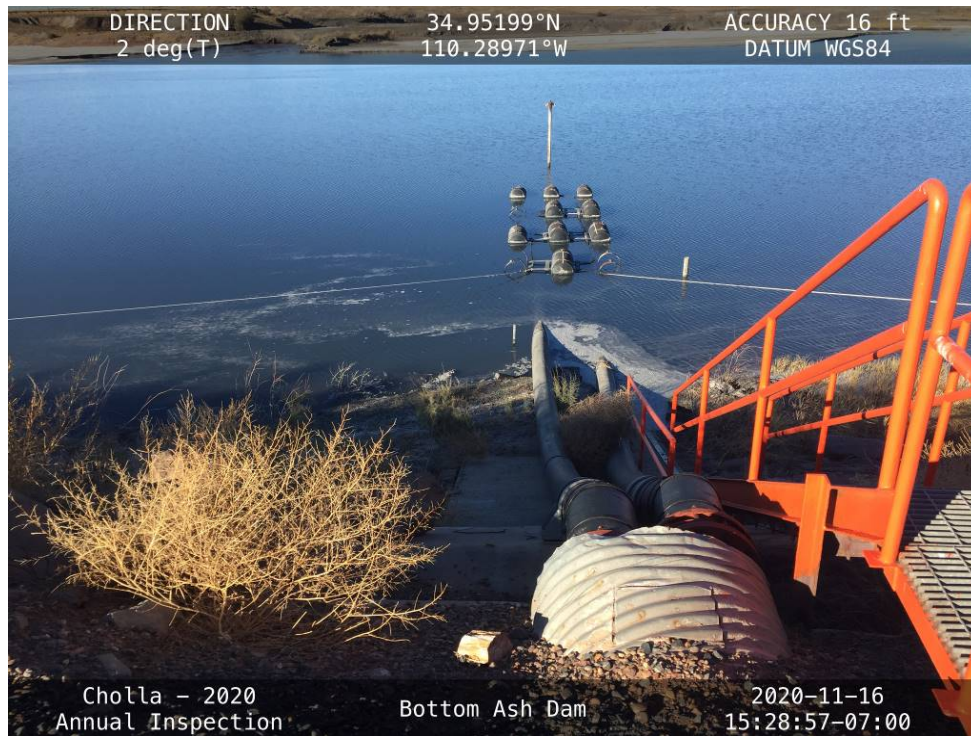
**20201116 – IMG\_2643**

The central siphon lines along the upstream slope of the South Embankment.

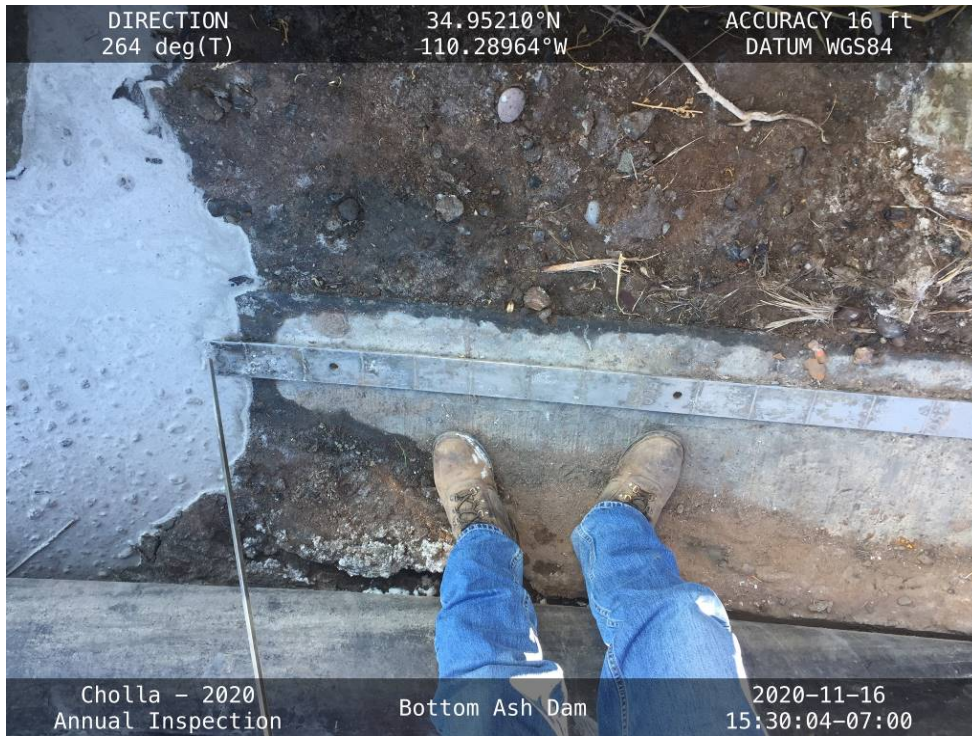
**20201116 – IMG\_2650**

The reservoir level staff gauge adjacent to the central siphon lines.

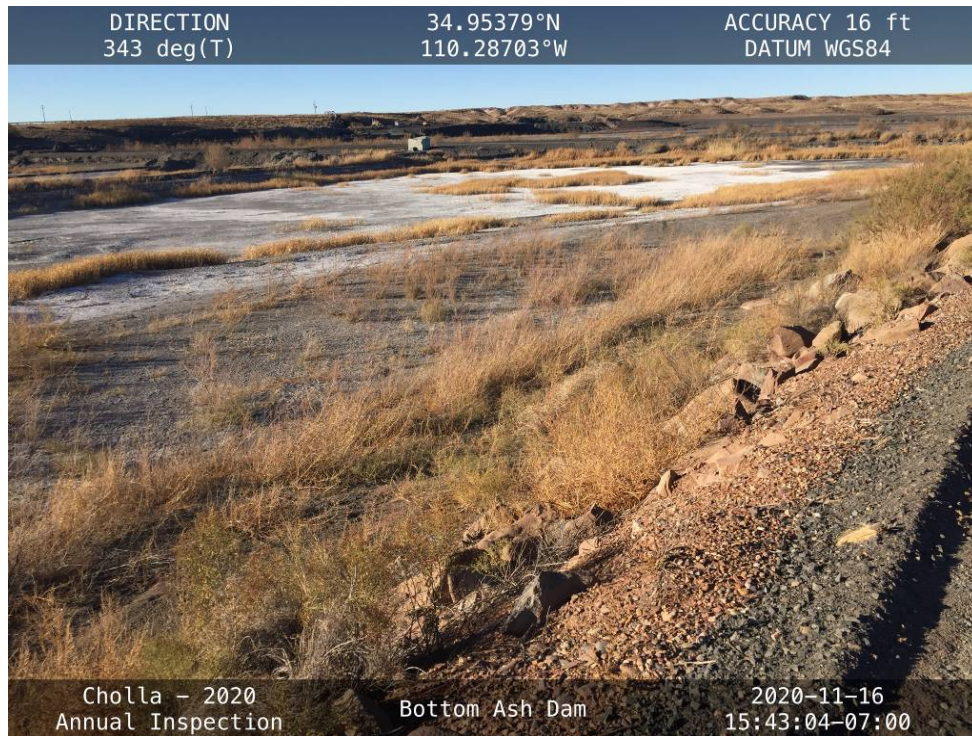
**20201116 – IMG\_2696**

The Divider Dike in the reservoir and vegetation on the upstream side of the East Embankment.

8) Remove vegetation from the upstream slope at the West Abutment.	Woody vegetation rooted in the embankment should be removed and the resulting disturbed area should be replaced with compacted material similar to the embankment material per NMOSE (2011).

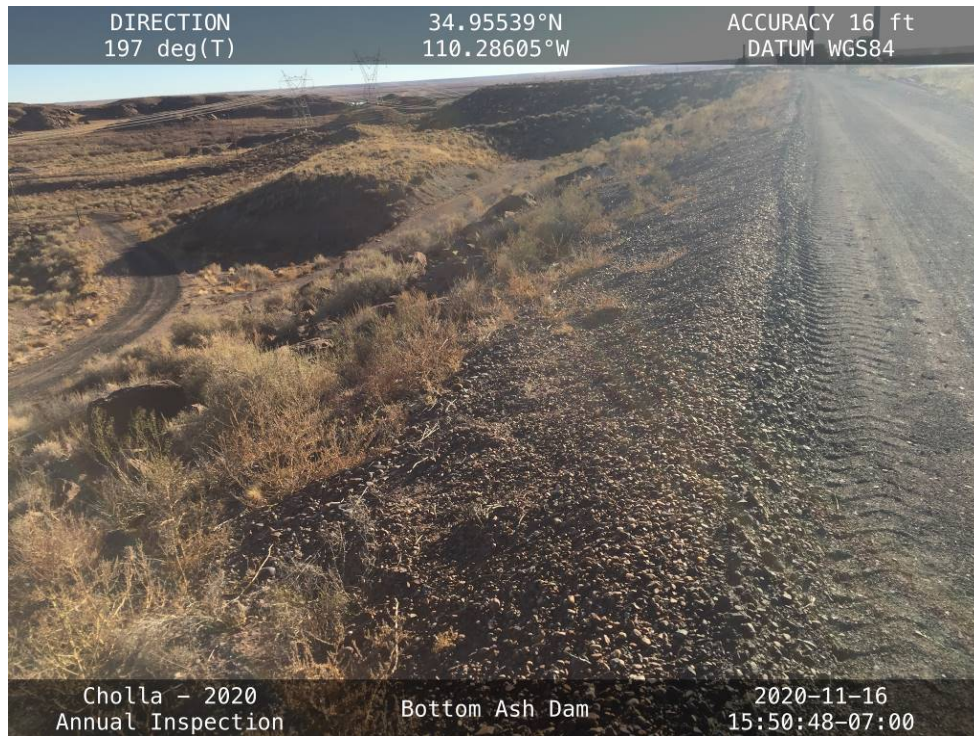
**20201116 – IMG\_2701**

The downstream slope of the East Embankment, facing south.

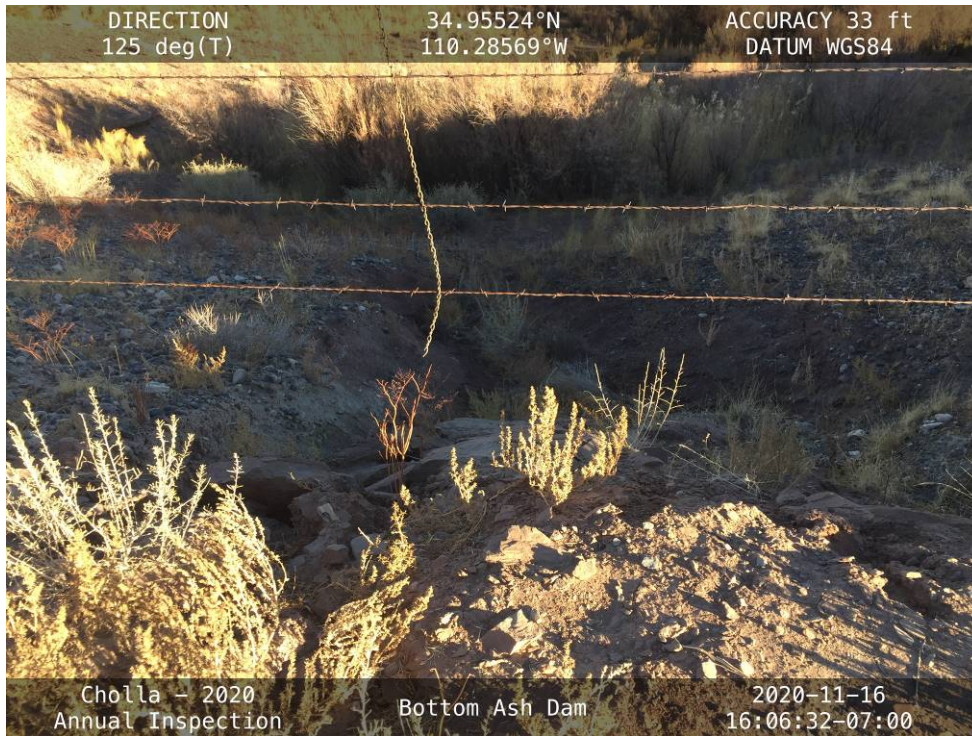
**20201116 – IMG\_2759**

An erosion gully on the downstream slope along the northern half of the East Embankment.

2) Monitor the erosion gullies at the downstream slope of the East Embankment.	Repair erosion if it exceeds 1 foot in depth.
3) Continue identifying and remediating scattered animal burrows and ant hills.	1) Mark ant hills and animal burrows identified during weekly inspections. 2) Continue remediating identified ant hills and animal burrows. NOTE: This will always be an ongoing maintenance activity.

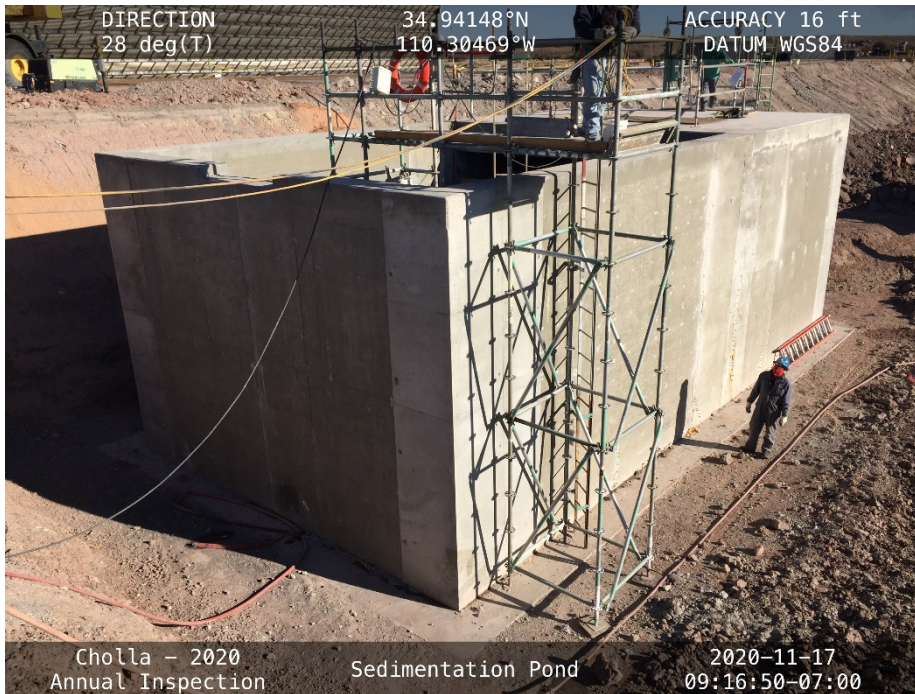
**20201117 – IMG\_2941**

The Divider Wall being removed and the resulting filled with compacted structural fill.

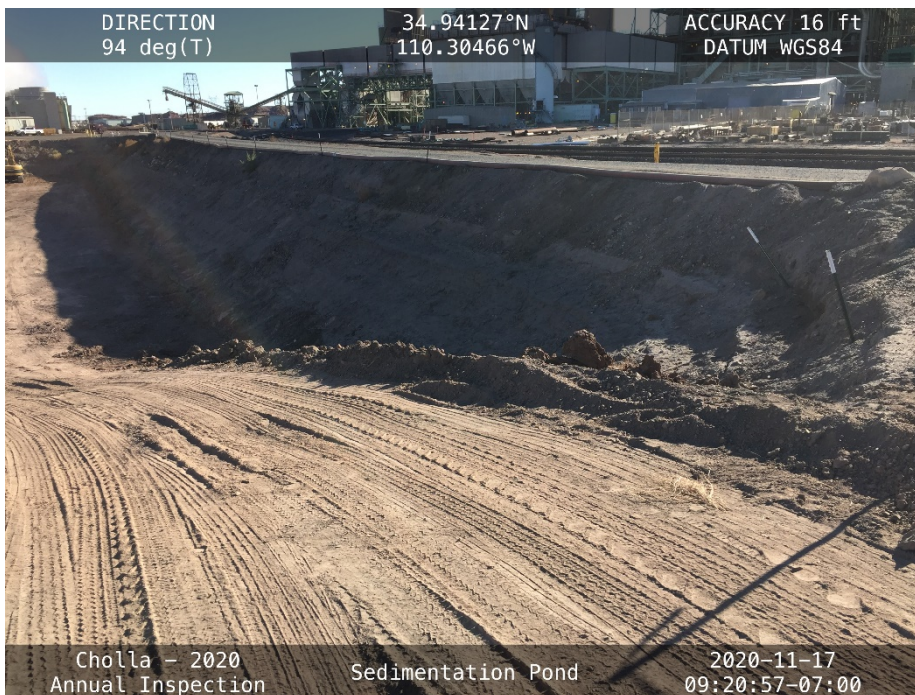
**20201117 – IMG\_2944**

The new Sedi Tank being constructed in the North Cell to replace the function of the Sedimentation Pond.

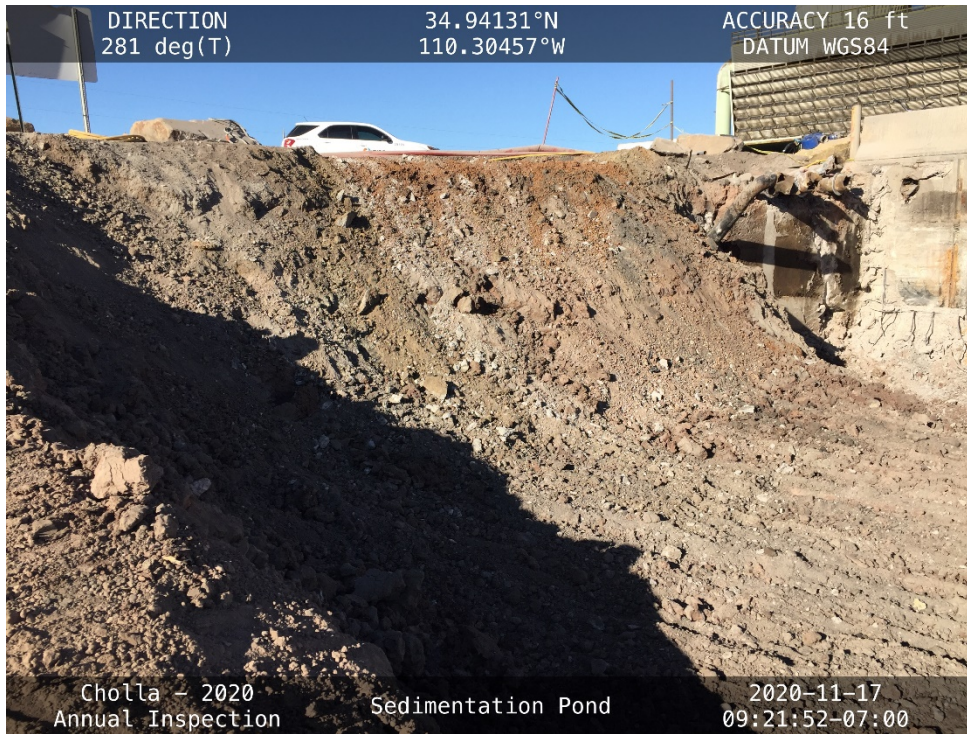
**20201117 – IMG\_2959**

The temporary access ramp in the South Cell (foreground) and the upstream slope of the south embankment (background), facing east from the west side.

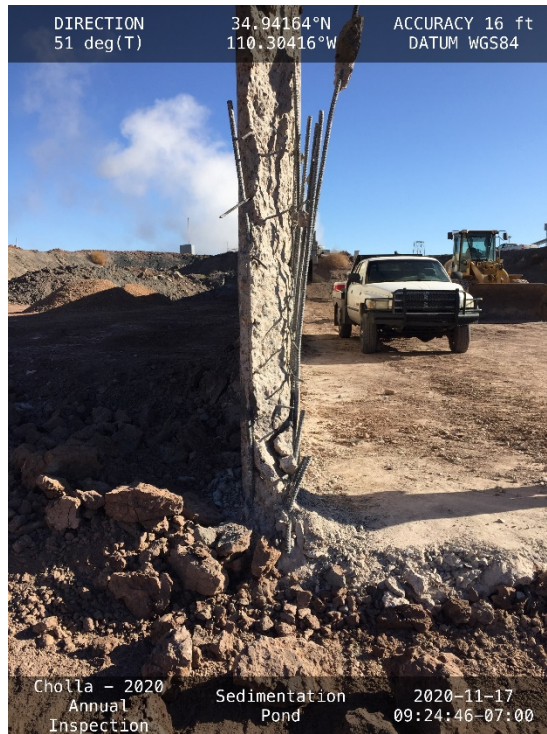
**20201117 – IMG\_2967**  
 The Sedi Tank contractor removing the Divider Wall and compacting structural fill in the void.

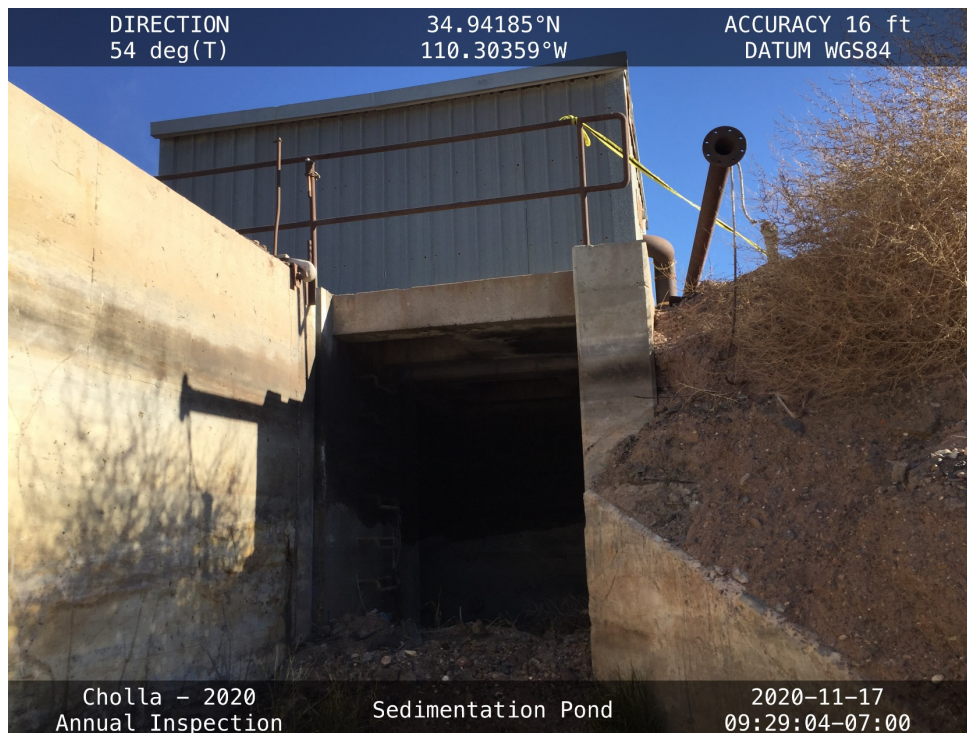
**20201117 – IMG\_2978**

The Divider Wall in a partially demolished condition, facing northeast.

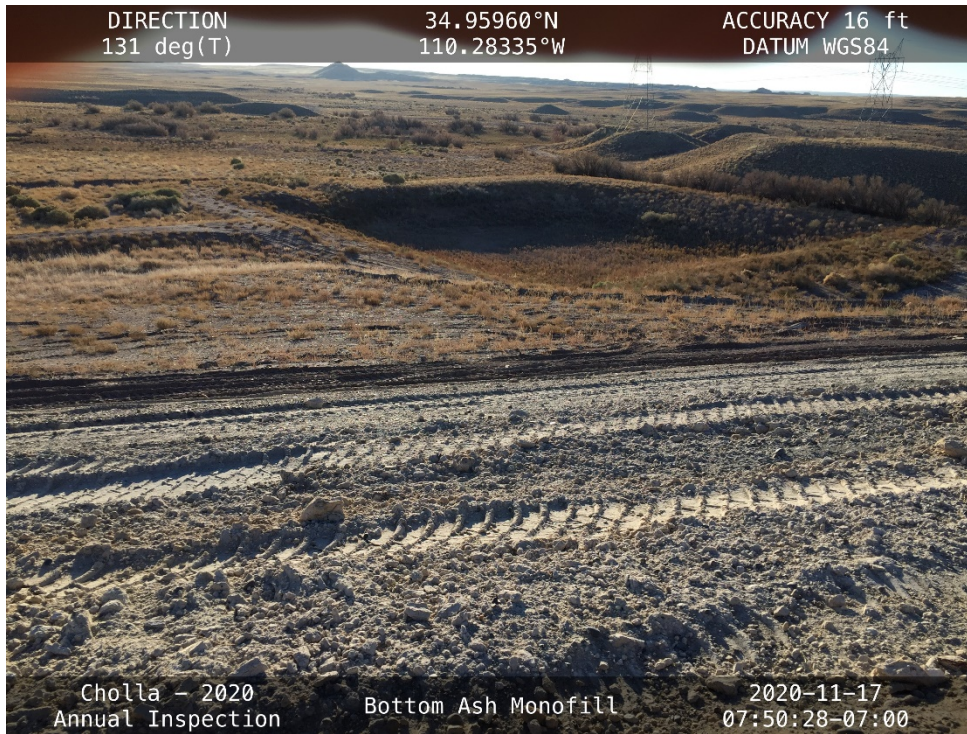
**20201117 – IMG\_2839**

Erosion gullies along the eastern slope of the Bottom Ash Monofill, facing west.

<b>Action Item</b>	<b>Action Status</b>
1) Minor erosion throughout the CCR unit.	Repair erosion if it exceeds 1 foot in depth. NOTE: This will always be an ongoing maintenance activity.

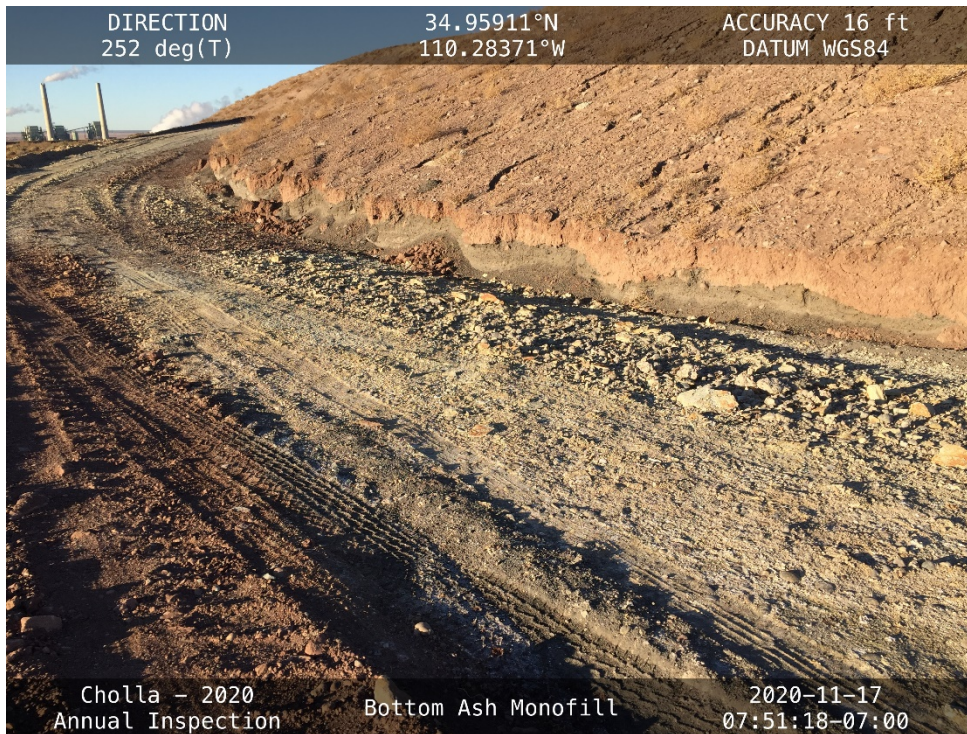
**20201117 - IMG\_2846**

The Stormwater Detention Basin, as seen from the eastern side of the Bottom Ash Monofill.

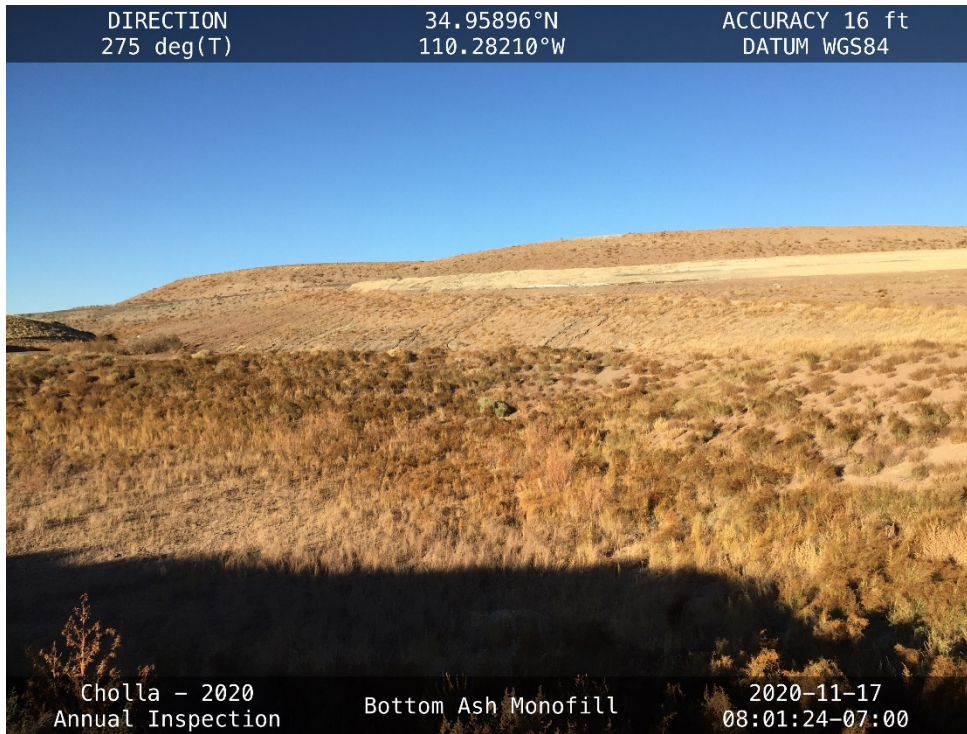
**20201117 – IMG\_2866**  
An incipient erosion rill where erosion was previously repaired in the northeast corner of the Stormwater Detention Basin.

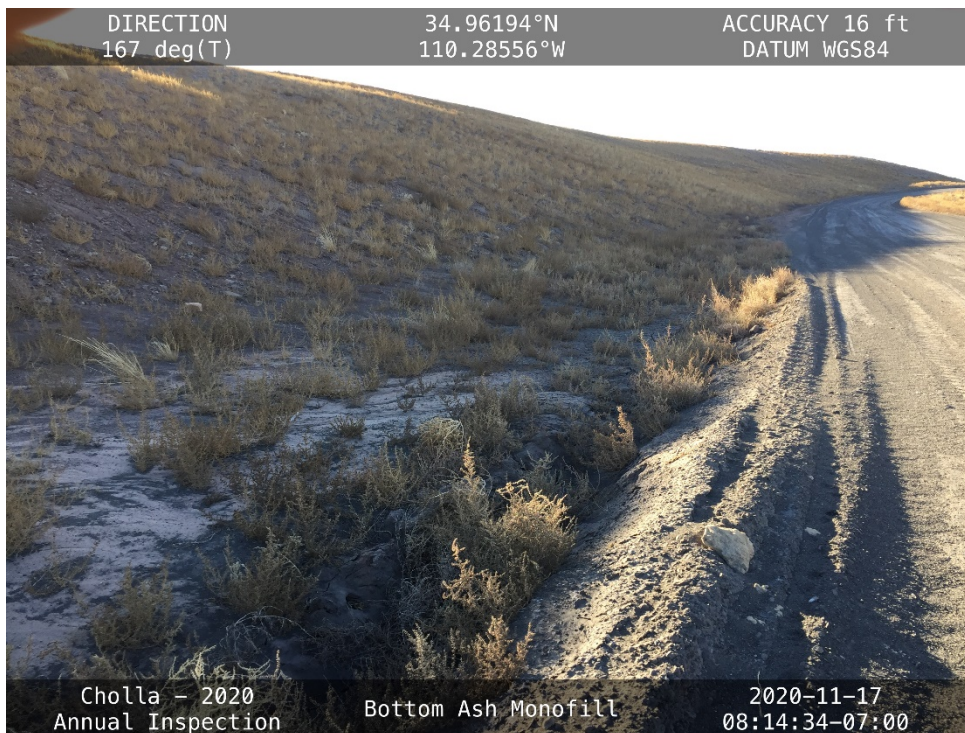
**20201117 – IMG\_2875**

Erosion rills where erosion was previously repaired in the northwest corner of the Stormwater Detention Basin.

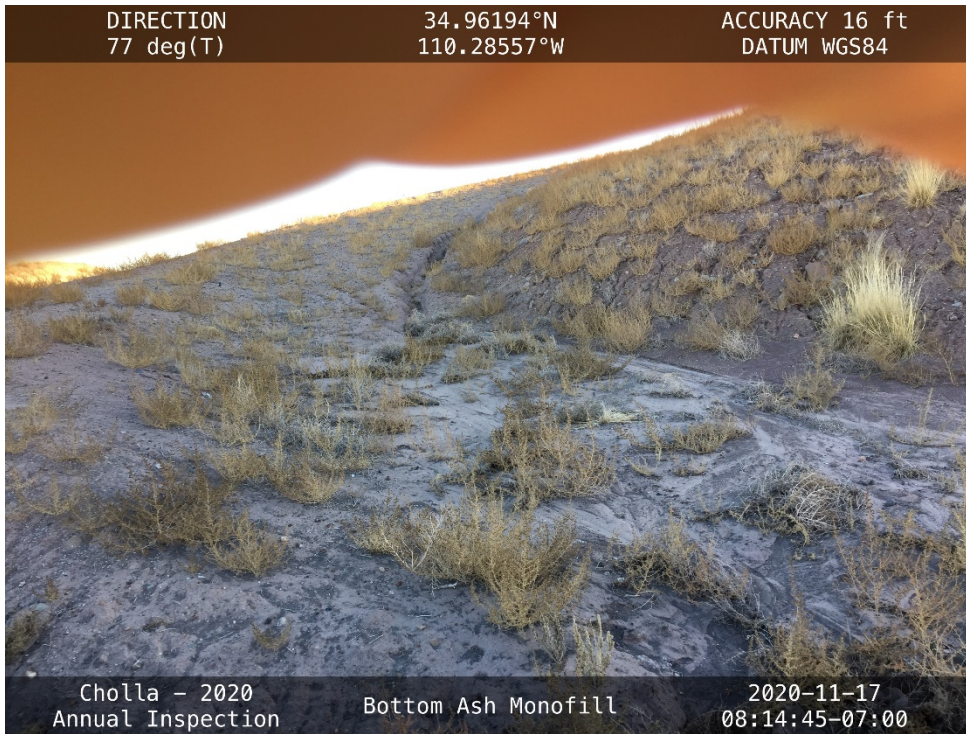
**20201117 – IMG\_2883**

The toe of the western slope, facing south from the north access ramp.

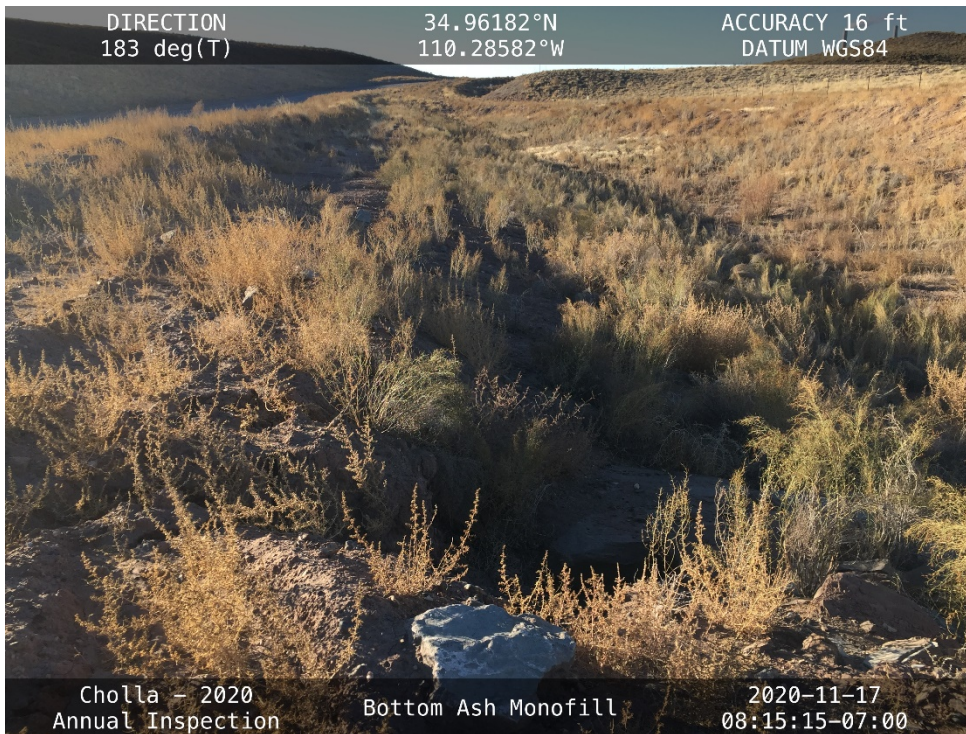
**20201117 – IMG\_2884**

Erosion on the north side of the western slope, facing east.

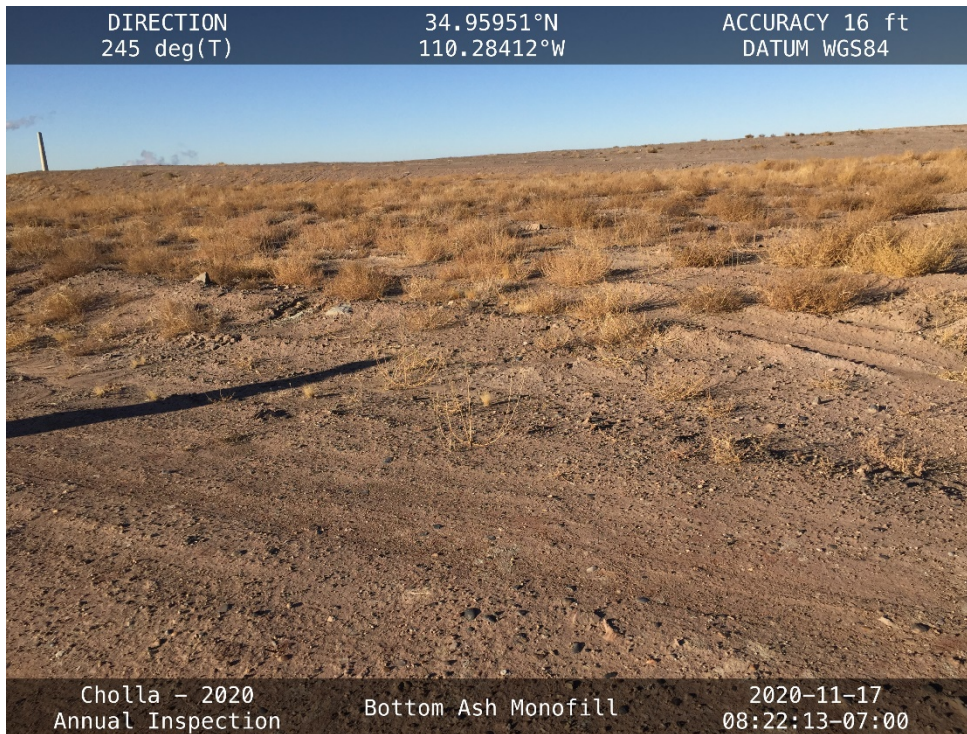
**20201117 - IMG\_2894**

An incipient erosion rill on the eastern slope near the top of the Bottom Ash Monofill.

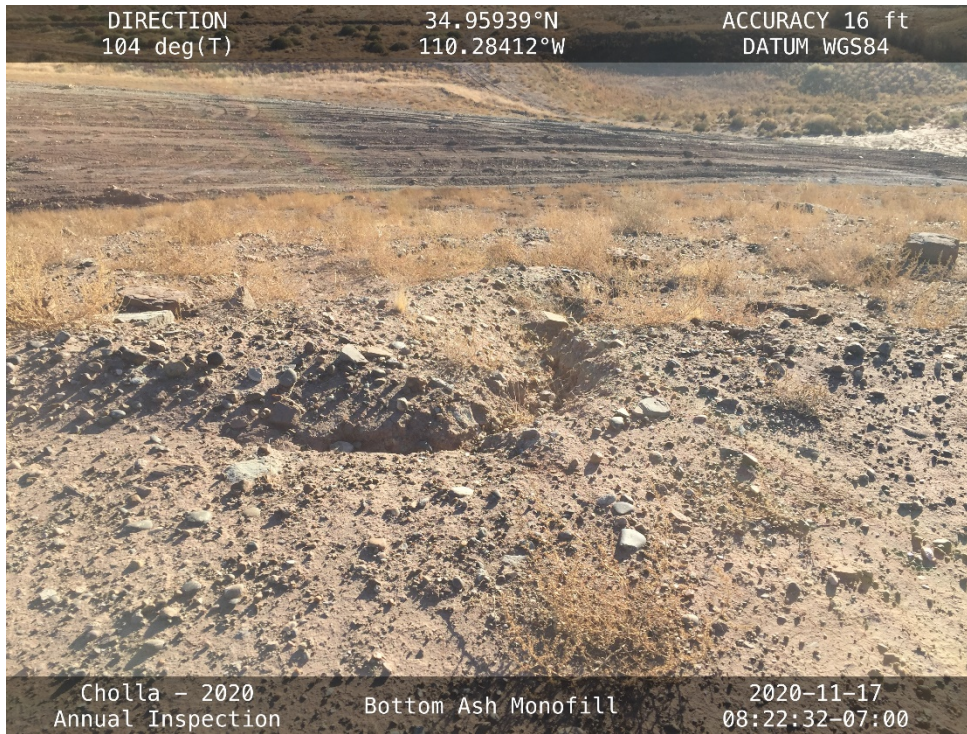
**20201117 - IMG\_2898**

Cover soil on the surface of the Bottom Ash Monofill, facing west along the top.
