CHOLLA POWER PLANT Fly Ash Dam, Bottom Ash Dam, and Bottom Ash Monofill

Annual CCR Impoundment and Landfill Inspection Report

2022

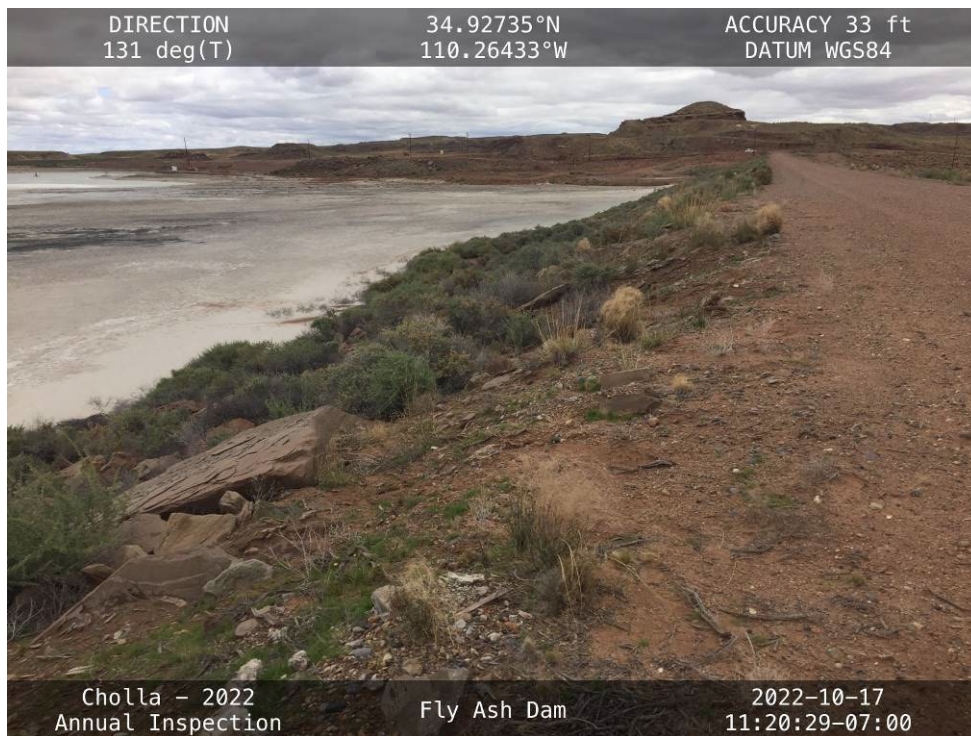
20221017 – IMG_3398

The upstream slope of the South Embankment, facing east.

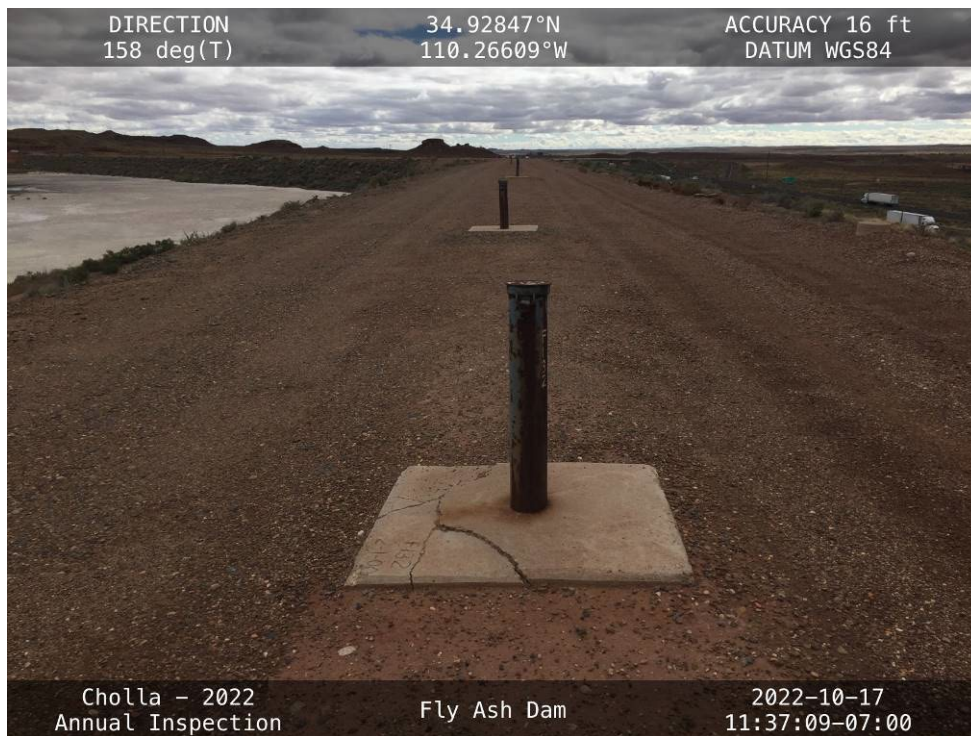
20221017 – IMG_3417

The core piezometers along the crest of the West Embankment, facing southeast.

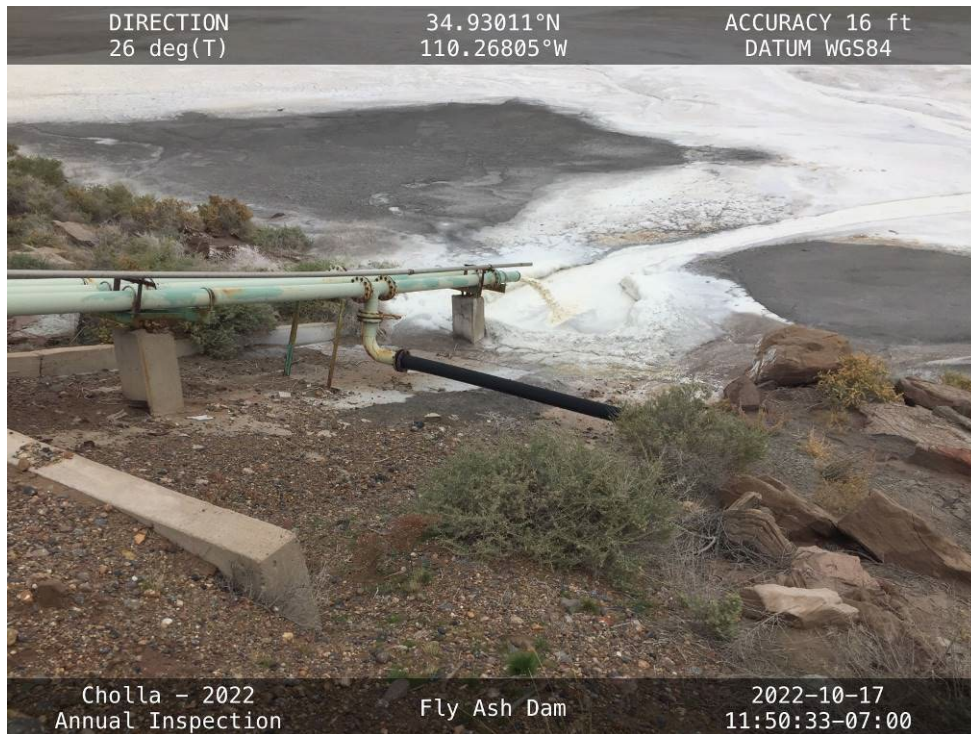
20221017 – IMG_3426

The inlet pipe depositing CCR into the impoundment.

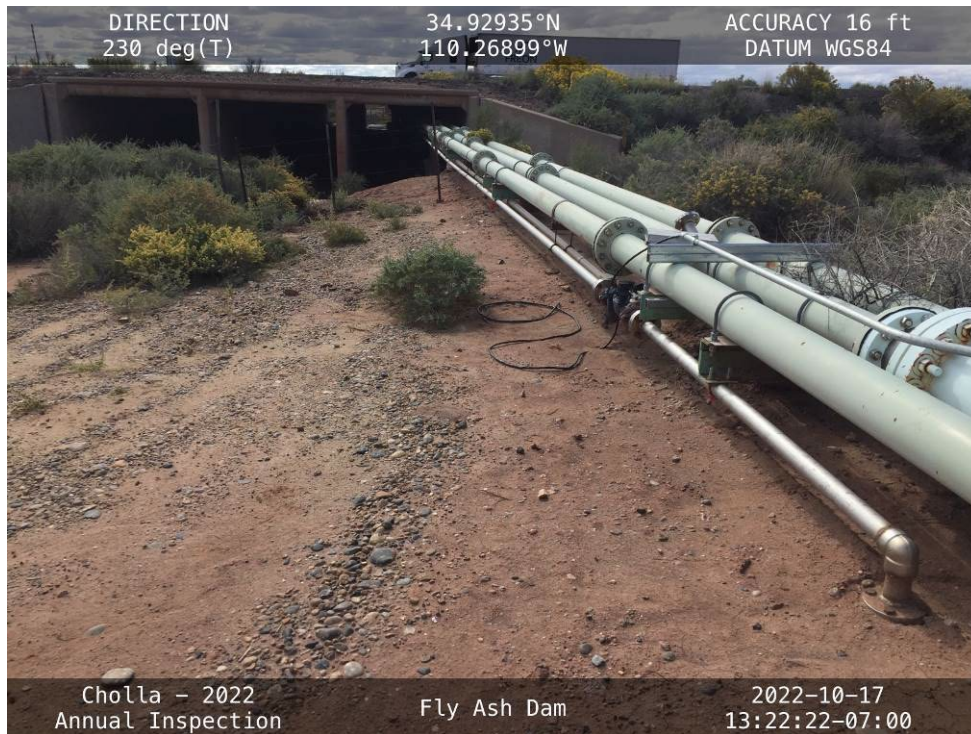
20221017 – IMG_3505

The Hunt totalizer.

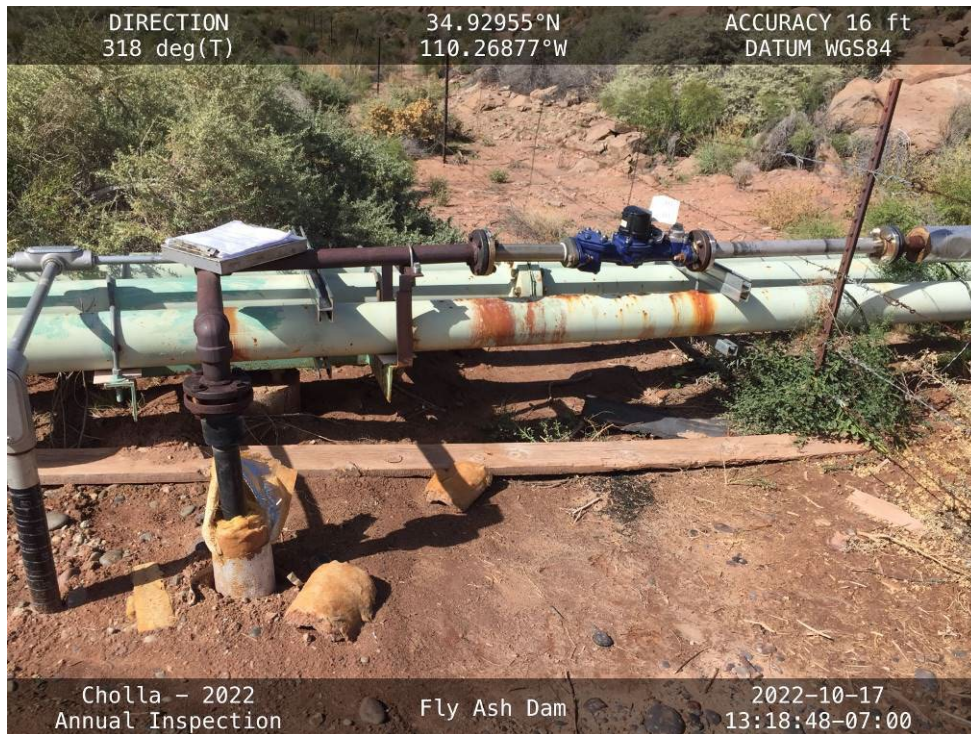
20221017 – IMG_3498

The Geronimo totalizer.

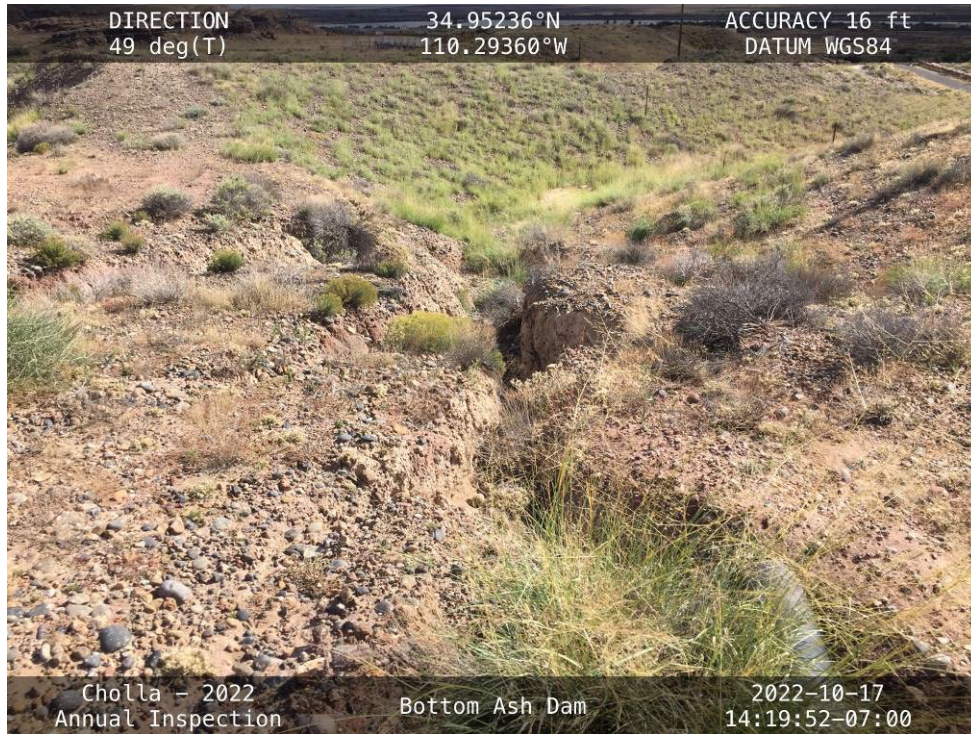
20221017 – IMG_3561

Erosion in the downstream groin of the Right Abutment, facing south from the abutment contact.

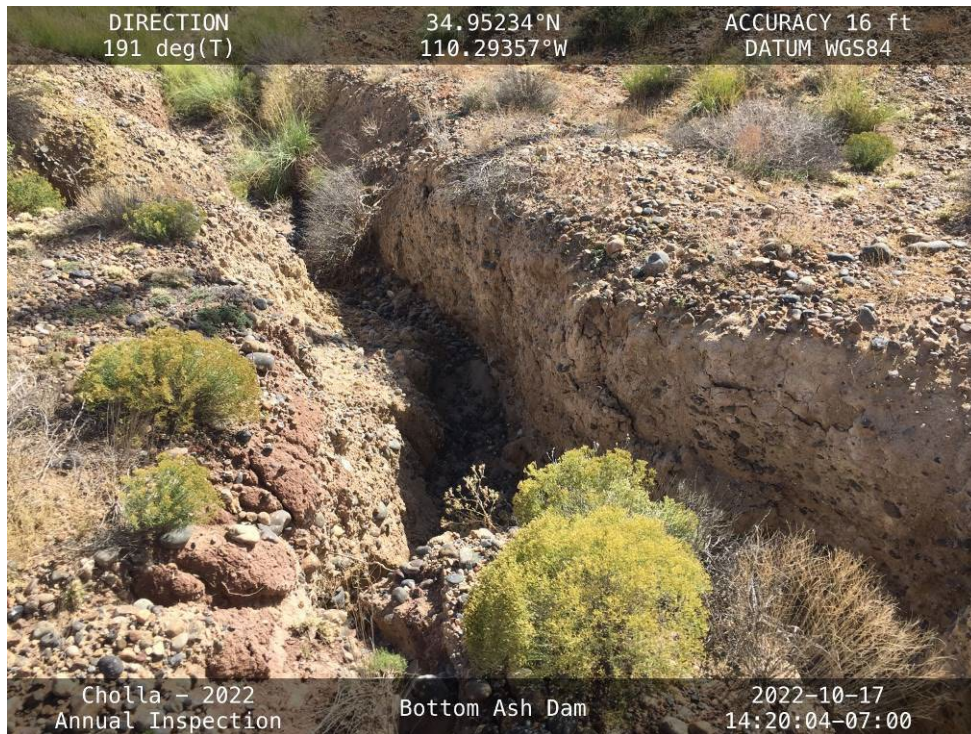
20221017 – IMG_3562

3.5 feet of erosion in the downstream groin of the Right Abutment.

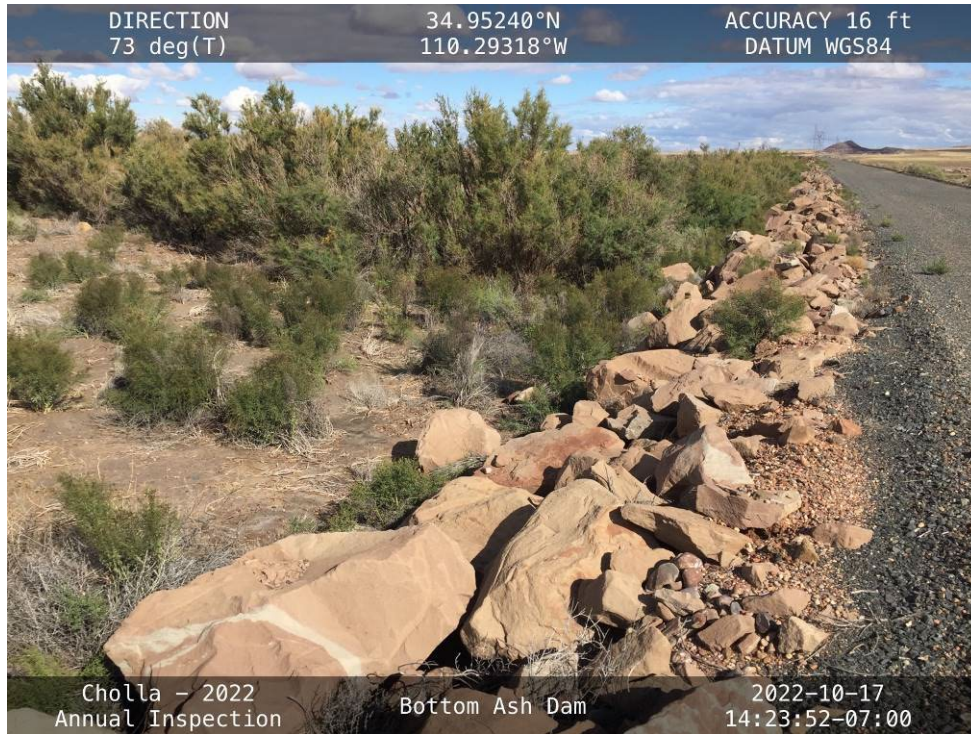
20221017 – IMG_3564

The South Embankment crest, facing east from the Right Abutment.

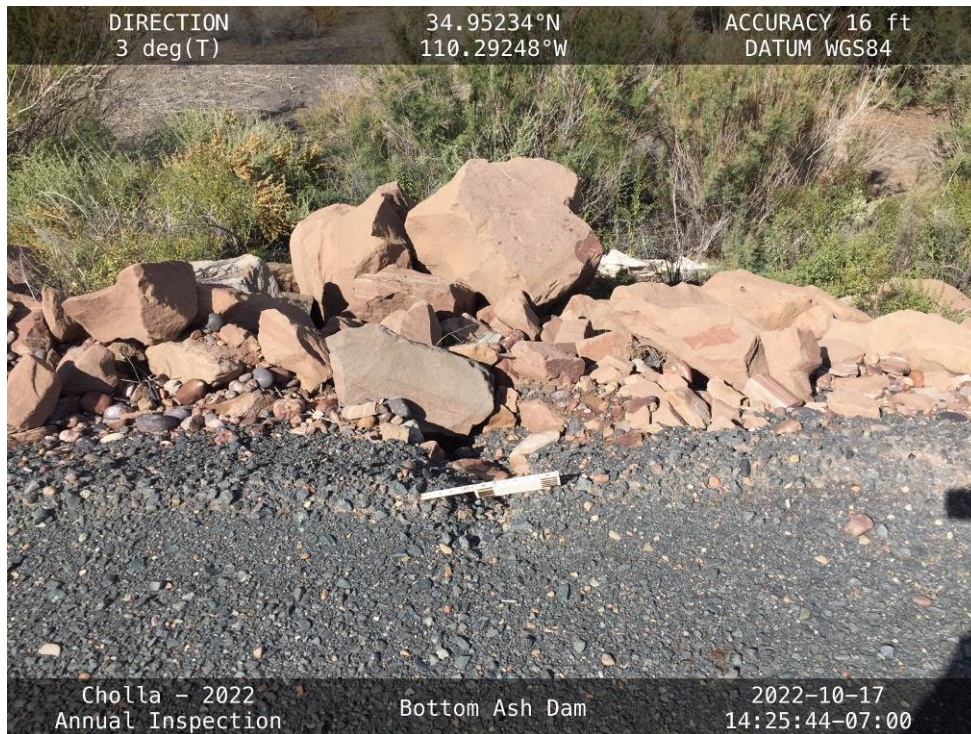
20221017 – IMG_3565

Trees and other woody vegetation to be removed from the South Embankment upstream slope.

9) Remove vegetation from the upstream slope at the Right Abutment.	Woody vegetation rooted in the embankment should be removed and the resulting disturbed area should be replaced with compacted material similar to the embankment material per NMOSE (2011).

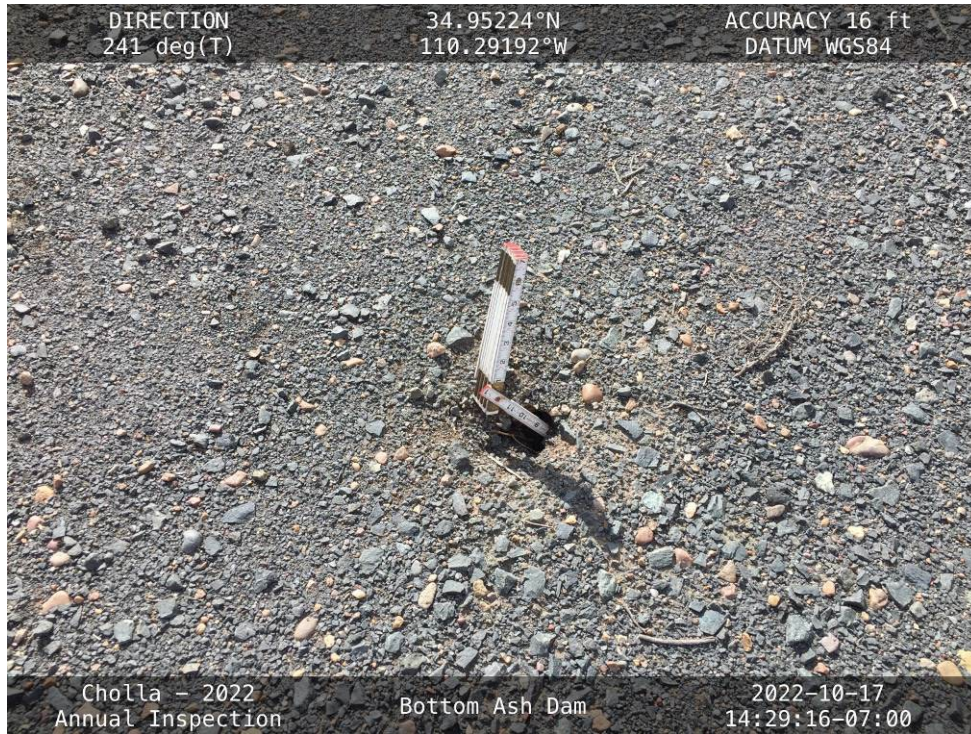
20221017 – IMG_3566

An incipient erosion channel on the upstream side of the South Embankment shoulder.

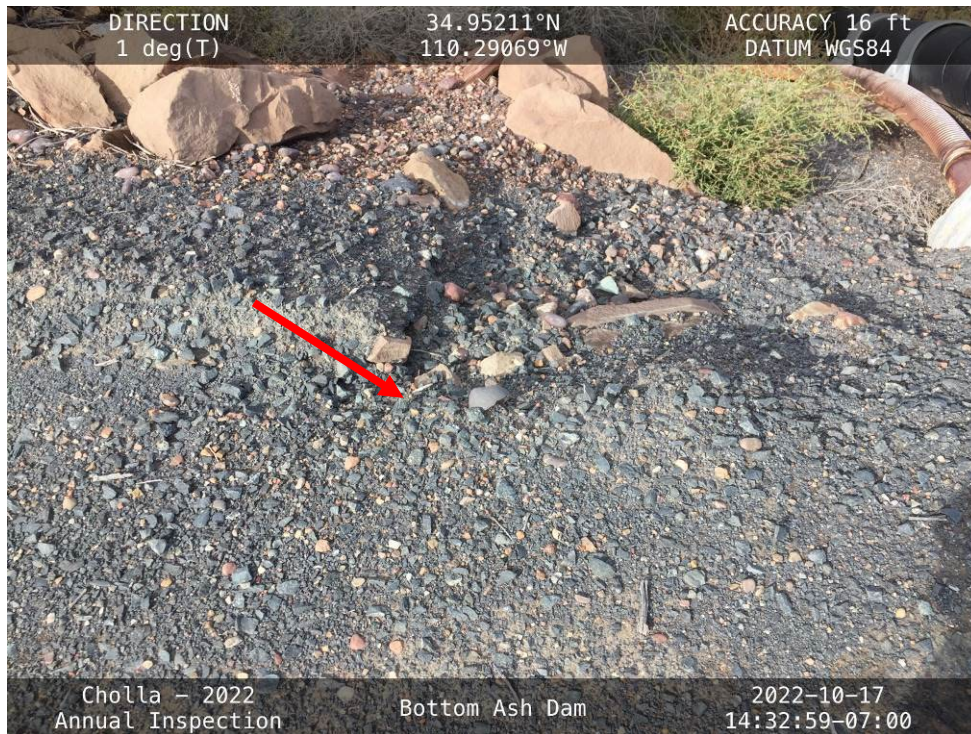
20221017 – IMG_3567

An erosion hole at least 10 inches deep on the South Embankment crest.

Action Item	Action Status
<p>1) Monitor the crest for erosion holes during weekly inspections. Record the location and sizes of erosion holes during the weekly inspections.</p> <p>There is a 21-inch-deep hole adjacent to the concrete on the west side of the central siphon line.</p>	<p>Establish a regular schedule (e.g., semi-annually) to remediate holes identified in the crest. Establish a procedure to track the appearance of new holes and the disappearance of old holes. NOTE: This will always be an ongoing maintenance activity.</p> <p>Repair the 21-inch-deep hole.</p>
<p>2) Repair the 3.5-foot-deep erosion in the downstream groin of the Right Abutment.</p>	<p>The erosion should be restored with compacted, well-graded fill at the direction of the APS geotechnical engineer.</p>
<p>3) Repair the erosion gullies at the downstream slope of the East Embankment and the erosion in the downstream groin of the Right Abutment.</p>	<p>Repair erosion that has exceeded 1 foot in depth.</p>

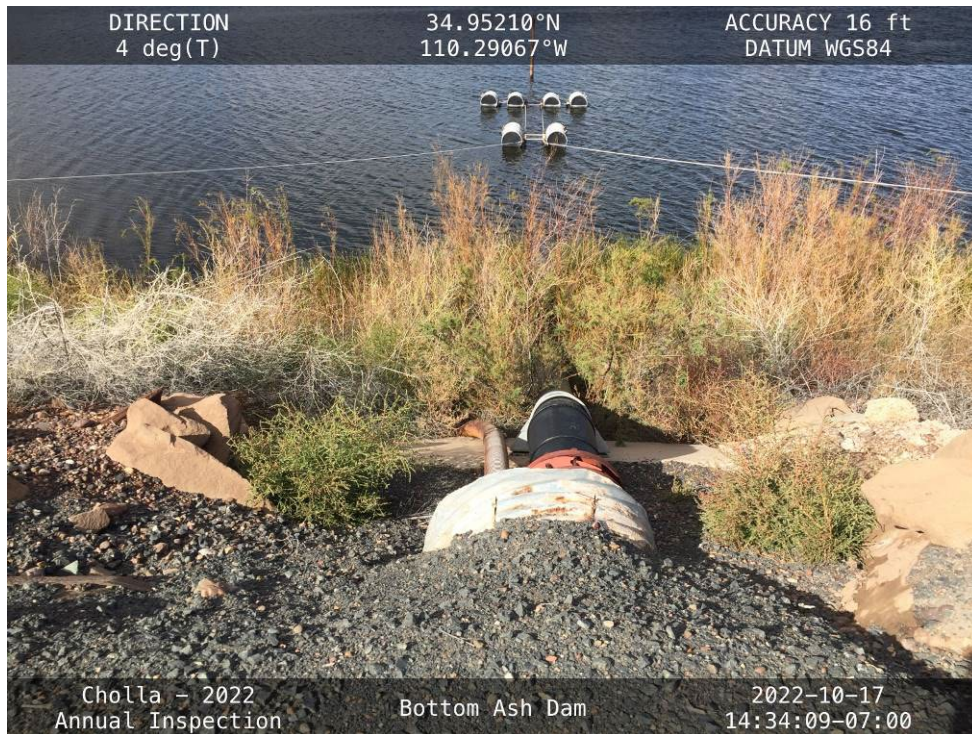
20221017 – IMG_3576

Minor erosion around the concrete encasement for the western siphon line, facing upstream.

10) Continue to monitor the erosion around the siphon line encasements and on the shoulder of the crest.	Repair erosion if the eroded depth exceeds 1 foot.

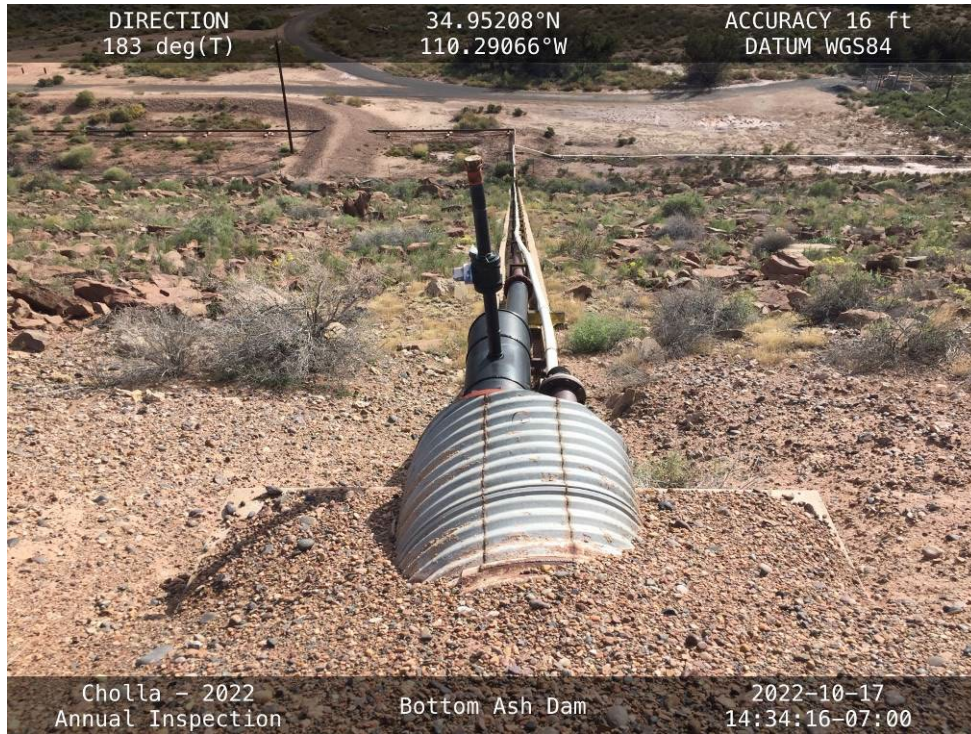
20221017 – IMG_3577

The western siphon line along the upstream slope of the South Embankment.

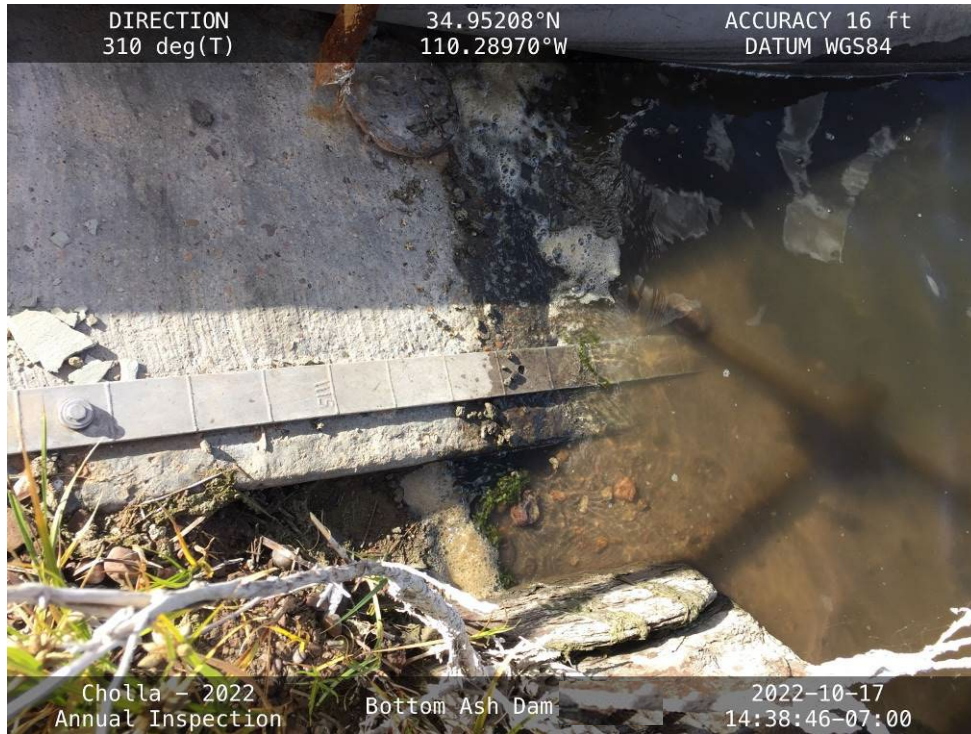
20221017 – IMG_3585

The support material on the downstream side of M-13 separating from the concrete.

12) The downstream section of support material is separating from the concrete at Settlement Monument M-13.	Monitor M-13 and repair the section of support material that is separating from the concrete only if a series of deviant readings are recorded for the horizontal or vertical measurements. Record the position of M-13 via GPS immediately before and after any repairs.

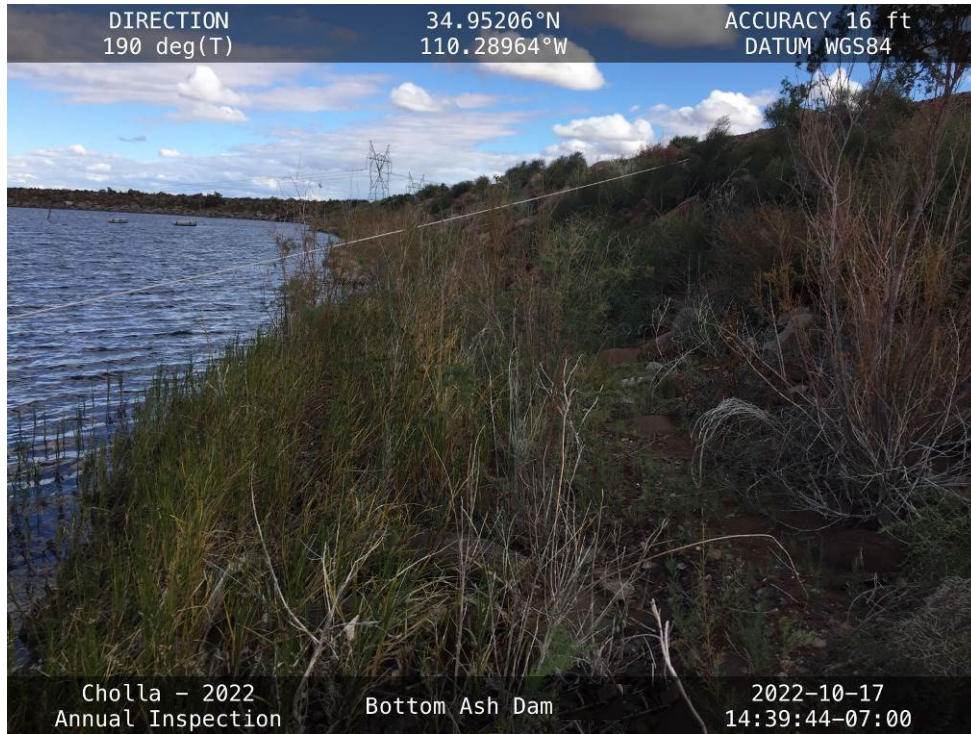
20221017 – IMG_3588

The upstream slope along the western half of the South Embankment, facing west.

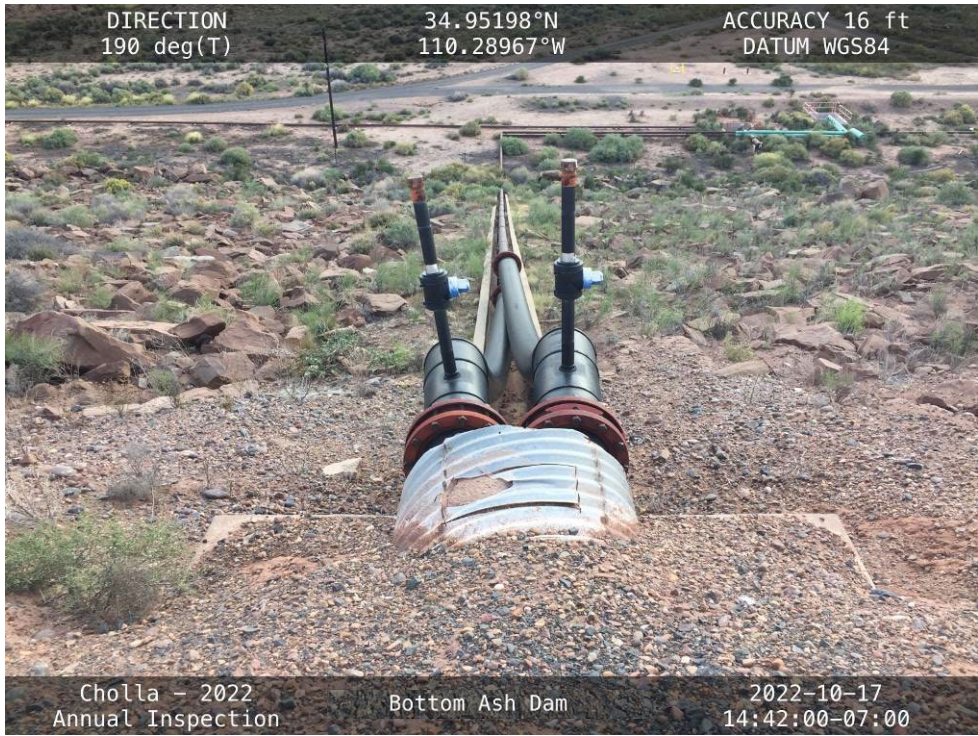
20221017 – IMG_3592

The central siphon lines along the upstream slope of the South Embankment.

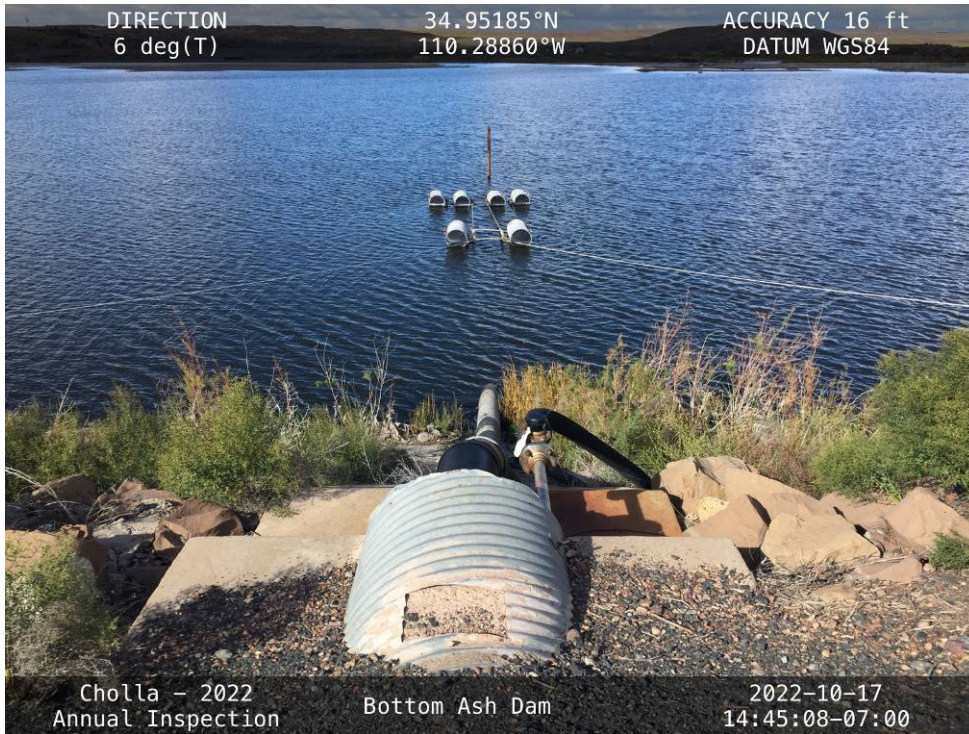
20221017 – IMG_3599

The upstream slope along the eastern half of the South Embankment and a small bush growing in the crest.

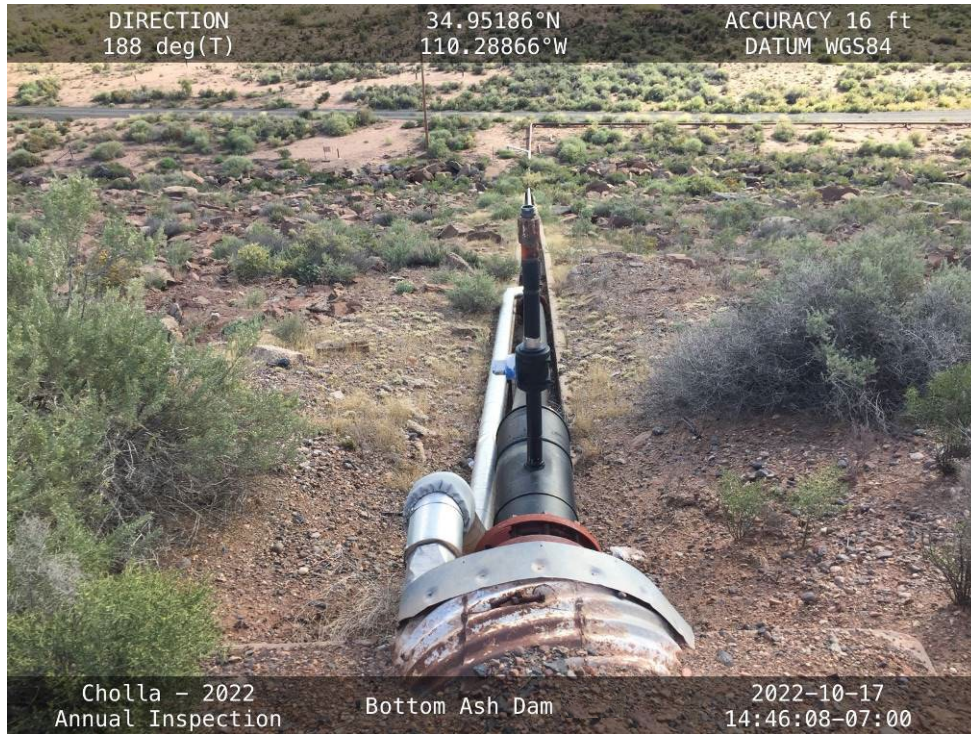
20221017 – IMG_3603

Action Item and First Instance of Observation	Resolution
1) The pumpback flowmeter at the eastern siphon line is broken (2021 inspection).	The flowmeter was replaced on December 22, 2021.

The new flowmeter on the eastern siphon pumpback line.

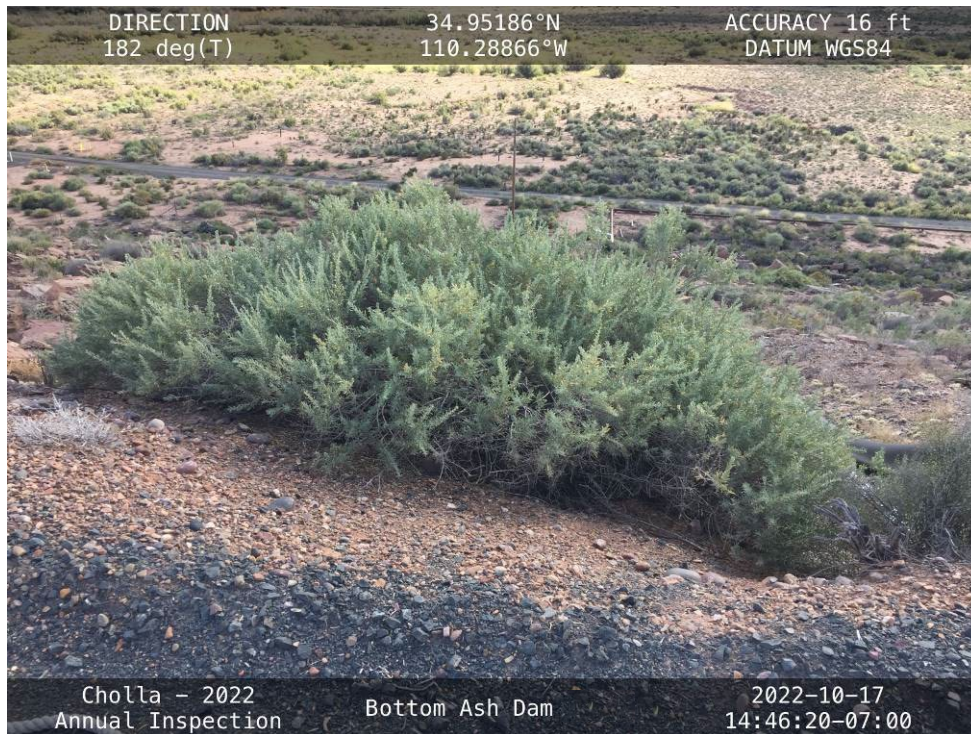
20221017 – IMG_3607

The eastern siphon line along the downstream slope of the South Embankment.

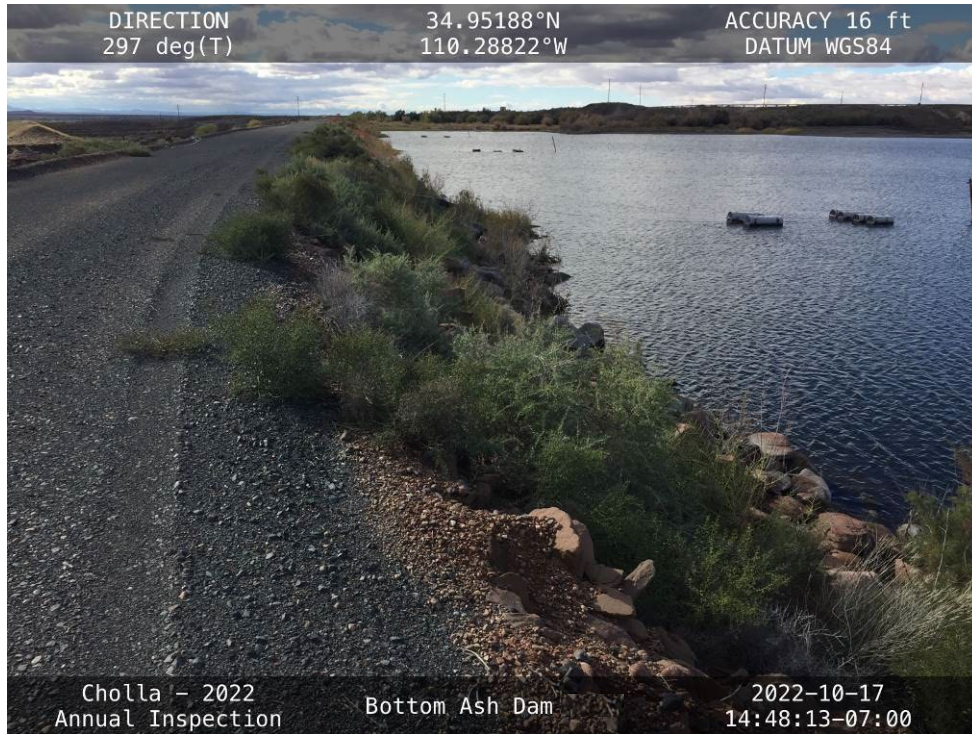
20221017 – IMG_3609

Vegetation to be removed along the downstream slope of the South Embankment.

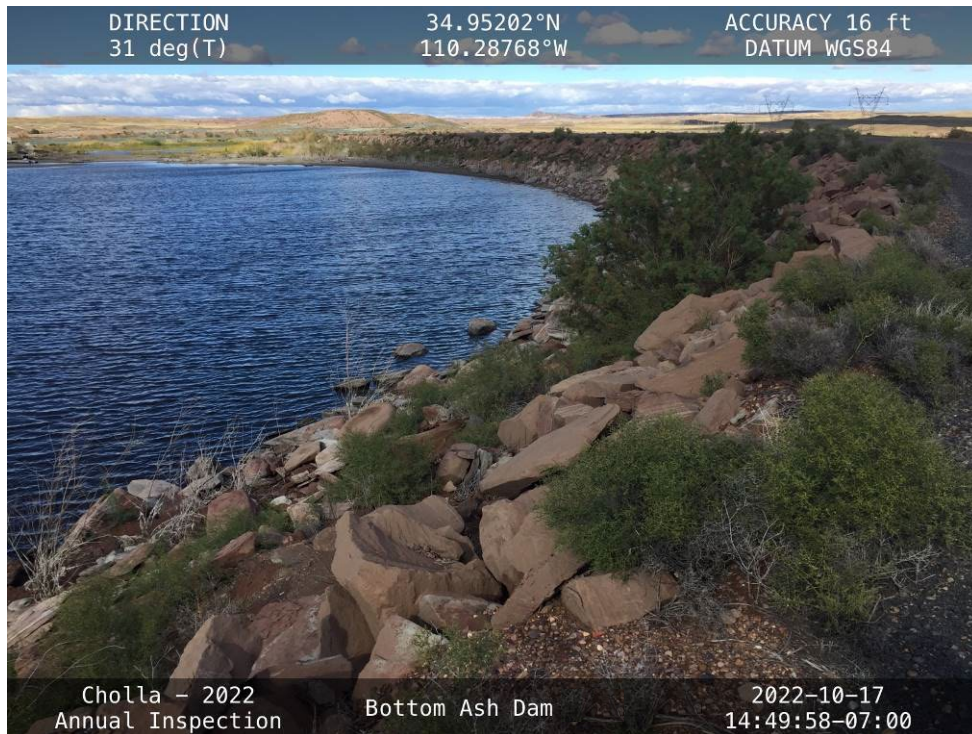
20221017 – IMG_3615

The upstream slope at the eastern end of the South Embankment, facing west.

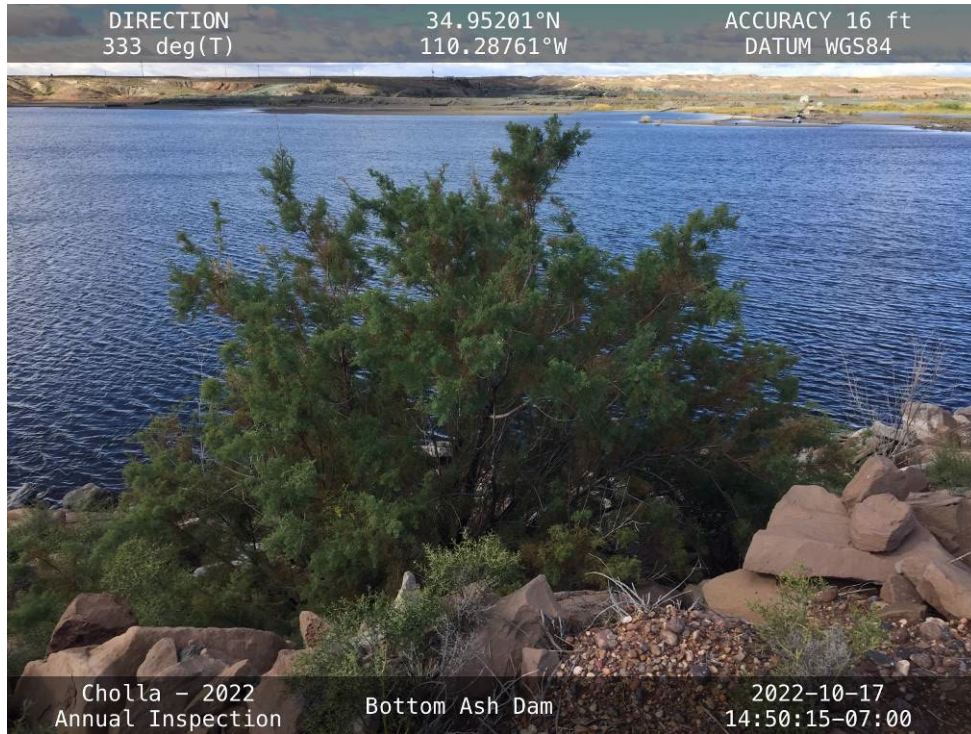
20221017 – IMG_3617

The upstream slope at the southern end of the East Embankment, facing north.

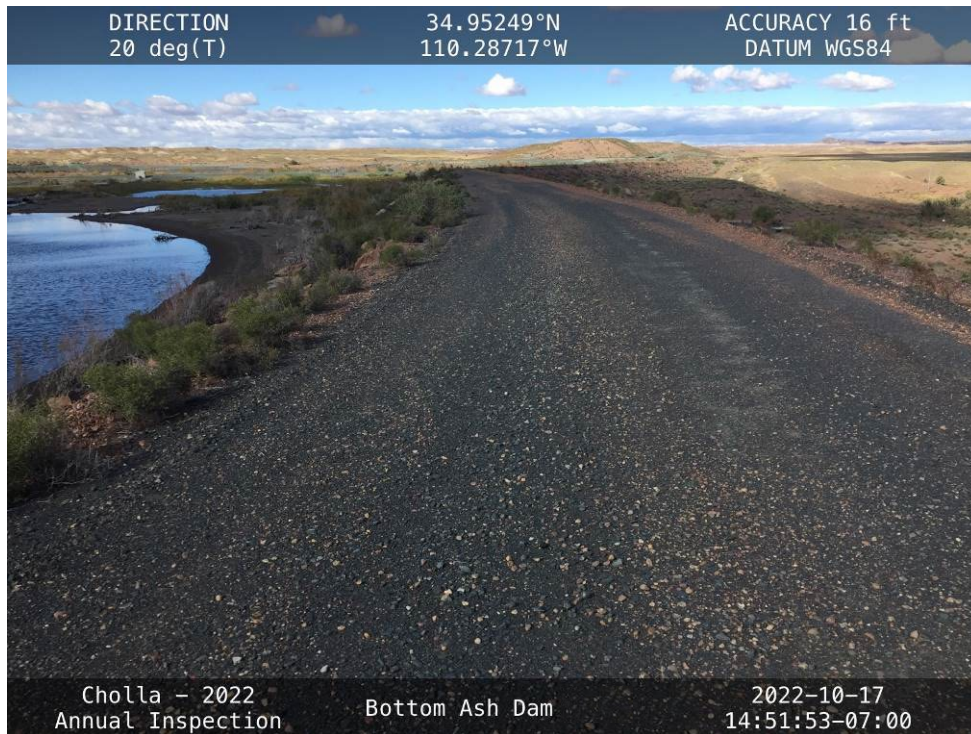
20221017 – IMG_3618

Vegetation to be removed along the upstream slope of the East Embankment.

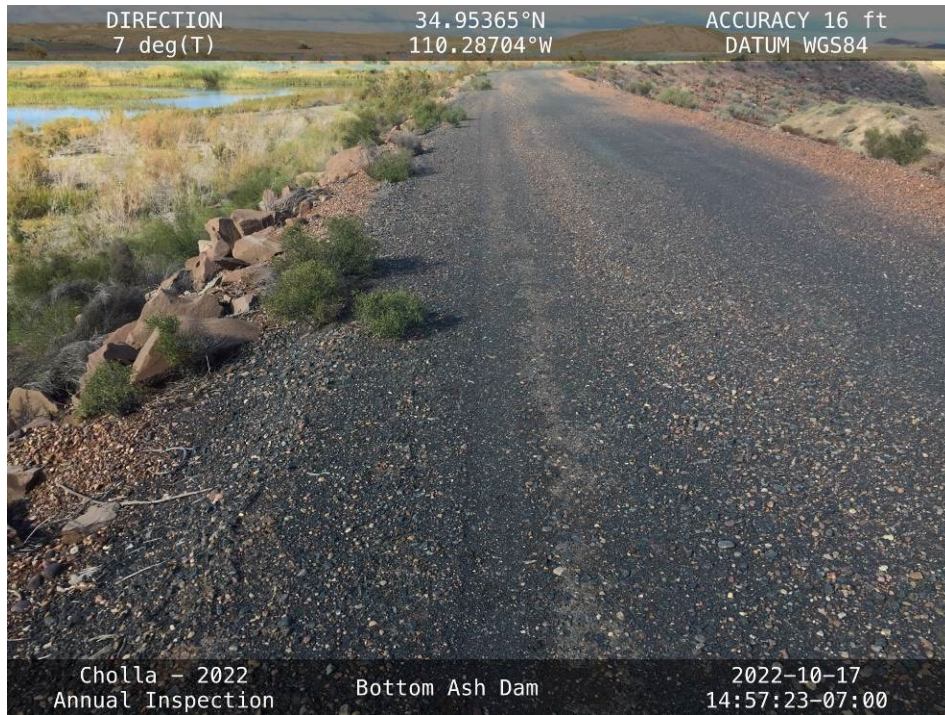
20221017 – IMG_3619

The crest of the East Embankment, facing north from the southern end.

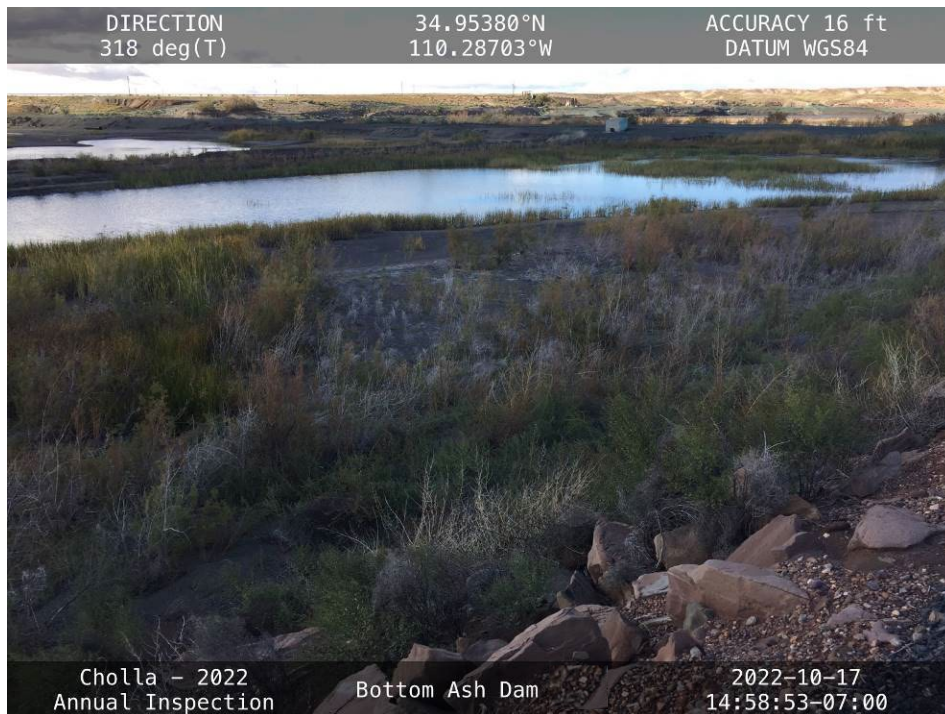
20221017 – IMG_3625

Area where a 2.5-inch-deep depression was observed along the upstream shoulder of the East Embankment during the 2021 inspection (2021 IMG_7052), not present during this inspection.

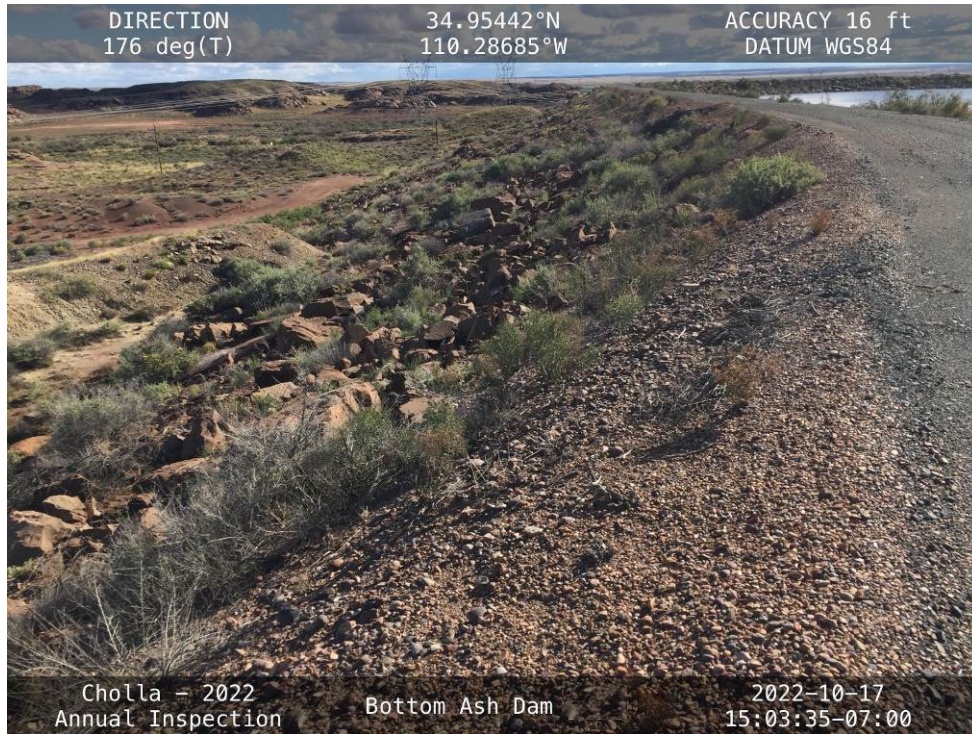
20221017 – IMG_3629
 A hole in the crest of the East Embankment, approximately 4 inches deep.

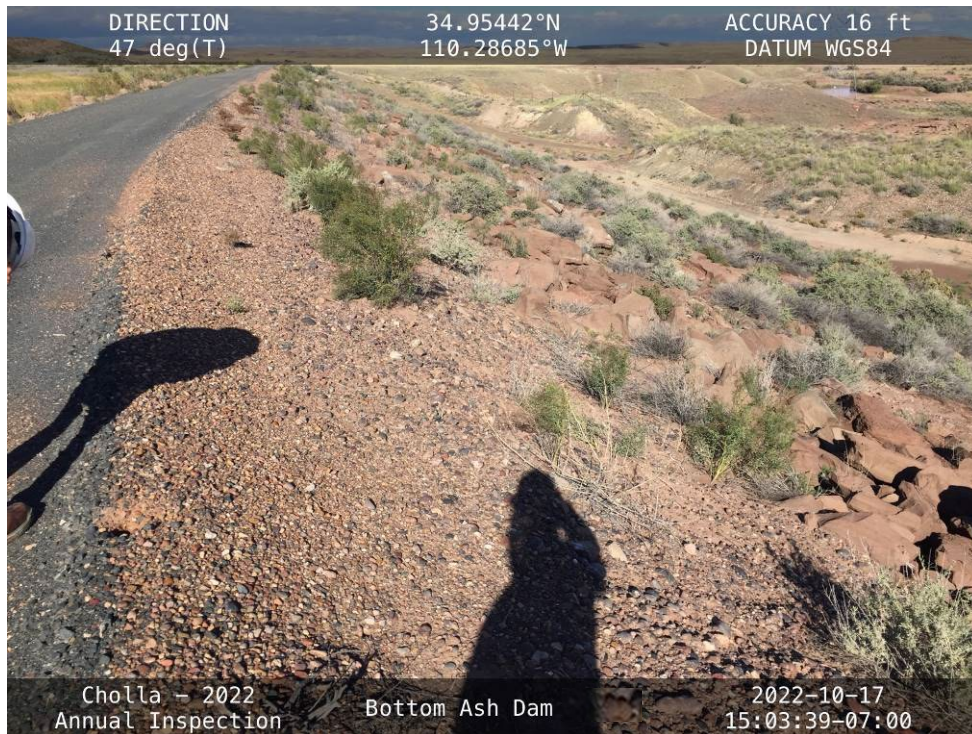
20221017 – IMG_3630

The downstream slope of the southern half of the East Embankment, facing south.

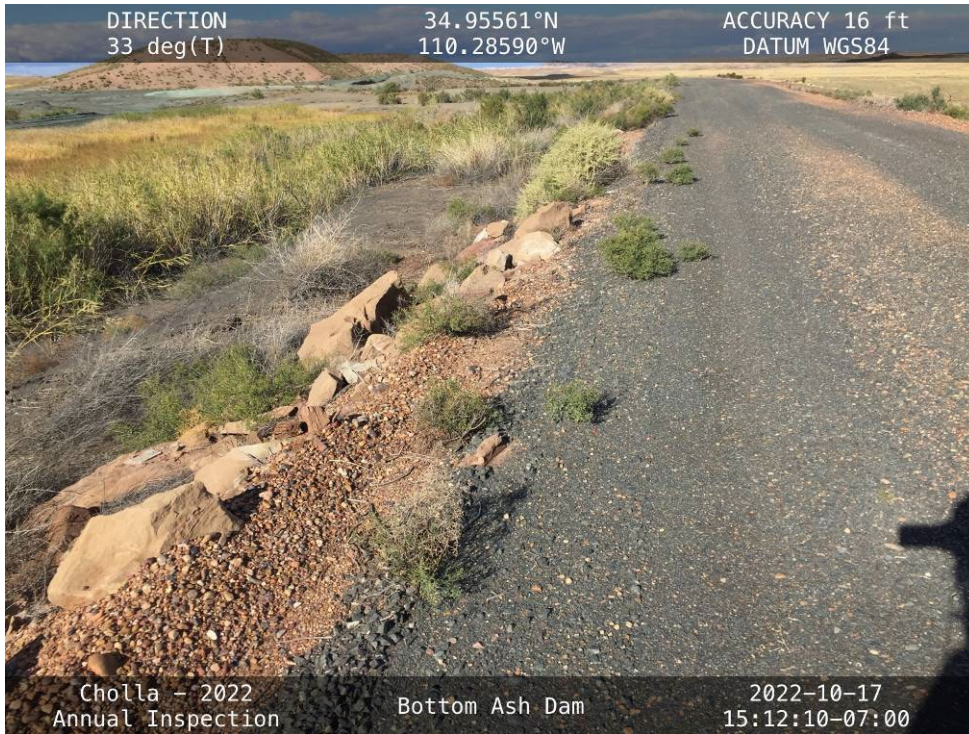
20221017 – IMG_3631

The downstream slope of the northern half of the East Embankment, facing northeast.

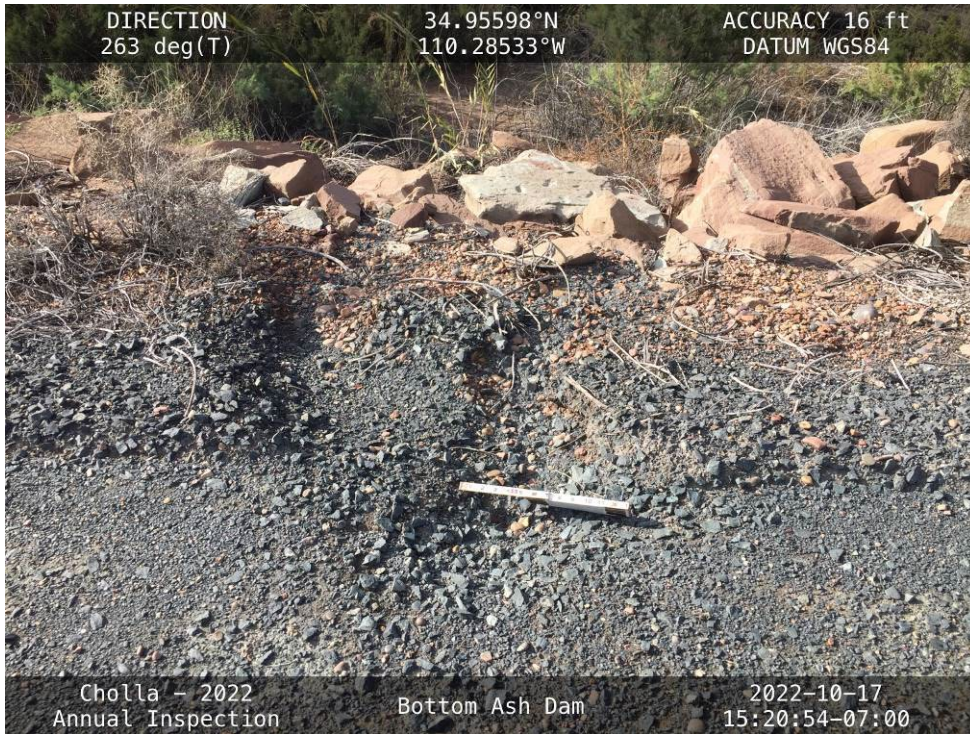
20221017 – IMG_3639

Erosion rills on the upstream slope of the East Embankment. The ruler is 19 inches long.

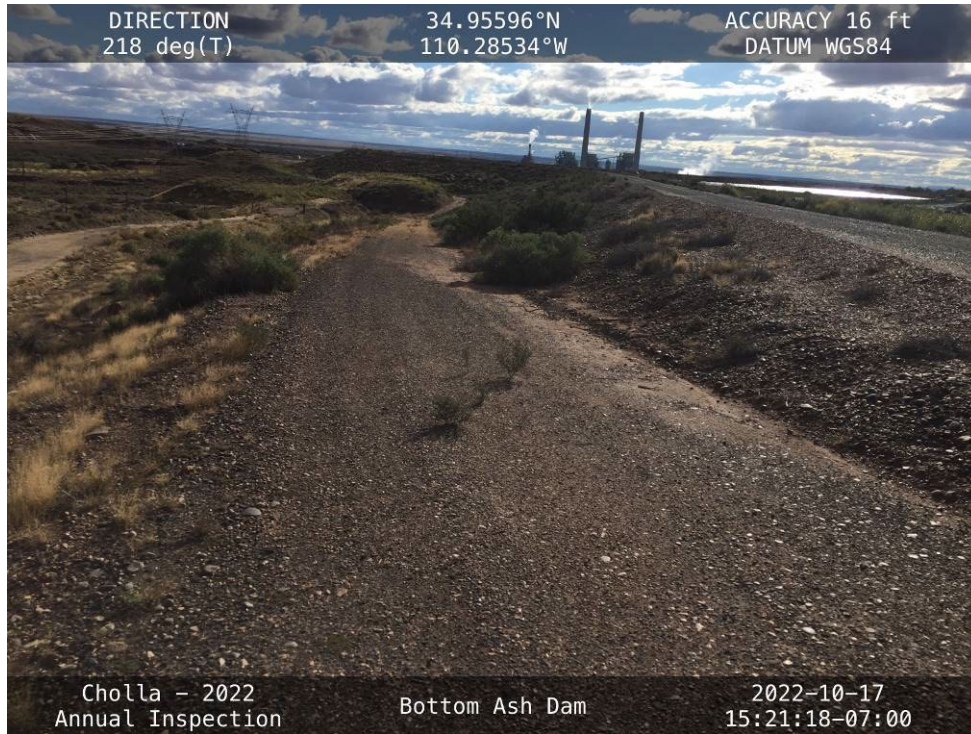
20221017 – IMG_3647

The crest of the East Embankment, facing southwest.
