CHOLLA POWER PLANT Fly Ash Dam, Bottom Ash Dam, and Bottom Ash Monofill

Annual CCR Impoundment and Landfill Inspection Report

2022

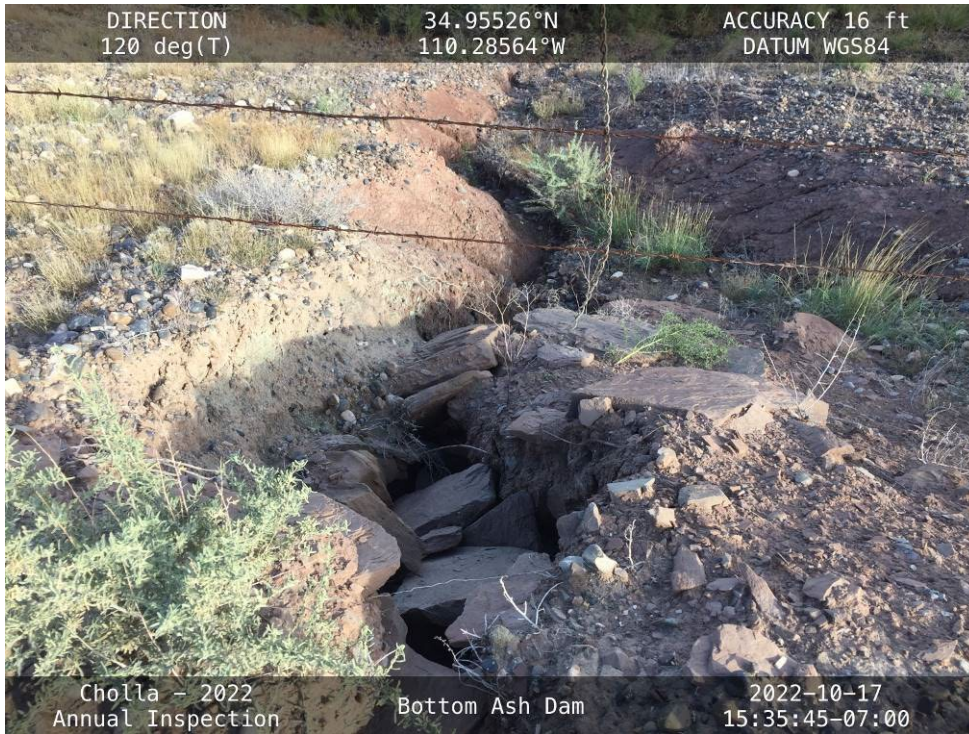
20221017 – IMG_3663

An erosion gully on the downstream slope along the northern half of the East Embankment.

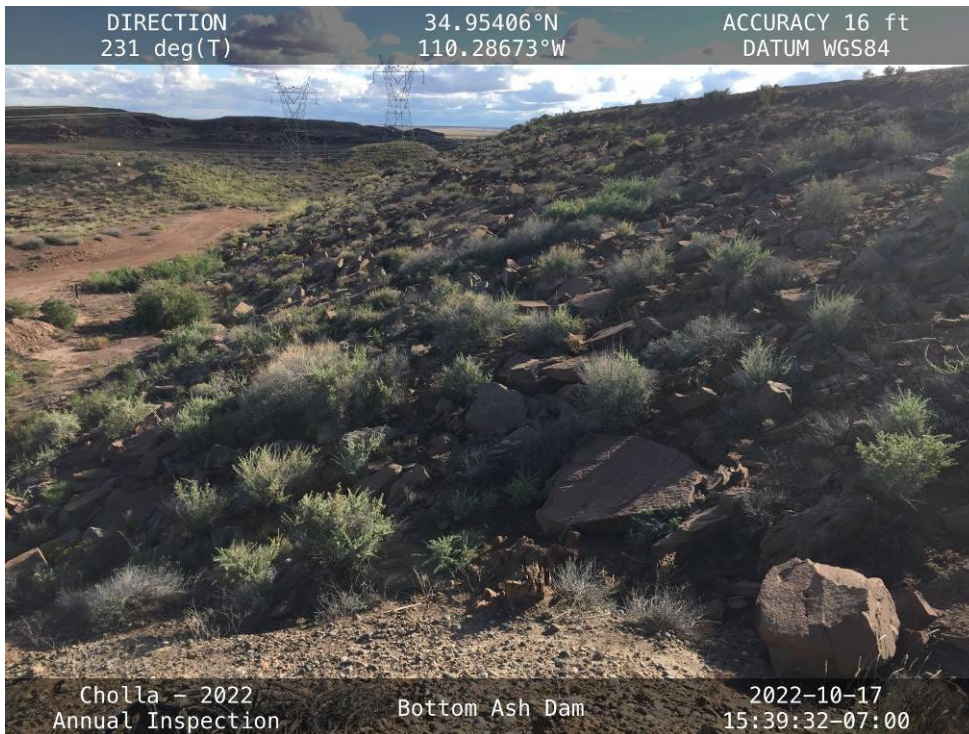
20221017 – IMG_3665

An erosion gully on the downstream slope along the northern half of the East Embankment.

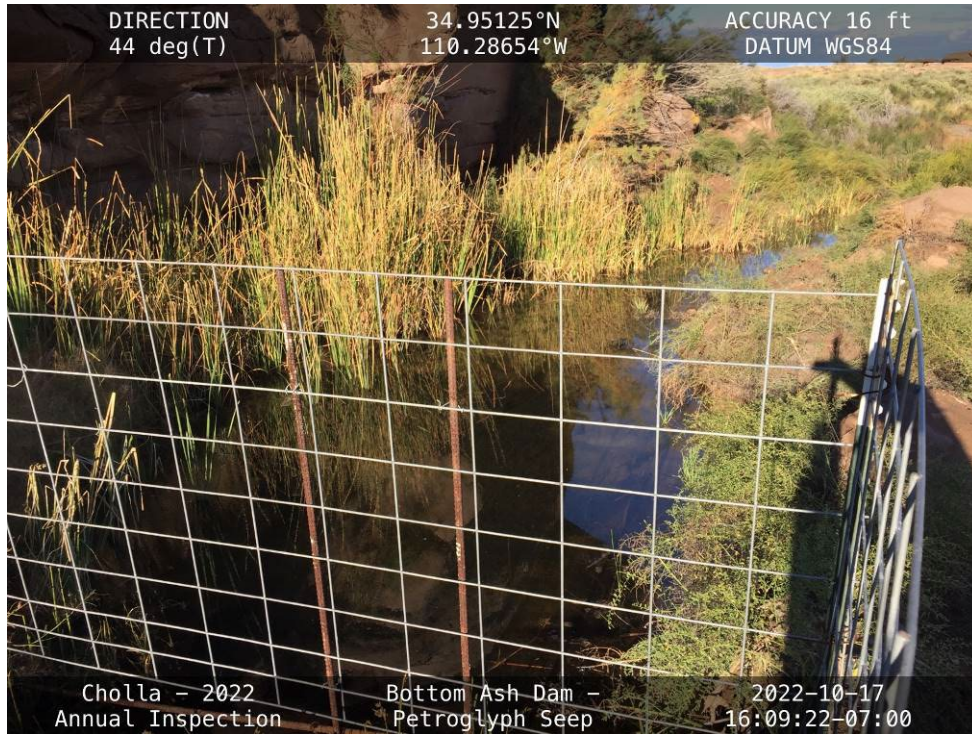
20221017 – IMG_3676

The P-226 seepage intercept area with standing water due to recent rain.

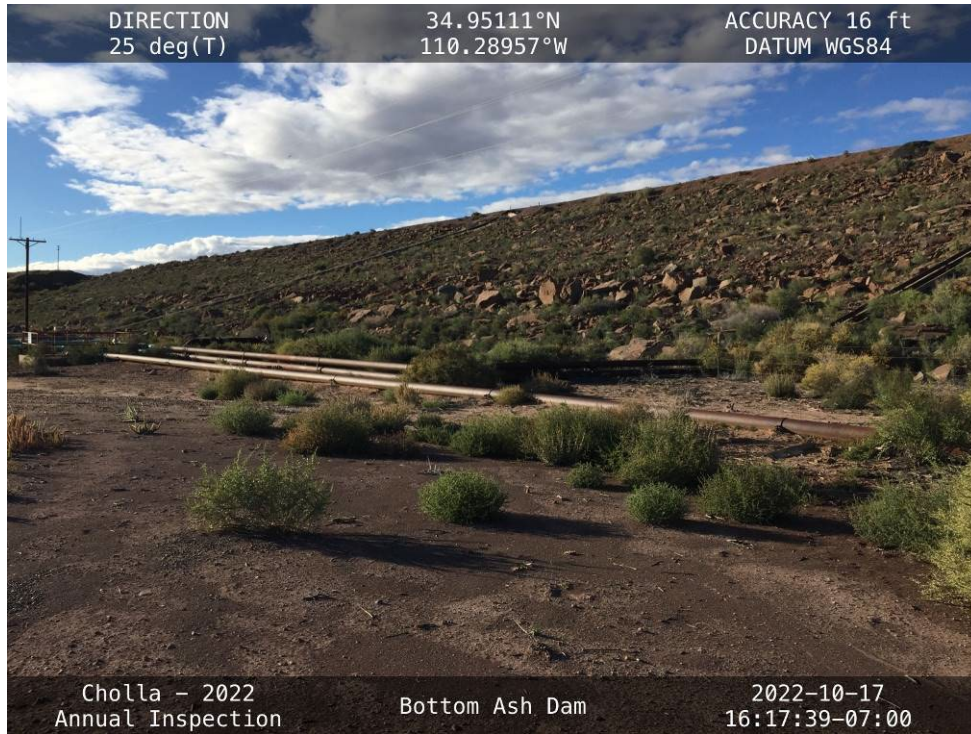
20221017 – IMG_3685

The downstream slope and toe of the Bottom Ash Dam, facing north from the southeast corner.

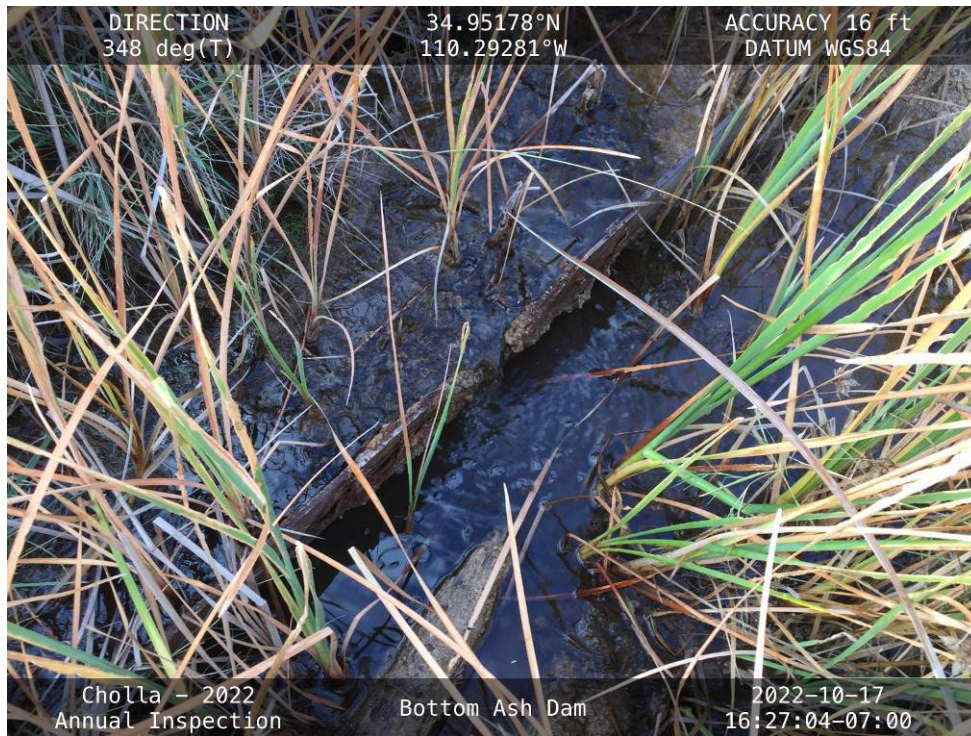
20221017 – IMG_3692

The West Abutment Weir, flowing at approximately 1.62 gpm.

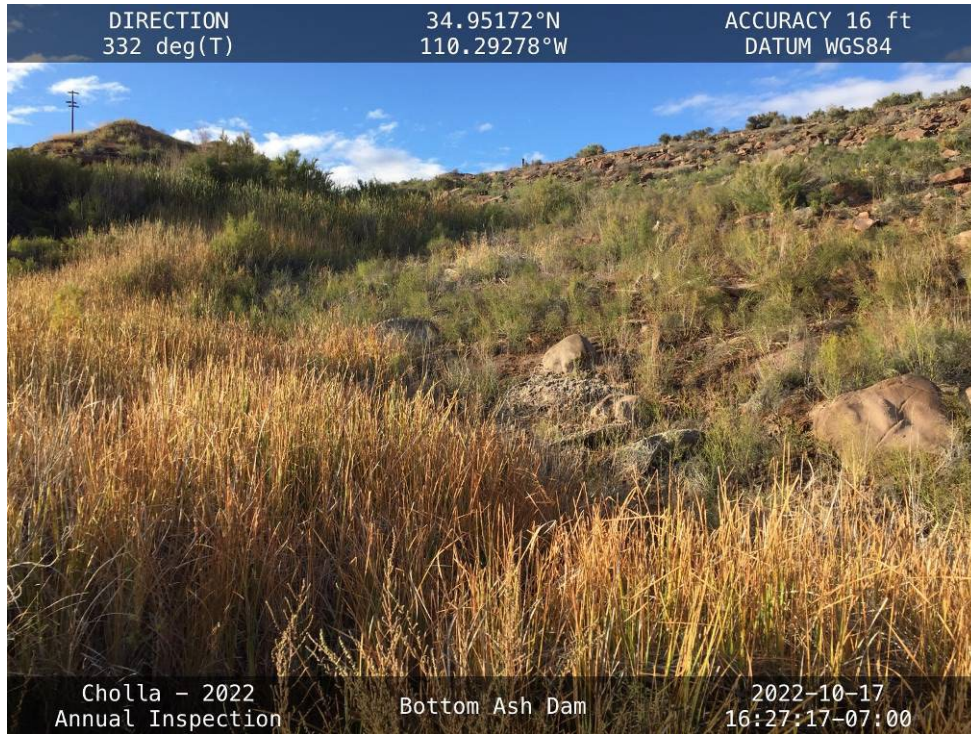
20221017 – IMG_3694

Grassy vegetation growing in the area near the West Abutment Weir.

8) Continue to monitor seepage areas, including the West Abutment Weir, for excessive vegetation.	Woody vegetation rooted in the embankment should be removed and the resulting disturbed area should be replaced with compacted material similar to the embankment material per NMOSE (2011).

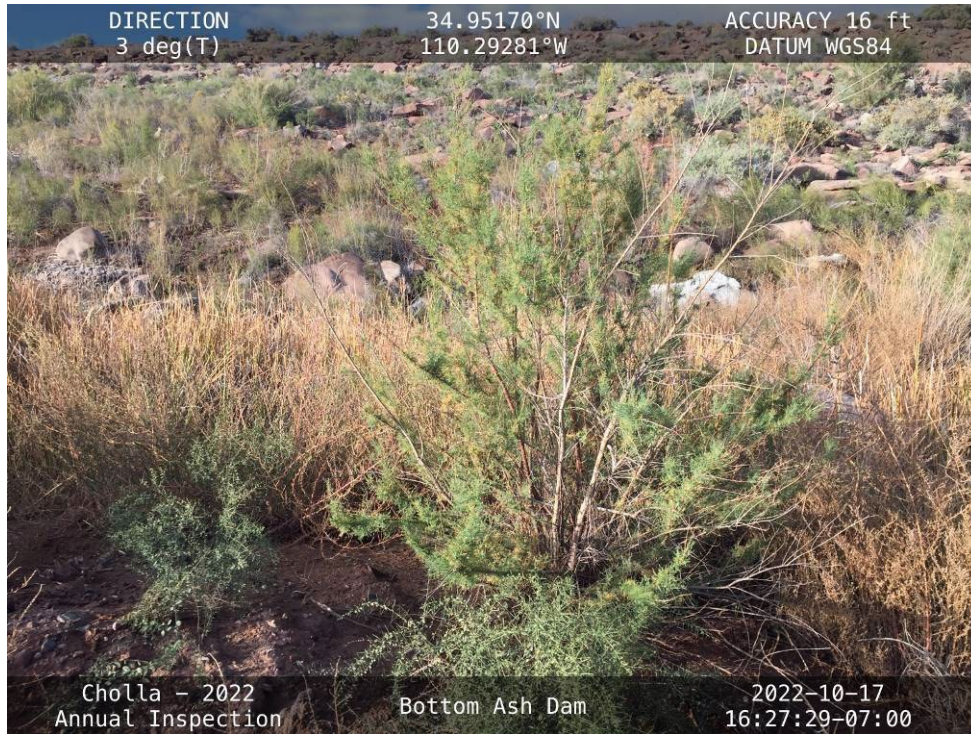
20221017 – IMG_3697

Vegetation to be removed at the toe of the South Embankment.

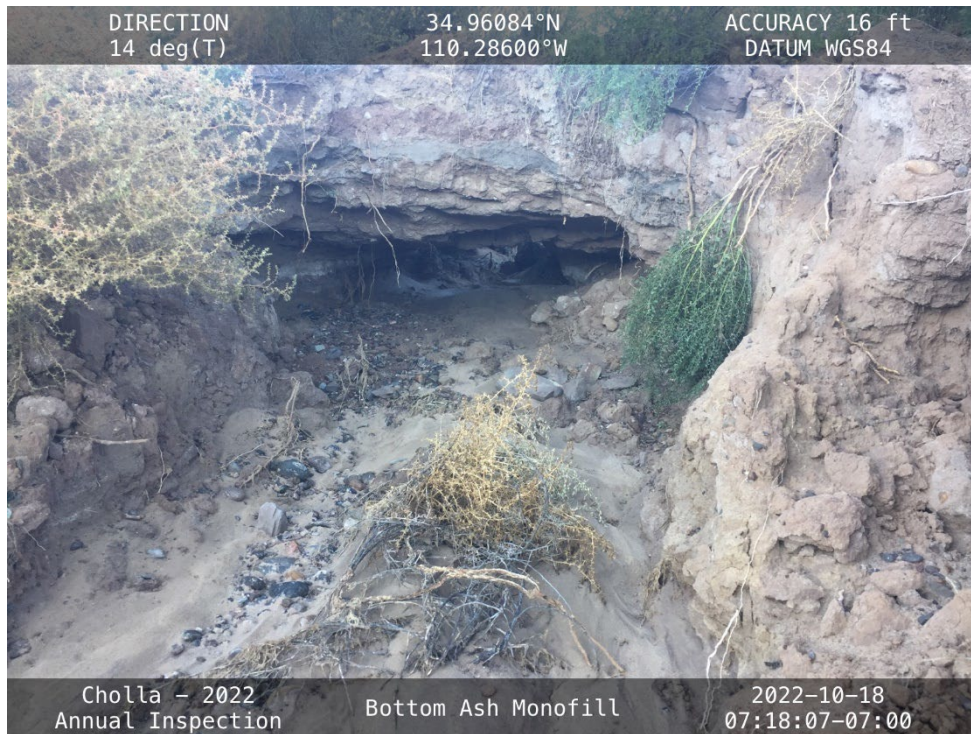
20221018 – IMG_3714

The head of the tunnel on the west side of the perimeter drainage channel that has formed by erosion.

3) Standing water was observed in the perimeter drainage channel.	Grade the channel to drain to the Stormwater Detention Basin.
4) Severe erosion on the west side of the perimeter drainage channel has resulted in a tunnel leading into the channel.	Repair the erosion and fill in the tunnel with compacted fill under the direction of the APS Geotechnical Engineer.

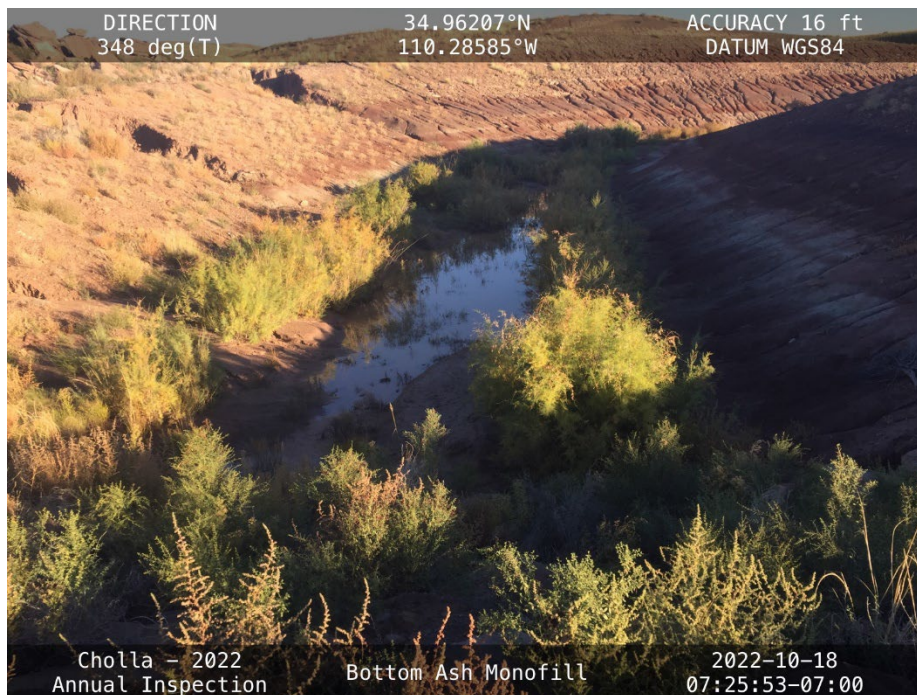
20221018 – IMG_3723

Standing water in the perimeter drainage channel on the west side of the BAM, facing north near the access road to the western stockpile.

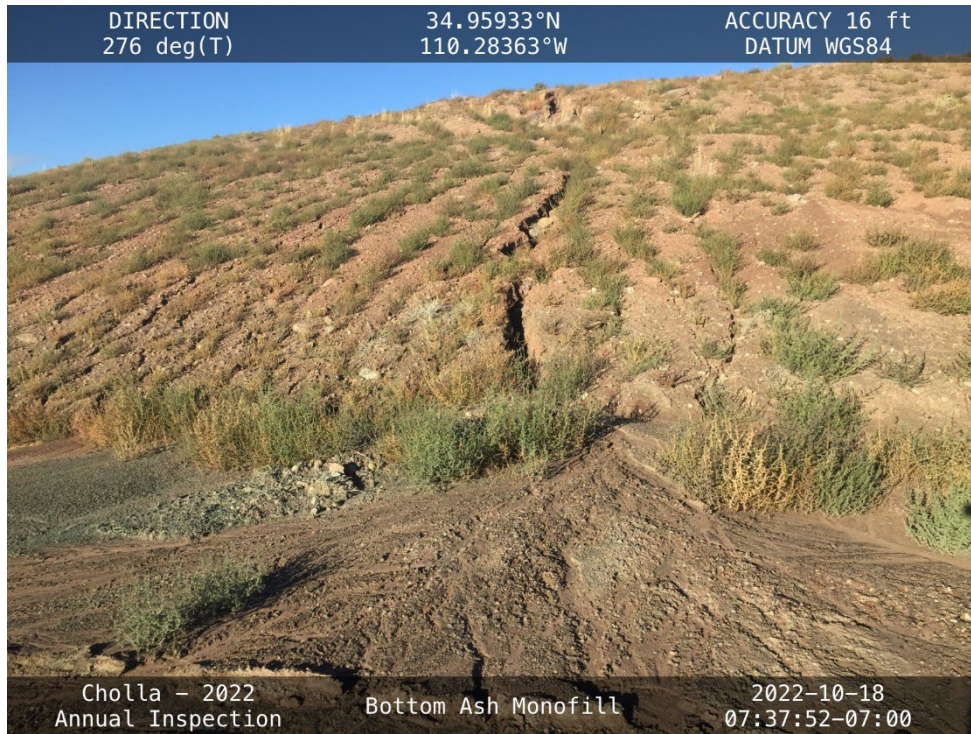
20221018 – IMG_3731

An erosion gully and resulting fan deposit on the southeast slope of the BAM.

Action Item	Action Status
1) Erosion gullies several feet deep were observed at various locations at the CCR unit. Some erosion gullies extended into the ash underlying the soil cover.	Repair the erosion once it exceeds 1 foot in depth or reaches the underlying ash. NOTE: This will always be an ongoing maintenance activity.

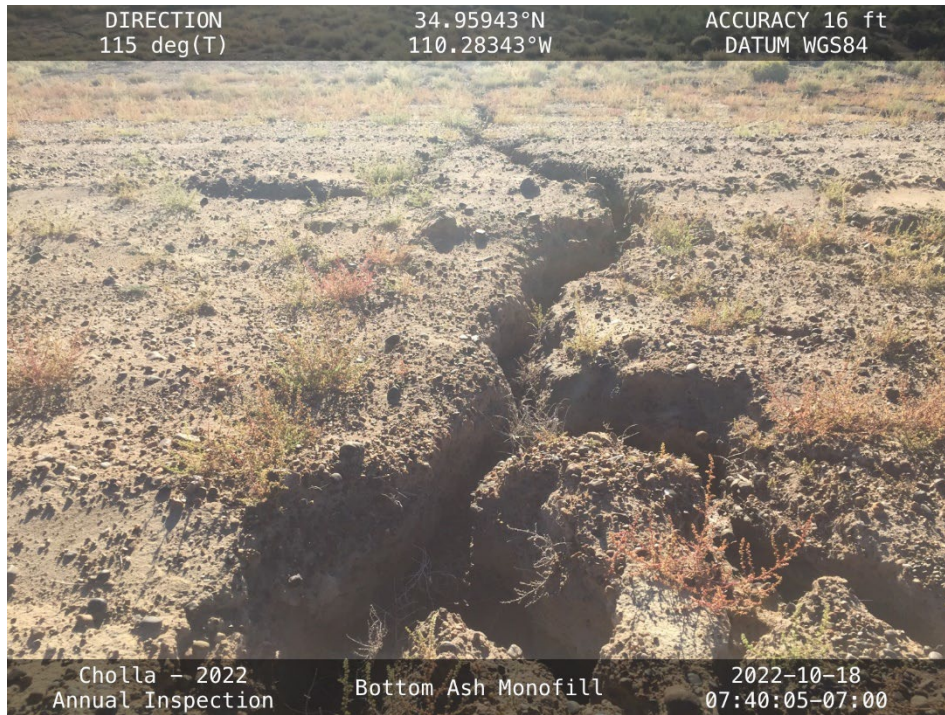
20221018 – IMG_3733

An erosion gully on the eastern slope near the top of the Bottom Ash Monofill, facing east toward the Stormwater Detention Basin.

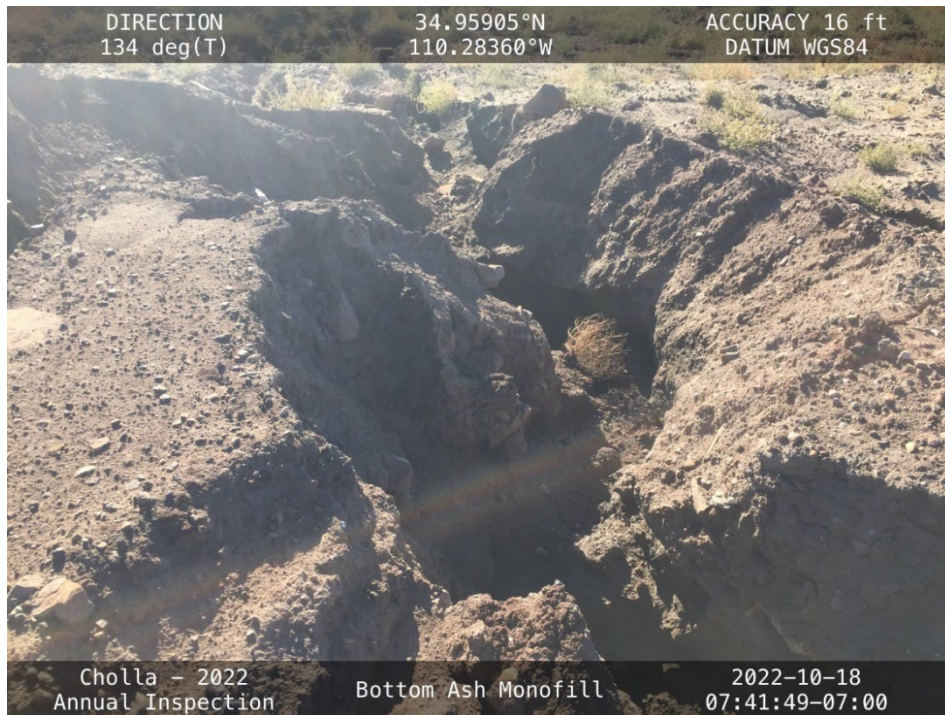
20221018 – IMG_3737

An erosion gully on the eastern slope near the top of the Bottom Ash Monofill, facing southeast.

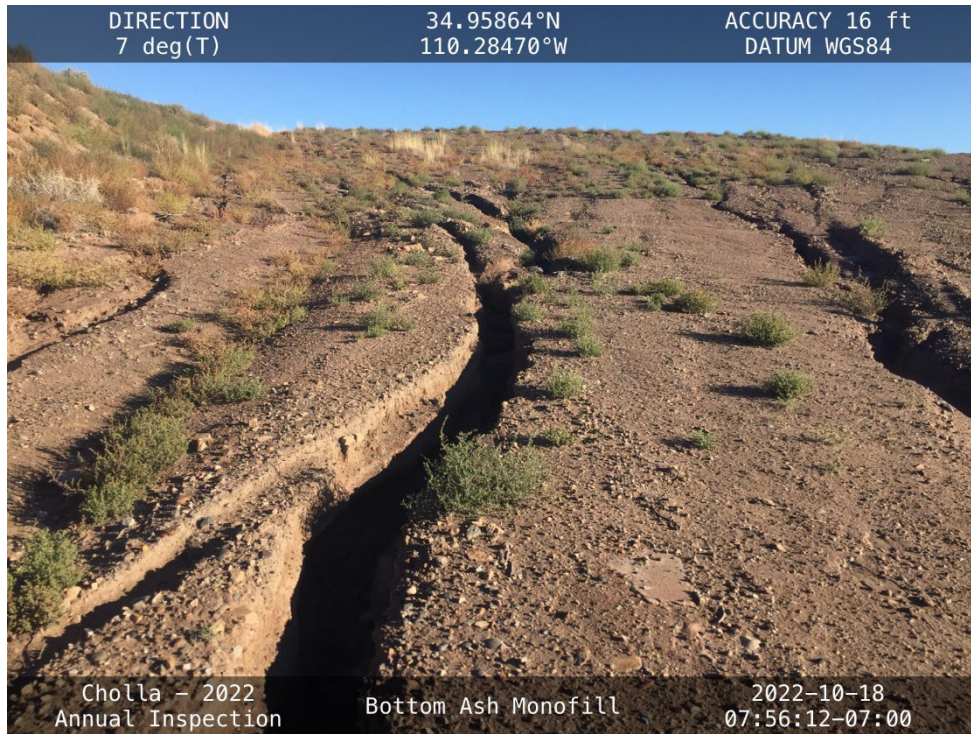
20221018 – IMG_3740

Two erosion gullies on the southern access ramp to the top of the Bottom Ash Monofill.

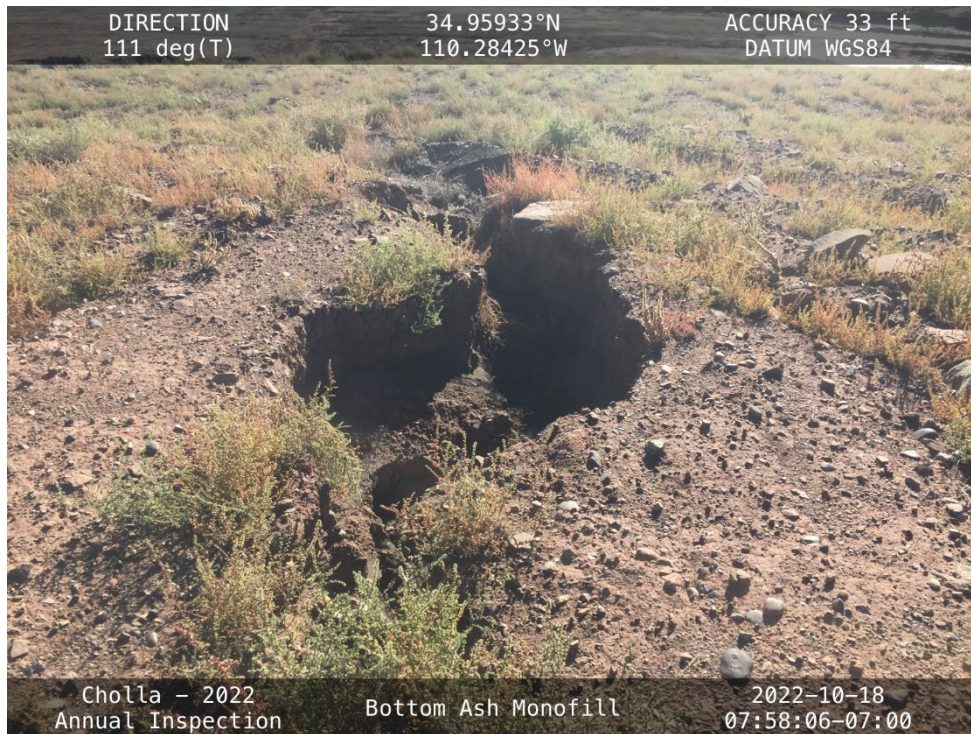
20221018 – IMG_3741

Two erosion gullies on the southern access ramp to the top of the Bottom Ash Monofill.

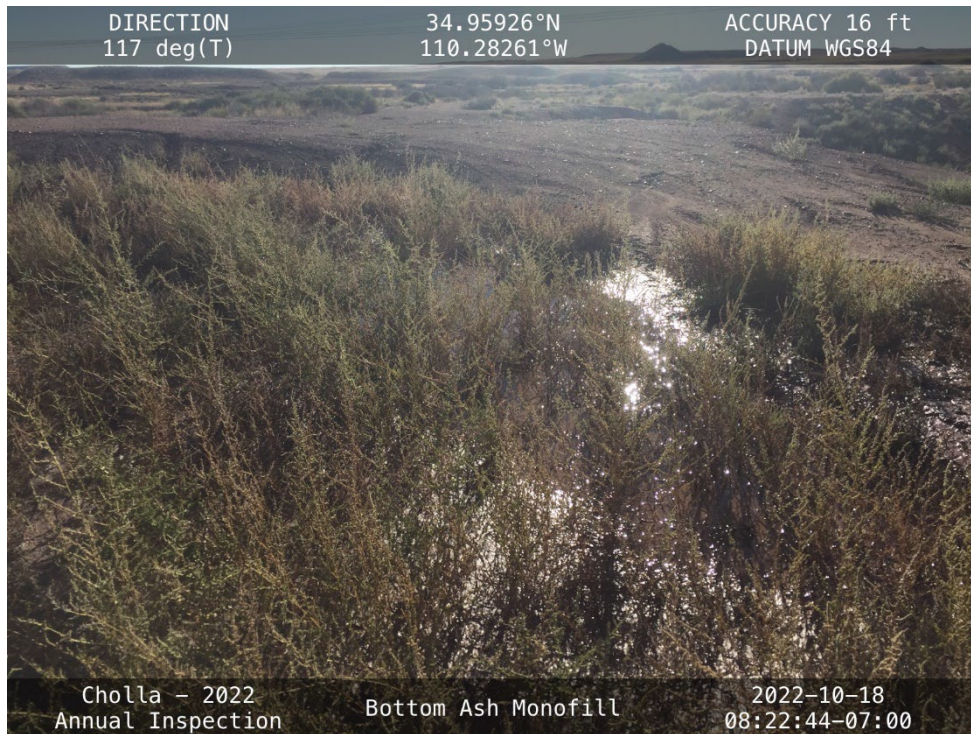
20221018 – IMG_3768

Standing water in the perimeter drainage channel on the north side of the Detention Basin.

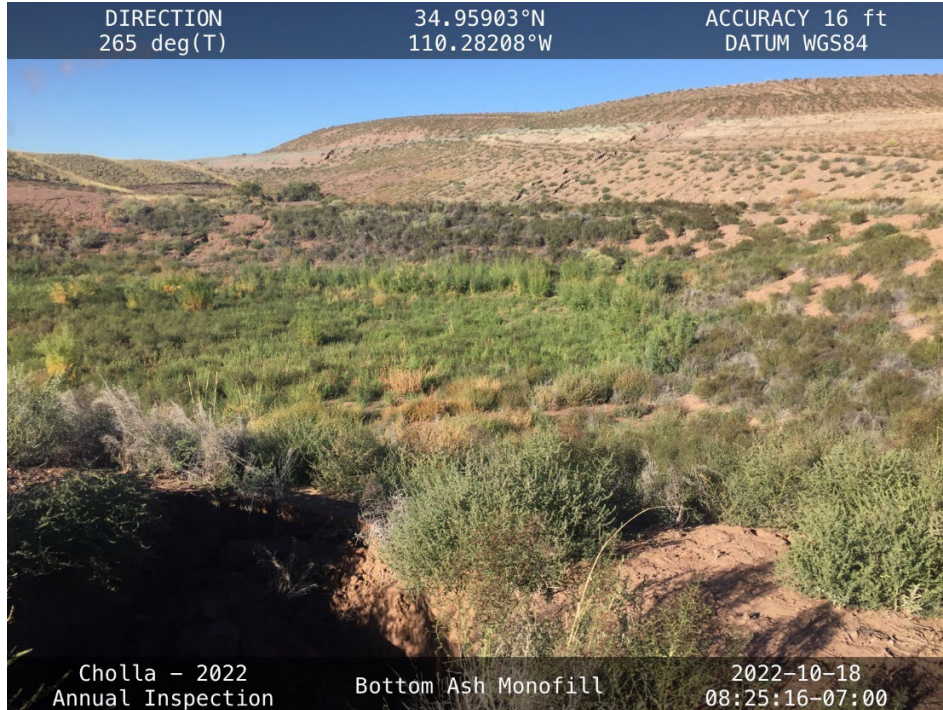
20221018 – IMG_3776

Erosion on the east side of the Stormwater Detention Basin where previous repairs had been made (2021 photo IMG_7263).

7) Severe erosion around the Stormwater Detention Basin.	Repair the erosion. Assess the gradients entering the Basin and consider reducing the entrance slope or placing riprap along the slopes to reduce the erosive potential of the run-on.

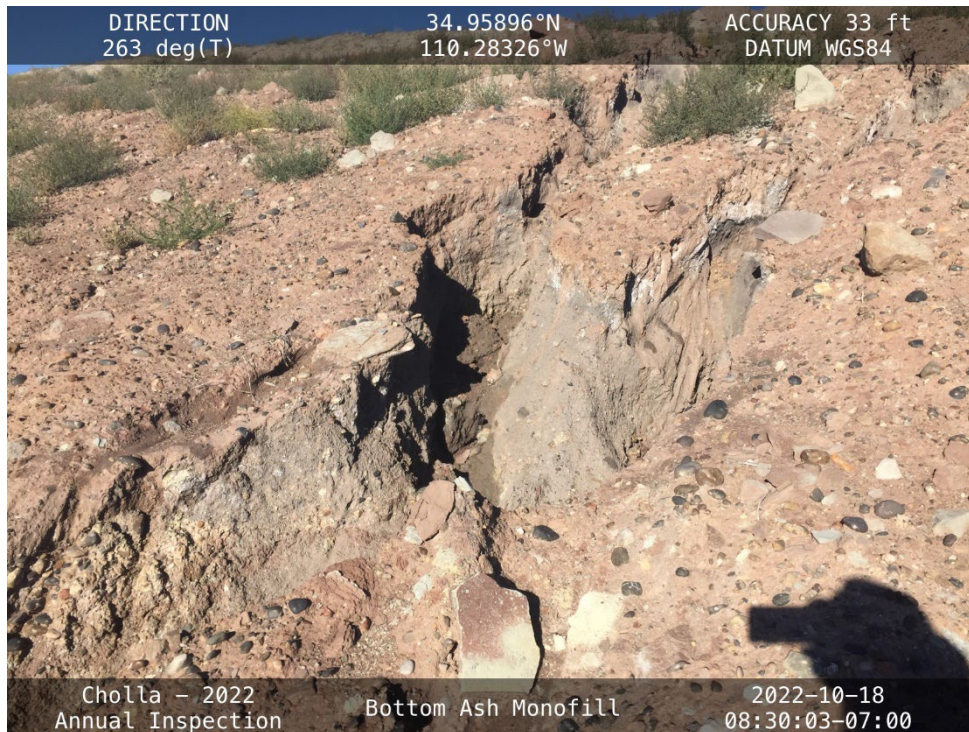
20221018 – IMG_3781

Eroded material deposited at the toe of the BAM, west of the Stormwater Detention Basin (more deposition at the toe compared to 2021 IMG_7255).

2) There is CCR at the eastern toe of the Bottom Ash Monofill, west of the Stormwater Detention Basin that has eroded off the eastern slope.	Repair the slope and remove the CCR from the toe.

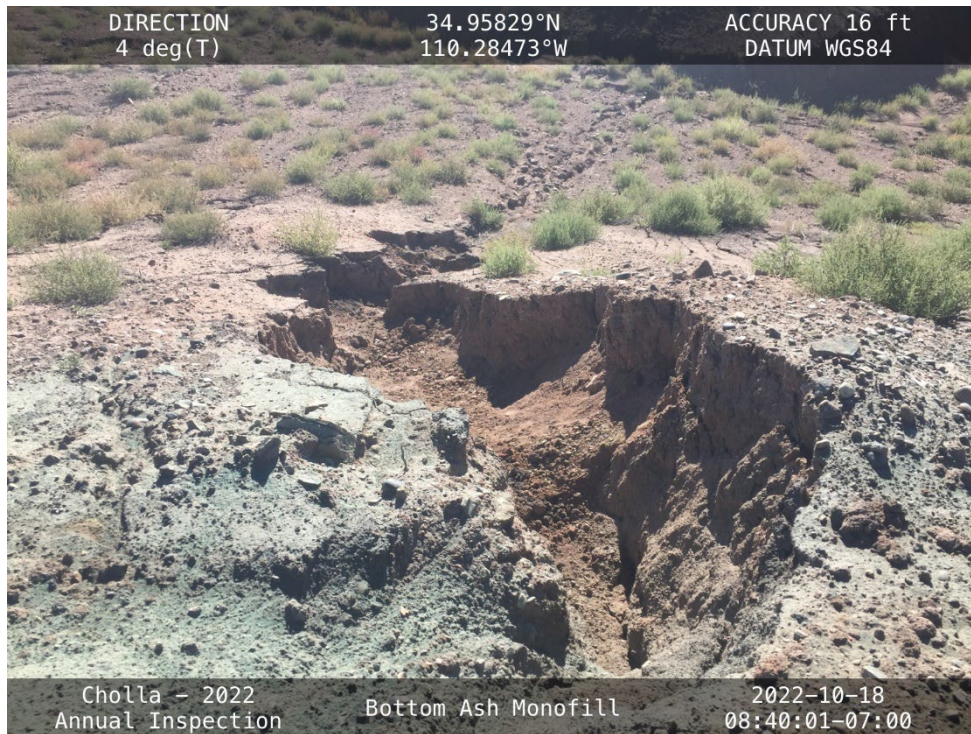
20221018 – IMG_3791

A low spot on the perimeter road at the top of the deep erosion in IMG_3737 and IMG_3784.
