CHOLLA POWER PLANT Fly Ash Dam, Bottom Ash Dam, Sedimentation Pond, and Bottom Ash Monofill

Annual CCR Impoundment and Landfill Inspection Report

2019

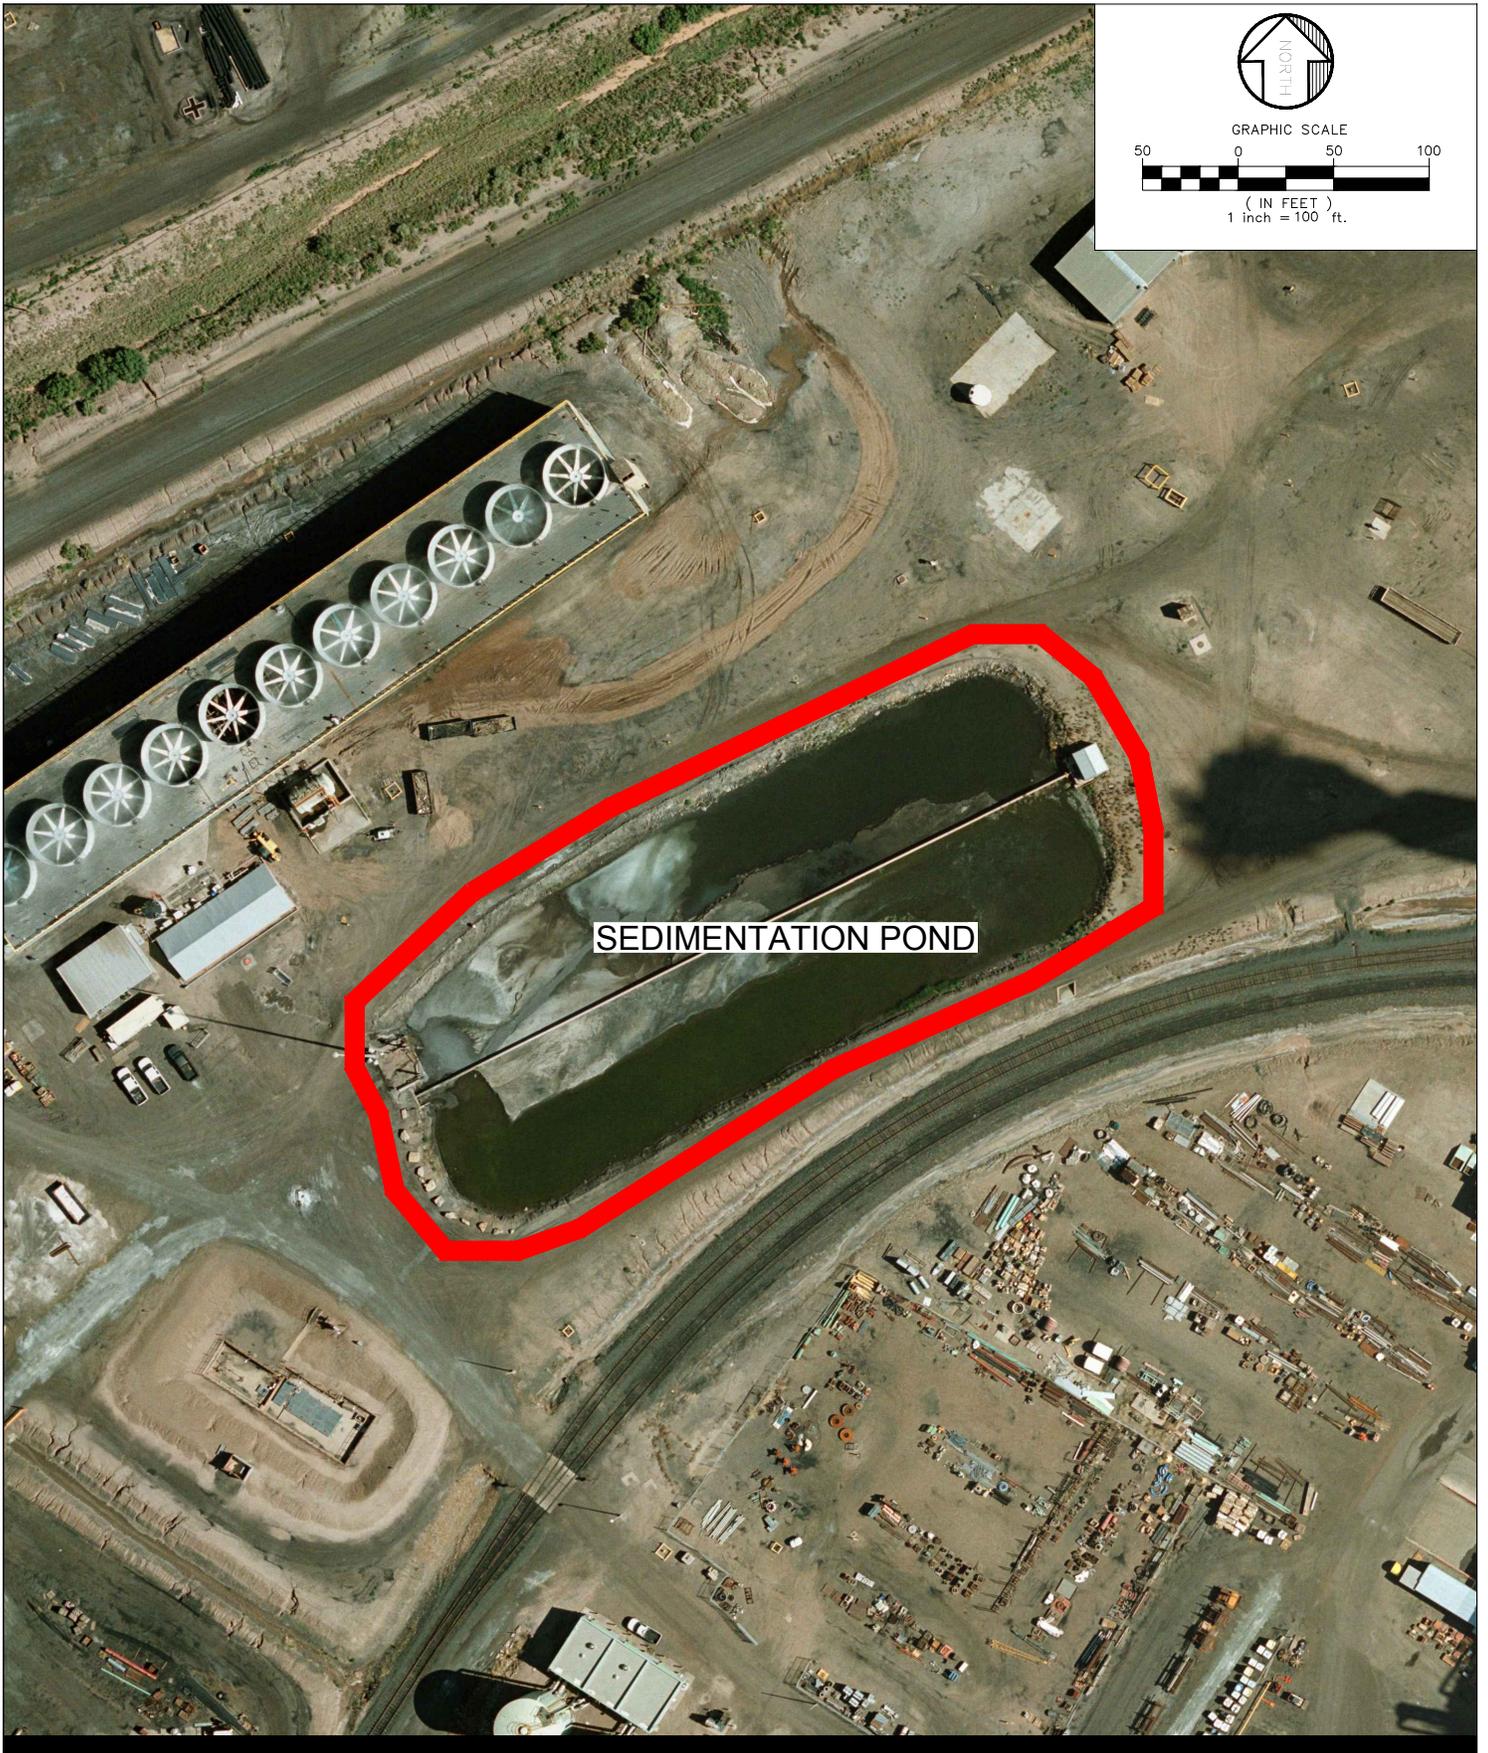
The Sedimentation Pond is represented on Figure 3 – Sedimentation Pond Site Map.

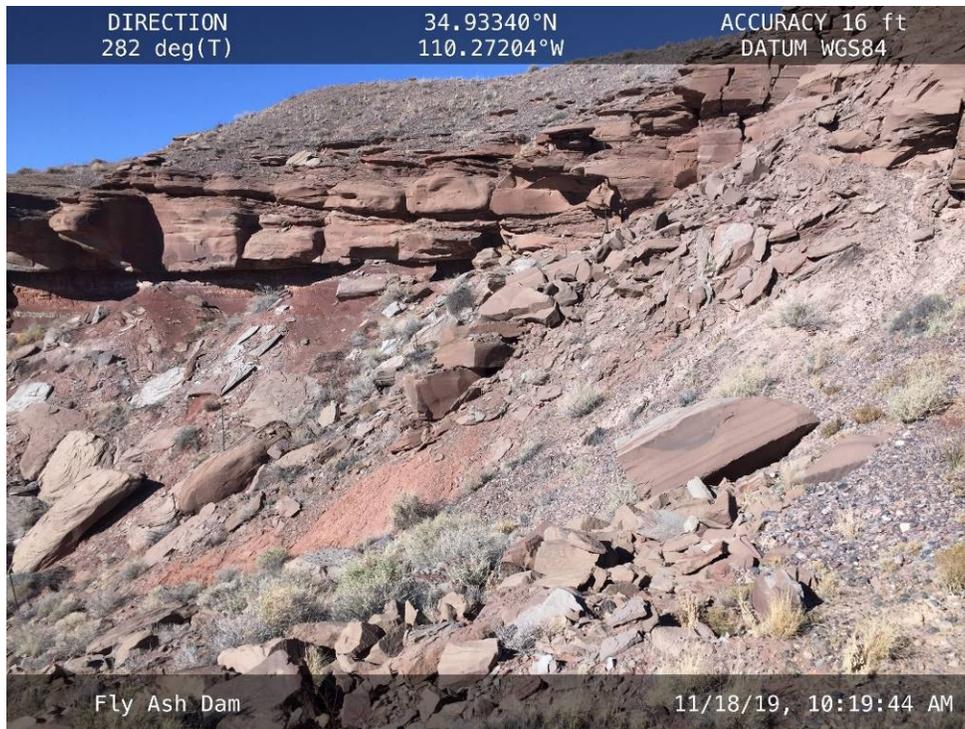
20191118 – IMG_5766
The downstream side of the Northwest Abutment contact.

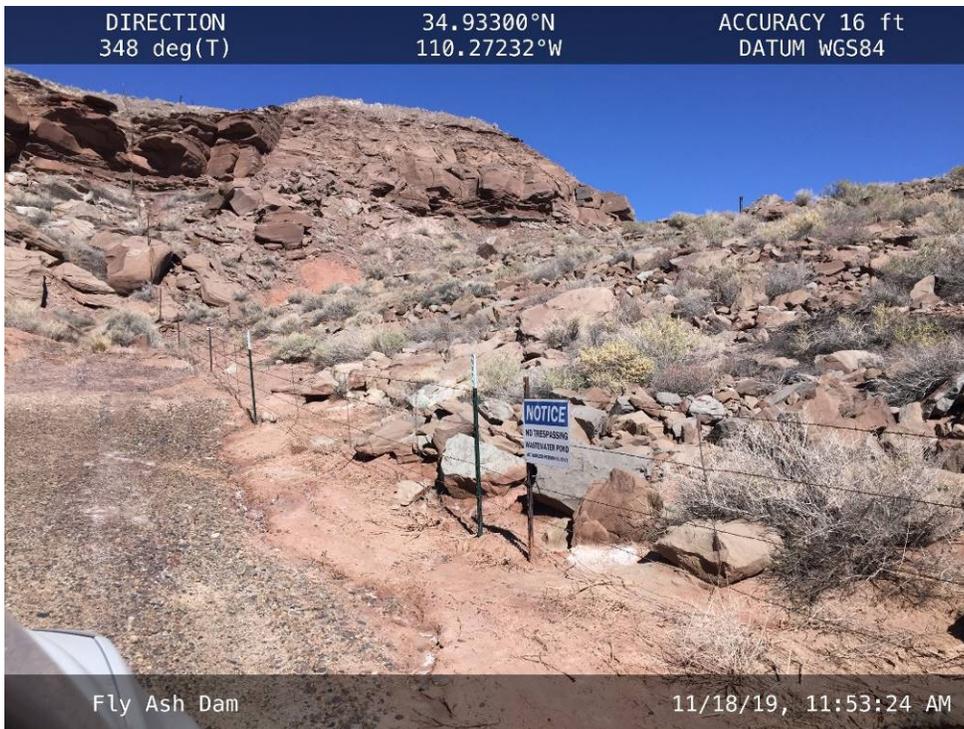
20191118 – IMG_5811

The Northwest Abutment contact, downstream slope, and area of historic erosion.

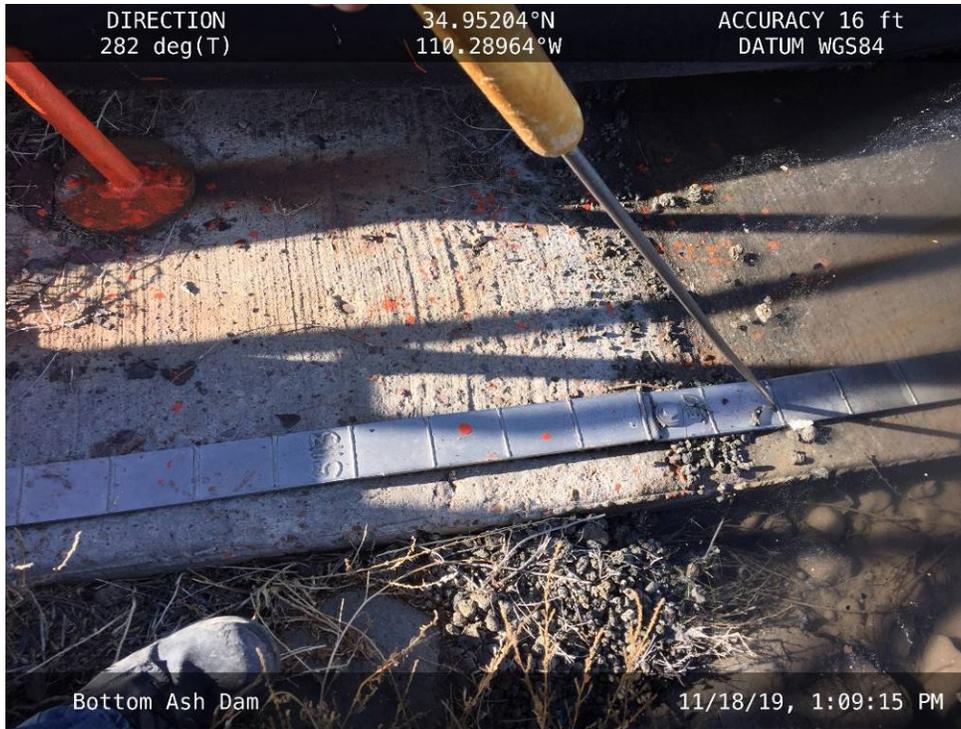
20191118 – IMG_5854

The reservoir level staff gauge adjacent to the central siphon lines.

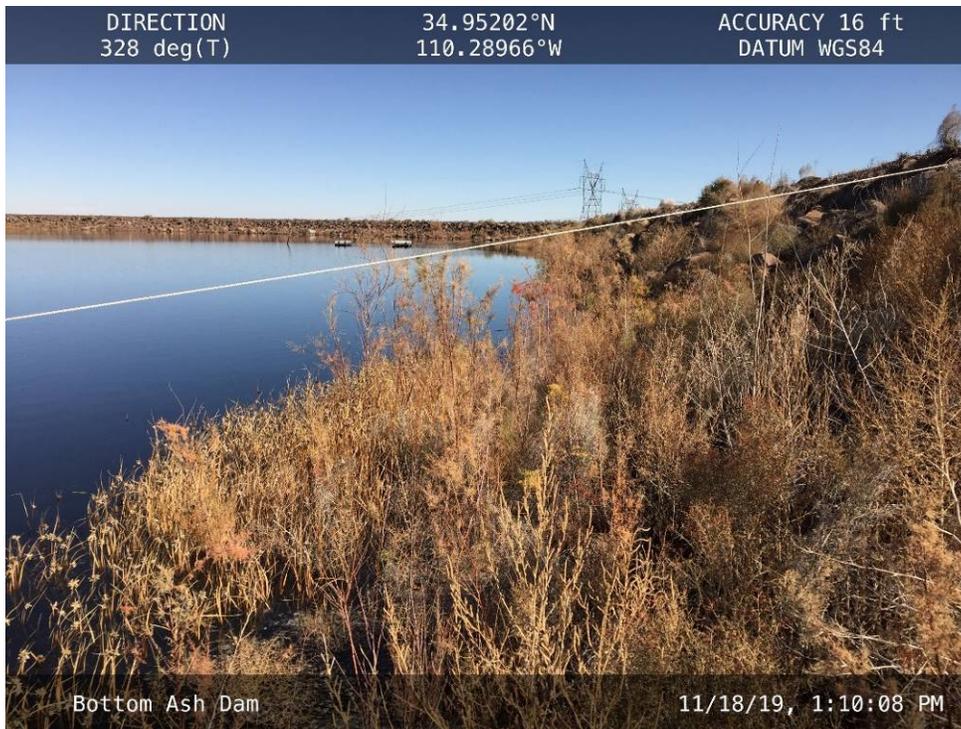
20191118 – IMG_5855

The upstream slope along the eastern half of the South Embankment, facing east.

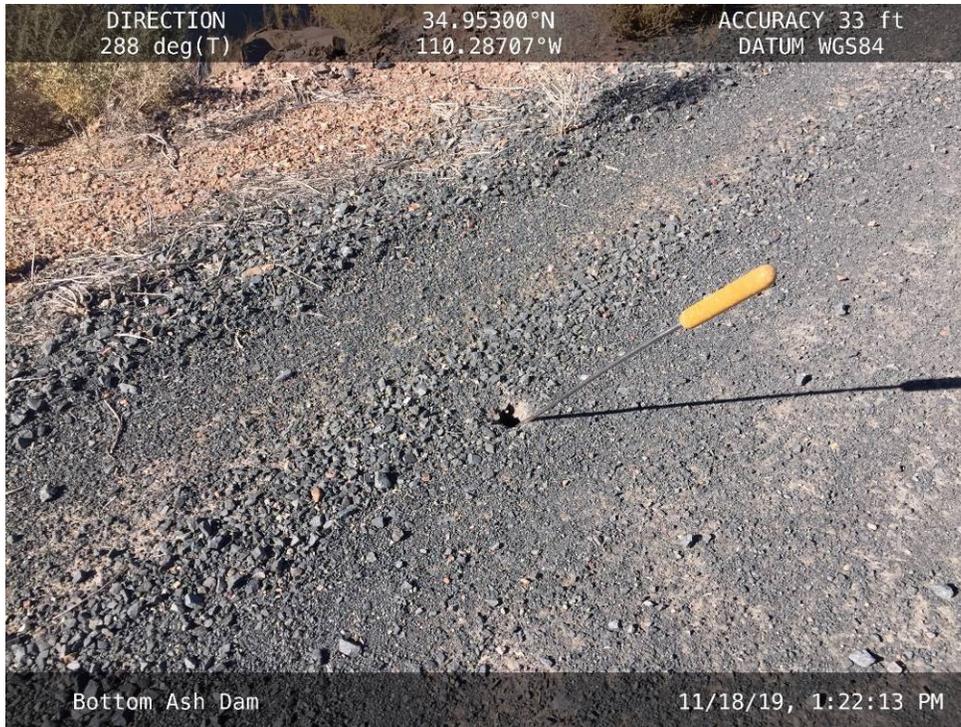
20191118 – IMG_5871

An erosion hole in the crest along the southern half of the East Embankment.

Action Item	Action Status
1) Record the location and sizes of erosion holes during the weekly inspections.	Repair the erosion holes and monitor the area around M-16 for cracking and new holes. NOTE: this is a carry-over from the 2018 report.

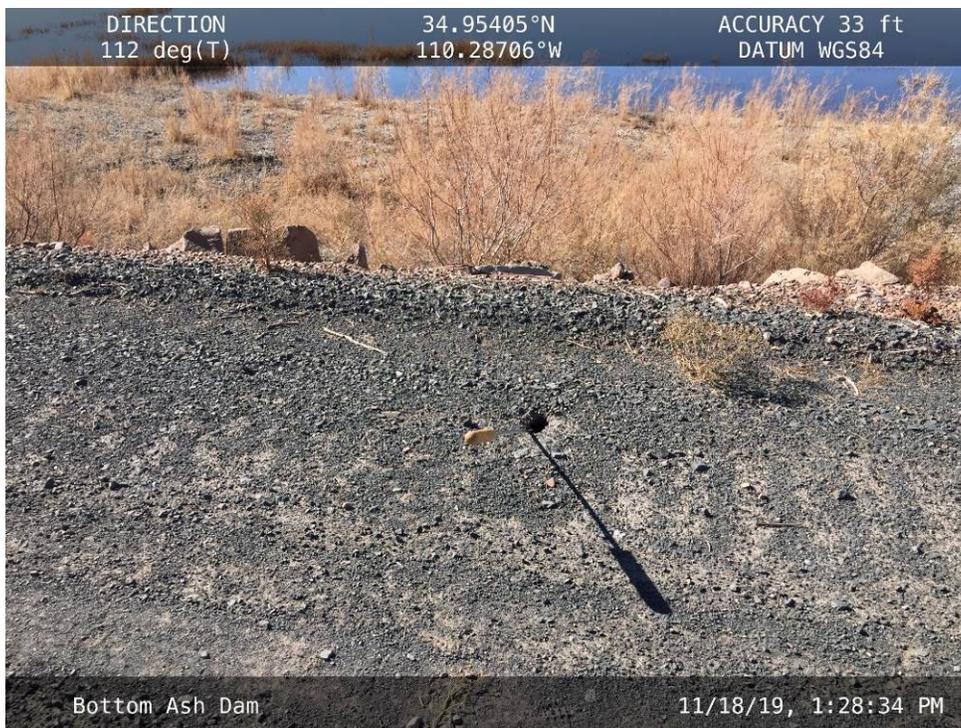
20191118 – IMG_5879

An erosion hole in the crest along the southern half of the East Embankment.

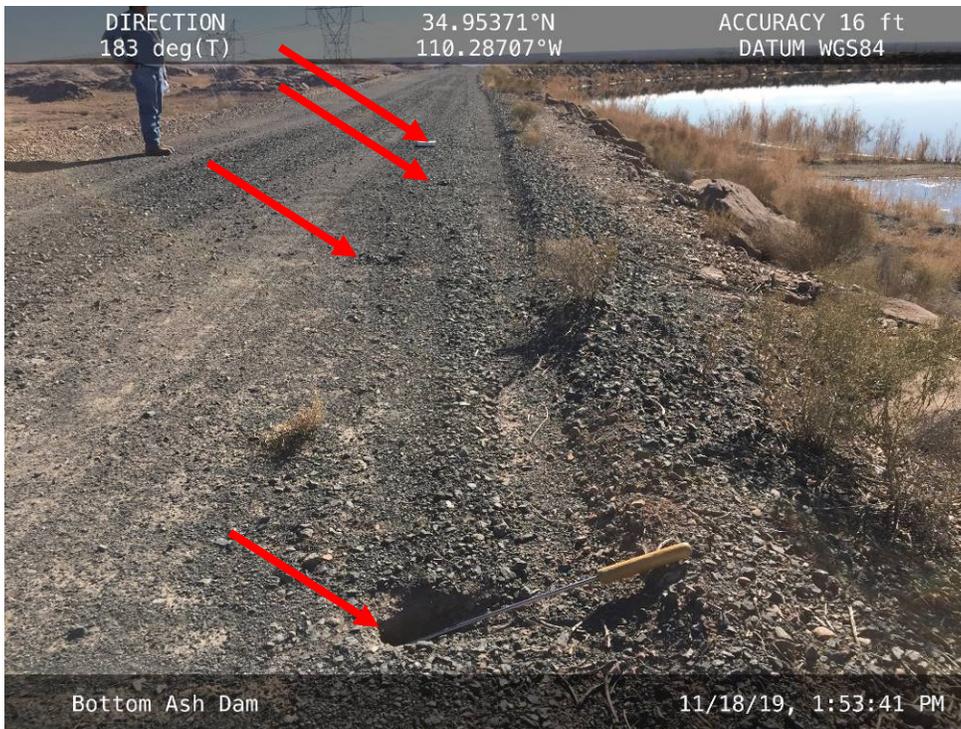
20191118 – IMG_5901

A series of erosion holes on the upstream shoulder of the crest near settlement monument M-16.

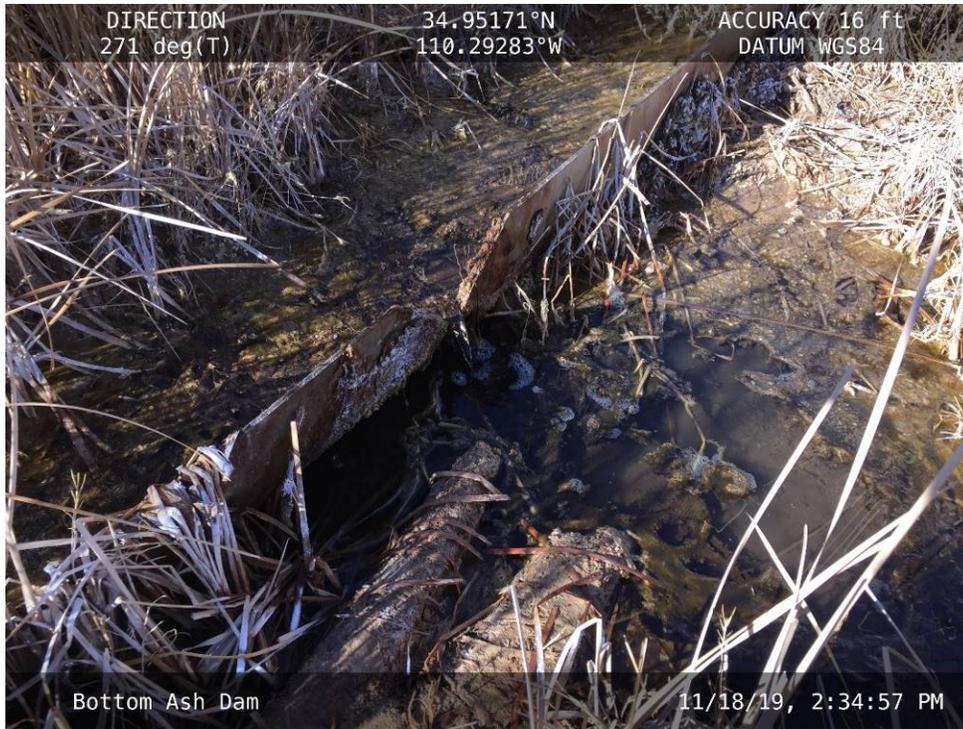
20191118 – IMG_5912

The West Abutment Weir at the downstream toe near the West Abutment.

7) Remove vegetation and debris from the West Abutment Weir.	Location is currently obscured and access is restricted. Location should be cleared so that it can be accessed and measured during regular inspections. Add to maintenance work list and repair as needed. NOTE: this is a carry-over from the 2018 report.

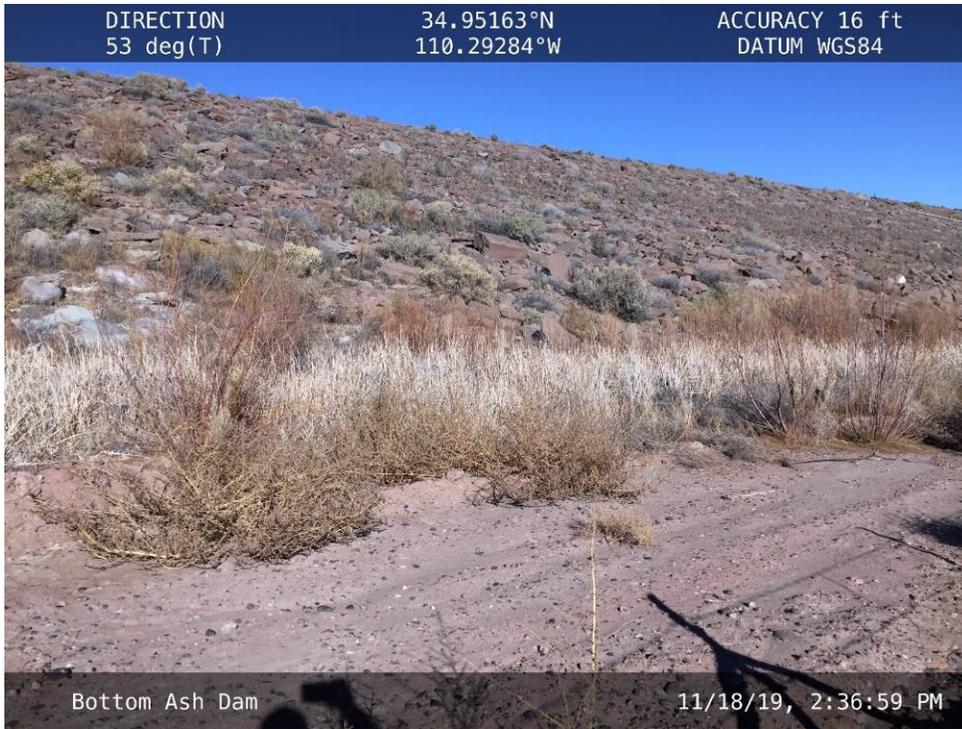
20191118 – IMG_5915

The downstream slope and toe of the South Embankment, east of the West Abutment Weir.

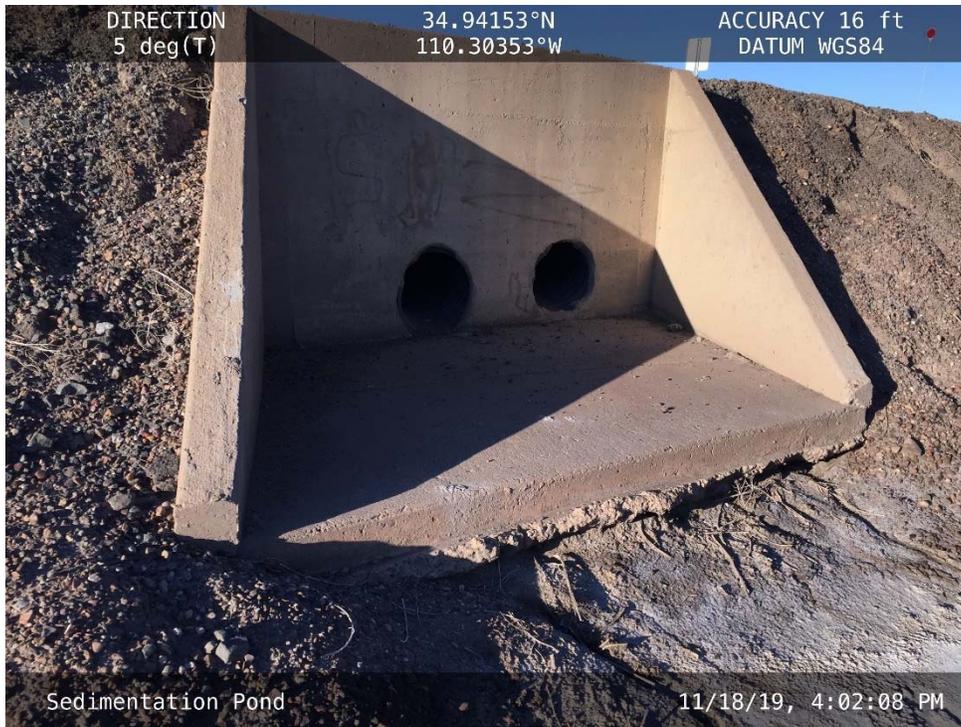
20191118 – IMG_6007

The concrete spillway on the downstream side of the south embankment.

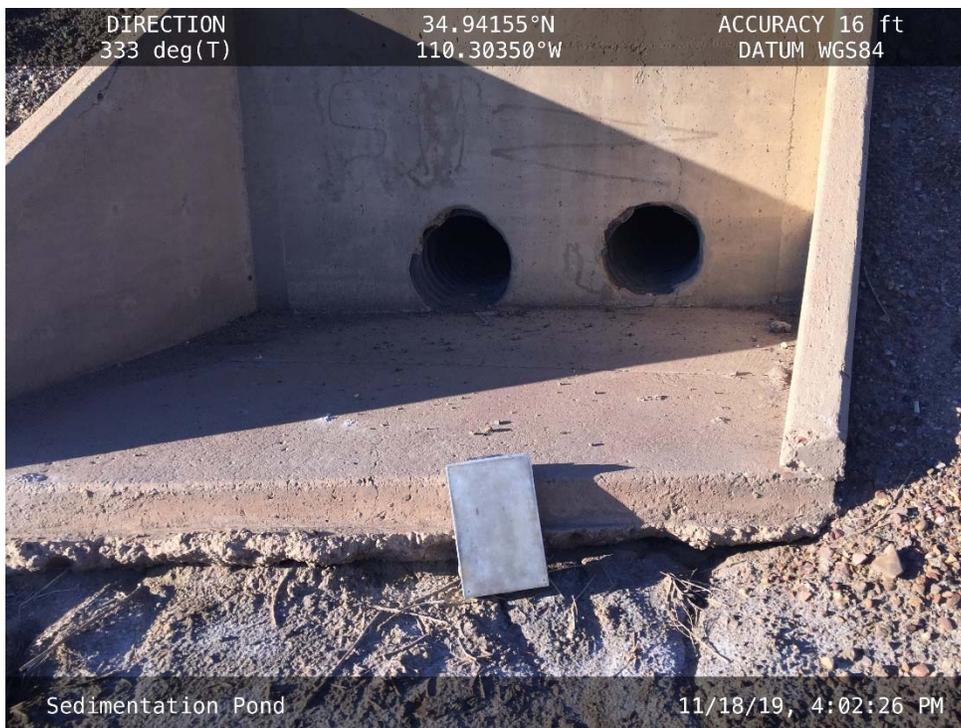
20191118 – IMG_6009

Erosion under the concrete spillway on the downstream side of the south embankment.

Action Item	Action Status
1) Monitor the erosion around the outfall structure and the surface of the CCR unit.	Repair as needed.
