# CHOLLA POWER PLANT Fly Ash Pond, Bottom Ash Pond, Sedimentation Pond and Bottom Ash Monofill

## Annual CCR Impoundment and Landfill Inspection Report

### 2015

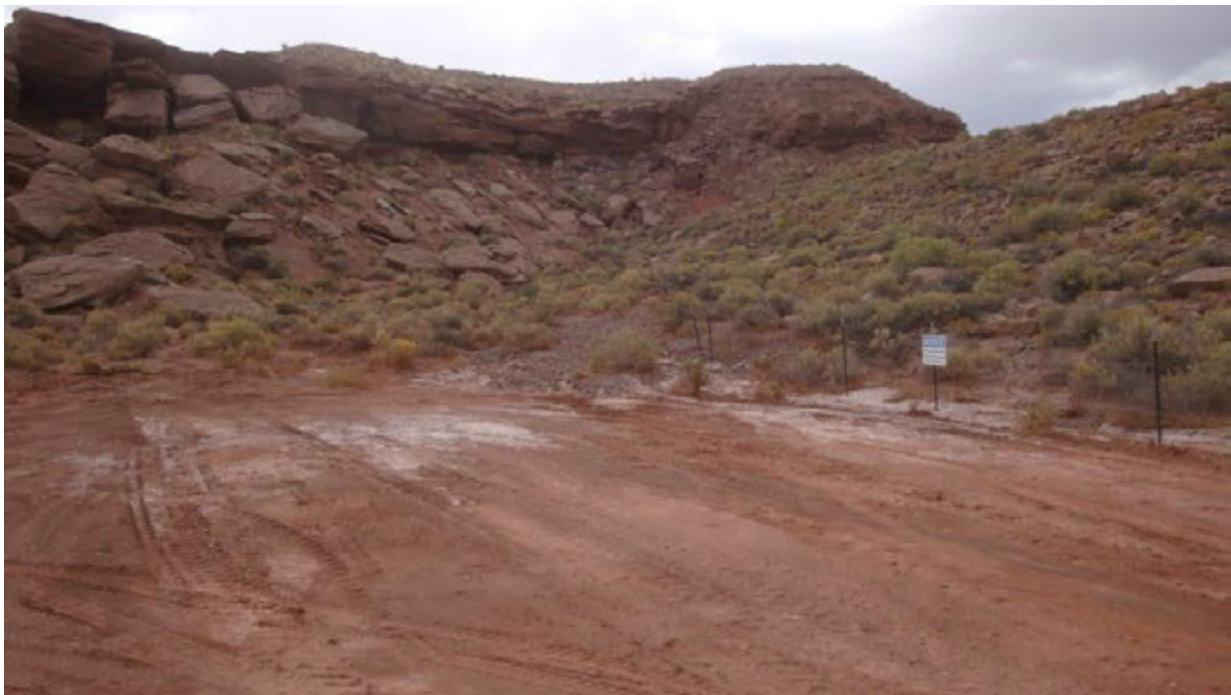
**20151016 – Photo 35**

Downstream slope. FGD/ash lines. Vegetation generally less than 3 feet high. Note rip rap facing on dam.

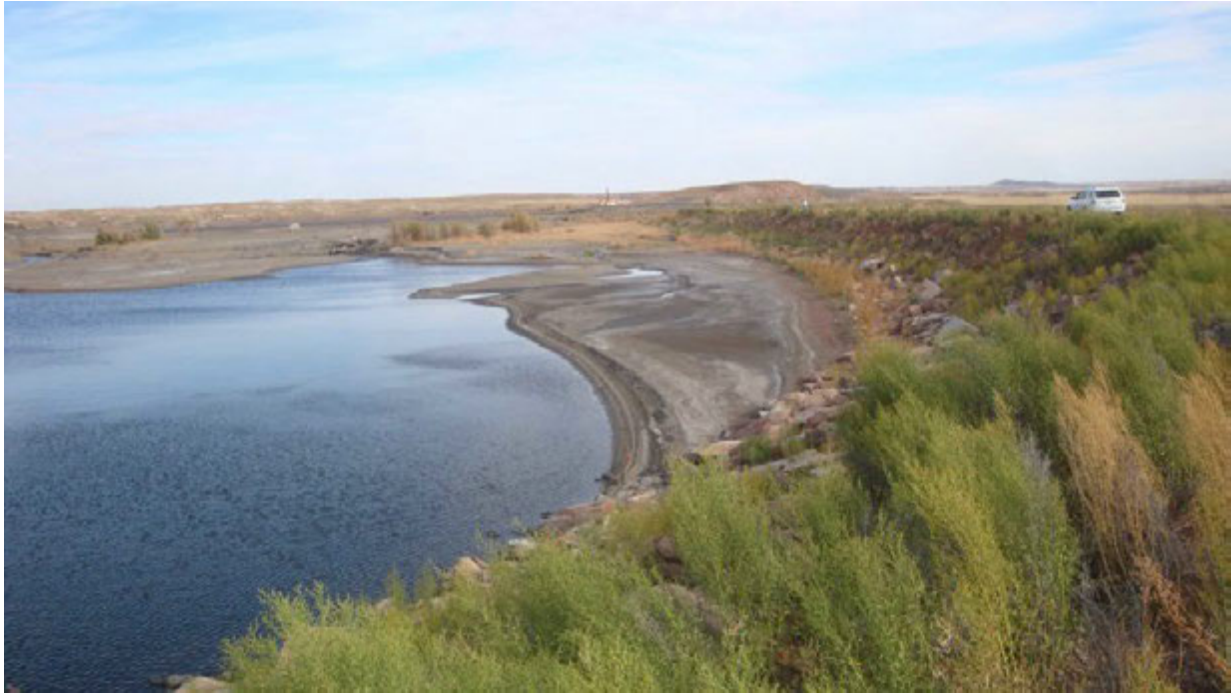
**20151016 – Photo 40**

Upstream slope. Vegetation exceeding 3-foot height adjacent to crest.

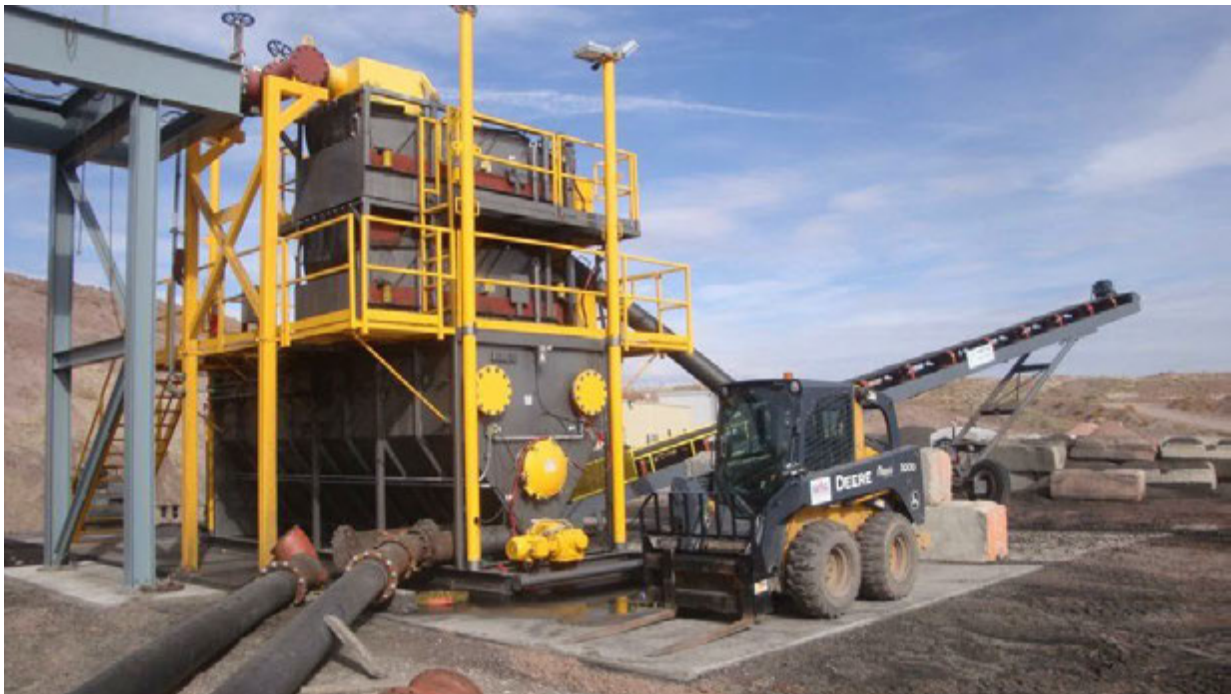
**20151016 – Photo 54**

SRMG Screening Plant. West side of impoundment. Not operational during inspection. Recovers specific gradation of bottom ash for beneficial reuse.

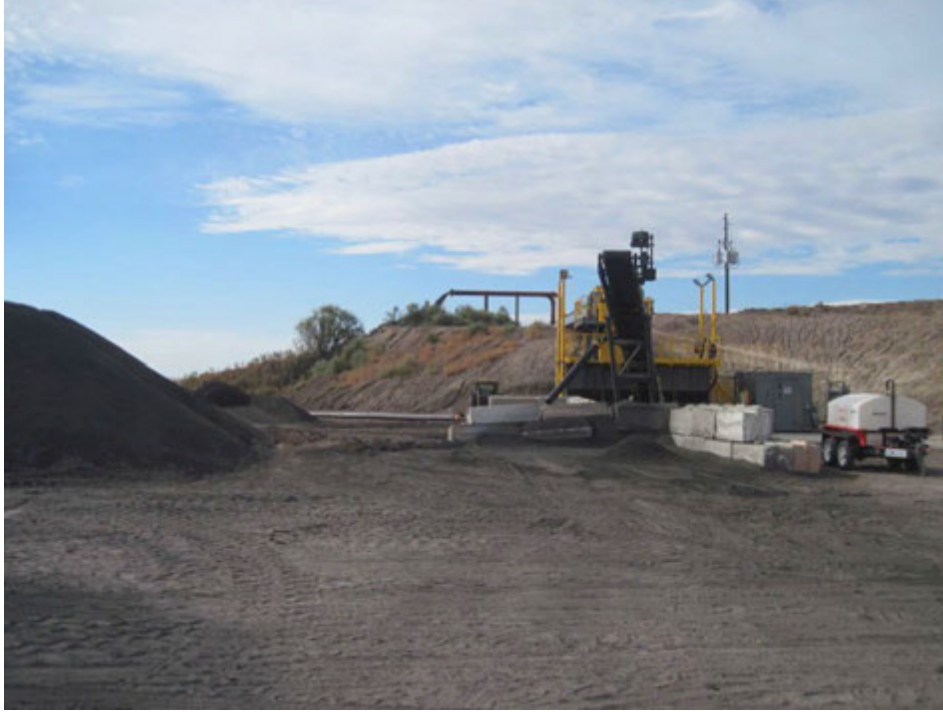
**20151016 – IMG\_2140**

SRMG Screening Plant. West side of impoundment. Bypass to impoundment visible in background.

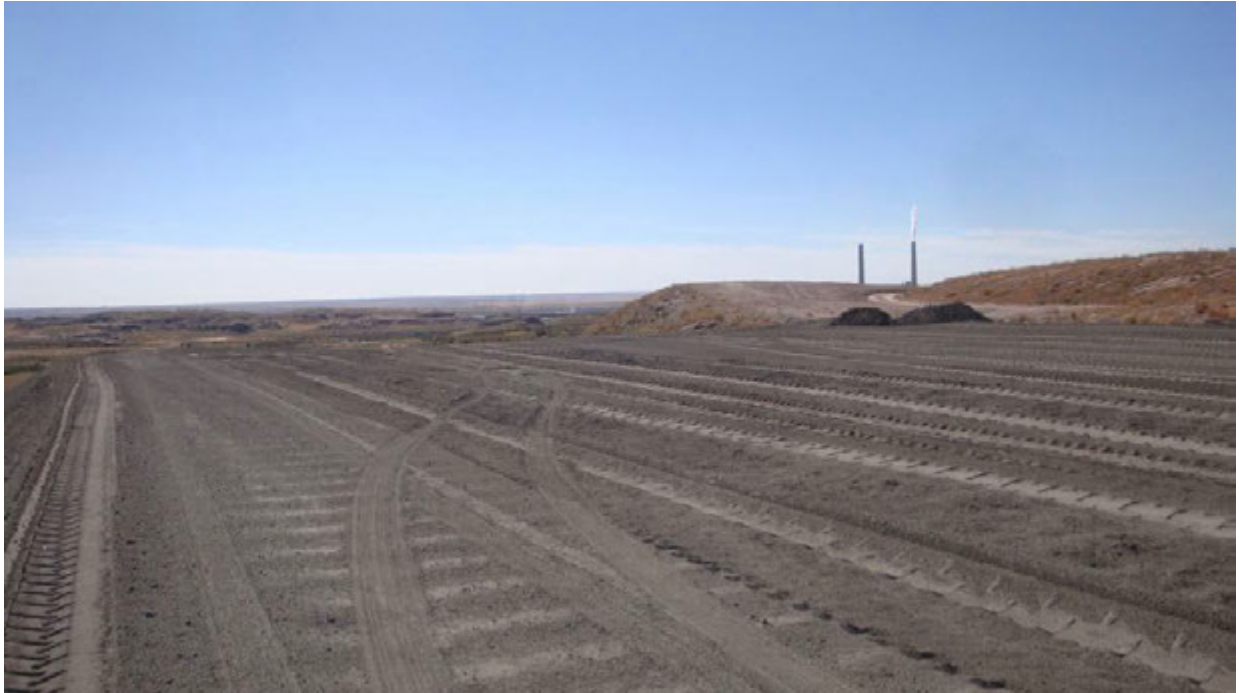
**20151016 – Photo 4**  
Fresh ash placement. Looking south.

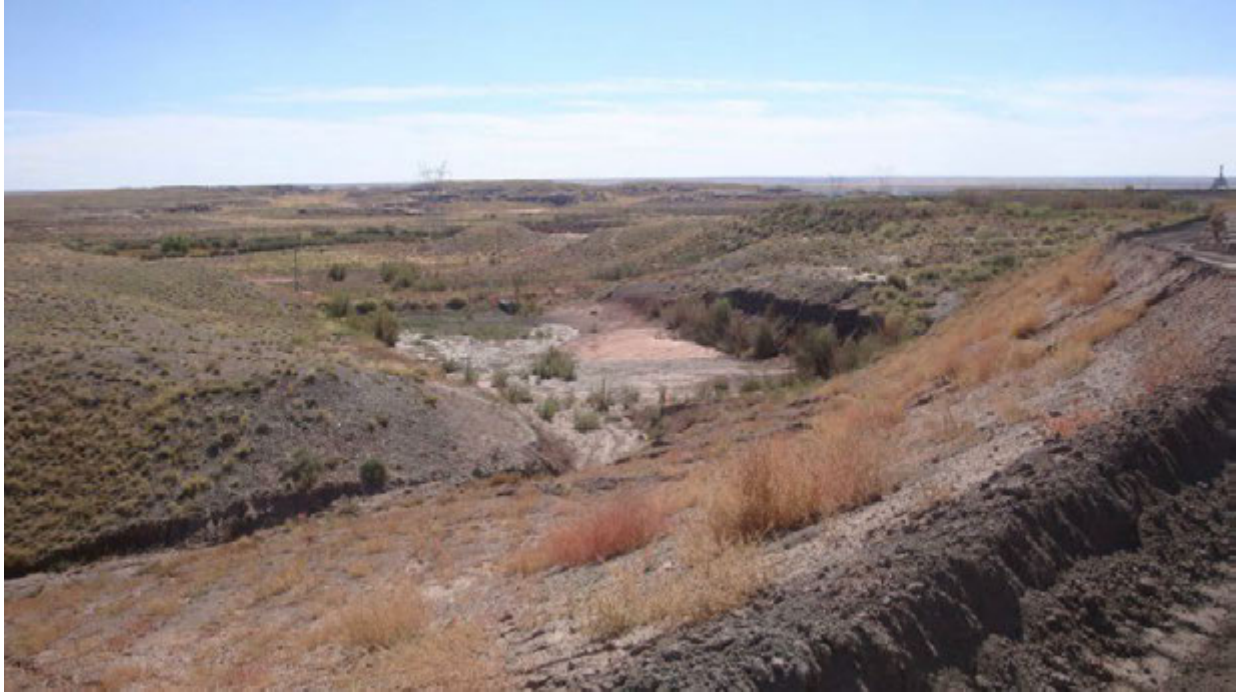
**20151016 – Photo 28**  
Run-off retention basin.
