# CHOLLA POWER PLANT Fly Ash Dam, Bottom Ash Dam, and Bottom Ash Monofill

## Annual CCR Impoundment and Landfill Inspection Report

2024

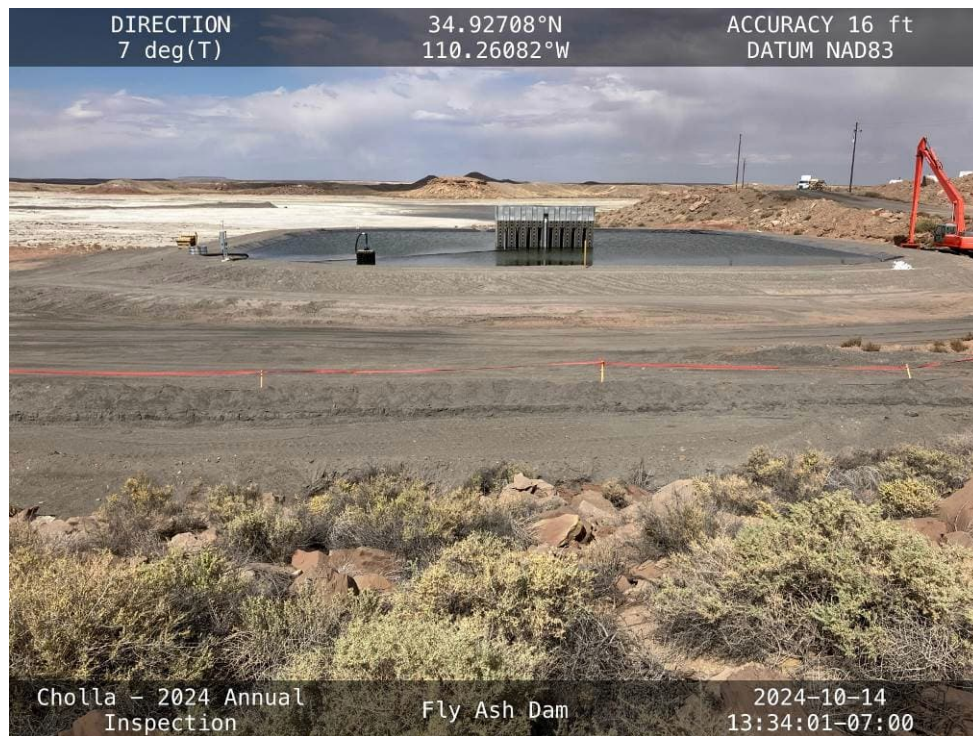
#### 20241014 – IMG\_6427

The EcoVap pond where APS is pumping pore water from the wells in the reservoir.

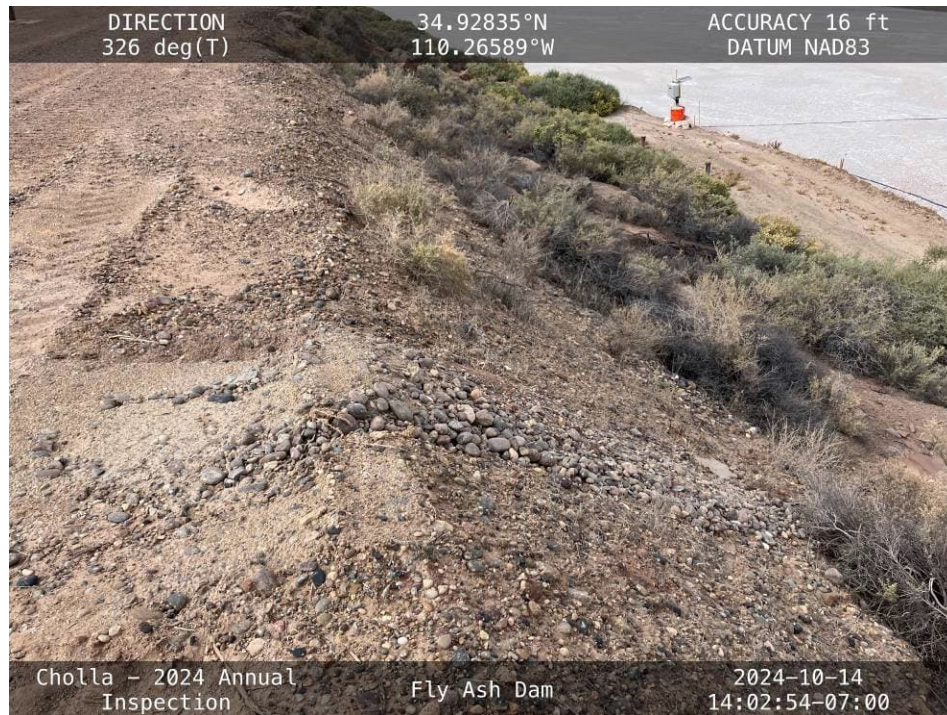
#### 20241014 – IMG\_6456

Location along the upstream slope where erosion 3.25 feet wide and 1.5 feet deep observed during the 2023 inspection has been repaired.

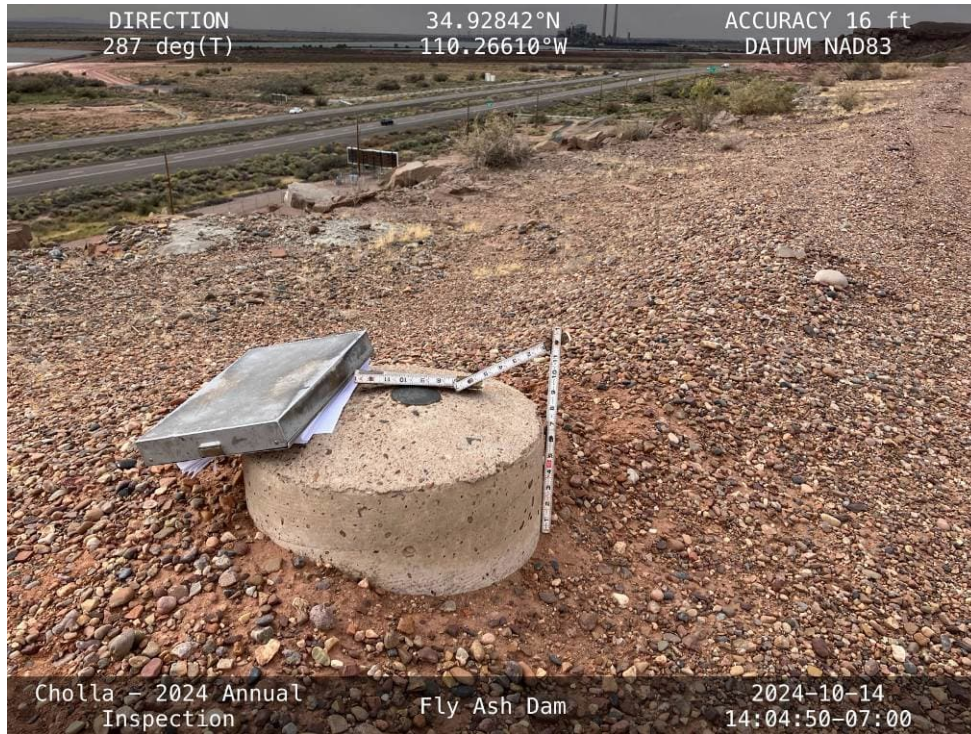
**20241014 – IMG\_6459**

Settlement Monument M-6, with approximately 8 inches of soil loss around the concrete.

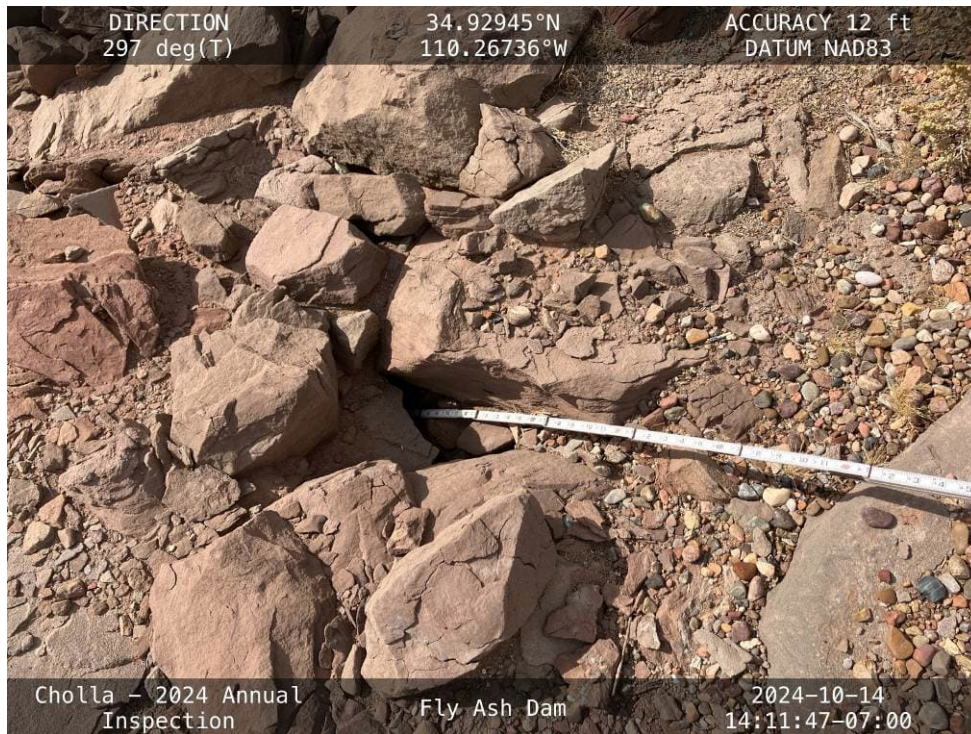
**20241014 – IMG\_6473**

A 1-foot deep hole was observed within the riprap on the downstream shoulder of the West Embankment crest (Photo IMG\_6473) and a 10-inch deep hole on the upstream shoulder of the West Embankment (Photo IMG\_6506). Continue to monitor the crest for progressive erosion and the appearance of new erosion holes. Repair holes when the depth exceeds 1 foot.

A 1-foot deep hole within the riprap on the downstream shoulder.

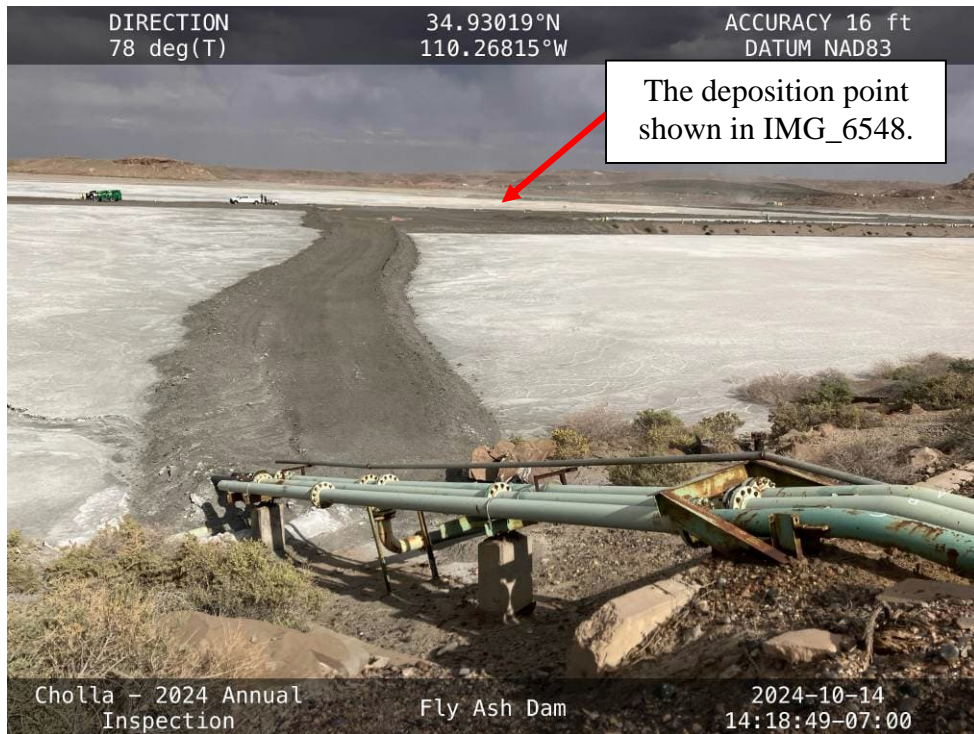
#### 20241014 – IMG\_6489

The inlet pipes on the upstream slope, with the extension buried under the bottom ash road.

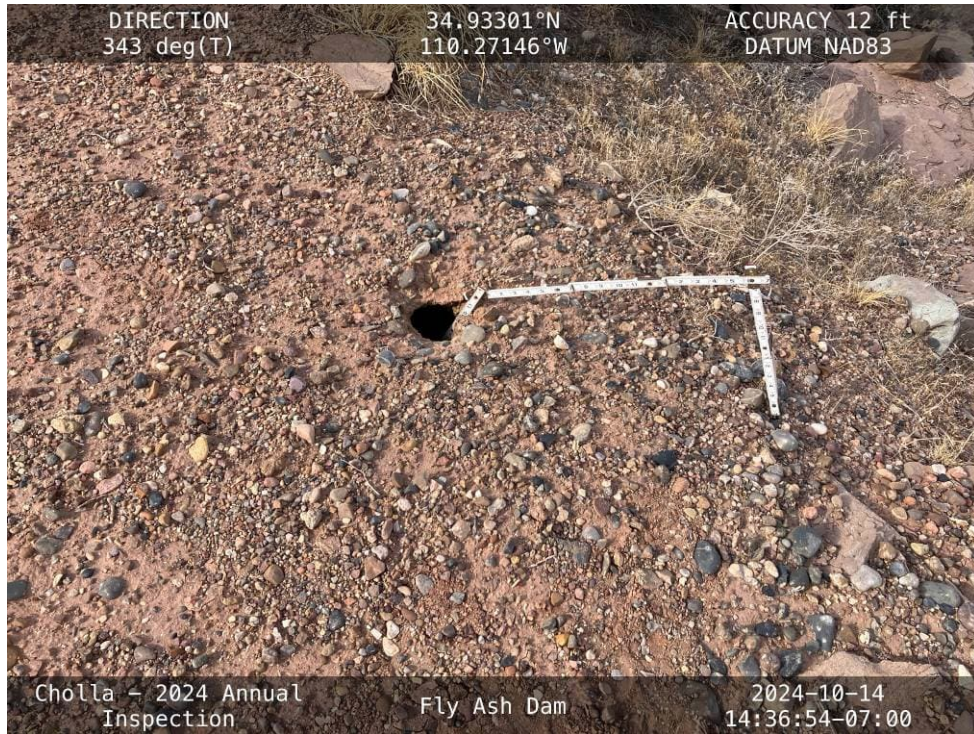
#### 20241014 – IMG\_6506

A 10-inch deep hole on the upstream shoulder of the West Embankment.

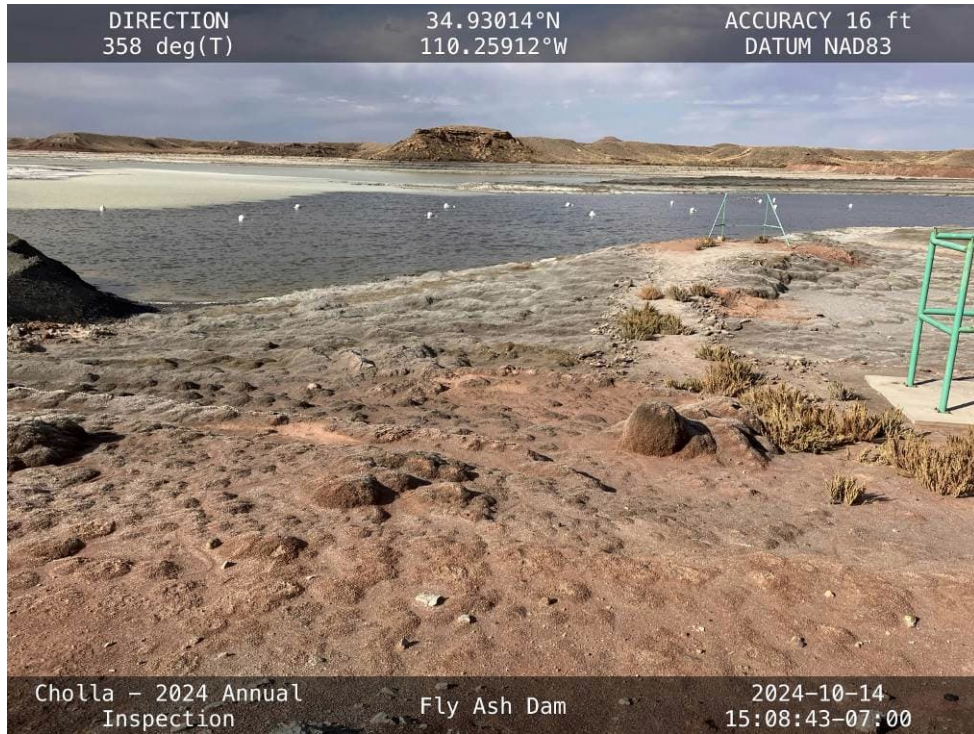
### 20241014 – IMG\_6521

Extraction wells installed in the reservoir.

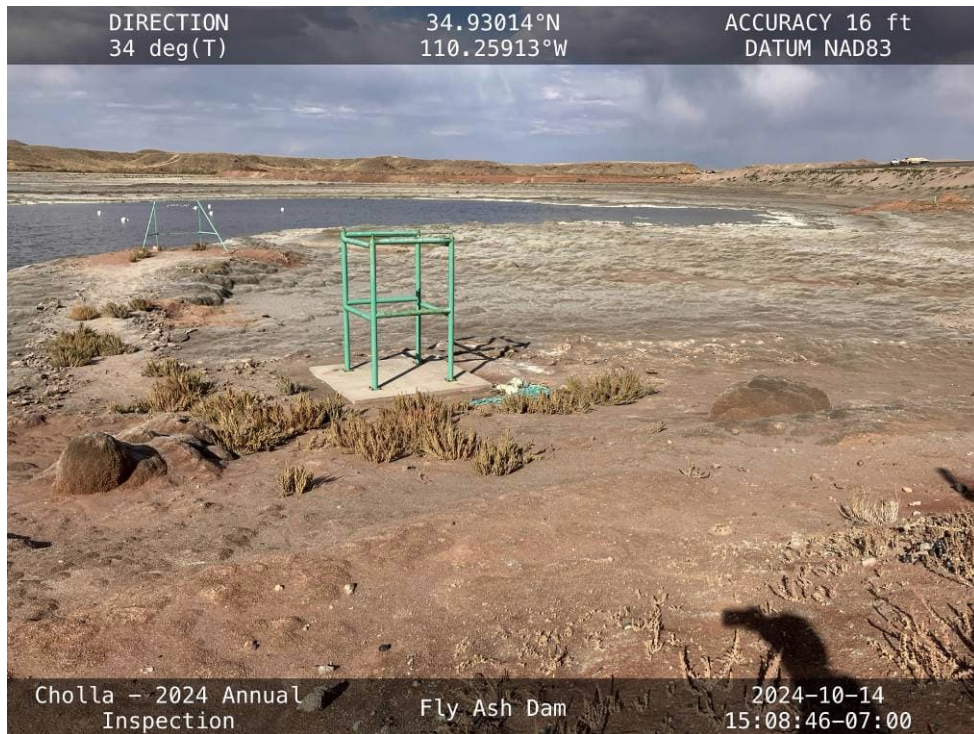
### 20241014 – IMG\_6527

The eastern side of the reservoir where the downdraft evaporators were.

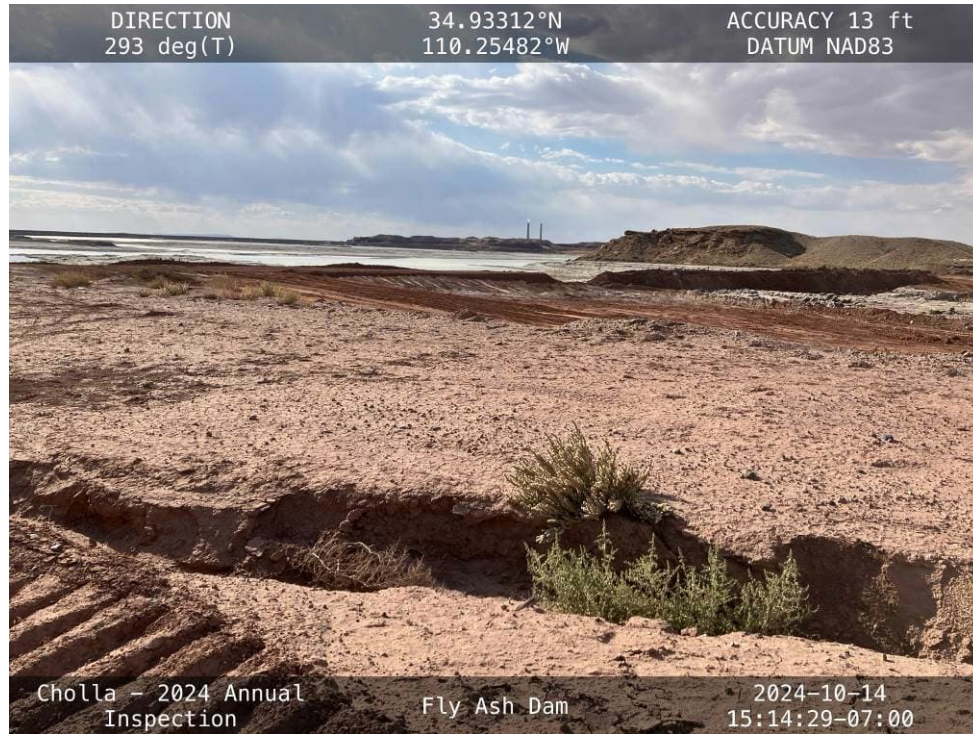
### 20241014 – IMG\_6530

The eastern side of the reservoir where the downdraft evaporators were.

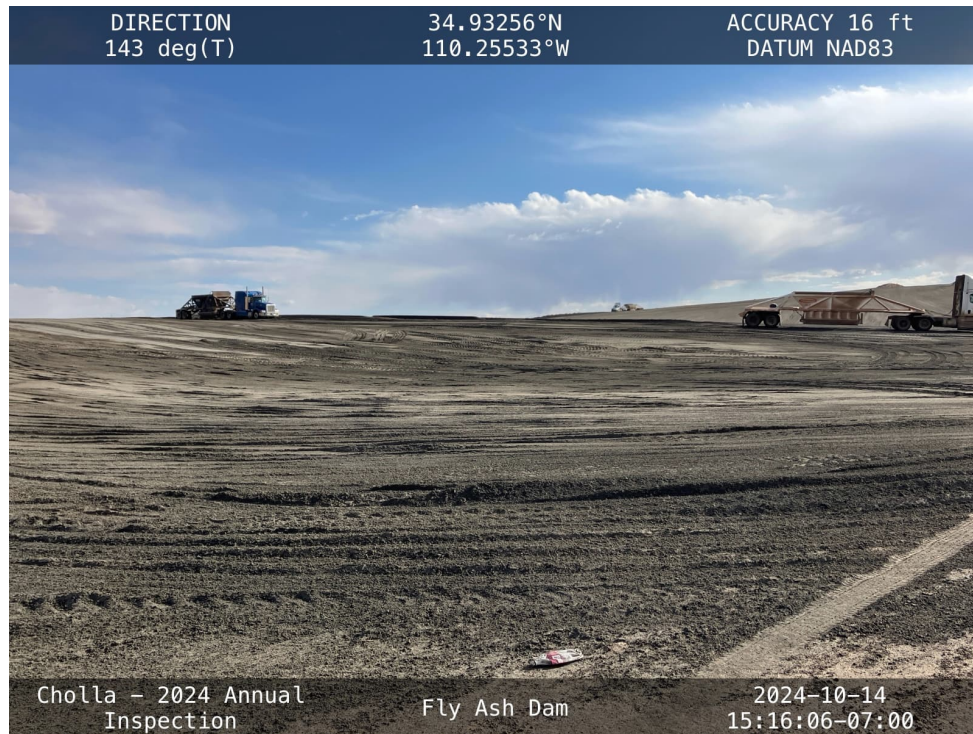
### 20241014 – IMG\_6541

The northeastern side of the reservoir where the East Evaporation Basin is being constructed.

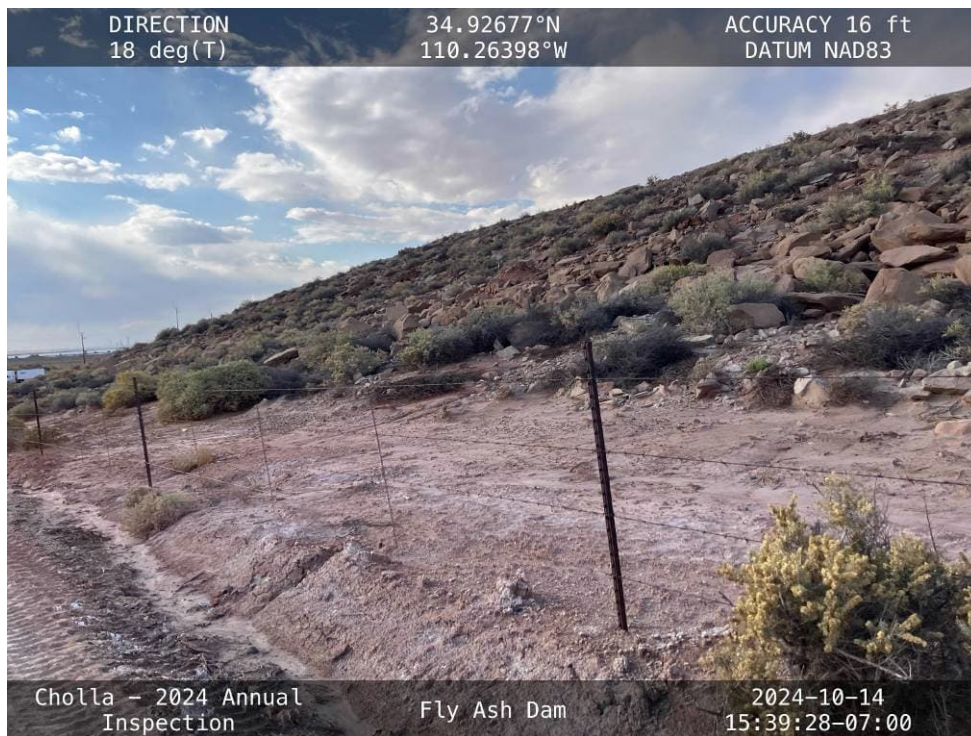
**20241014 – IMG\_6568**  
The downstream slope and toe of the South Embankment.

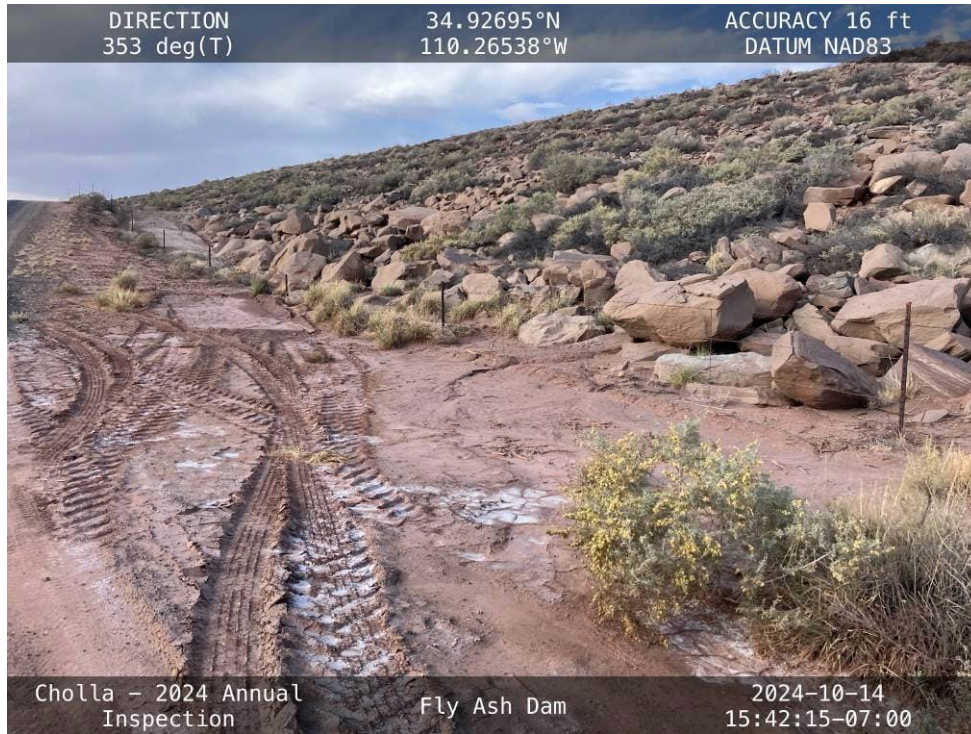
**20241014 – IMG\_6573**  
The downstream slope and toe of the South Embankment.

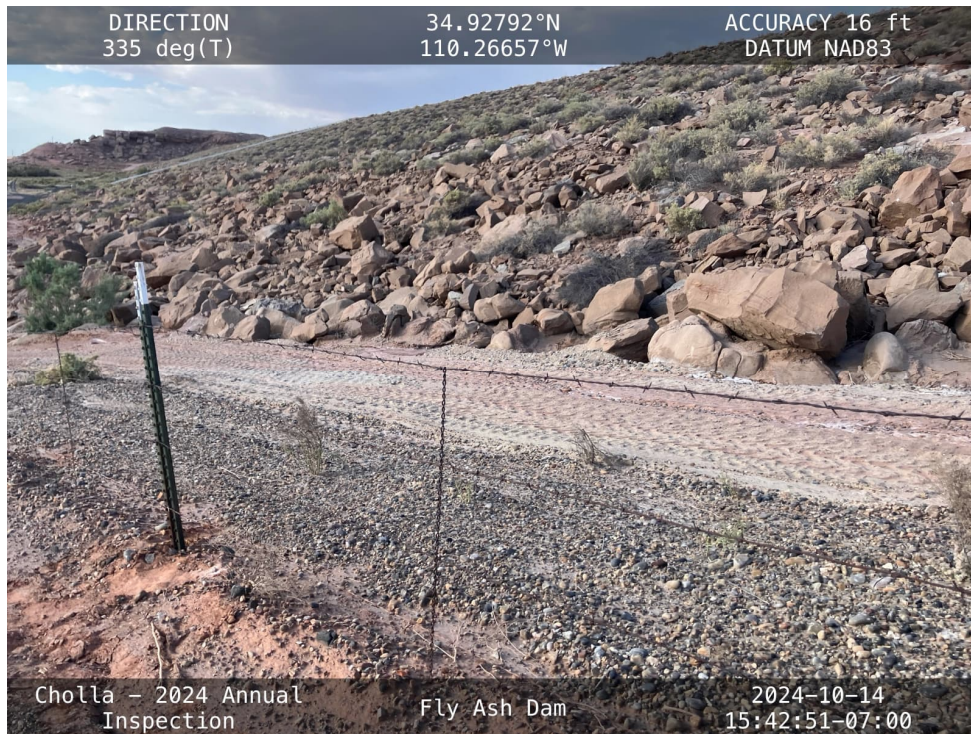
### 20241014 – IMG\_6578

The downstream slope and toe of the West Embankment.

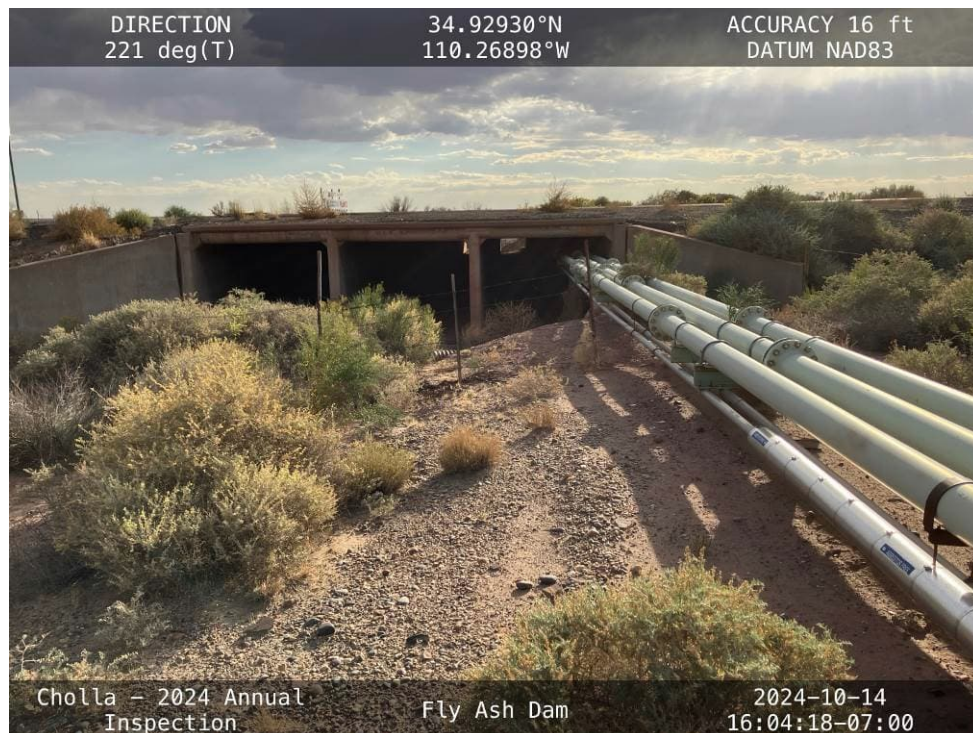
**20241014 – IMG\_6596**  
The Geronimo Seep area, facing northwest.

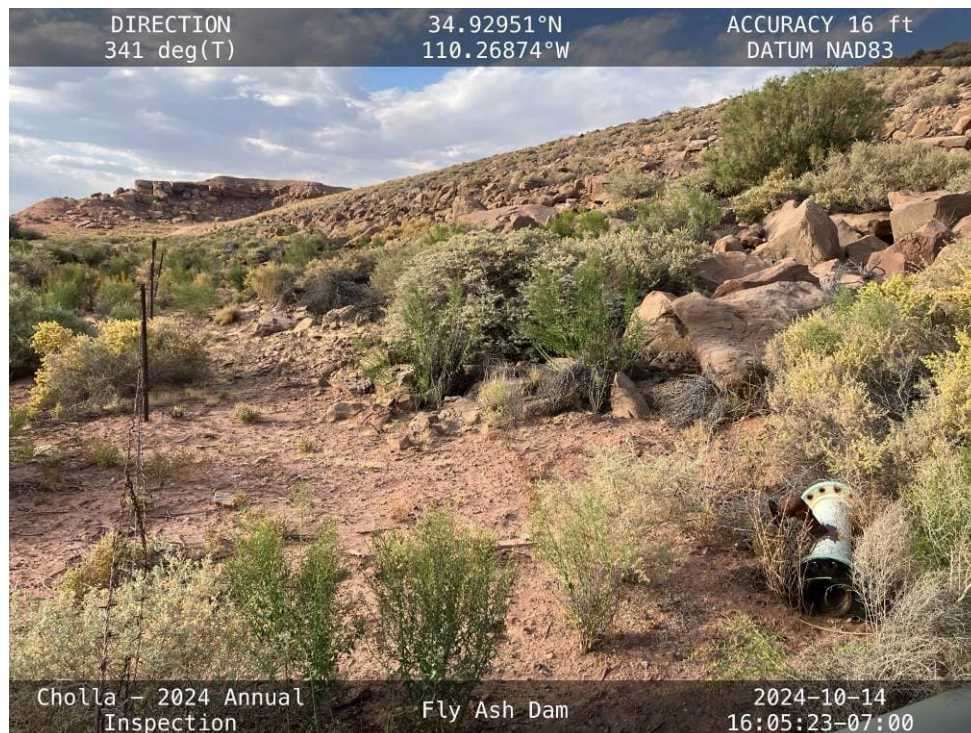
### 20241014 – IMG\_6606

The Geronimo totalizer and the inlet pipes along the downstream slope.

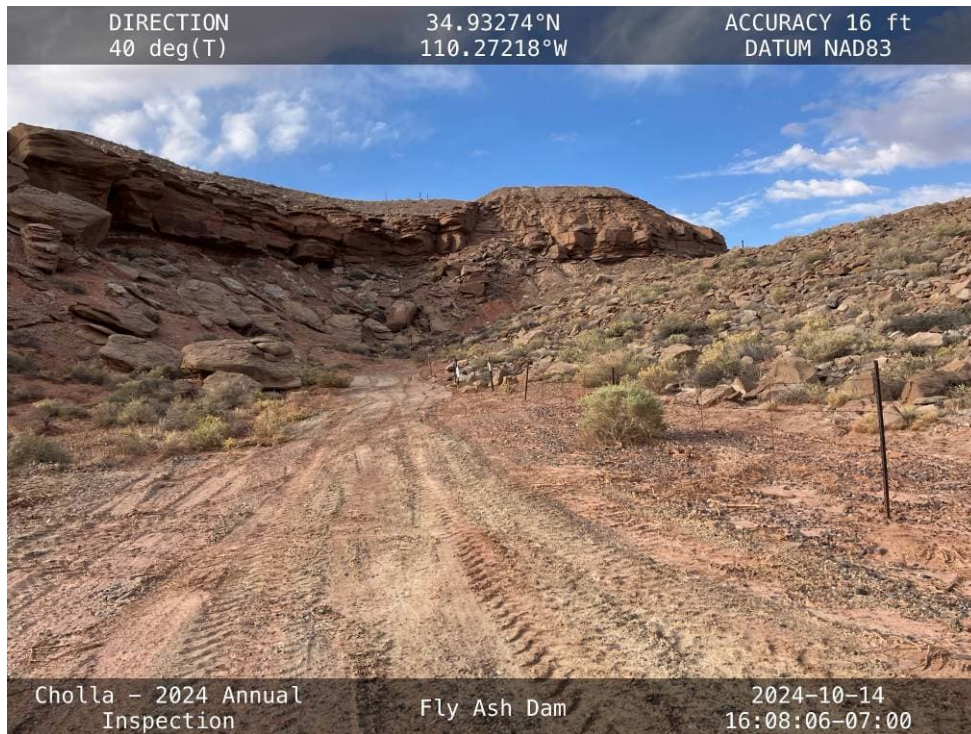
### 20241014 – IMG\_6610

The downstream toe of the West Embankment, facing southeast from the inlet pipes.

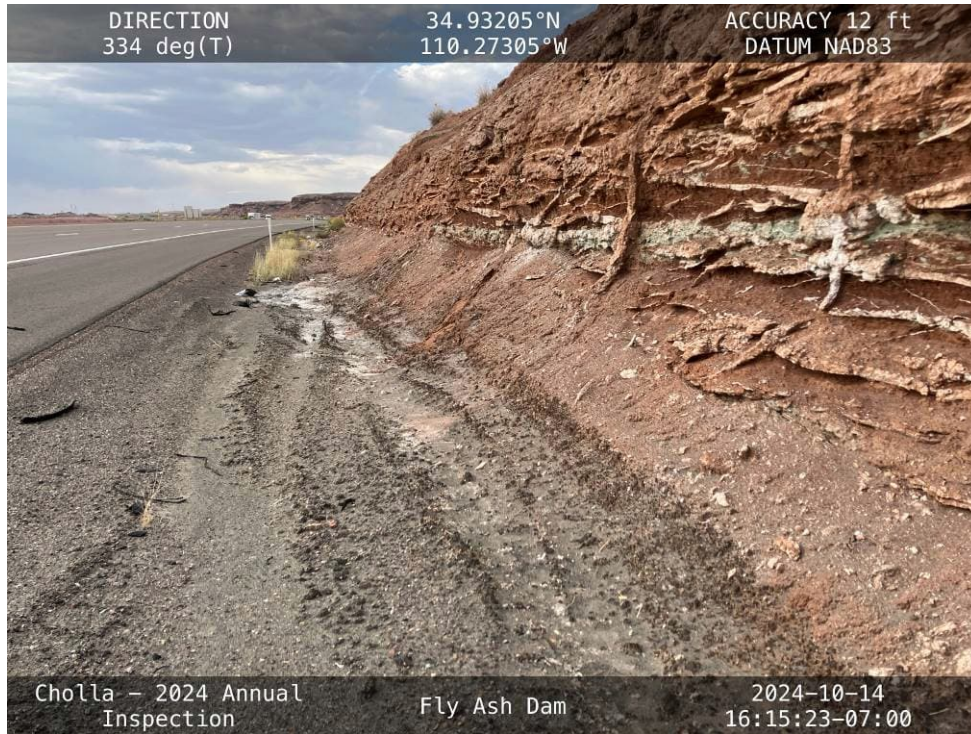
### 20241014 – IMG\_6620

The Right Abutment groin on the downstream slope, facing toward the abutment contact.

8) Continue monitoring the groin of the Right Abutment, the downstream slope, and the access road near the Geronimo sumps for erosion.	Repair the erosion at the Right Abutment and continue to repair other areas when the eroded depth exceeds 1 foot.

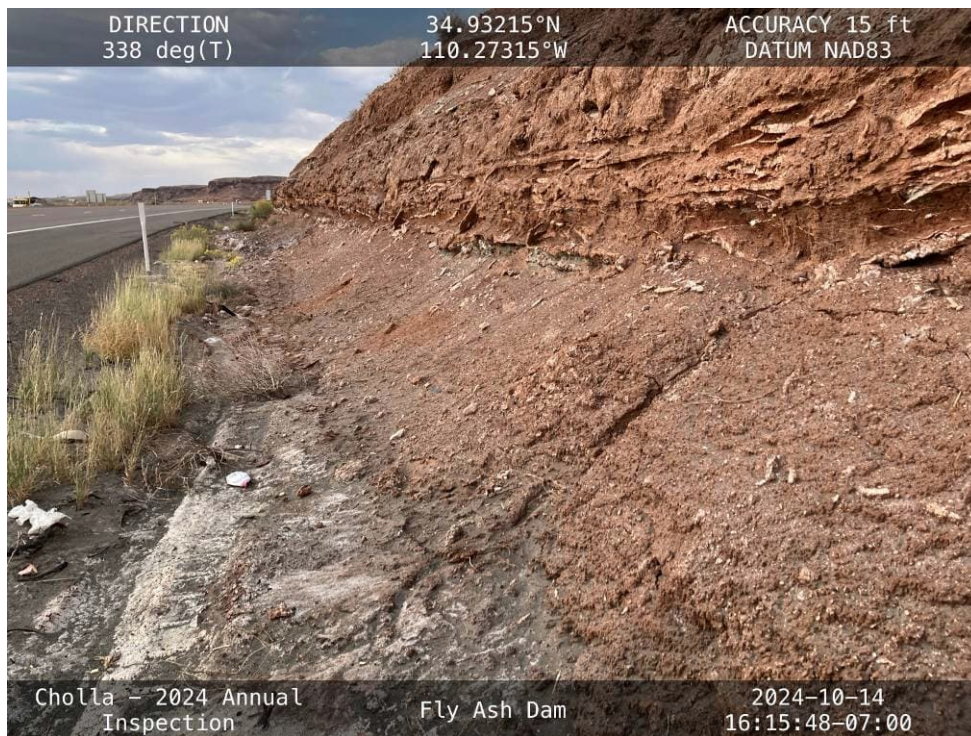
**20241014 – IMG\_6622**  
The I-40 seep.

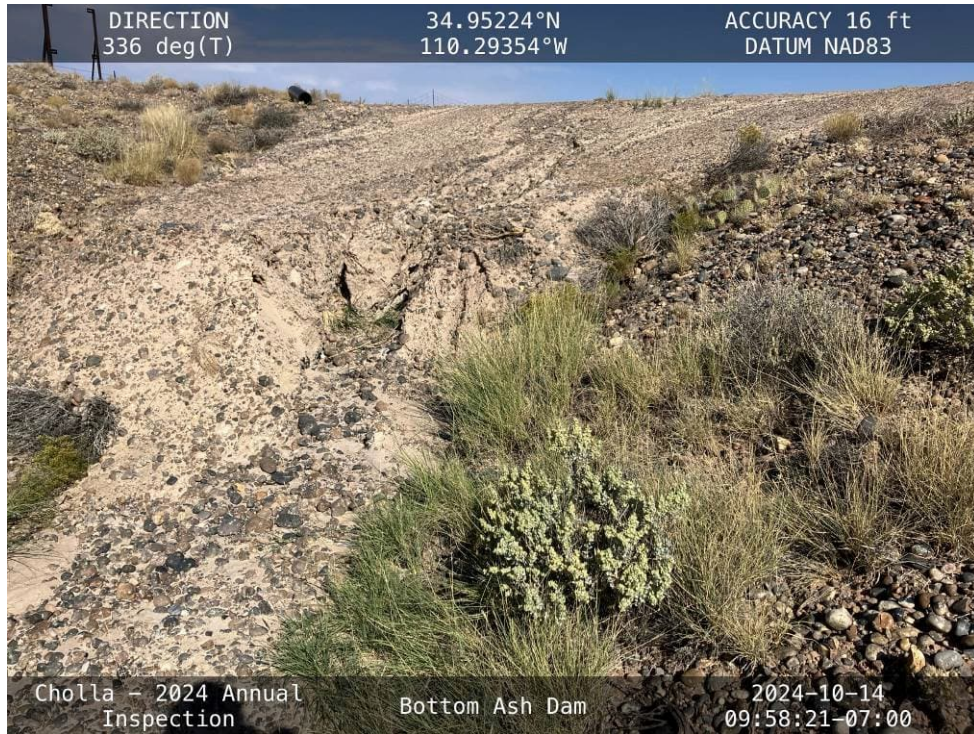
**20241014 – IMG\_6625**  
The I-40 seep.

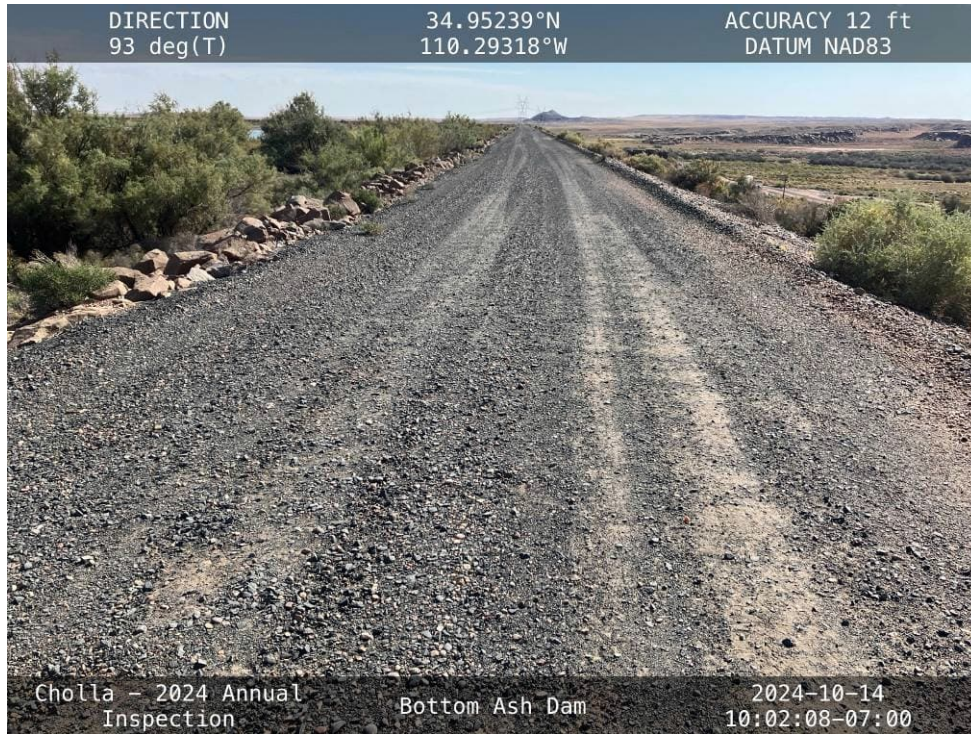
### 20241014 – IMG\_6117

The downstream slope of the South Embankment, facing east from the Right Abutment.

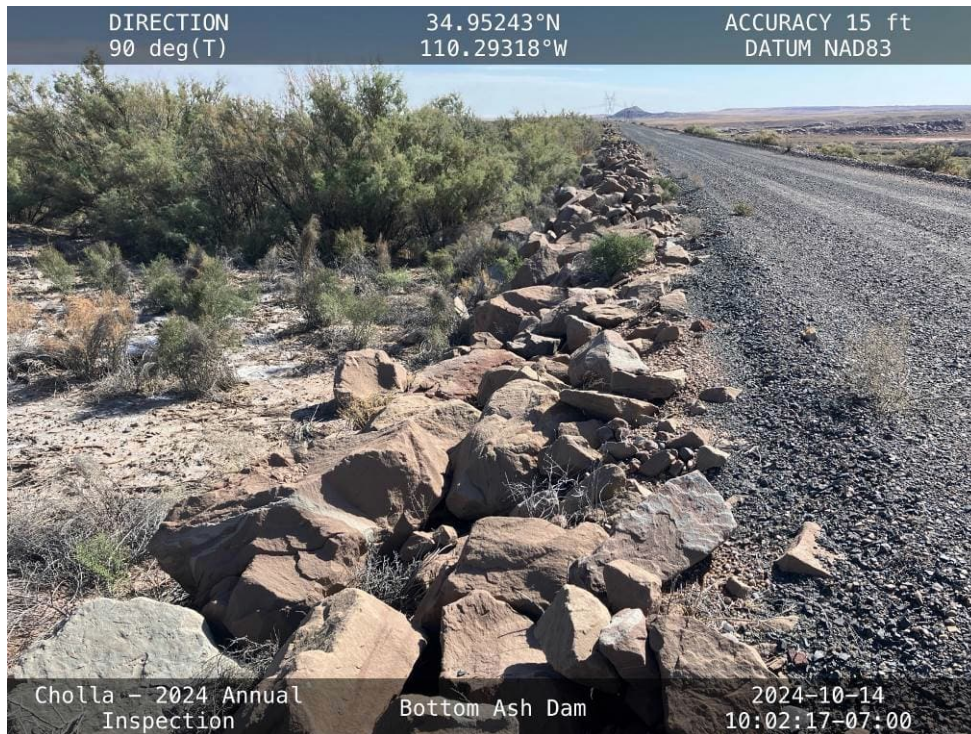
### 20241014 – IMG\_6118

The South Embankment crest, facing east from the Right Abutment.

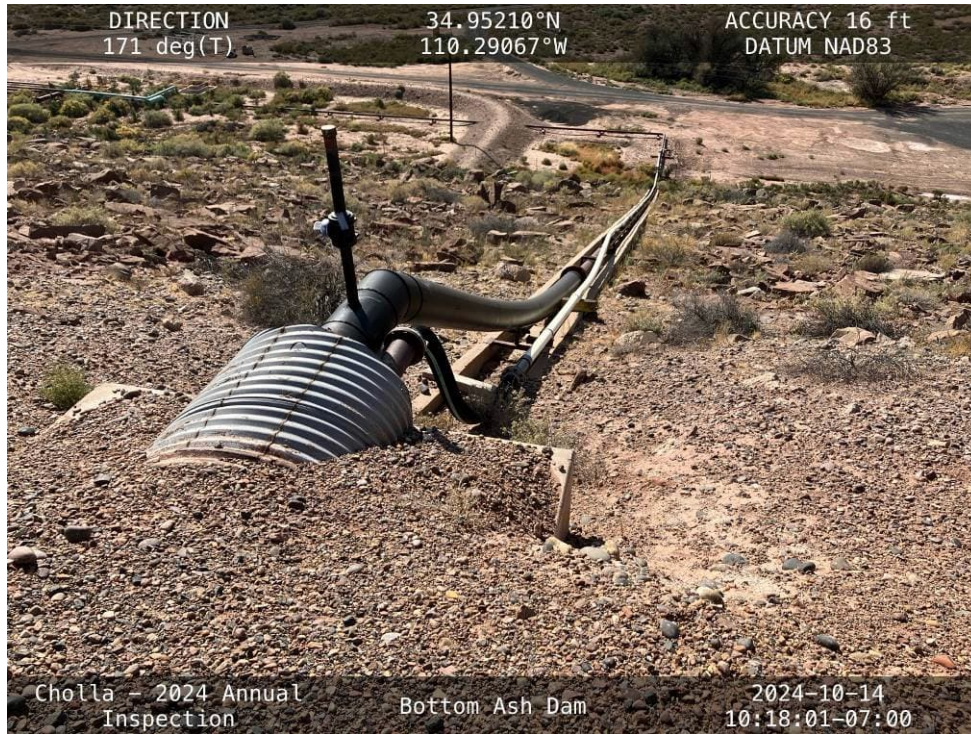
**20241014 – IMG\_6130**

Minor erosion around the concrete encasement for the western siphon line, facing upstream.

4) Continue to monitor the erosion around the siphon line encasements and on the shoulder of the crest.	Repair erosion if the eroded depth exceeds 1 foot.

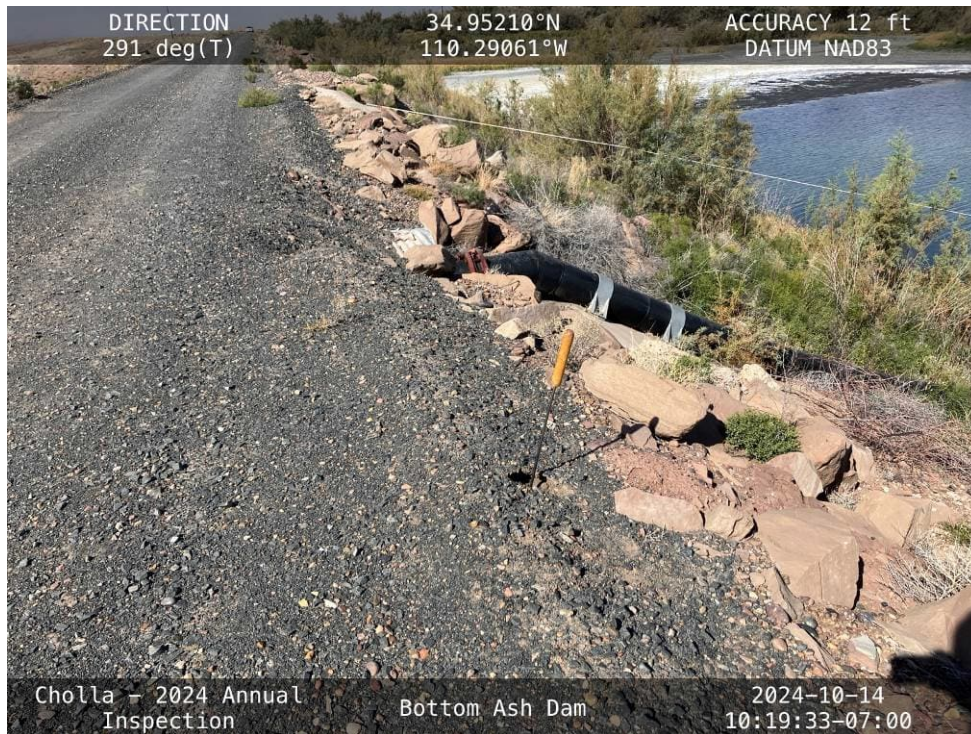
#### 20241014 – IMG\_6135

The western siphon line along the downstream slope of the South Embankment.

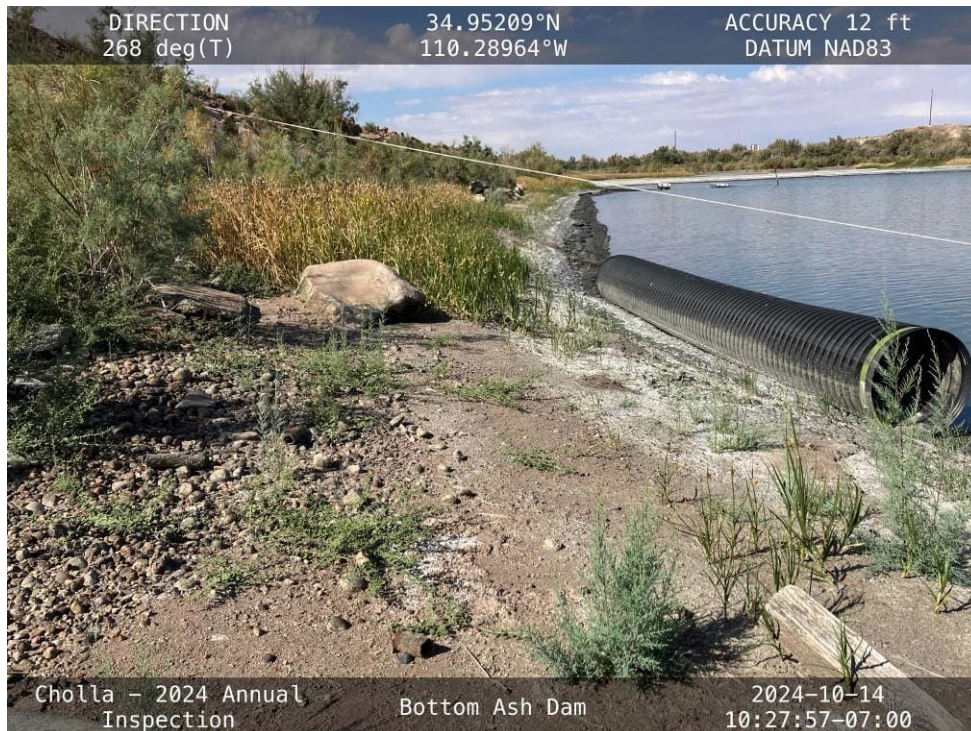
### 20241014 – IMG\_6153

The reservoir level staff gauge adjacent to the central siphon lines. The water level is at EL 5106.65 feet.

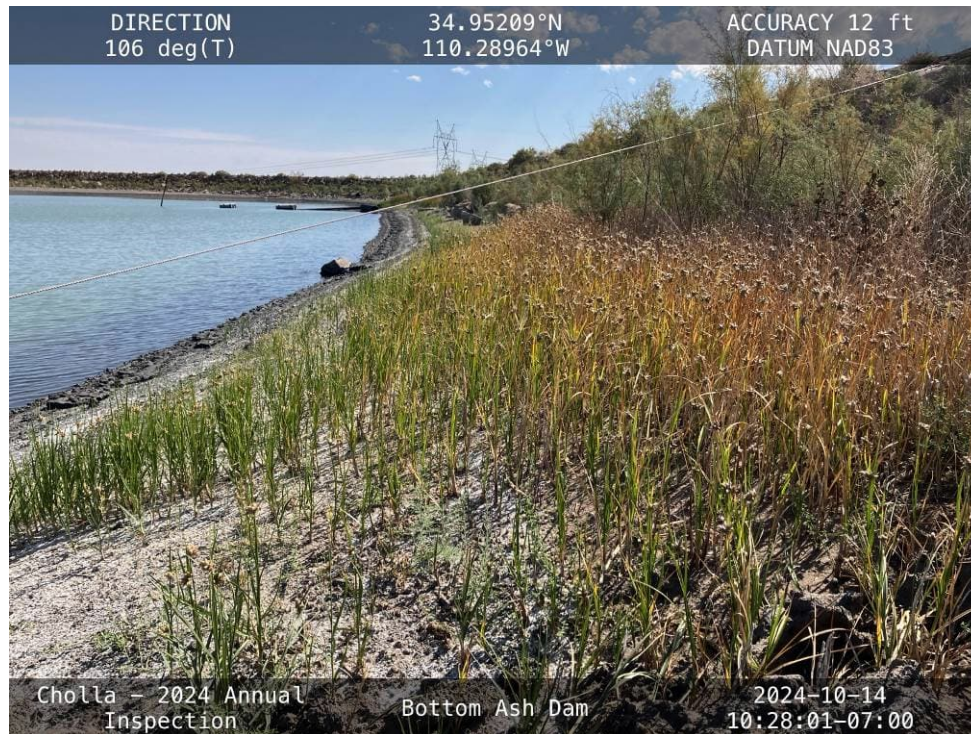
### 20241014 – IMG\_6156

The upstream slope along the western half of the South Embankment, facing west.

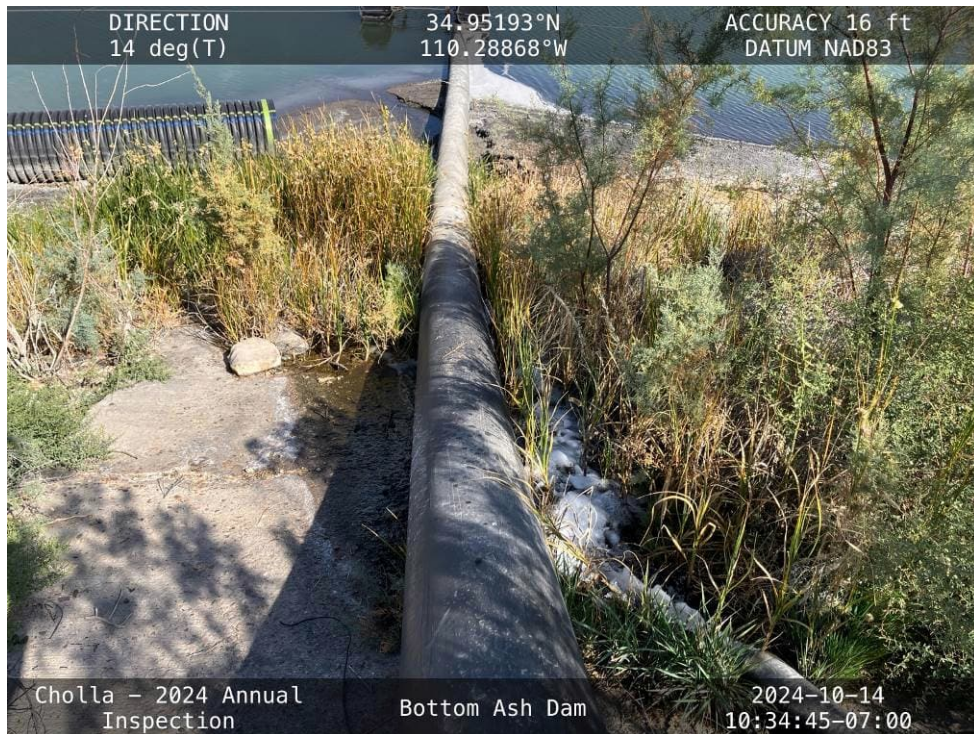
**20241014 – IMG\_6166**

The eastern siphon line along the upstream slope of the South Embankment.

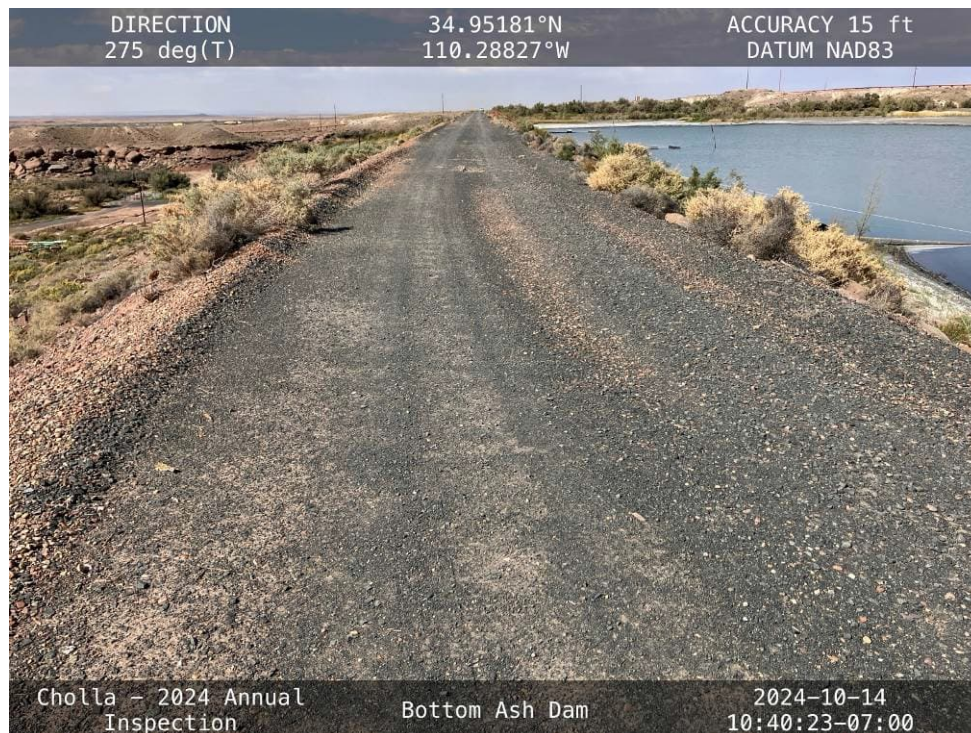
### 20241014 – IMG\_6175

The downstream slope of the South Embankment, facing west from the east end.

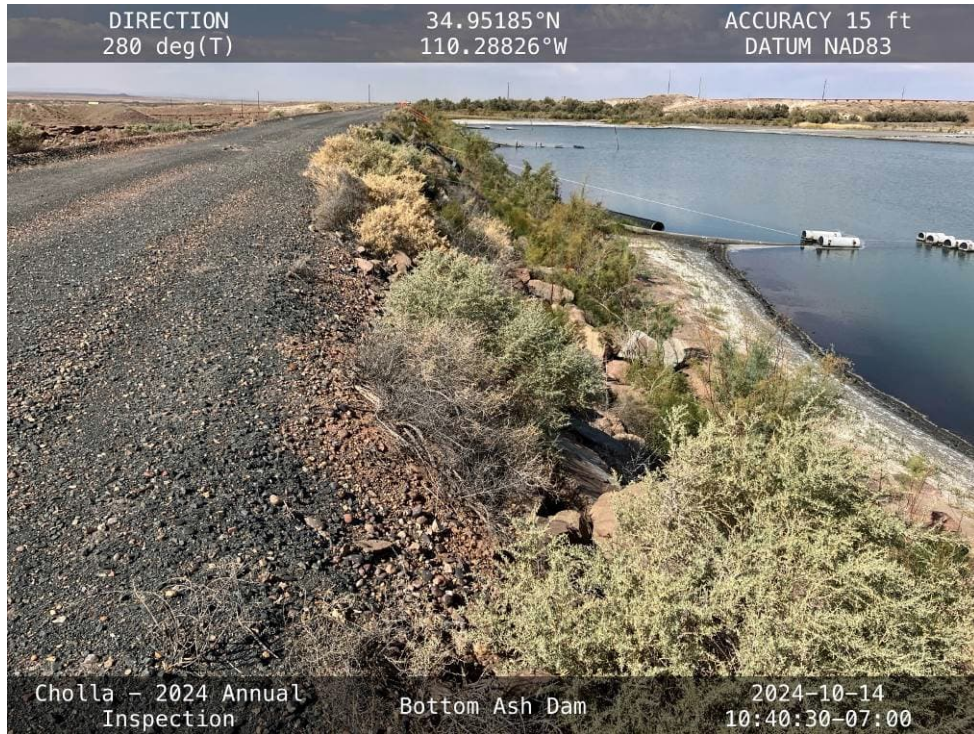
### 20241014 – IMG\_6176

The crest of the South Embankment, facing west from the east end.

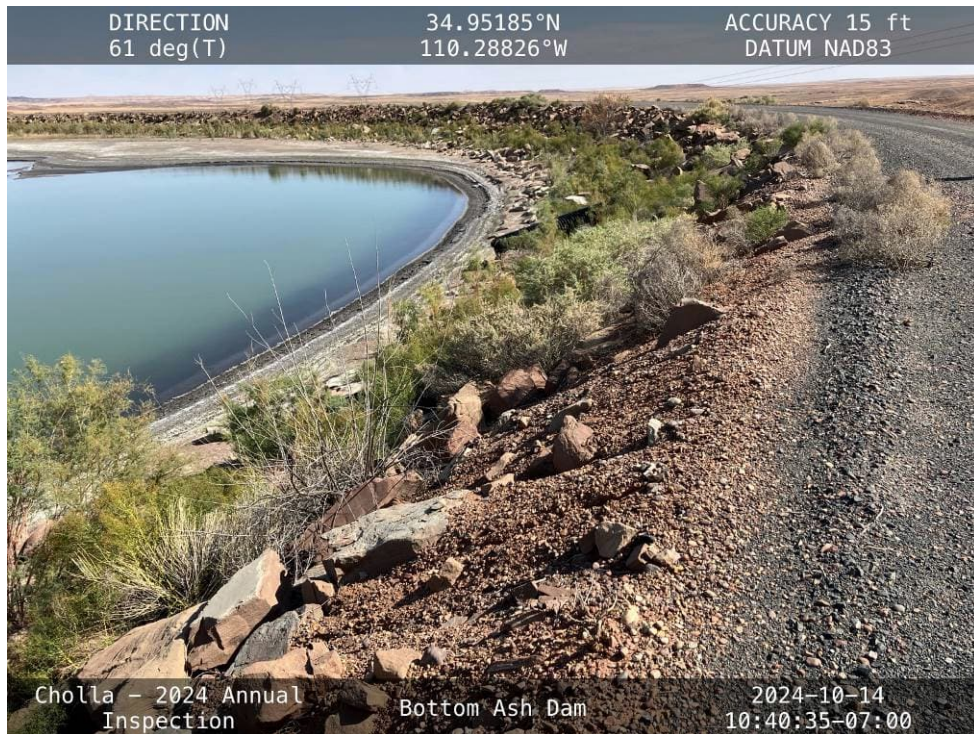
#### 20241014 – IMG\_6177

The upstream slope of the South Embankment, facing west from the east end.

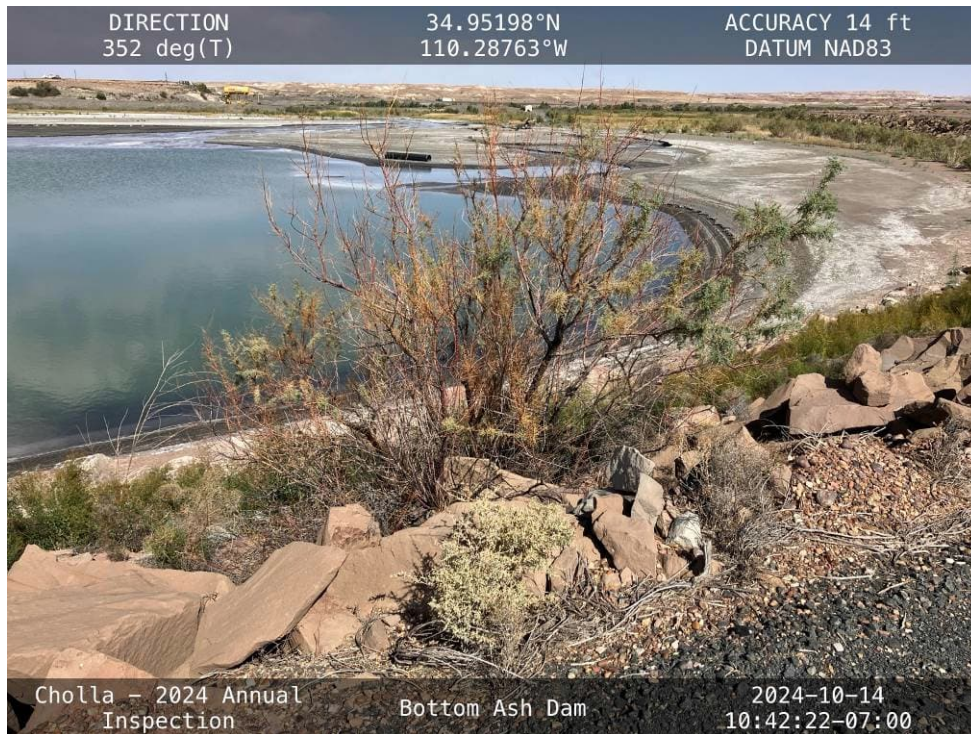
#### 20241014 – IMG\_6180

Vegetation to be removed along the downstream slope of the South Embankment.

6) Remove vegetation from the upstream slope at the Right Abutment.	Woody vegetation rooted in the embankment should be removed and the resulting disturbed area should be replaced with compacted material similar to the embankment material per NMOSE (2011).

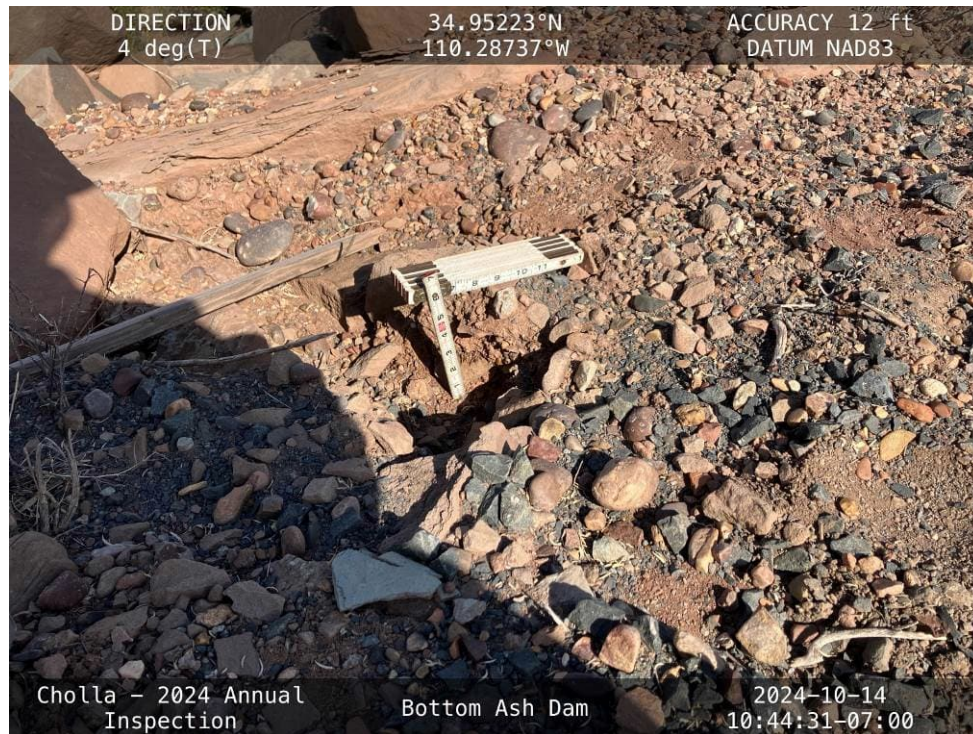
#### 20241014 – IMG\_6185

Vegetation to be removed along the upstream slope of the East Embankment.
