# CHOLLA POWER PLANT Fly Ash Dam, Bottom Ash Dam, and Bottom Ash Monofill

## Annual CCR Impoundment and Landfill Inspection Report

2024

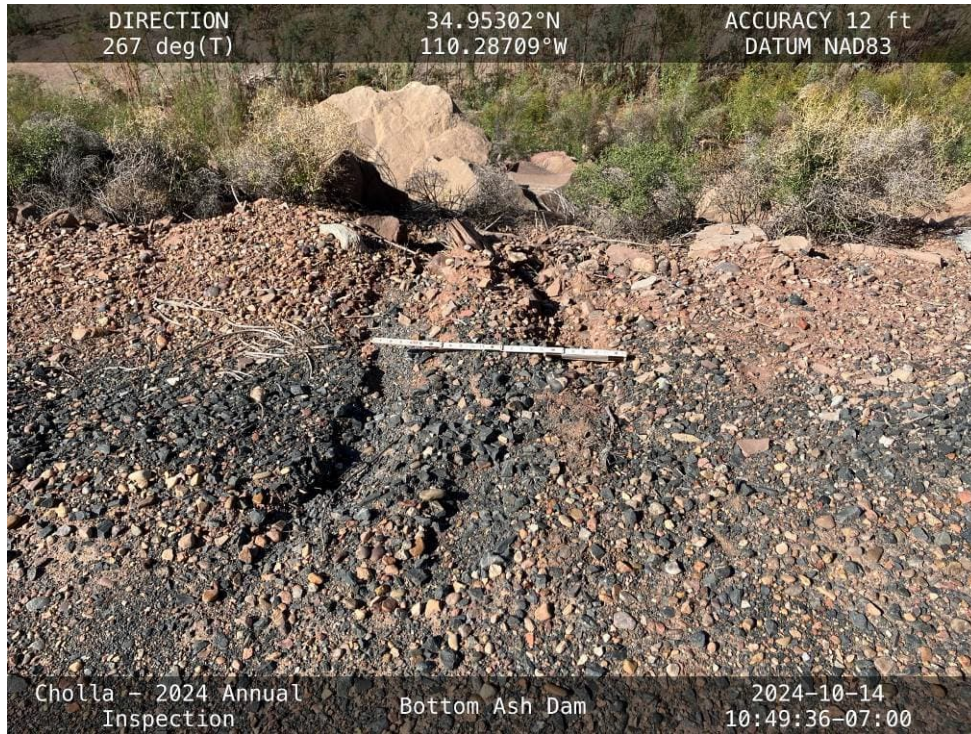
### 20241014 – IMG\_6189

A 6-inch deep hole forming along the upstream shoulder of the East Embankment.

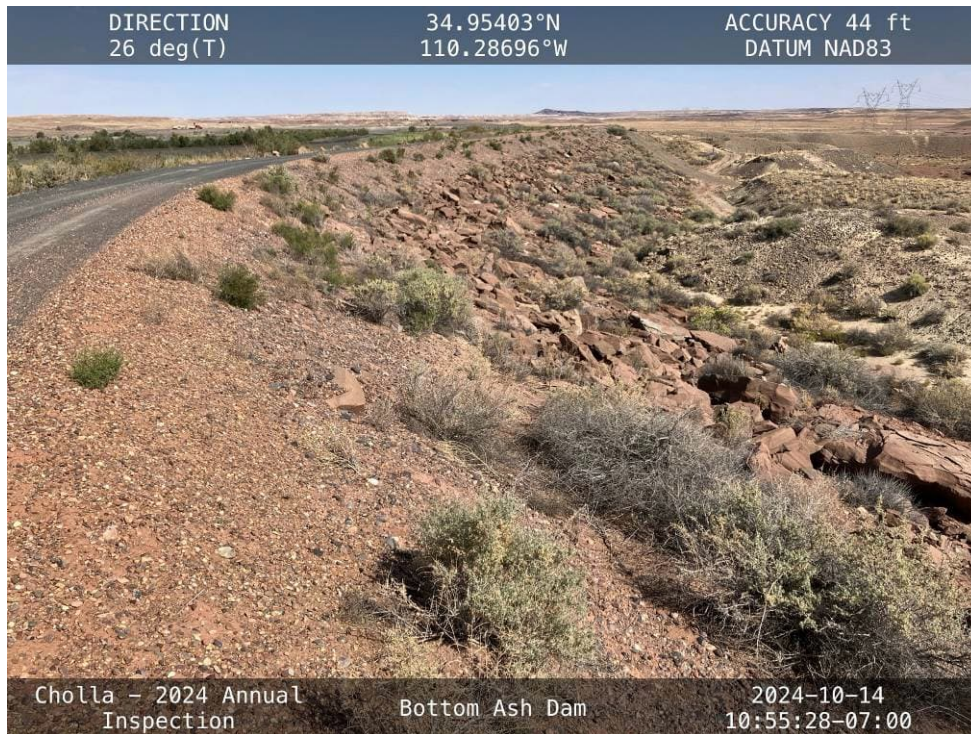
#### 20241014 – IMG\_6191

Erosion rills forming along the upstream shoulder of the East Embankment.

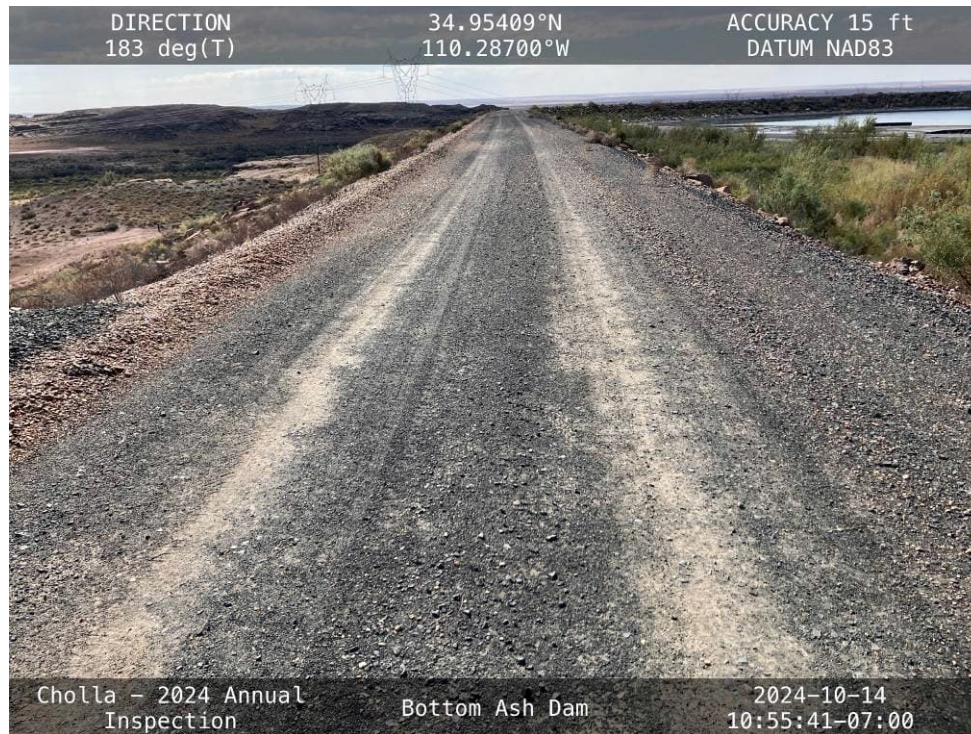
#### 20241014 – IMG\_6194

The downstream slope of the northern half of the East Embankment, facing northeast.

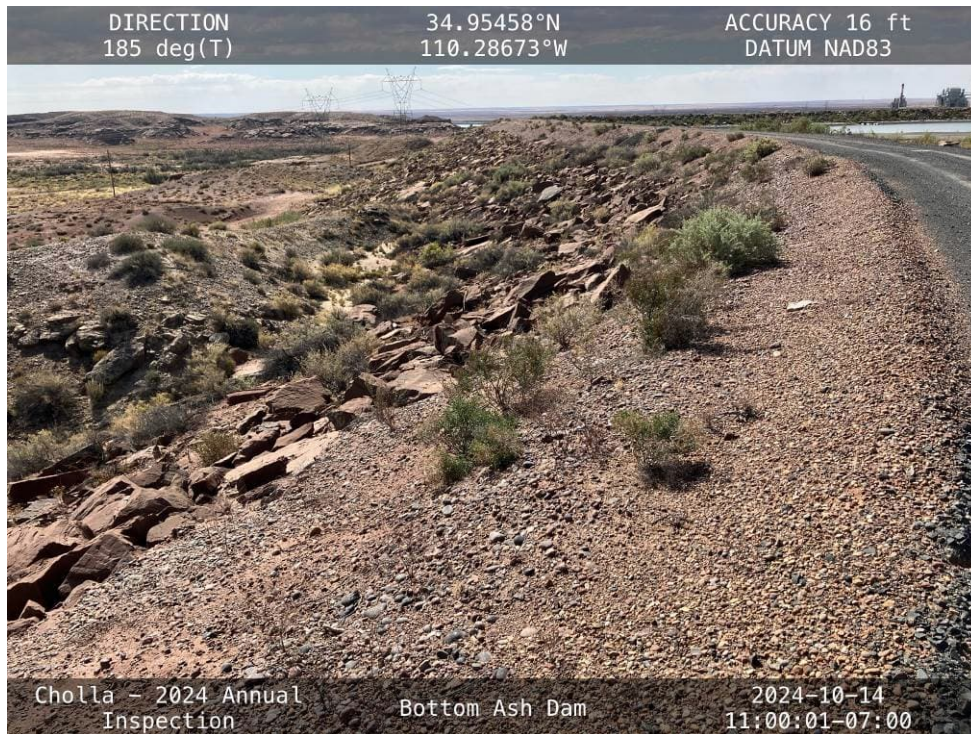
**20241014 – IMG\_6206**

A 7-inch wide, 5-inch deep erosion rill on the upstream shoulder of the East Embankment.

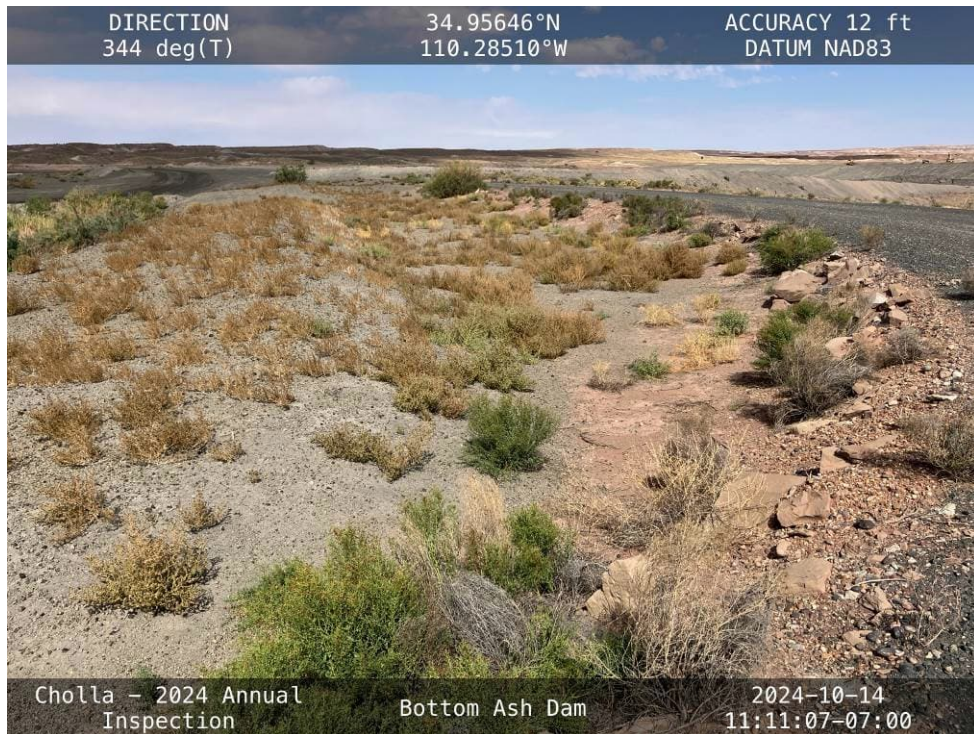
**20241014 – IMG\_6212**

An ant hill on the upstream shoulder of the East Embankment.

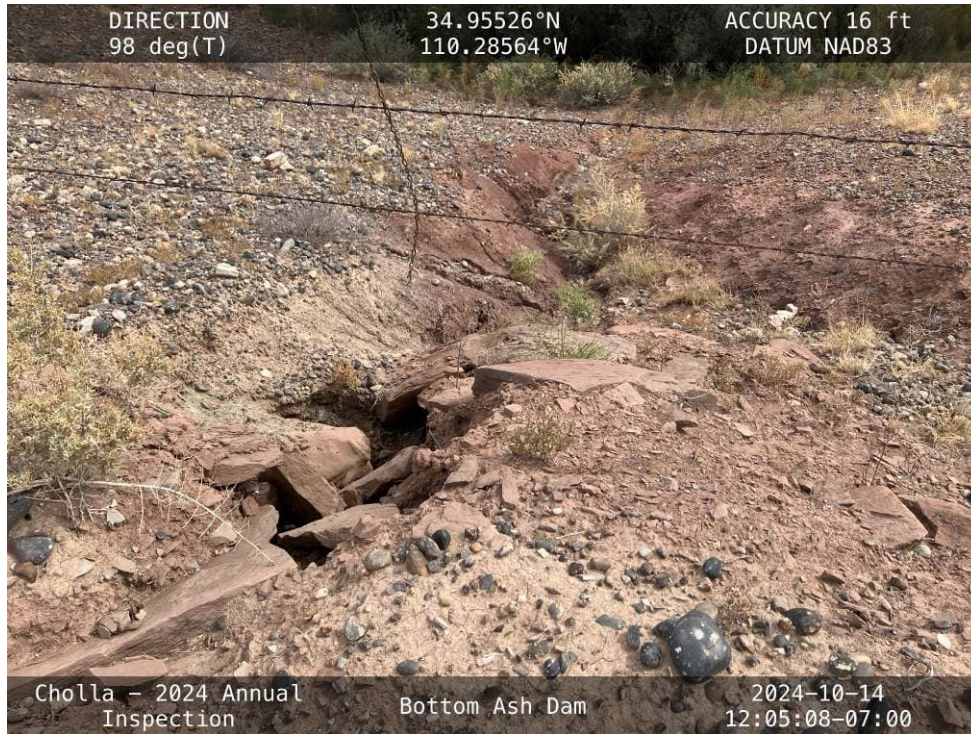
**20241014 – IMG\_6334**

An erosion gully on the downstream slope along the northern half of the East Embankment.

8) Repair the erosion gullies at the downstream slope of the East Embankment.	The erosion should be restored with compacted, well-graded fill at the direction of the APS geotechnical engineer.

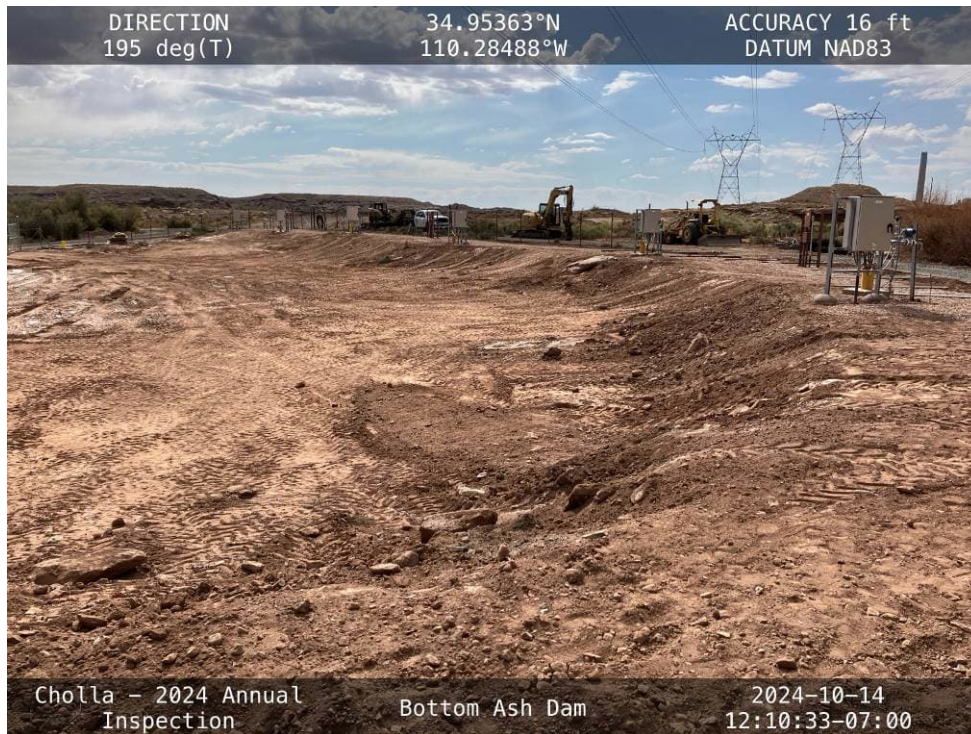
### 20241014 – IMG\_6337

An erosion gully on the downstream slope along the northern half of the East Embankment.

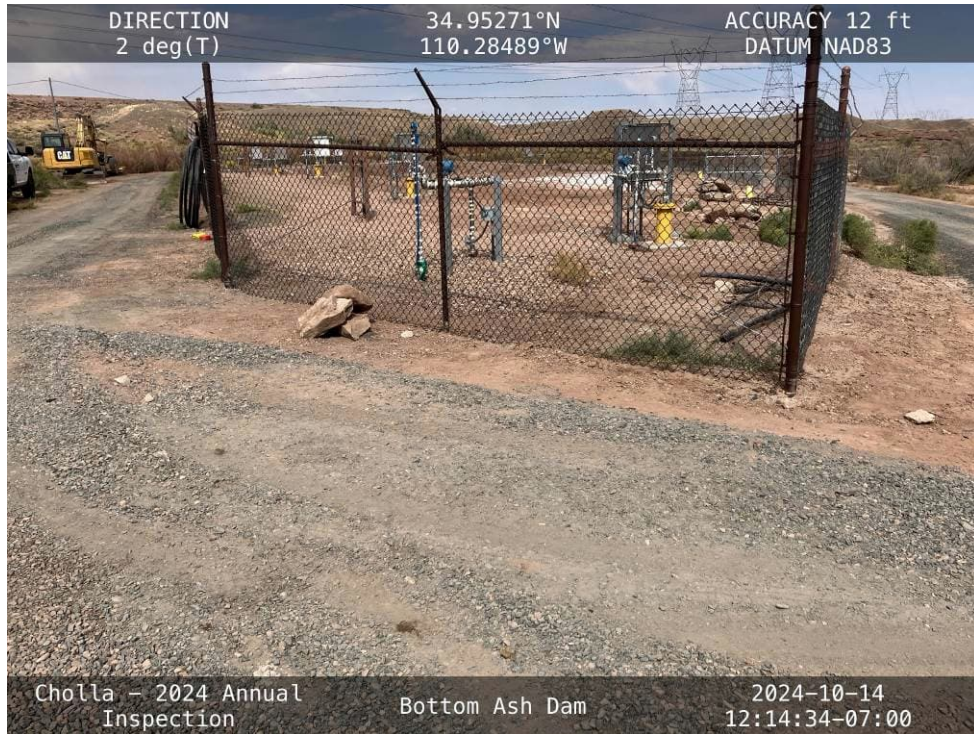
### 20241014 – IMG\_6343

APS replacing the wells in the P-226 seepage intercept area.

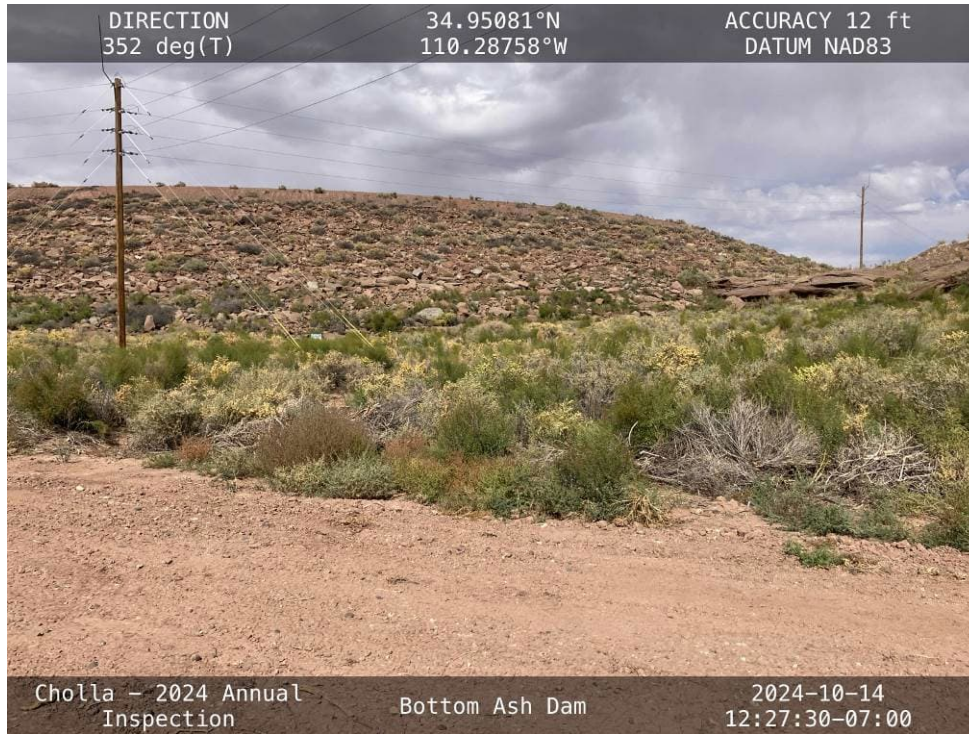
**20241014 – IMG\_6355**  
The ditch adjacent to the Petroglyph Seep, regraded since the 2023 inspection.

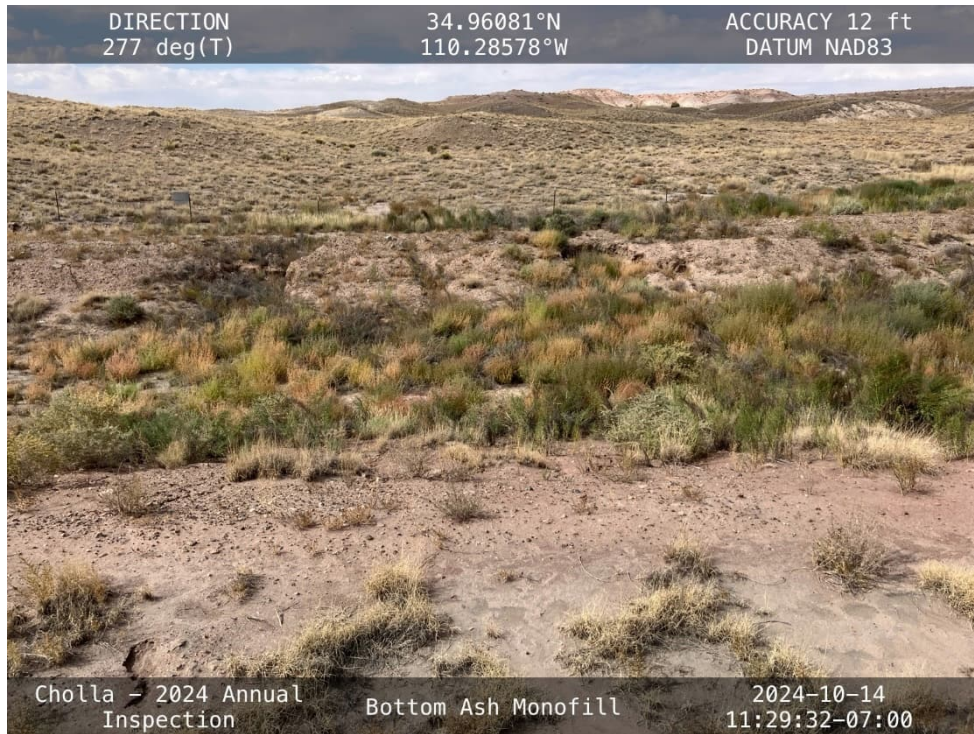
#### 20241014 – IMG\_6254

APS removing CCR from the BAM.

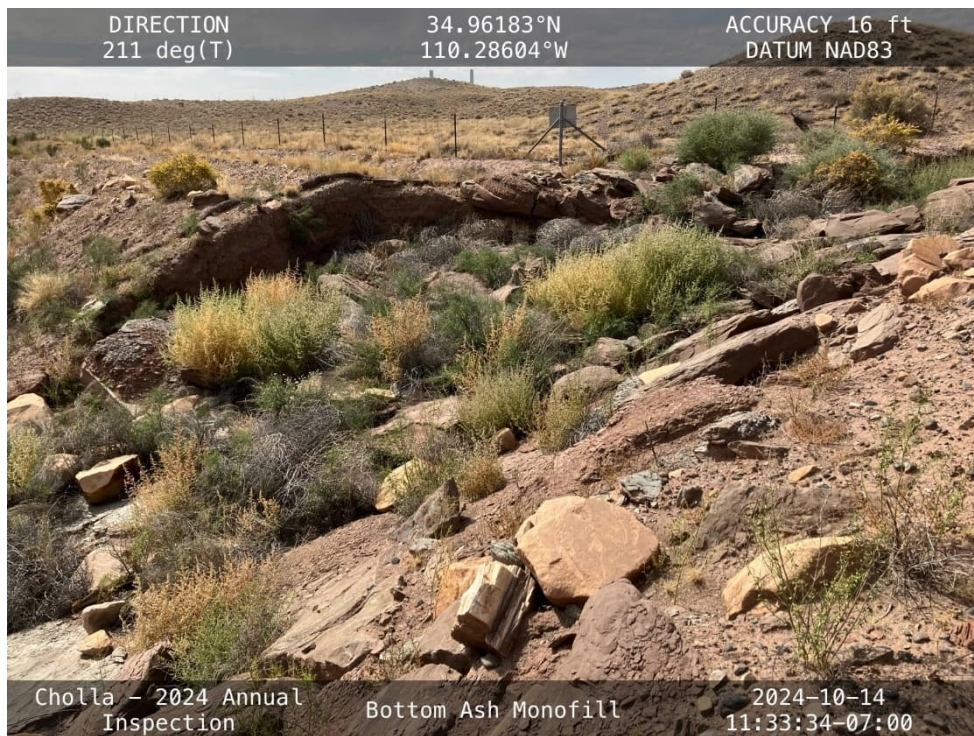
### 20241014 – IMG\_6272

Erosion along the drainage channel on the west side of the BAM, facing west.
