**FOUR CORNERS POWER PLANT
Lined Ash Impoundment,
Lined Decant Water Pond,
Combined Waste Treatment Pond,
Upper Retention Sump, and
Dry Fly Ash Disposal Area**

**Annual
CCR Impoundment and
Landfill Inspection Report
2018**

**GENERATION ENGINEERING
Design Engineering
P.O. BOX 53999
PHOENIX, ARIZONA 85072**

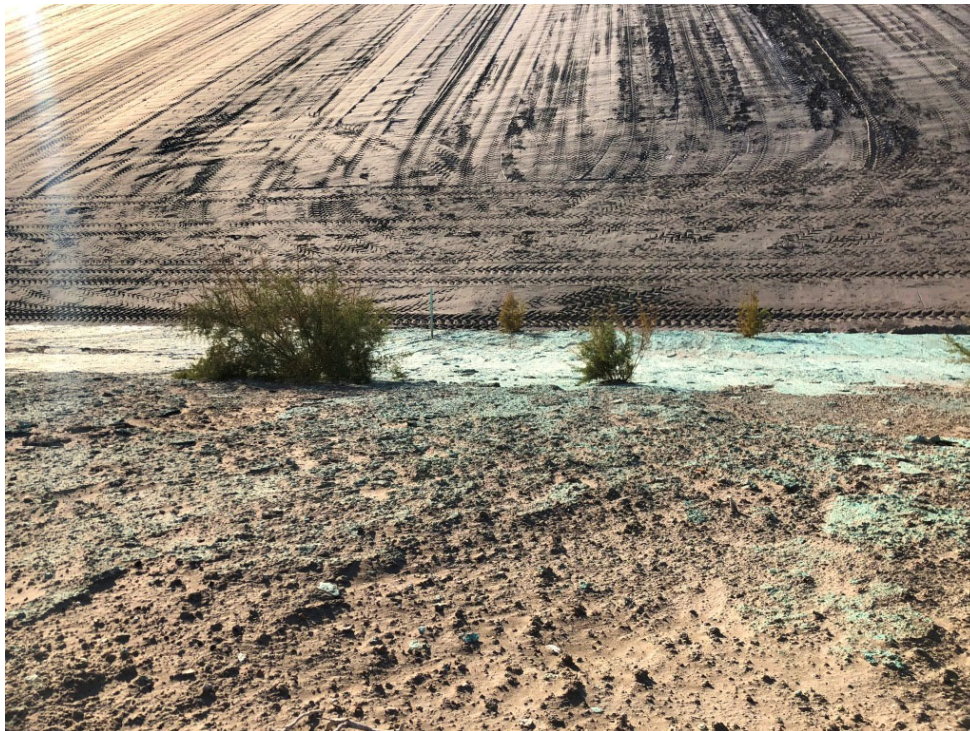
20181025 – IMG_0950

Woody vegetation growing on the downstream slope of the South Embankment.

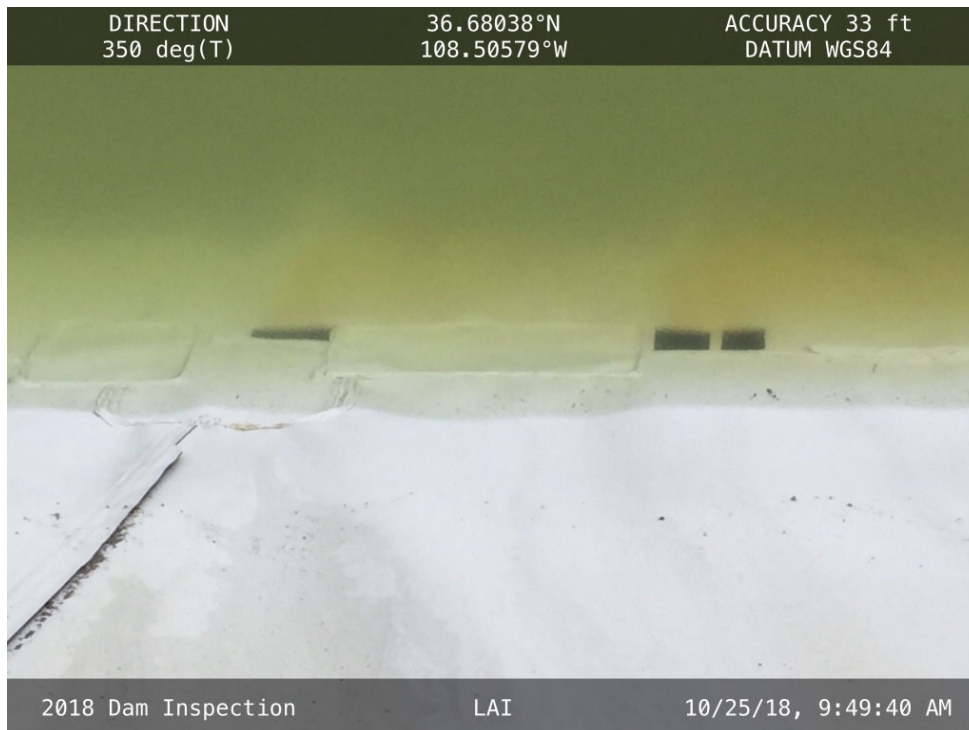
20181025 – IMG_1386

- i. During the inspection, four rectangular holes in the geomembrane liner were observed along the South Embankment below the impounded water level (Photos IMG_1227 and IMG_1386). The straight edges along each hole suggests the holes were cut intentionally (compare Photo IMG_1229 and IMG_1235 in Appendix A of this Inspection Report with Photo IMG_5216 and IMG_5228 in Appendix A of the 2017 Inspection Report). One of the holes appeared to be draining water from underneath the geomembrane liner at the time of the inspection, but the three other holes appeared to be allowing the upstream clay blanket to erode into the impoundment. All of the holes in the geomembrane liner should be repaired as soon as it can be safely done and the purpose for creating the holes should be investigated. The LAI embankment was designed to be stable without the geomembrane liner (URS Corporation 2012); however, the upstream slope and the toe drain along the South Embankment should be monitored for evidence of internal erosion. Evidence could include benching along the upstream slope due to the erosive action of water against the clay and cloudy seepage flowing out of the toe drain. The South Embankment toe drain was dry on the date of this inspection (photo IMG_1415). APS does not believe that the presence of water beneath the liner, nor the damage to the liner itself presents a safety concern since the LAI was designed to be stable without the presence of the liner.

Clay eroding out of three holes cut in the liner along the upstream slope of the South Embankment.

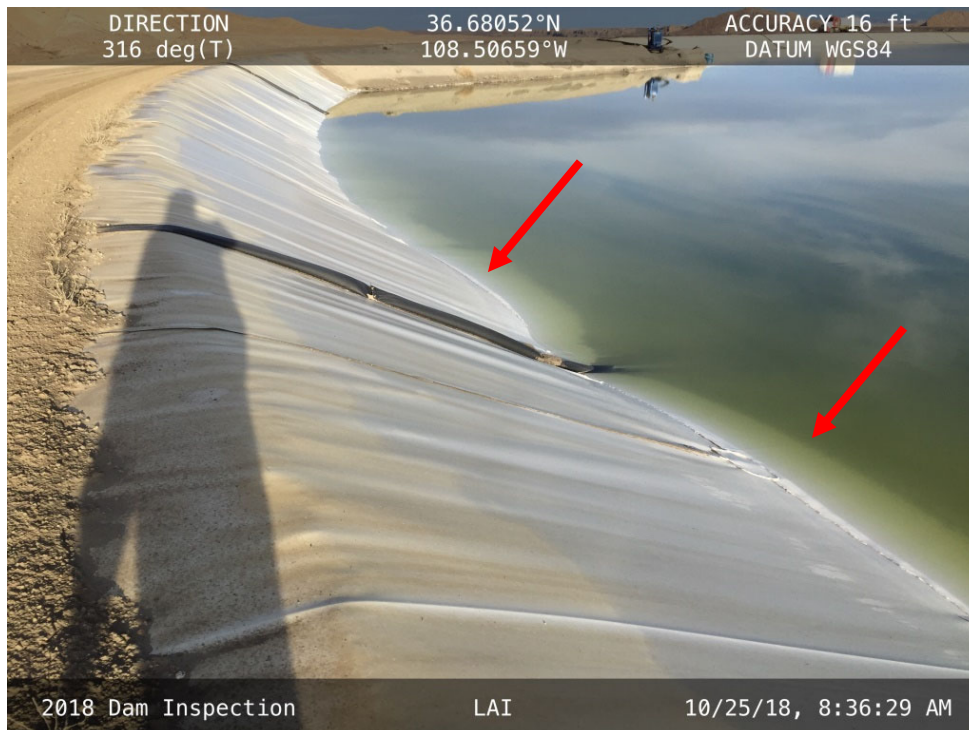
20181025 – IMG_1244

- ii. A depression (Photo IMG_1233) and two bulges (Photo IMG_1244) were observed along the upstream slope in the Southwest Corner of the impoundment. These features are near the holes, trapped water, and erosion described in comment i and may be related. The causes of the depression and bulges should be investigated and these features should be repaired.

Bulges in the geomembrane liner in the Southwest Corner of the LAI.

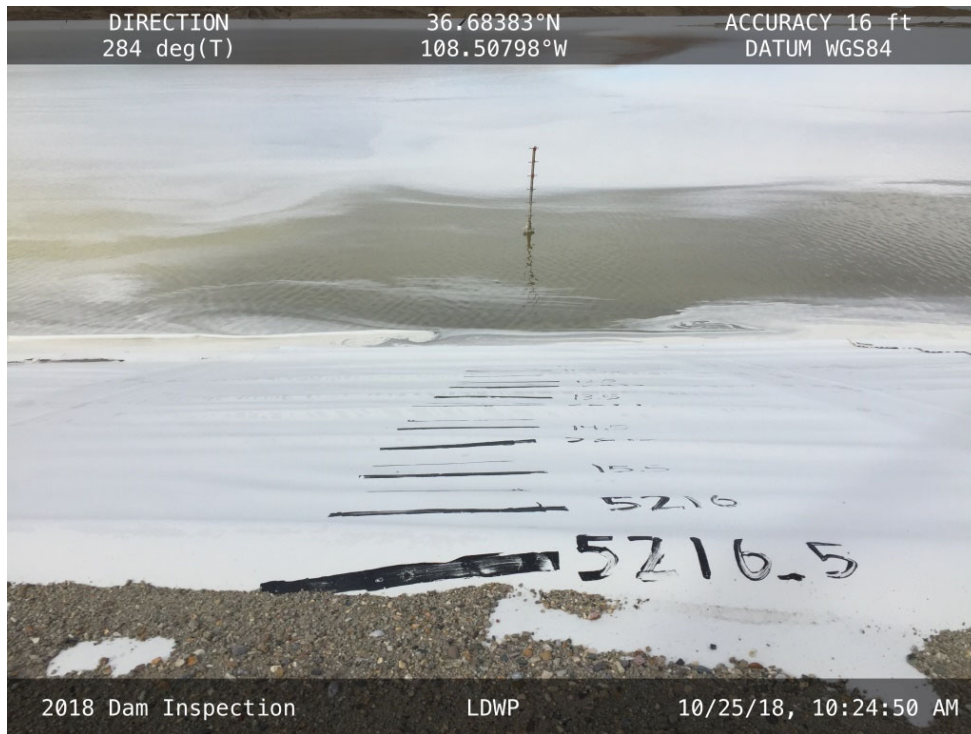
20181025 – IMG_1413

The staff gauge and water elevation markings on the east side of the LDWP.

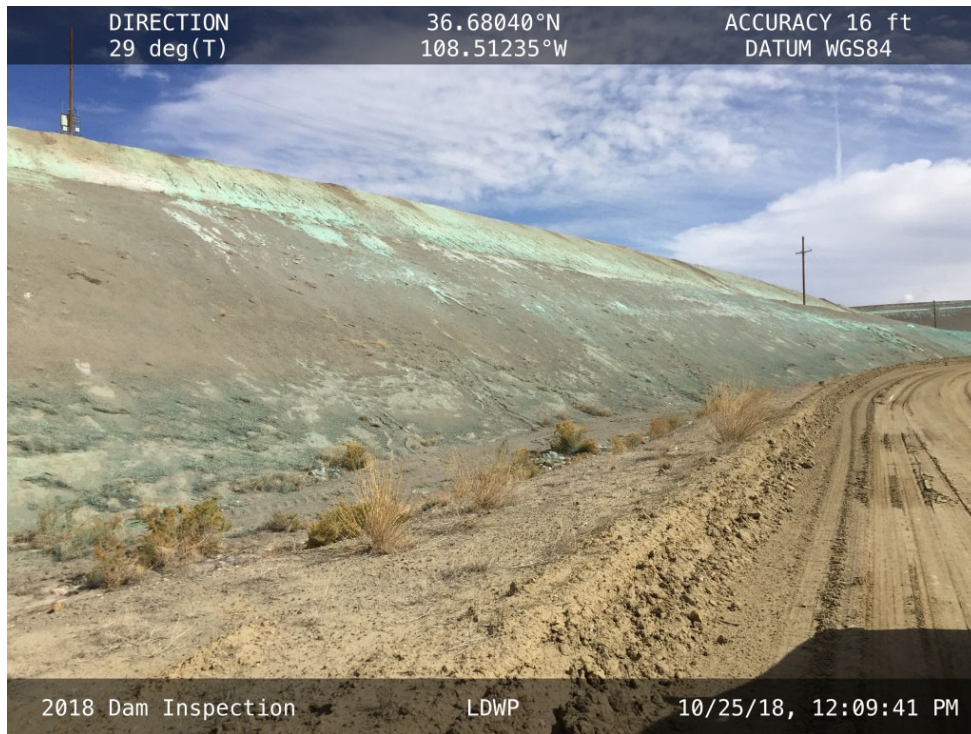
20181025 – IMG_1438

A second shallow surface slough on the lowermost bench of the West Embankment.

Observed Condition	Action Item
1) Two sloughs were observed on the lowermost bench of the West Embankment.	Repair the areas and monitor the slope.
2) The liner in the anchor trench in the central portion of the West Embankment appeared to be pulling out of the trench.	Investigate the cause of the damage and repair the liner as necessary.
3) Minor erosion rilling was observed on the North and West downstream slopes of the LDWP at the time of the inspection.	Continue ongoing repair program for repairing rills if the erosion depth exceeds 1 foot.
4) There are small holes and tears in the liner along the North and East Embankments.	Repair the tears and holes.

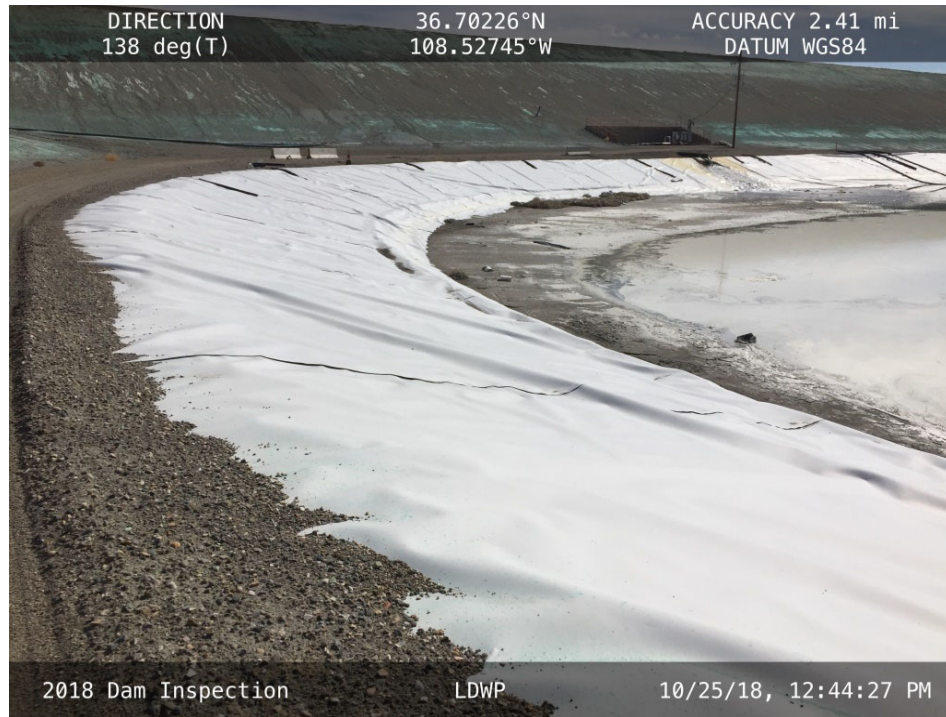
20181025 – IMG_1530

Small tears in the liner along the North Embankment already marked with a pin flag (these were also observed during the 2017 inspection).

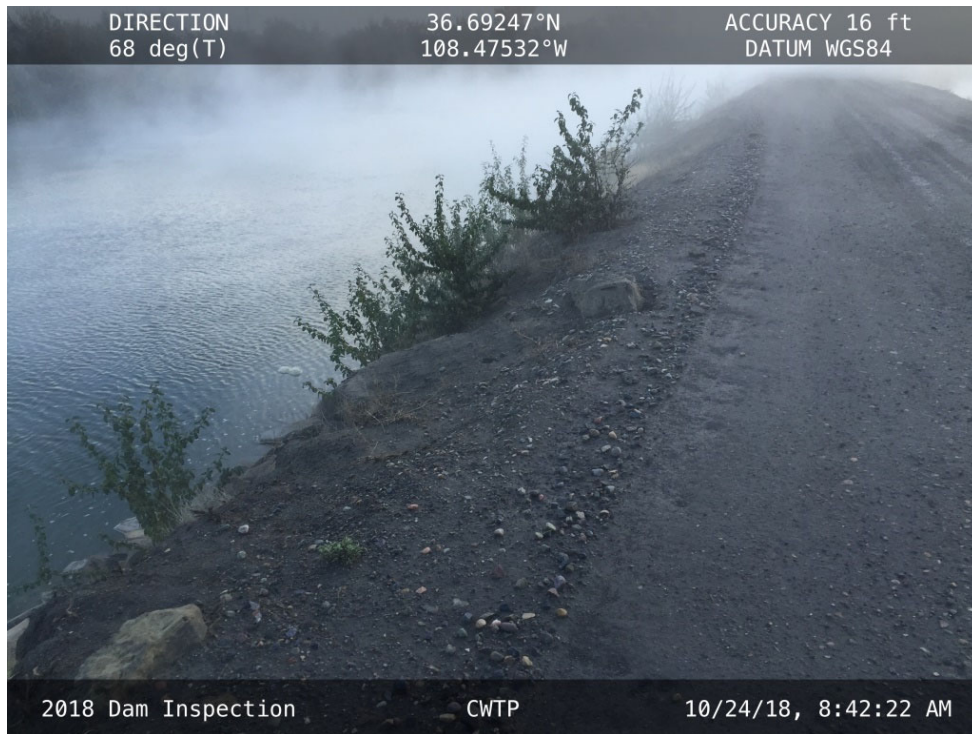
20181024 – IMG_0914

Observed Condition	Action Item
1) Vegetation removal along the upstream and downstream slopes should be performed in accordance with the NMOSE vegetation maintenance guidelines “ <i>Vegetation Management on Dams</i> ” (2011) reference.	This is an ongoing maintenance requirement.

Vegetation on the downstream slope of the CWTP embankment.

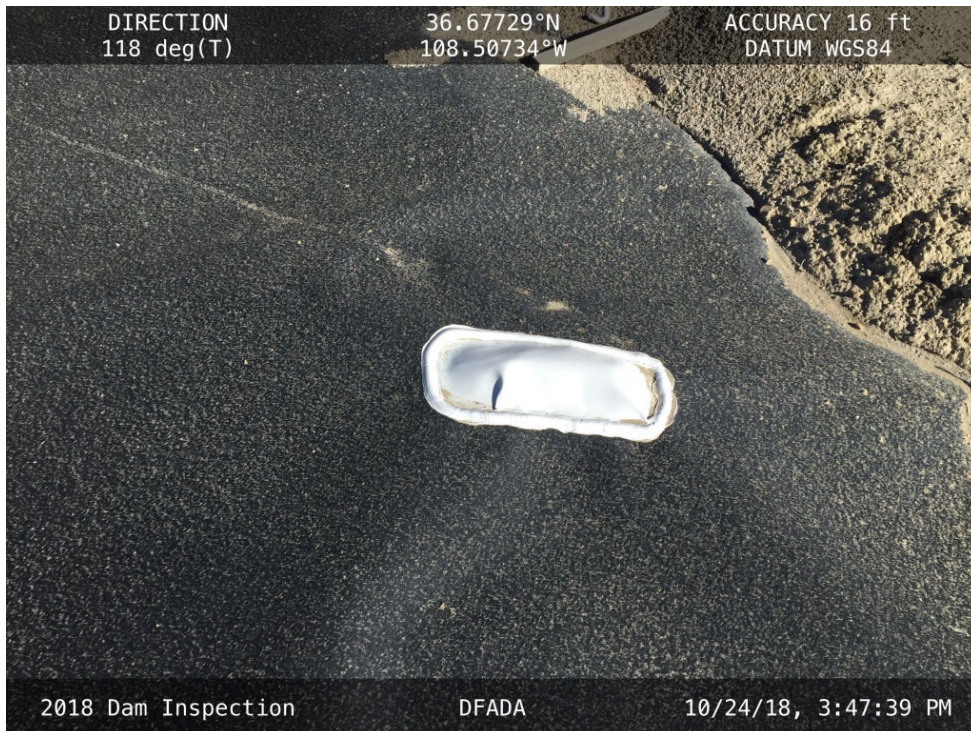
20181024 – IMG_1150

A repair in the DFADA Cell 1 leachate collection pond liner.

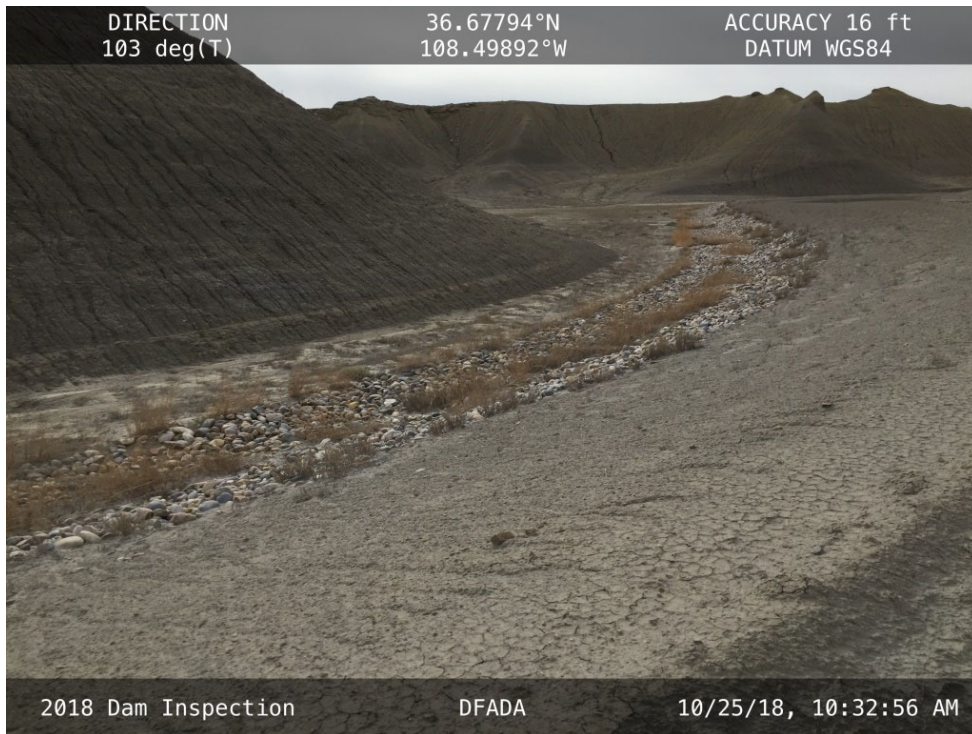
20181025 – IMG_1417

The Stormwater Diversion Channel around the eastern edge of DFADA Cell 2, facing east.

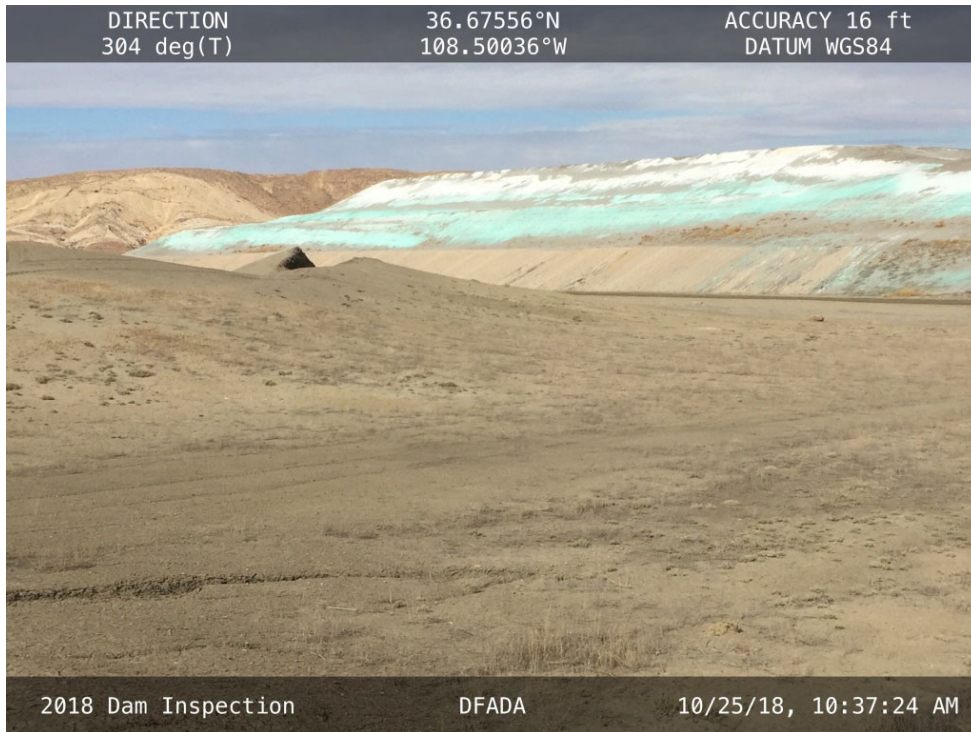
20181025 – IMG_1425
The south slope of DFADA Cell 1, facing northwest.

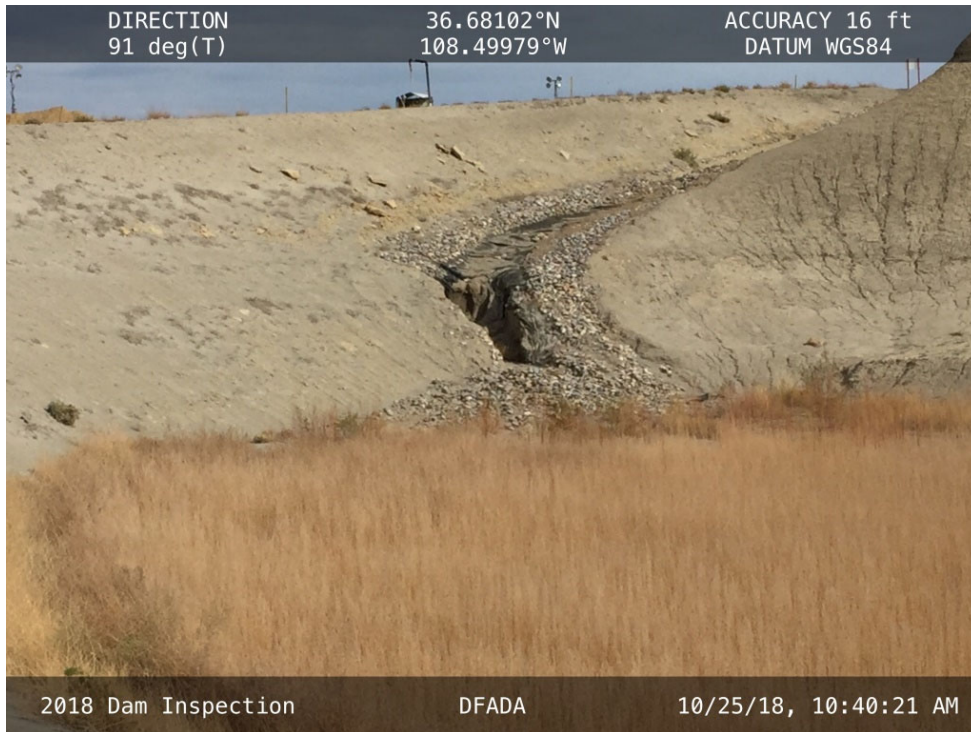
20181025 – IMG_1429

Inlet to the Stormwater Diversion Channel, facing east from the ash haul road.

Observed Condition	Action Item
1) There is erosion at the inlet and outlet of the Stormwater Diversion Channel.	With future expansion of the DFADA, perform an engineering re-evaluation to understand whether the run off pattern has changed or whether a different erosion control method should be applied. Monitor erosion and repair as required. Alternately, place additional sandstone riprap in the eroded area.
2) Several plants are growing through the Pyramat geosynthetic along the western toe of Cell 1.	Monitor the plant growth and remove the vegetation if it is determined to be damaging the primary geomembrane liner.
3) Vacuum truck operators were allowing ash to be blown across the site while it was being unloaded.	Monitor contractor activities and enforce dust control plan.
