**FOUR CORNERS POWER PLANT
Lined Ash Impoundment,
Lined Decant Water Pond,
Combined Waste Treatment Pond,
and Dry Fly Ash Disposal Area**

**Annual
CCR Impoundment and
Landfill Inspection Report
2019**

**GENERATION ENGINEERING
Design Engineering
P.O. BOX 53999
PHOENIX, ARIZONA 85072**

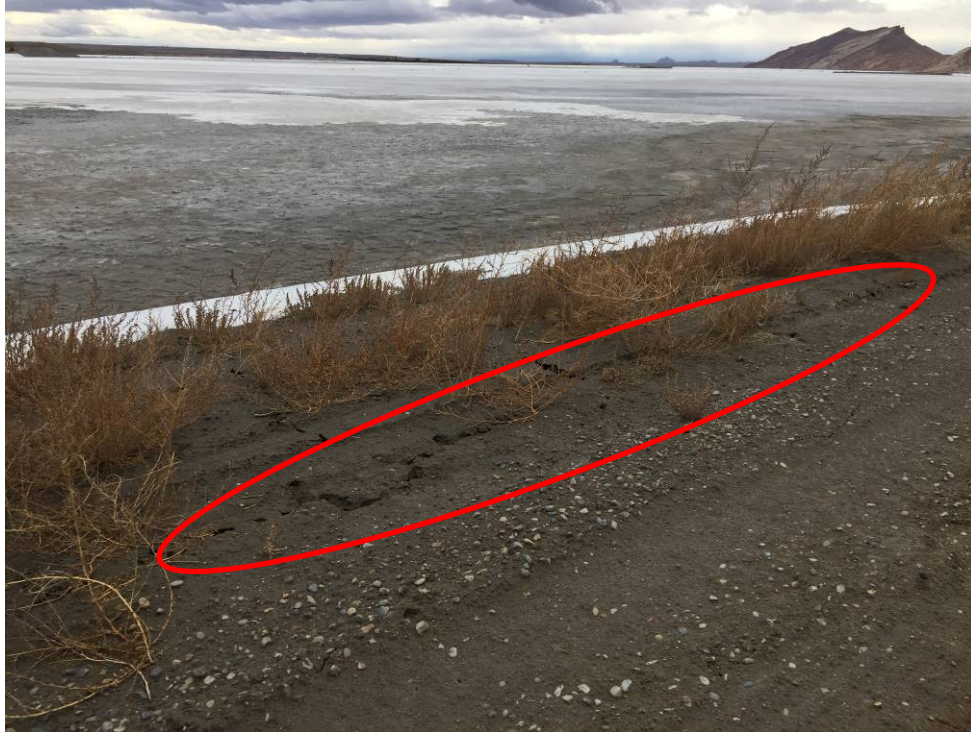
20191120 – IMG_6612

DAM EMBANKMENT CHECKLIST											
3	DAM CREST										
a	Settlements, slides, depressions?				X						
b	Misalignment?				X						
c	Longitudinal/Transverse cracking?	Cracks were observed along portions of the geomembrane liner anchor trench in the Northwest Embankment. See Photos IMG_6612 and IMG_6622.									
d	Animal burrows?				X						
e	Adverse vegetation?				X						
f	Erosion?				X

Longitudinal cracks at the anchor trench along the Northwest Embankment.

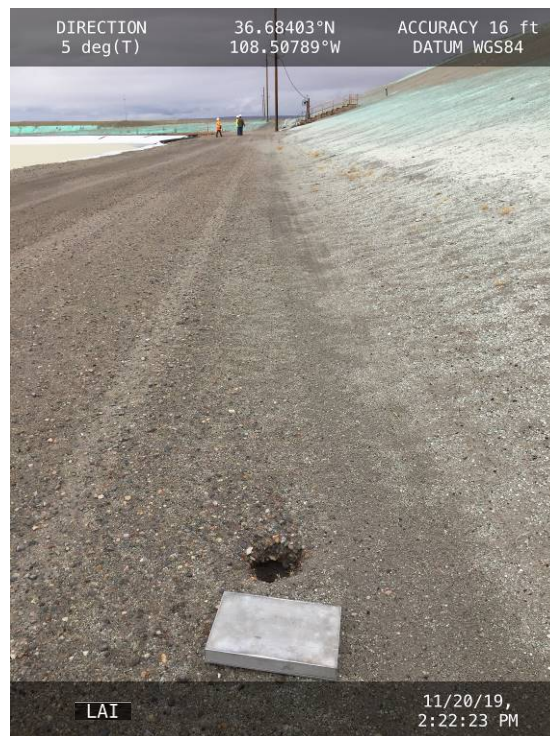
20191120 – IMG_6732

A hole at the downstream toe of the West Embankment.

4) There is a small hole in the crest of the LDWP along the LAI toe of the West Embankment.	Repair the hole under the direction of a geotechnical engineer.

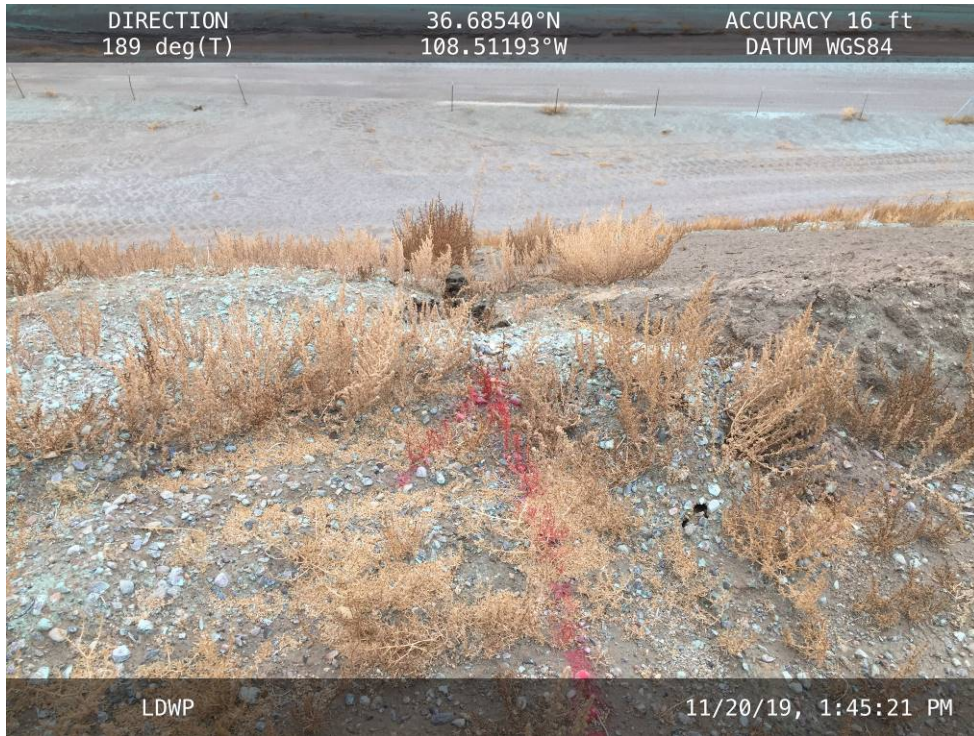
20191120 – IMG_6643

Incipient erosion on the downstream slope in the northwest corner marked for repair.

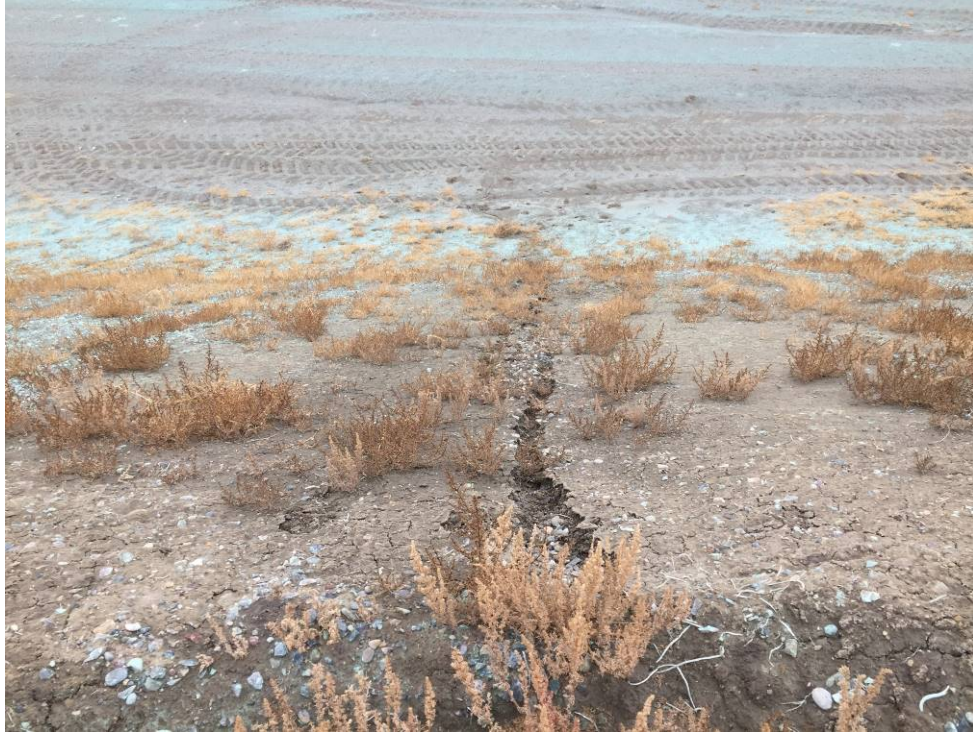
20191120 – IMG_6648

An incipient erosion rill on the downstream slope of the West Embankment.

2) Minor erosion rilling was observed on the West and South downstream slopes of the LDWP at the time of the inspection.	Continue ongoing repair program for repairing rills if the erosion depth exceeds 1 foot.

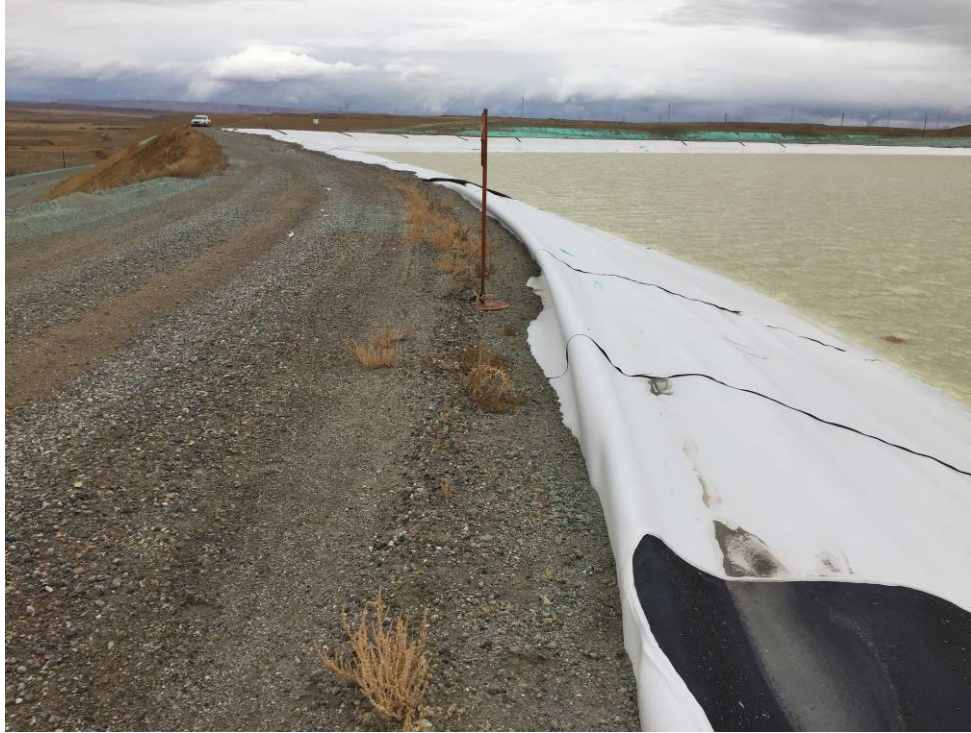
20191120 – IMG_6652

The liner pulling out of the anchor trench in the northern portion of the West Embankment.

Observed Condition	Action Item
1) The liner in the anchor trench in the central portion of the West Embankment appeared to be pulling out of the trench.	Continue to monitor the liner in the anchor trench. Re-anchor the liner if the liner continues to pull out of the trench.

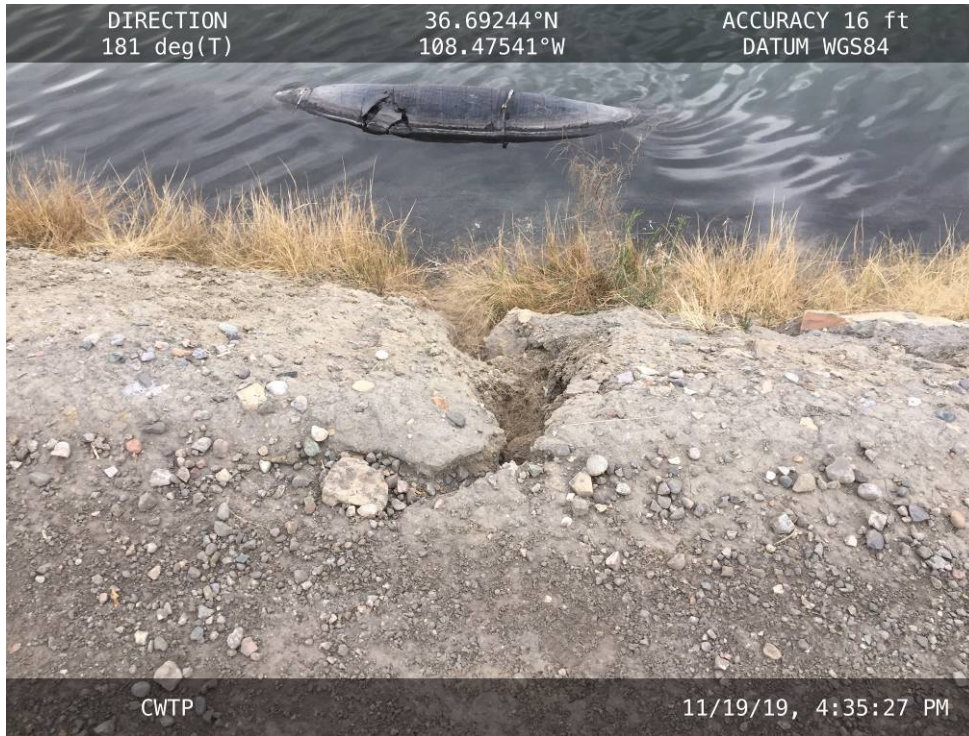
20191119 – IMG_6255

Erosion on the upstream slope along the northern portion of the embankment.

2) Instances of minor erosion were observed along the upstream and downstream slopes.	Continue to monitor these areas and repair erosion if it exceeds 1 foot in depth.

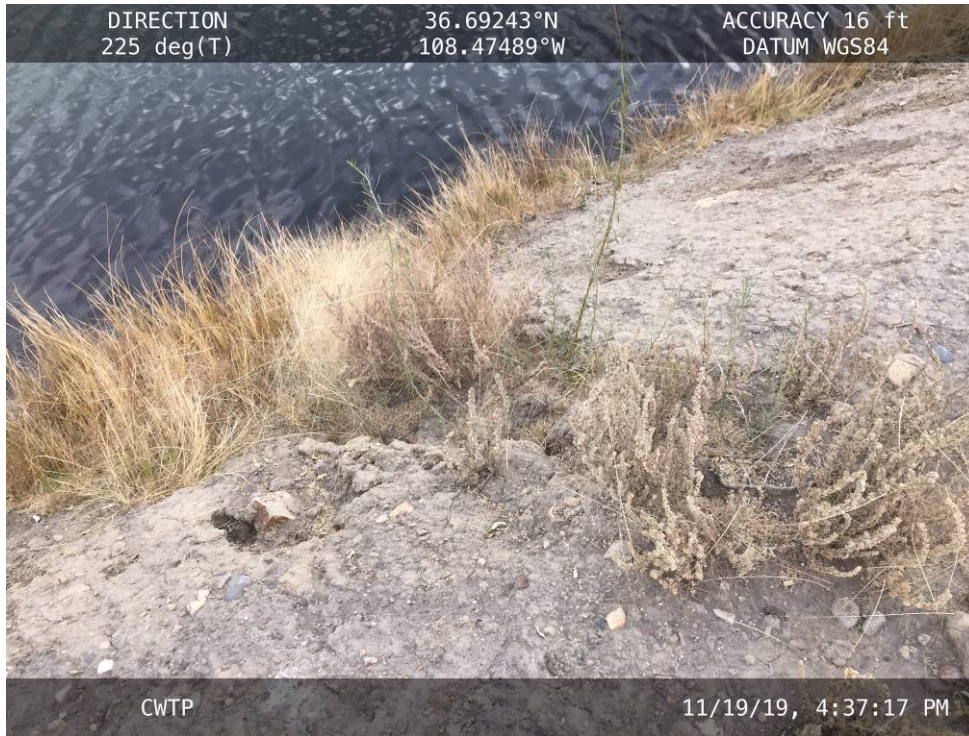
20191119 – IMG_6260

Erosion on the downstream slope along the northern portion of the embankment.

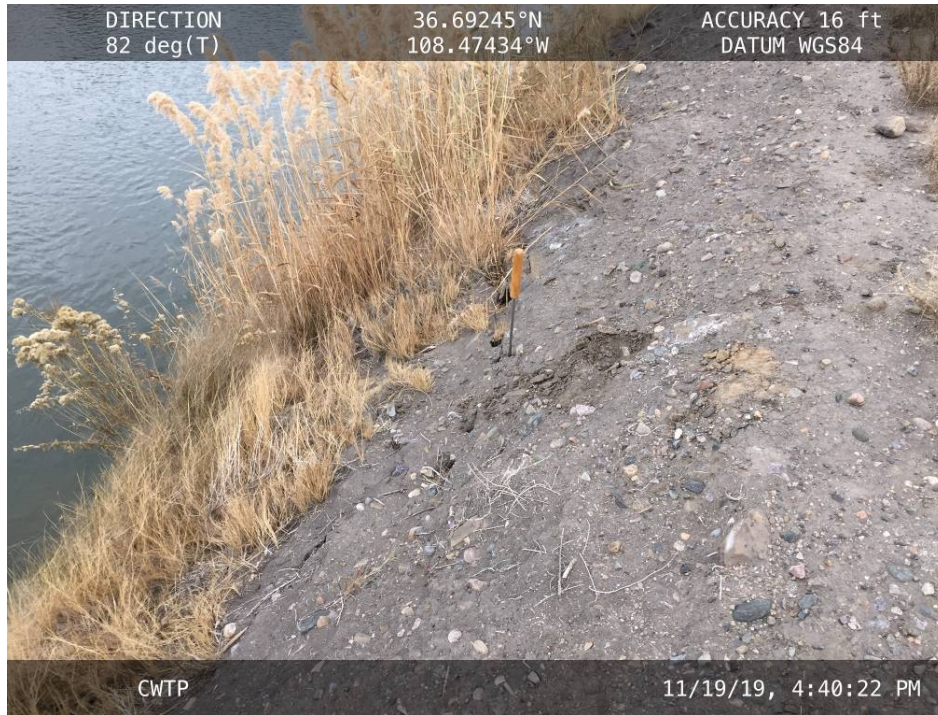
20191119 – IMG_6266

west-east to northwest-southeast (Photo IMG_6266). The area should be monitored and the cracks should be repaired to prevent a disruption to the normal operation of the CCR unit if they are observed to expand.

Aligned holes and a possible tension crack on the downstream slope where the embankment transitions from west-east to northwest-southeast.

3) A series of aligned holes, up to 2 feet deep and across a length of approximately 4 feet, was observed on the downstream slope where the embankment transitions from west-east to northwest-southeast.	The area should be monitored and repaired if the cracks expand in depth or extent..

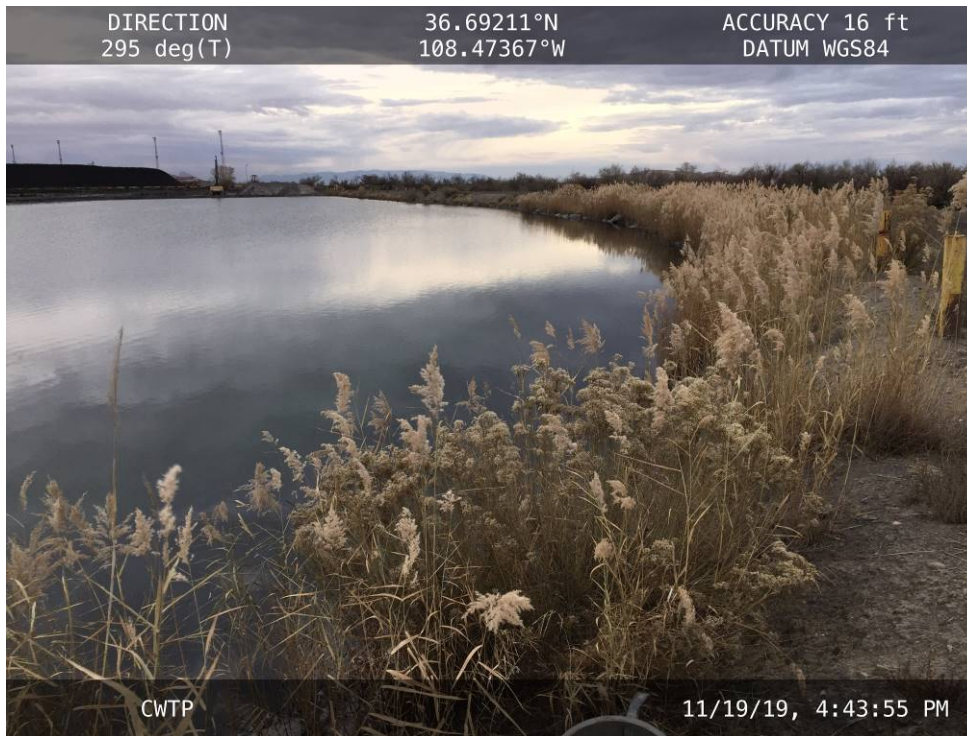
20191119 – IMG_6273

The crest of the CWTP embankment, facing southeast toward the Right Abutment.

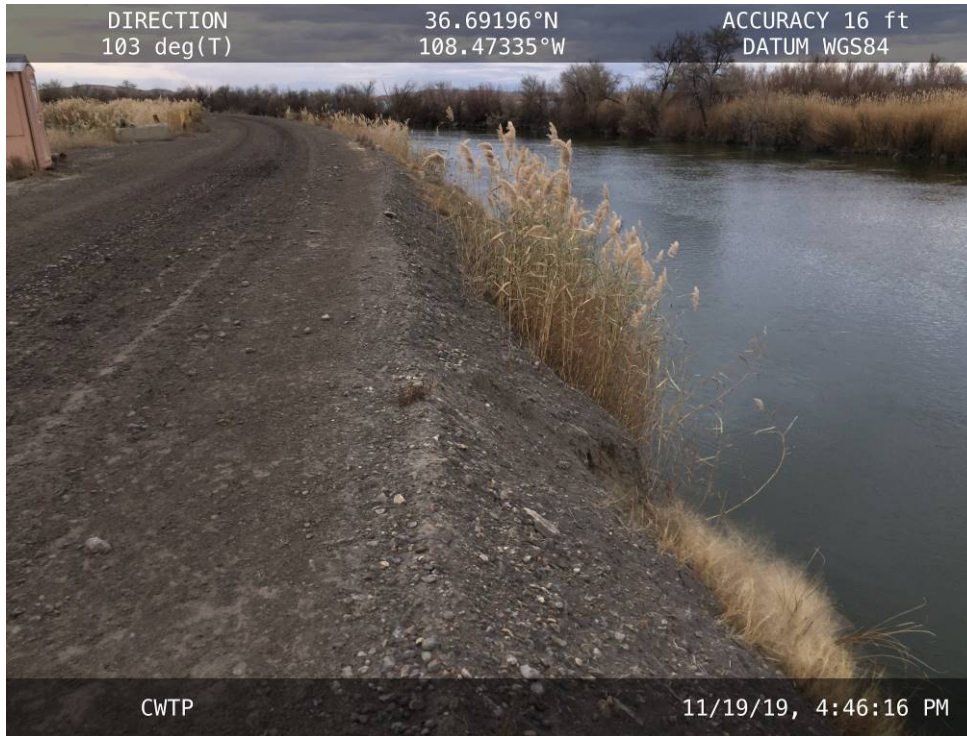
20191119 – IMG_6274

Observed Condition	Action Item
1) Vegetation (grass, small trees, and shrubs) was observed on portions of the upstream and downstream slopes during this inspection.	This is an ongoing maintenance requirement. The grasses should be cut and vegetation removal along the upstream and downstream slopes should be performed in accordance with the NMOSE vegetation maintenance guidelines “ <i>Vegetation Management on Dams</i> ” (2011) reference.

The reservoir and vegetation along the upstream slope of the embankment, facing northwest.

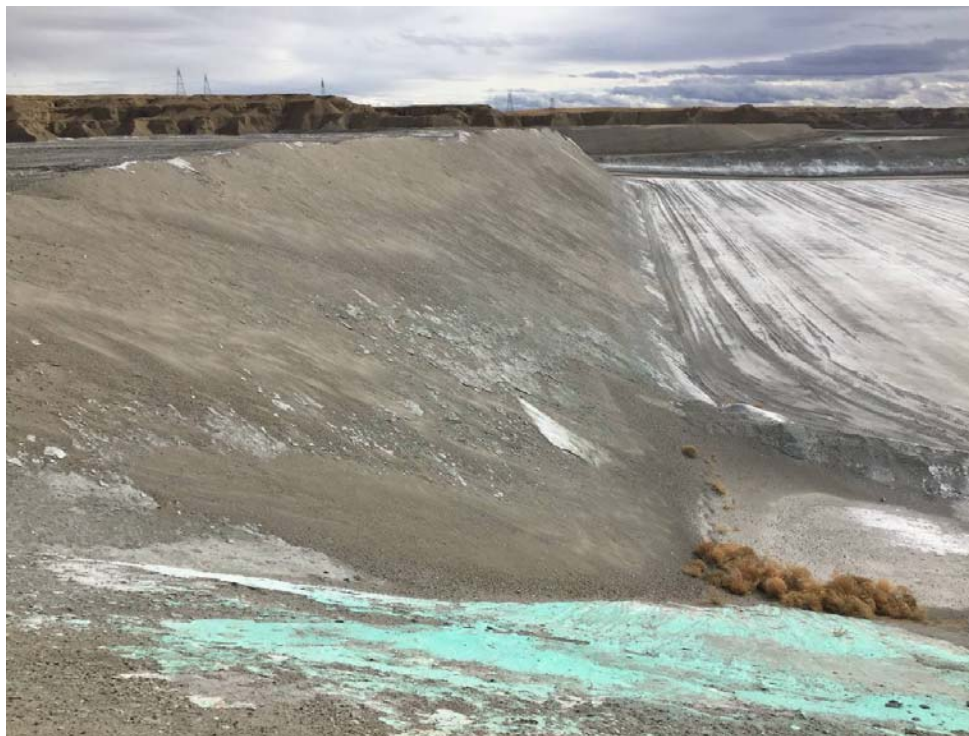
20191120 – IMG_6510

DFADA Cell 2 (background) and the central portion of Cell 3 (foreground), facing south.

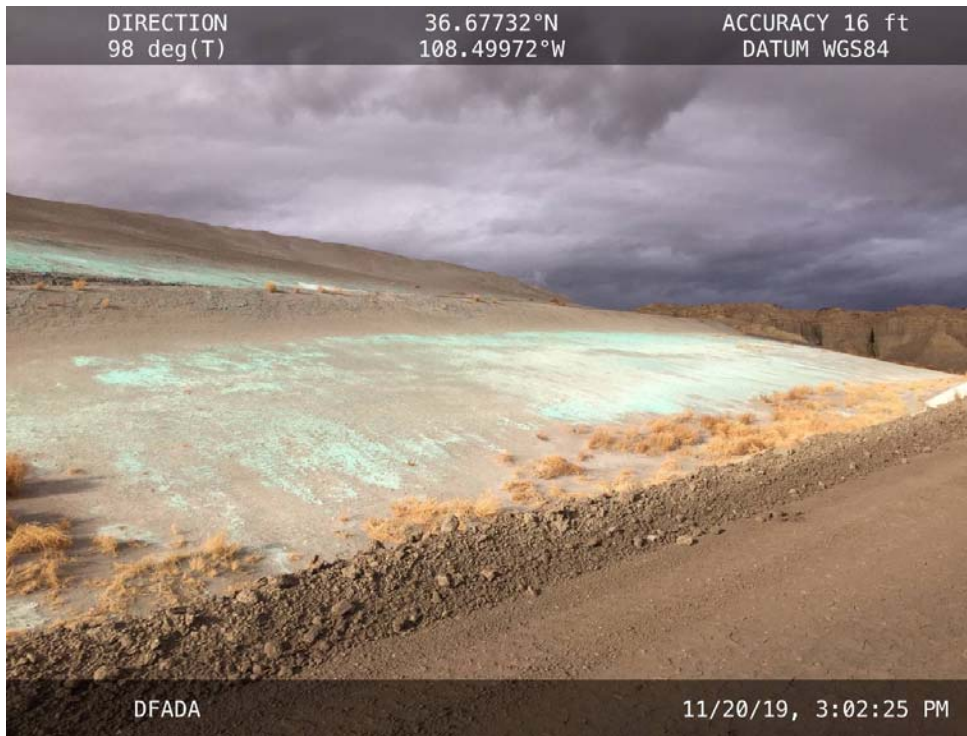
20191120 – IMG_6811

The south slope of DFADA Cell 2, facing northeast from the road along the toe.

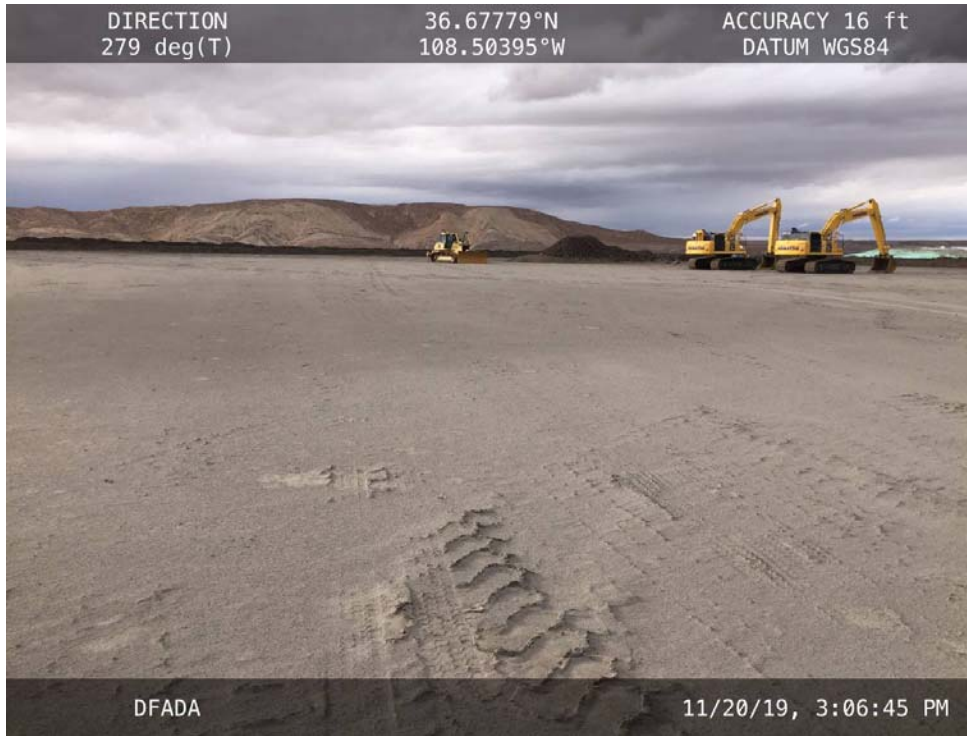
20191120 – IMG_6813

The southeastern slope of DFADA Cell 2, facing northeast from the road along the toe.

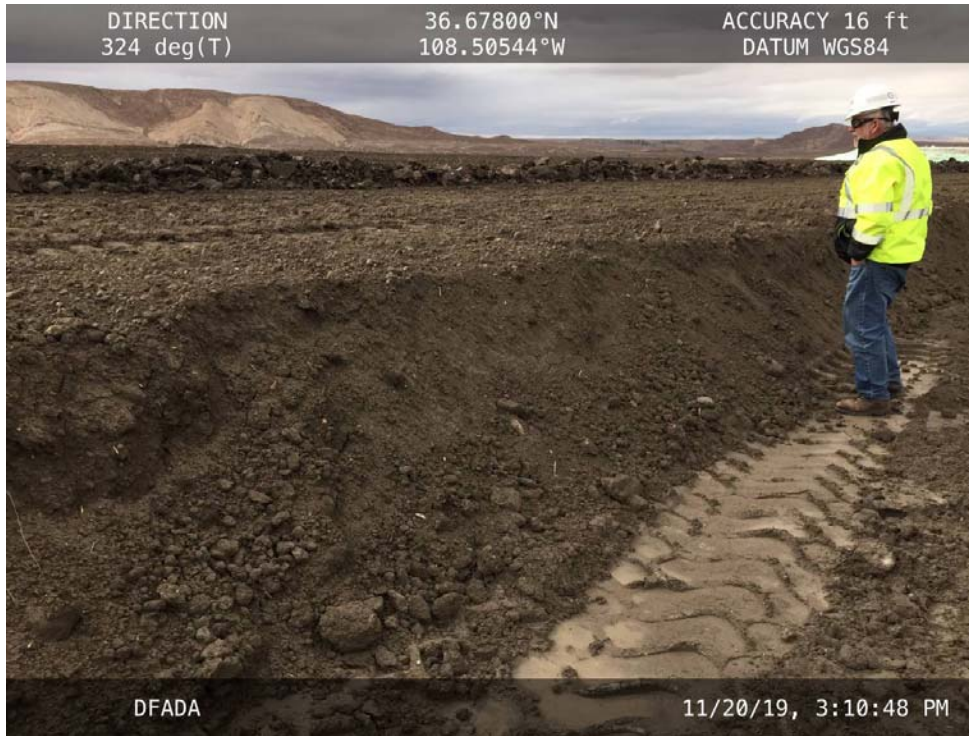
20191120 – IMG_6839
 Subgrade preparation in the footprint of the proposed DFADA Site 4, facing south from Cell 1.

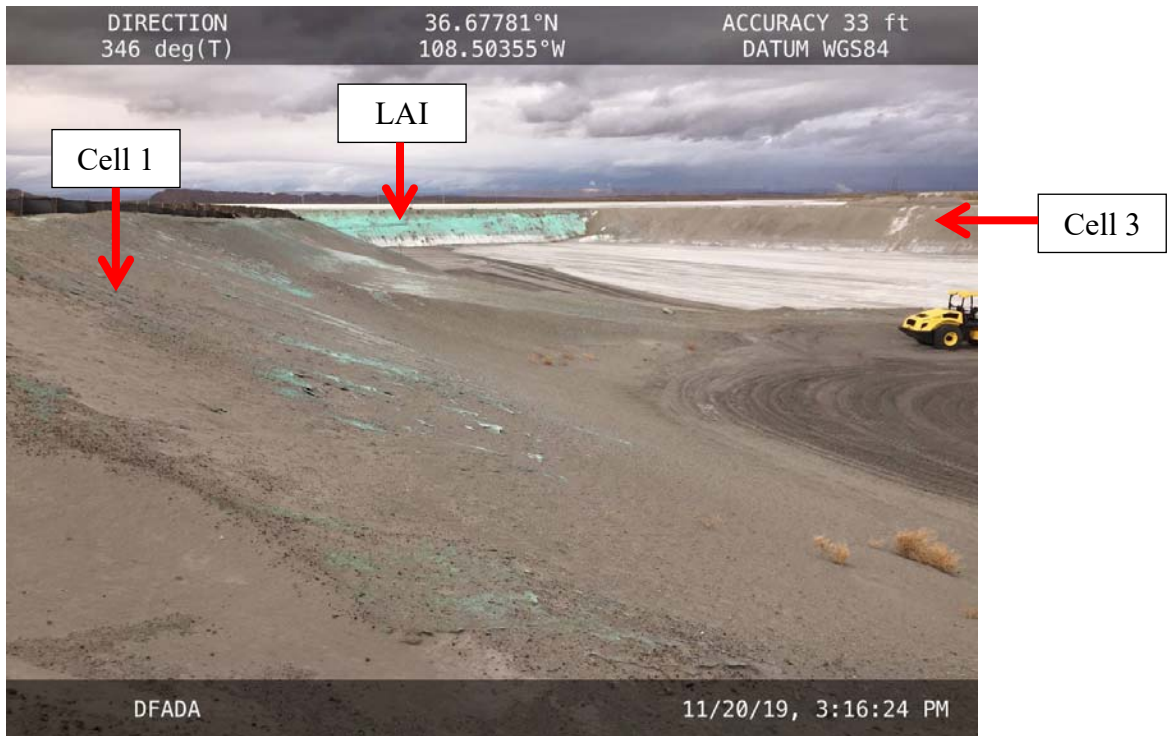
20191120 – IMG_6842

The infiltration layer of the alternative final cover system placed on top of Cell 1.

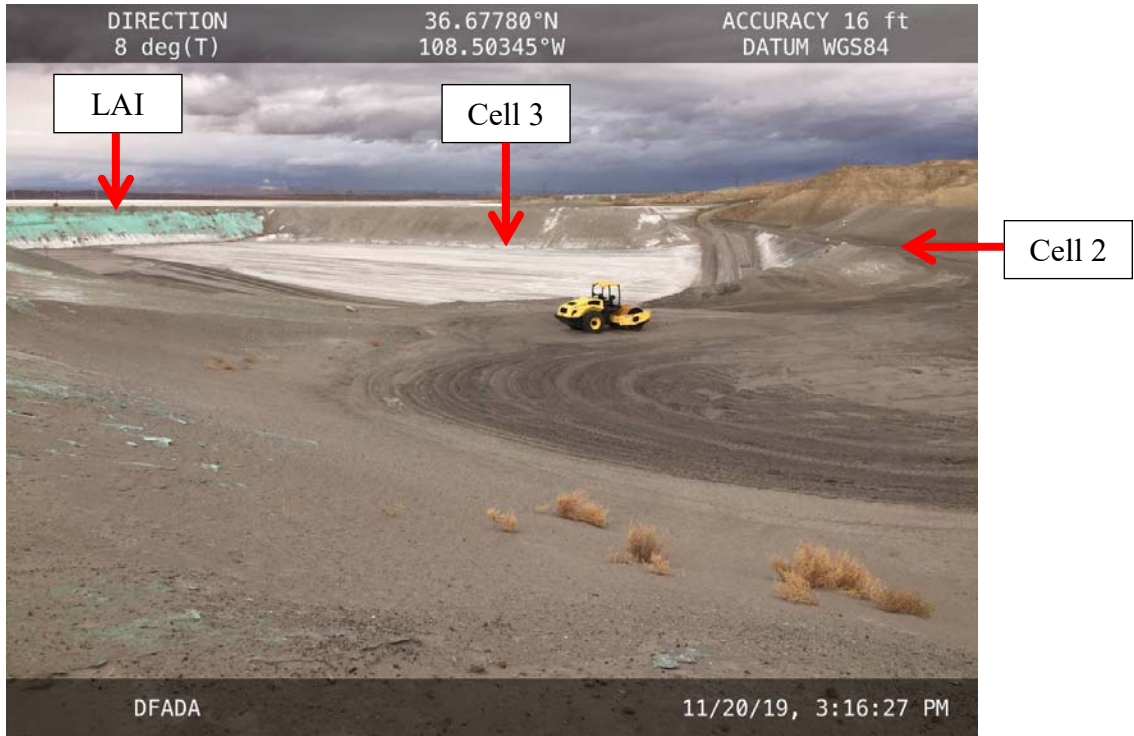
20191120 – IMG_6848

DFADA Cells 1 and 3, facing north from the southeast corner of Cell 1 (LAI in the background).

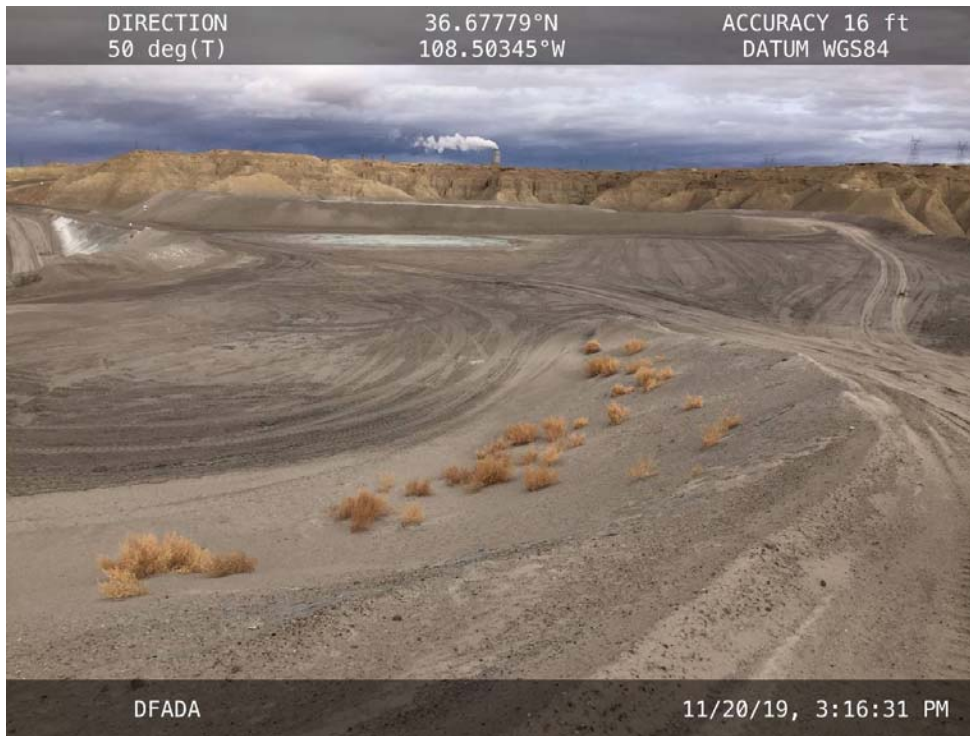
20191120 – IMG_6849

DFADA Cells 3 and 2, facing north from the southeast corner of Cell 1 (LAI in the background).

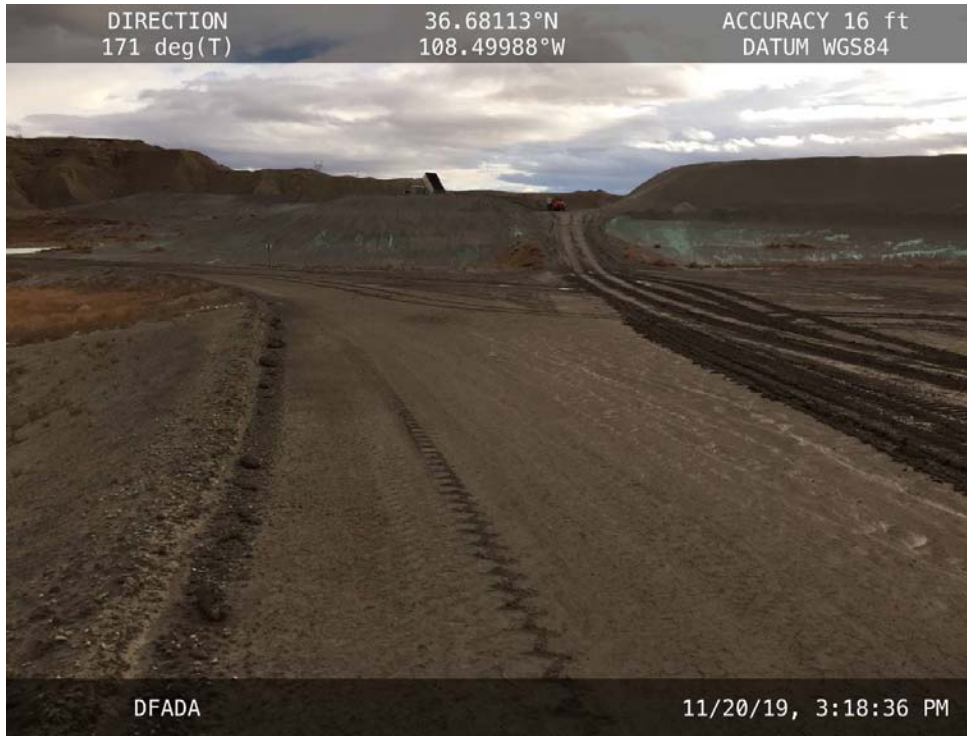
20191120 – IMG_6850

The top of Cell 2, facing east from the southeast corner of Cell 1.

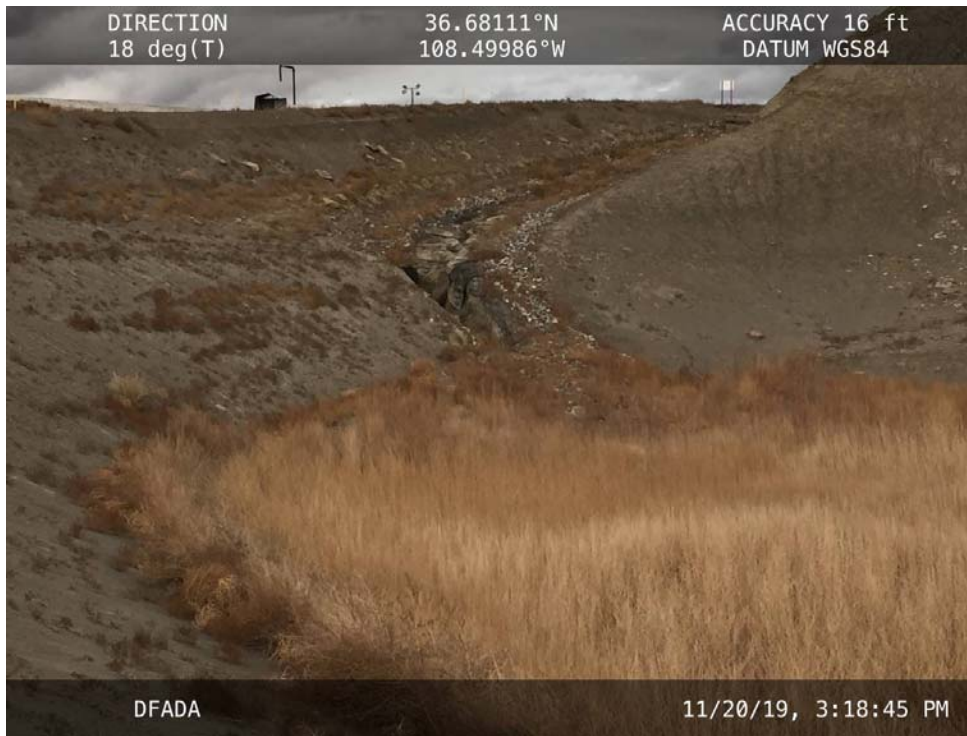
20191120 – IMG_6853

The north side of Cell 2, facing south from the inlet of the Stormwater Diversion Channel.
