**FOUR CORNERS POWER PLANT
Lined Ash Impoundment,
Lined Decant Water Pond,
Combined Waste Treatment Pond,
Dry Fly Ash Disposal Area,
and Return Water Pond**

**Annual
CCR Impoundment and
Landfill Inspection Report
2021**

**GENERATION ENGINEERING
Design Engineering
P.O. BOX 53999
PHOENIX, ARIZONA 85072**

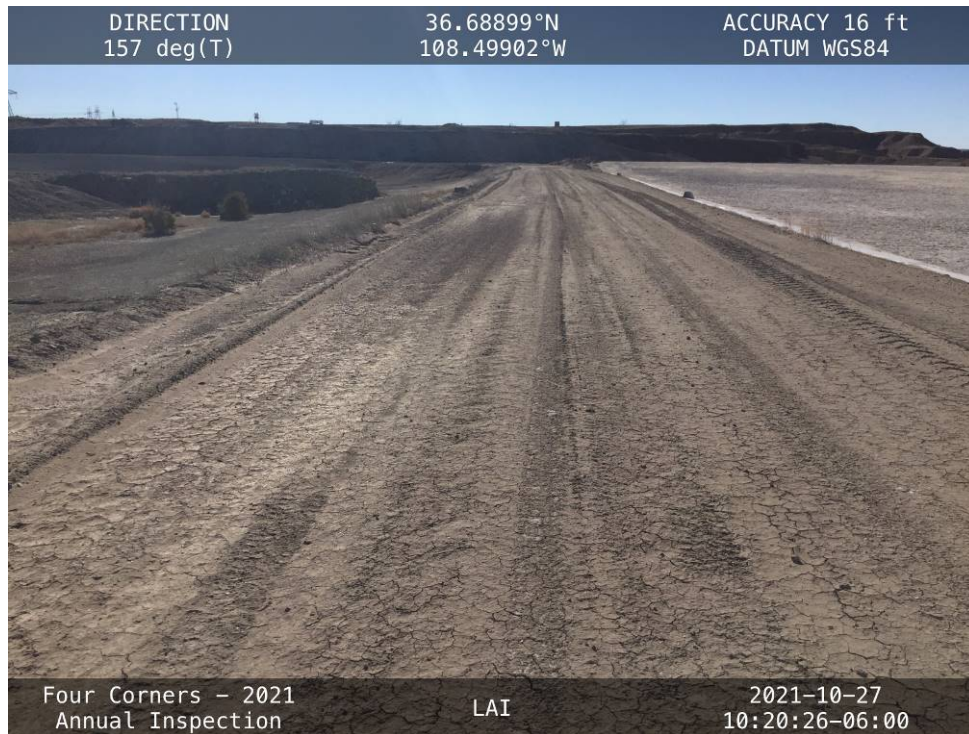
20211027-IMG_7617

The crest of the East Embankment, facing southeast near the north V-ditch.

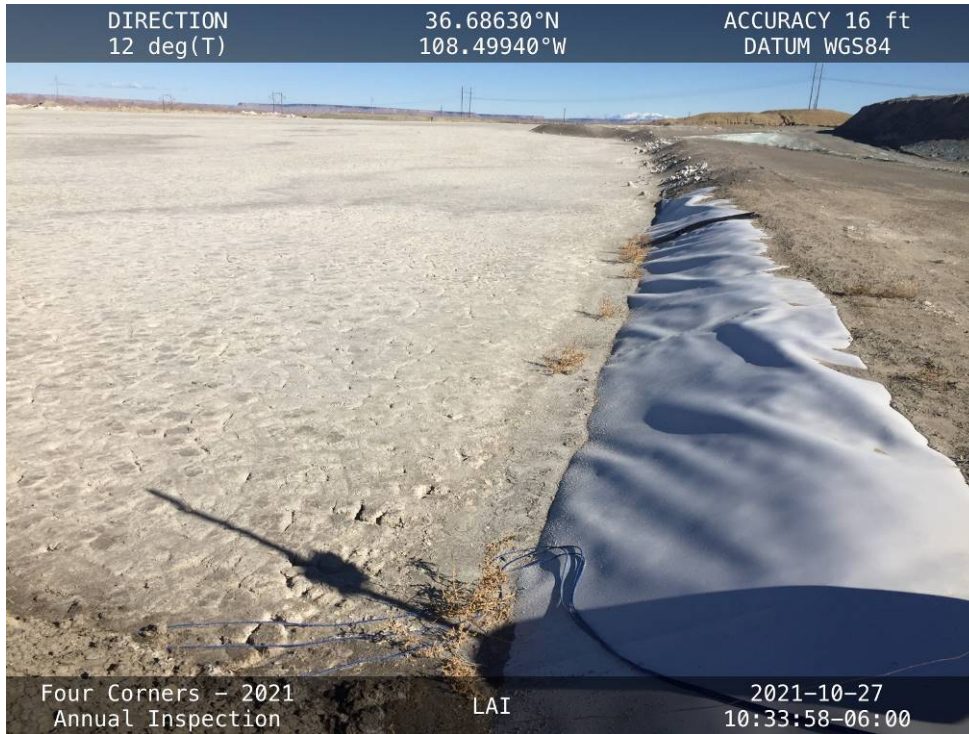
20211027-IMG_7649

The upstream slope of the East Embankment, facing north from the middle section.

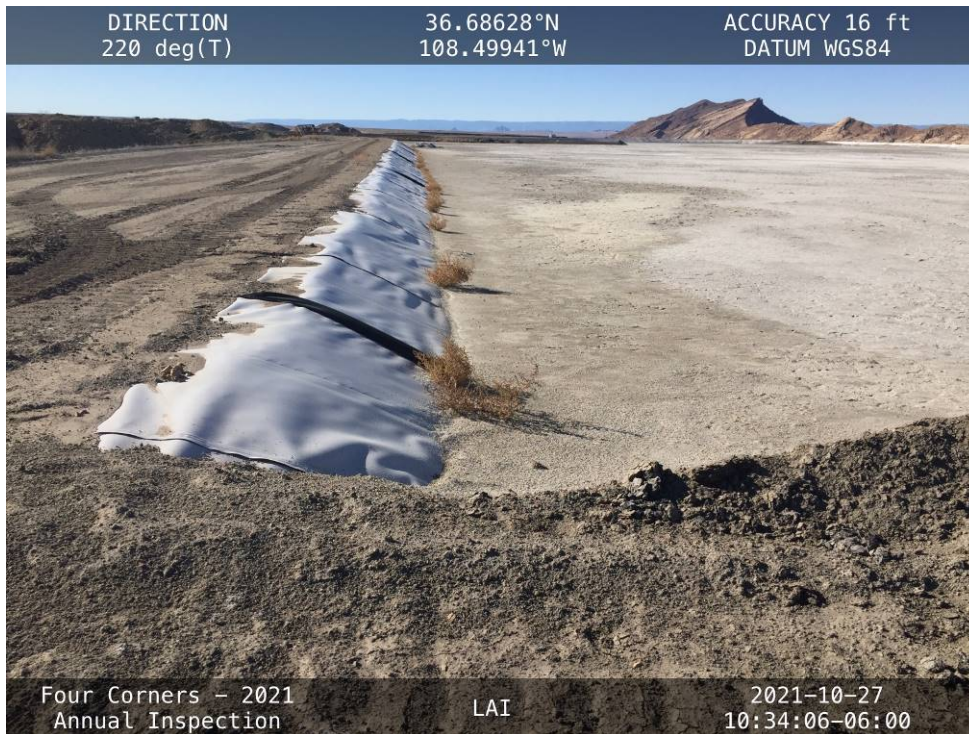
20211027-IMG_7650

The upstream slope of the East Embankment, facing south from the middle section.

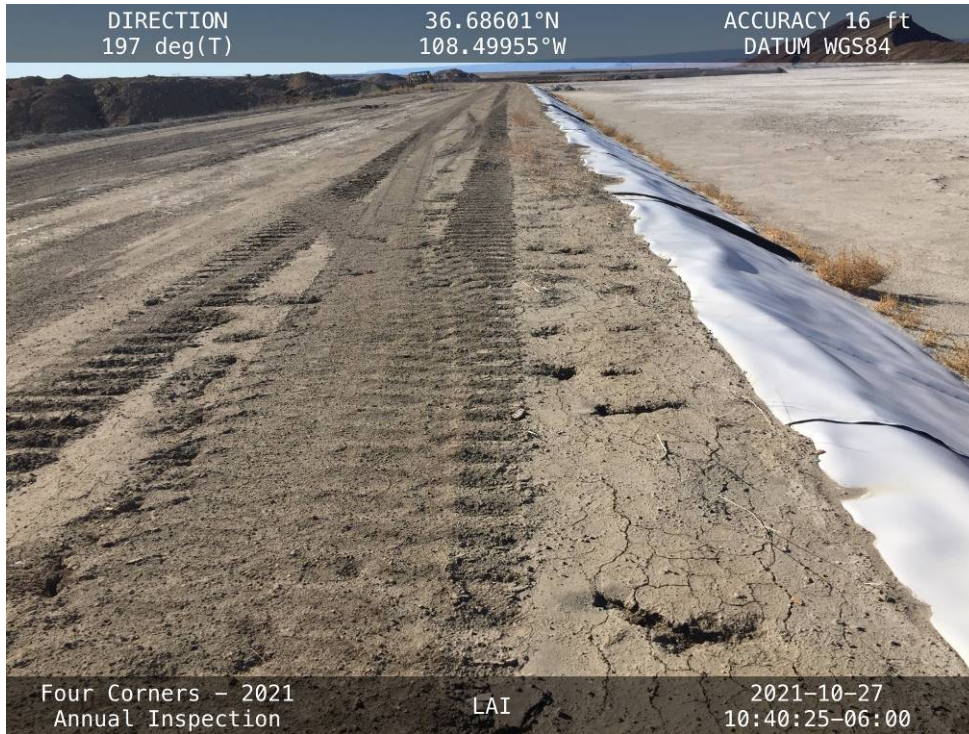
20211027-IMG_7653

DAM EMBANKMENT CHECKLIST											
3	DAM CREST										
a	Settlements, slides, depressions?	See comment ii.									
b	Misalignment?			X					X		
c	Longitudinal/Transverse cracking?	Small holes (1-2 inches in diameter) along the crest were observed in various locations (Photos IMG_7653, IMG_7567, IMG_7757, IMG_7768, and IMG_7776). Mud cracks observed on the East Embankment during the 2020 inspection were still present, but not as prominent during this inspection.									
d	Animal burrows?			X							
e	Adverse vegetation?			X							
f	Erosion?			X

Holes in the East Embankment crest along the anchor trench, facing south.

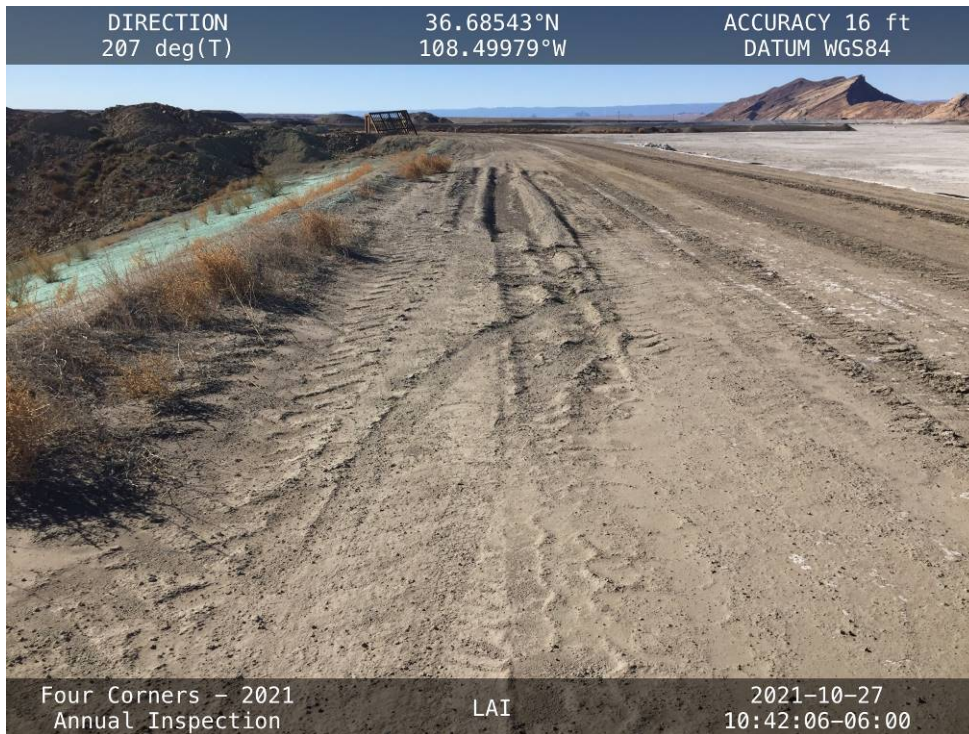
20211027-IMG_7656

- ii. Ruts were observed on the downstream side of the South Embankment crest (Photo IMG_7698) and the downstream side of the East Embankment crest (Photo IMG_7656). These did not appear to be affecting the structural integrity of the dam, but drivers should be instructed to avoid driving through these areas and such depressions should be repaired.

Ruts in the East Embankment crest, facing south.

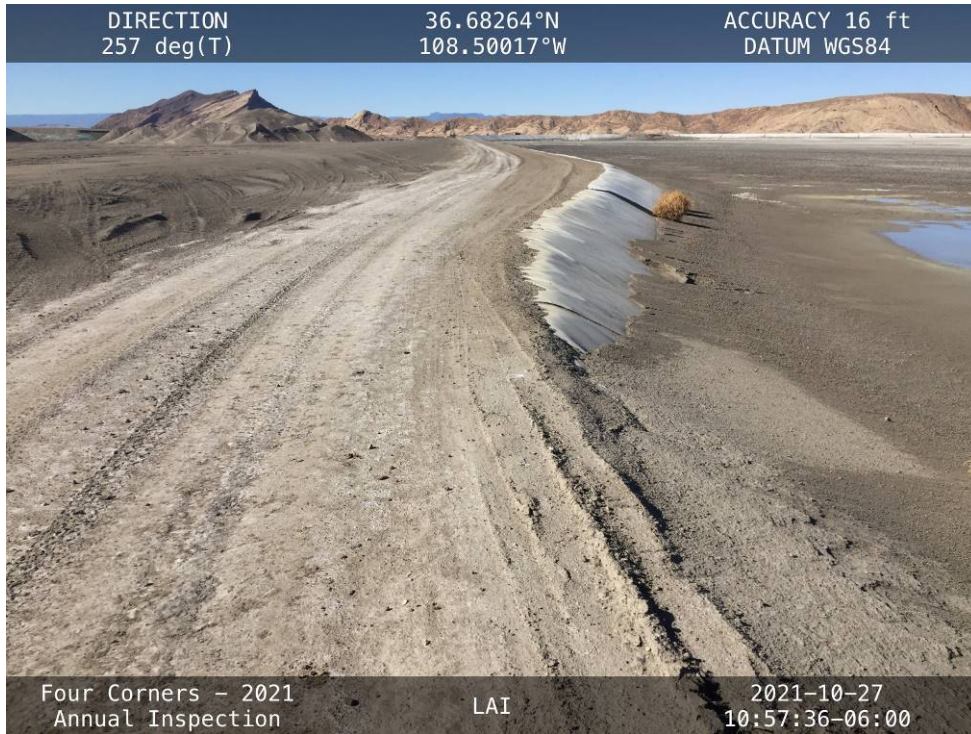
20211027-IMG_7674

The South Embankment crest and upstream slope, facing southwest from the eastern end.

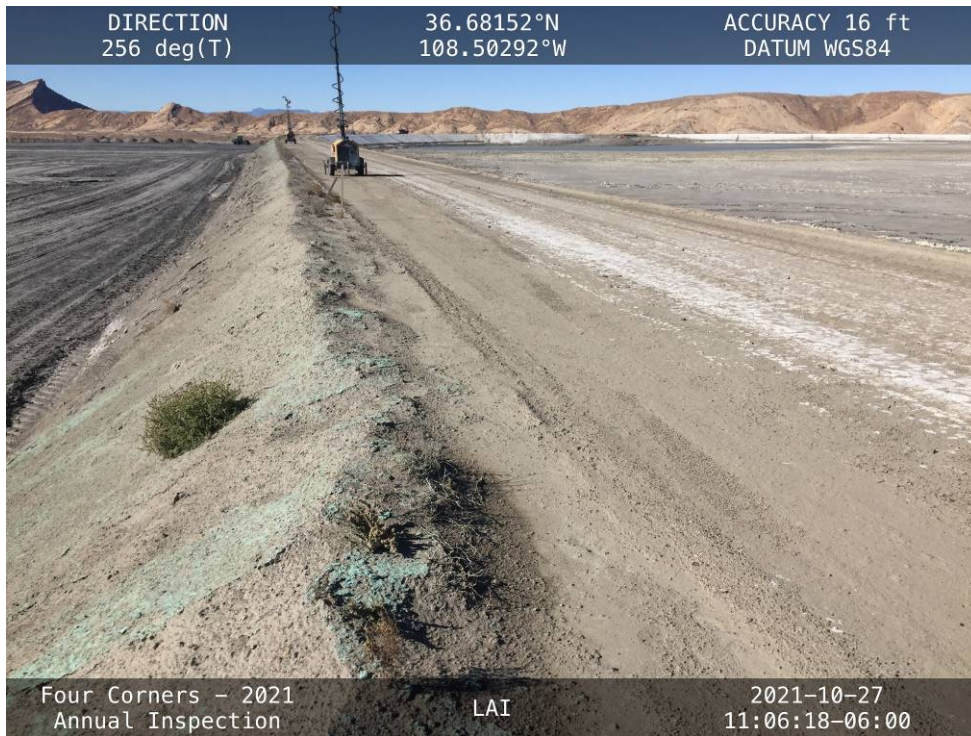
20211027-IMG_7686

The downstream slope of the South Embankment, facing west from the DFADA.

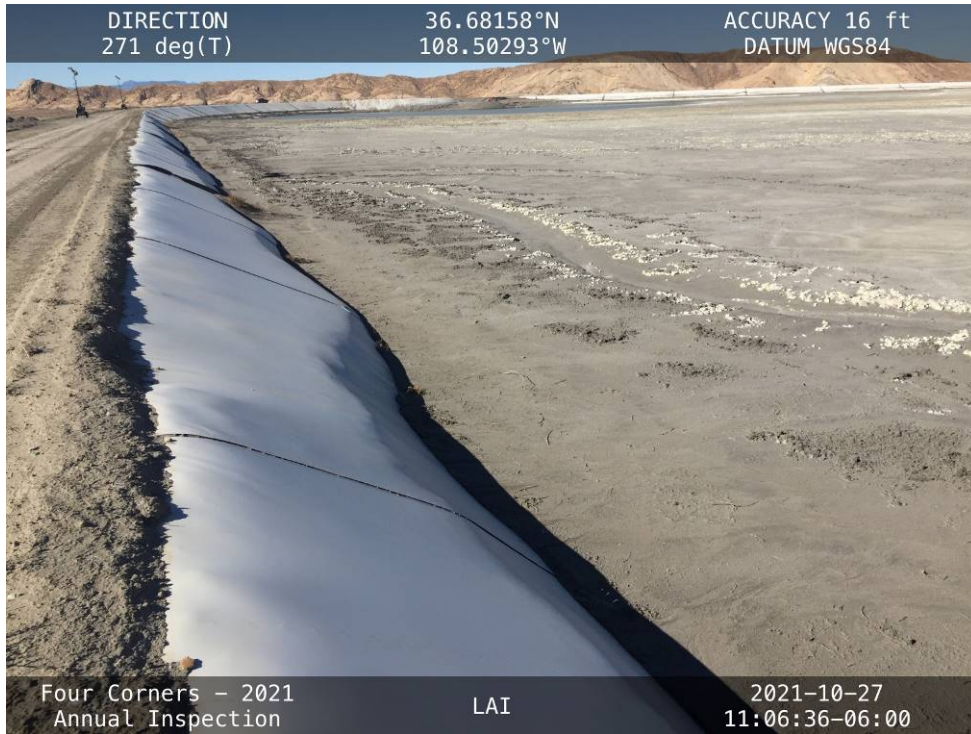
20211027-IMG_7688

- iii. The uneven depressions and bulges along the South Embankment observed during previous inspections were present during this inspection (Photos IMG_7688 and IMG_7709). Several of these depressions and bulges are in the vicinity of previously observed holes in the upstream liner that were later patched and may be due to the presence of water trapped underneath the liner. The presence and actual causes of the bulges should be recorded, and the geotechnical engineer should be consulted. Repair documentation should be maintained with the operating record.

The South Embankment upstream slope, facing southwest from the middle of the embankment.

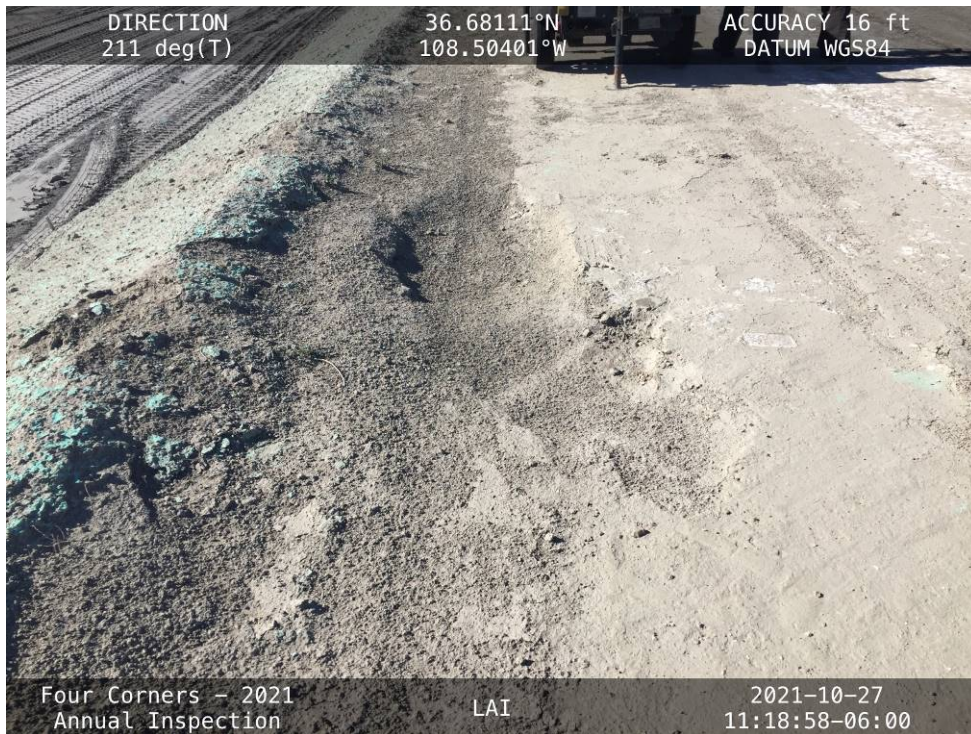
20211027-IMG_7698

A shallow depression on the downstream half of the South Embankment crest.

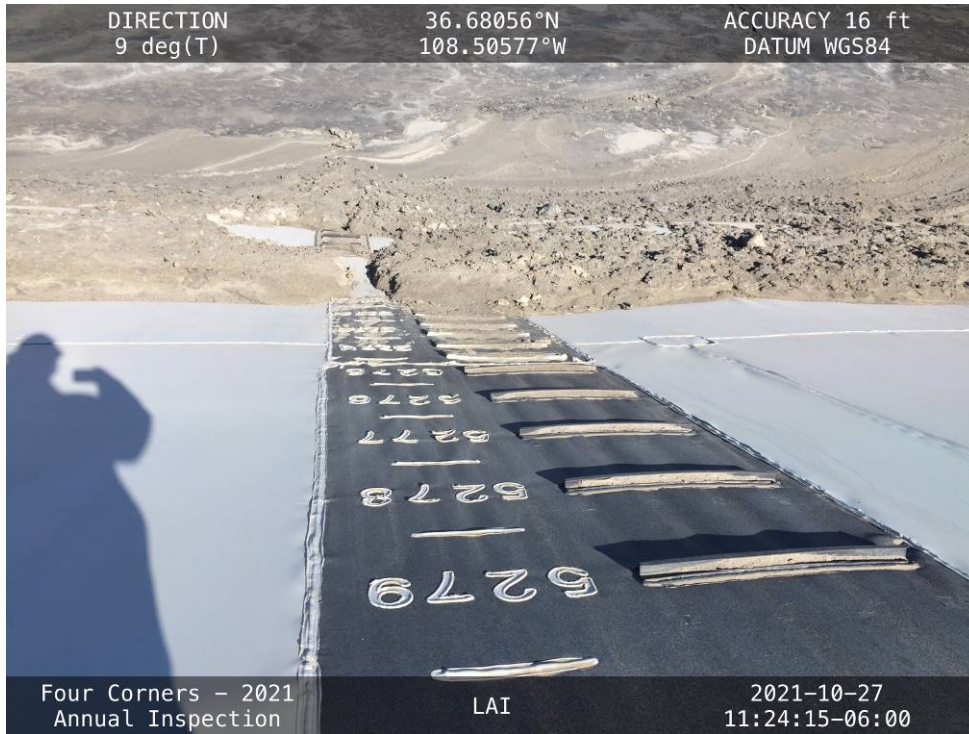
20211027-IMG_7713

The LAI staff gage at STA 36+00 at the time of the inspection.

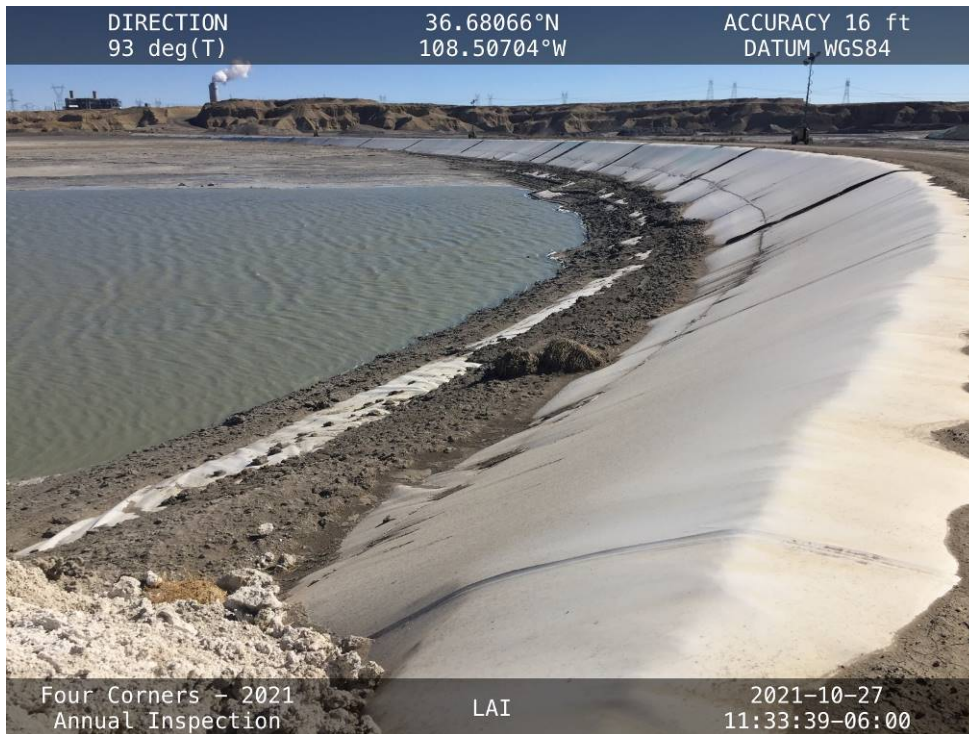
20211027-IMG_7729

The upstream slope of the South Embankment, facing east from the Southwest Corner.

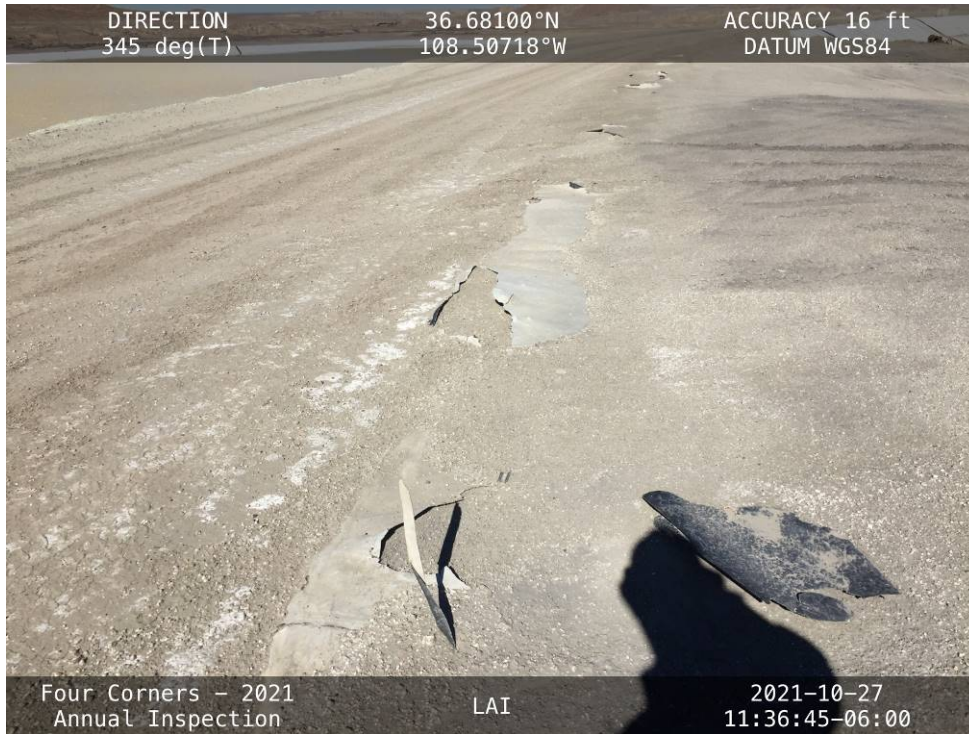
20211027-IMG_7730

There are tears in the exposed liner at the cenosphere mining area in the Southwest Corner (Photo IMG_7730). The working area for the cenosphere mining operation is built into the reservoir area and the liner damage is not affecting the integrity of the embankment. The area should be monitored.

Tears in the exposed liner at the cenosphere mining area in the Southwest Corner.

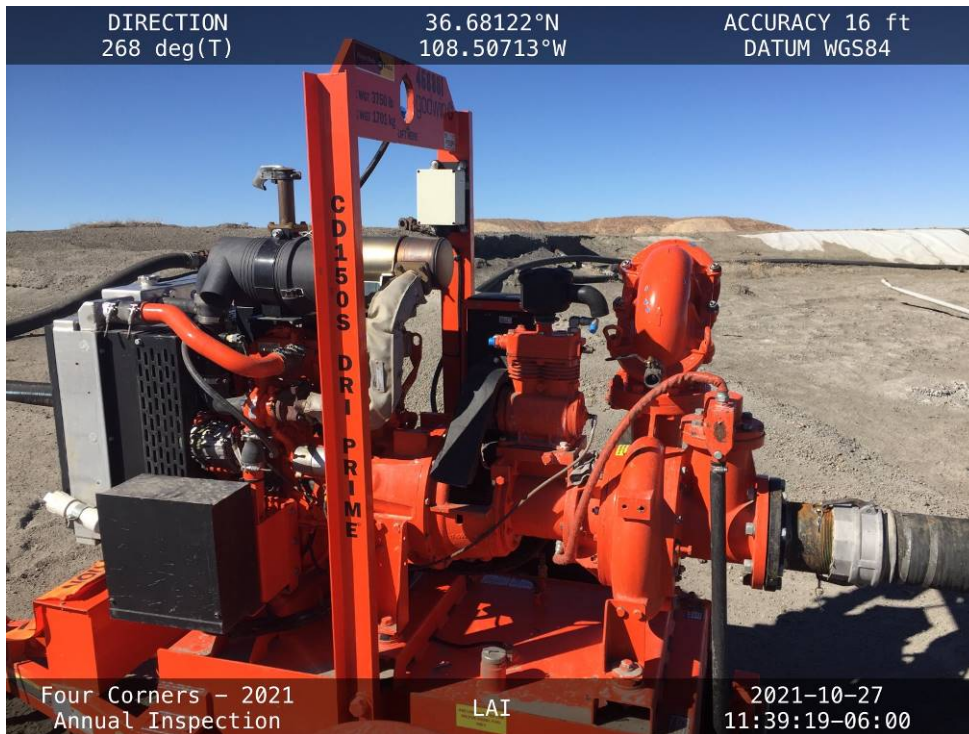
20211027-IMG_7738

The pump currently being used to remove water and transport it from the LAI to the LDWP.

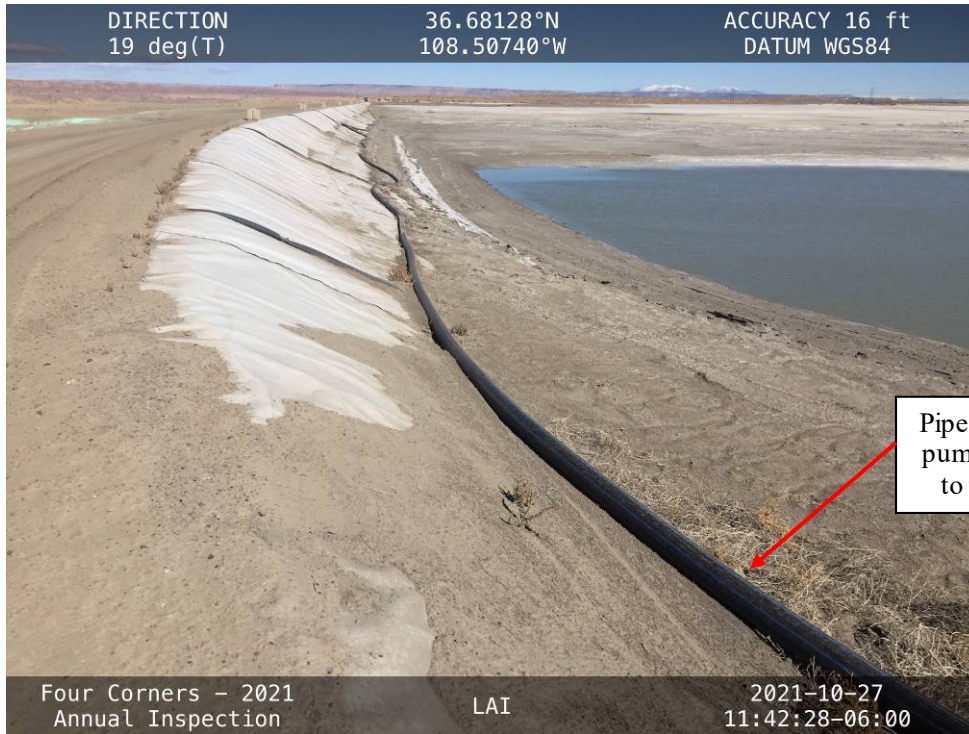
20211027-IMG_7742

The upstream slope of the West Embankment, facing north from the Southwest Corner.

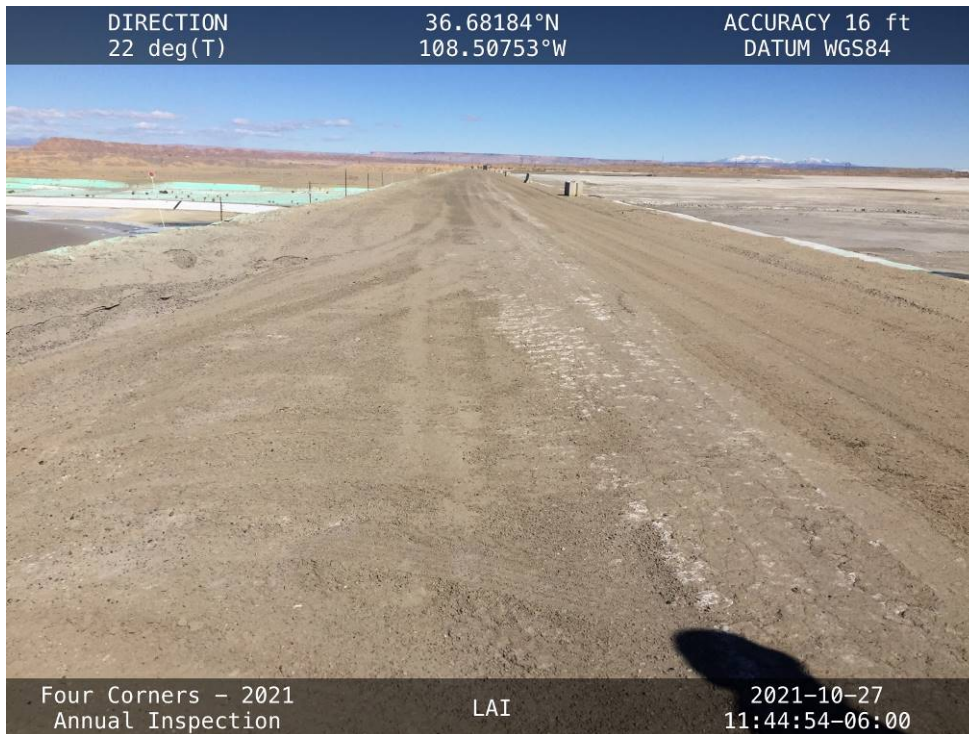
20211027-IMG_7743

The crest of the West Embankment, facing north from the Southwest Corner.

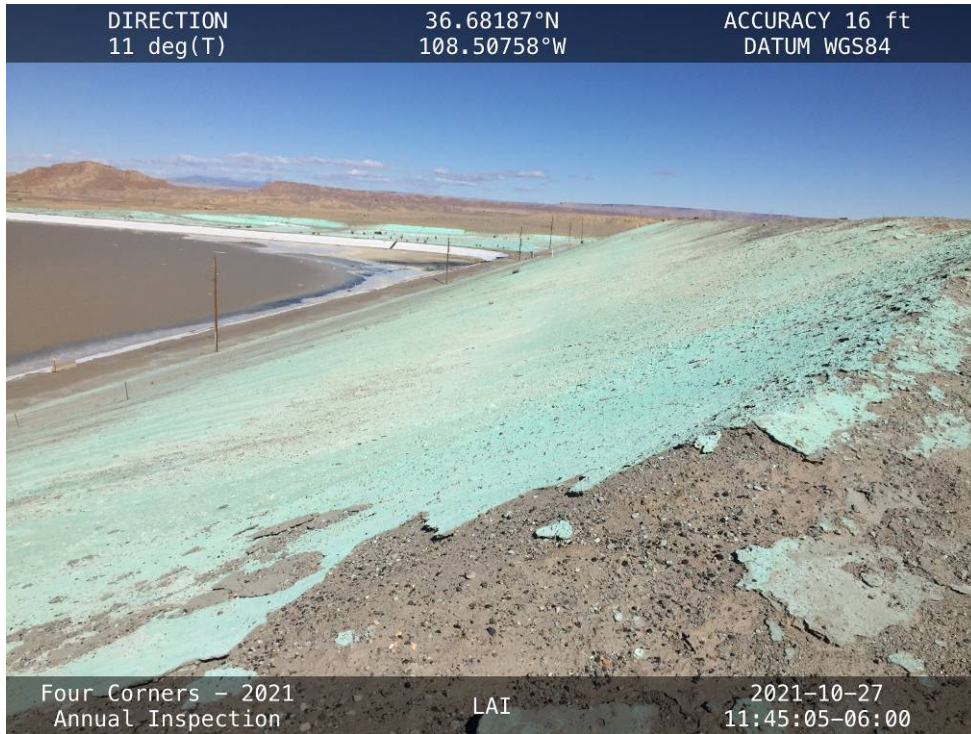
20211027-IMG_7744

The downstream slope of the West Embankment, facing north from the LDWP access ramp.

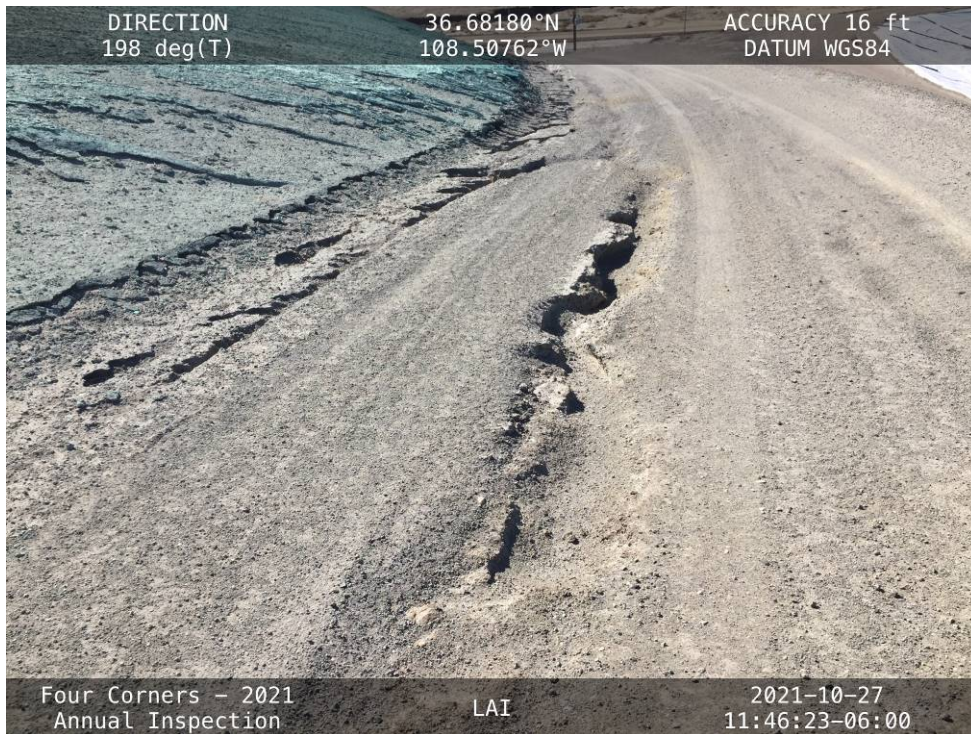
20211027-IMG_7751

Erosion on the LDWP access ramp, facing south.

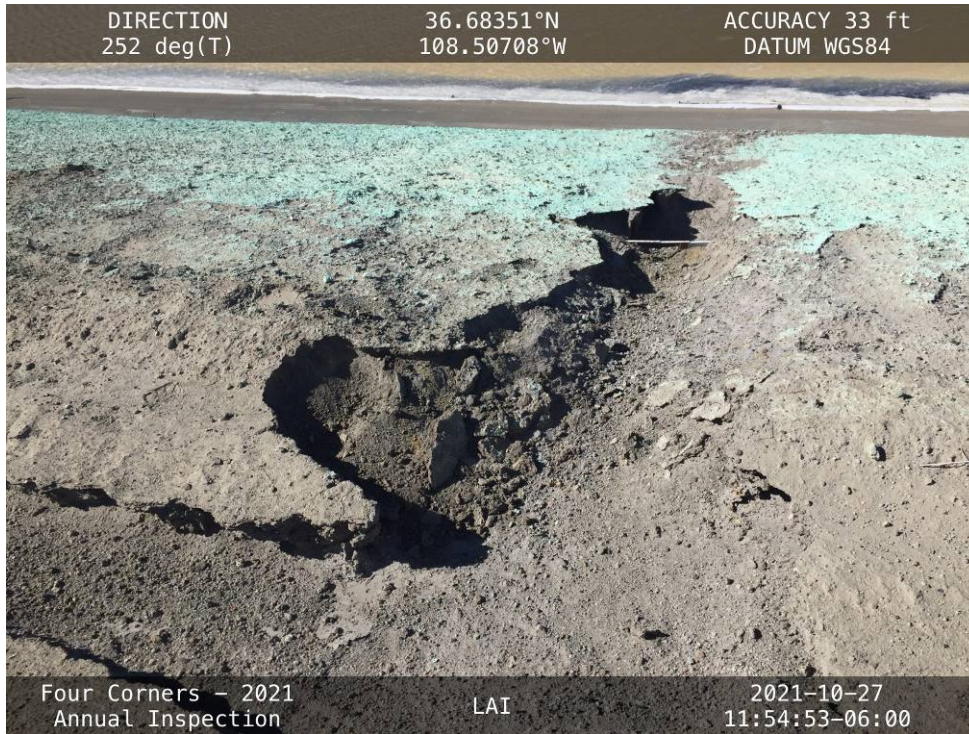
20211027-IMG_7758

Erosion along the upper portion of the West Embankment, facing downstream from the crest.

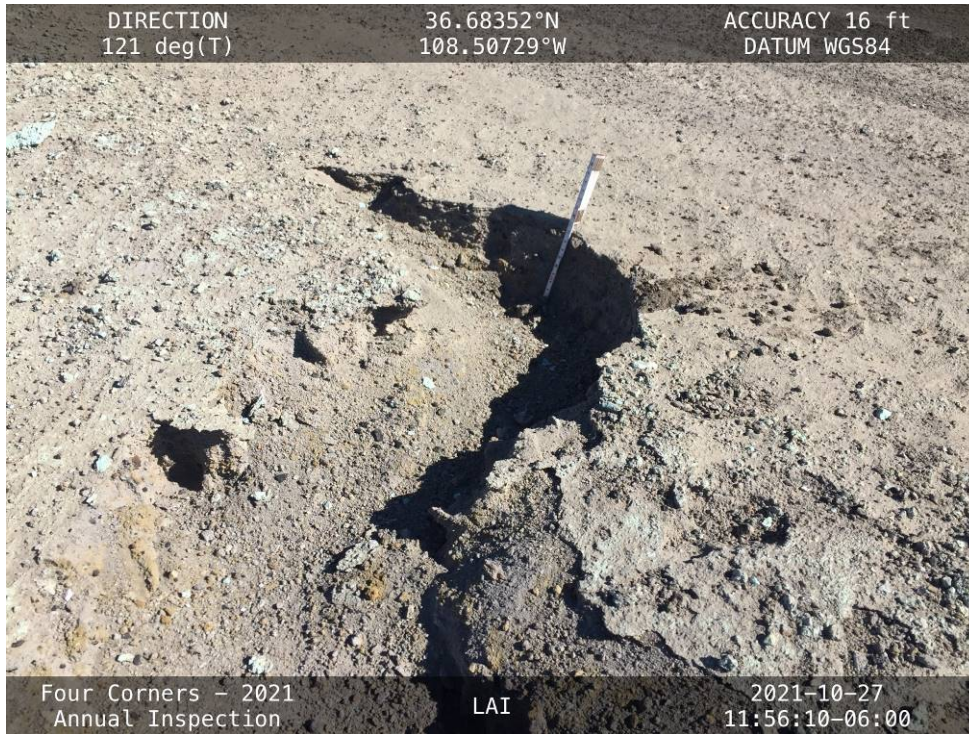
20211027-IMG_7762

10 inches of erosion along the upper portion of the West Embankment downstream slope.

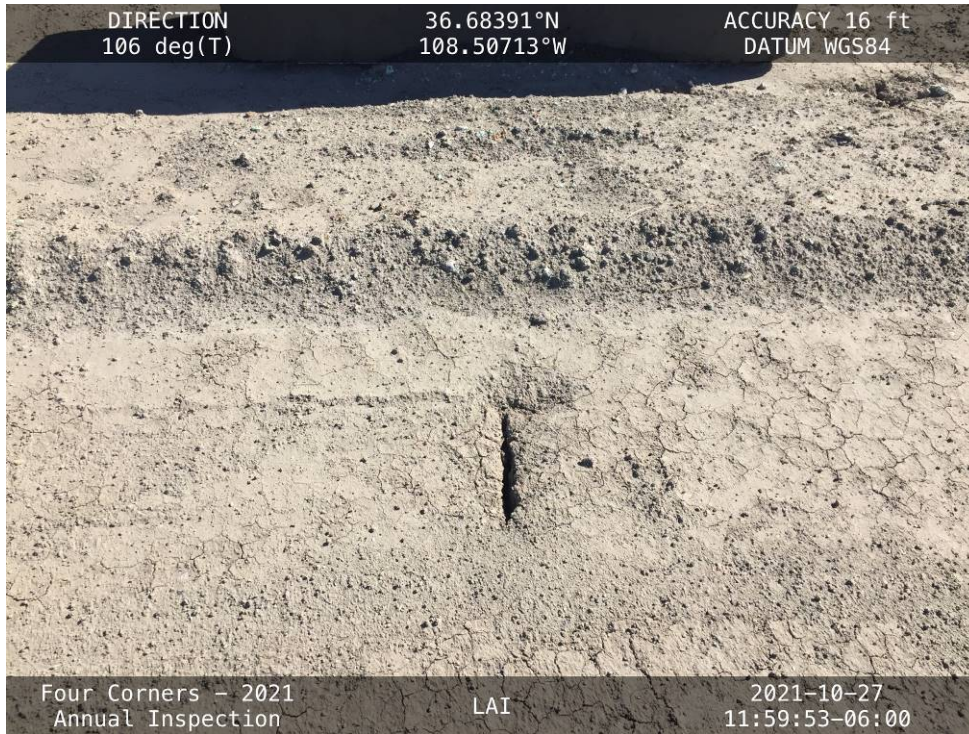
20211027-IMG_7768

A liner mud crack on the upstream side of the West Embankment crest.

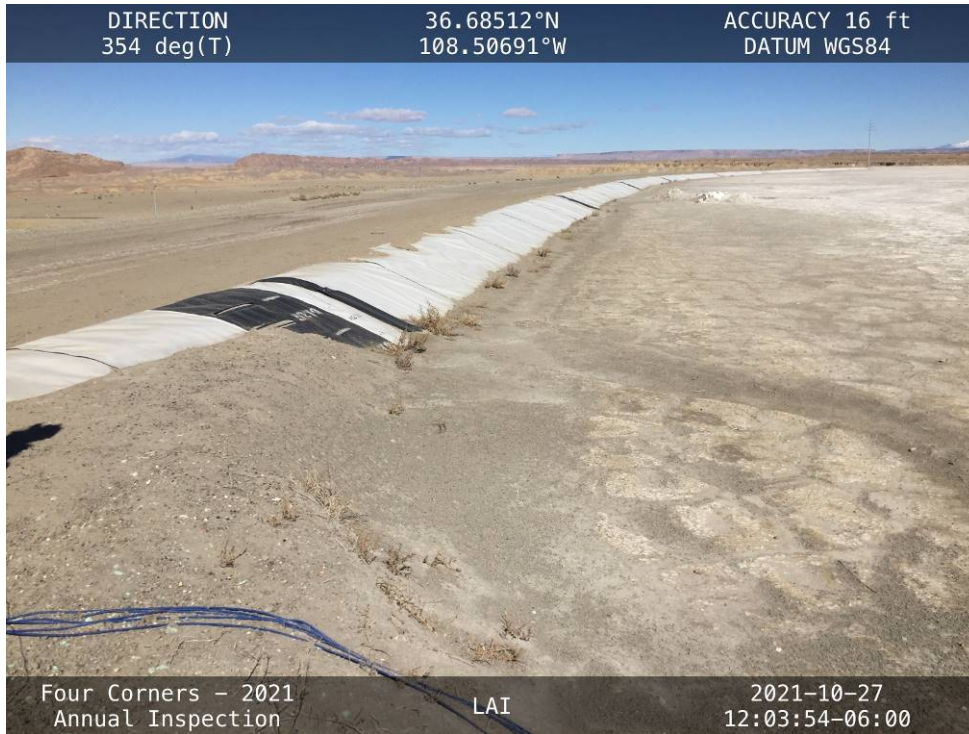
20211027 – IMG_7772

The upstream slope of the West Embankment, facing north from the Drop Inlet Structure ramp.

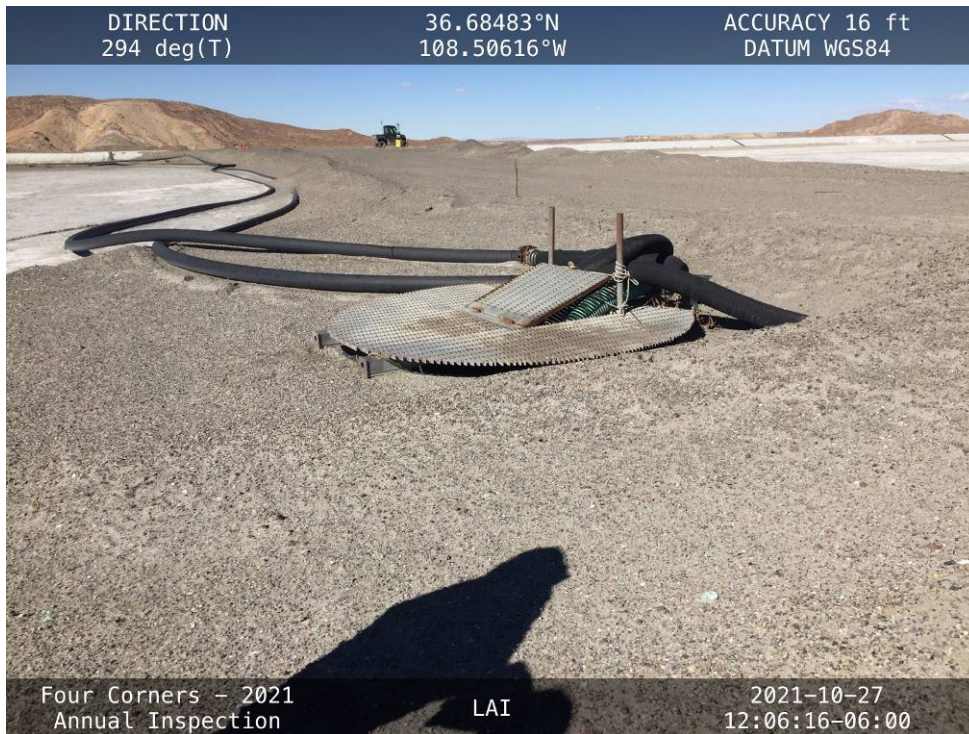
20211027 – IMG_7775

The Drop Inlet Structure, facing west from inside the LAI reservoir.

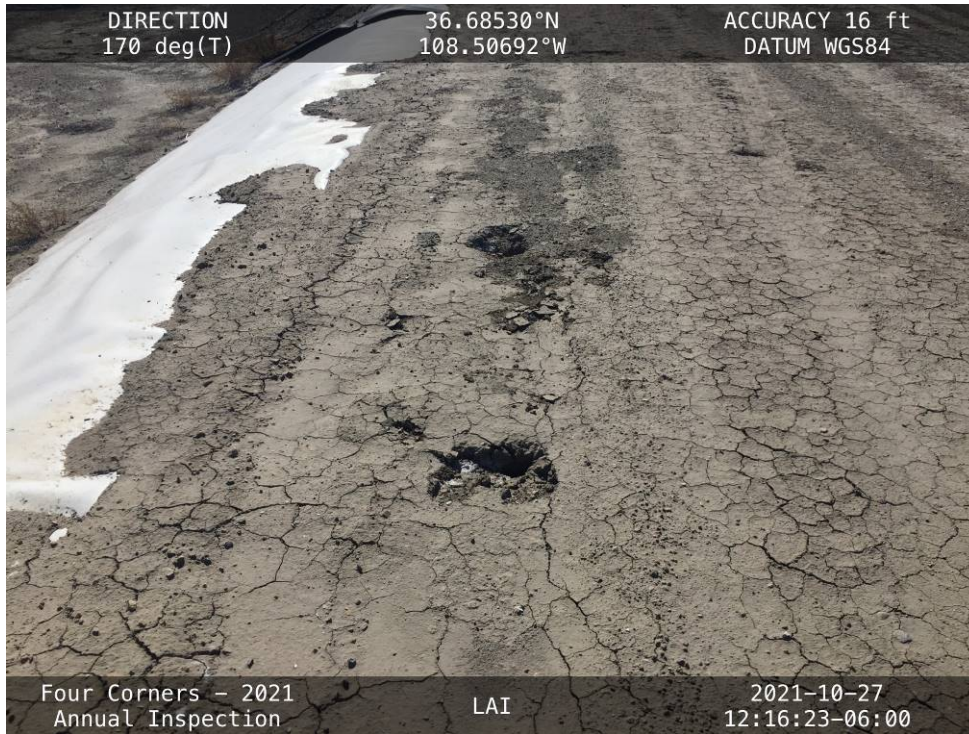
20211027-IMG_7776

Holes in the mud cracks along the anchor trench north of the Drop Inlet Structure.

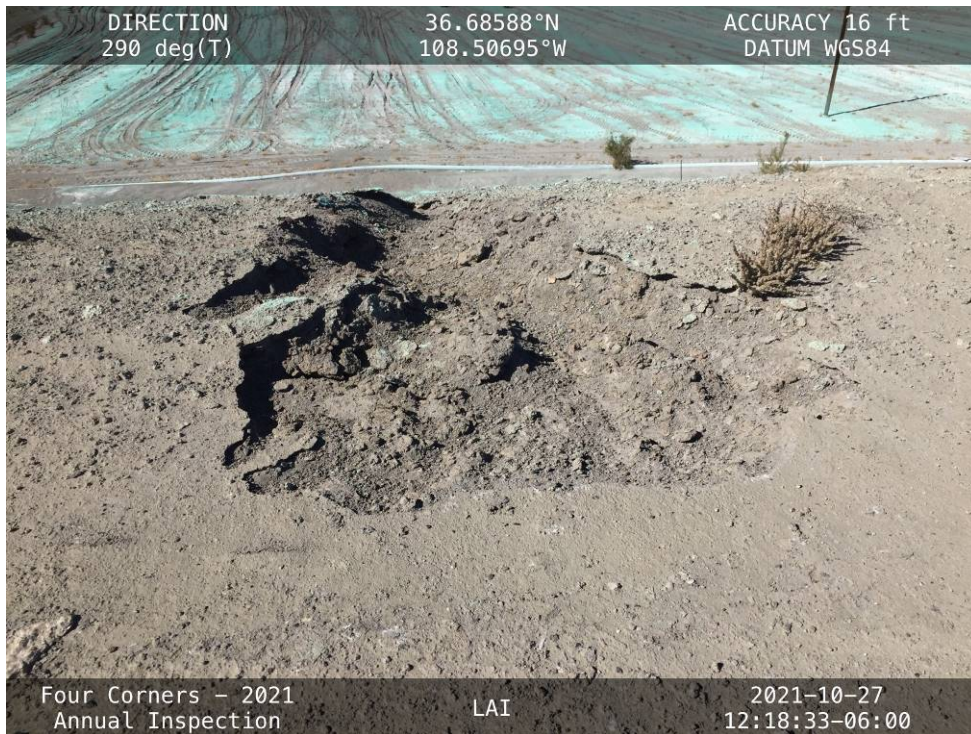
20211027-IMG_7784

Erosion along the upper portion of the West Embankment, facing downstream from the crest.

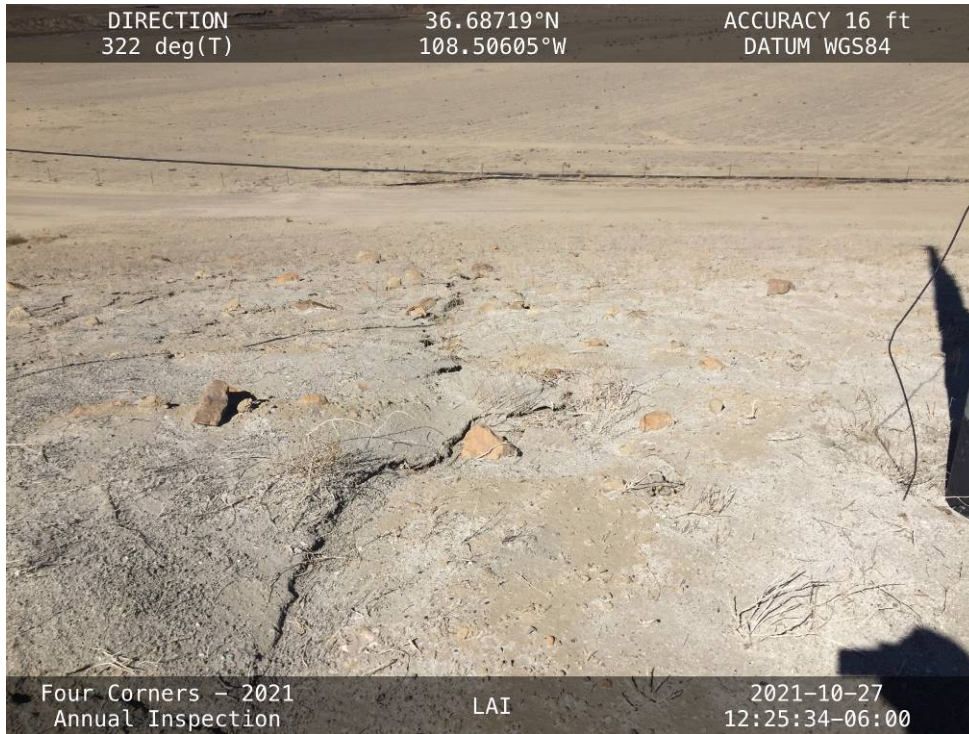
20211027-IMG_7794

An erosion rill on the downstream slope of the Northwest Embankment.

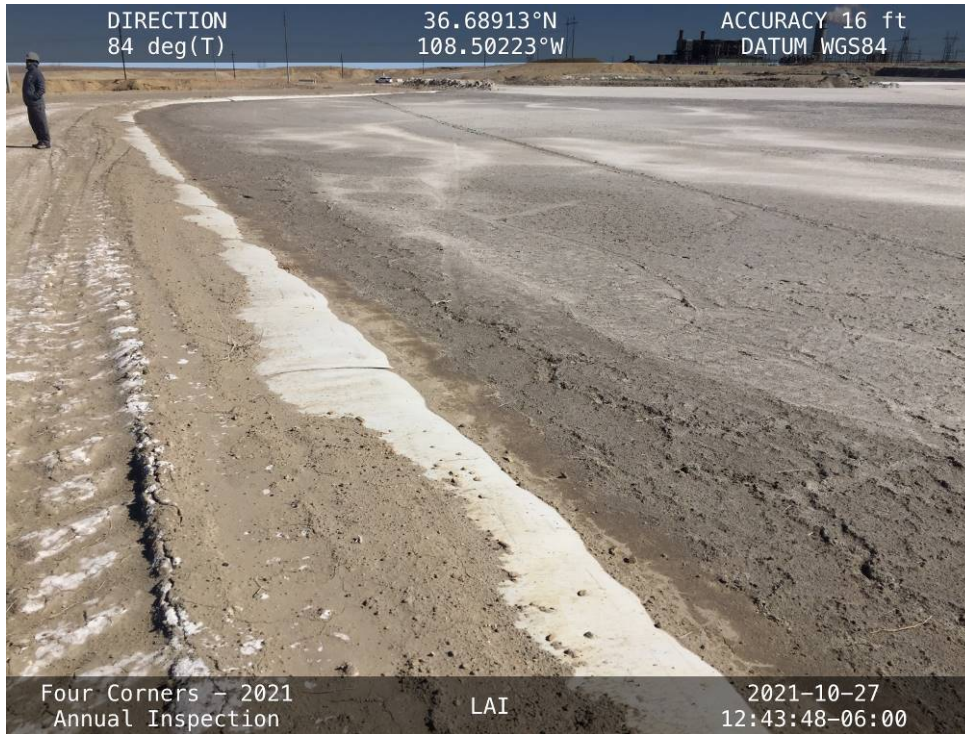
20211027-IMG_7814

Ash at the north side of the LAI within inches of the crest elevation.

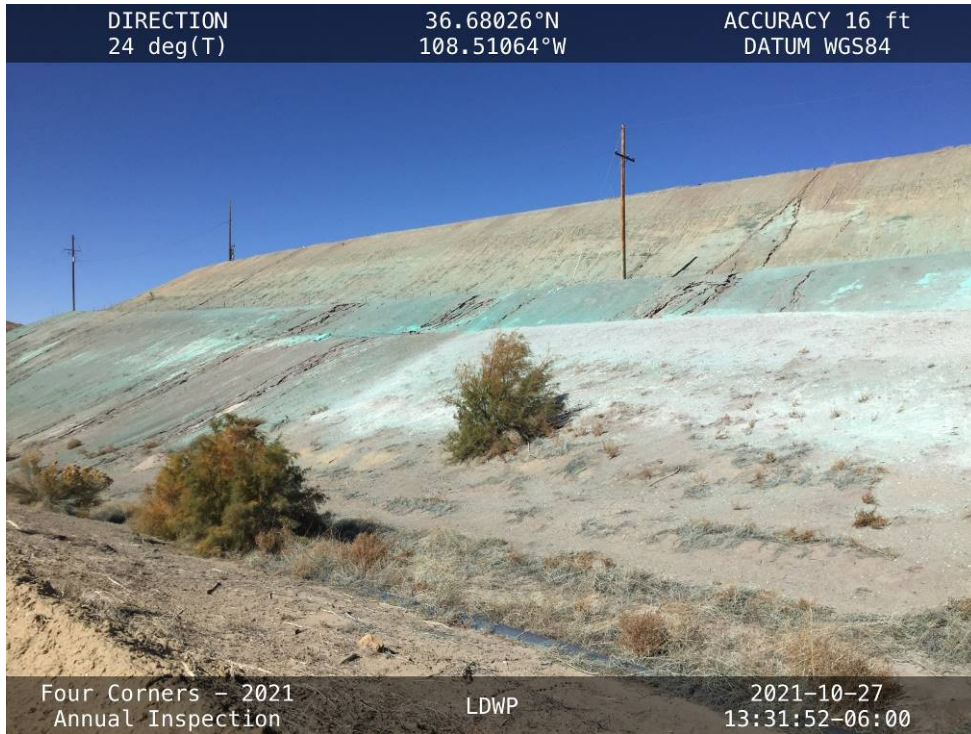
20211027 – IMG_7866

Erosion on the western half of the South Embankment downstream slope, facing north from the toe.

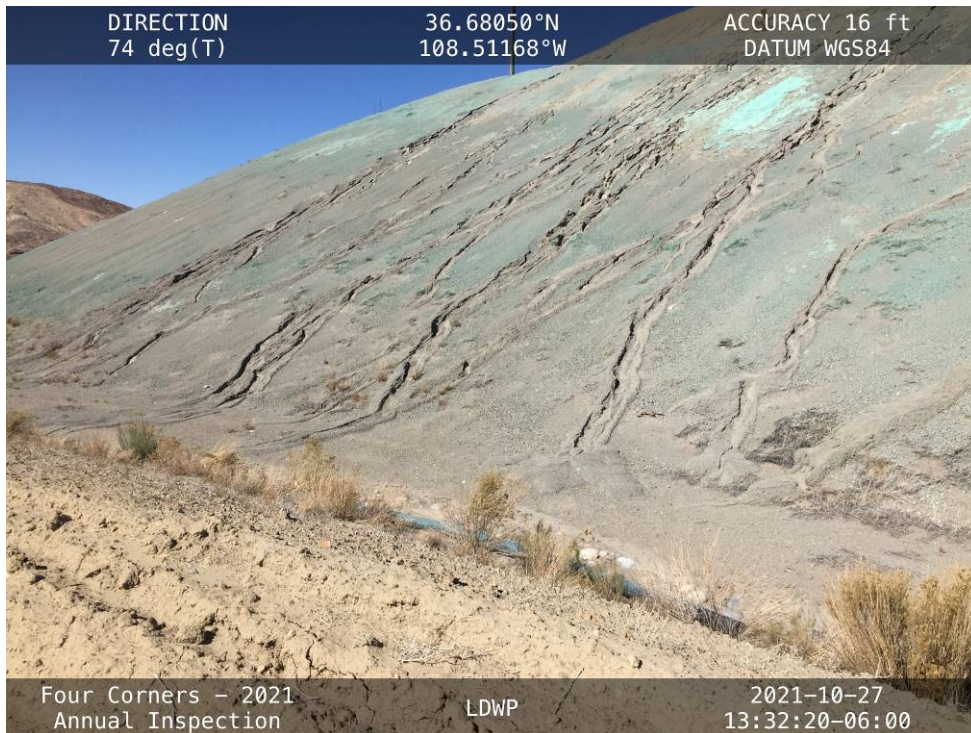
20211027 – IMG_7868

Erosion on the downstream slope at the western end of the South Embankment.

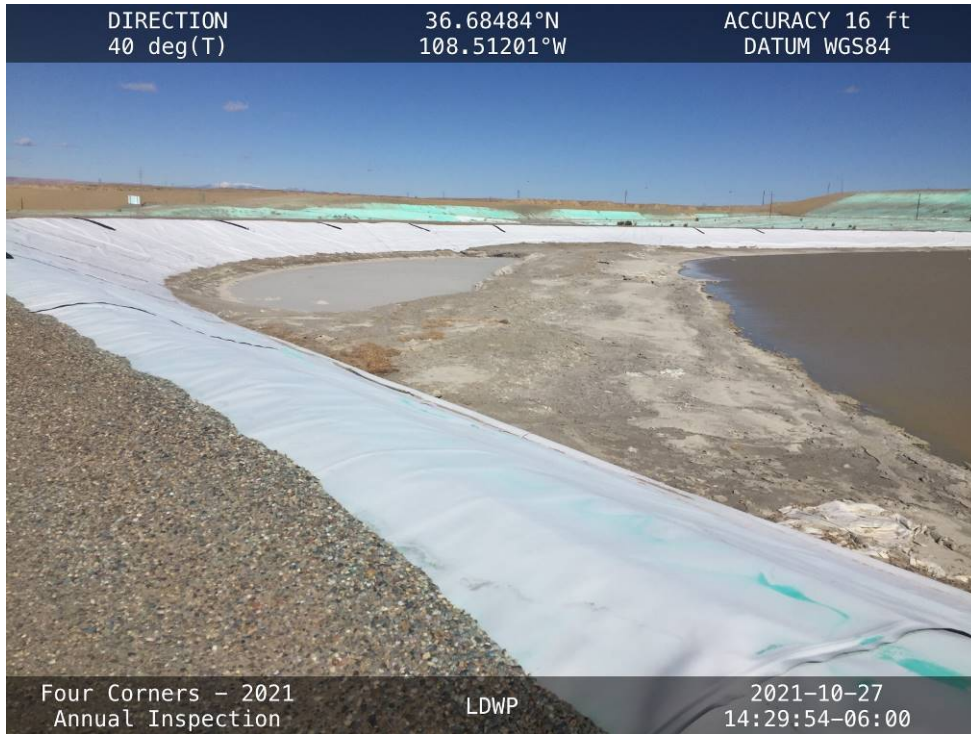
20211027-IMG_7954
The liner pulling out of the anchor trench in the northern portion of the West Embankment.

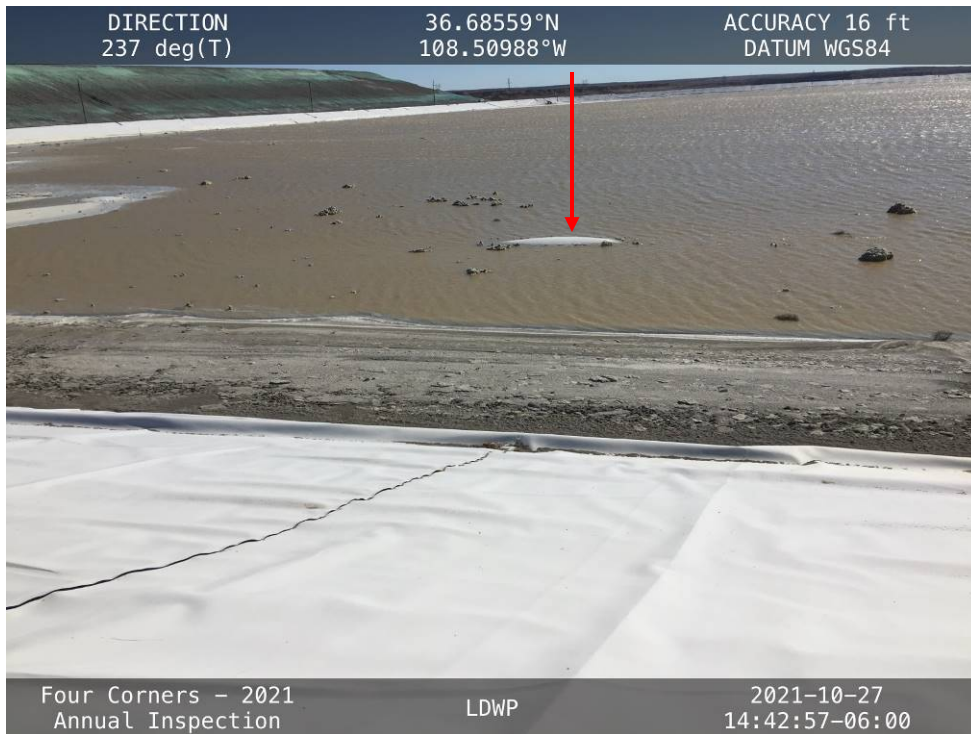
20211027 – IMG_7975

A hole in the liner along the North Embankment marked with a pin flag.
