**FOUR CORNERS POWER PLANT
Lined Ash Impoundment,
Lined Decant Water Pond,
Combined Waste Treatment Pond,
Dry Fly Ash Disposal Area,
and Return Water Pond**

**Annual
CCR Impoundment and
Landfill Inspection Report
2021**

**GENERATION ENGINEERING
Design Engineering
P.O. BOX 53999
PHOENIX, ARIZONA 85072**

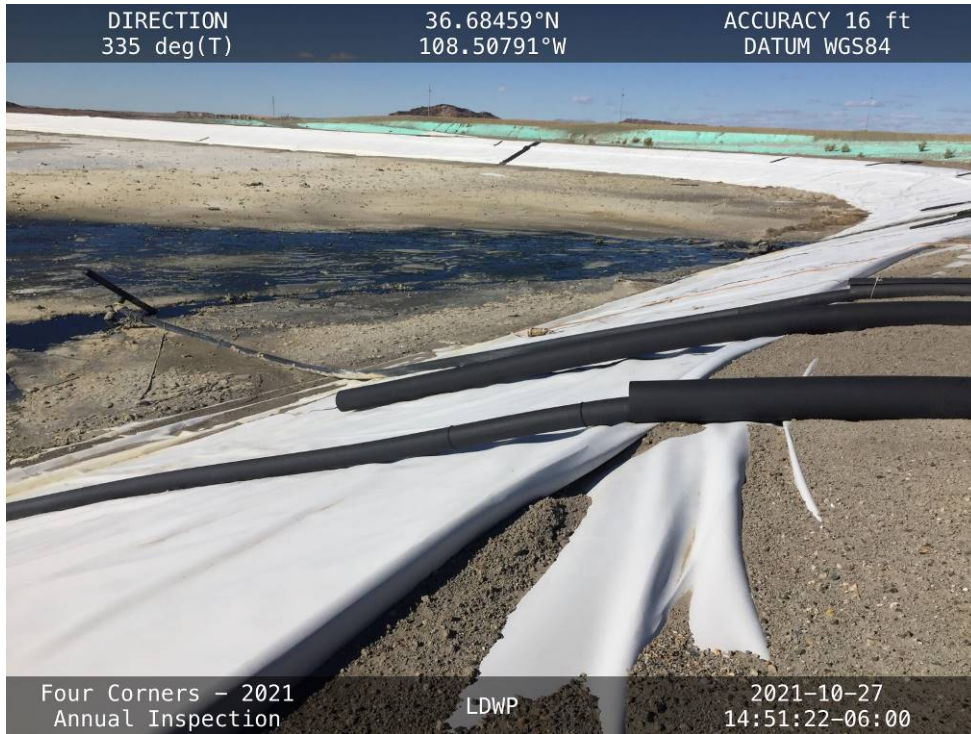
20211027-IMG_8001

Erosion on the crest near the suction intake lines in the northeast corner of the LDWP.

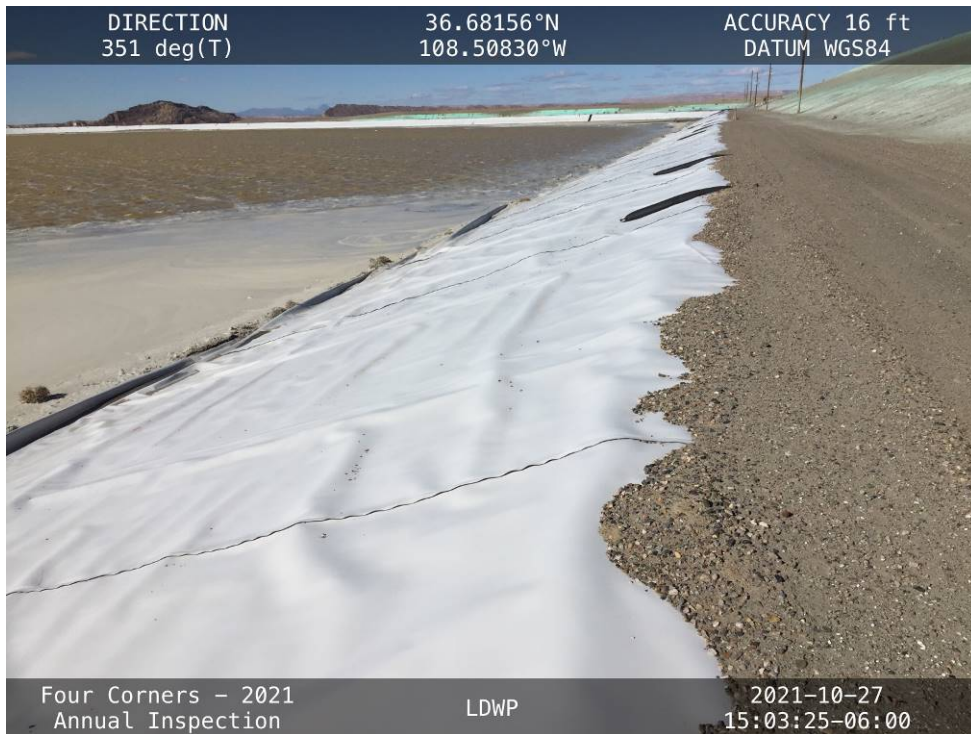
20211027-IMG_8009

Portions of the liner exposed in the anchor trench along the East Embankment crest.

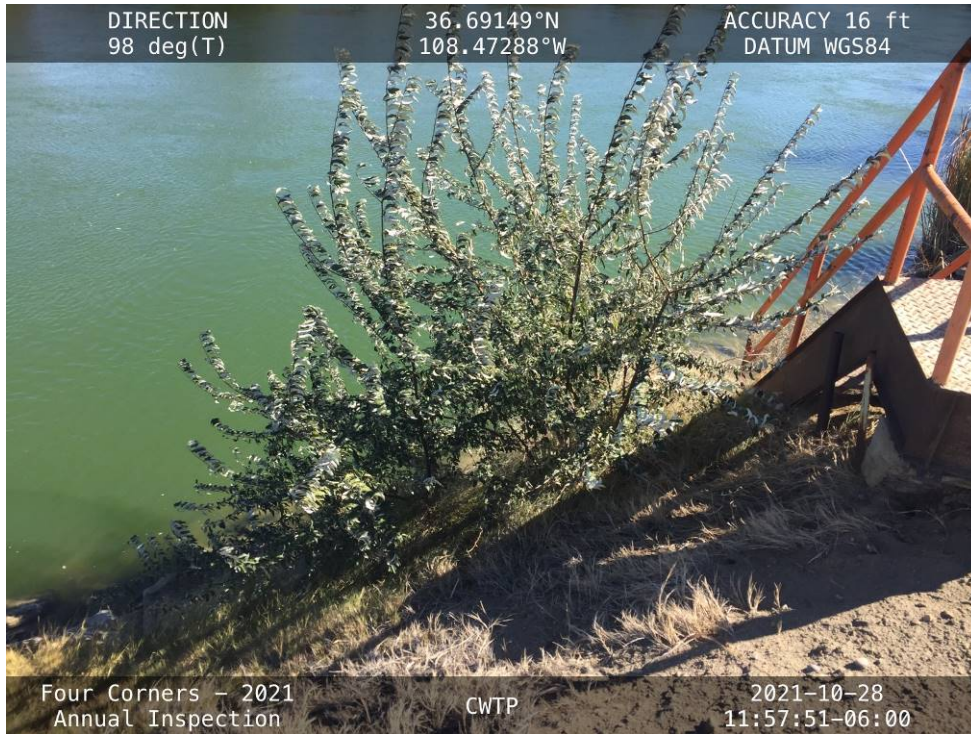
20211028-IMG_8336

Vegetation on the downstream slope at the Right Abutment.

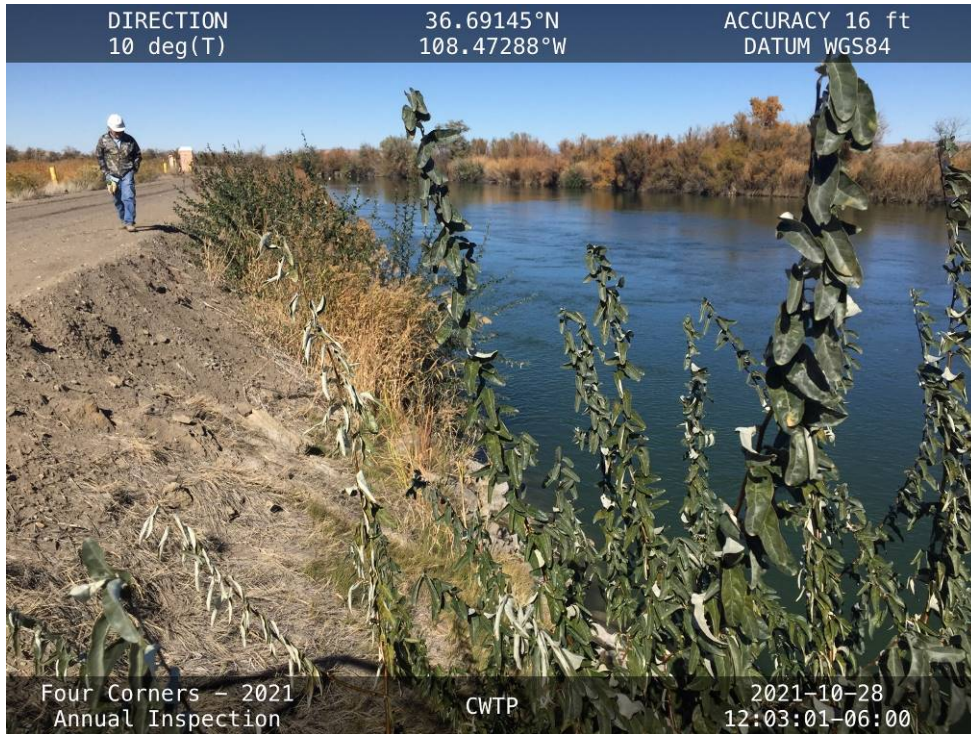
20211028-IMG_8352

The downstream slope along the eastern portion of the embankment, facing northwest.

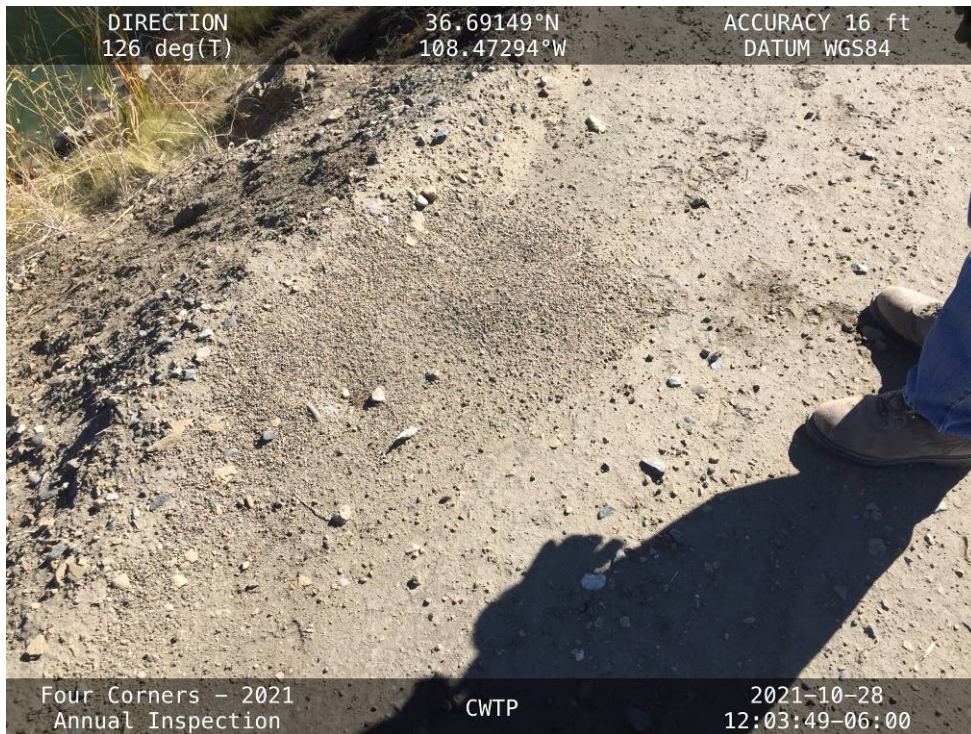
20211028-IMG_8353

An ant hill on the downstream shoulder of the embankment.

6) Ant hills were observed along the embankment crest and animals have been known to burrow in the area.	This is an ongoing maintenance requirement. Repair ant hills and animal burrows as needed.

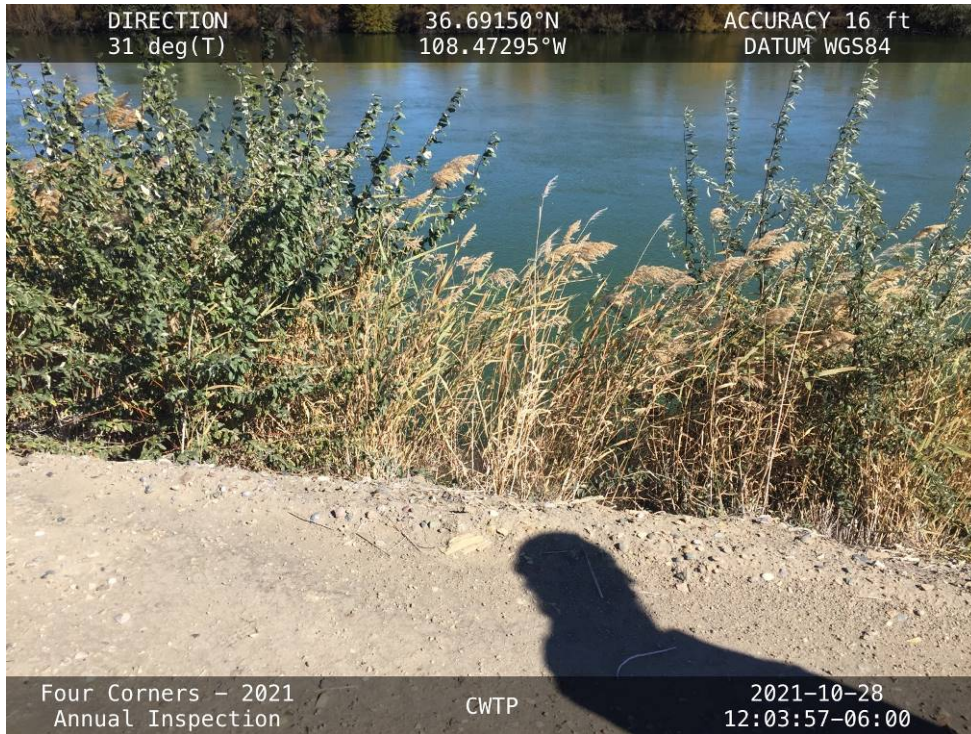
20211028-IMG_8354

Vegetation to be removed from the downstream slope of the East Embankment.

Action Item	Action Status
1) Vegetation (grass, small trees, and shrubs) was observed on portions of the upstream and downstream slopes during this inspection.	This is an ongoing maintenance requirement. The grasses should be cut and vegetation removal along the upstream and downstream slopes should be performed in accordance with the NMOSE vegetation maintenance guidelines “ <i>Vegetation Management on Dams</i> ” (2011) reference.

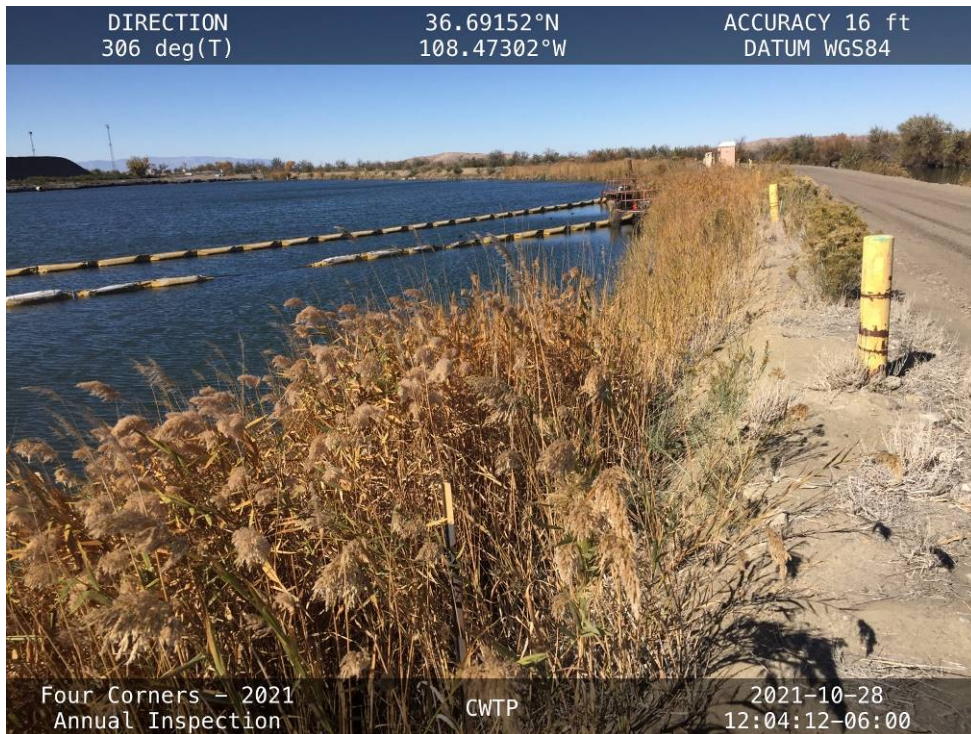
20211028-IMG_8356

The reservoir and vegetation along the upstream slope of the embankment, facing northwest.

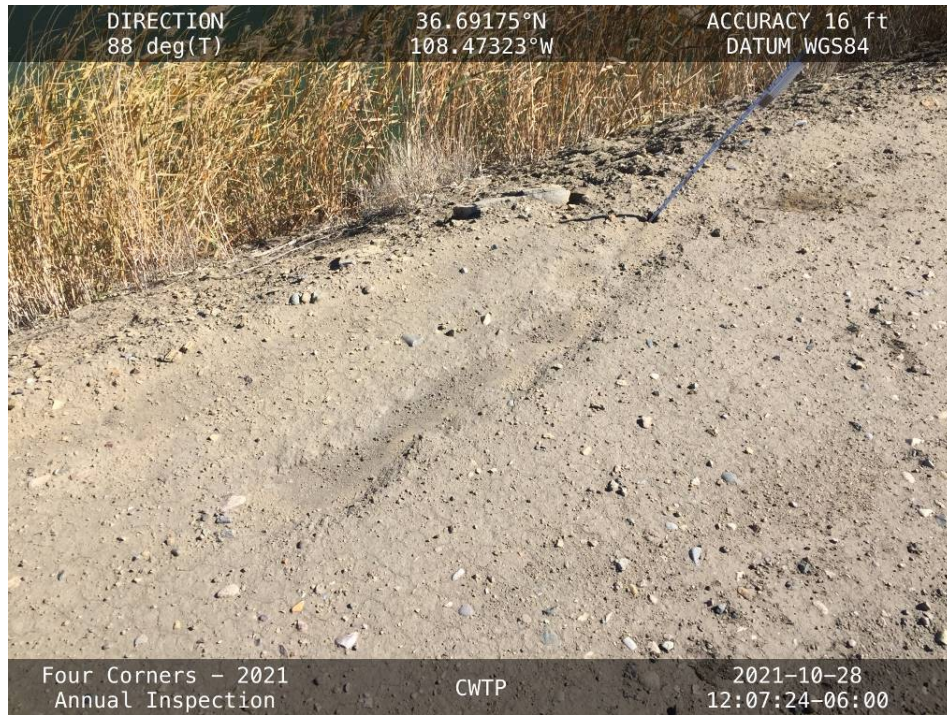
20211028 – IMG_8358

A zone of loose material on the upstream half of the crest also observed during the 2020 inspection (2020 Photo IMG_3273).

3) The soil along the upstream edge of the crest was observed to be loose and weak over a distance of approximately 4 feet near the longitudinal crack observed in 2020.	Investigate the cause of the weak soil and repair the crest.

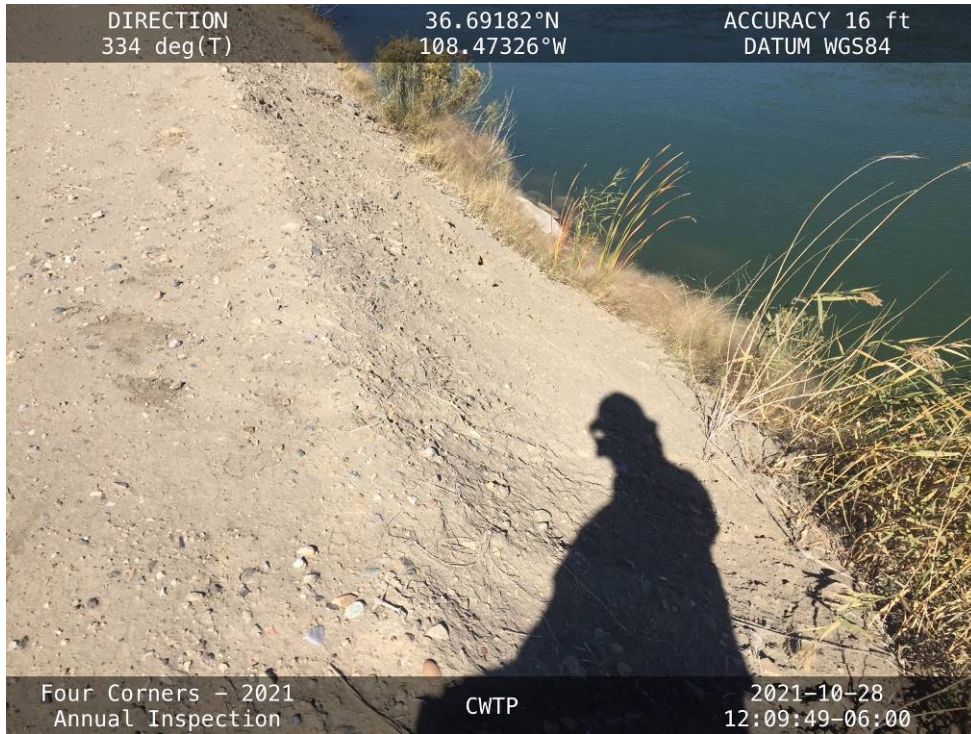
20211028-IMG_8361

IMG_8361 and IMG_8366: Location of the 11.5-foot long tension crack observed during the 2020 and 2018 inspections. Not observed during this inspection, but the ground appears to be less vegetated; the surficial material may have sloughed into the canal.

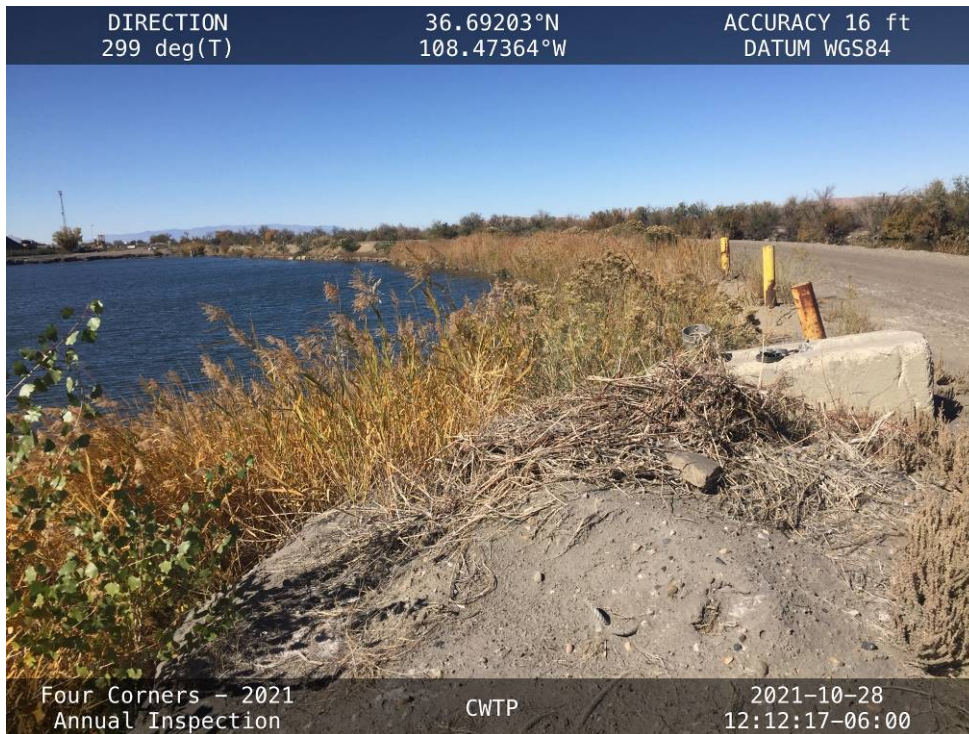
20211028-IMG_8376

The reservoir and vegetation along the upstream slope of the embankment, facing northwest.

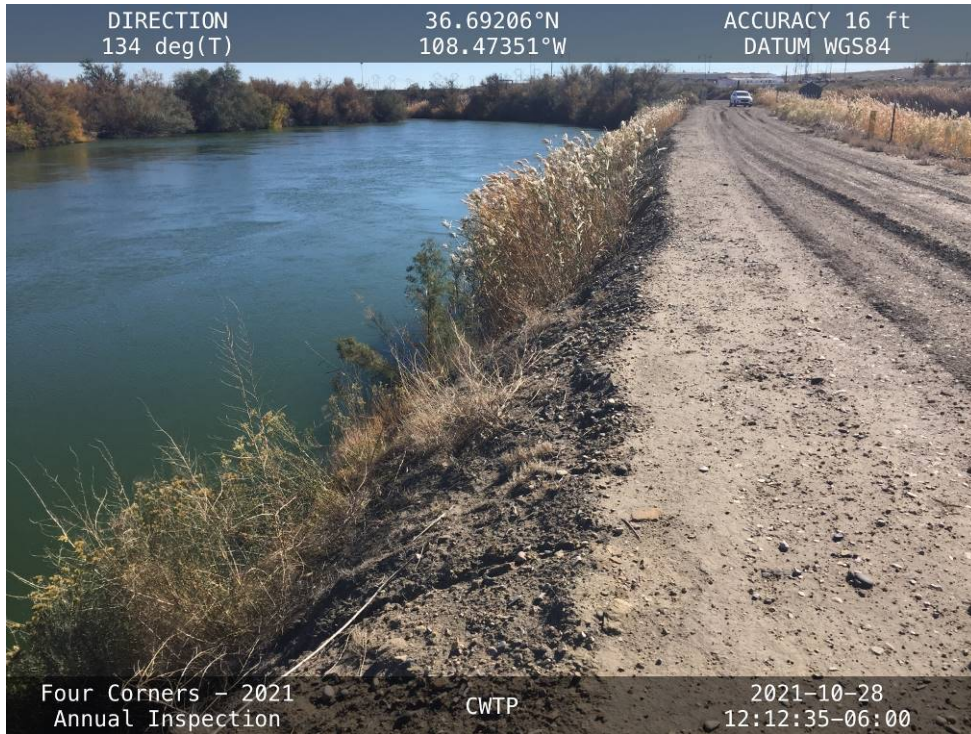
20211028-IMG_8378

The downstream slope along the eastern portion of the embankment, facing southeast.

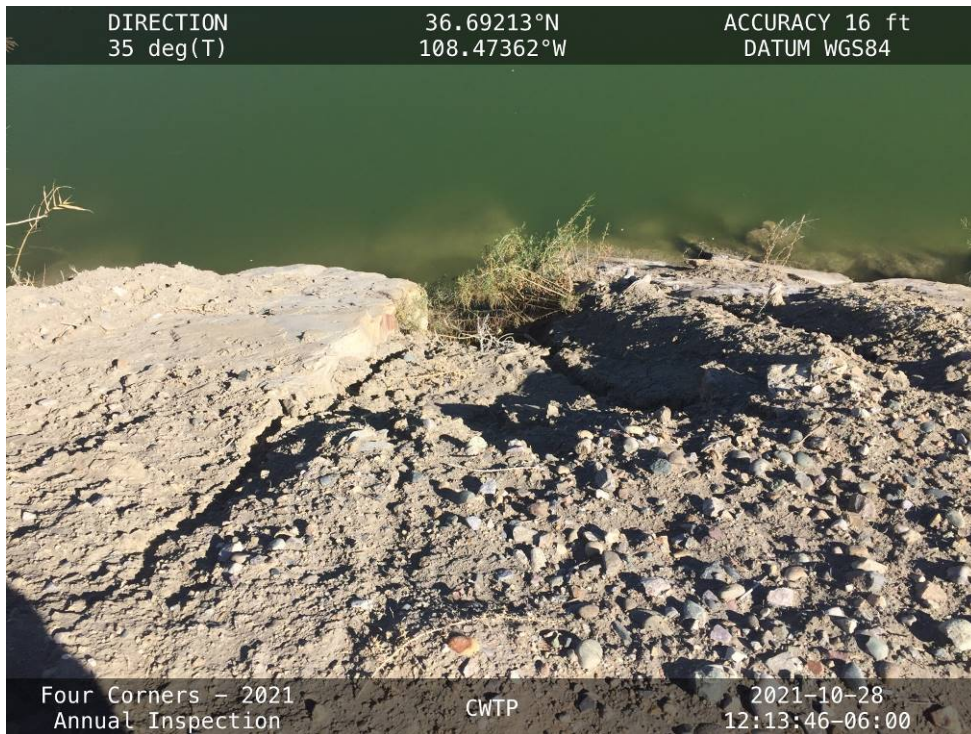
20211028-IMG_8383

Erosion in a portion of the downstream slope.

2) Instances of minor erosion were observed along the upstream and downstream slopes.	Continue to monitor these areas and repair erosion if it exceeds 1 foot in depth.

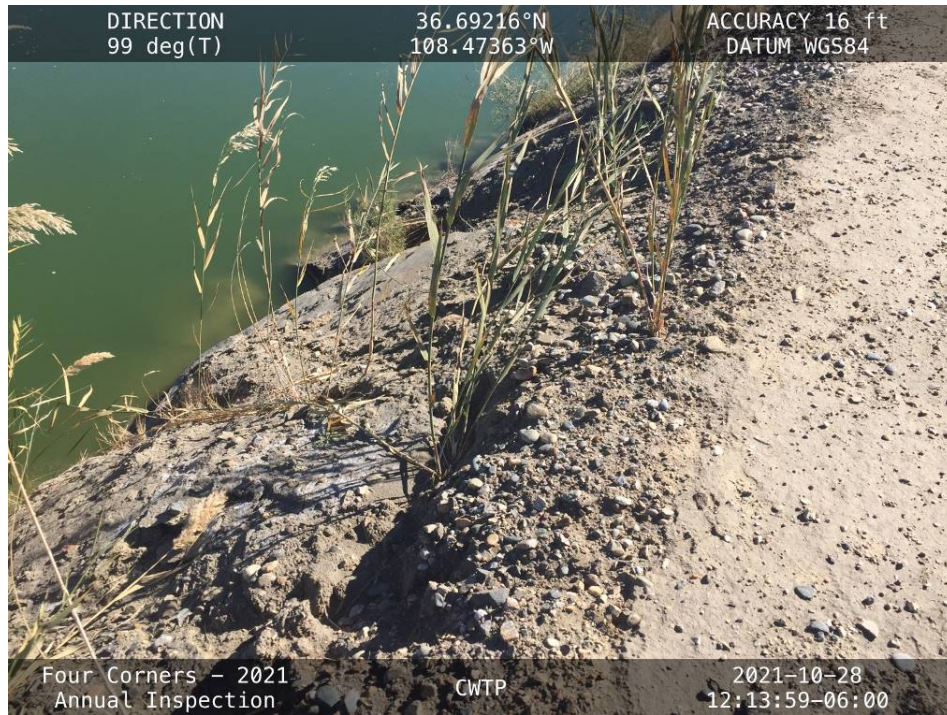
20211028 – IMG_8386

Vegetation growing where a riprap boulder is separating from the rest of the slope (2020 Photo IMG_3258).

4) A 6-foot long longitudinal crack was observed on the downstream slope where a piece of riprap is separating from the soil.	Repair the crack to prevent the riprap from sliding down the slope.

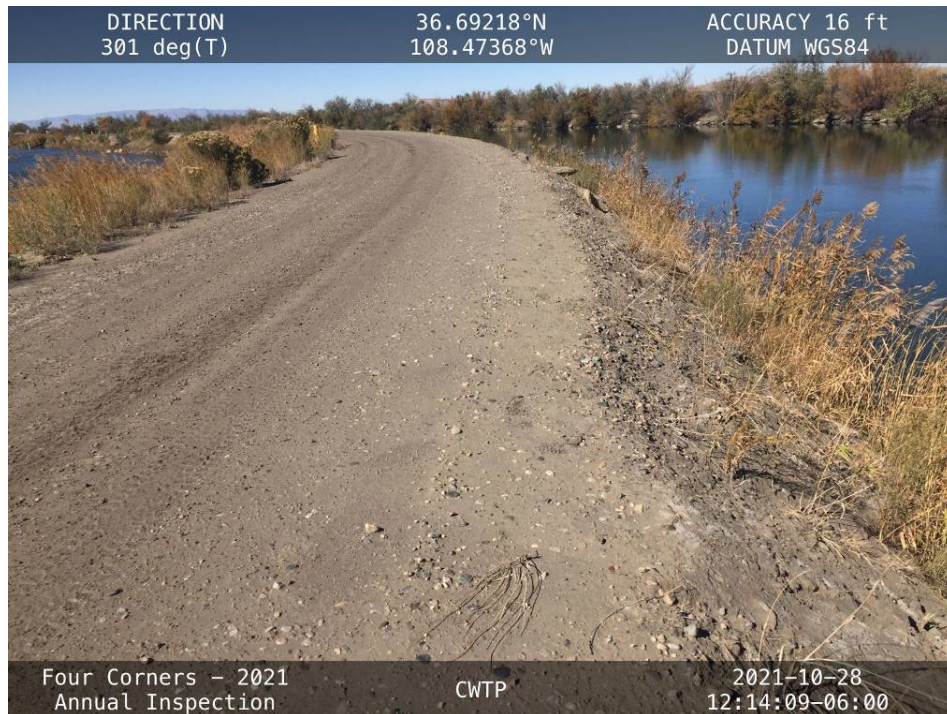
20211028 – IMG_8388

The crest along the eastern portion of the embankment, facing northwest.

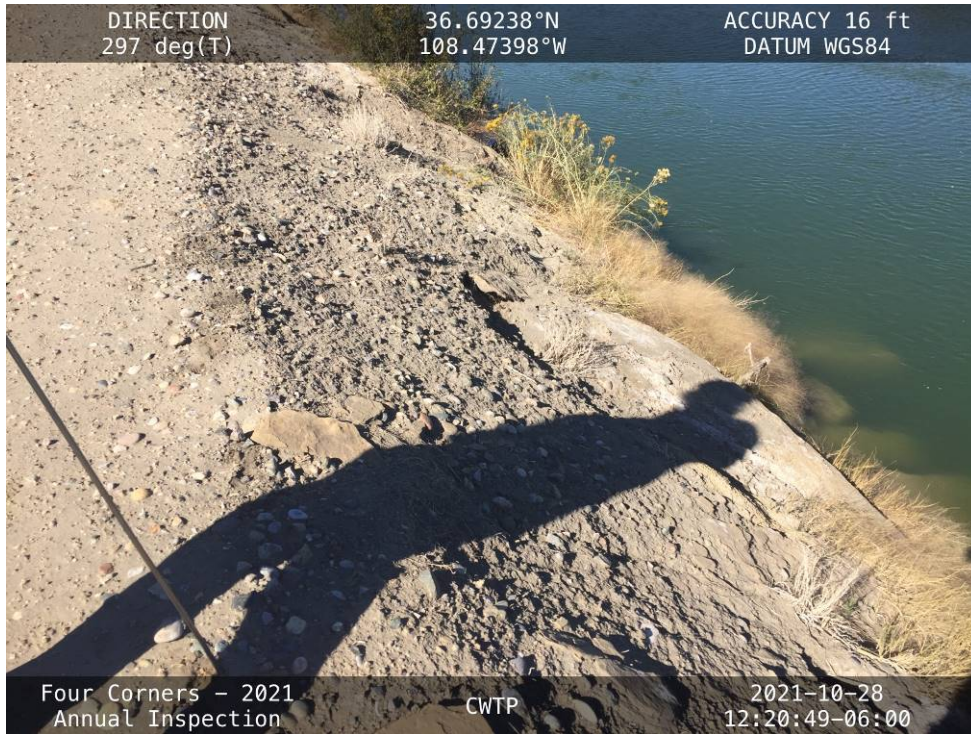
20211028-IMG_8397

A riprap boulder separating from the rest of the downstream slope.

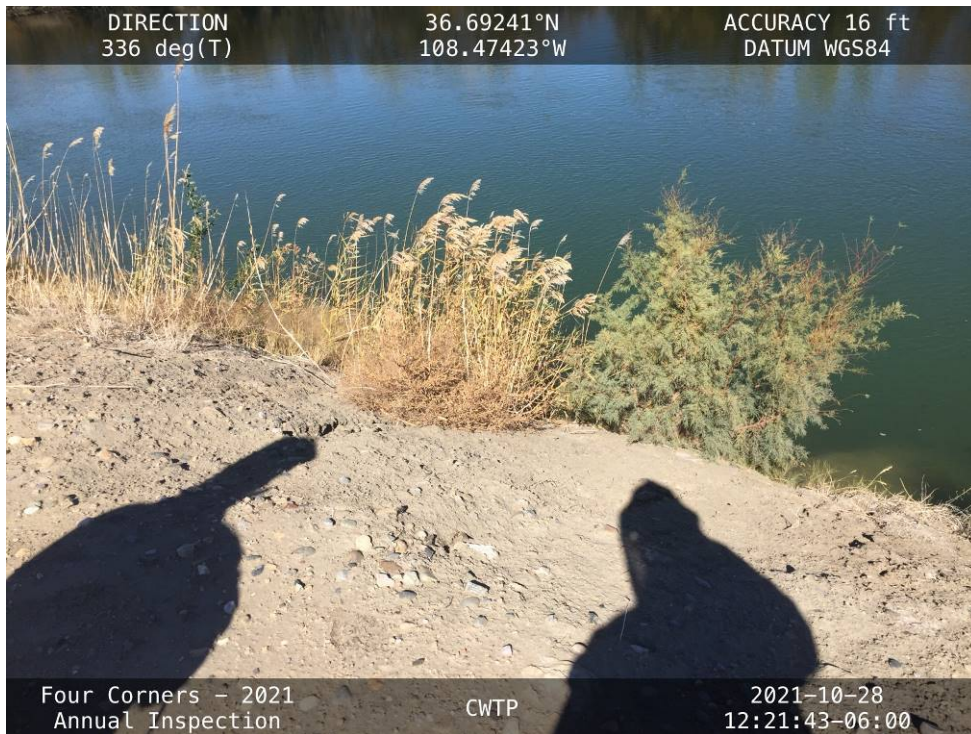
20211028-IMG_8401

Vegetation to be removed from the downstream slope near the curved section of the CWTP.

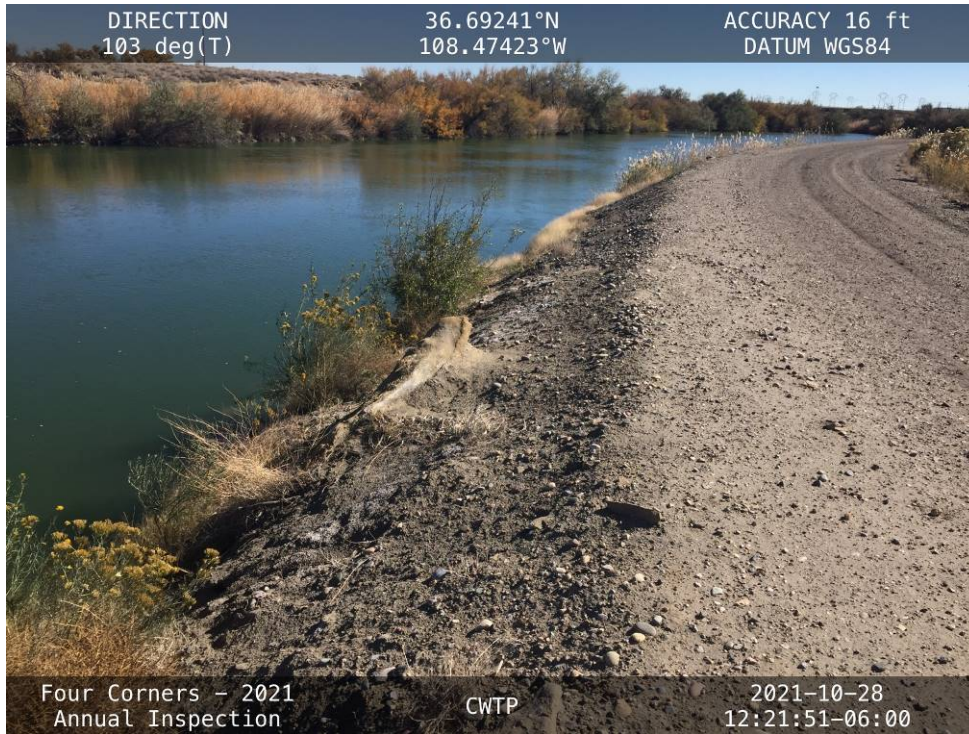
20211028-IMG_8402

The downstream slope along the northern portion of the embankment, facing east.

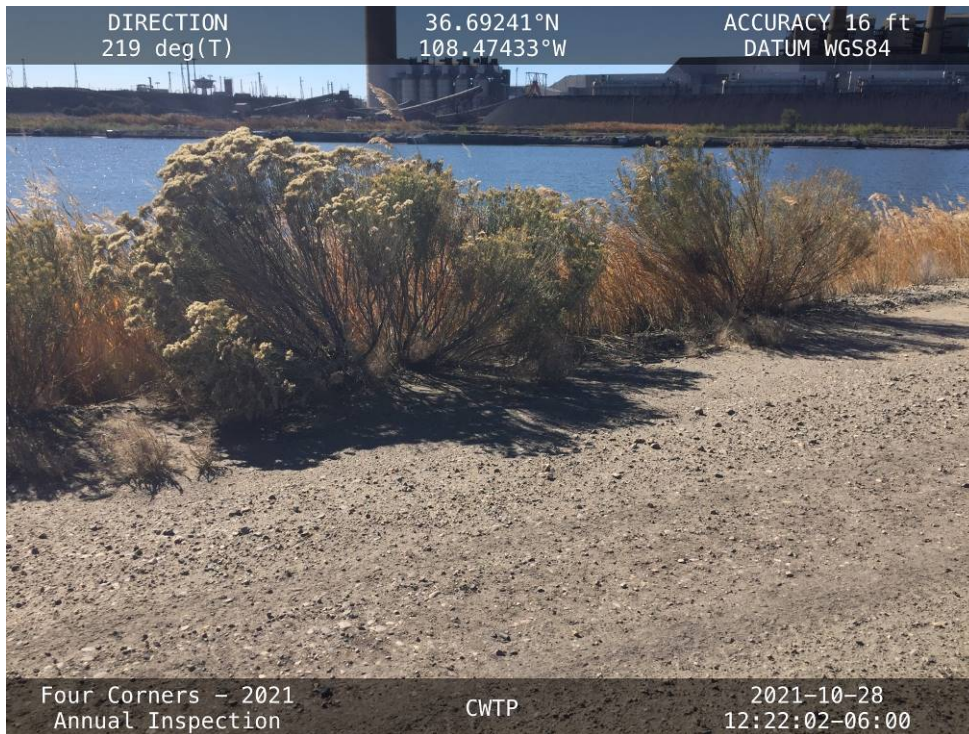
20211028-IMG_8403

Vegetation to be removed from the upstream slope of the North Embankment.

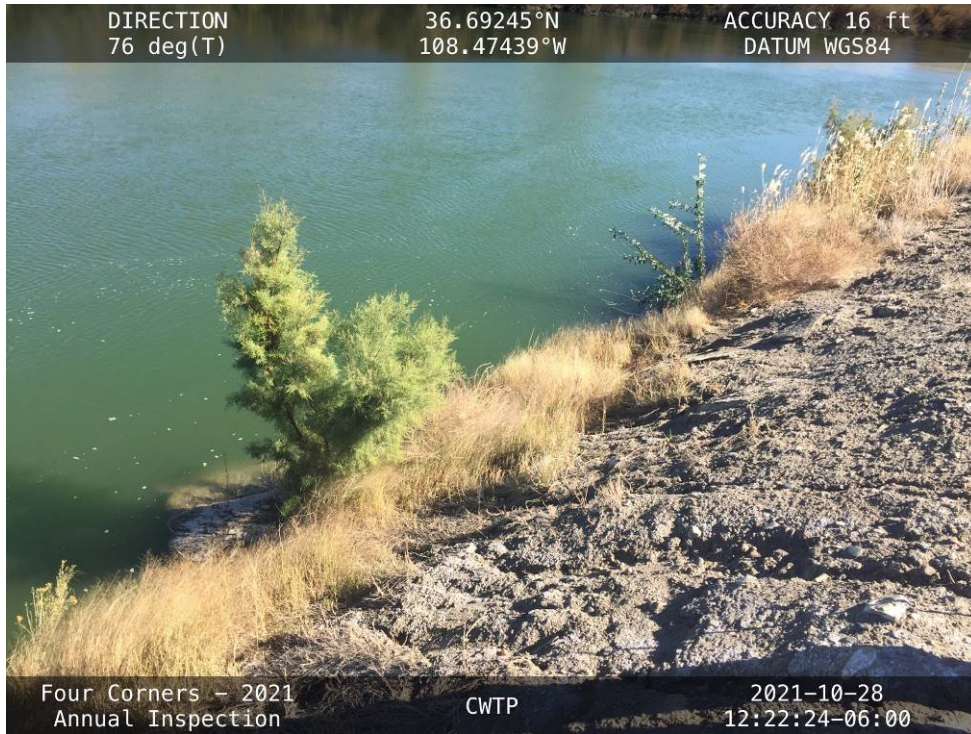
20211028-IMG_8406

Vegetation to be removed from the downstream slope of the North Embankment.

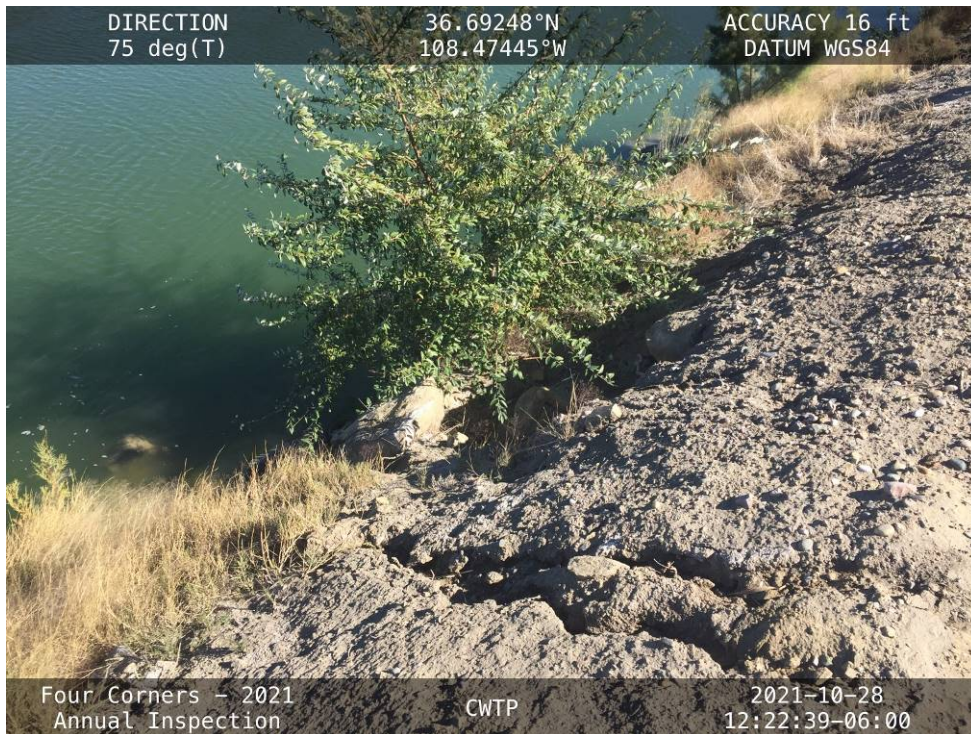
20211028-IMG_8407

Vegetation to be removed from the downstream slope, with rills forming in the foreground.

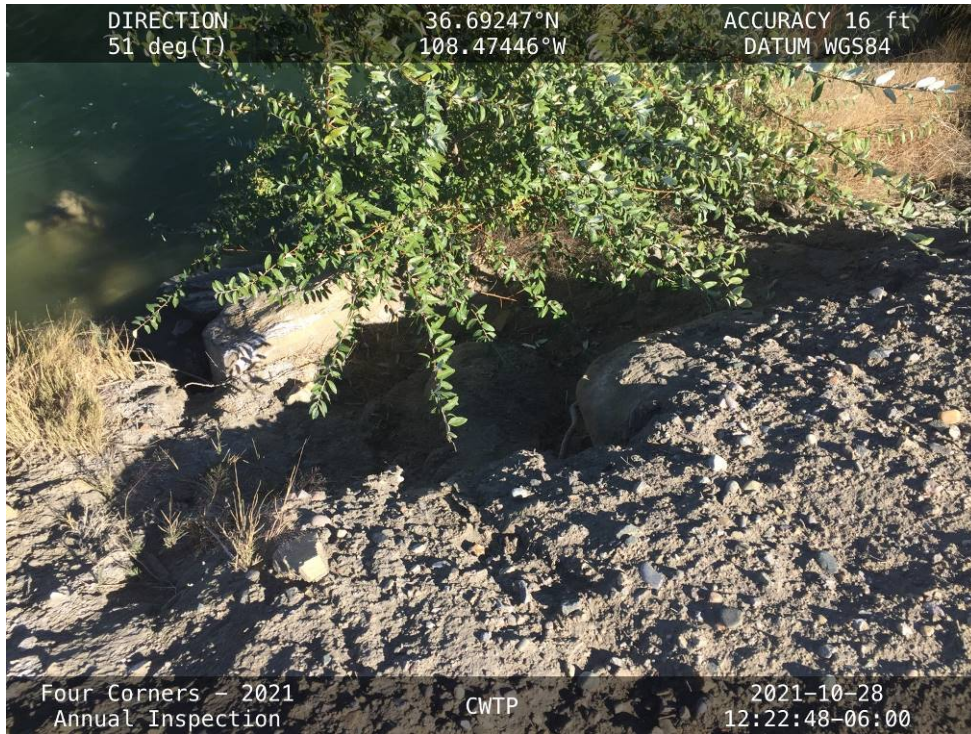
20211028-IMG_8409

Erosion around vegetation to be removed from the downstream slope of the North Embankment.

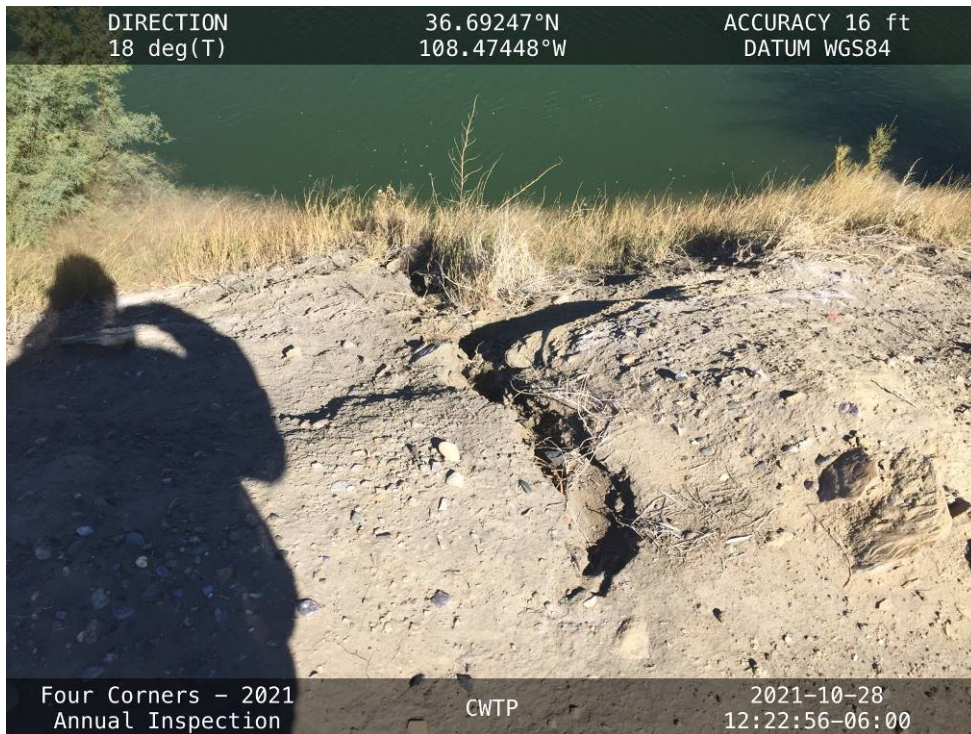
20211028-IMG_8410

An erosion rill forming on the downstream slope of the North Embankment.

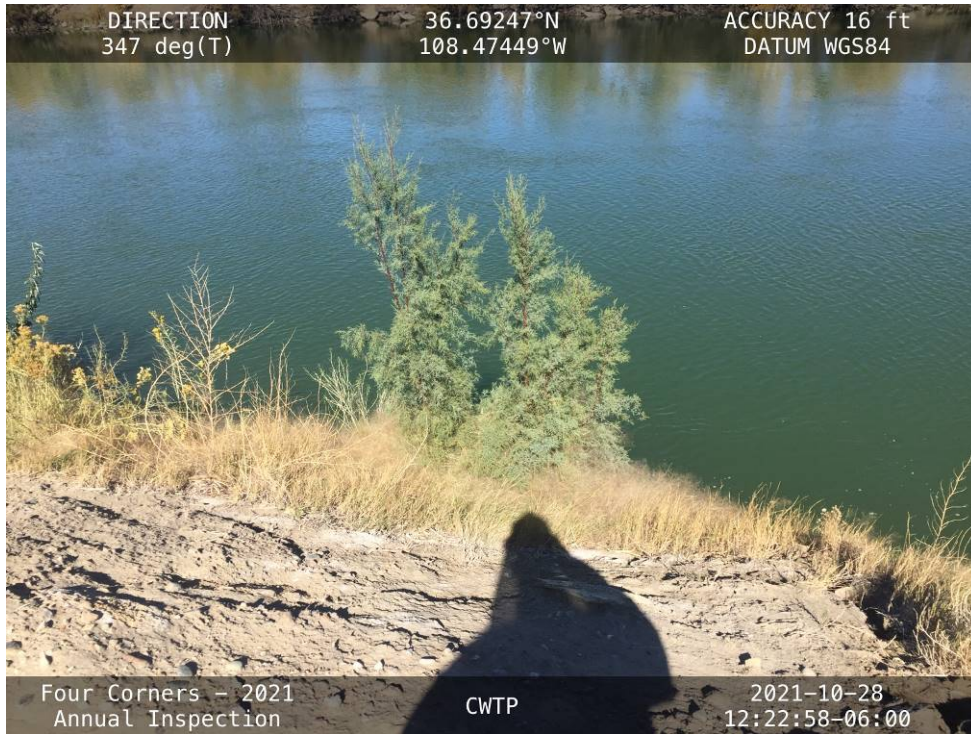
20211028-IMG_8411

Vegetation to be removed from the downstream slope of the North Embankment.

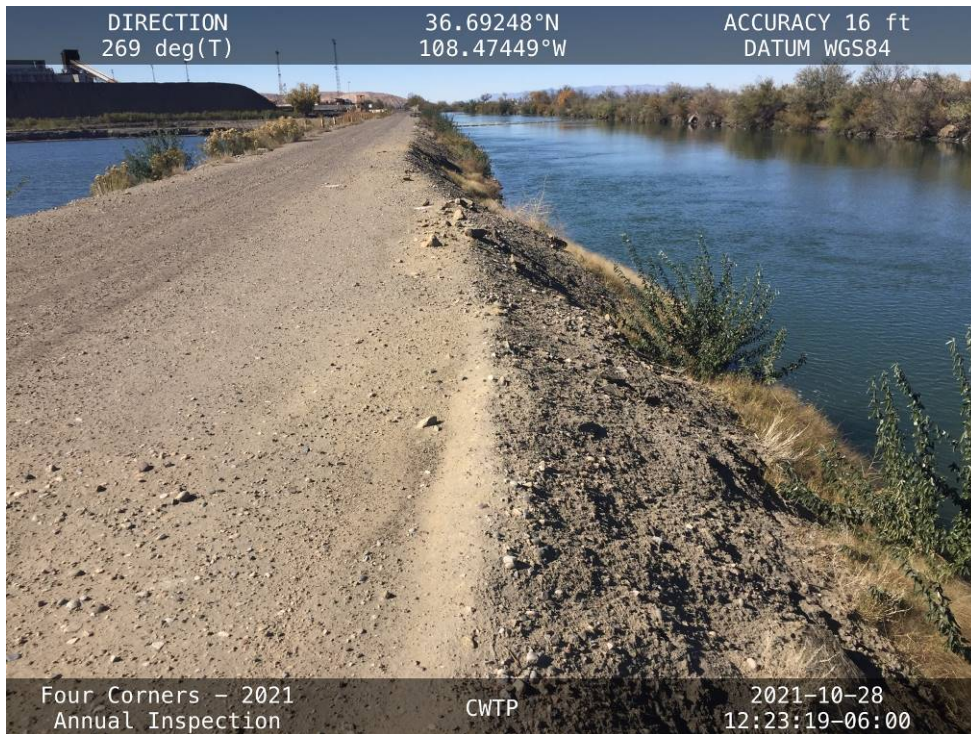
20211028-IMG_8413

The downstream slope along the North Embankment, facing west.

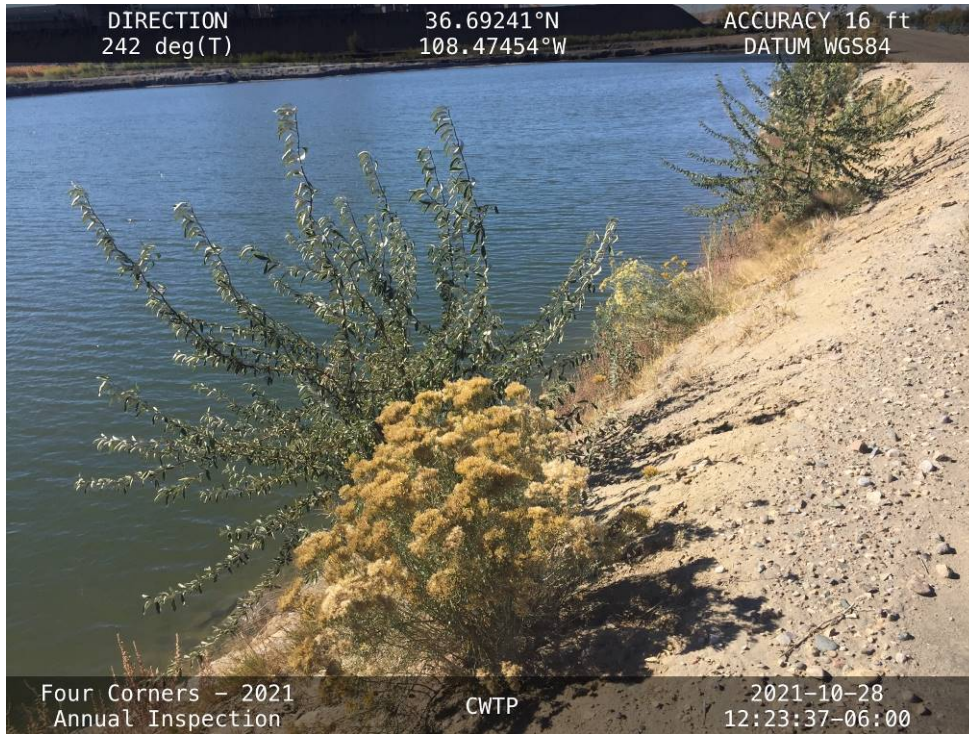
20211028-IMG_8414

Vegetation to be removed from the upstream slope of the North Embankment.

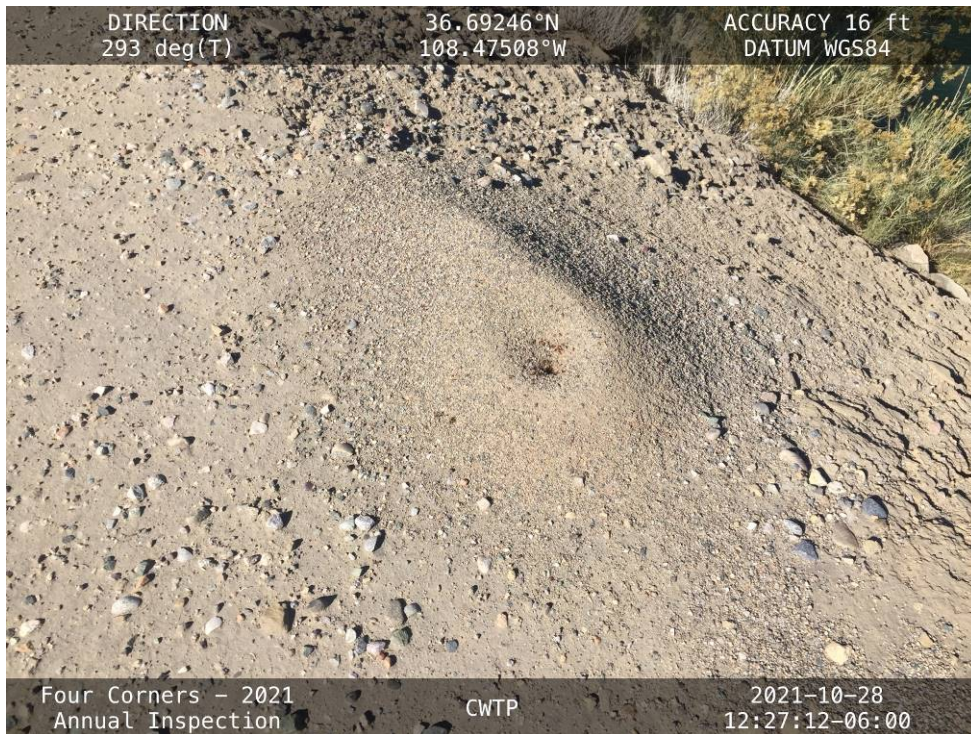
20211028-IMG_8431

An ant hill on the downstream shoulder of the embankment.

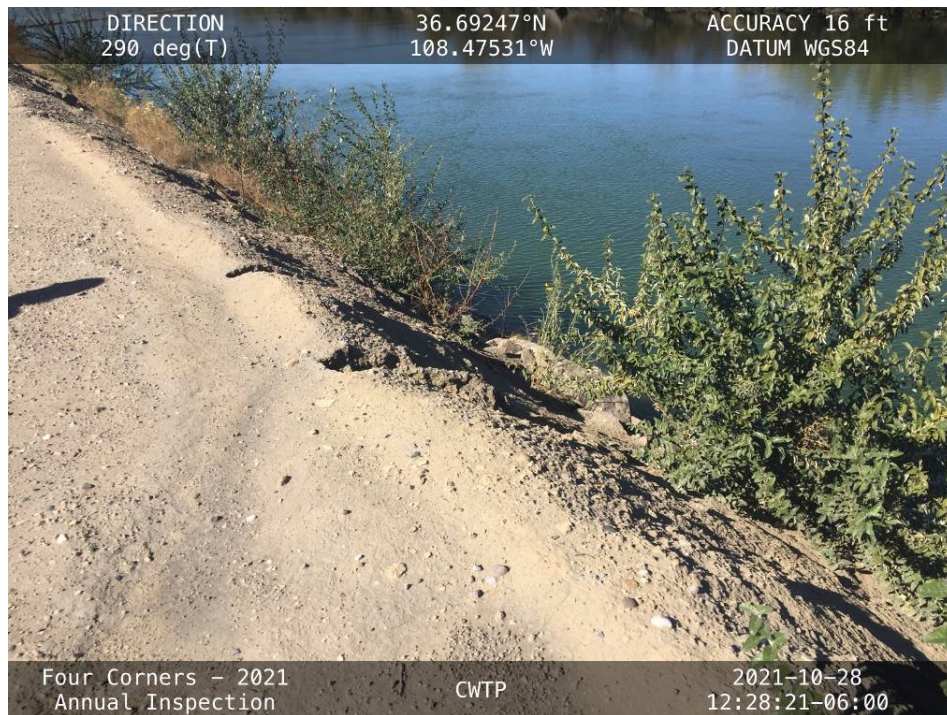
20211028-IMG_8439

Incipient erosion rills and vegetation to be removed from the downstream slope of the North Embankment.

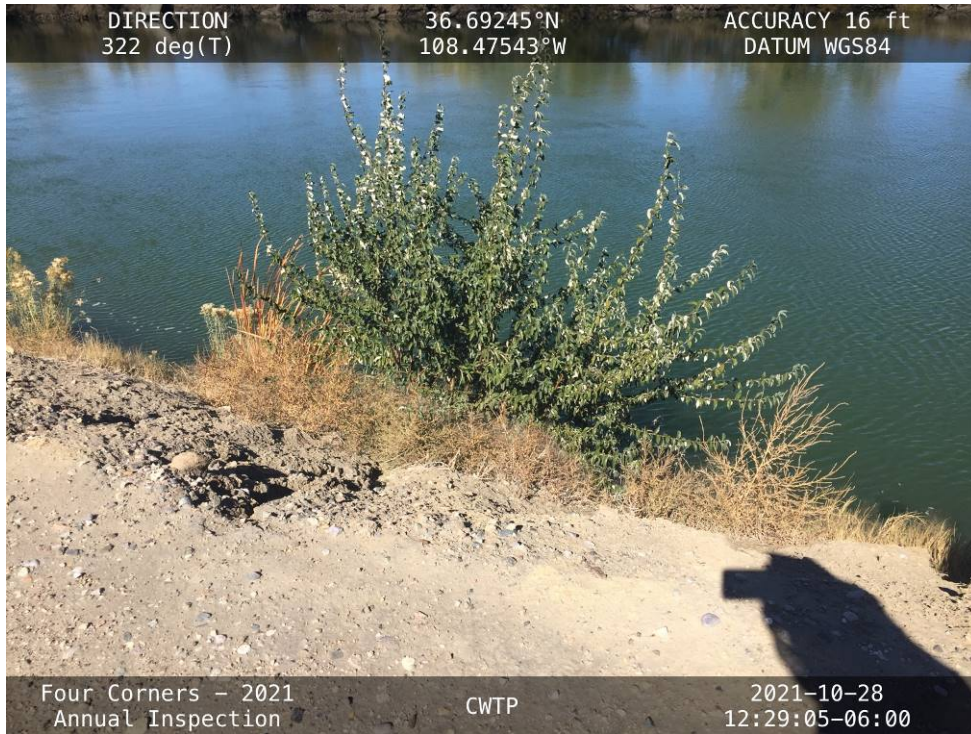
20211028-IMG_8440

Vegetation to be removed from the downstream slope of the North Embankment.

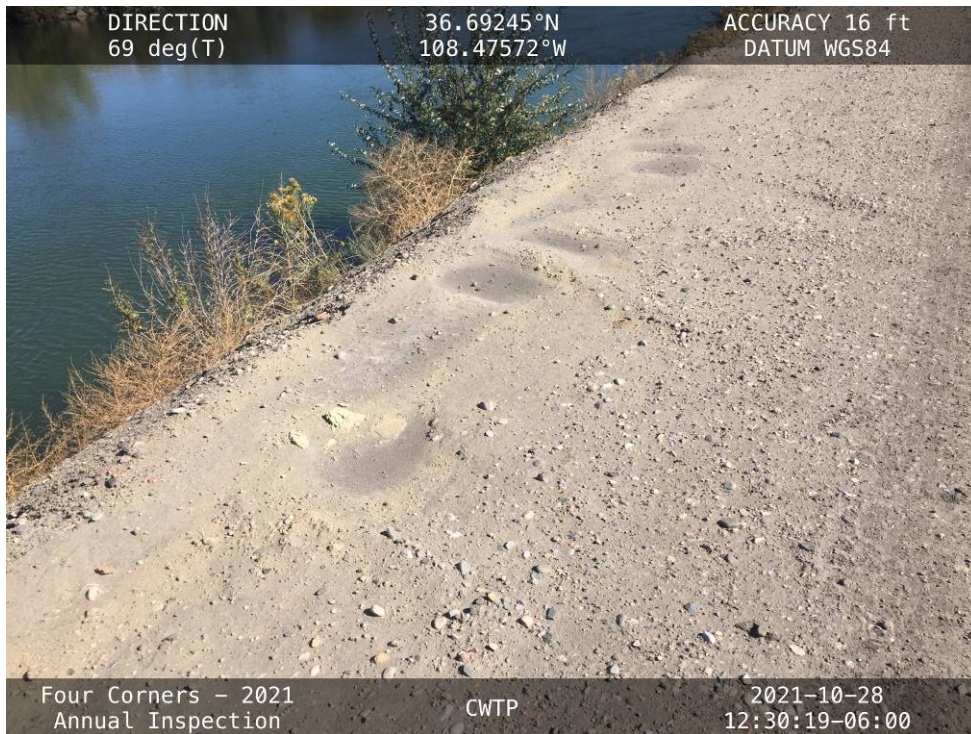
20211028-IMG_8448

Shallow depressions on the downstream shoulder of the North Embankment.

8) A set of shallow depressions was observed on the downstream shoulder of the North Embankment near the 18-inch pipe that transfers water from the canal to the CWTP.	Monitor the depressions and repair them if they are observed to expand.

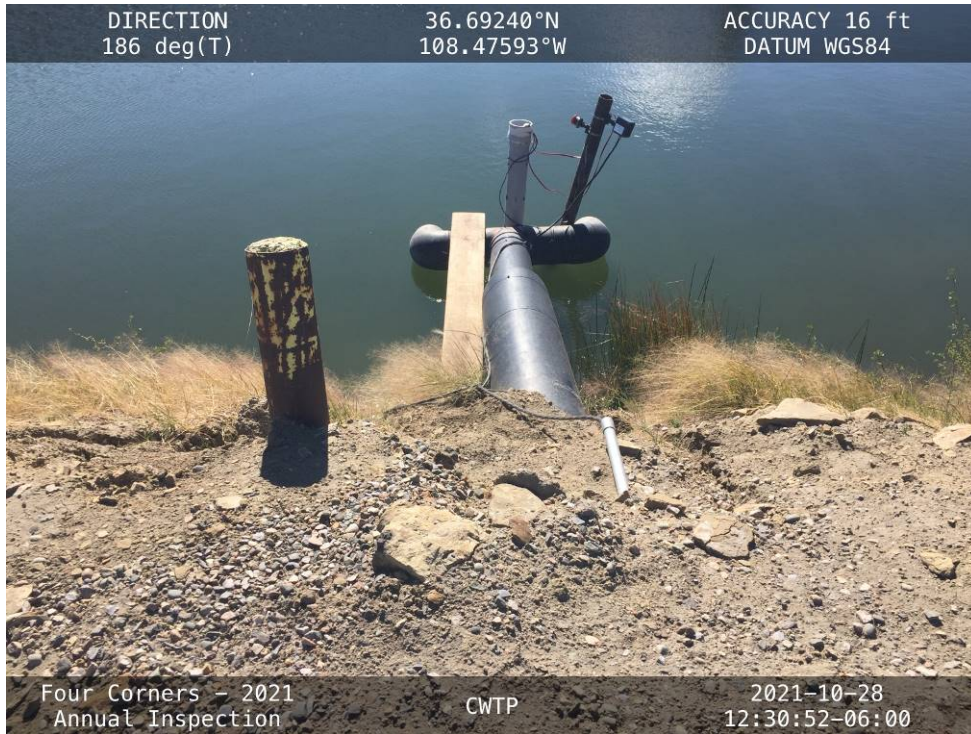
20211028-IMG_8454

The 18-inch pipe that transfers water from the canal to the CWTP and the water level transducer.

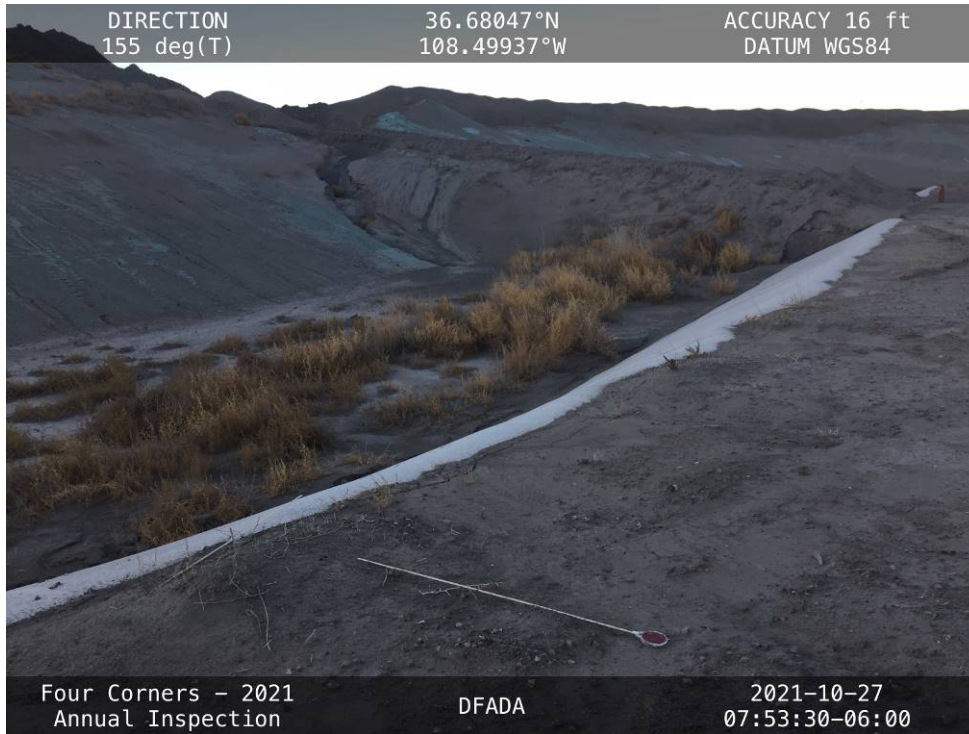
20211027-IMG_7478

An erosion gully in the groin of the access ramp to Cell 2, facing south from the north side.
