**FOUR CORNERS POWER PLANT
Lined Ash Impoundment,
Lined Decant Water Pond,
Combined Waste Treatment Pond,
Dry Fly Ash Disposal Area,
and Return Water Pond**

**Annual
CCR Impoundment and
Landfill Inspection Report
2021**

**GENERATION ENGINEERING
Design Engineering
P.O. BOX 53999
PHOENIX, ARIZONA 85072**

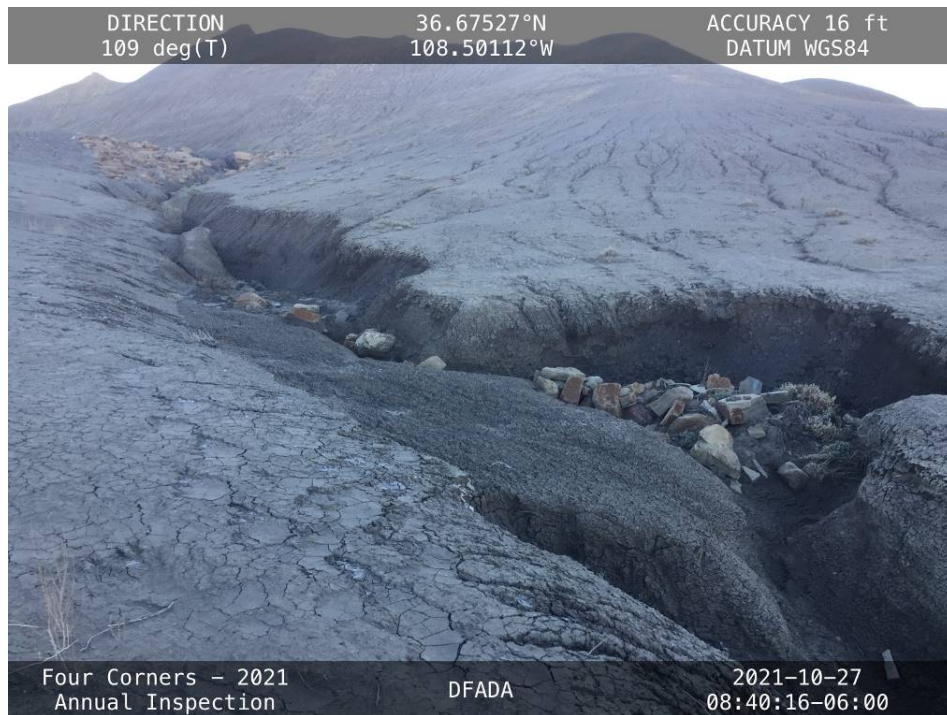
20211027 – IMG_7533

An erosion gully where the Stormwater Diversion Channel previously terminated, immediately upstream of the section lined with cement-treated base.

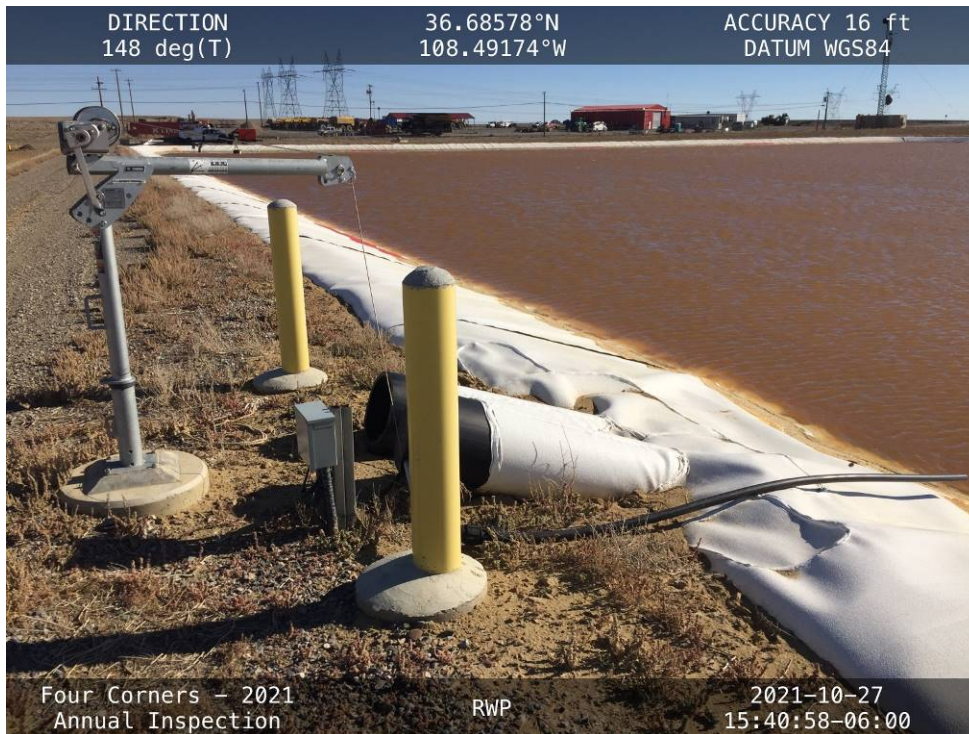
20211027-IMG_8034

The LCRS pump control for RWP Pump 004 on the north side of the RWP.

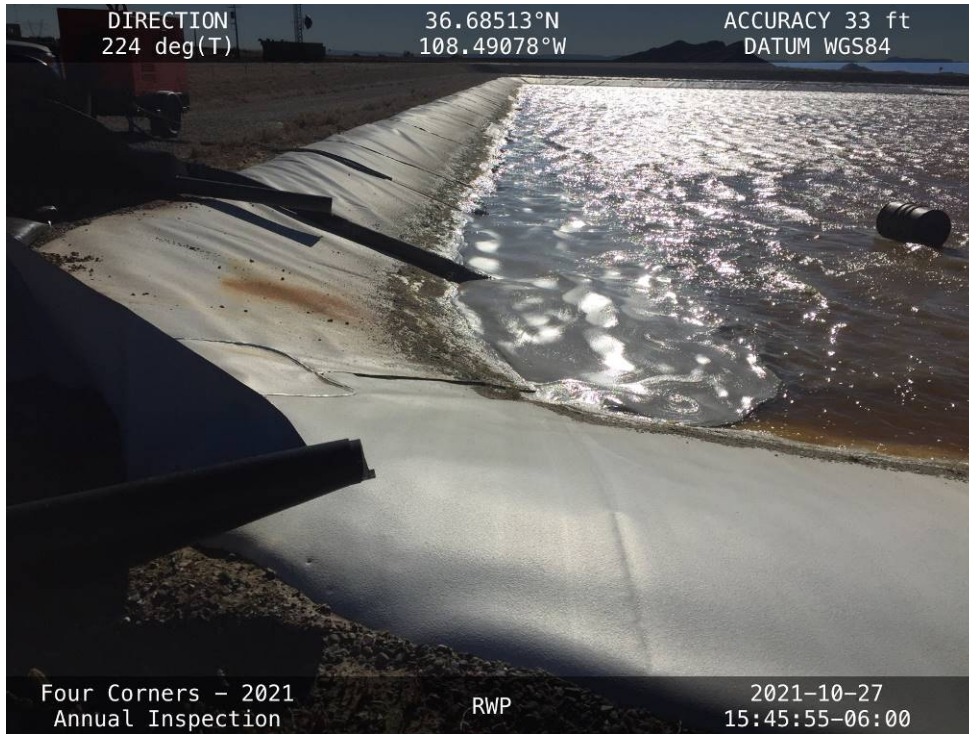
20211027-IMG_8040

3) The liner was observed to be pulling out of the anchor trench along the Northeast Embankment.	Monitor this area and repair the liner/trench if pullout begins to affect the embankment or the structural integrity of the CCR unit.

The liner pulling out of the anchor trench along the Northeast Embankment.

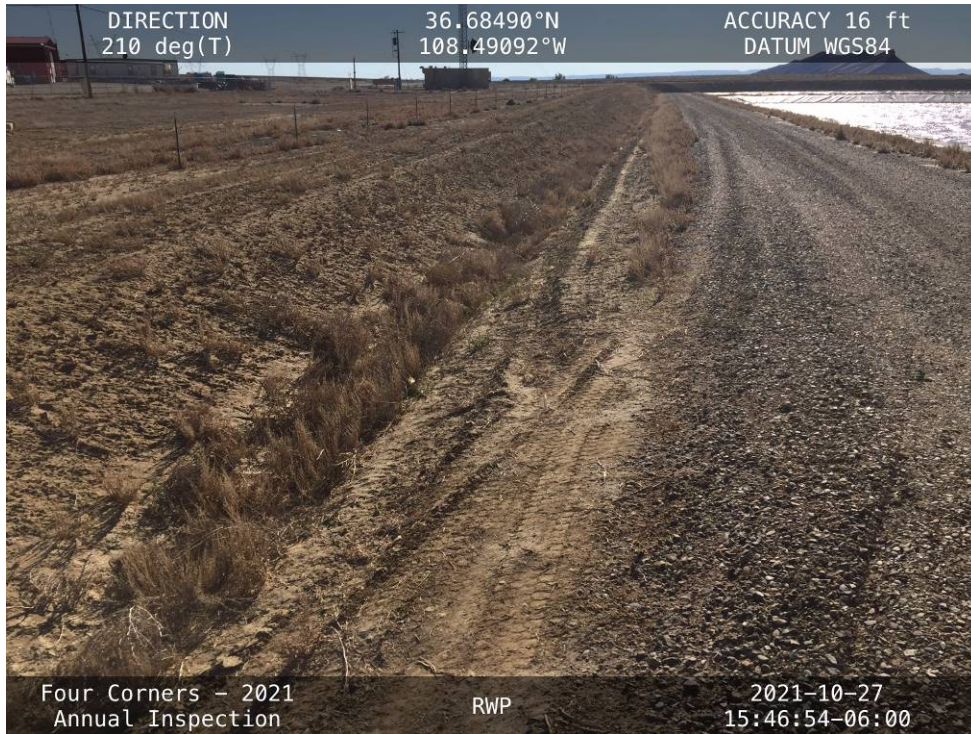
20211027-IMG_8047

The crest of the Southeast Embankment, facing southwest from the northeast corner.

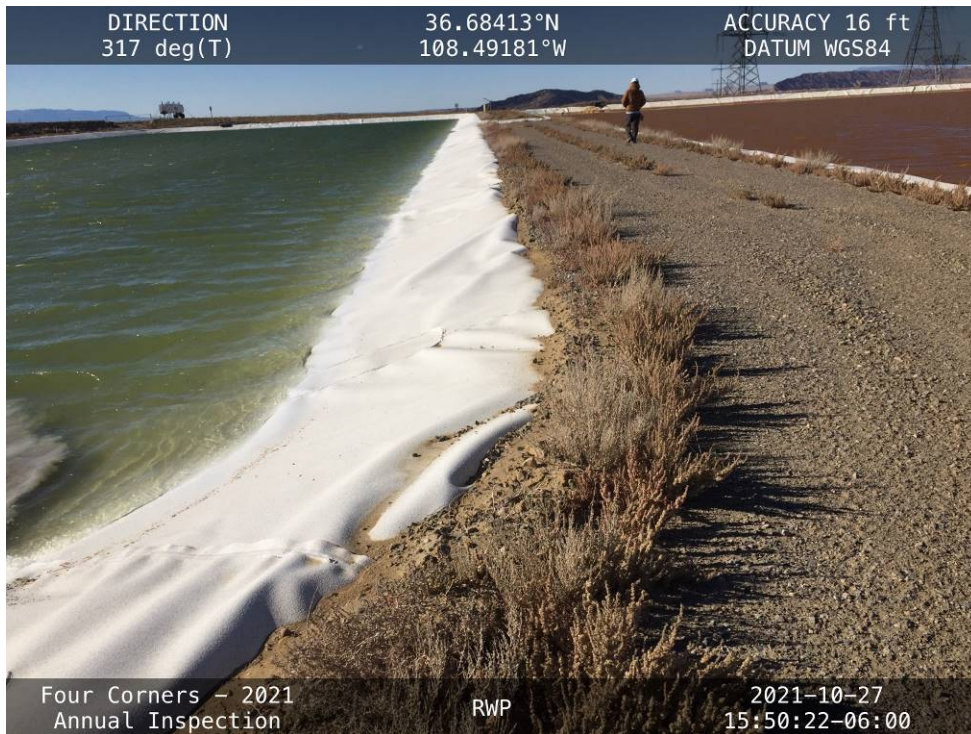
20211027-IMG_8056

The crest of the FGD Pond cell Internal Embankment, facing northwest.

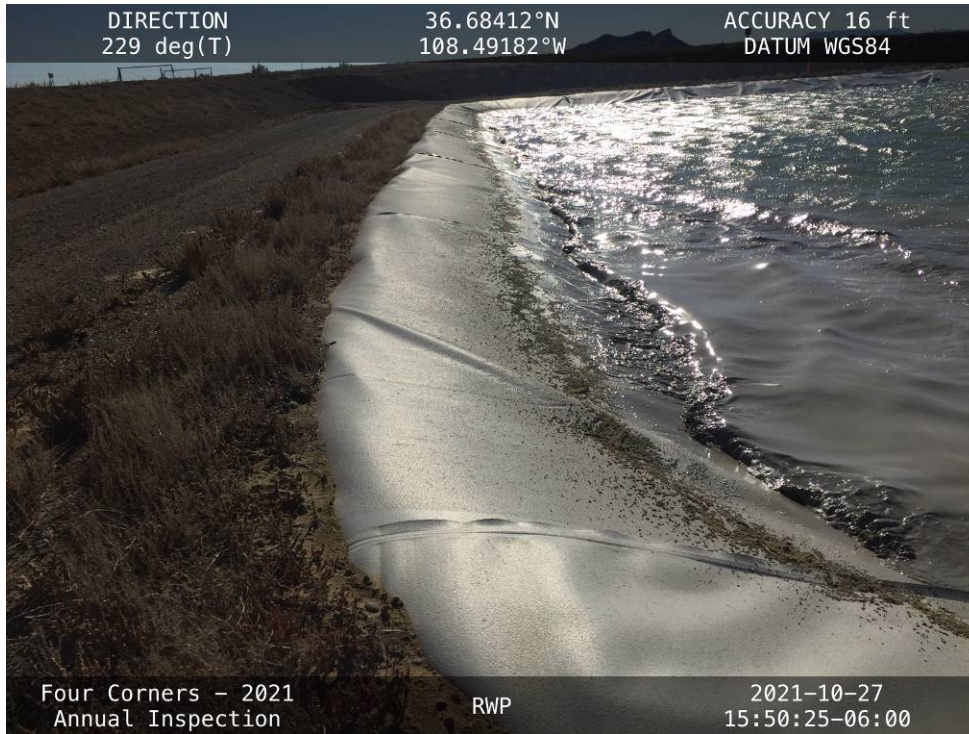
20211027-IMG_8057

The upstream slope of the FGD Pond cell Internal Embankment, facing northwest.

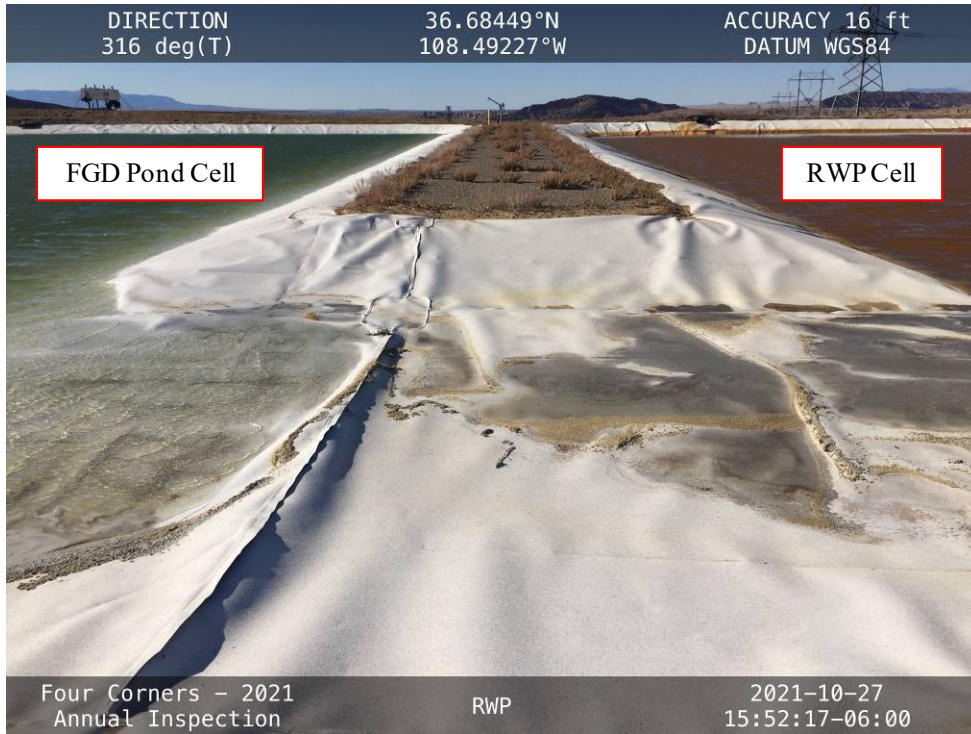
20211027-IMG_8059

The crest of the FGD Pond cell Southeast Embankment, facing southwest.

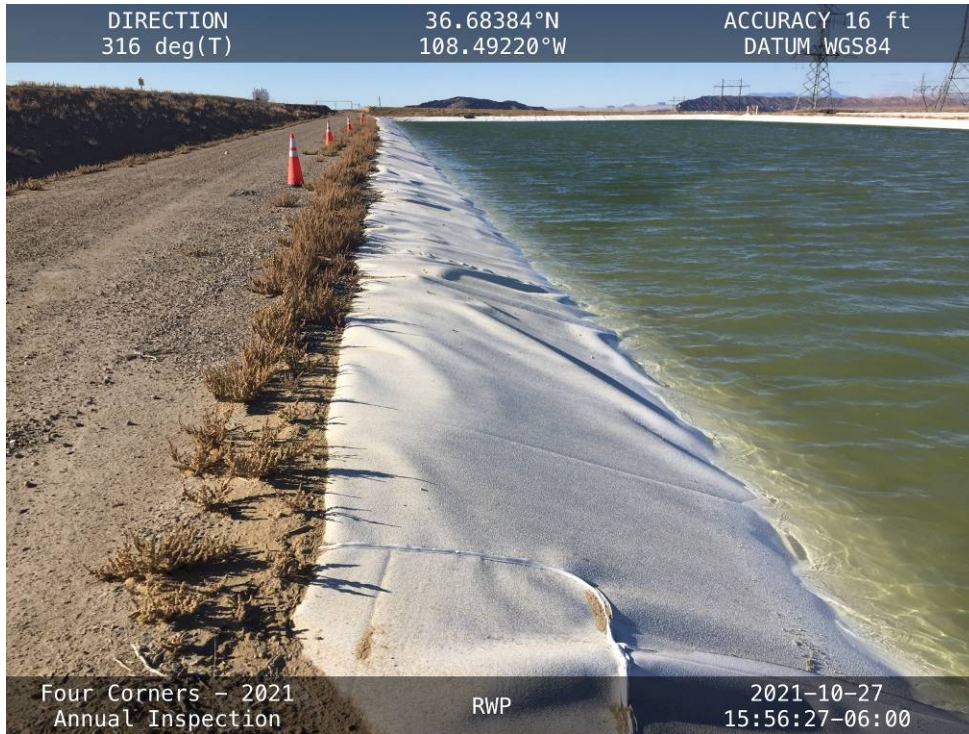
20211027 – IMG_8075

The crest of the FGD Pond cell South Embankment, facing northwest.

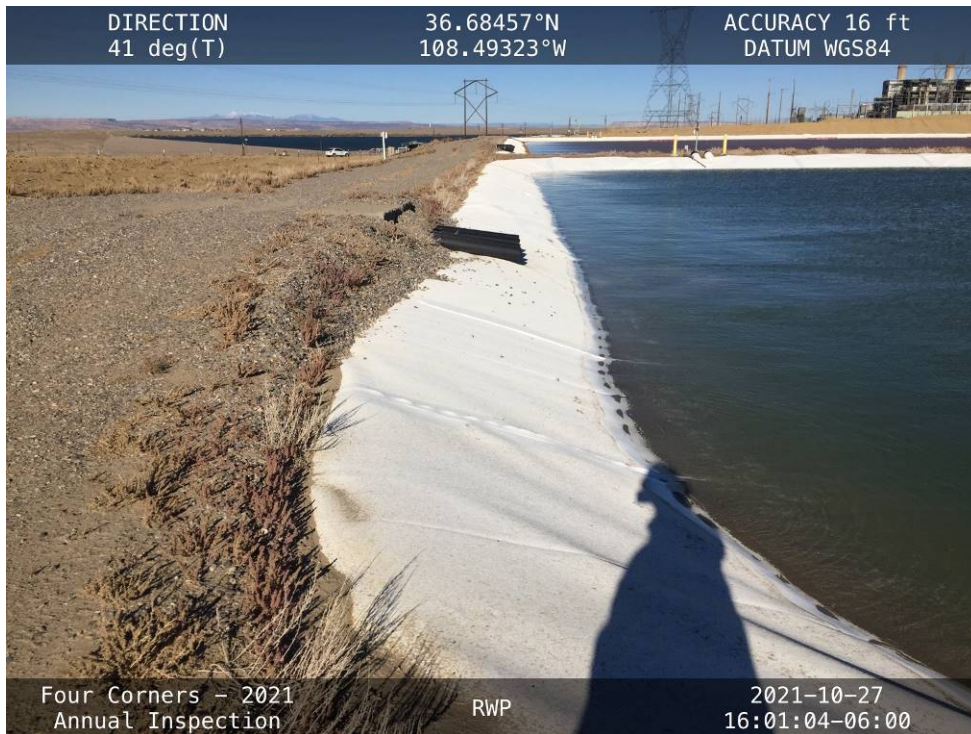
20211027-IMG_8082

The crest of the FGD Pond cell Northwest Embankment, facing northeast.

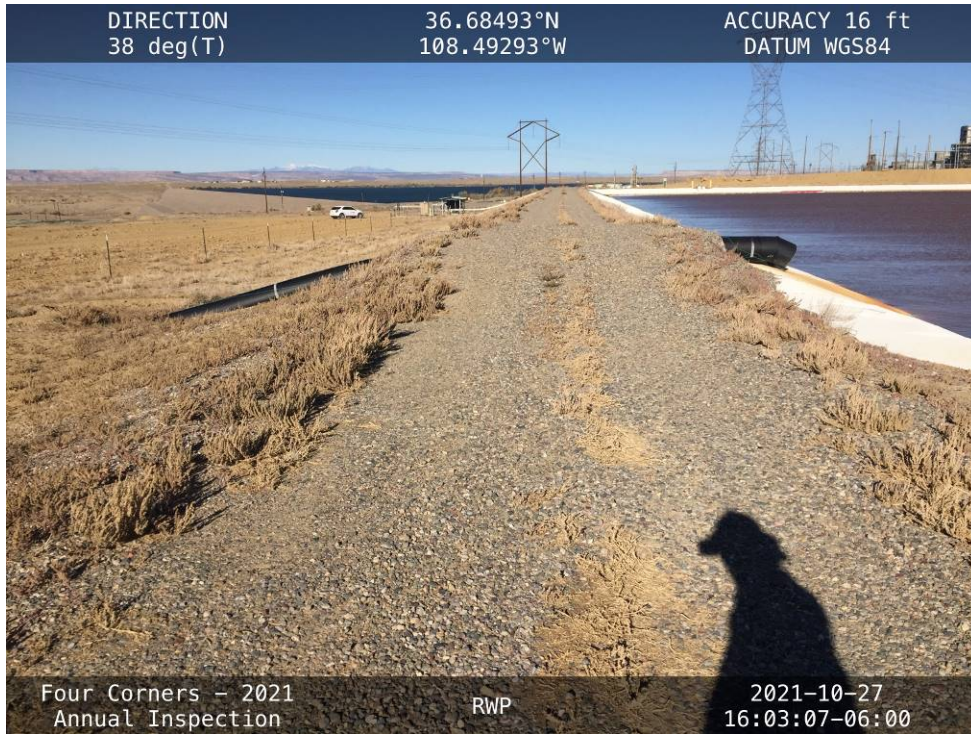
20211027-IMG_8095
The downstream slope of RWP Cell Northwest Embankment, facing northeast.

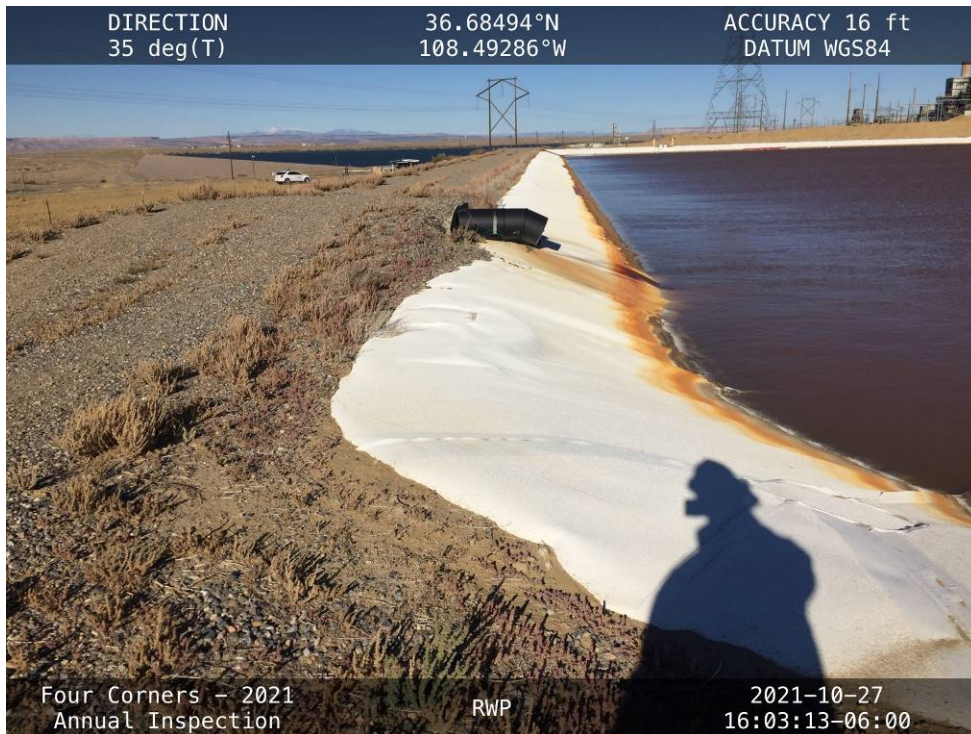
20211027-IMG_8096

The crest of the RWP Cell Northwest Embankment, facing northeast.

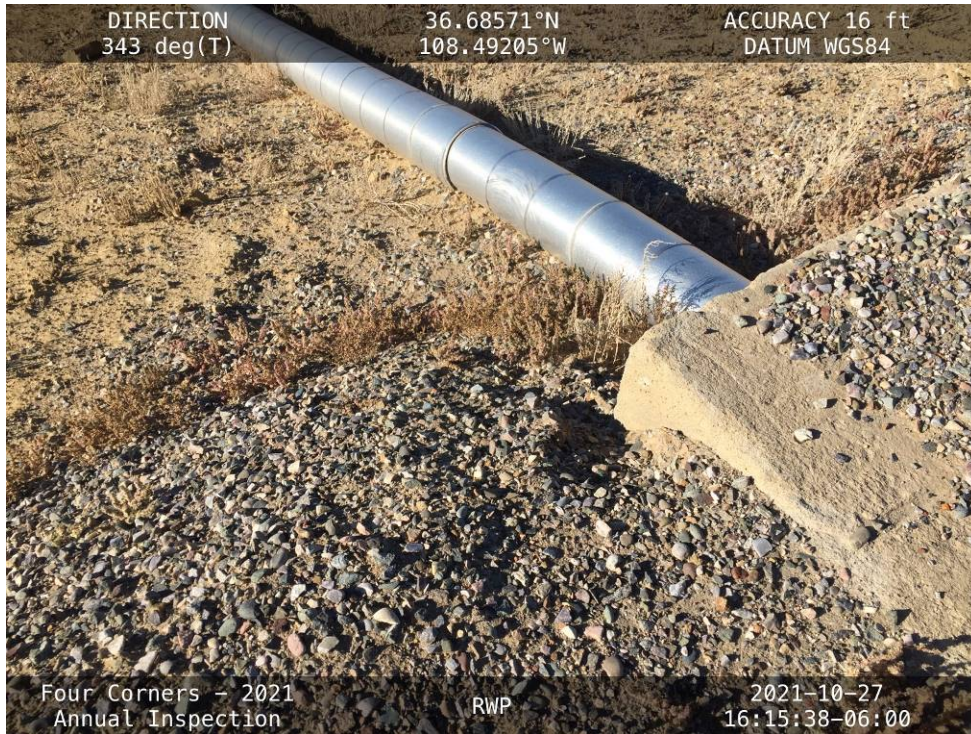
20211027-IMG_8122
 The return water pipe and pumps along the downstream slope of the Northwest Embankment.
