**FOUR CORNERS POWER PLANT
Lined Ash Impoundment,
Lined Decant Water Pond,
Combined Waste Treatment Pond,
Upper Retention Sump, and
Dry Fly Ash Disposal Area**

**Annual
CCR Impoundment and
Landfill Inspection Report
2016**

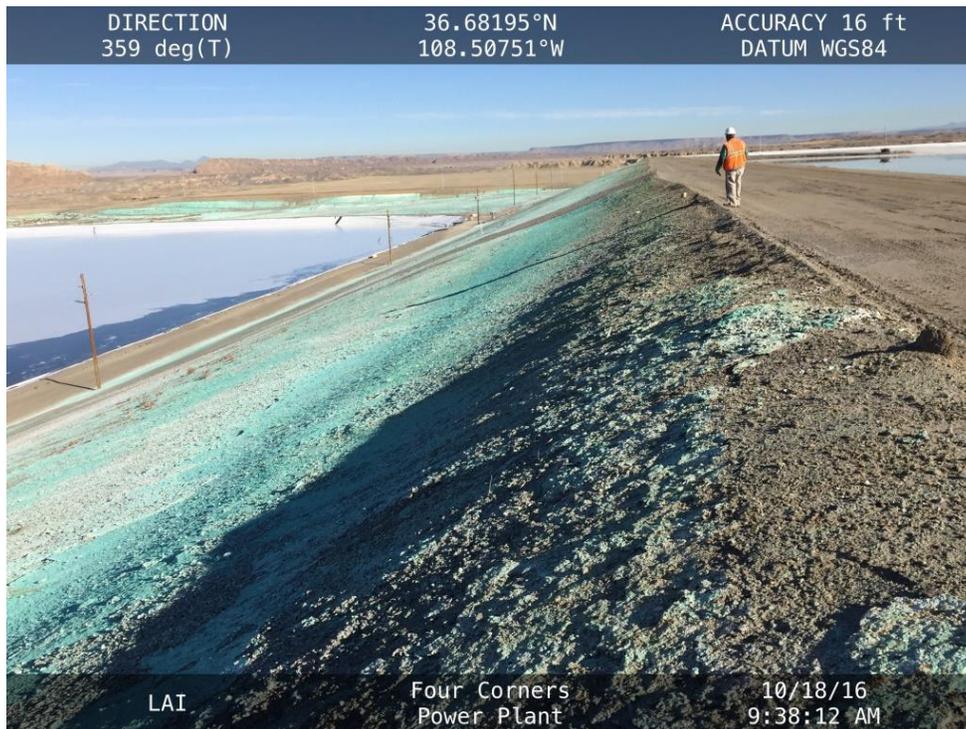
20161018 – IMG_1768
 The downstream slope of the West Embankment, facing north.

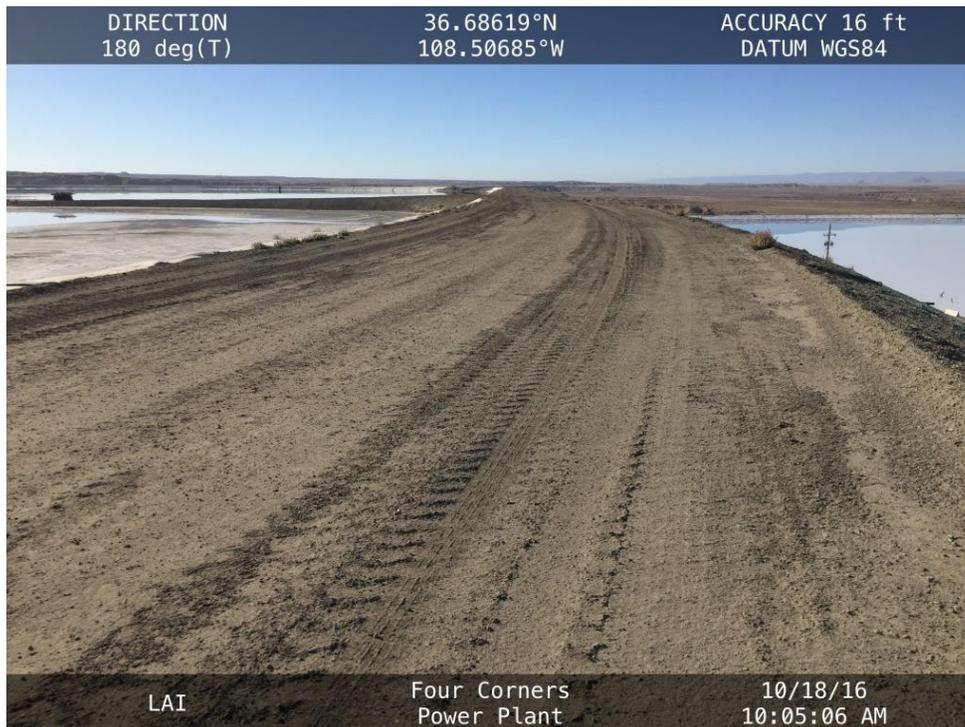
20161018 – IMG_1799
 The crest of the West Embankment, facing south.

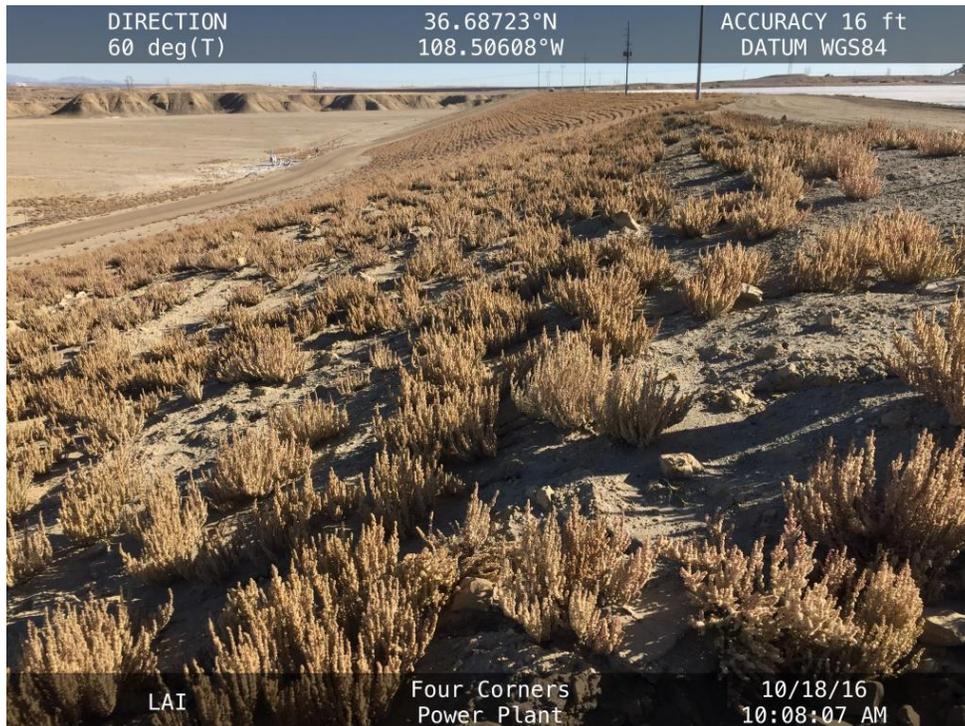
20161018 – IMG_1803

The Northwest Embankment of the LAI, facing east. The slope was regraded and drill-seeded as part of the adjacent Ash Pond 6 (left side of photo) closure.

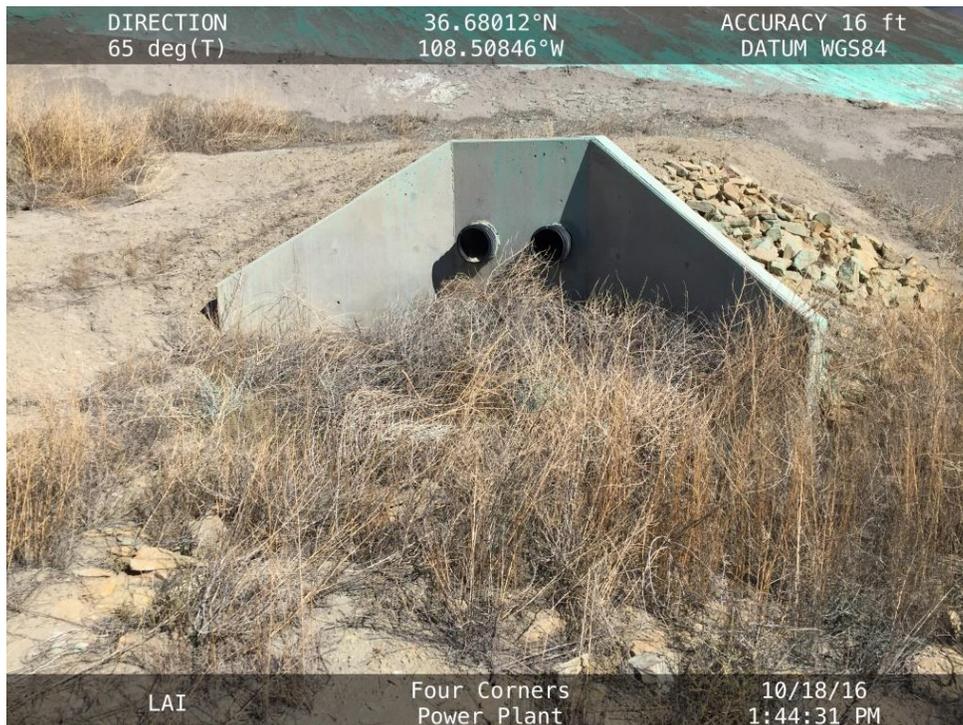
20161018 – IMG_1910

The French drain (South Toe Drain) outlet southwest of the LAI South Embankment in a dry condition.

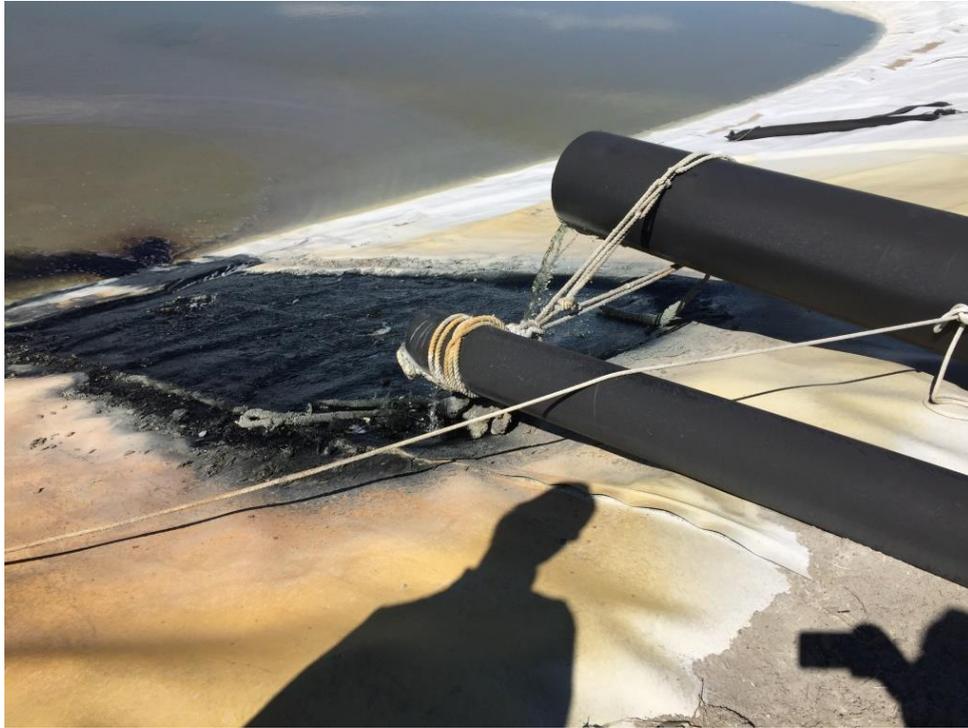
20161018 – IMG_1850

The 8-inch and 16-inch HDPE outlet pipes conveying decant water from the LAI.

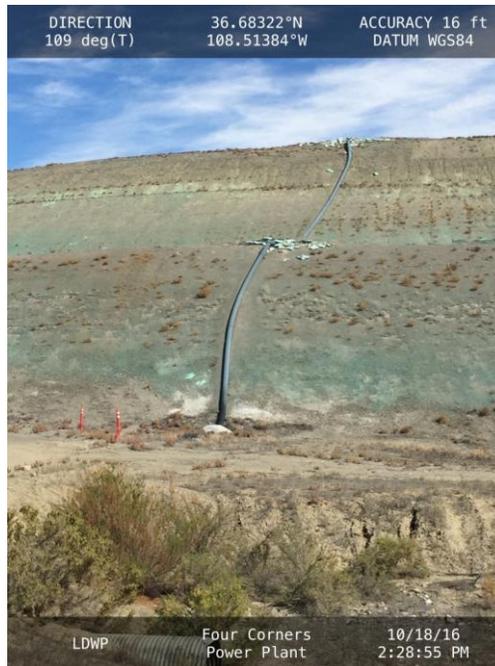
20161018 – IMG_1925

The pipe connecting to the Pond 3 Pump House across the West Embankment of the LDWP, facing east.

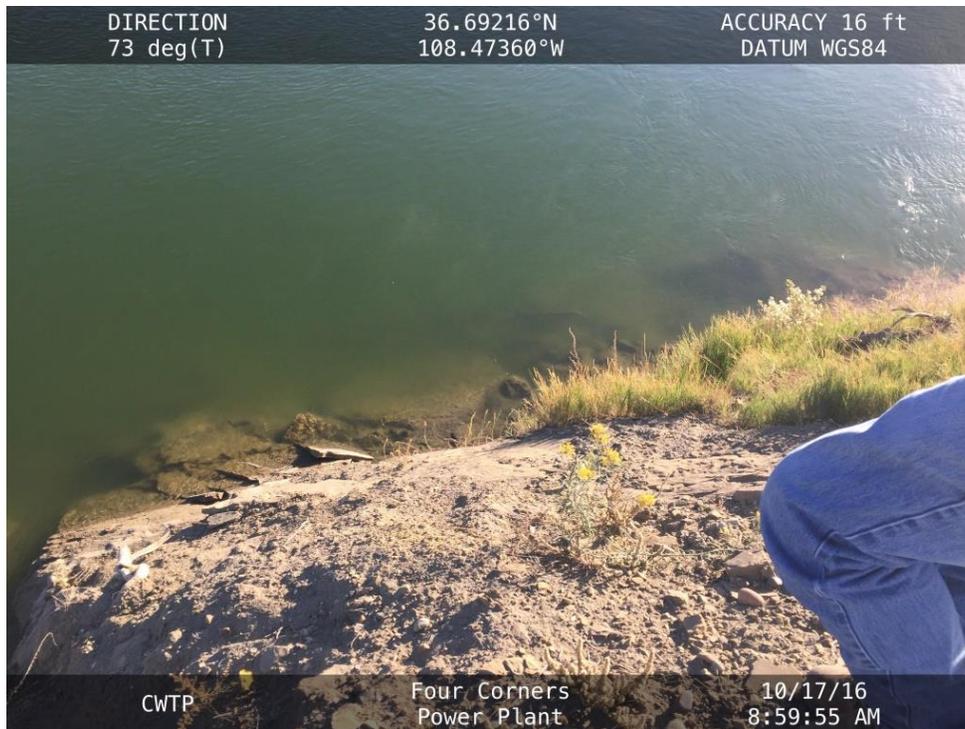
20161017 – IMG_1497
Riprap below the water line along the downstream slope.

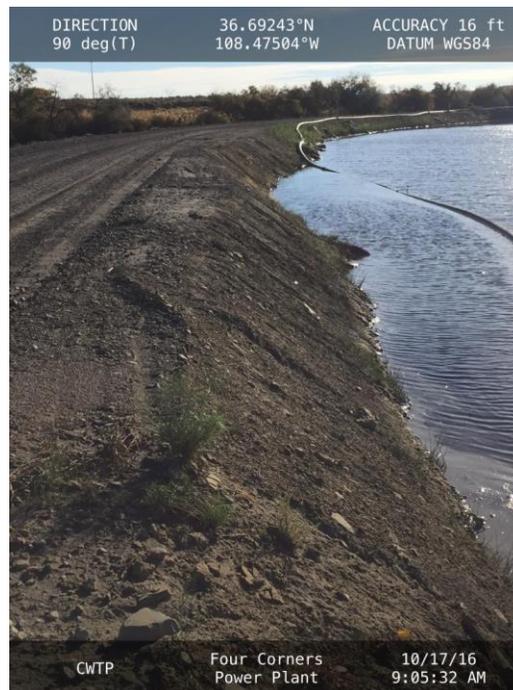
20161017 – IMG_1508

The upstream slope of the CWTP along the northern section, facing east.

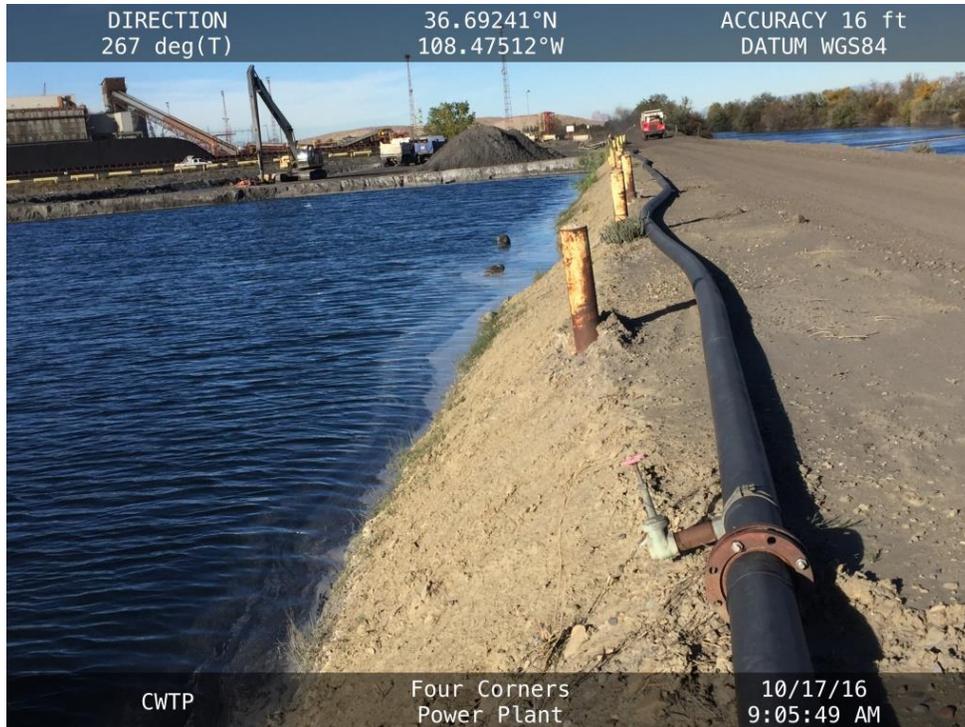
20161017 – IMG_1510

The upstream slope of the CWTP along the northern section, facing west.

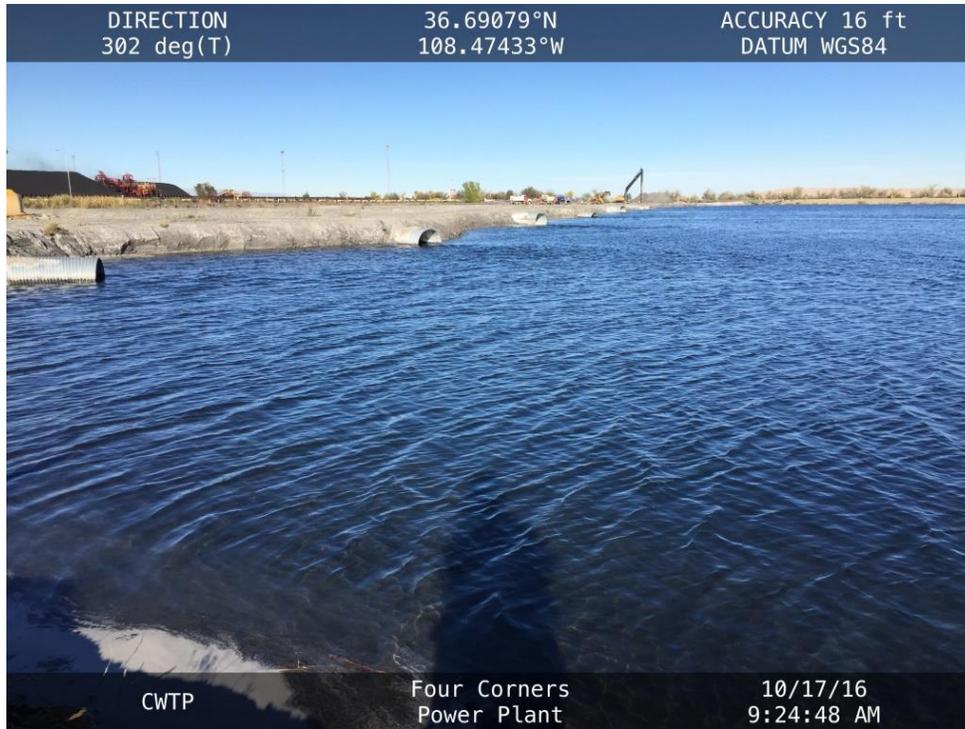
20161017 – IMG_1538
Outlet pipes connecting individual decant cells to the CWTP.

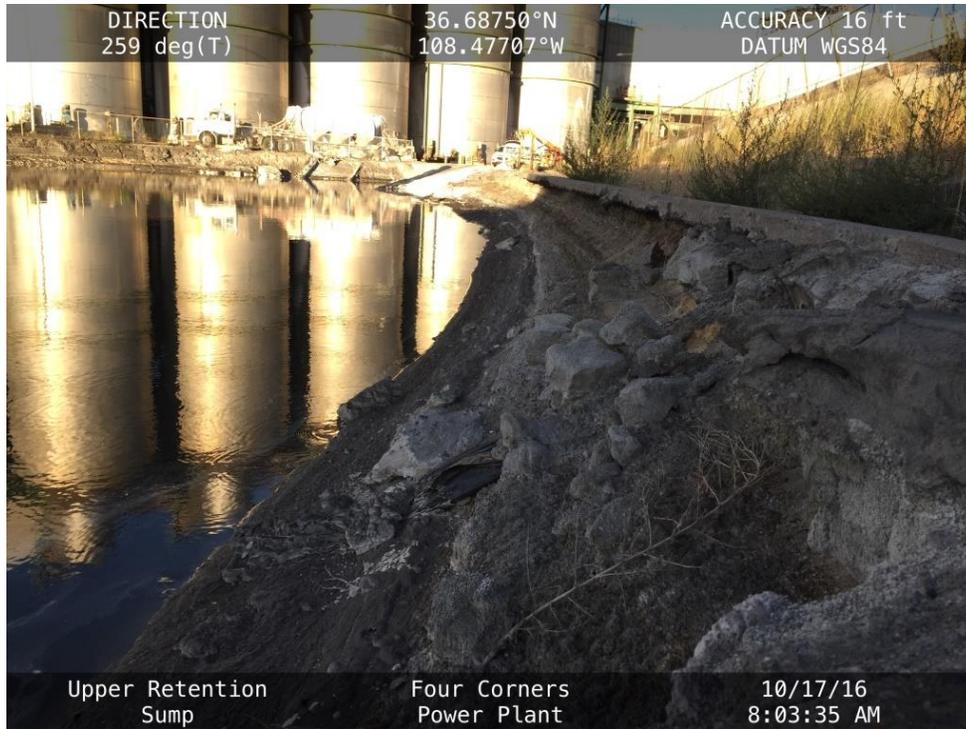
20161017 – IMG_1425

The north side of the Upper Retention Sump, facing west.

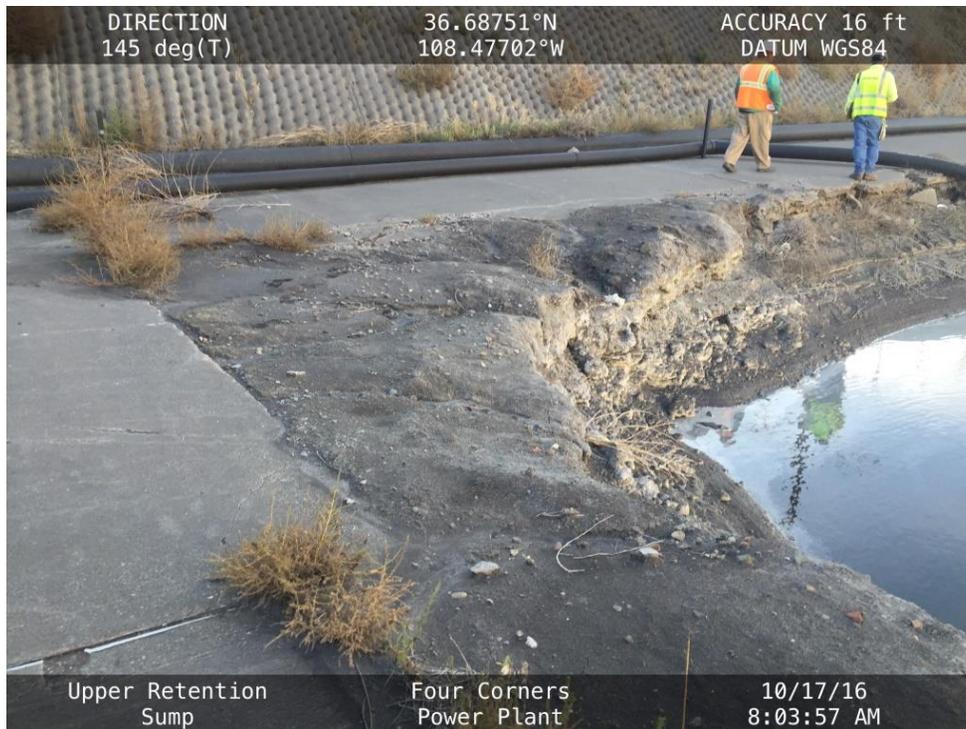
20161017 – IMG_1428

The northeast corner of the Upper Retention Sump, facing east.

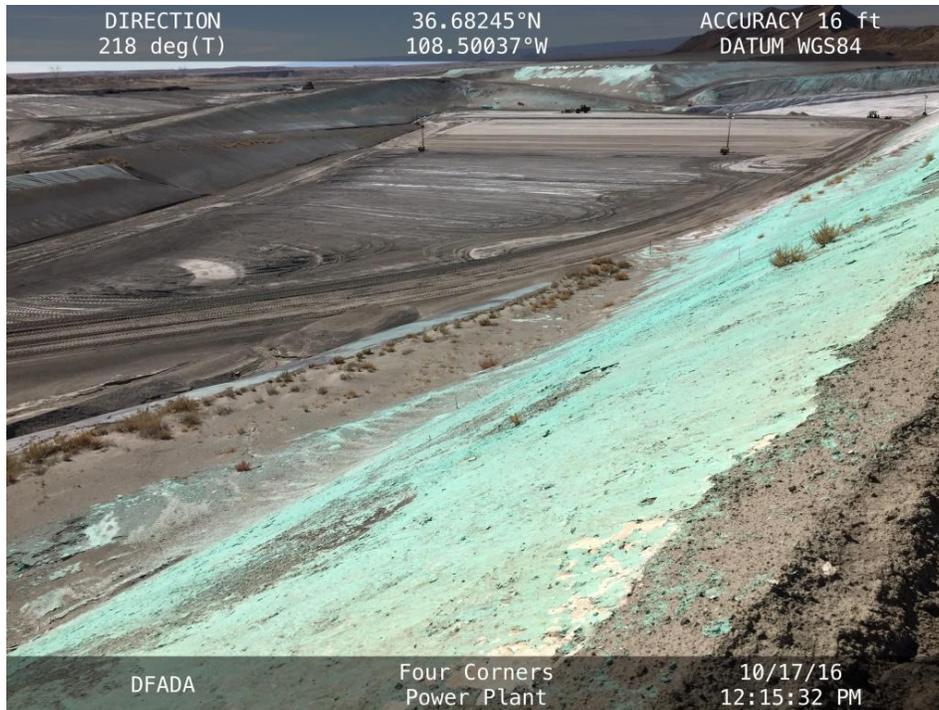
20161017 – IMG_1607

Overview of Cell 3 from the South Embankment of the LAI, facing southwest.

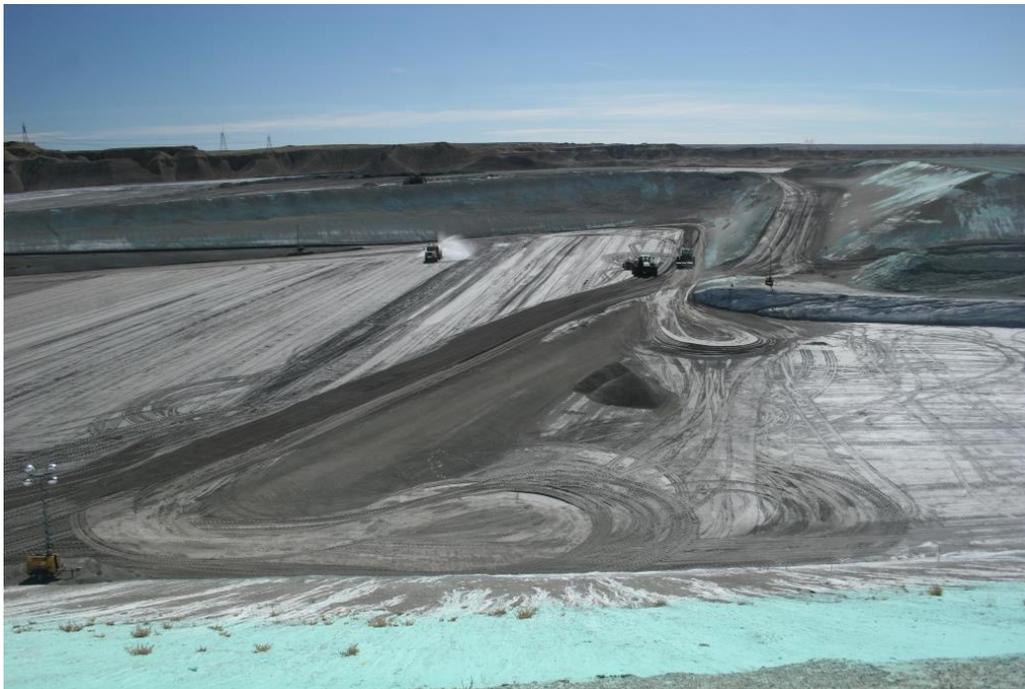
20161017 – IMG_0095

Ongoing ash placement in Cell 3, facing south from the South Embankment of the LAI.

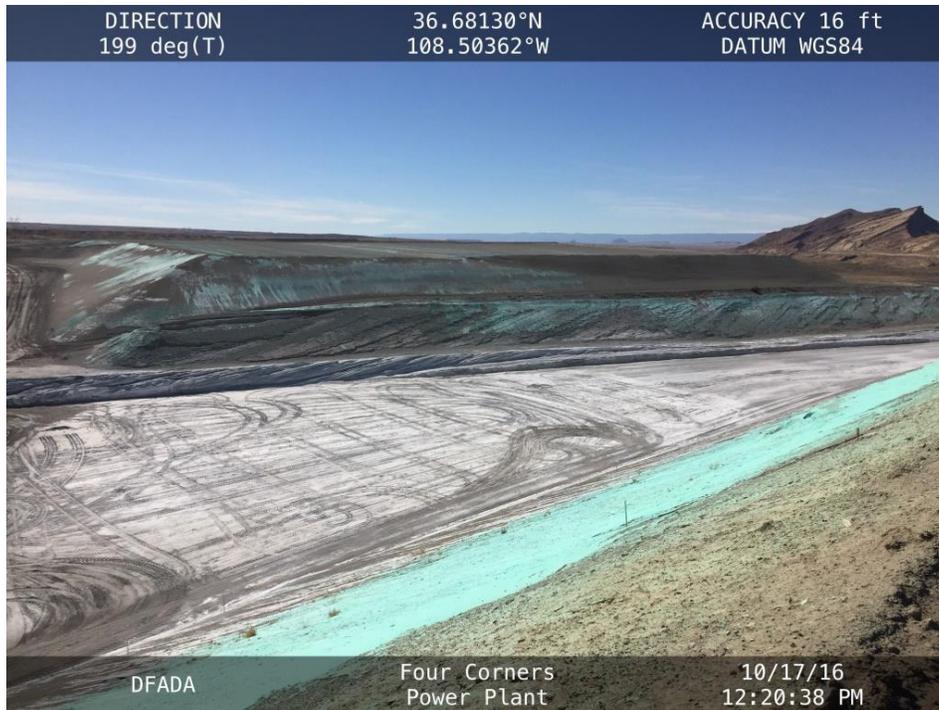
20161017 – IMG_1611

The north side of Cell 1, facing south from the South Embankment of the LAI.

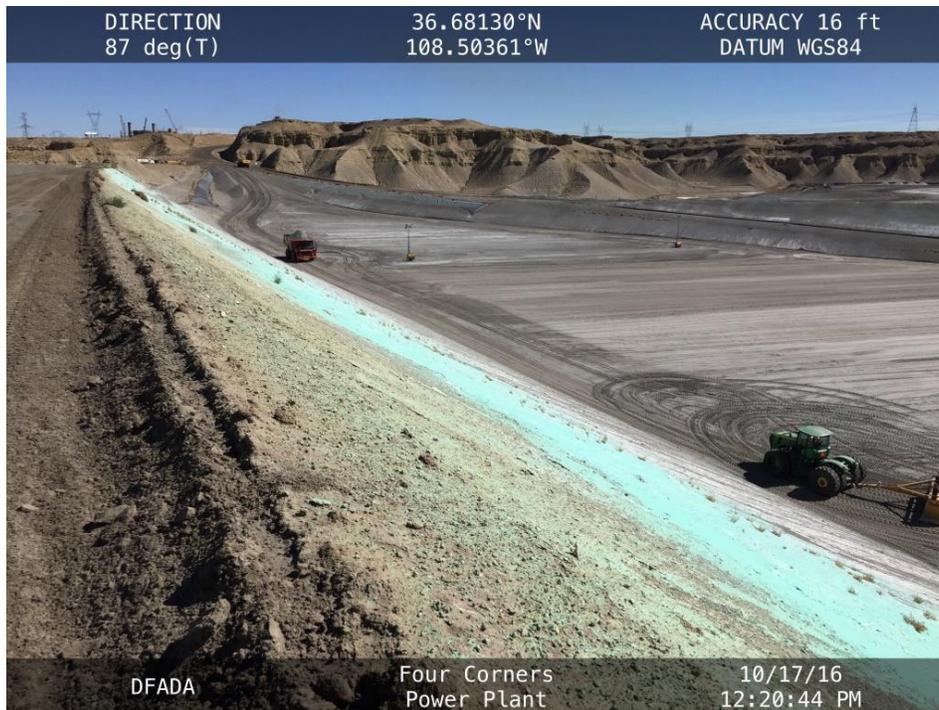
20161017 – IMG_1612

Ongoing CCR, ash placement in Cell 3, facing east from the South Embankment of the LAI.

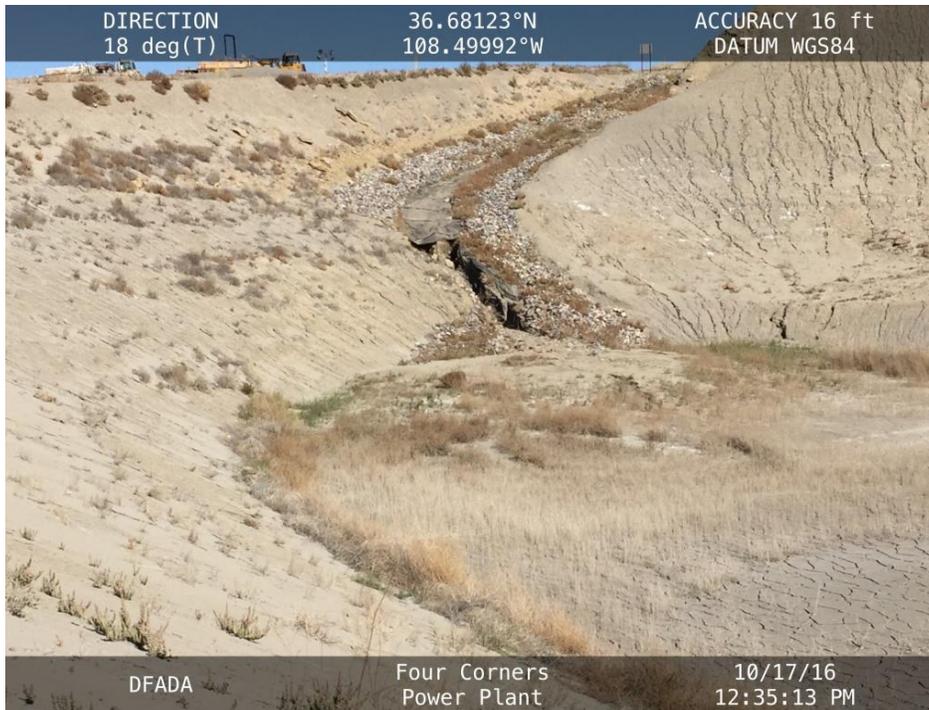
20161017 – IMG_1614

Inlet to the Storm Water Diversion Channel, facing east from the ash haul road.

Observed Condition	Action Item
1) There is erosion at the inlet and outlet of the Storm Water Diversion Channel.	Perform an engineering re-evaluation to understand whether the run off pattern has changed or whether a different erosion control method should be applied.
2) There is damage to the geomembrane liner on the east side of the Cell 1 collection pond.	Repair the liner.
3) Several plants are growing through the Pyramat geosynthetic along the toe of Cell 1.	Monitor the plant growth and remove the vegetation if it is determined to be damaging the primary geomembrane liner.

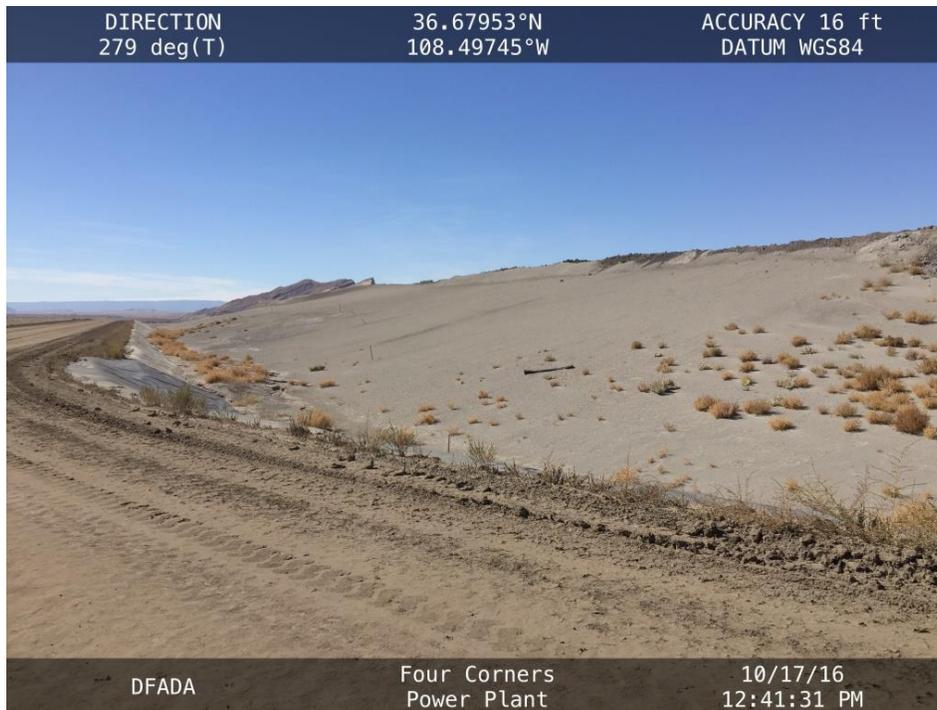
20161017 – IMG_1620

The eastern toe of Cell 2, facing west.

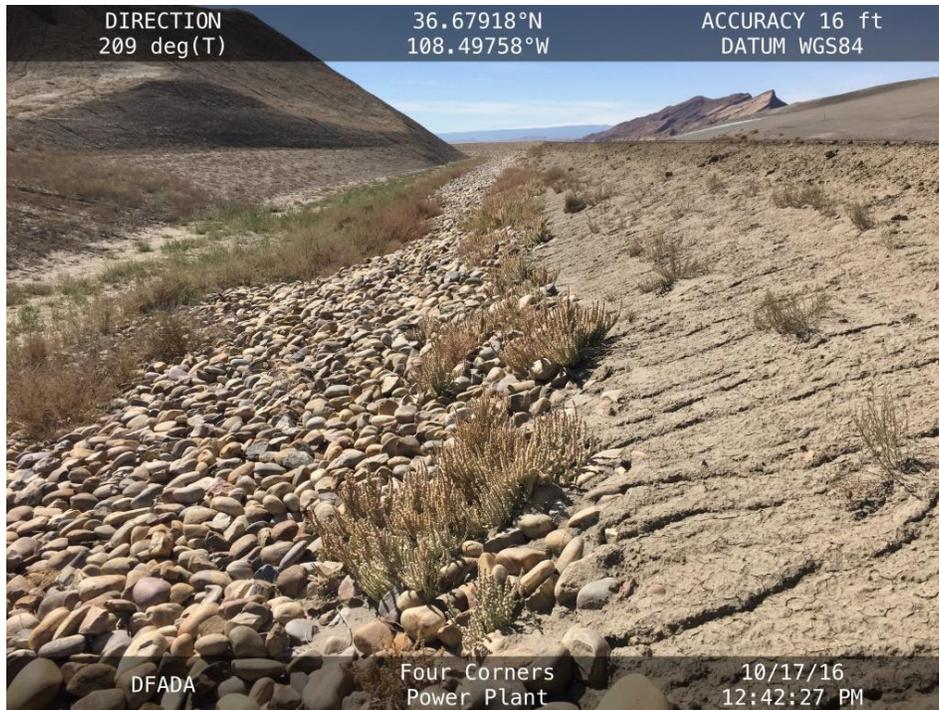
20161017 – IMG_1622
 The diversion channel south of the DFADA, facing southwest.

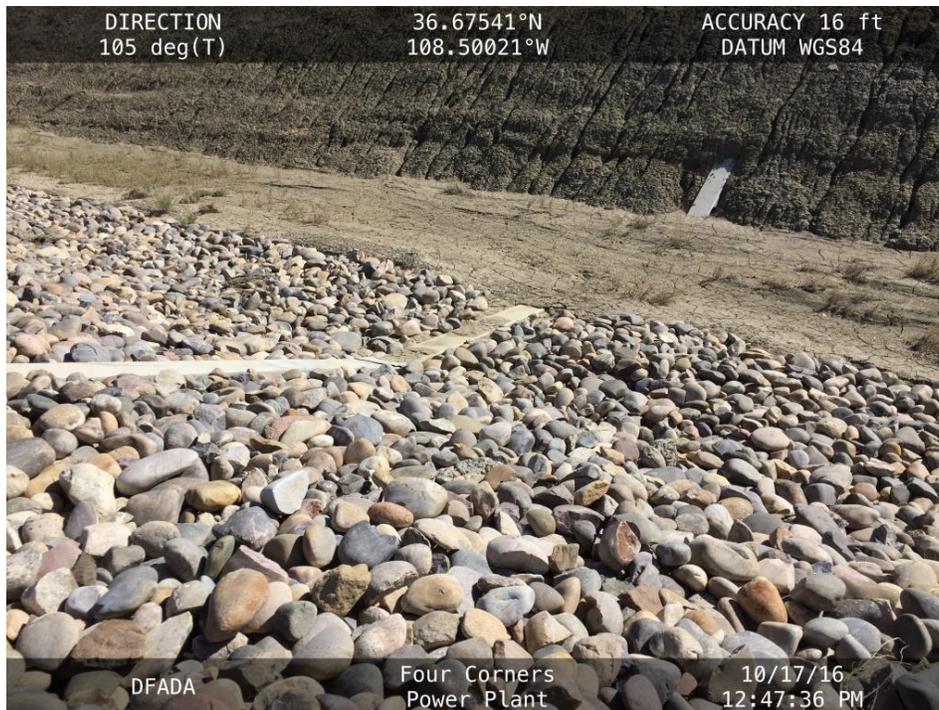
20161017 – IMG_1628
 Sediment in the diversion channel south of the DFADA.

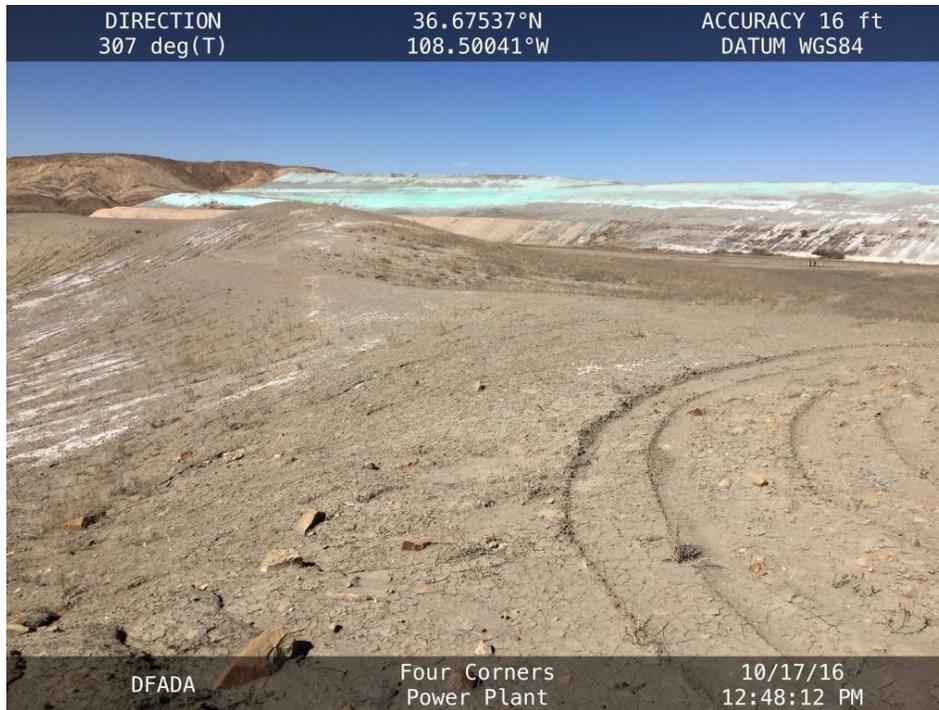
20161017 – IMG_1636
The south slope of Cell 1, facing northwest.

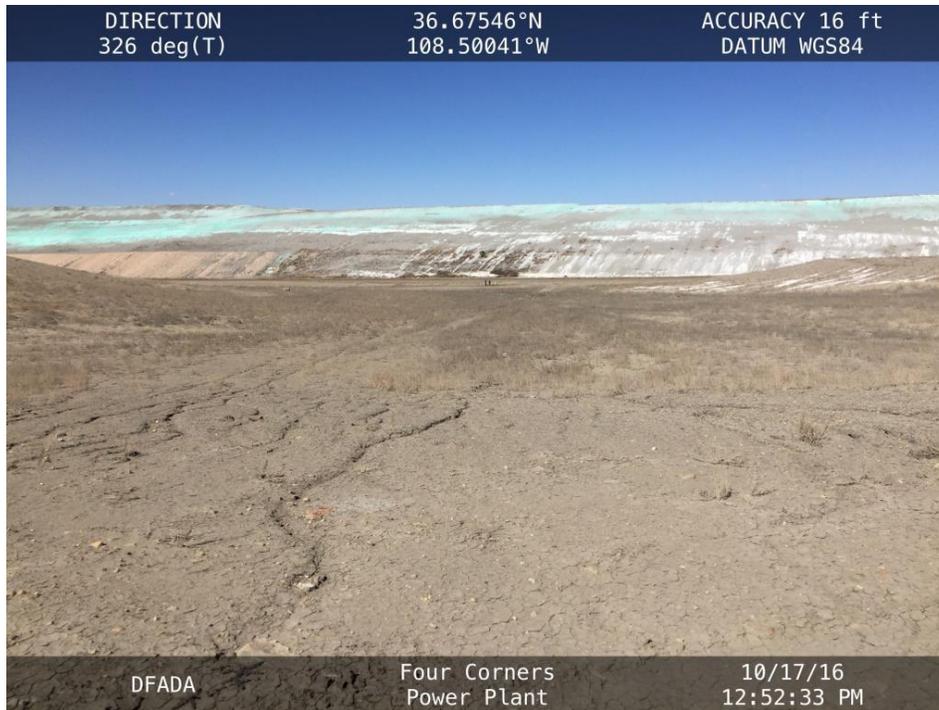
20161017 – IMG_1646
The south slope of Cells 1 and 2, facing north.

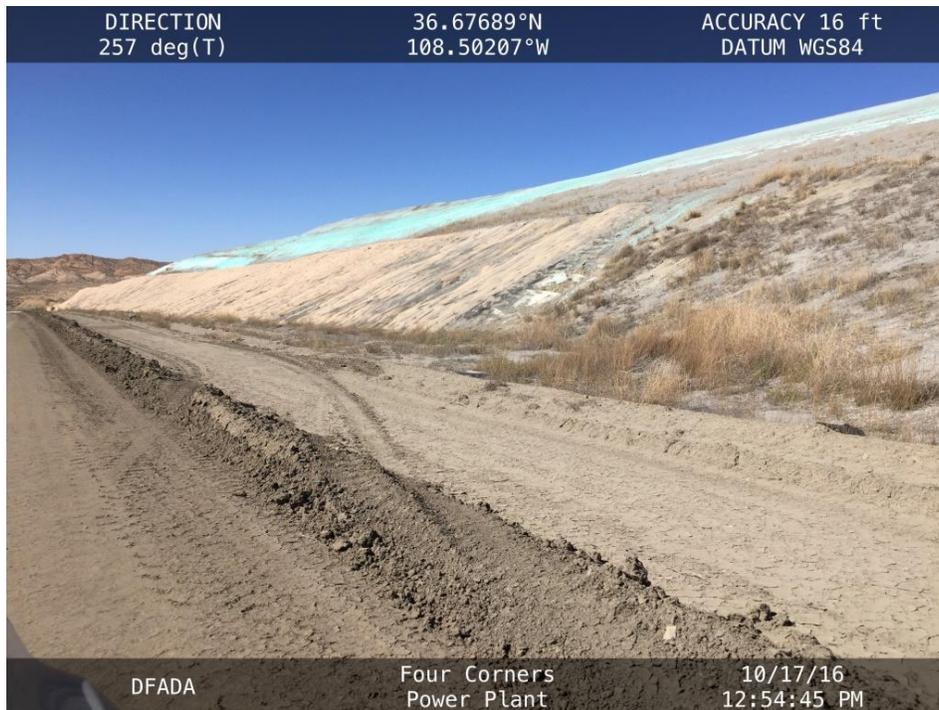
20161017 – IMG_1649
The south slope of Cell 1, facing west along the toe.

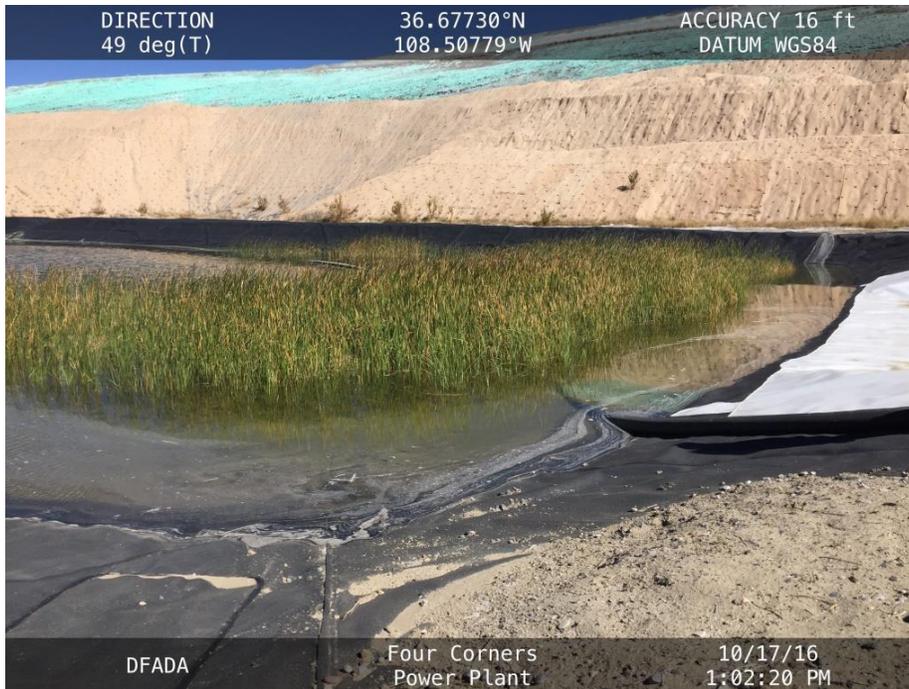
20161017 – IMG_1658
 Vegetation growing in the Cell 1 collection pond.

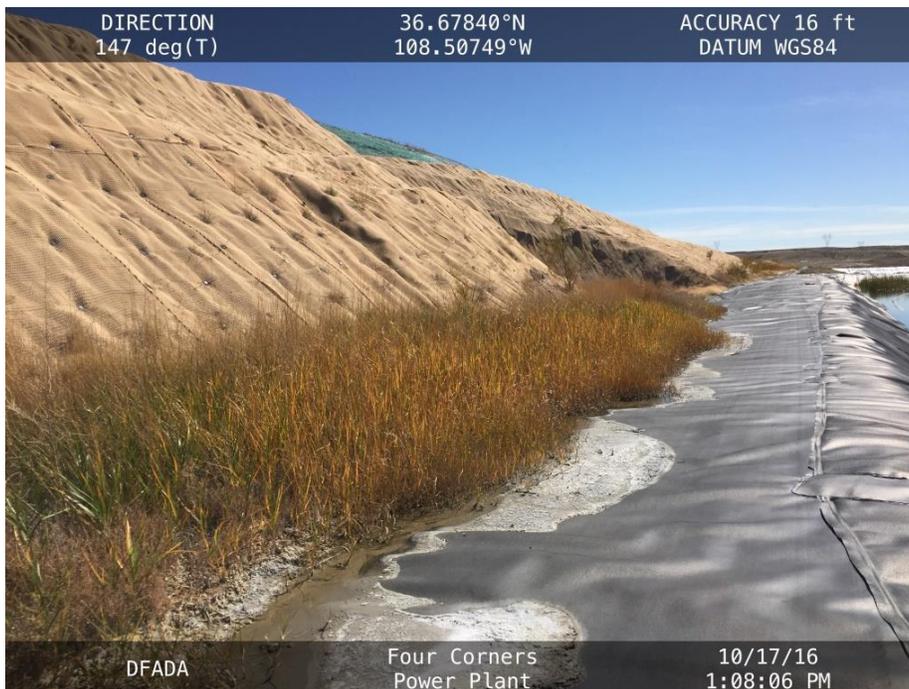
20161017 – IMG_1677

Vegetation growing toe of western slope of Cell 1 at the collection pond.

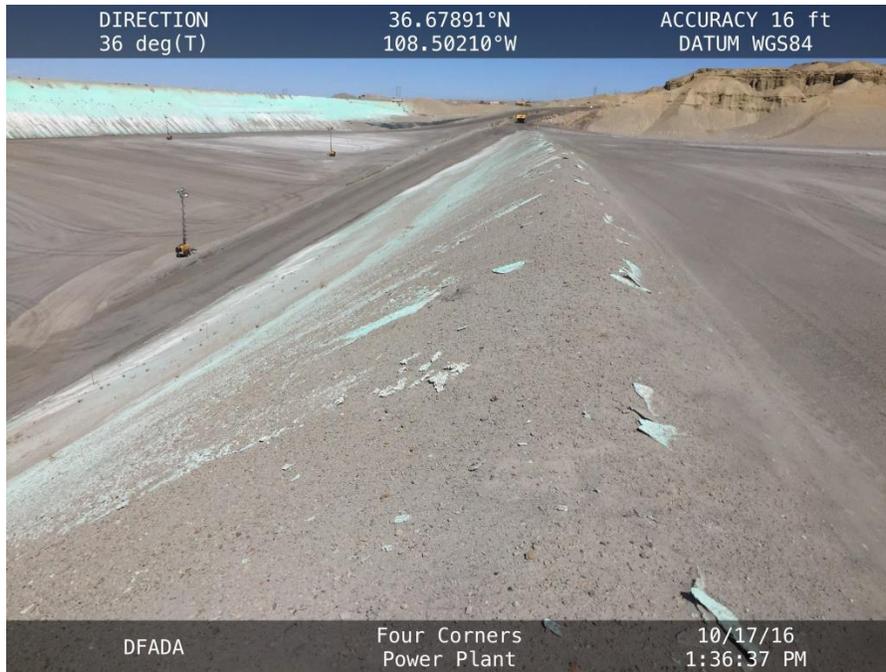
20161017 – IMG_1697

The internal slope between the north side of Cell 2 and the south side of Cell 3, facing northeast.

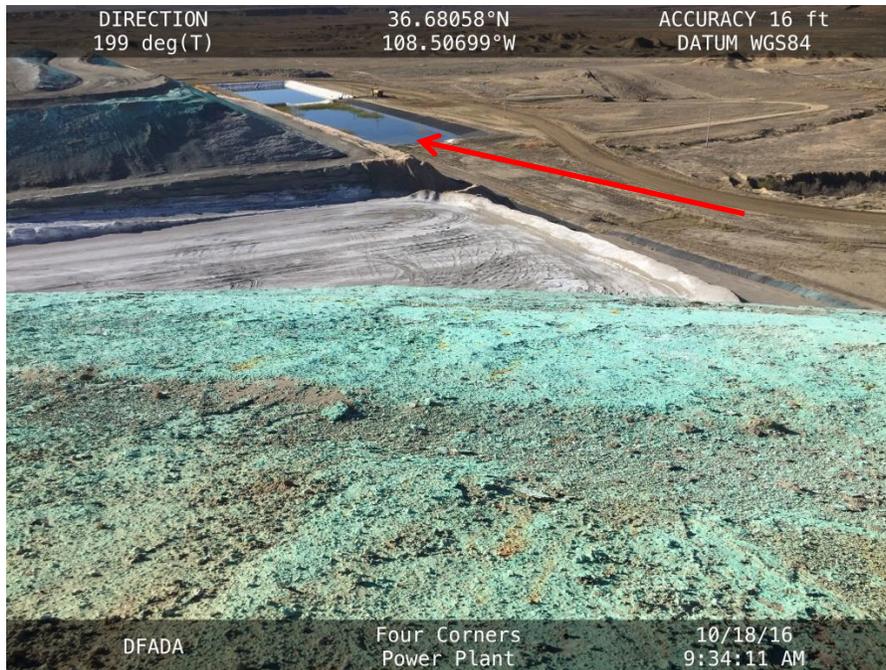
20161018 – IMG_1754

The two leachate collection ponds for the DFADA, facing south from the South Embankment of the Lined Ash Impoundment (LAI),

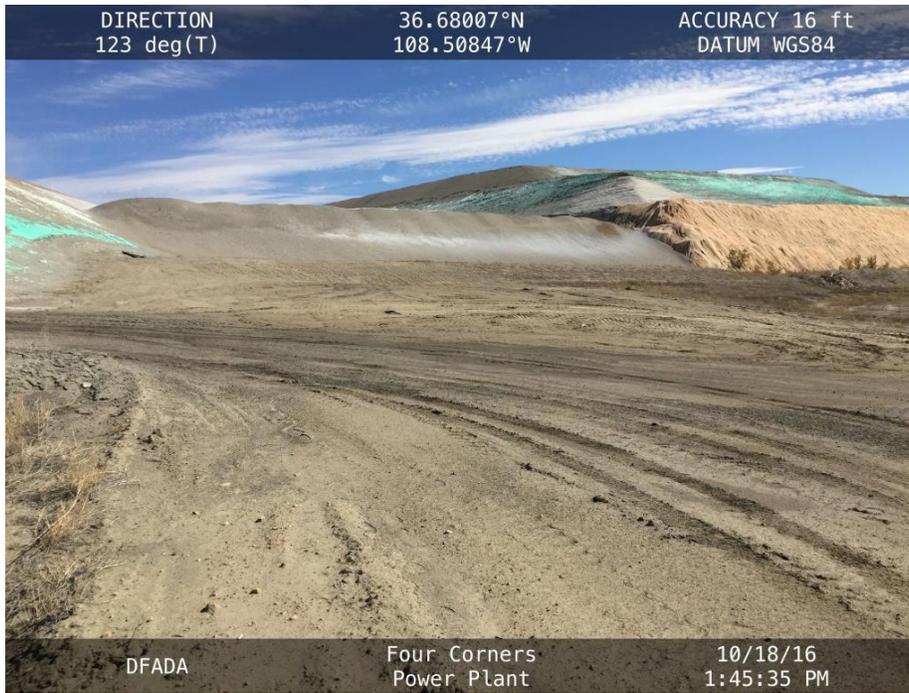
20161018 – IMG_1912

The contact between Cell 3 (center), the LAI (left), and Cell 1 (right), facing east.
