FOUR CORNERS POWER PLANT

**Lined Ash Impoundment,
Lined Decant Water Pond,
Combined Waste Treatment Pond,
Upper Retention Sump, and
Dry Fly Ash Disposal Area**

Annual CCR Impoundment and Landfill Inspection Report 2017

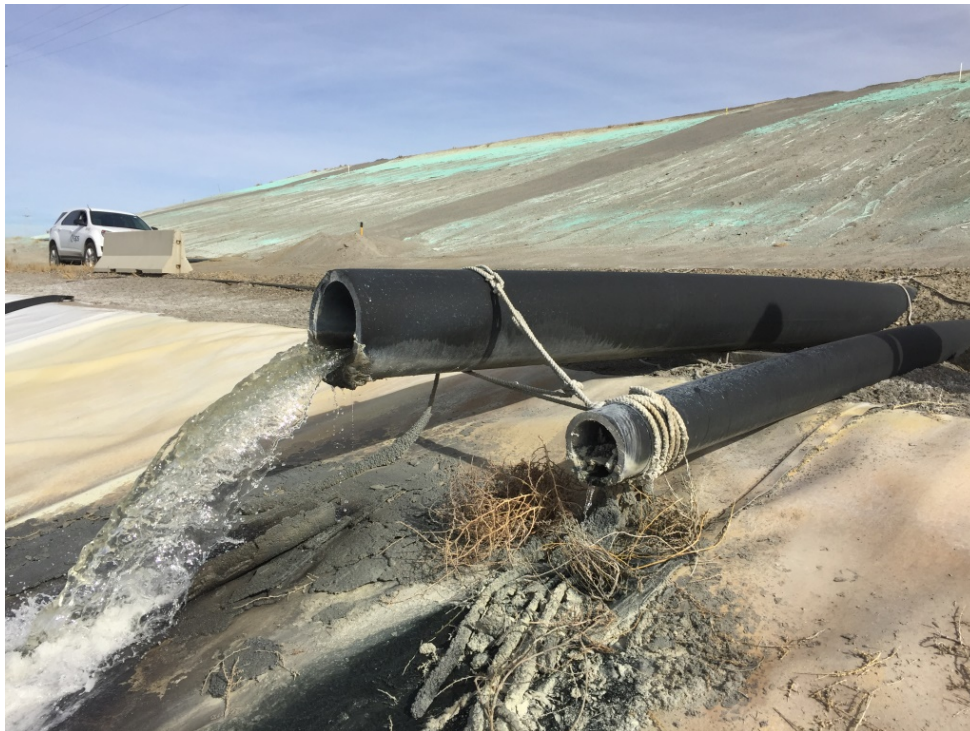
20171113 – IMG_1893

The 16-inch and 8-inch diameter HDPE gravity pipe outlets draining into the LDWP.

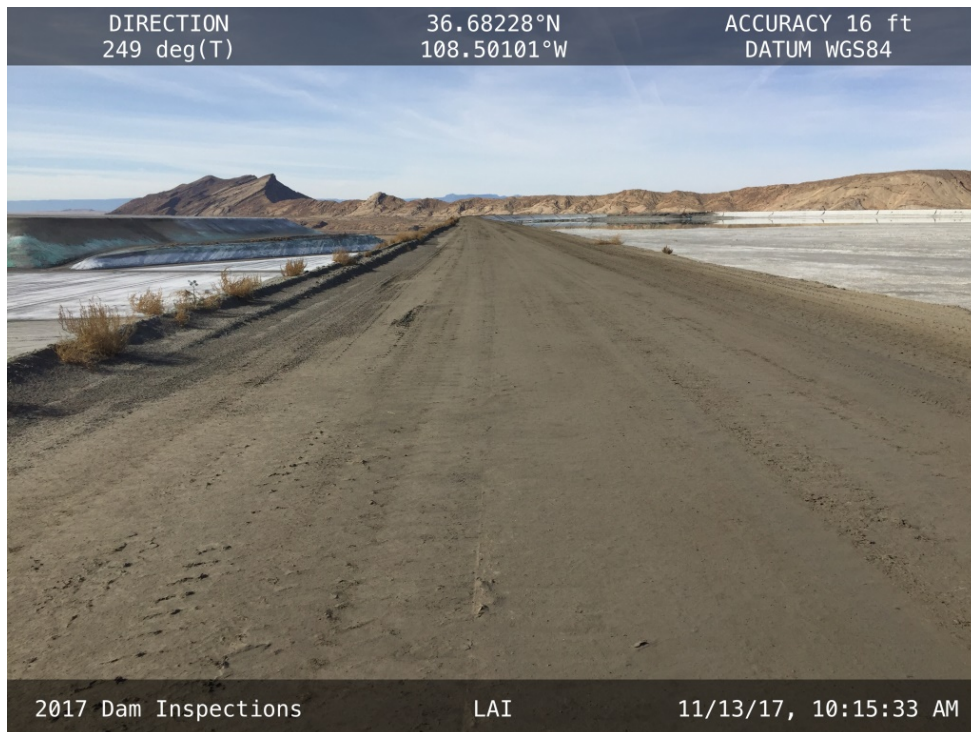
20171113 – IMG_5193

The crest of the South Embankment, facing west.

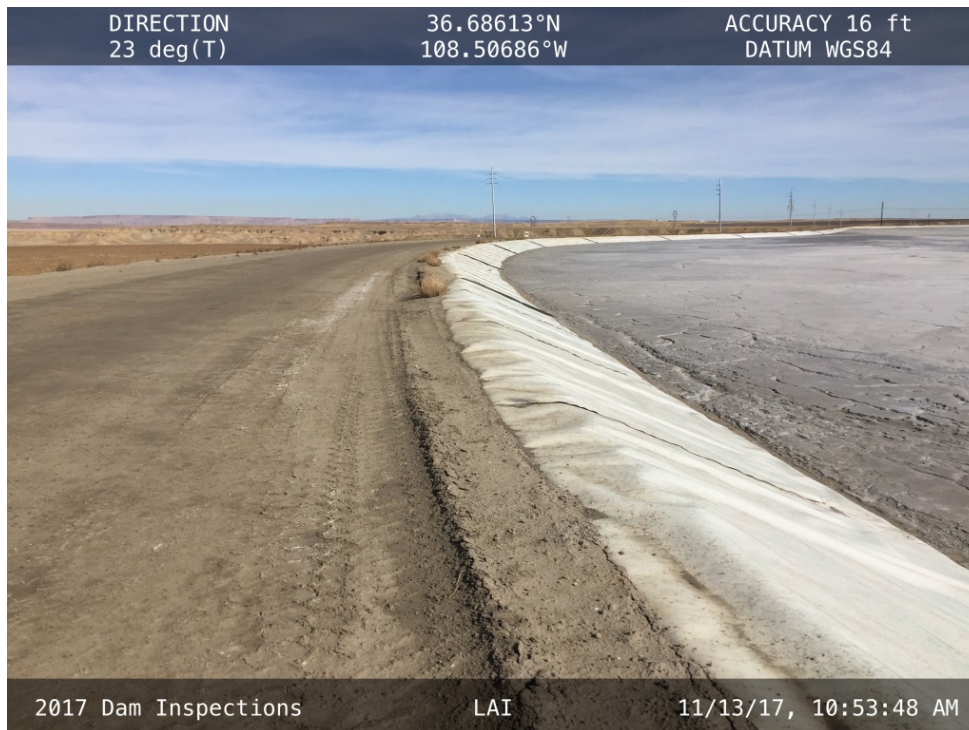
20171113 – IMG_5263

The crest and upstream slope of the Northwest Embankment, facing north.

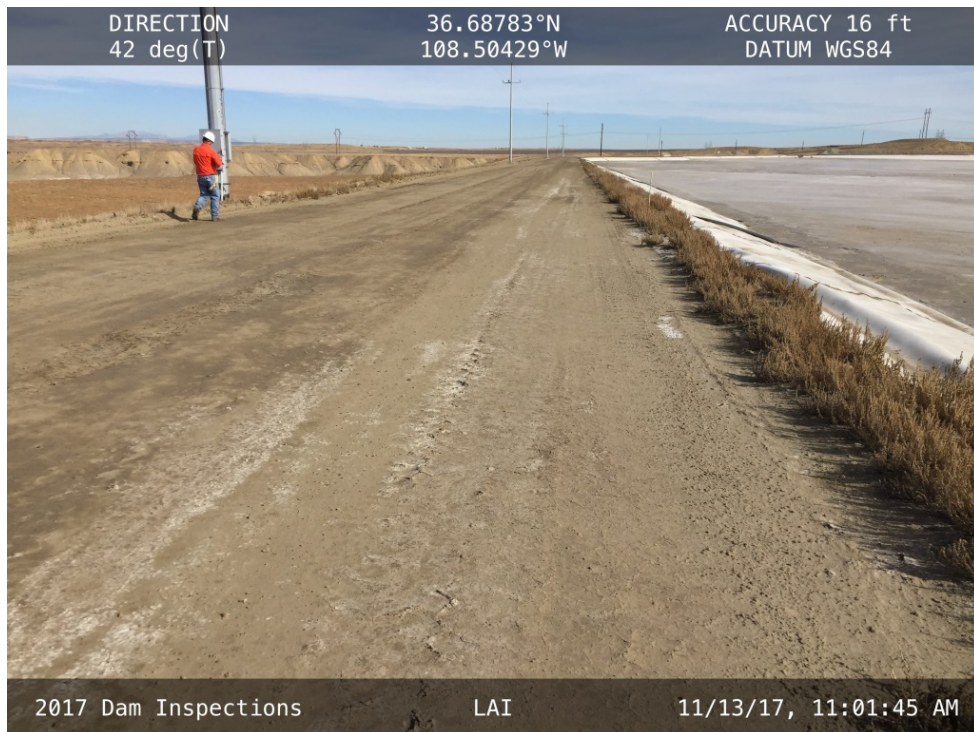
20171113 – IMG_5277
The crest of the Northwest Embankment, facing northwest.

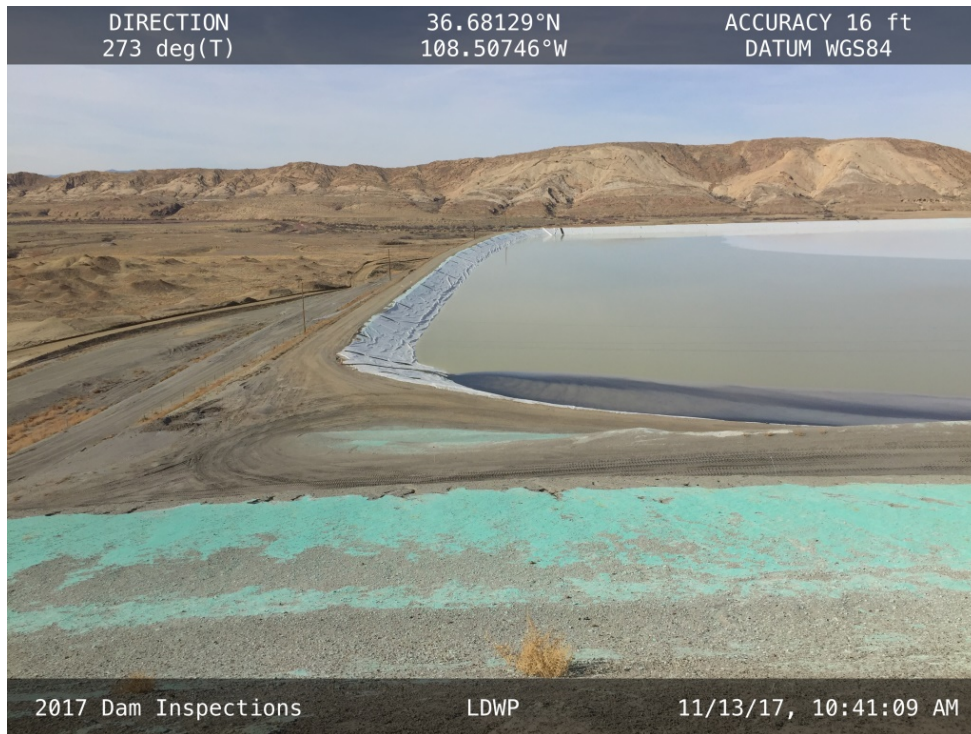
20171113 – IMG_5239

The upstream slope and South Embankment crest, facing west from the crest of the LAI.

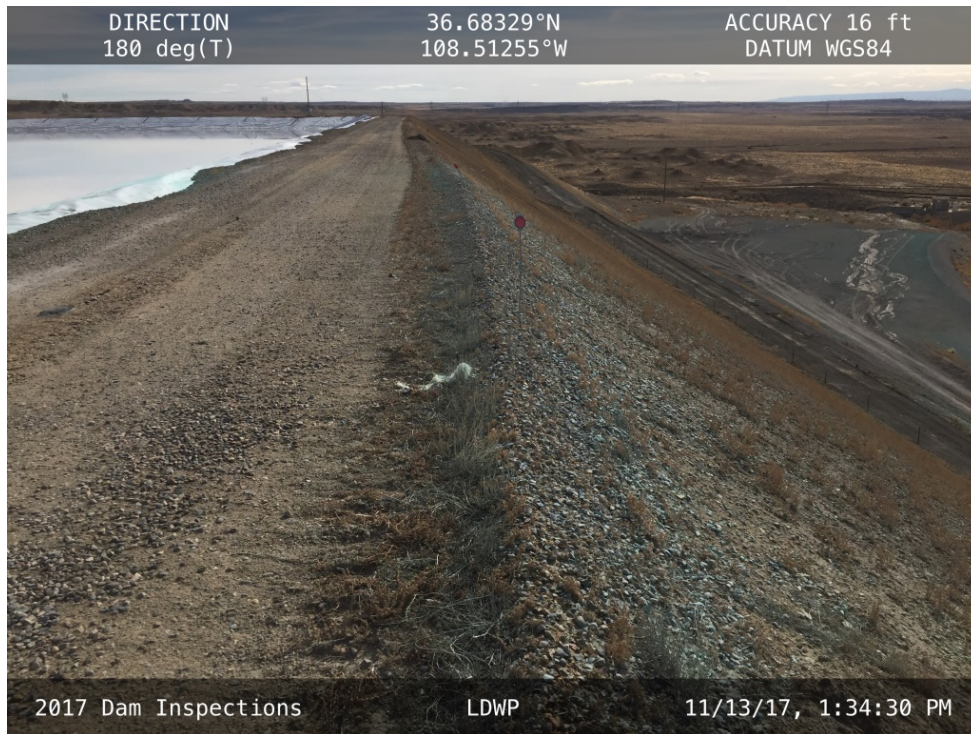
20171113 – IMG_5390

The West Embankment crest and downstream slope, facing south.

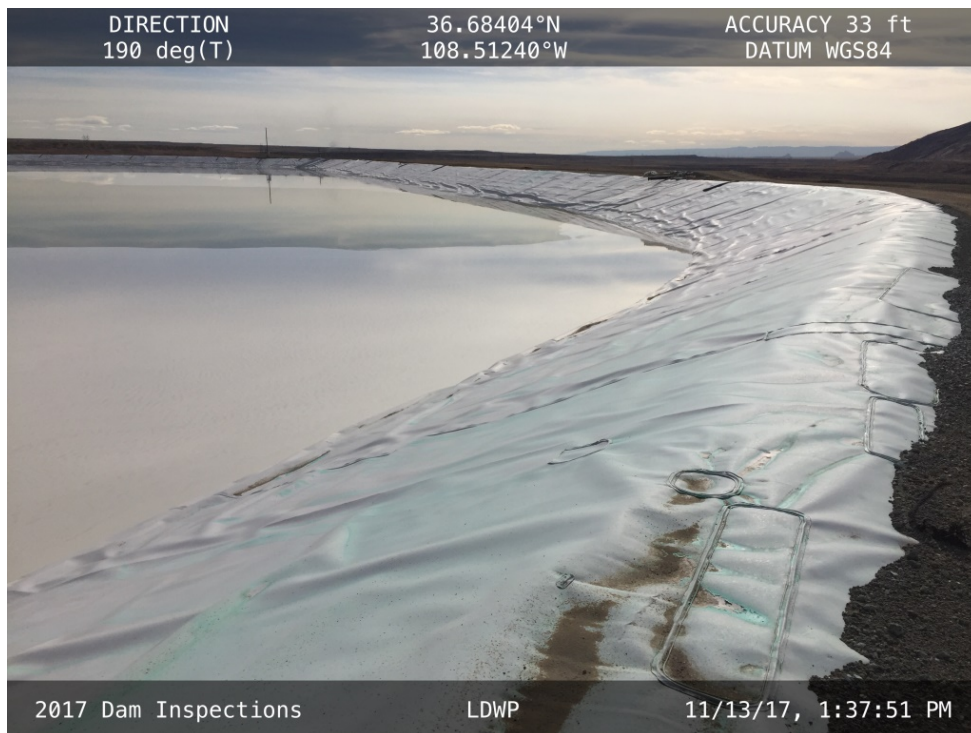
20171113 – IMG_5404

The West Embankment upstream slope, facing south from the center of the embankment.

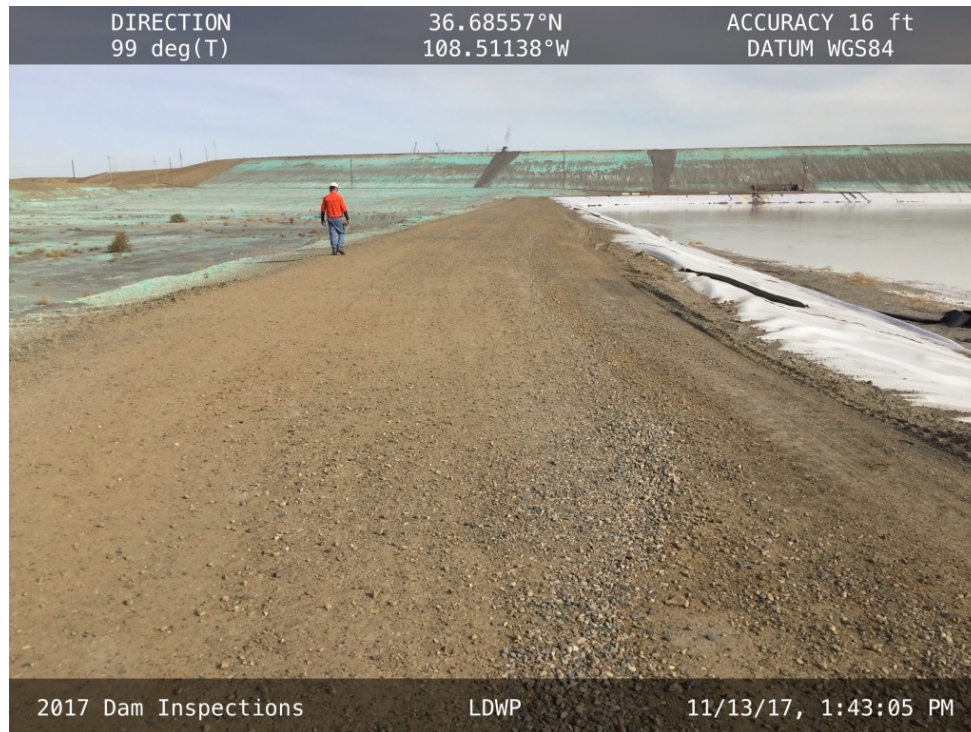
20171113 – IMG_5424
The North Embankment crest, facing east.

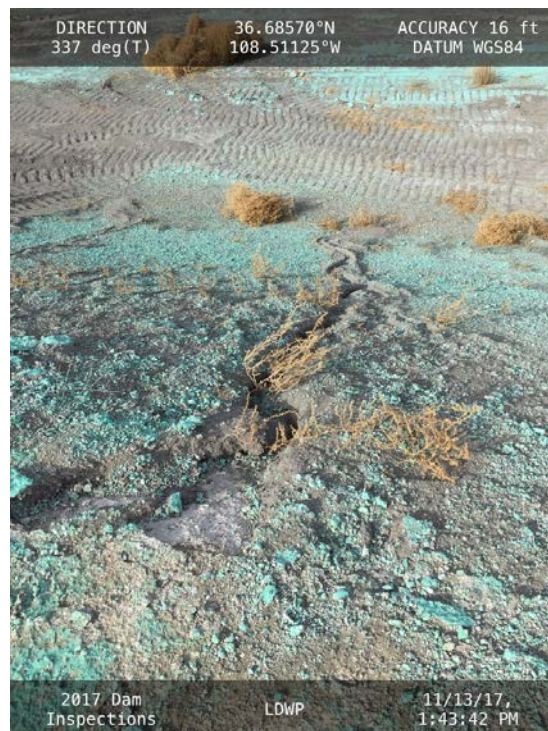
20171113 – IMG_5425
Erosion rill forming along the North Embankment downstream slope, facing toward the toe.

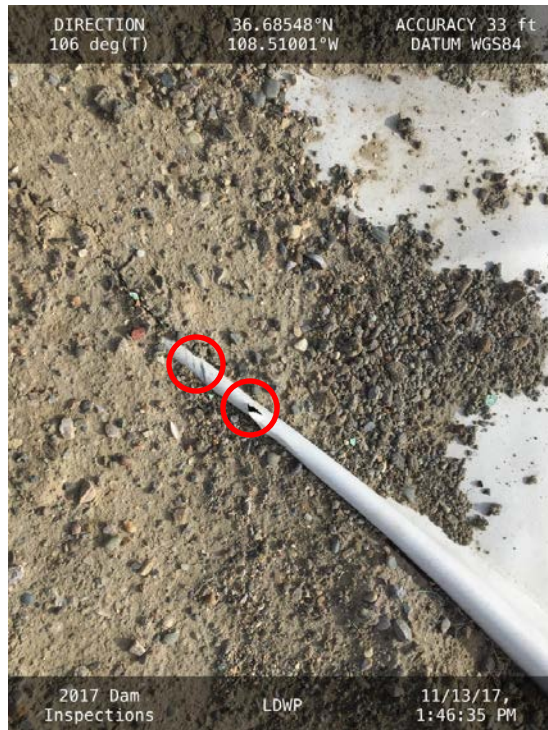
20171113 – IMG_5429
Tears in the liner along the North Embankment.

Observed Condition	Action Item
1) The liner in the anchor trench in the central portion of the West Embankment appeared to be pulling out of the trench.	Investigate the cause of the damage and repair the liner as necessary.
2) Minor erosion rilling, was observed on the external slopes of the LDWP at the time of the inspection.	Continue ongoing repair program for repairing rills if the erosion depth exceeds one foot.
3) There are small holes and tears in the liner along the South, North, and East Embankments.	Repair the tears and holes.

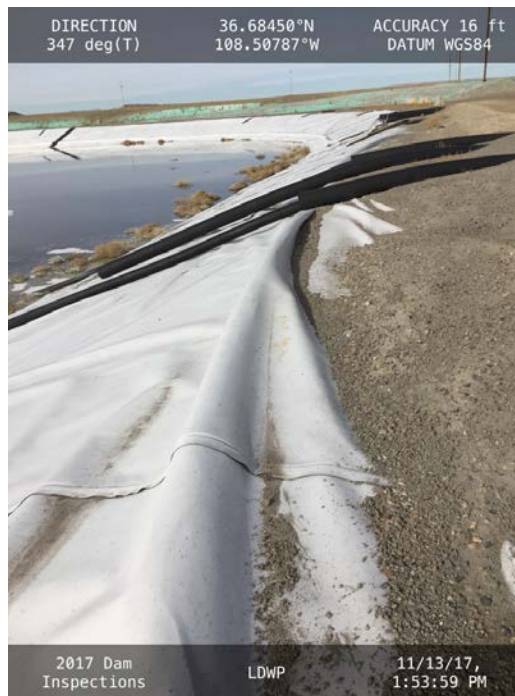
20171113 – IMG_5435

The liner pulling out of the anchor trench in the East Embankment.

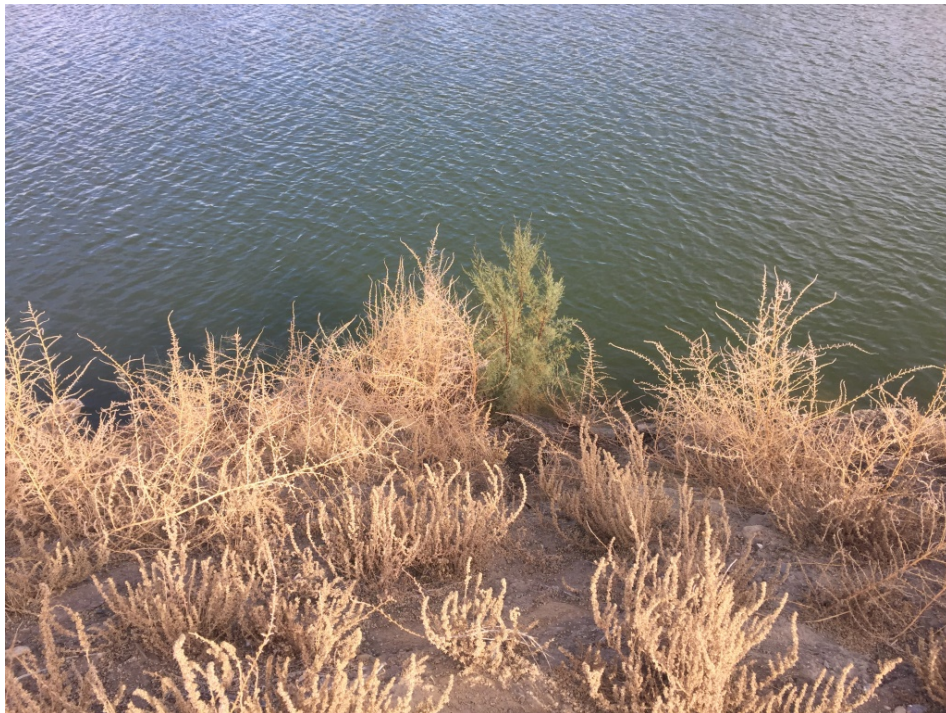
20171114 – IMG_1927

Woody vegetation along the downstream slope to be monitored and removed when necessary.

Observed Condition	Action Item
1) Vegetation removal along the upstream and downstream slopes should be performed in accordance with the NMOSE vegetation maintenance guidelines “ <i>Vegetation Management on Dams</i> ” (2011) reference.	This will be an ongoing maintenance requirement.
2) Several instances of minor erosion were observed on the downstream slope above the riprap.	Continue ongoing repair program for repairing erosion if the erosion depth exceeds one foot.
3) There is an HDPE pipe laying across the upstream slope along most of the embankment.	Recommend removal of the pipe.

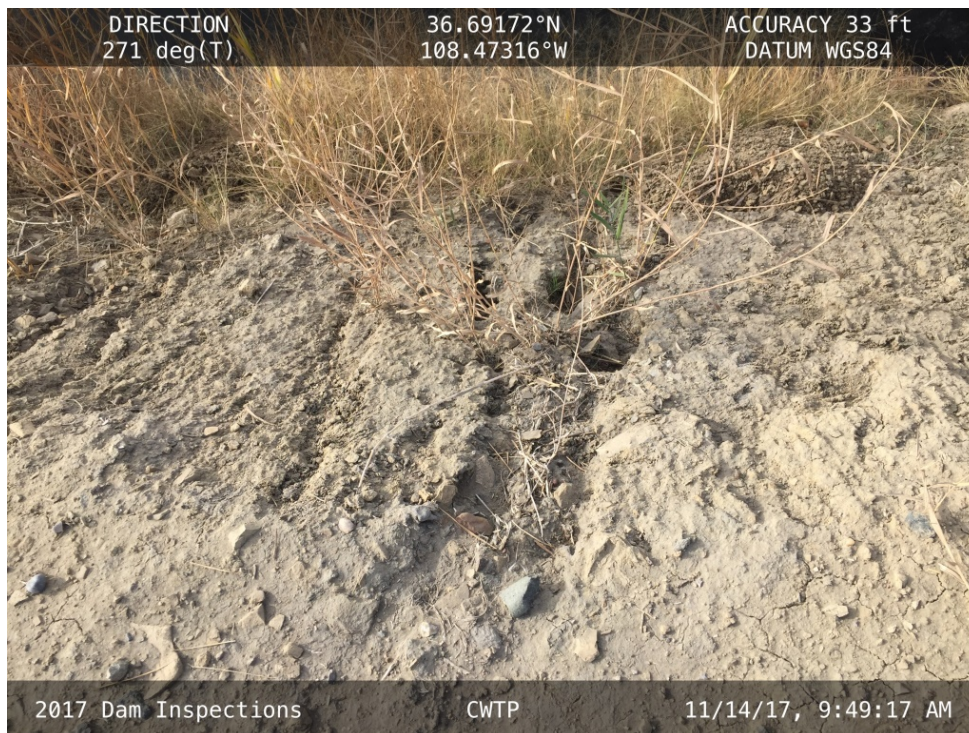
20171114 – IMG_5598

Minor erosion rills forming on the embankment.

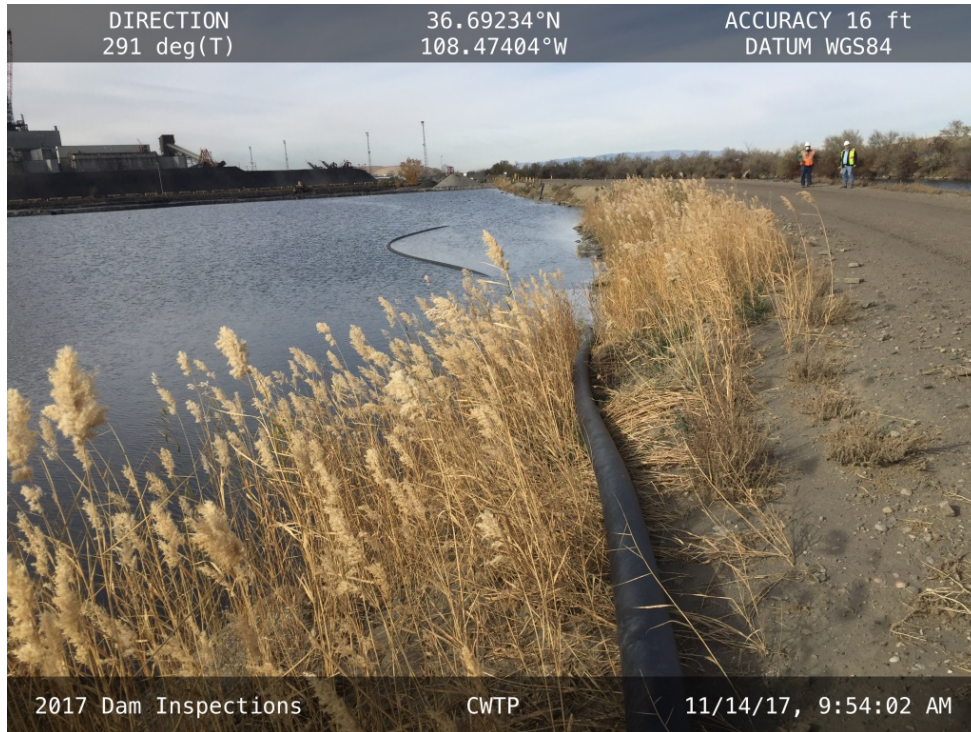
20171114 – IMG_5607

A pipe laying across the upstream slope of the embankment, facing west.

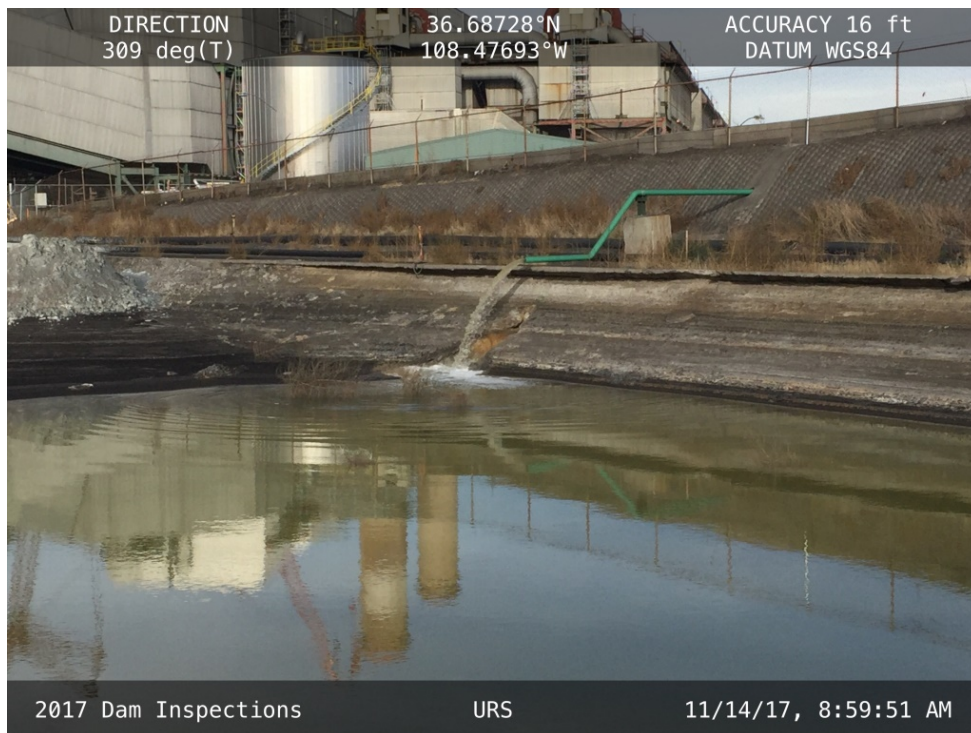
20171114 – IMG_5550

The new discharge pipe along the north side of the Upper Retention Sump, facing northwest.

Observed Condition	Action Item
1) Erosion beneath the new discharge pipe on the North Embankment and below the edge of the crest.	Monitor the erosion and repair as necessary. This will be an ongoing maintenance requirement.
2) There has been uncontrolled dumping resulting in garbage being placed in the CCR unit.	Investigate who has been improperly disposing of material and remediate the situation.

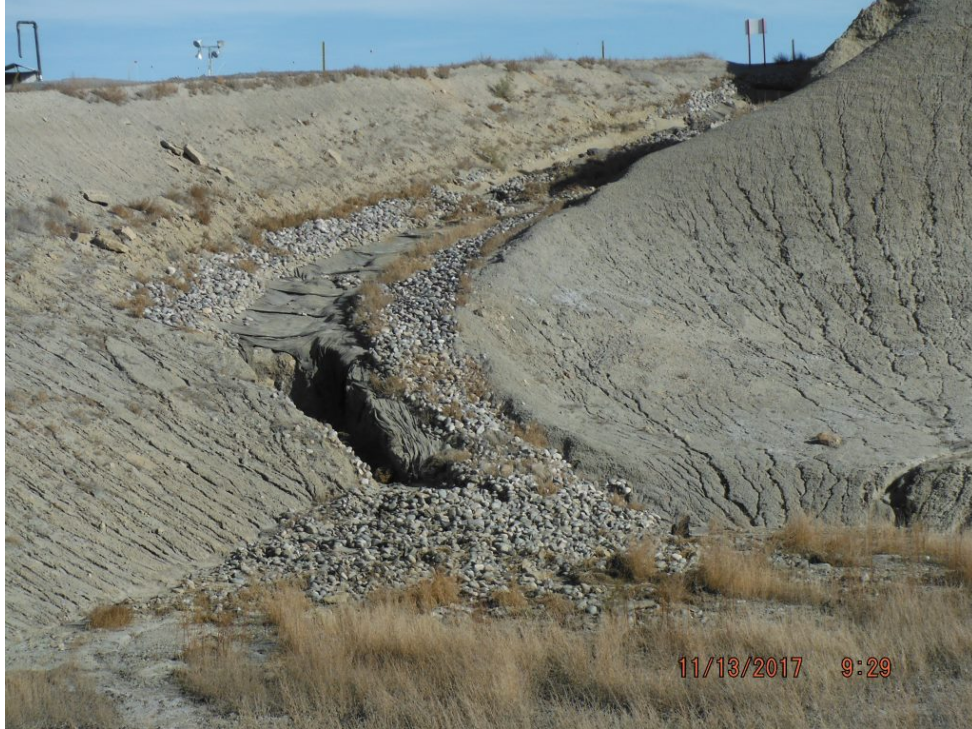
20171113 – DSCF8381
Inlet to the Storm Water Diversion Channel, facing east from the ash haul road.

Observed Condition	Action Item
1) There is erosion at the inlet and outlet of the Storm Water Diversion Channel.	With future expansion of the DFADA, perform an engineering re-evaluation to understand whether the run off pattern has changed or whether a different erosion control method should be applied. Monitor erosion and repair as required.

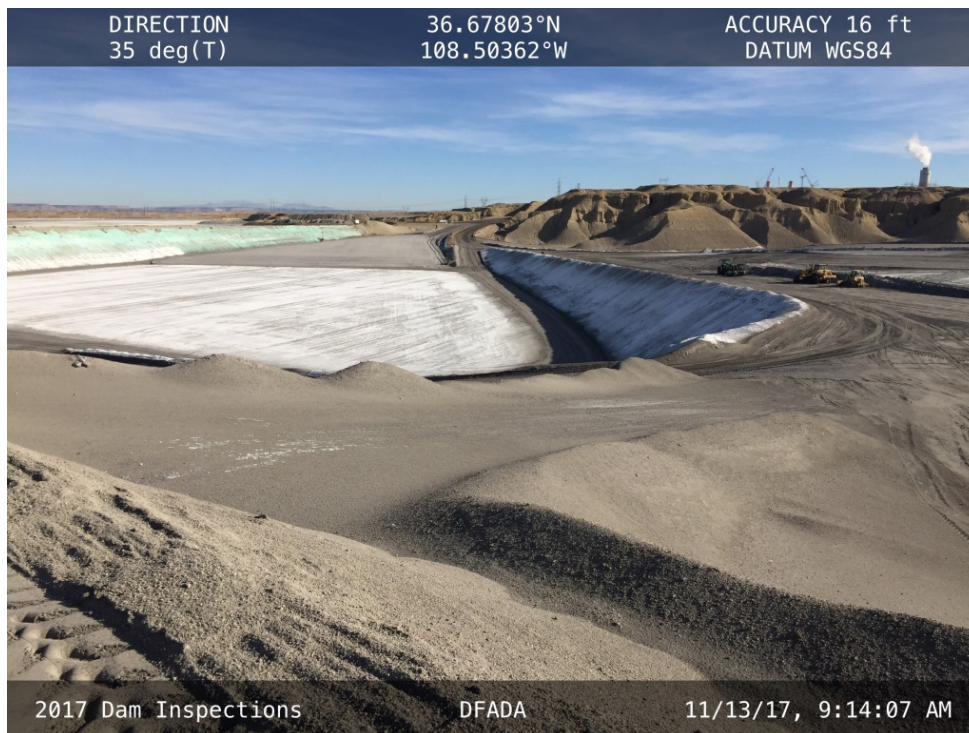
20171113 – IMG_5075

The top of Cell 3, facing west from the east side of Cell 3.

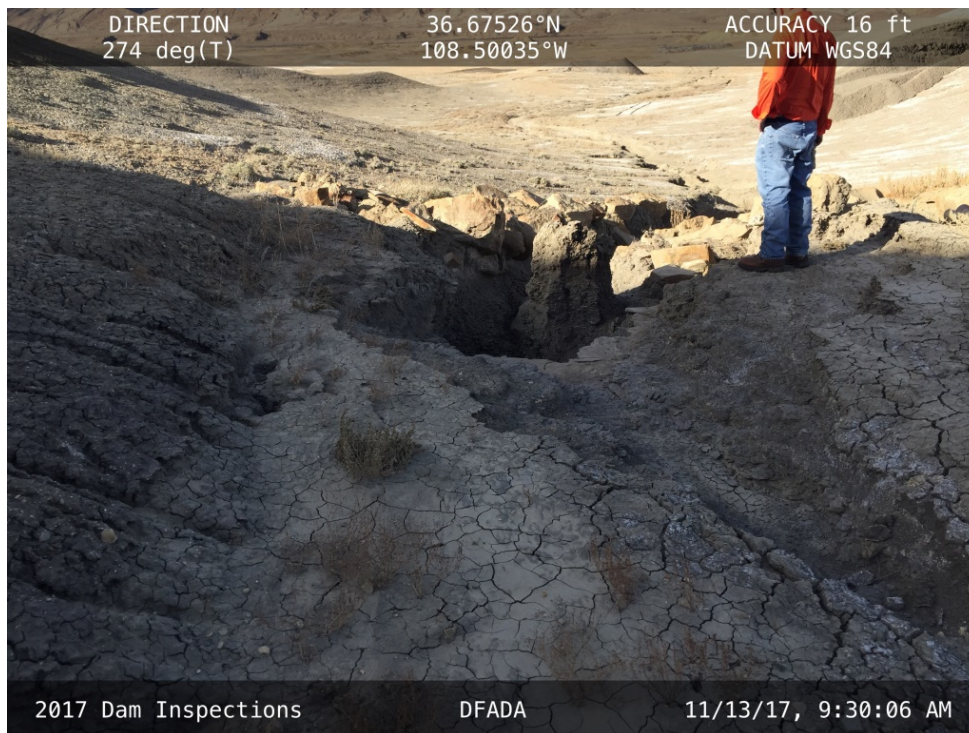
20171113 – IMG_5121
The southeastern toe of Cell 2, facing southwest.

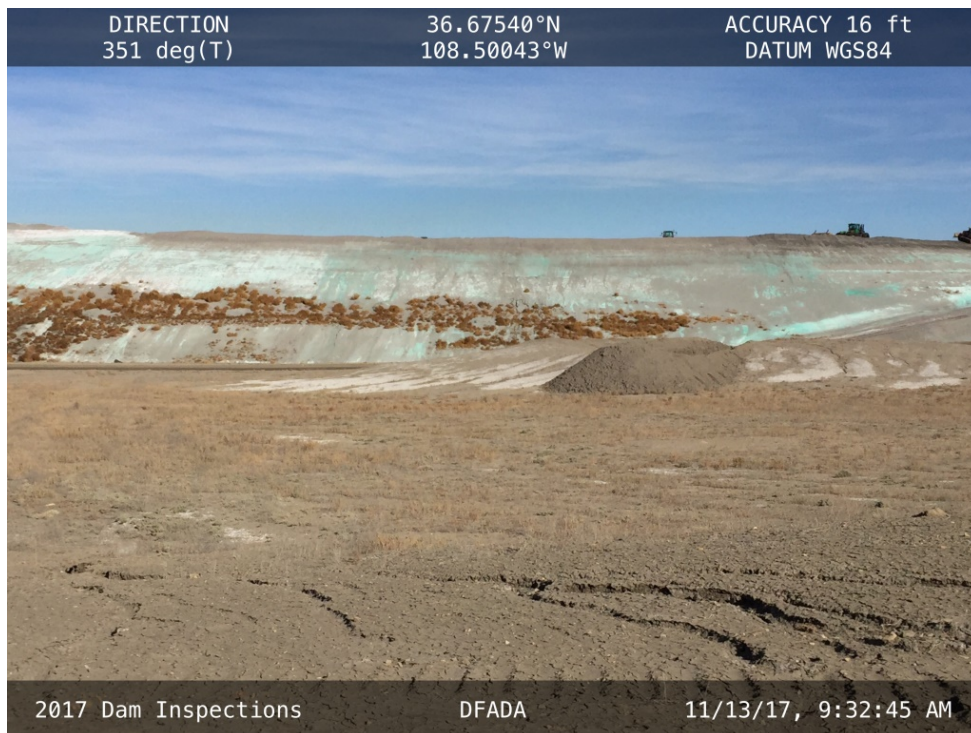
20171113 – IMG_5138
The south slope of Cell 1, facing northwest.

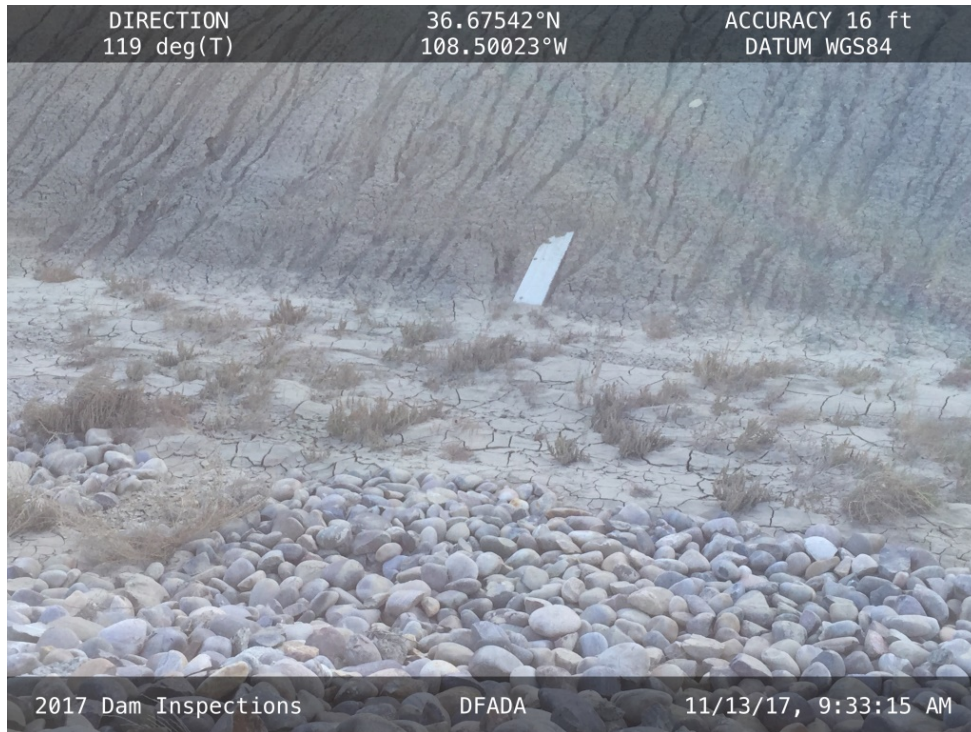
20171113 – IMG_5141
The south slope of Cells 1 and 2, facing north.

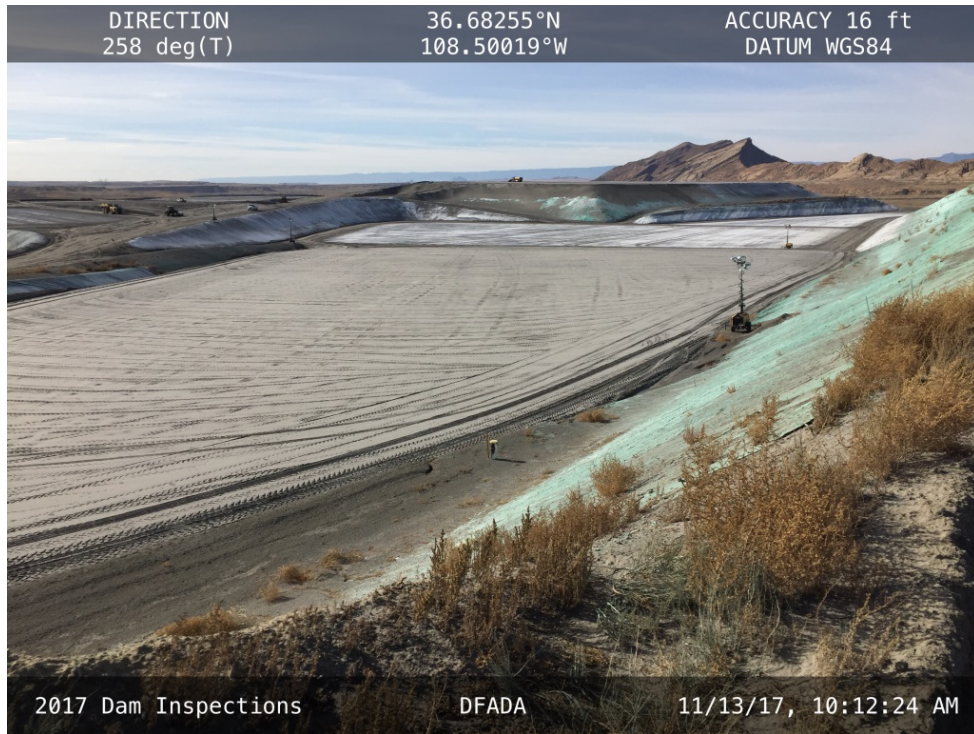
20171113 – IMG_5179
A tear in the geomembrane liner of the Cell 1 collection pond.

3) There is damage to the geomembrane liner along the Cell 2 collection pond, the saddle between the Cell 1 and Cell 2 collection ponds, and the Cell 3 berm.	Repair the liner.

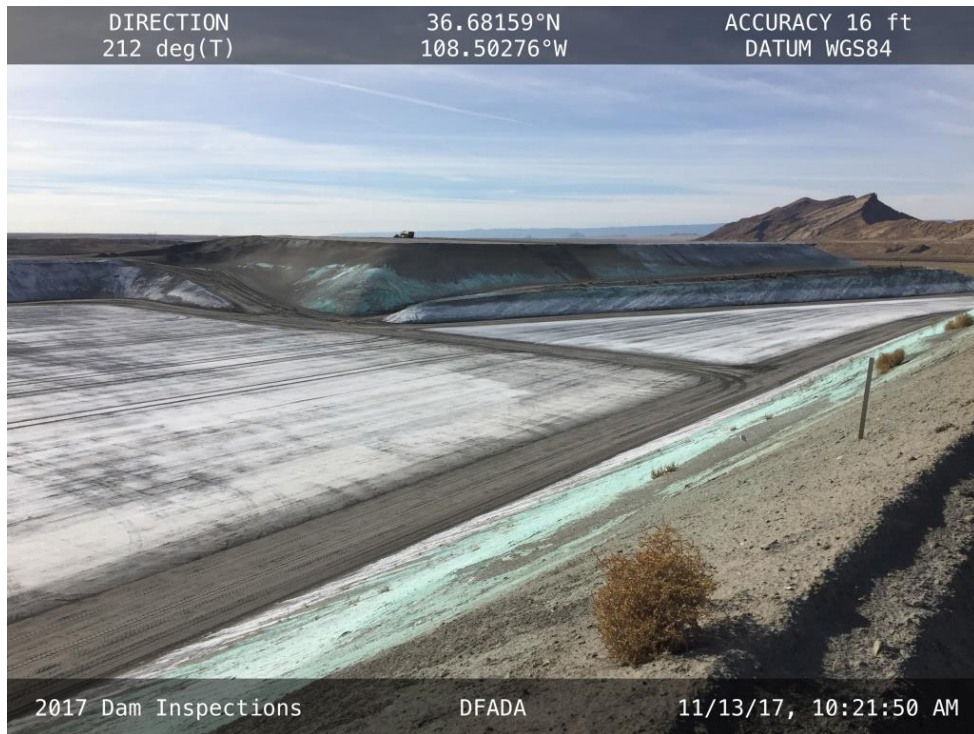
20171113 – IMG_5187

Overview of the eastern half of Cell 3 from the LAI South Embankment, facing southwest.

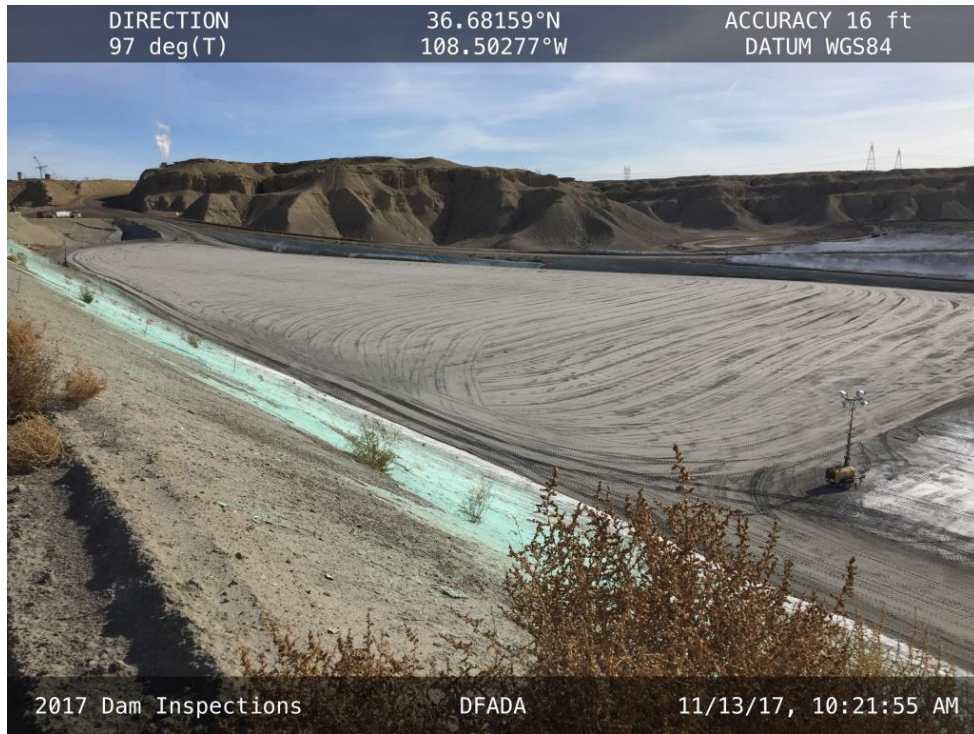
20171113 – IMG_5207

Overview of the western half of Cell 3 from the LAI South Embankment, facing southwest.
