**FOUR CORNERS POWER PLANT
Lined Ash Impoundment,
Lined Decant Water Pond,
Combined Waste Treatment Pond,
Dry Fly Ash Disposal Area,
and Return Water Pond**

**Annual
CCR Impoundment and
Landfill Inspection Report
2022**

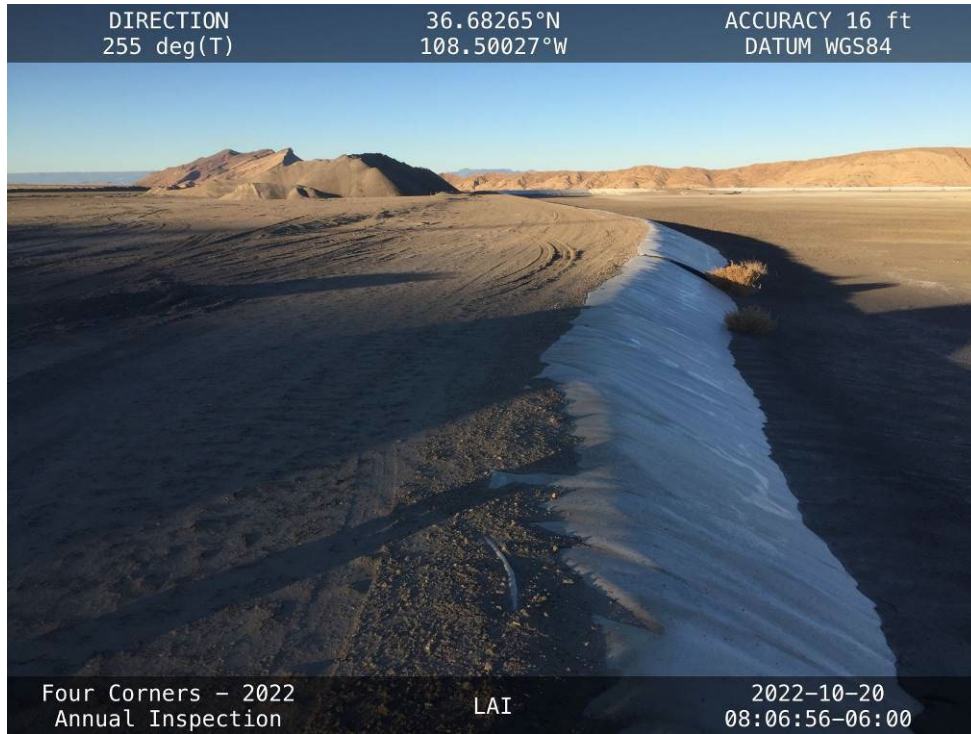
20221020 – IMG_4409

The South Embankment crest and upstream slope, facing southwest from the eastern end.

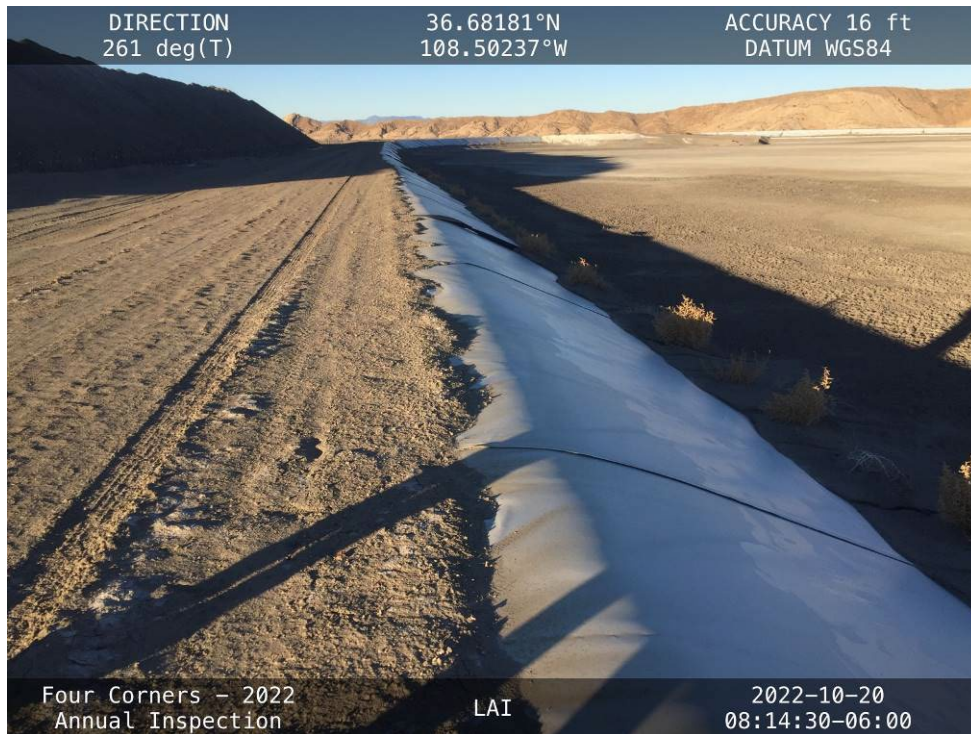
20221020 – IMG_4416

The South Embankment upstream slope, facing southwest from the middle of the embankment.

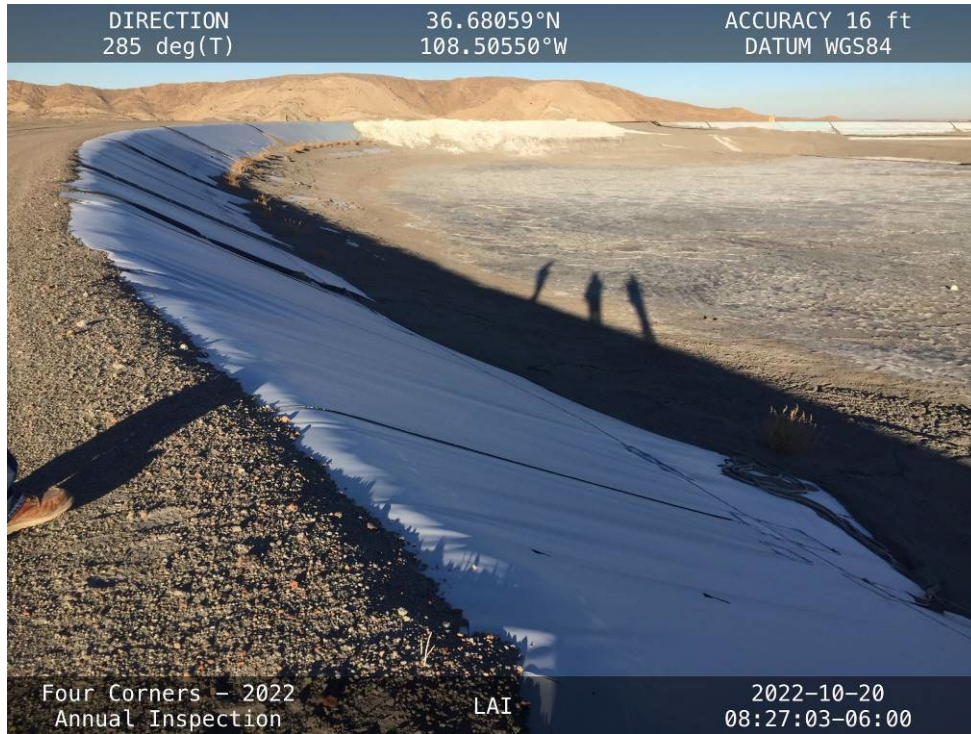
20221020 – IMG_4426

The upstream slope of the South Embankment, facing west toward the Southwest Corner.

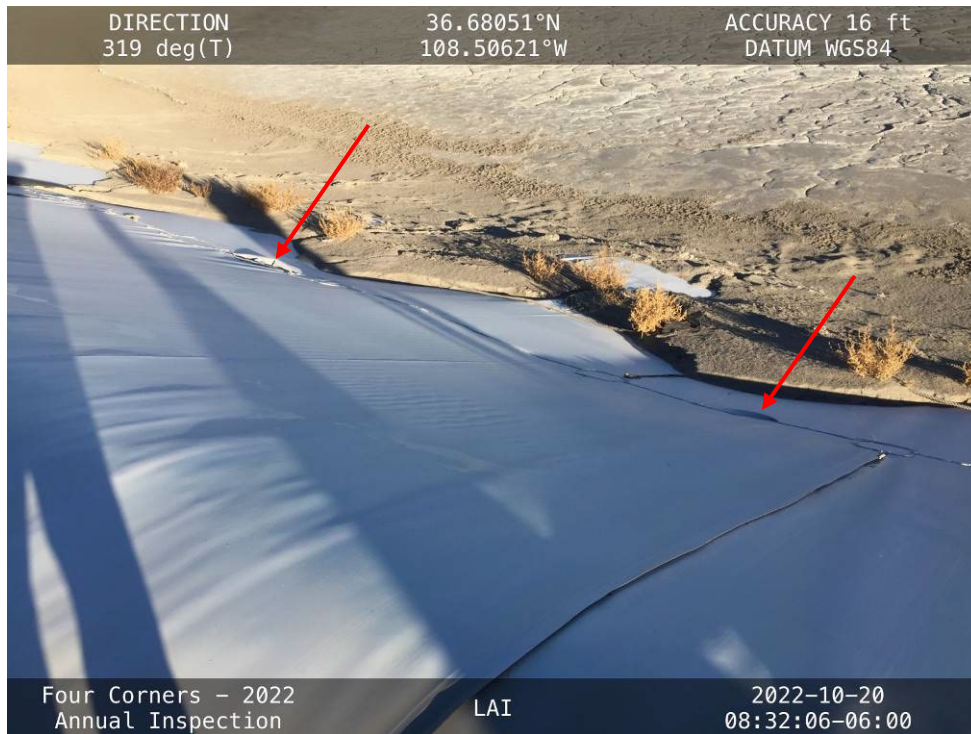
20221020 – IMG_4443

Undulations in the liner and tears along the horizontal seam in the Southwest Corner.

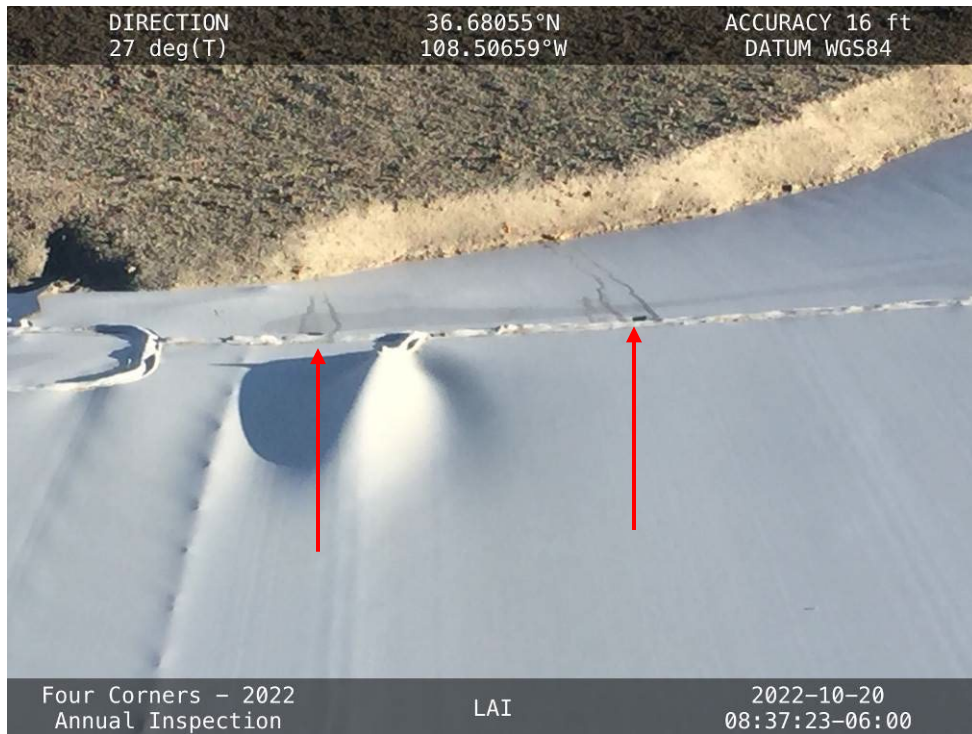
20221020 – IMG_4450

Water seeping from the horizontal seam in the liner in the Southwest Corner.

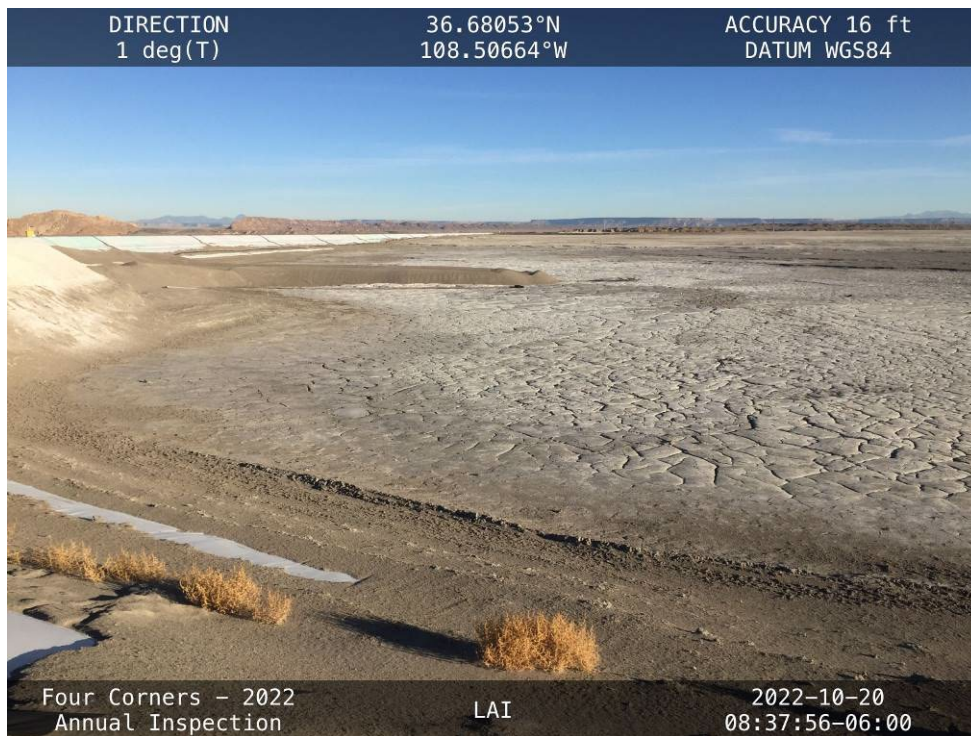
20221020 – IMG_4453

The Southwest Corner of the LAI with no water impounded in the reservoir.

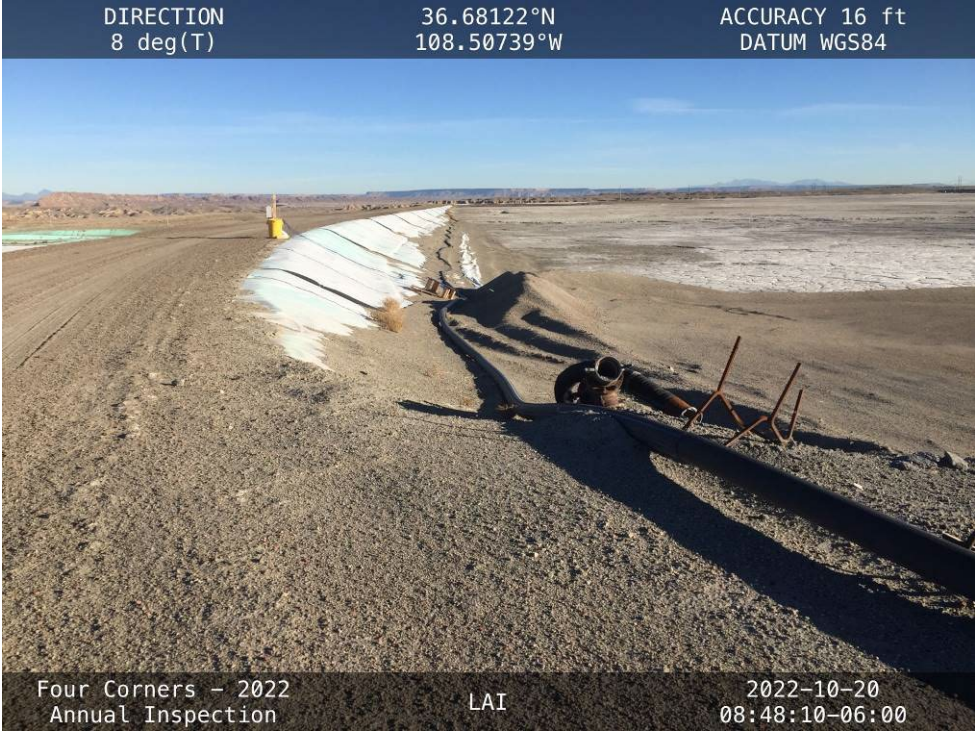
20221020 – IMG_4464

The upstream slope of the West Embankment, facing north from the Southwest Corner.

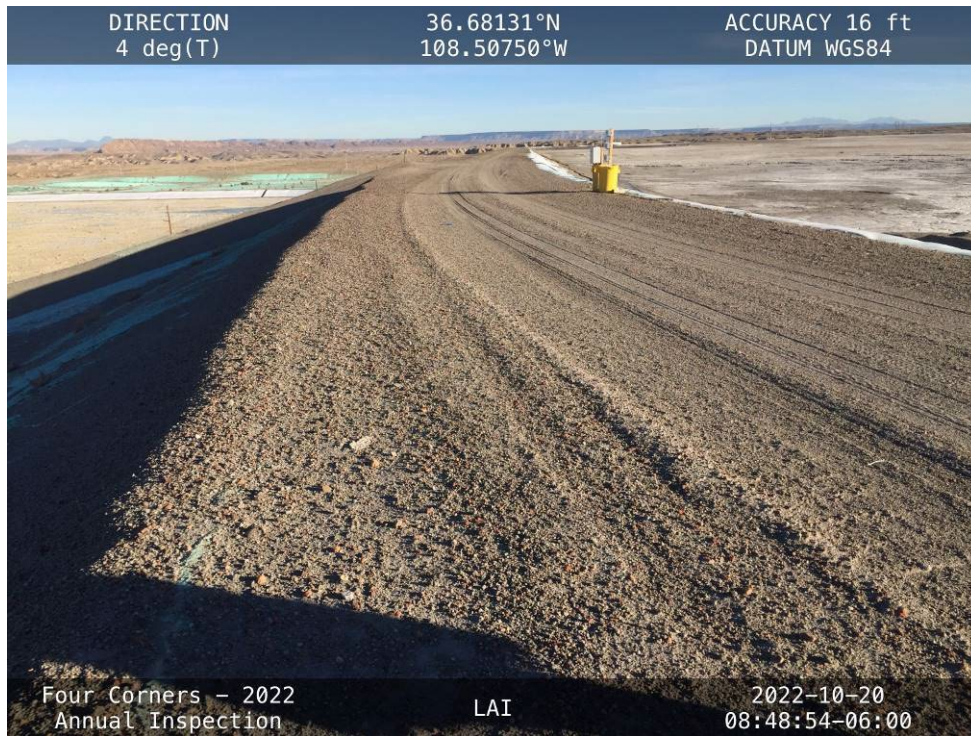
20221020 – IMG_4468

The crest of the West Embankment, facing north from the Southwest Corner.

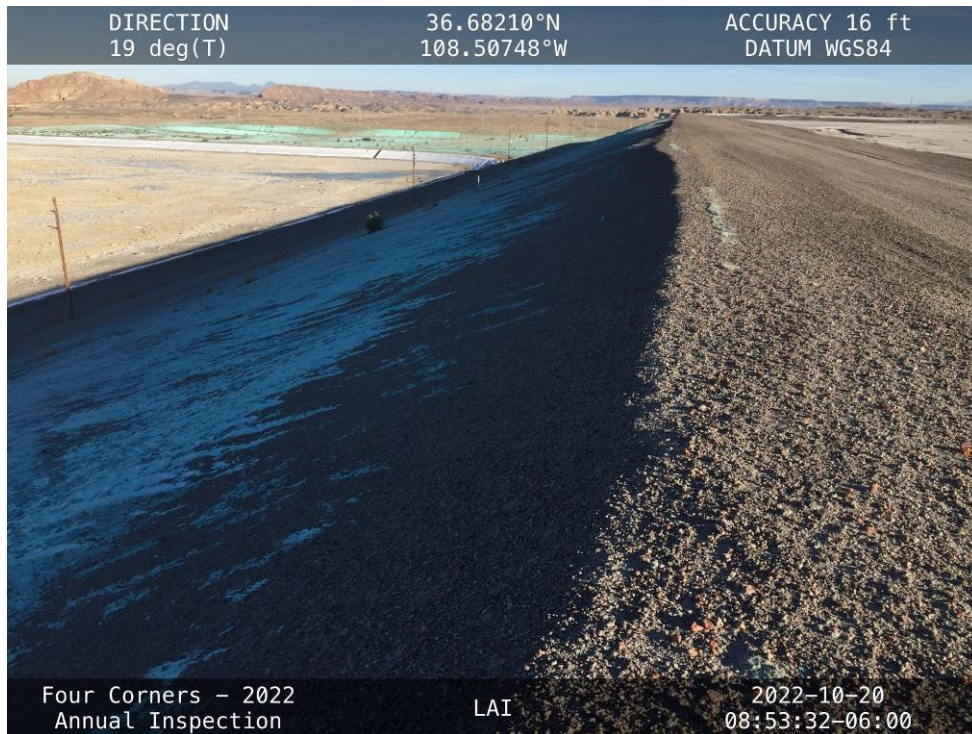
20221020 – IMG_4474

The downstream slope of the West Embankment, facing north from the crest.

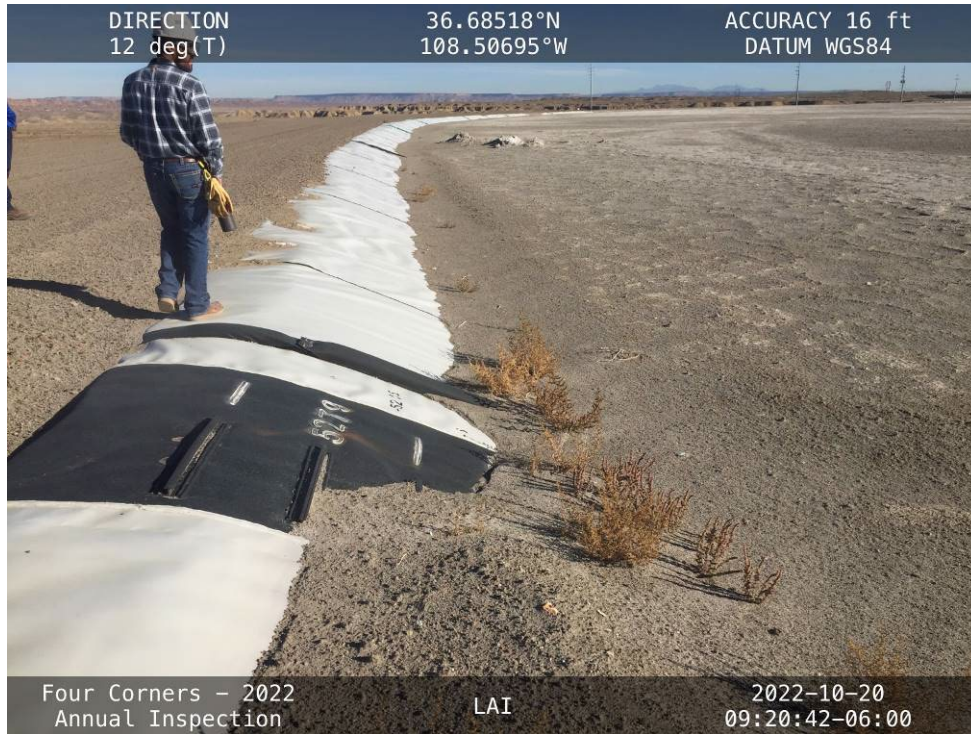
20221020 – IMG_4485

The upstream slope of the West Embankment, facing north from the Drop Inlet Structure ramp.

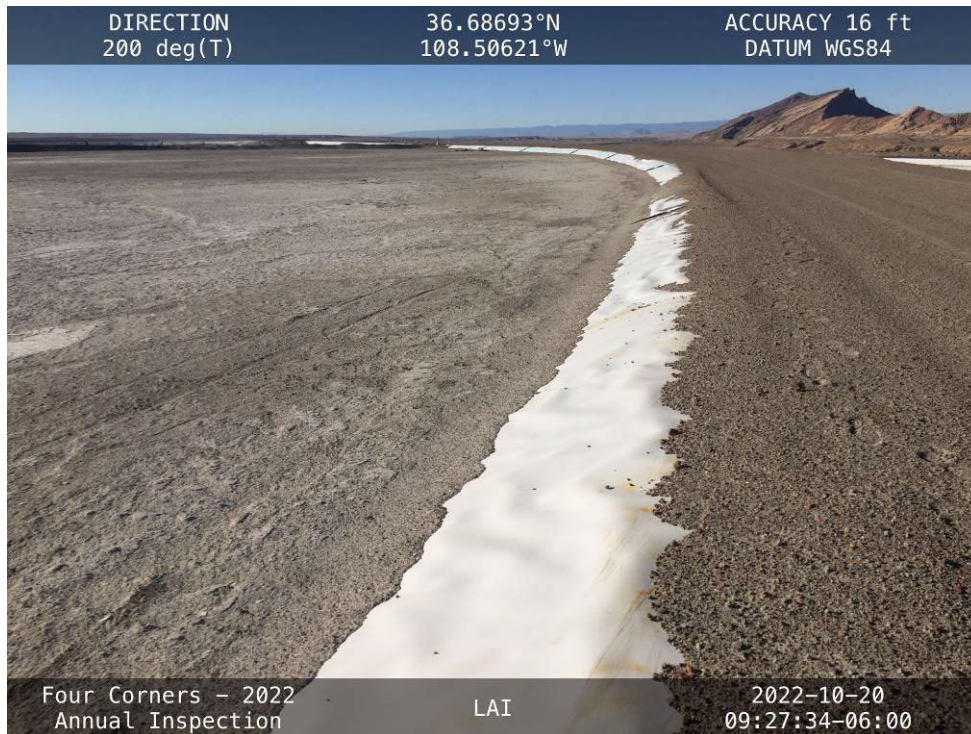
20221020 – IMG_4490

The impounded ash level along the north side of the West Embankment, facing south.

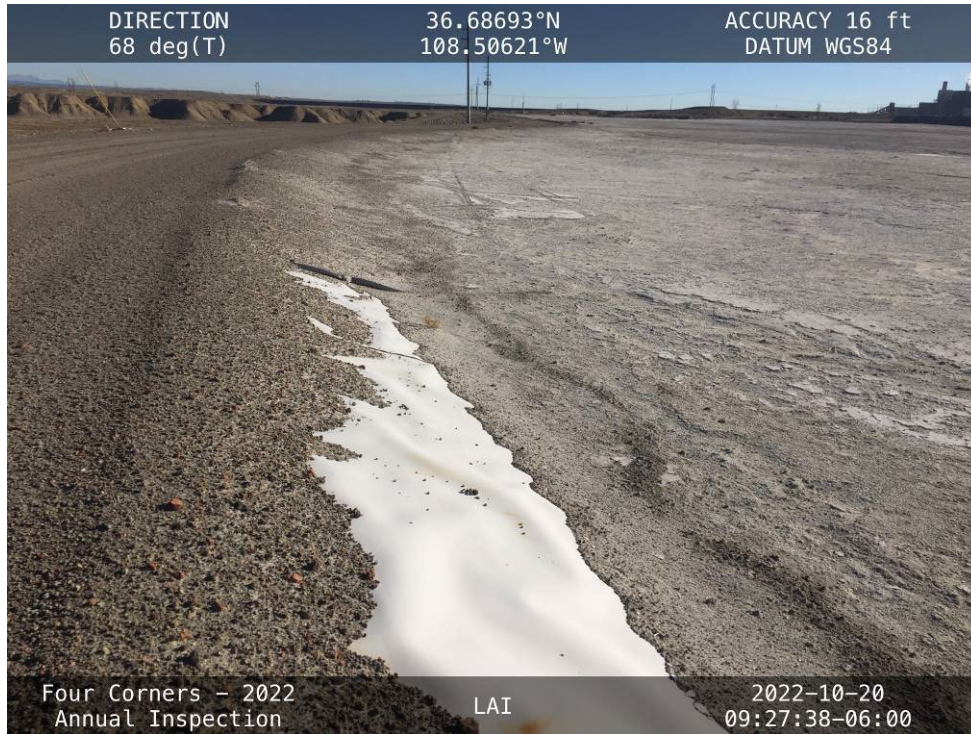
20221020 – IMG_4491

The impounded ash level nearly at the crest of the Northwest Embankment, facing northeast.

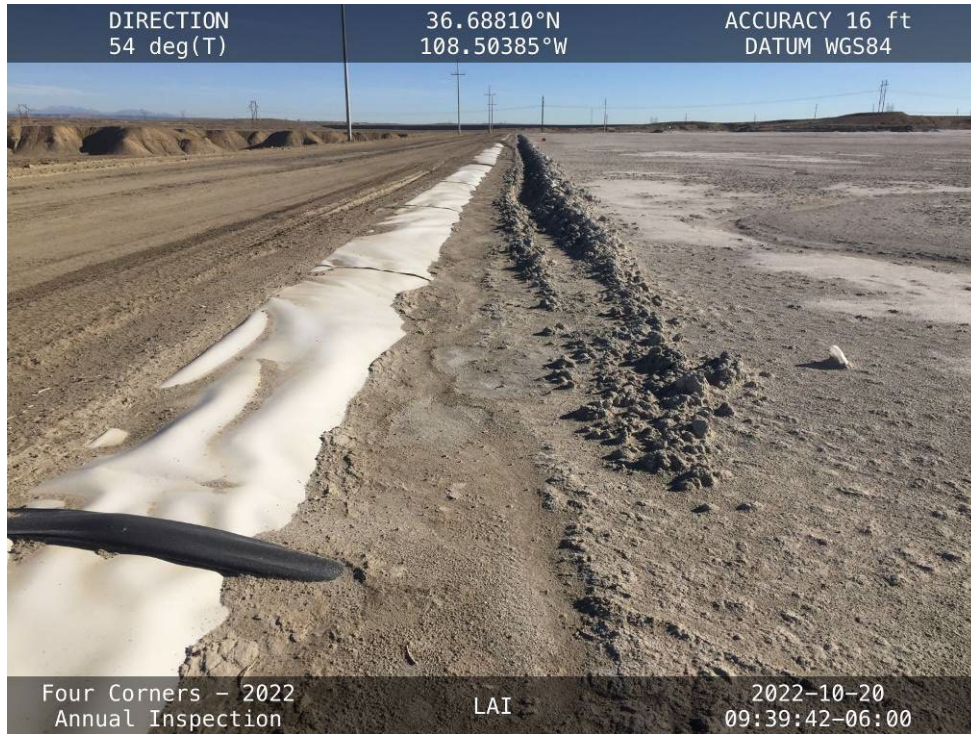
20221020 – IMG_4505

A diversion channel along the Northwest Embankment to keep stormwater away from the crest, facing northeast.

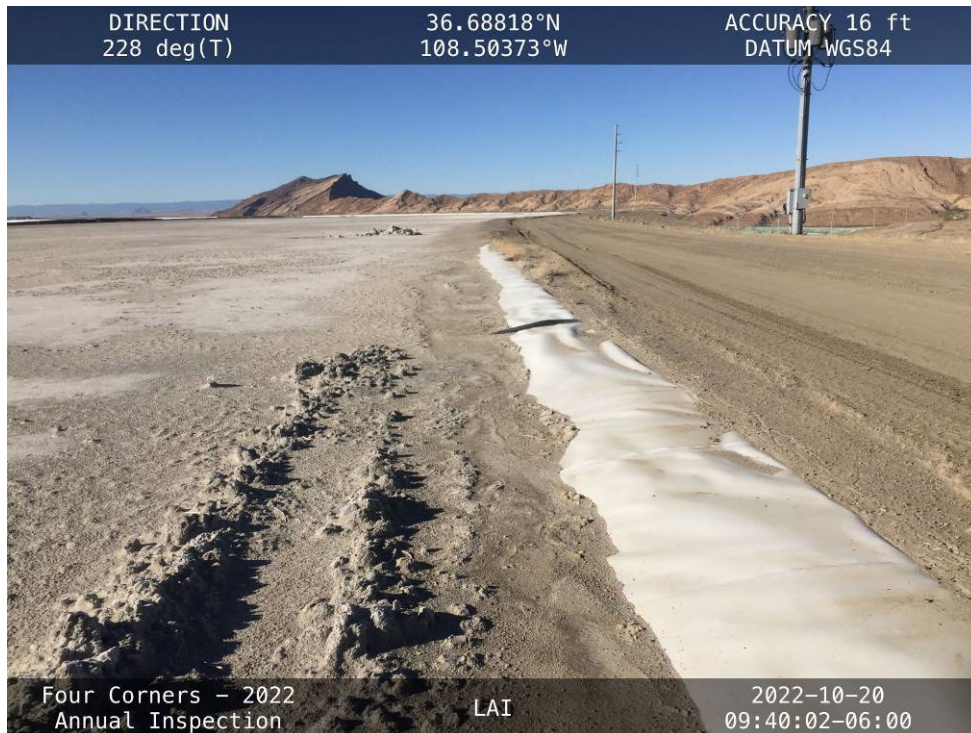
20221020 – IMG_4506

The impounded ash along the Northwest Embankment, facing southwest.

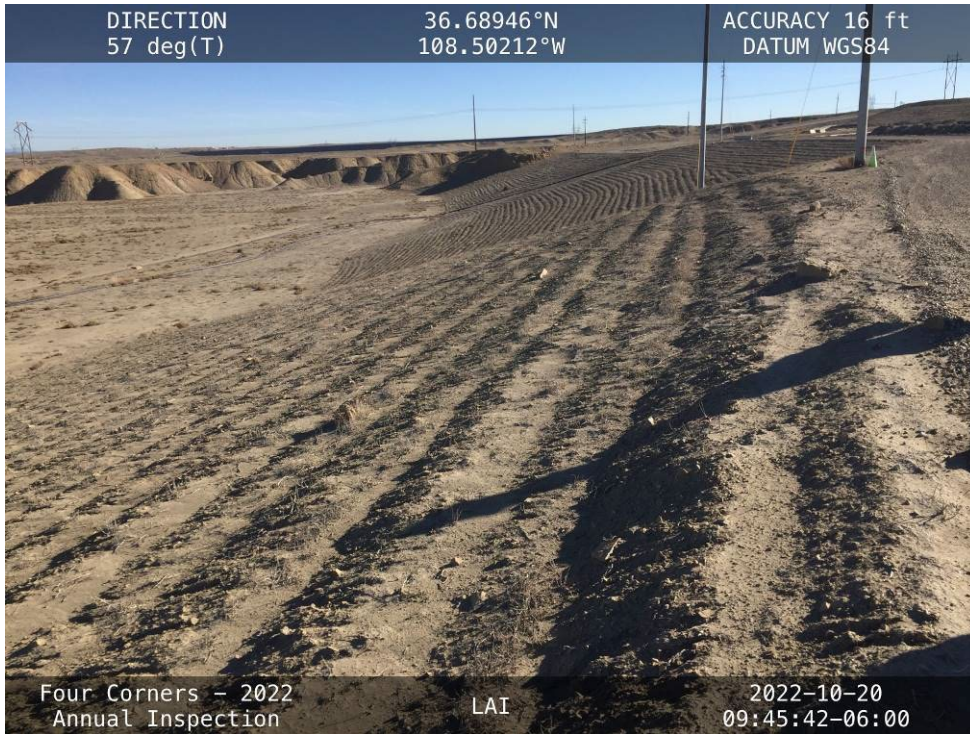
20221020 – IMG_4510

The downstream slope of the Northwest Embankment, facing northeast.

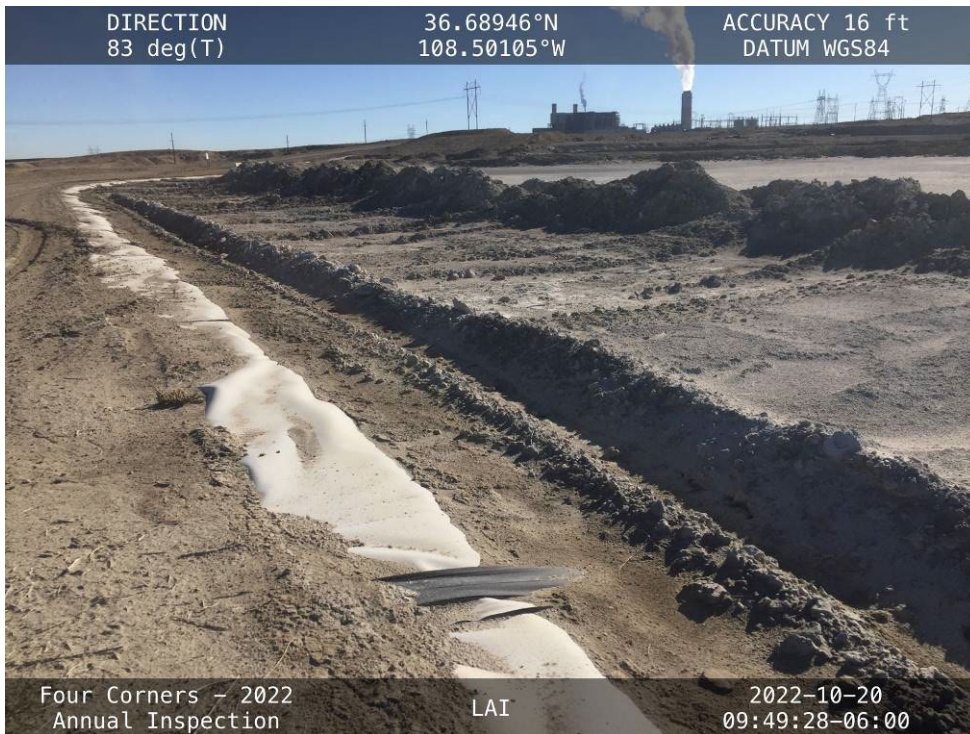
20221020 – IMG_4512

Ash and the CCR berm constructed to keep stormwater off the crest at the north V-ditch, facing northeast.

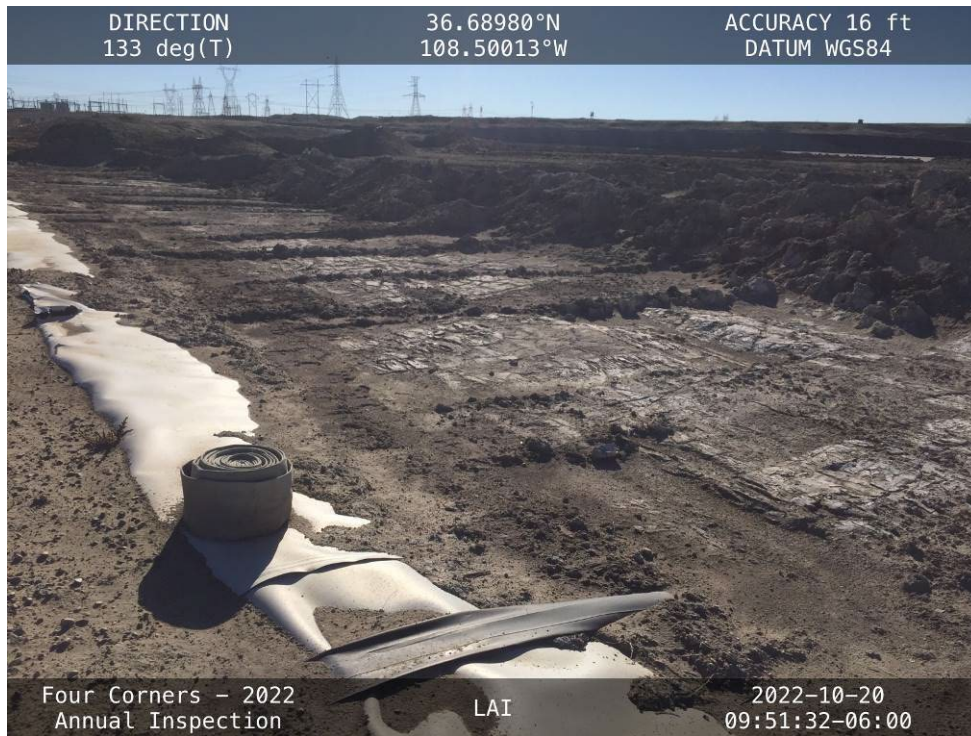
20221020 – IMG_4517

The CCR berm constructed to keep stormwater off the crest at the north V-ditch, facing northeast.

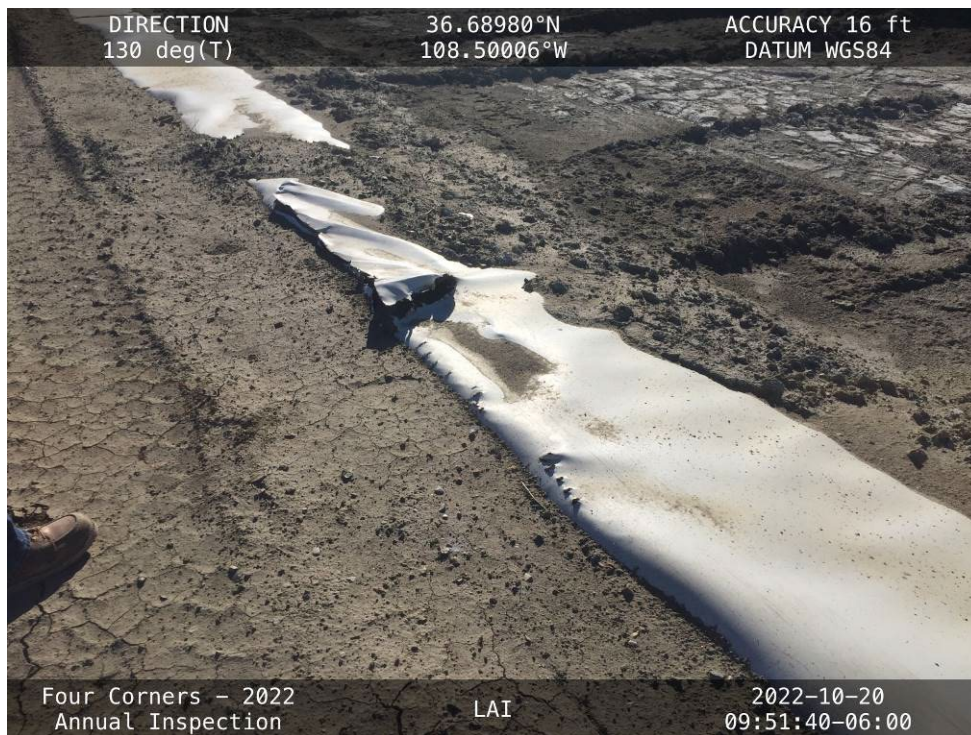
20221020 – IMG_4518

Tears in the liner near the north V-ditch where the ash berm was constructed.

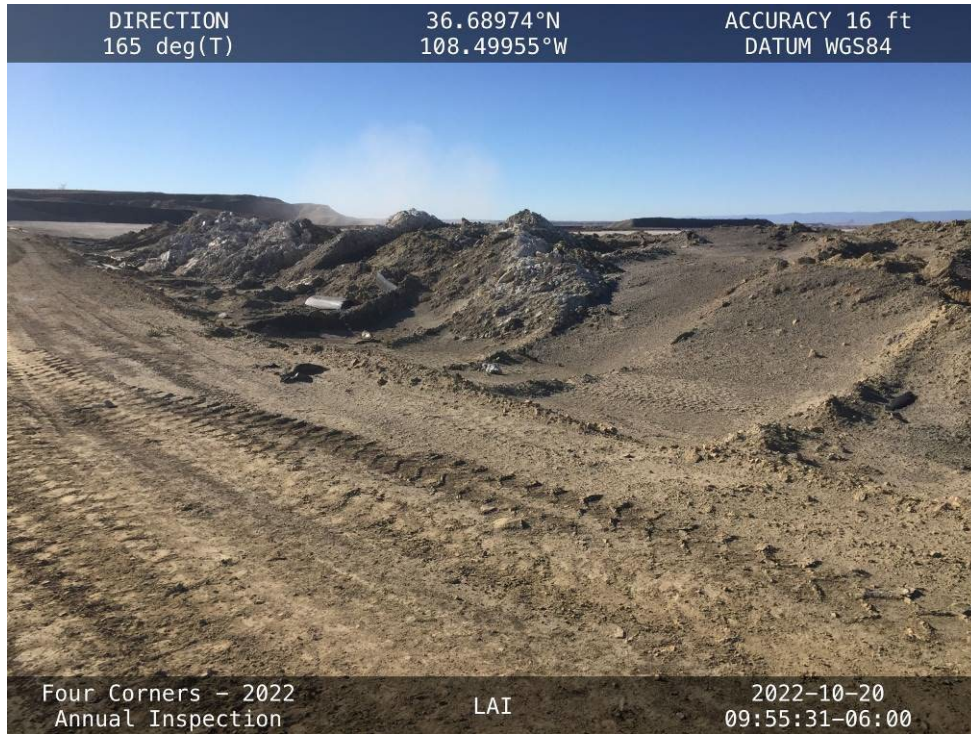
20221020 – IMG_4524

The CCR berm constructed to keep stormwater off the crest at the north V-ditch, facing south.

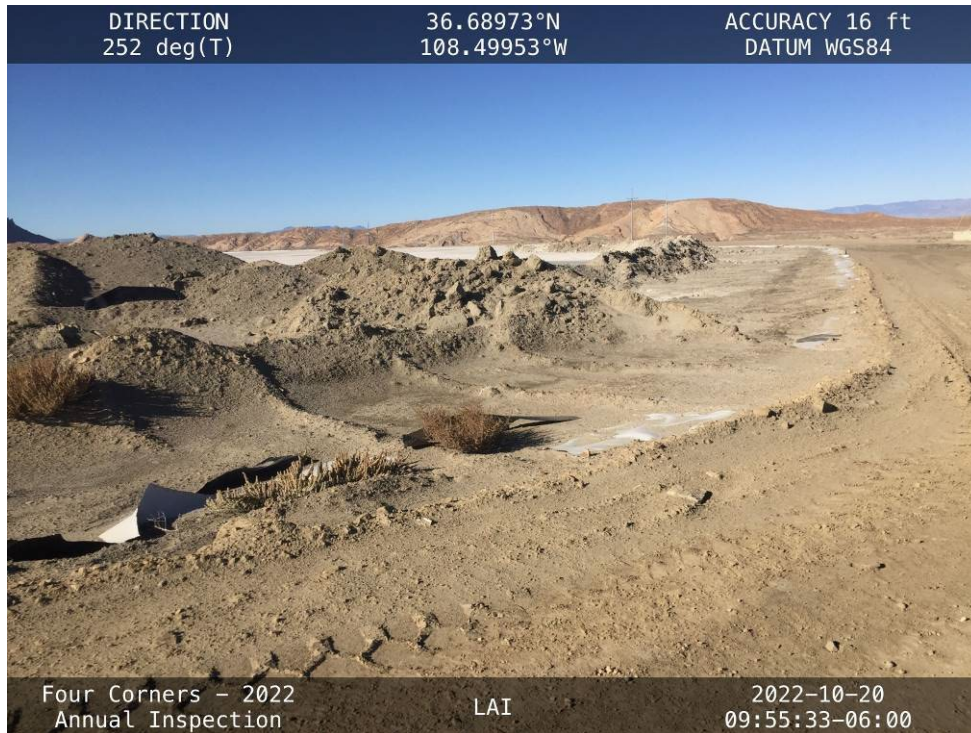
20221020 – IMG_4526

The CCR berm constructed to keep stormwater off the crest at the north V-ditch, facing west.

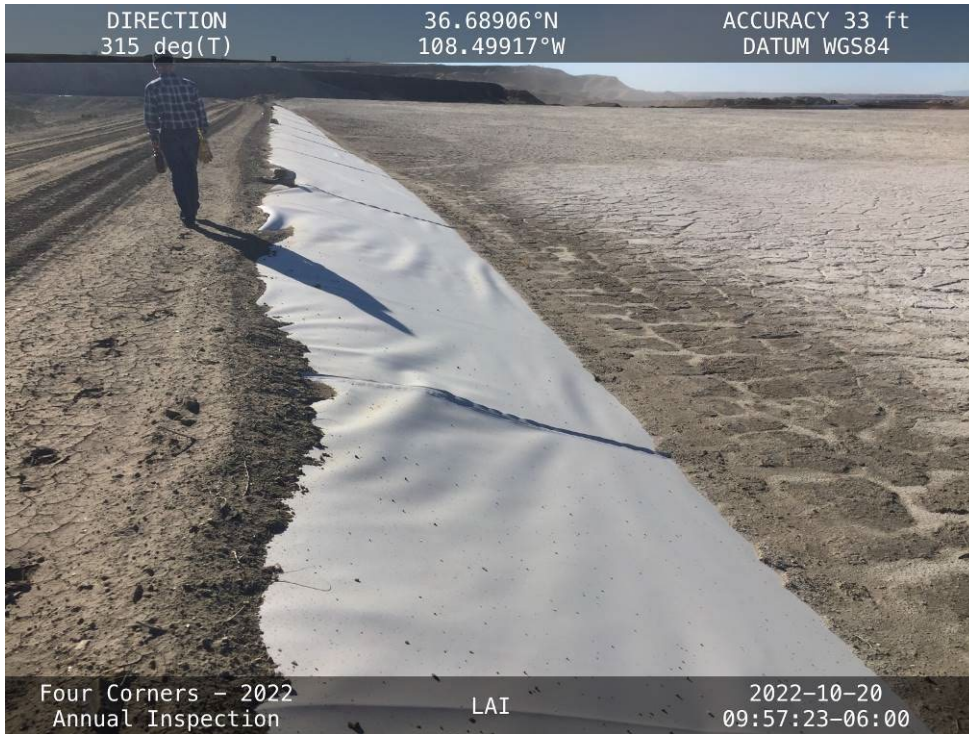
20221020 – IMG_4527

The upstream slope of the East Embankment, facing south near the north V-ditch.

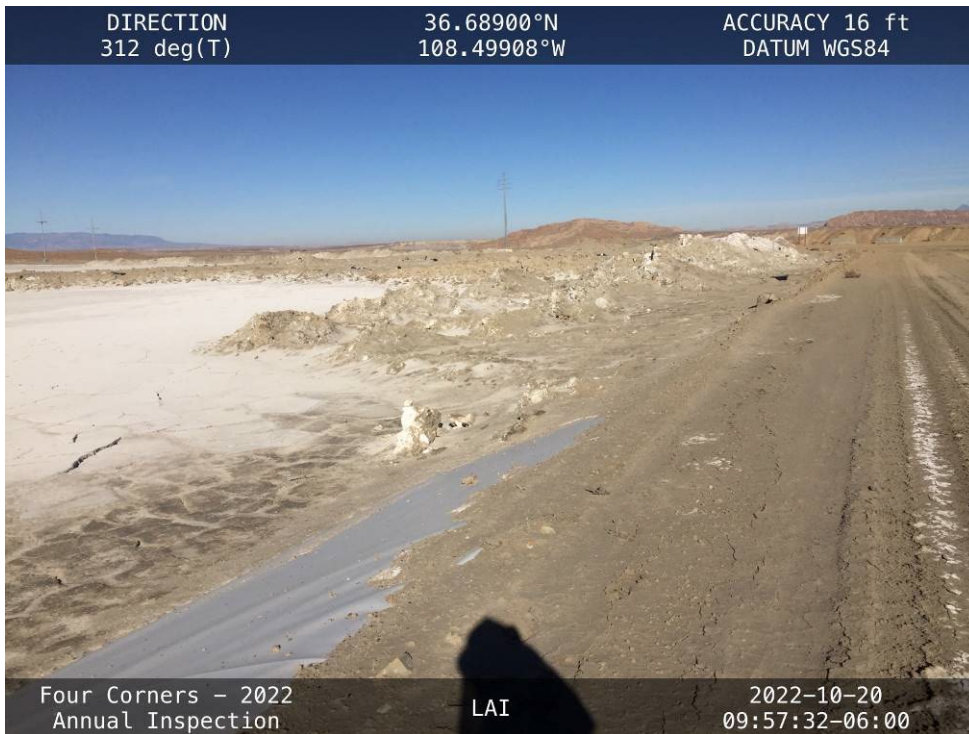
20221020 – IMG_4528

The CCR berm constructed to keep stormwater off the crest at the north V-ditch, facing northwest.

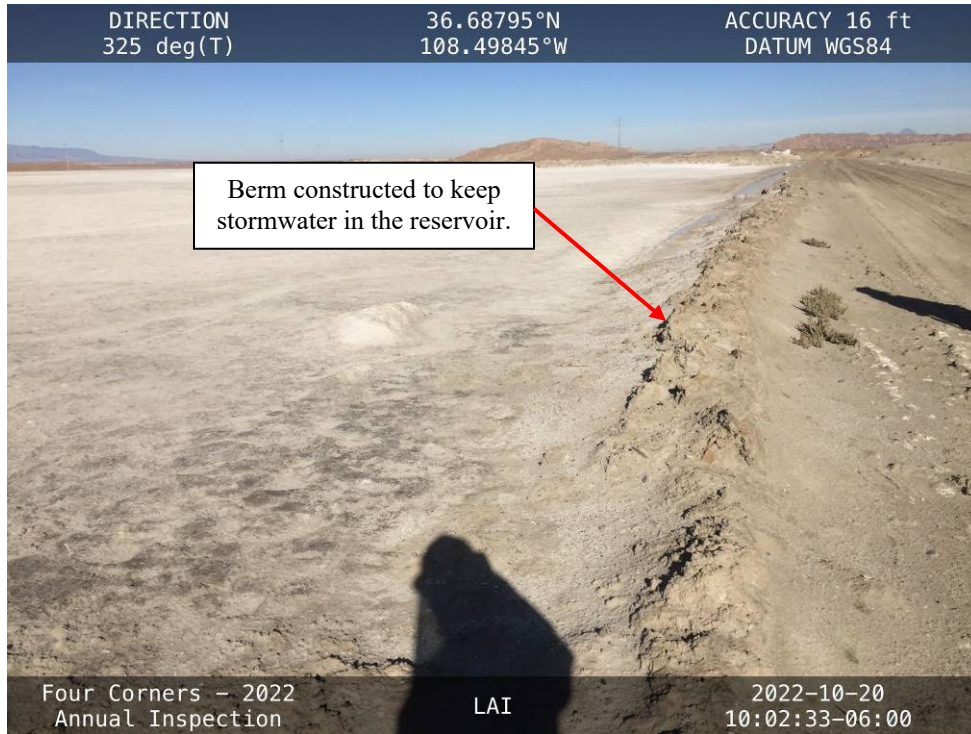
20221020 – IMG_4534

The East Embankment, regraded north of the old V-ditch, facing north.

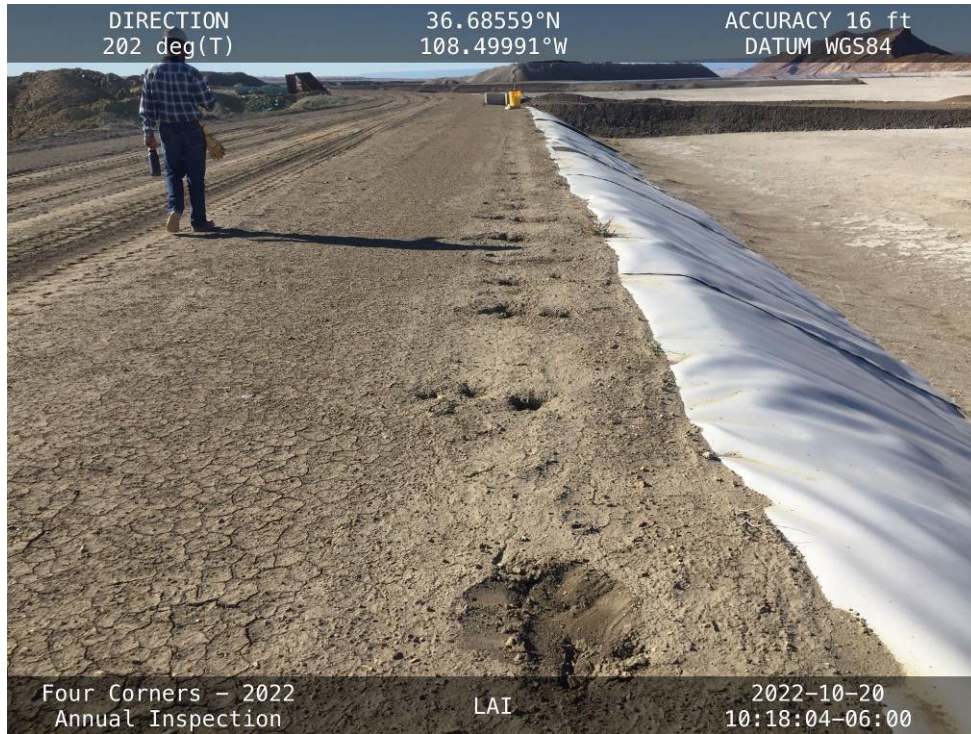
20221020 – IMG_4560

A series of shallow holes in the East Embankment anchor trench, facing south.

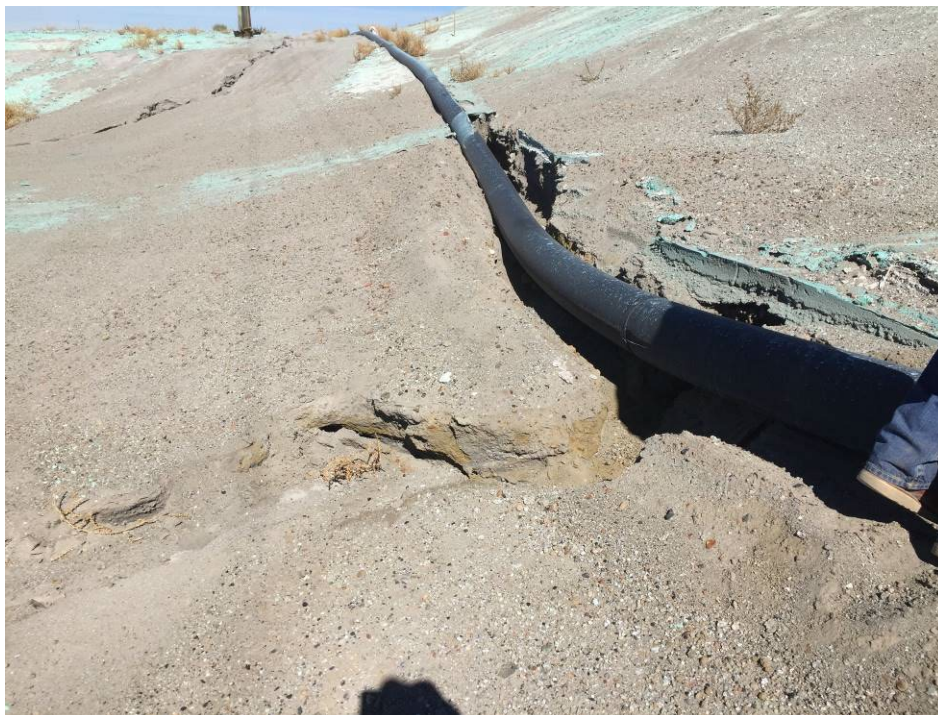
20221020 – IMG_4822

Erosion gullies at the toe of the West Embankment around the return water pipe from the LAI/LDWP pump station.

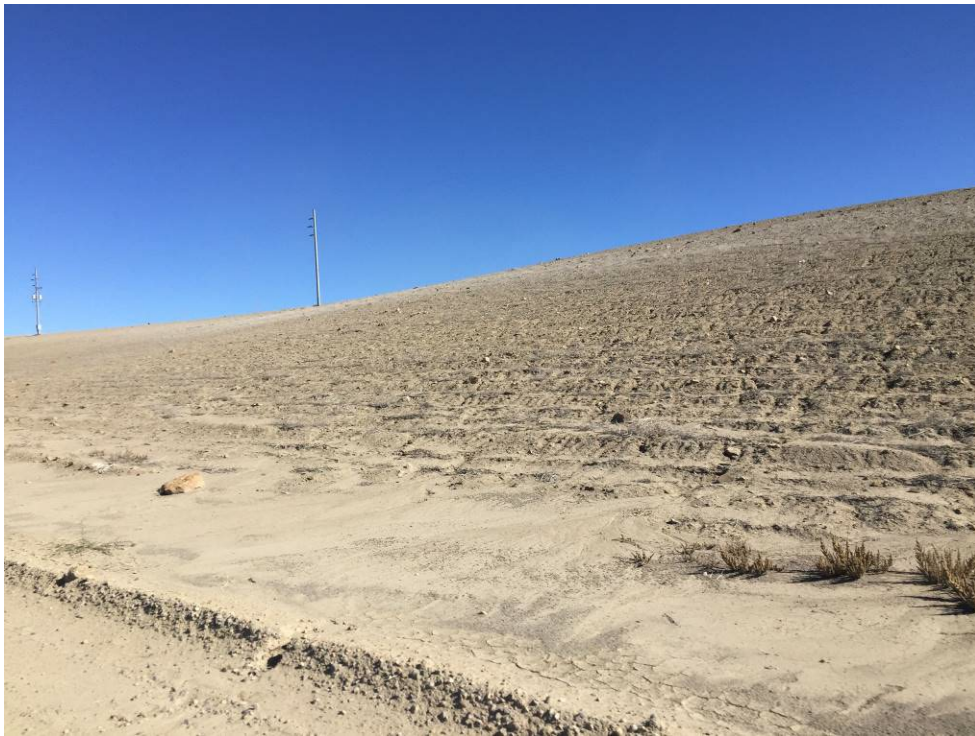
20221020 – IMG_4909

The downstream slope of the Northwest Embankment, looking northeast along the toe.

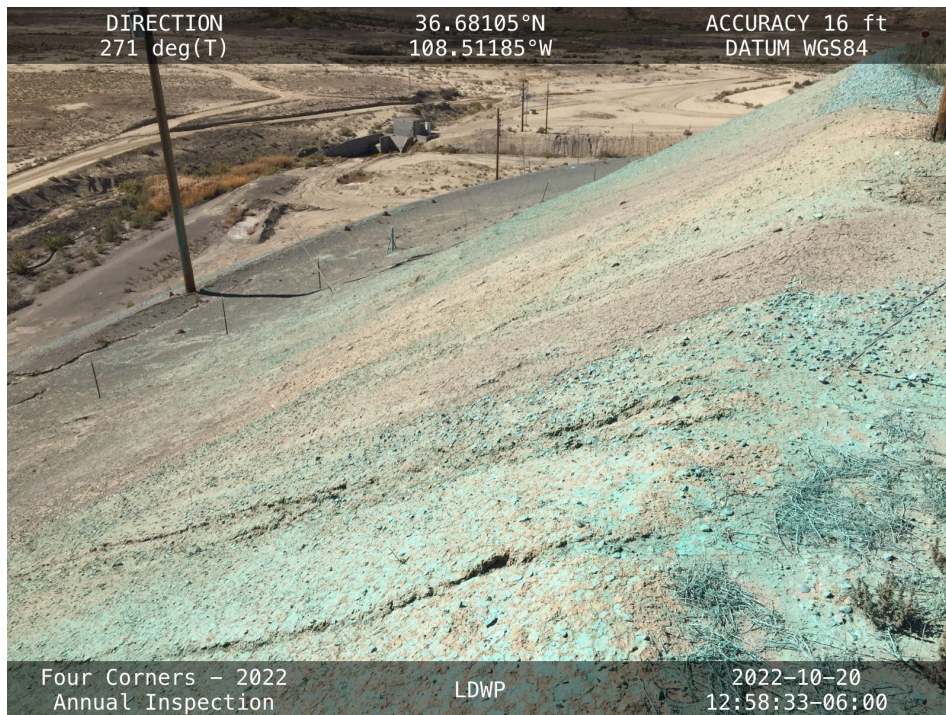
20221020 – IMG_4760

Minor erosion on the downstream slope of the South Embankment, facing west toward the Pond 3 Pump House.

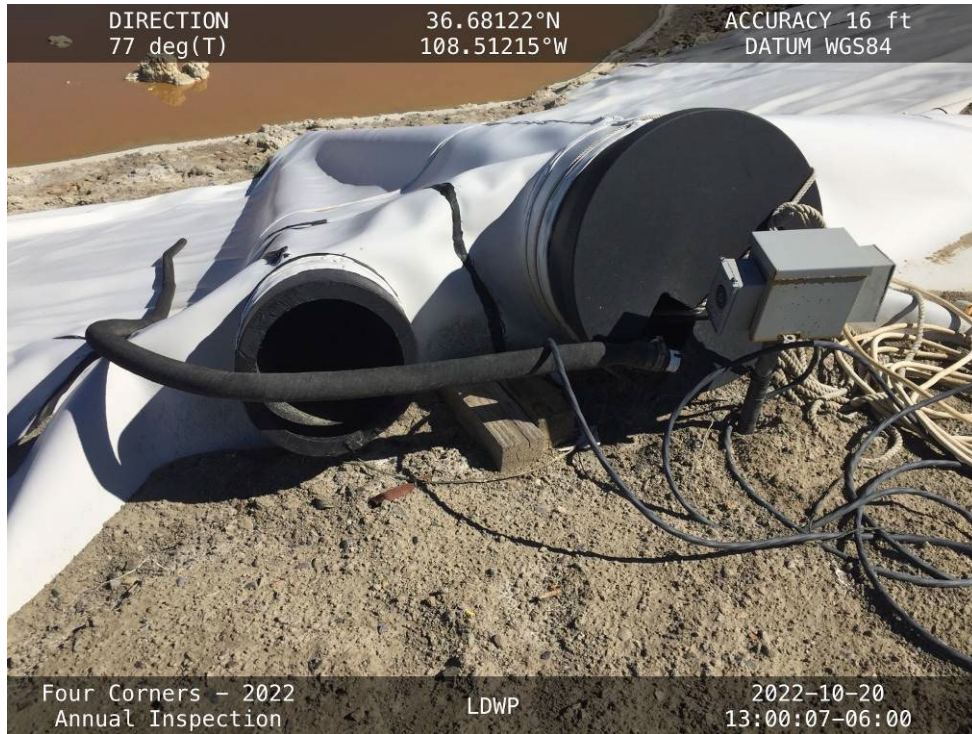
20221020 – IMG_4766

The Interstitial Evacuation Pump access pipes in the southwest corner of the LDWP.

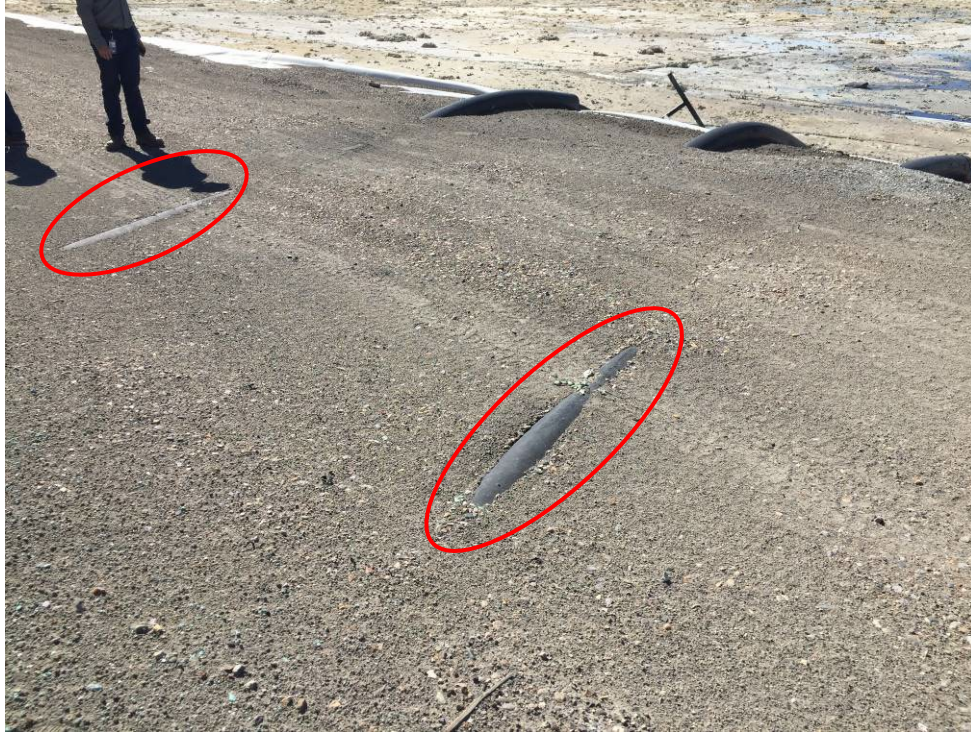
20221020 – IMG_4861

Portions of the outer pipes for the suction intake lines exposed across the East Embankment crest.

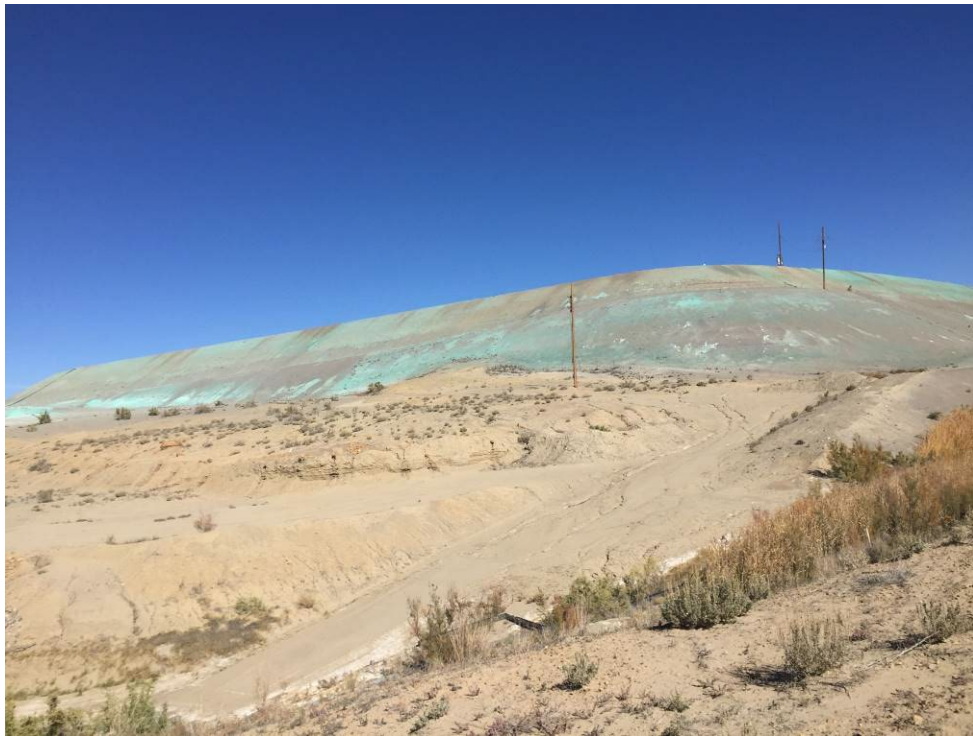
20221020 – IMG_4893

The West Embankment slope, facing north from the toe road near the Pond 3 Pump House.

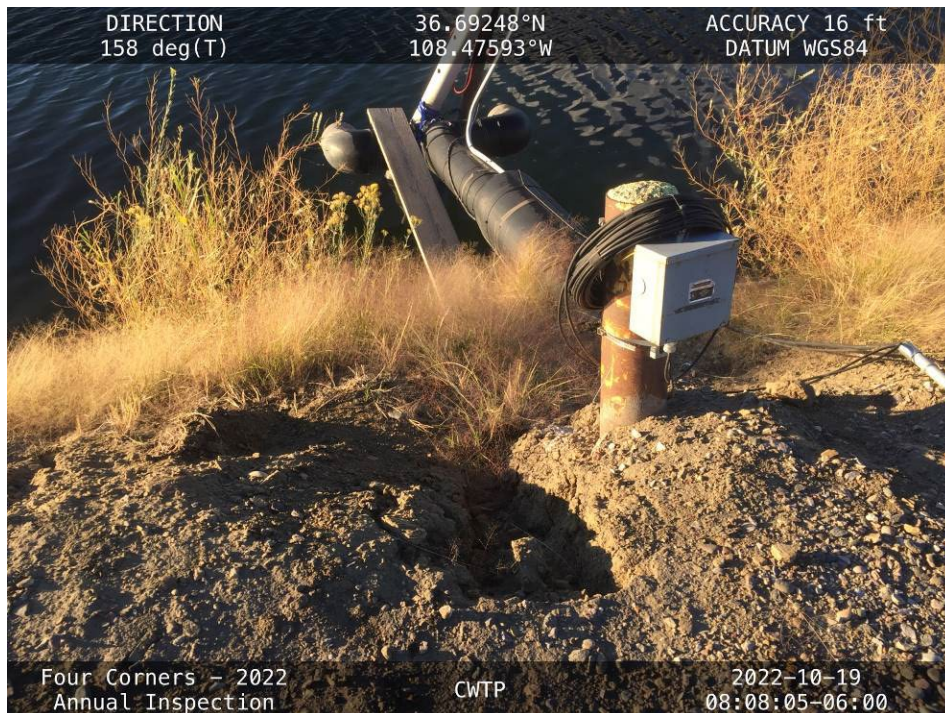
20221019 – IMG_3997

Erosion around the water level transducer and the 18-inch pipe that transfers water from the canal to the CWTP.
