**FOUR CORNERS POWER PLANT
Lined Ash Impoundment,
Lined Decant Water Pond,
Combined Waste Treatment Pond,
Dry Fly Ash Disposal Area,
and Return Water Pond**

**Annual
CCR Impoundment and
Landfill Inspection Report
2022**

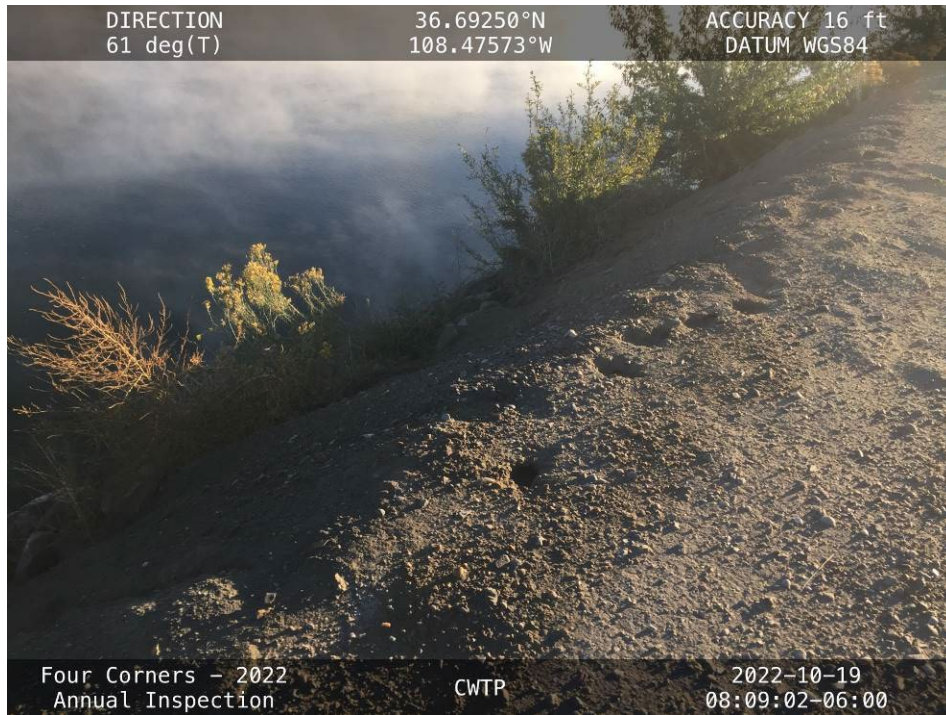
20221019 – IMG_3998

Shallow holes on the downstream shoulder of the North Embankment where there were depressions in 2021 (2021 IMG_8448).

6) Two small erosion holes were observed on the downstream shoulder of the East Embankment crest.	Repair the holes.
7) A set of shallow holes was observed on the downstream shoulder of the North Embankment near the 18-inch pipe that transfers water from the canal to the CWTP.	Regrade this area and repair the holes.

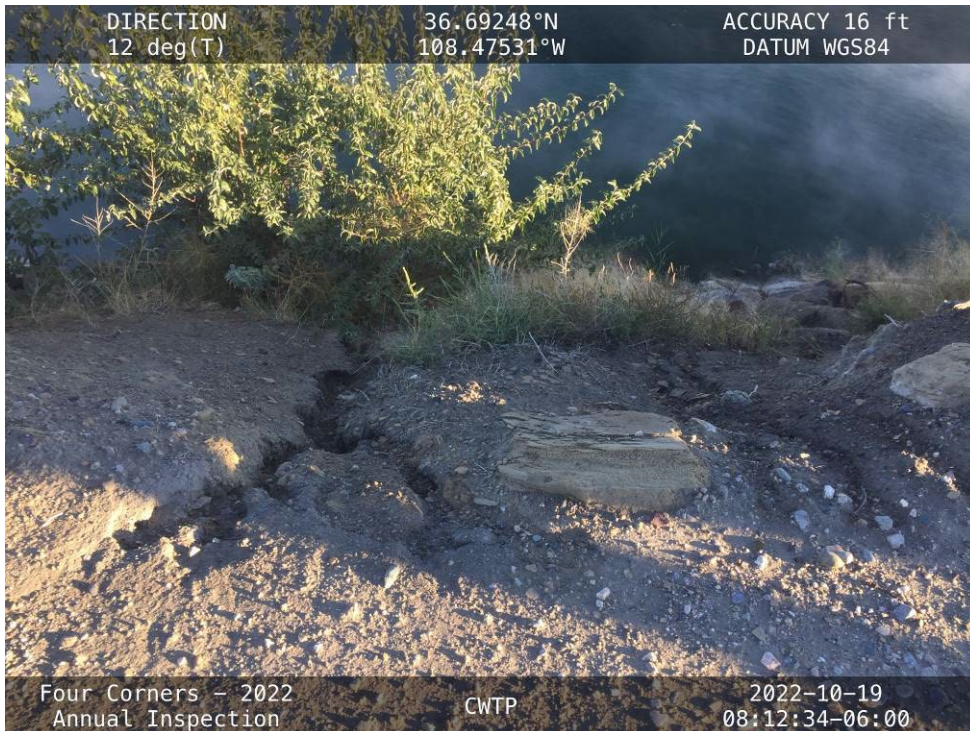
20221019 – IMG_4006

Erosion rills on the downstream slope of the North Embankment.

2) Instances of erosion, including one location with 14 inches of erosion, were observed along the upstream and downstream slopes.	Continue to monitor these areas and repair erosion if it exceeds 1 foot in depth.

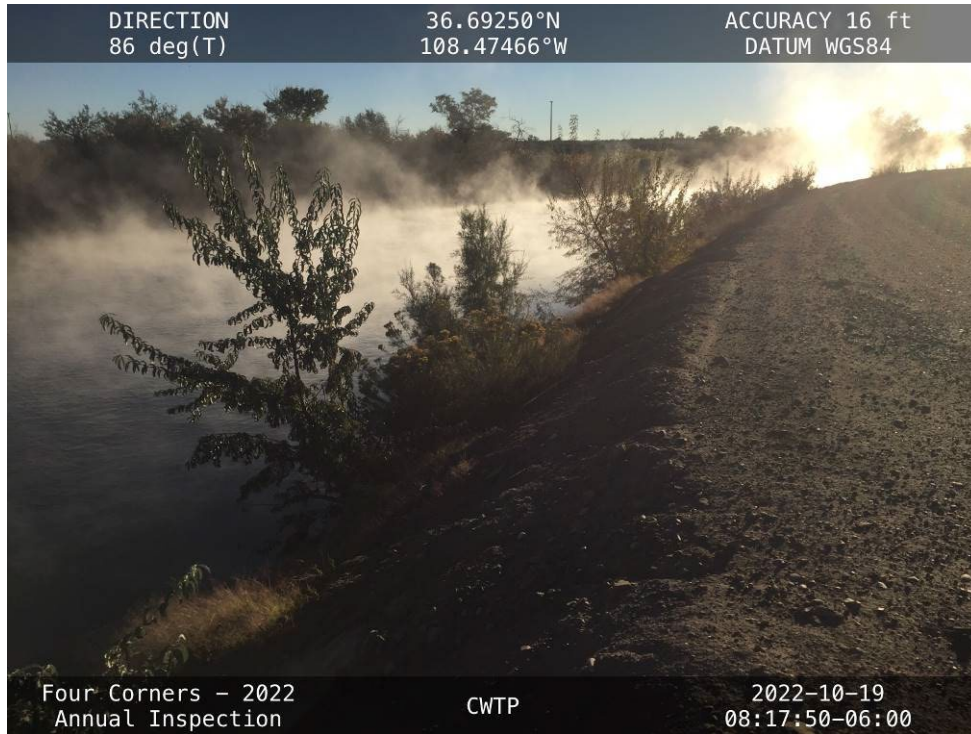
20221019 – IMG_4009

Vegetation to be removed from the downstream slope of the North Embankment.

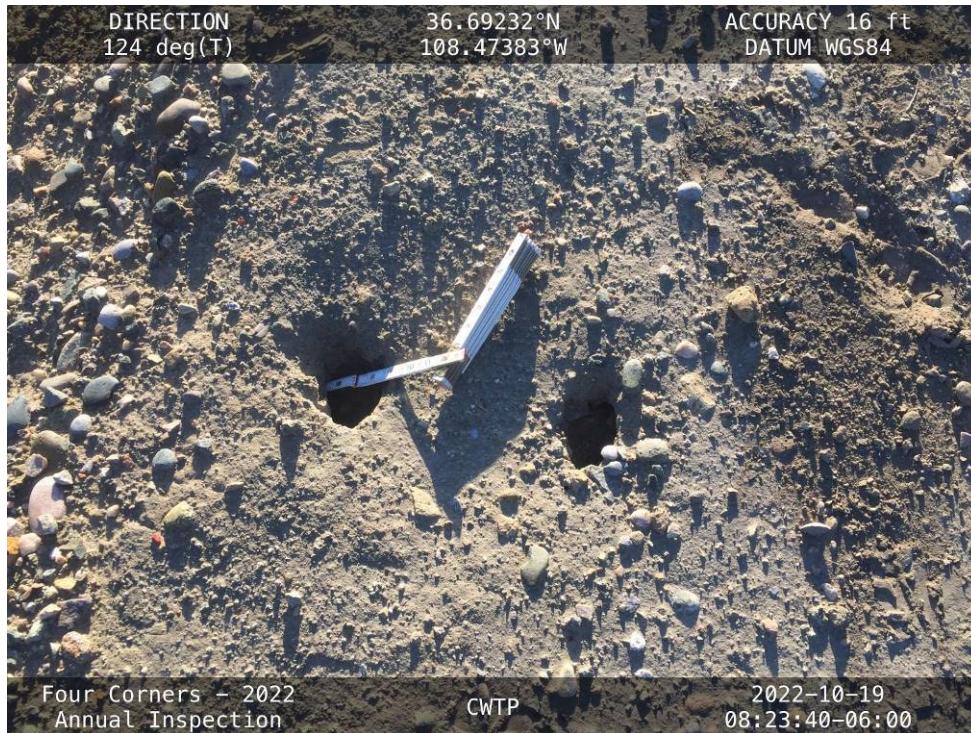
20221019 – IMG_4016

Two erosion holes up to 9 inches deep on the crest along the curved section of the embankment.

9) Two erosion holes up to 9 inches deep were observed on the crest along the curved section of the embankment.	Monitor the erosion holes and repair them if they are observed to expand.

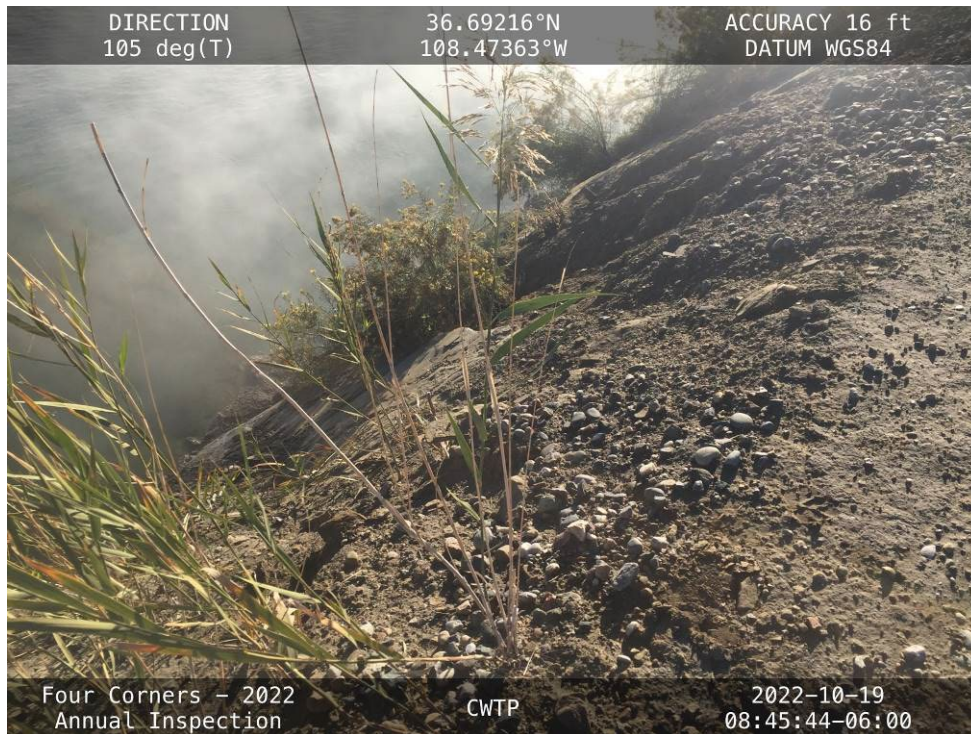
20221019 – IMG_4072

Action Item and First Instance of Observation	Resolution
1) A 6-foot-long longitudinal crack was observed on the downstream slope where a piece of riprap is separating from the soil (2020 and 2021 inspections).	The crack was not observed during the 2022 inspection. It is possible that the riprap boulder has been dislodged.

Area where a riprap boulder was separating from the rest of the slope during the 2021 inspection.

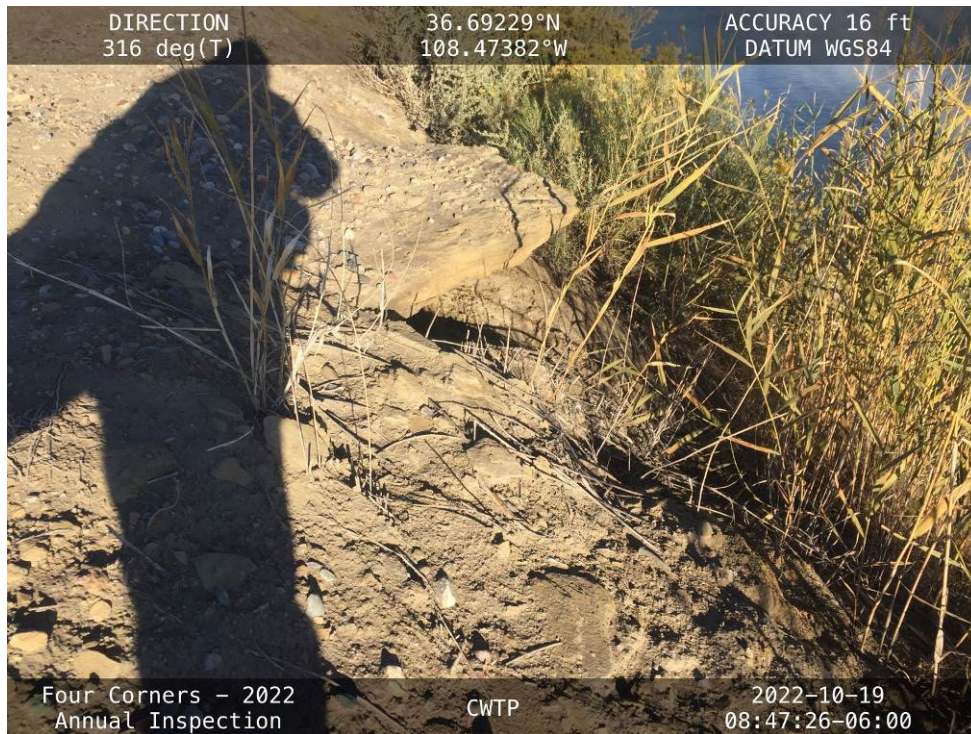
20221019 – IMG_4080

Erosion under riprap along the downstream slope.

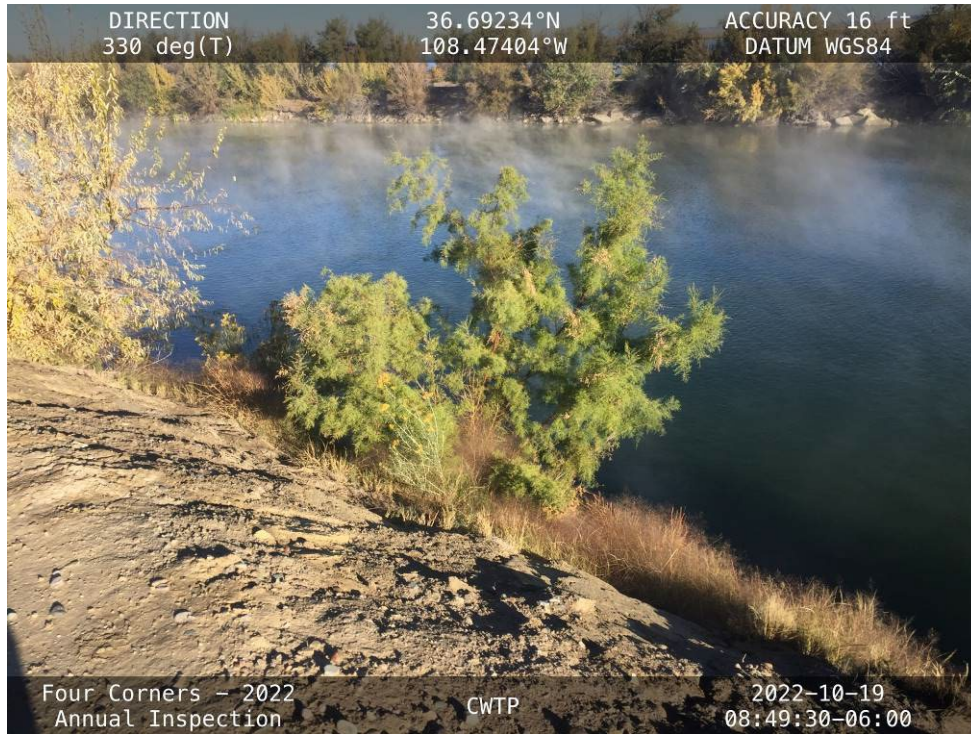
20221019 – IMG_4085
Vegetation to be removed from the downstream slope.

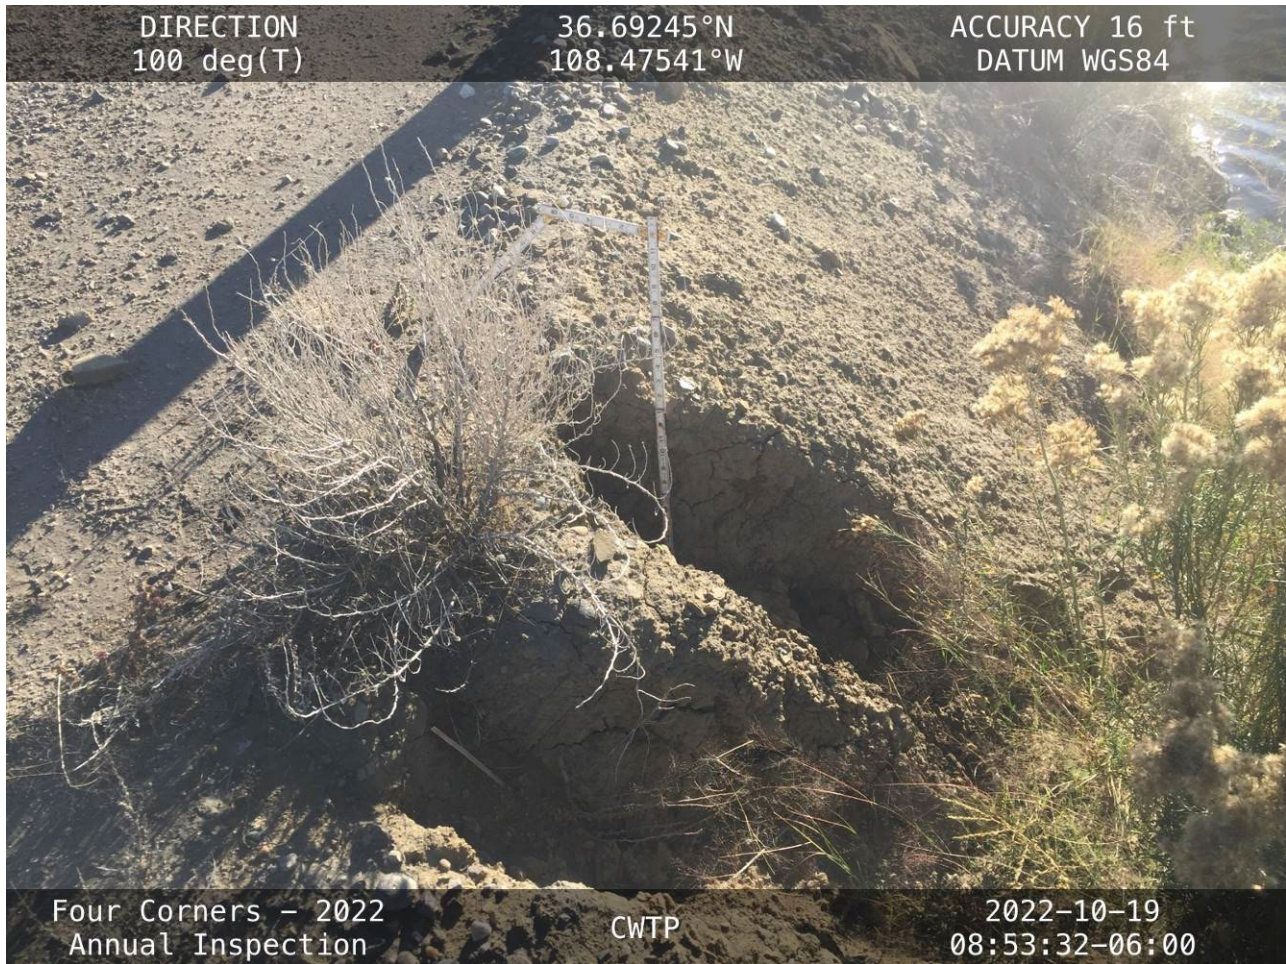
20221019 – IMG_4091

Approximately 14 inches of erosion along the upstream slope of the North Embankment.

4) Erosion along the upstream slope resulting in an irregular face.	Continue to monitor the area repair the area if required to bring it to the design slope (2H:1V).

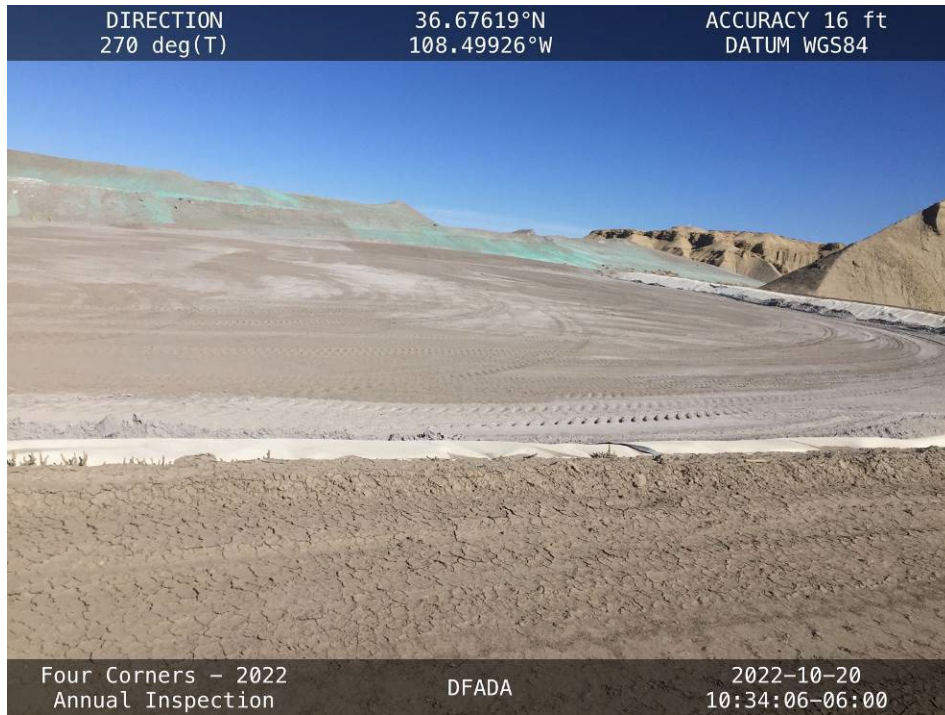
20221020 – IMG_4587

An erosion gully where the Stormwater Diversion Channel previously terminated, immediately upstream of the section lined with cement-treated base.

Action Item	Action Status
1) There is erosion at the Stormwater Diversion Channel inlet and outlet.	Monitor erosion and repair the area. Alternately, place additional sandstone riprap in the eroded area.

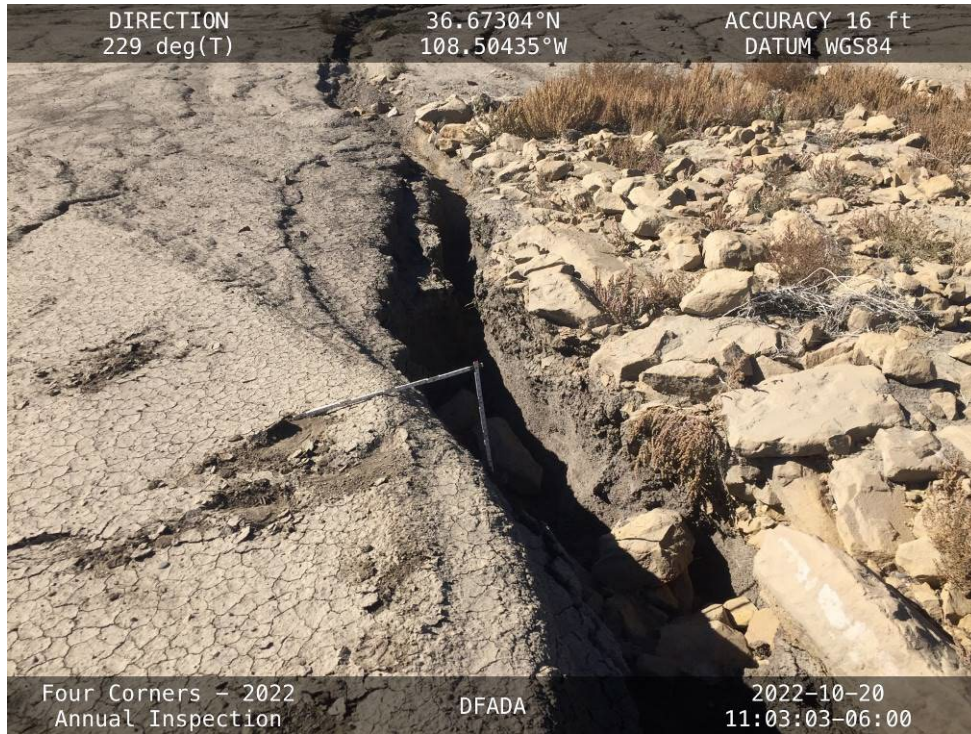
20221020 – IMG_4636

Erosion around the new outlet for the Stormwater Diversion Channel.

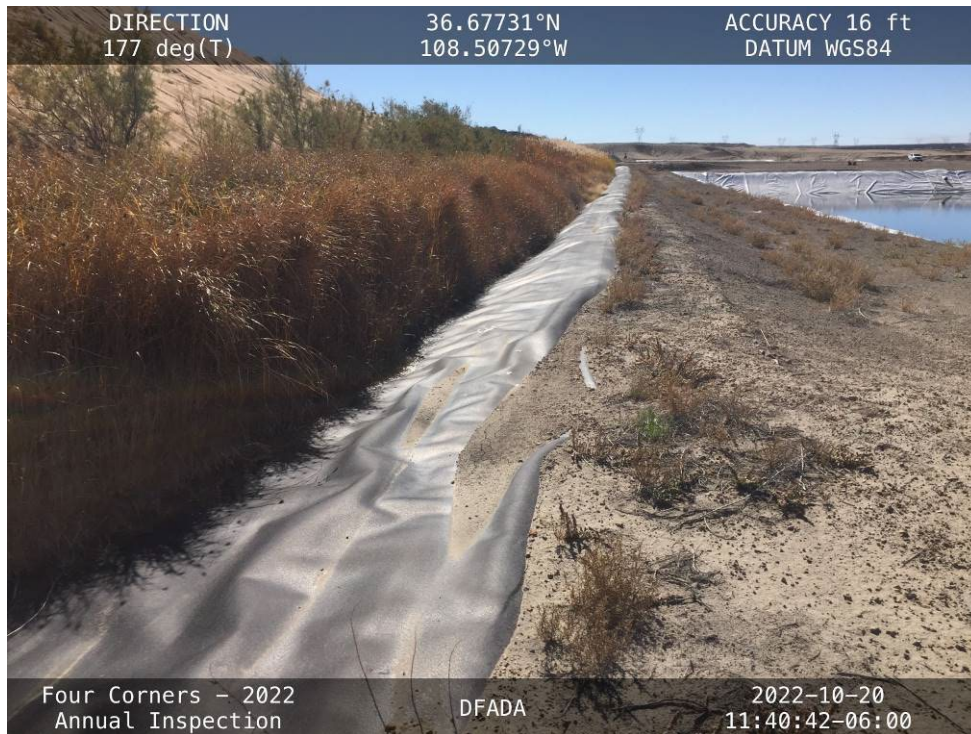
20221020 – IMG_4656

Reeds along the western toe of Cell 1, facing north from the southwest corner.

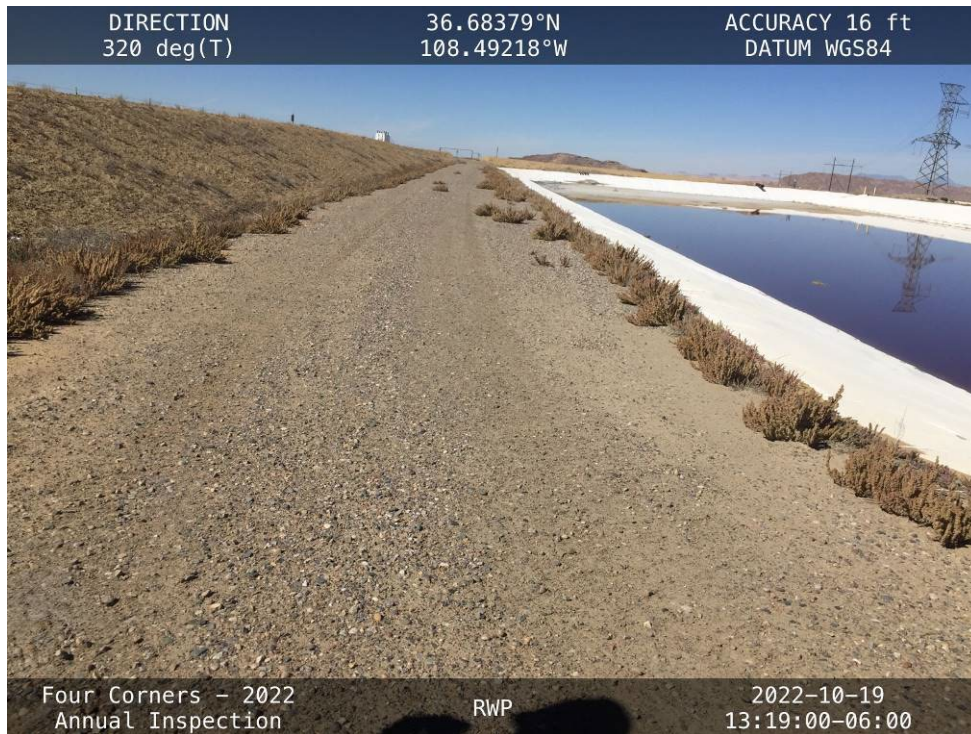
20221019 – IMG_4349

The upstream slope of the FGD Pond cell Southwest Embankment, facing northwest.

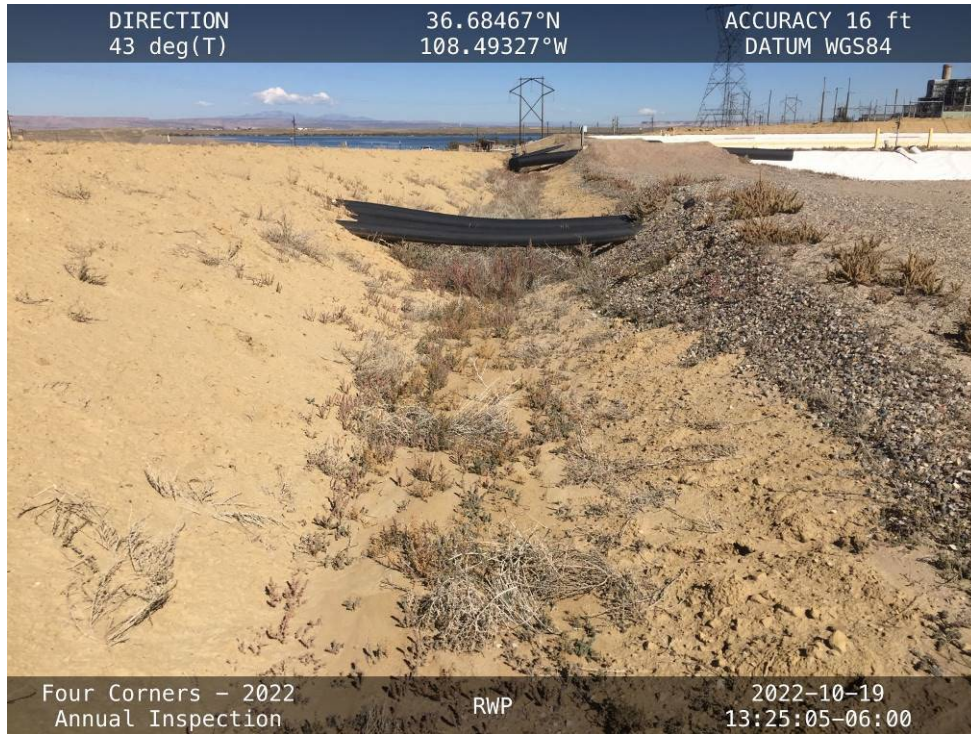
20221019 – IMG_4358
Sediment and brush filling the drainage ditch on the western corner of the RWP.

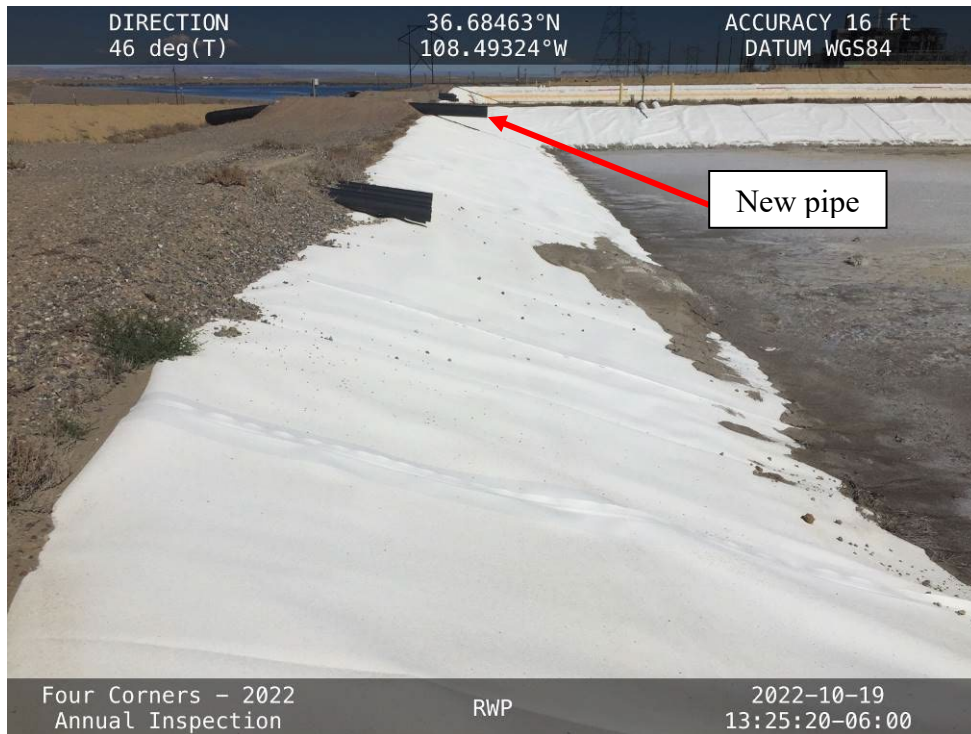
20221019 – IMG_4360

The crest of the FGD Pond cell Northwest Embankment, facing northeast.

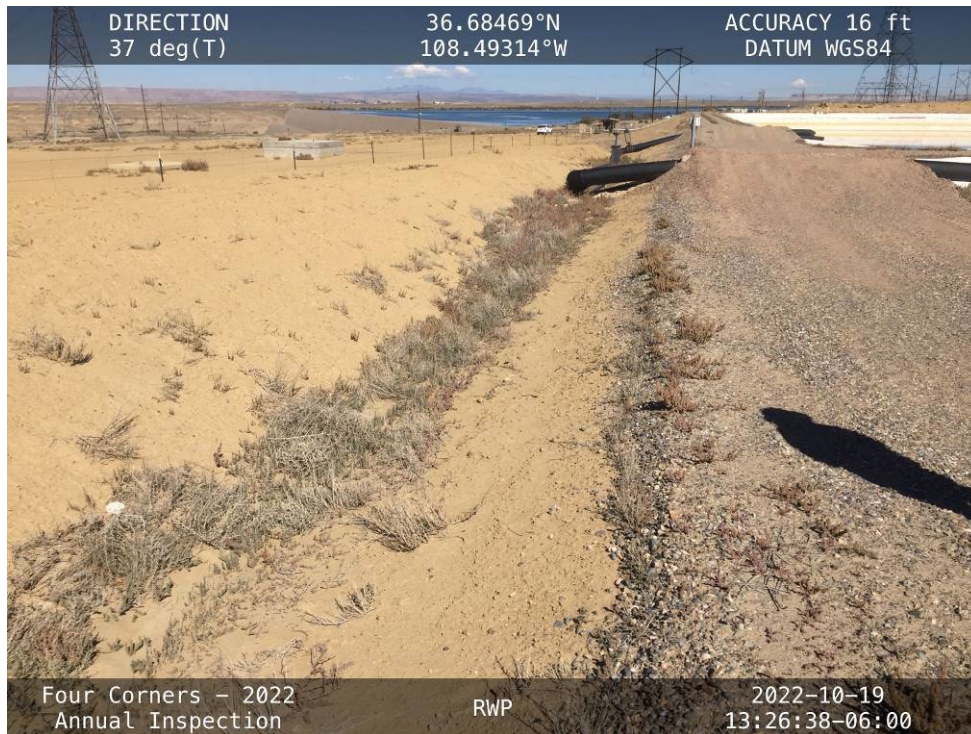
20221019 – IMG_4366

The FGD Pond cell Inlet Pipes.

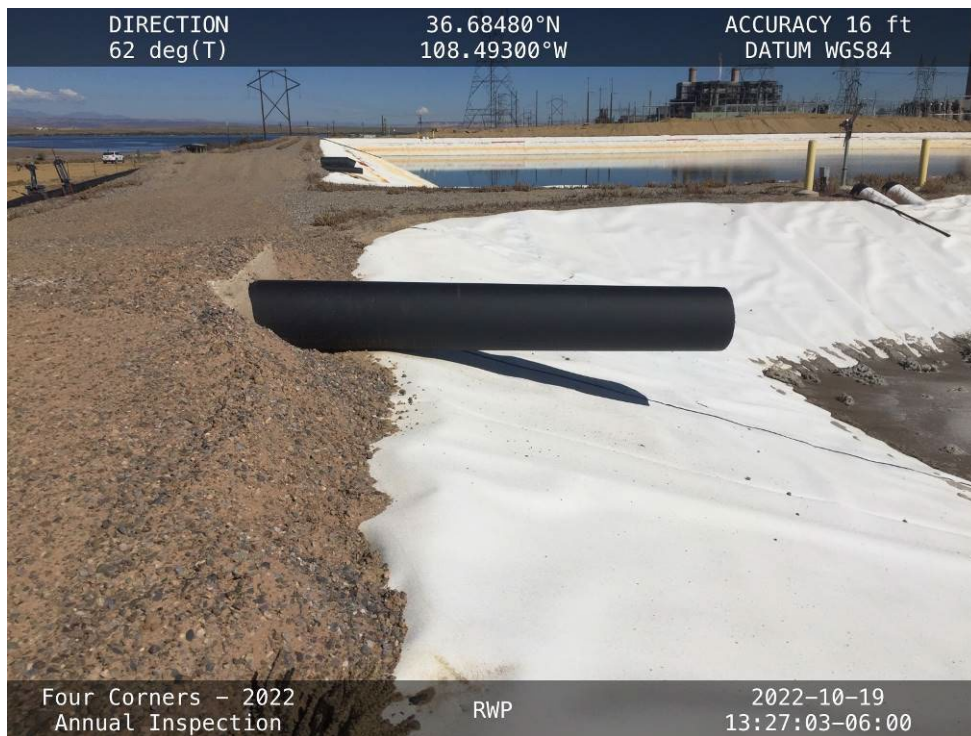
20221019 – IMG_4368

The downstream slope of RWP Cell Northwest Embankment, facing northeast.

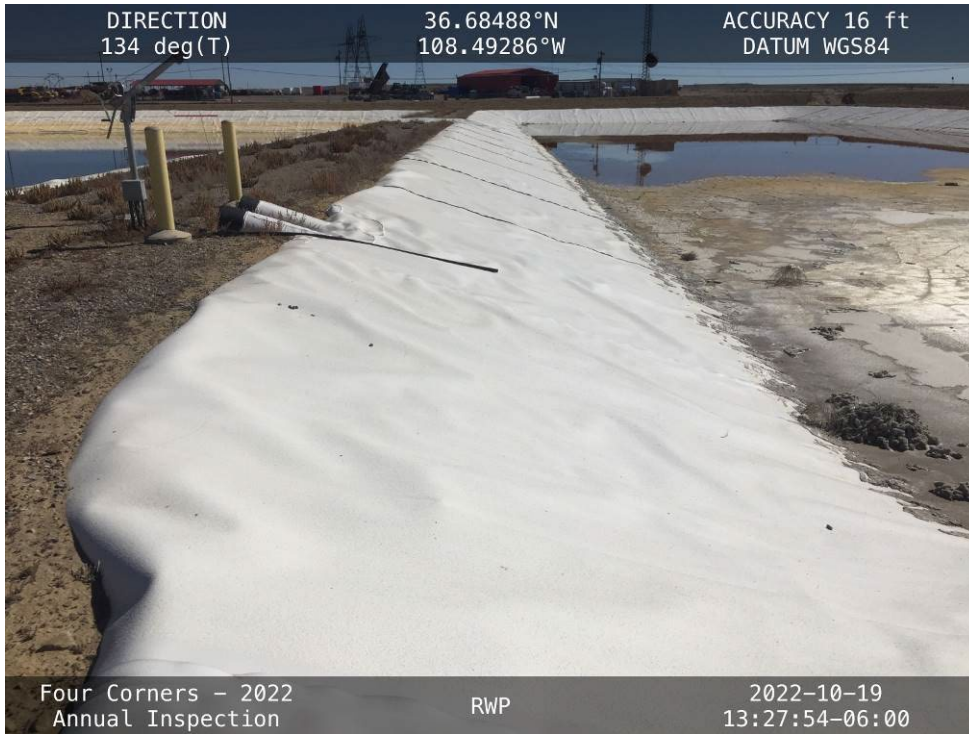
20221019 – IMG_4369

The new pipe between the RWP and FGD Pond cells.

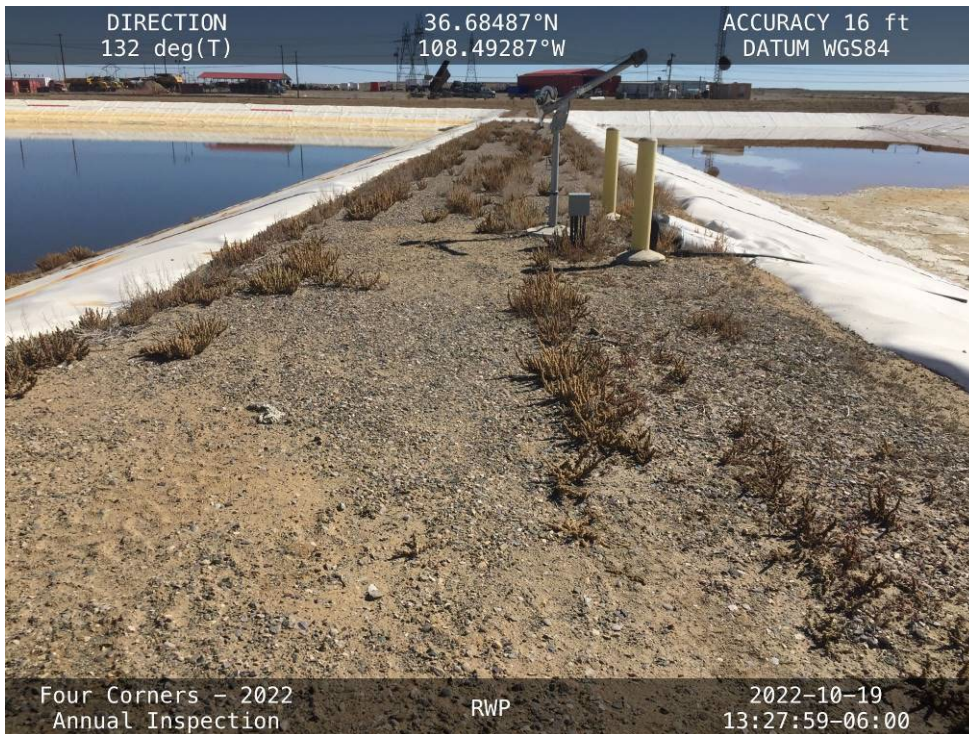
20221019 – IMG_4372

The upstream slope of the FGD Pond cell Internal Embankment, facing southeast.

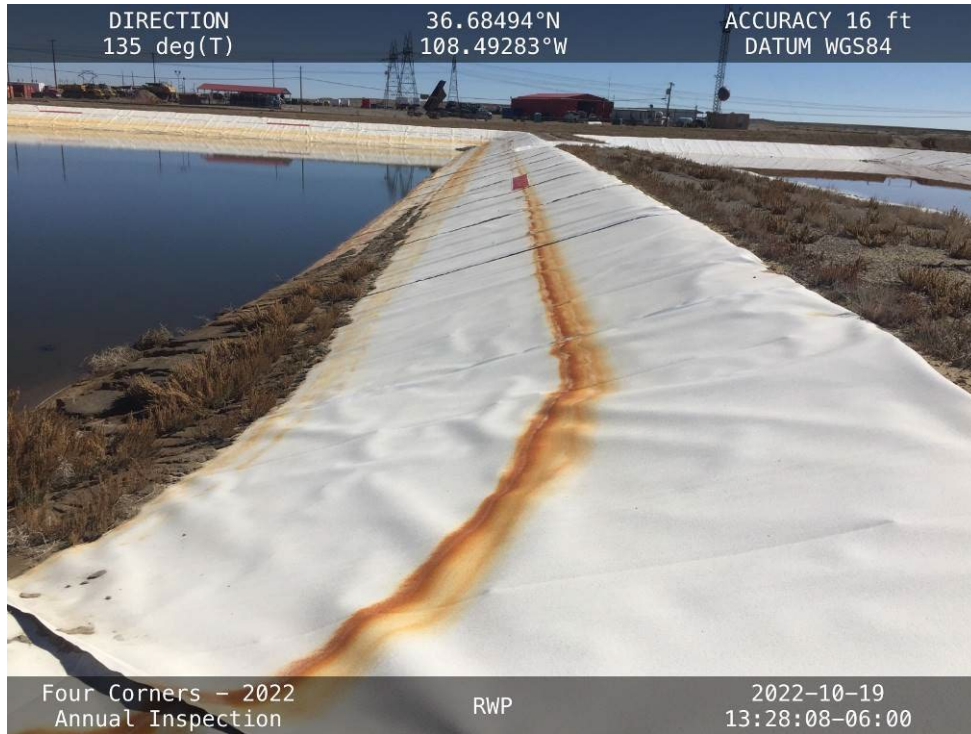
20221019 – IMG_4373

The crest of the FGD Pond cell Internal Embankment, facing southeast.

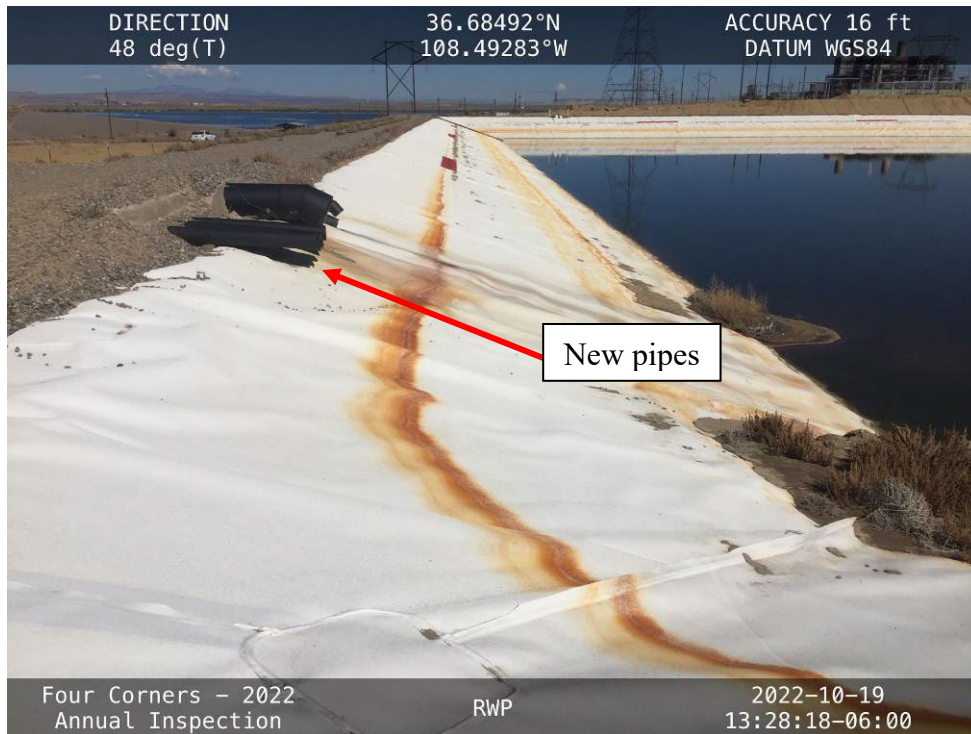
20221019 – IMG_4374

The upstream slope of the RWP Internal Embankment, facing southeast.

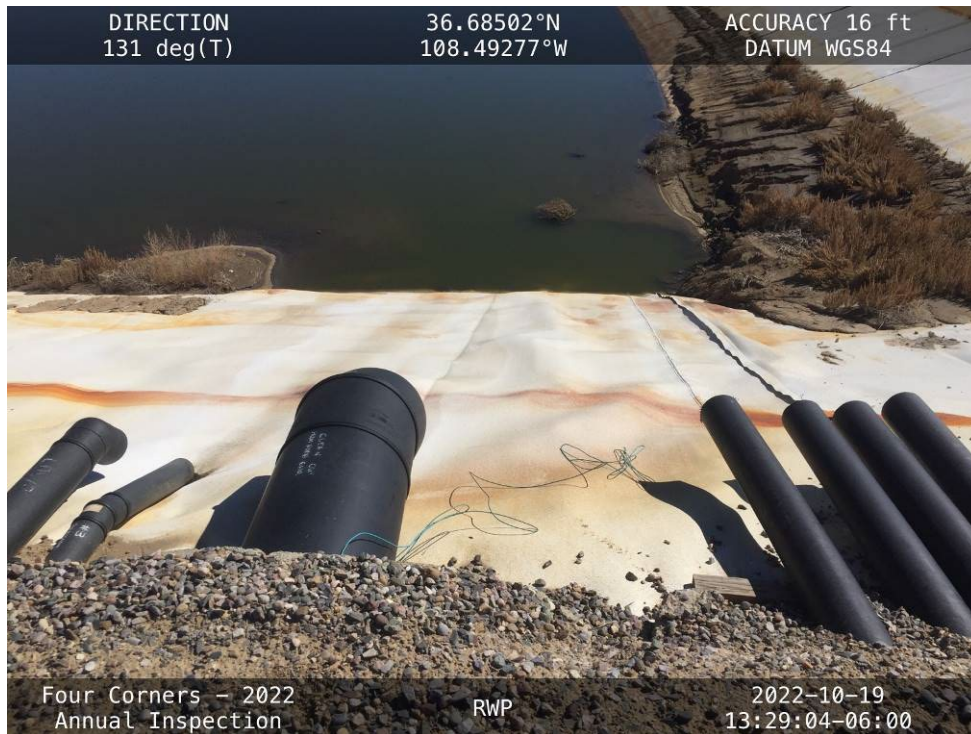
20221019 – IMG_4378

The new pipes between the RWP and FGD Pond cells at the crossing into the RWP cell.
