**FOUR CORNERS POWER PLANT  
Lined Ash Impoundment,  
Lined Decant Water Pond,  
Combined Waste Treatment Pond,  
Dry Fly Ash Disposal Area,  
and Return Water Pond**

**Annual  
CCR Impoundment and  
Landfill Inspection Report  
2023**

**GENERATION ENGINEERING  
Design Engineering  
P.O. BOX 53999  
PHOENIX, ARIZONA 85072**

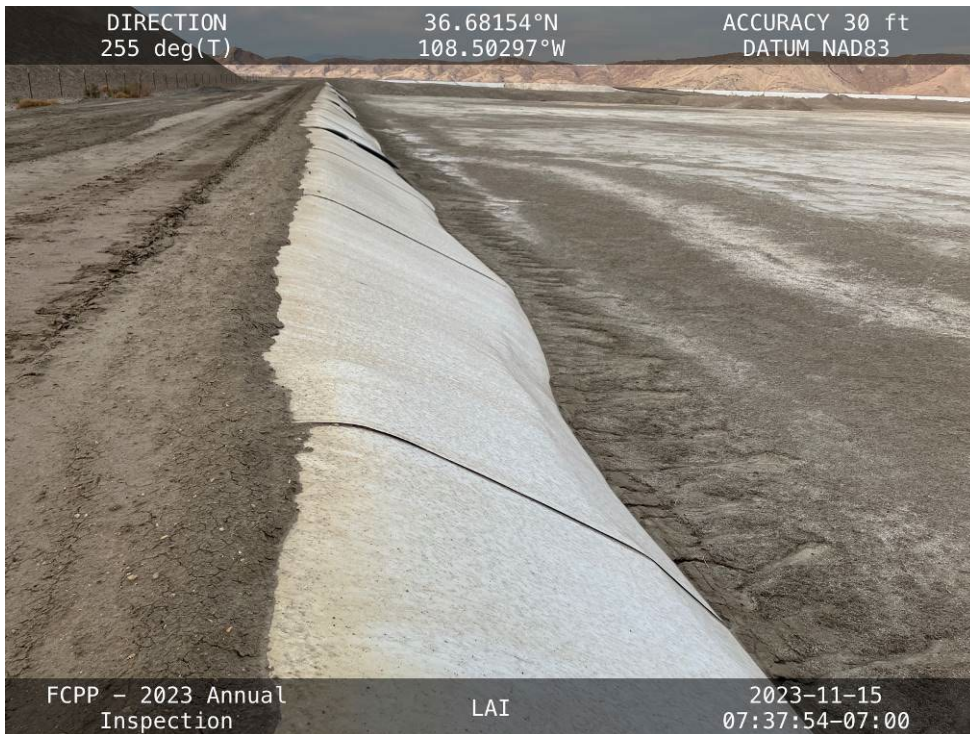
**20231115 – IMG\_2296**

The South Embankment upstream slope with a very tight liner and irregular, steeper areas.

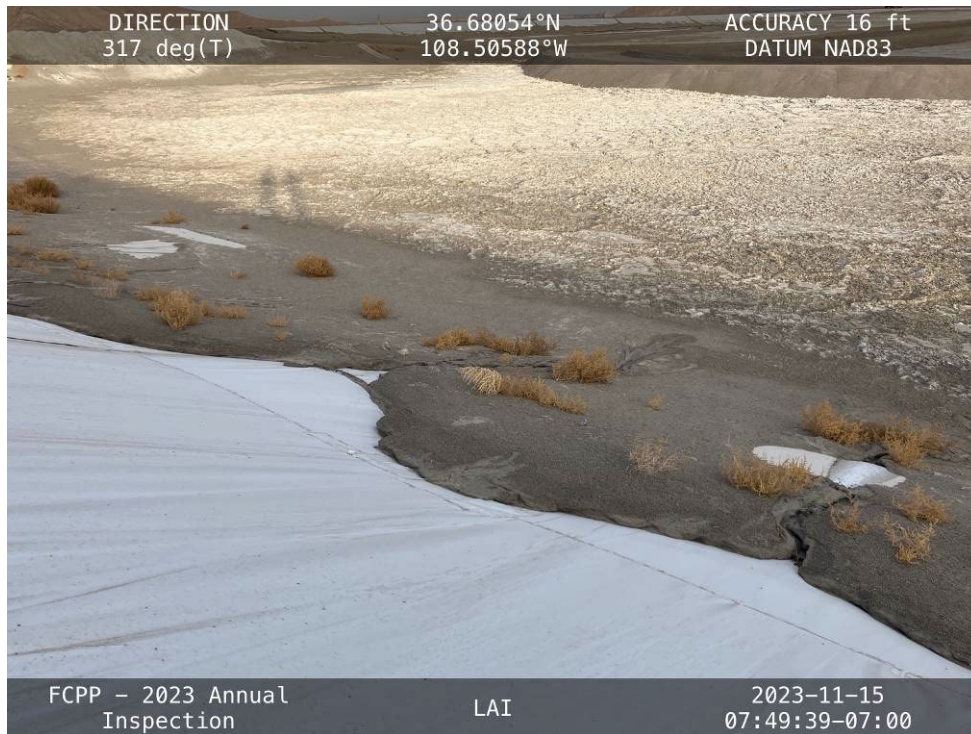
**20231115 – IMG\_2320**

Exposed liner within the reservoir, indicating bulges below the ash.

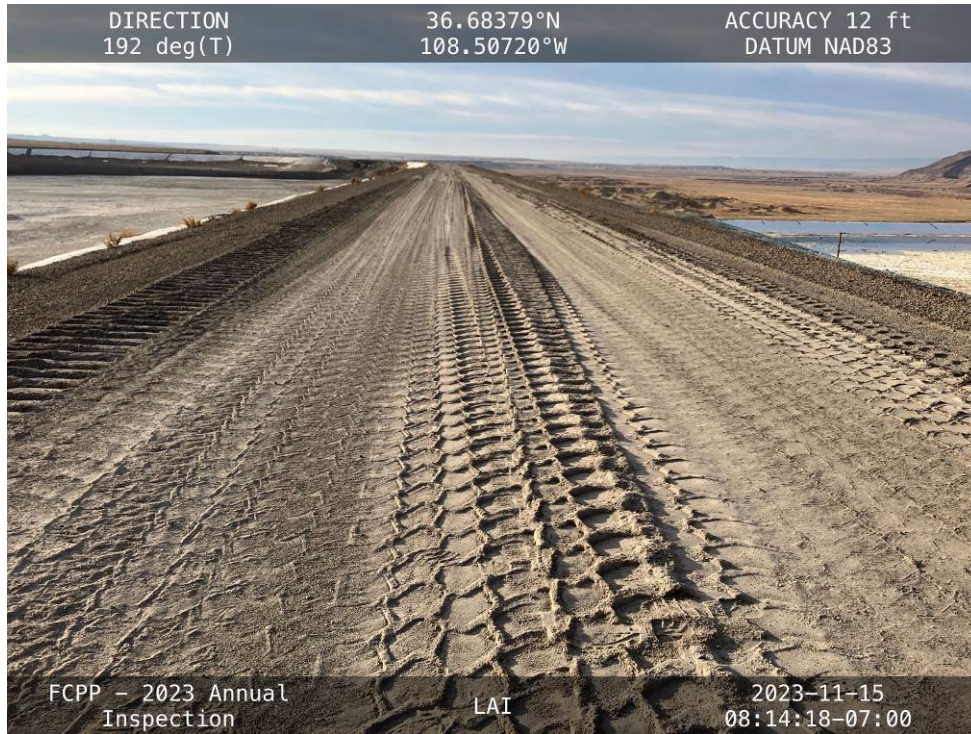
**20231115 – IMG\_2370**

The West Embankment crest on the haul truck travel route. The surficial ash is breaking down.

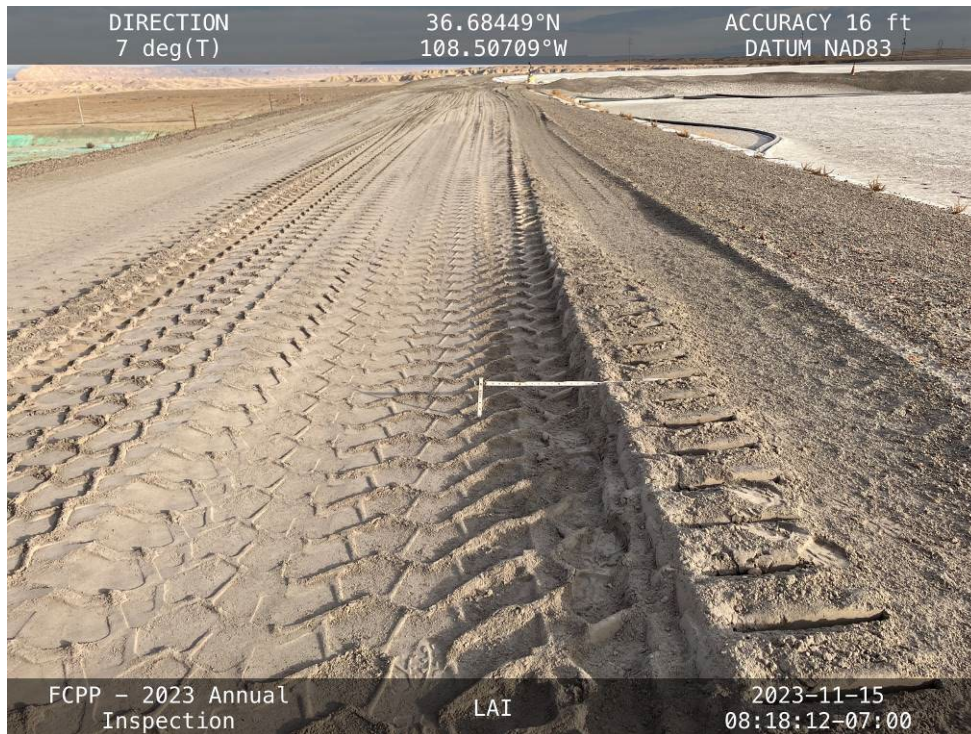
**20231115 – IMG\_2376**

- iv. Ruts and a depression were observed along the West Embankment (Photos IMG\_2361 and IMG\_2376). The rut in the middle of the West Embankment in IMG\_2376 was caused by haul trucks that are taking ash to the impoundment to construct access roads. This rut is in the area of the crest that was reinstated as described in comment i. The depression on the downstream shoulder of the West Embankment near the southern access ramp may be the result of erosion at the ramp/crest interface or the result of trucks driving into a less-compacted zone of ash. Regrade the West Embankment crest and instruct haul truck

A rut in the West Embankment crest on the haul truck travel route, approximately 6 inches deep.

operators to vary their travel paths to prevent creating ruts. Repair the depression near the southern access ramp.

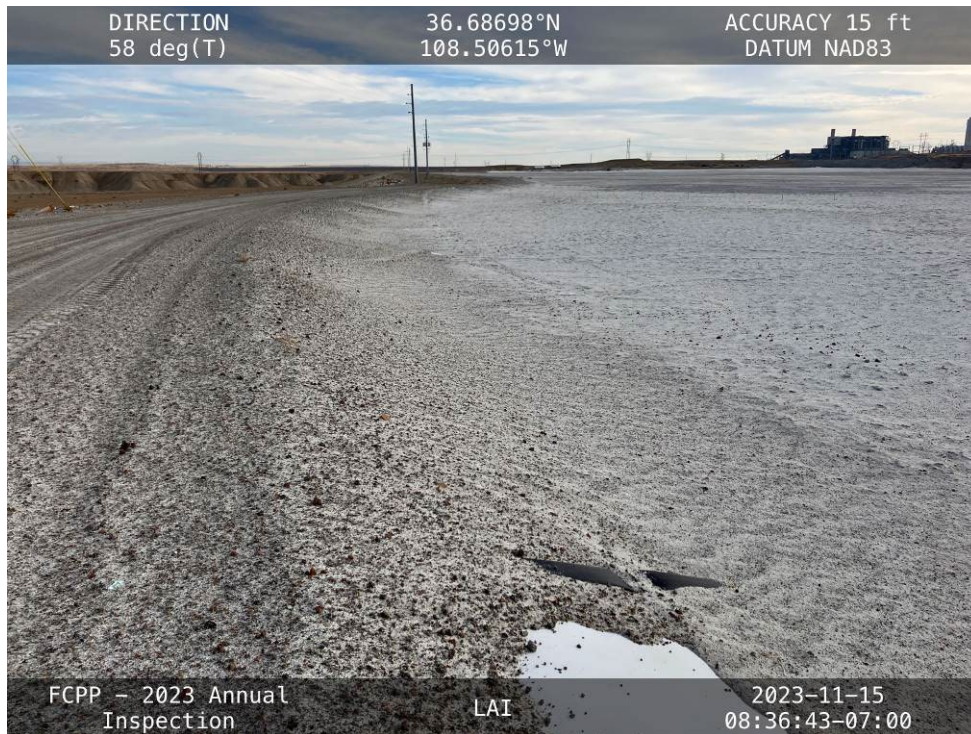
**20231115 – IMG\_2404**

CCR is impounded nearly up to the crest along some portions of the Northwest Embankment. APS previously constructed a diversion channel along the northern half of the Northwest Embankment (the Northwest Embankment crest elevation increases from southwest to northeast) to keep stormwater away from the crest; however, the diversion channel was filled with sediment during this inspection. The LAI is sloped from the northeast to the southwest such that surface water should flow to the Southwest Corner where there is available capacity. The diversion channel should be re-excavated or replaced with a permanent solution and the design surface flow regime should be maintained at all times.

The impounded ash level at the crest of the Northwest Embankment covered with FGD, facing northeast.

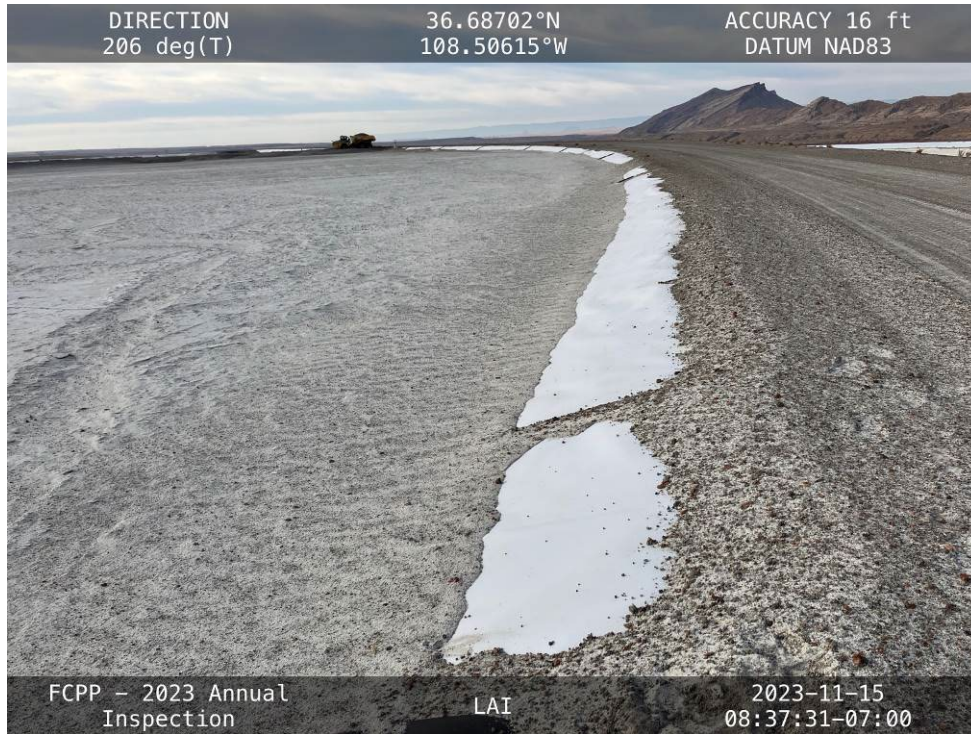
**20231115 – IMG\_2406**

The impounded ash level along the north side of the West Embankment, facing south.

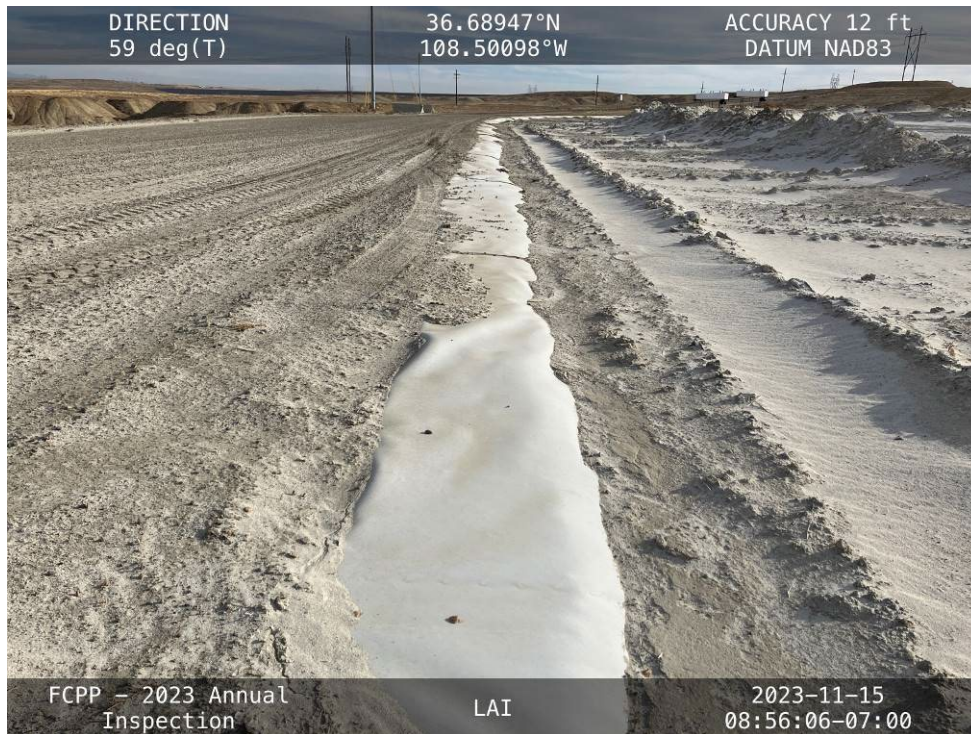
**20231115 – IMG\_2429**

Shallow rutting and tire tracks at the Northwest Embankment access ramp.

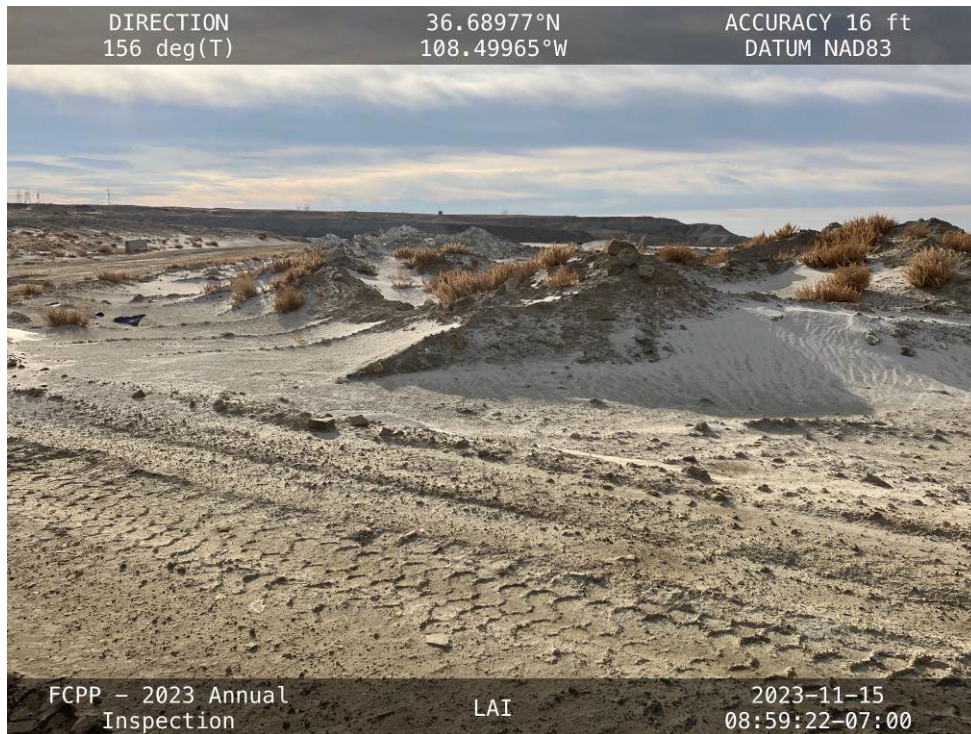
**20231115 – IMG\_2441**

Tears in the liner near the north V-ditch where the ash berm was constructed.

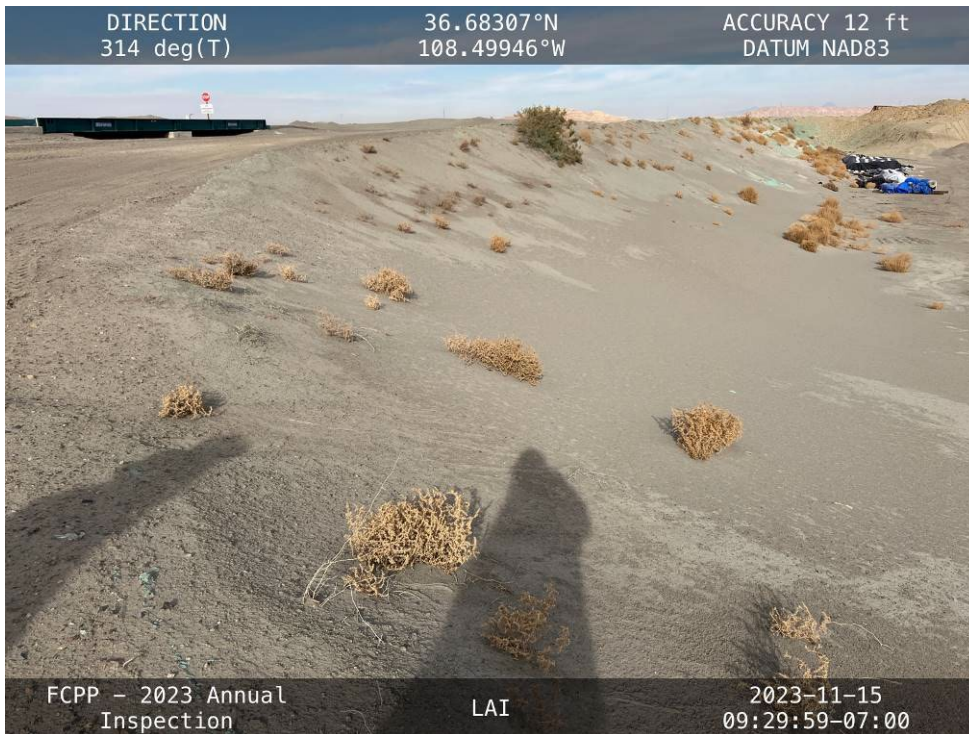
**20231115 – IMG\_2494**

The downstream slope at the southern end of the East Embankment, with vertical scarps.

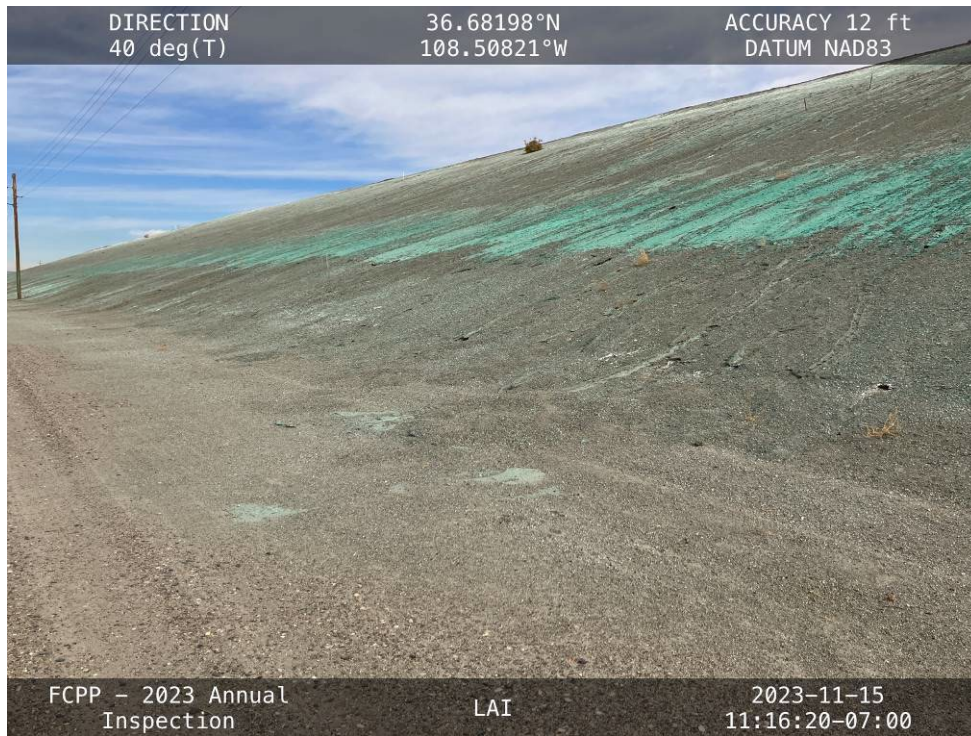
**20231115 – IMG\_2693**  
Erosion rills on the West Embankment covered with dust suppressant.

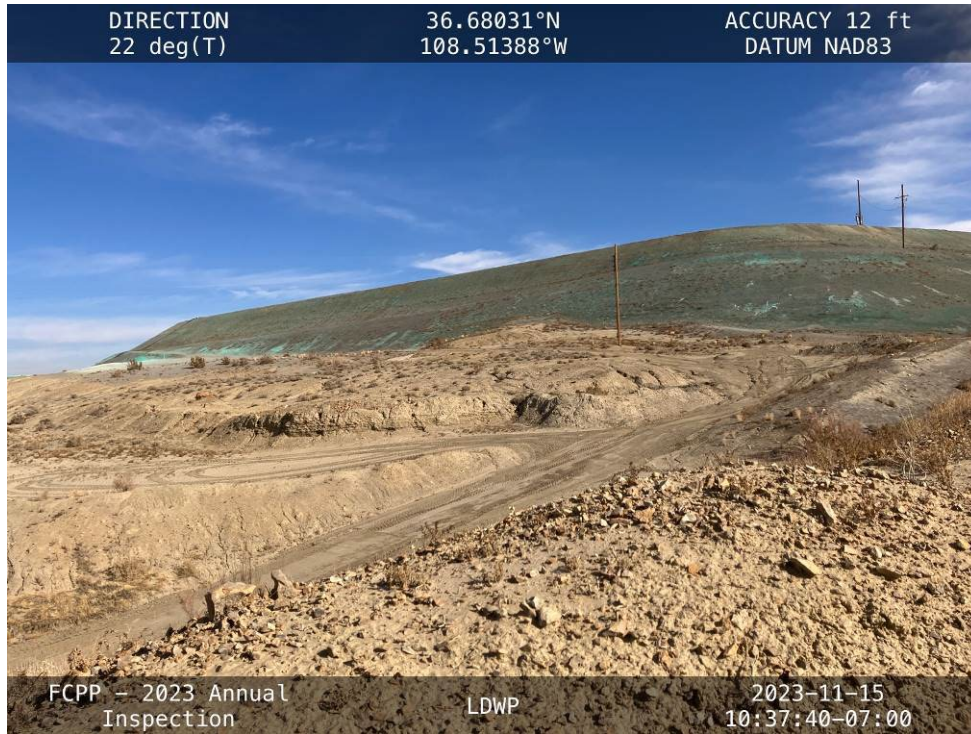
**20231115 – IMG\_2600**

The western half of the South Embankment downstream slope, facing north from the toe.

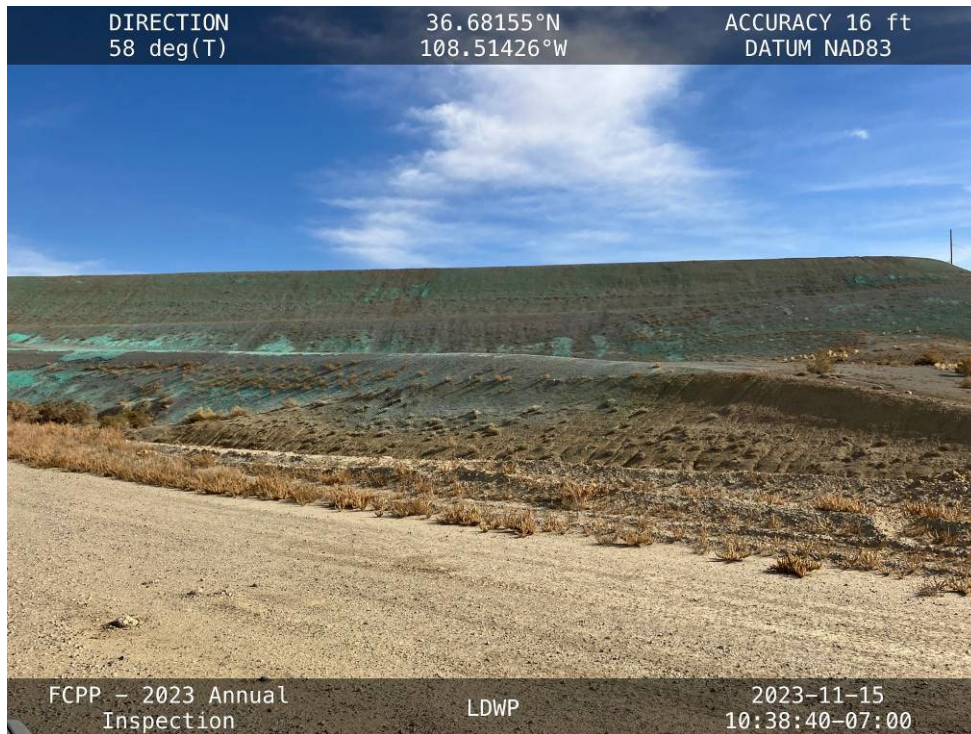
**20231115 – IMG\_2602**

The West Embankment slope, facing northeast from the toe road near the Pond 3 Pump House.

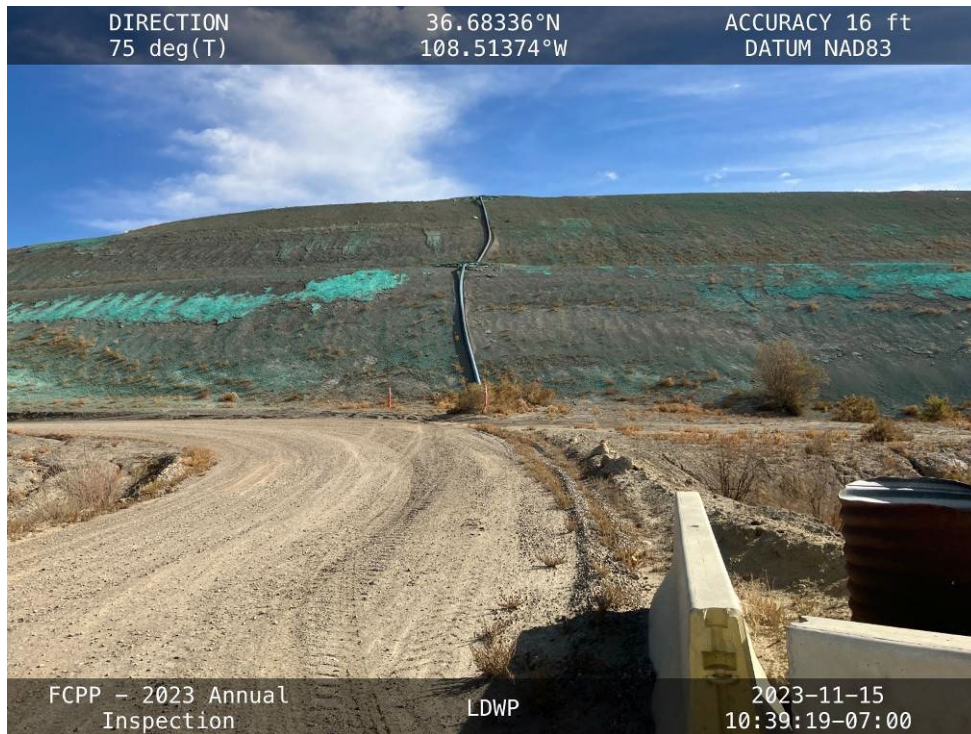
**20231115 – IMG\_2605**

The West Embankment slope, facing east from the toe road north of the Pond 3 Pump House.

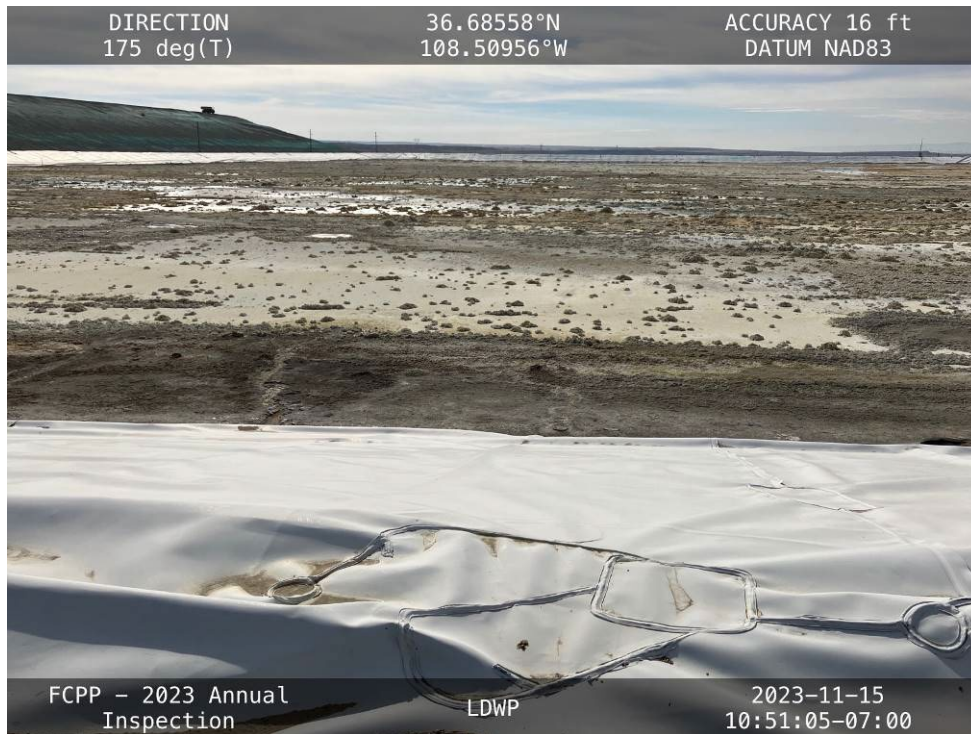
**20231115 – IMG\_2630**

The north side of the reservoir, facing east from the North Embankment crest.

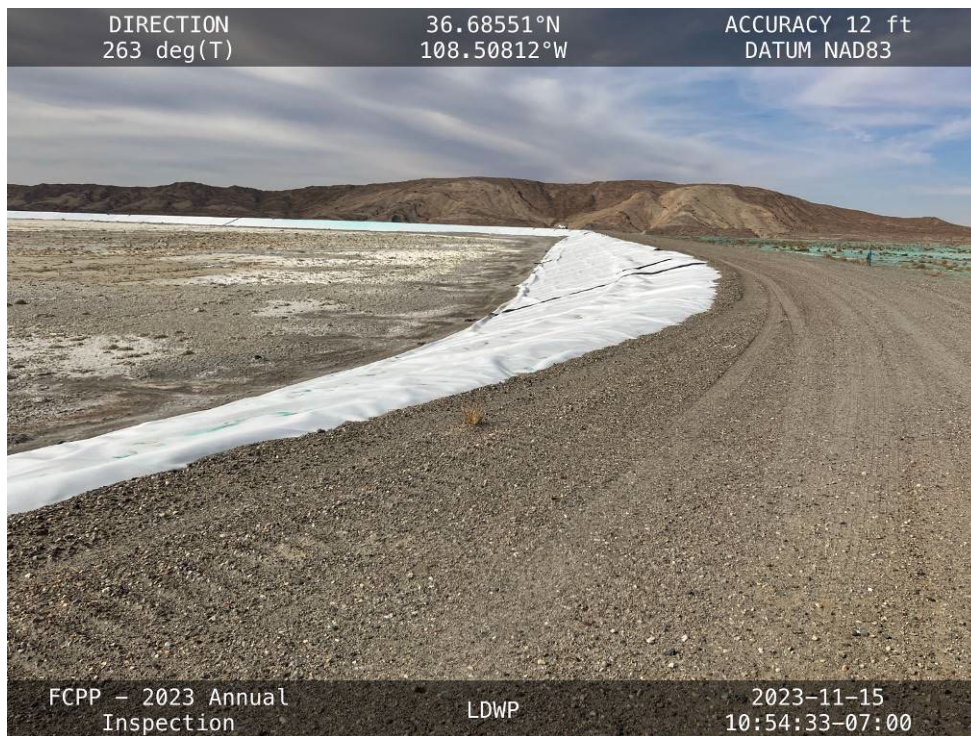
**20231115 – IMG\_2633**

The north side of the reservoir, facing south from the North Embankment crest.

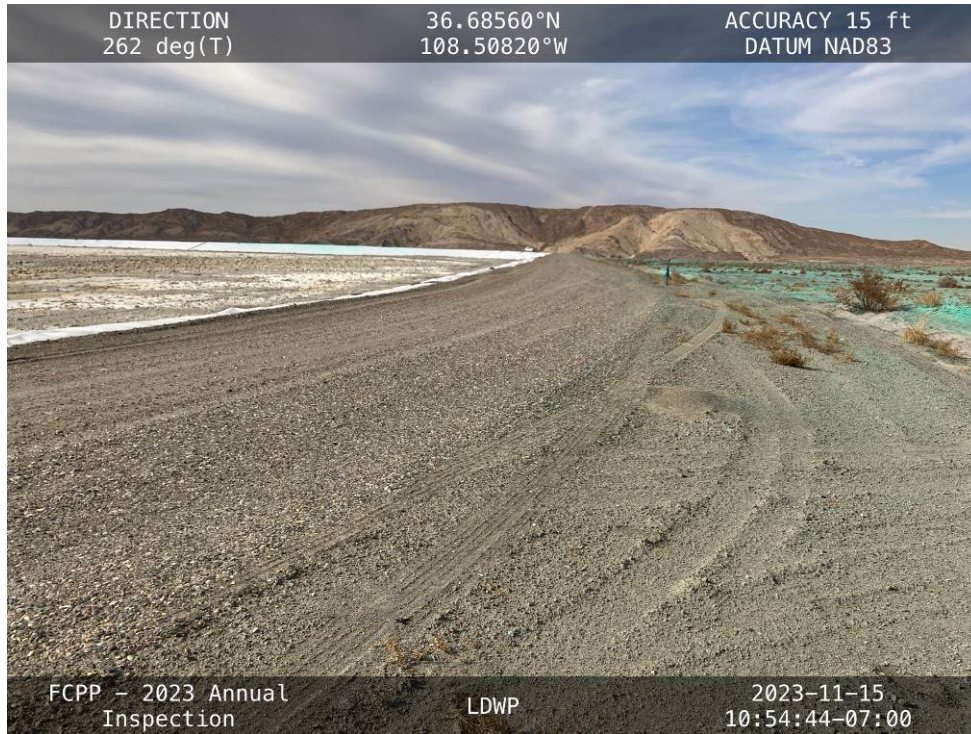
**20231115 – IMG\_2644**

The upstream slope of the North Embankment, facing west from the northeast corner.

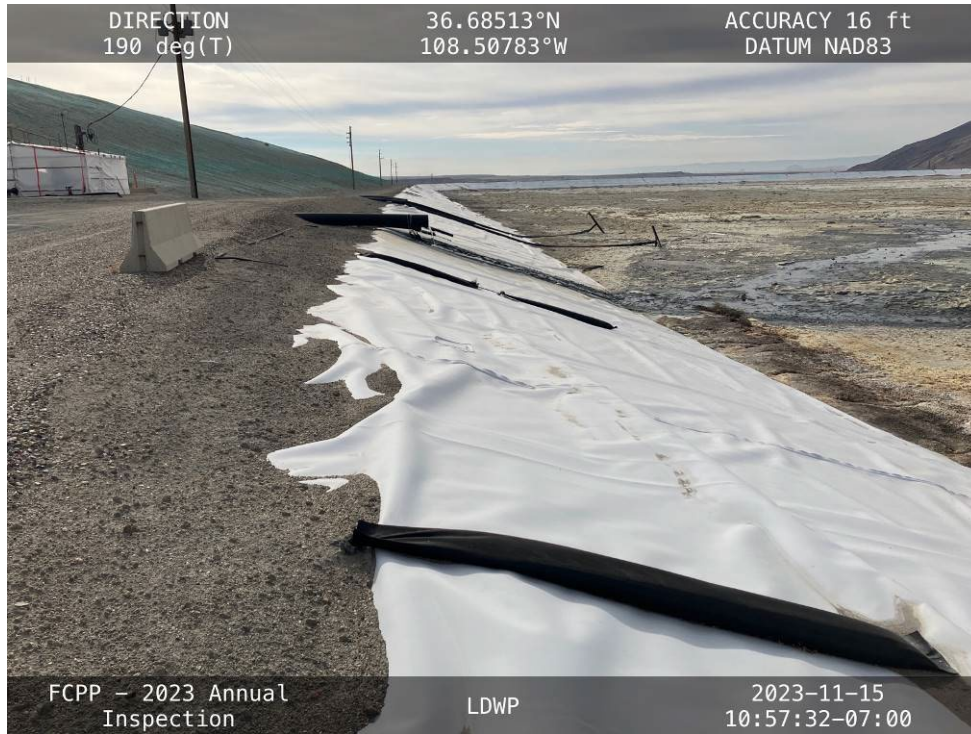
**20231115 – IMG\_2651**  
 The crest of the East Embankment, facing south from the northeast corner.

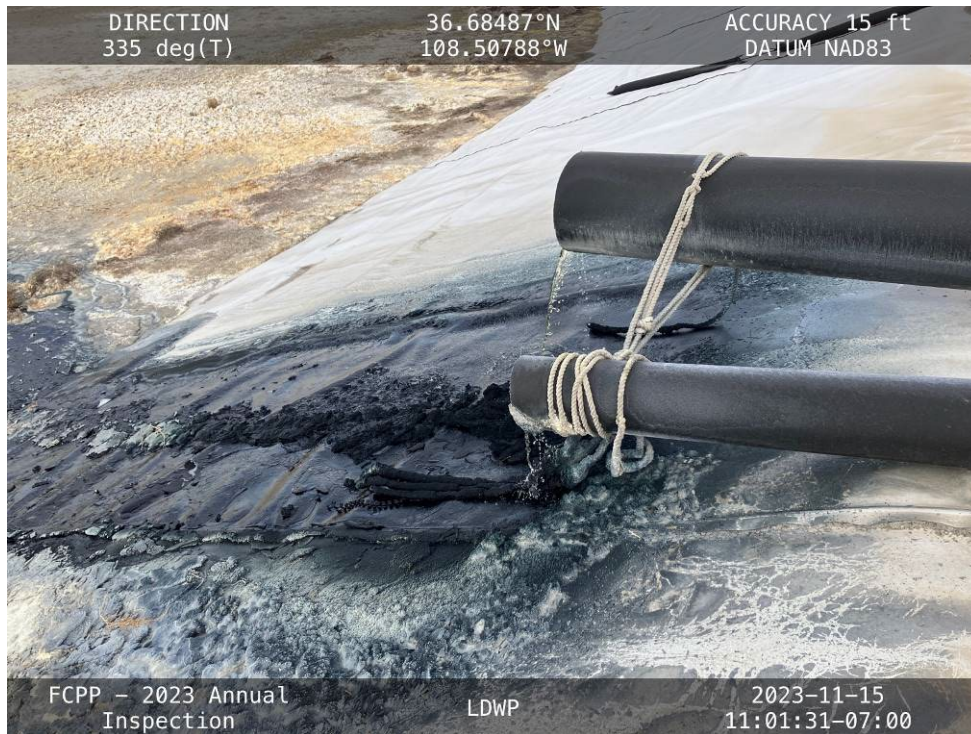
**20231115 – IMG\_2665**  
The suction intake lines in the northeast corner of the LDWP.

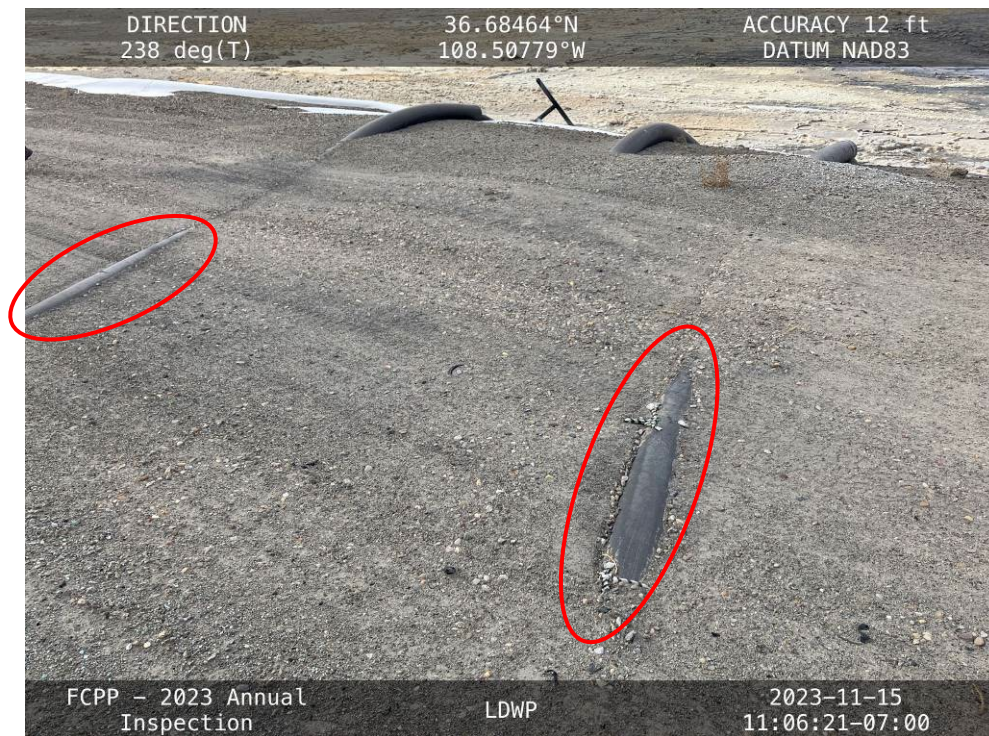
**20231115 – IMG\_2666**

The 8-inch and 16-inch HDPE outlet pipes conveying decant water from the LAI.

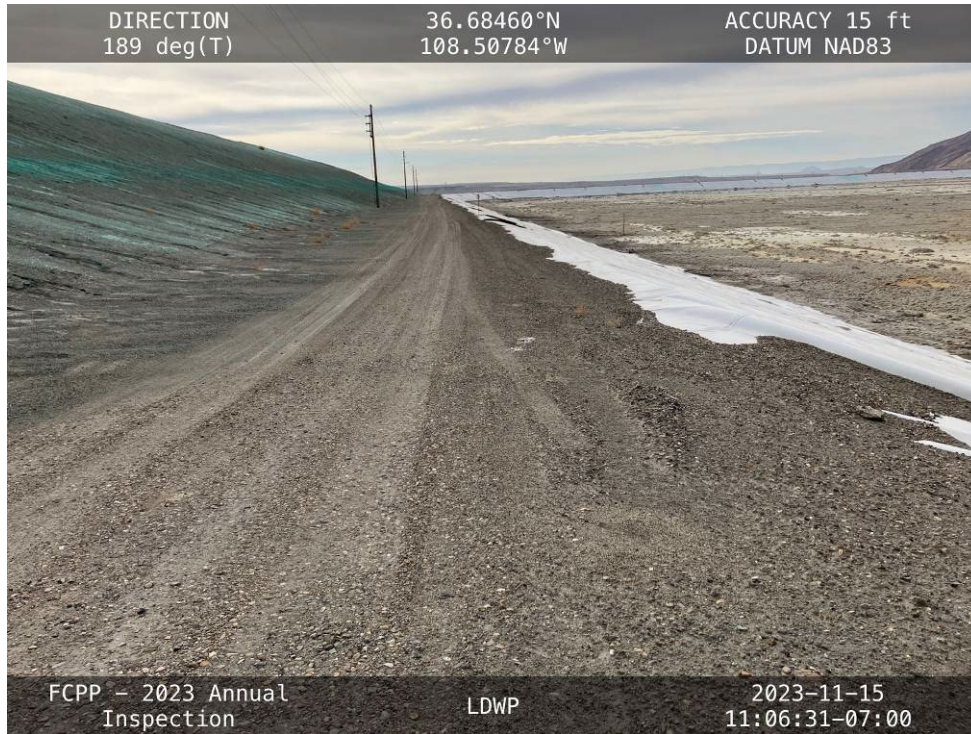
**20231115 – IMG\_2678**

Portions of the outer pipes for the suction intake lines exposed across the East Embankment crest.

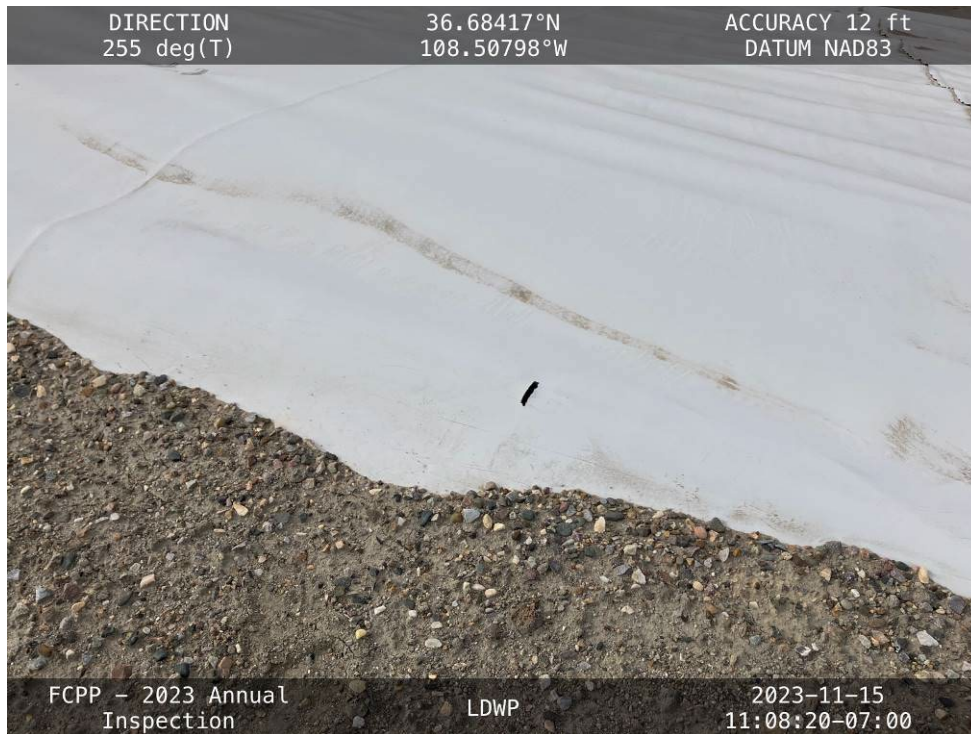
**20231115 – IMG\_2680**

The upstream slope of the East Embankment, facing south from the northern half of the LDWP.

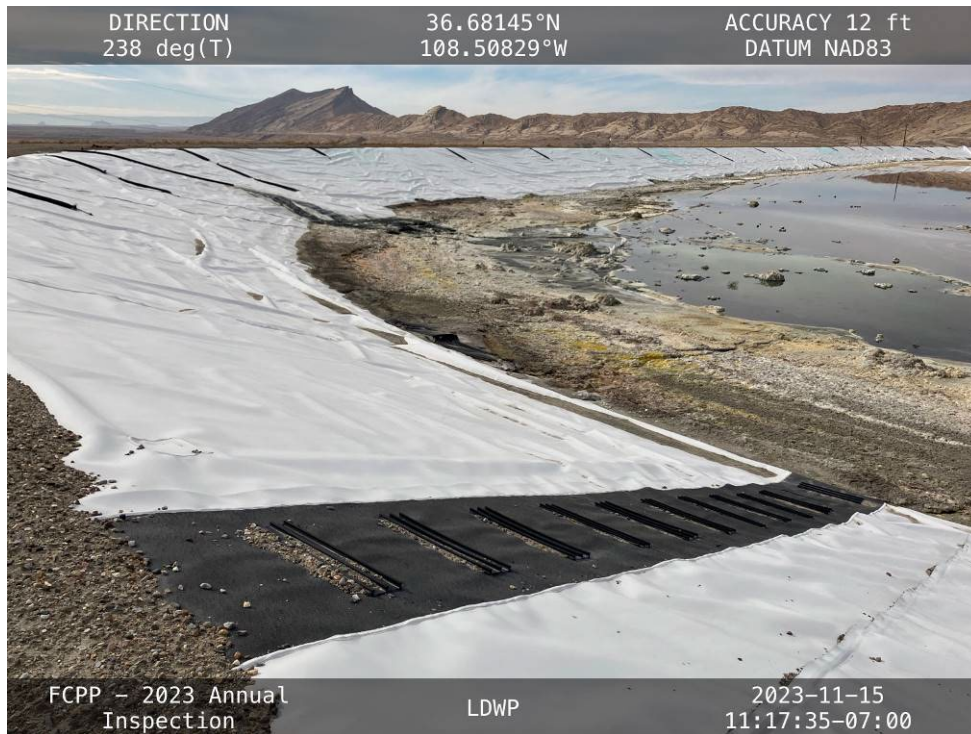
**20231115 – IMG\_2694**

Portions of the liner exposed in the anchor trench along the East Embankment crest adjacent to a rut.

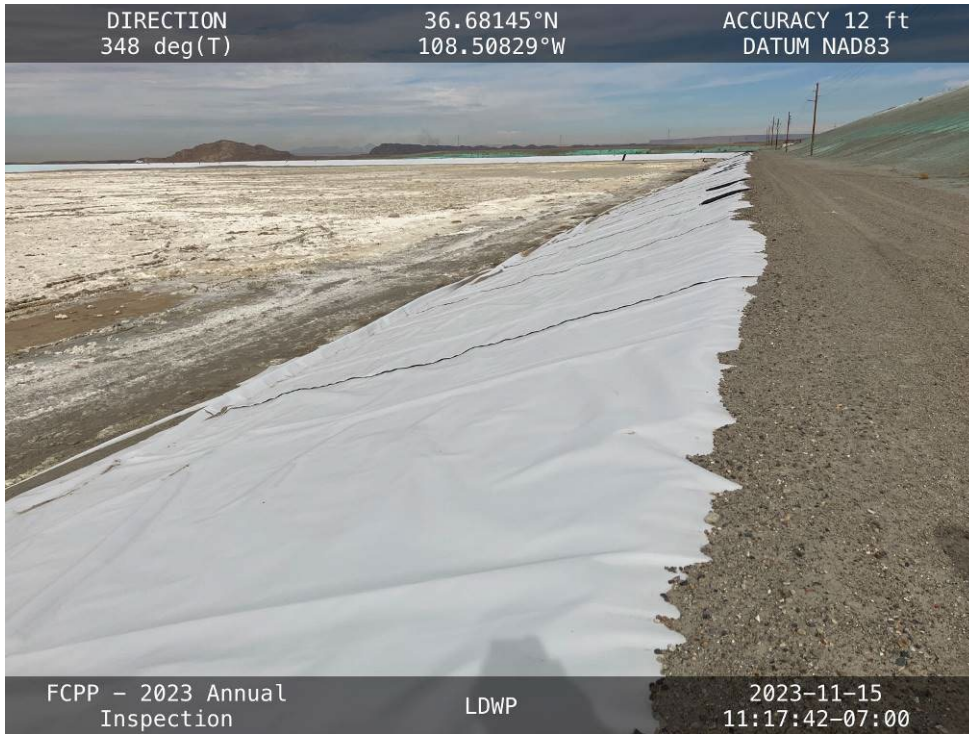
**20231115 – IMG\_2700**

The upstream slope of the South Embankment, facing west from the southeast corner.

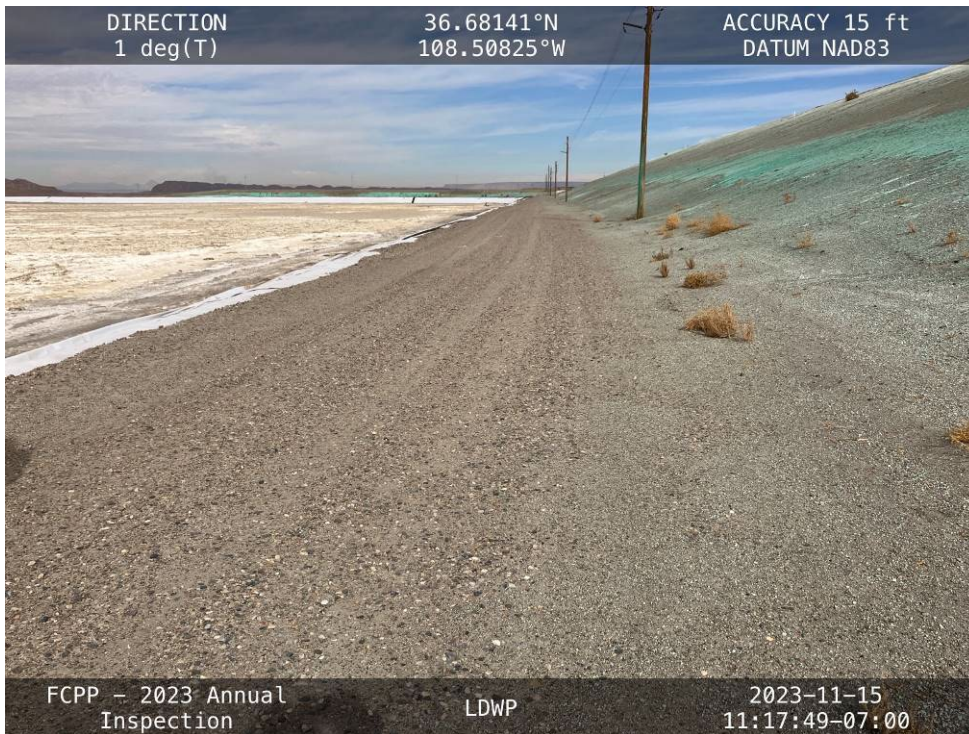
**20231115 – IMG\_2704**

The upstream slope of the East Embankment, facing north from the south end.

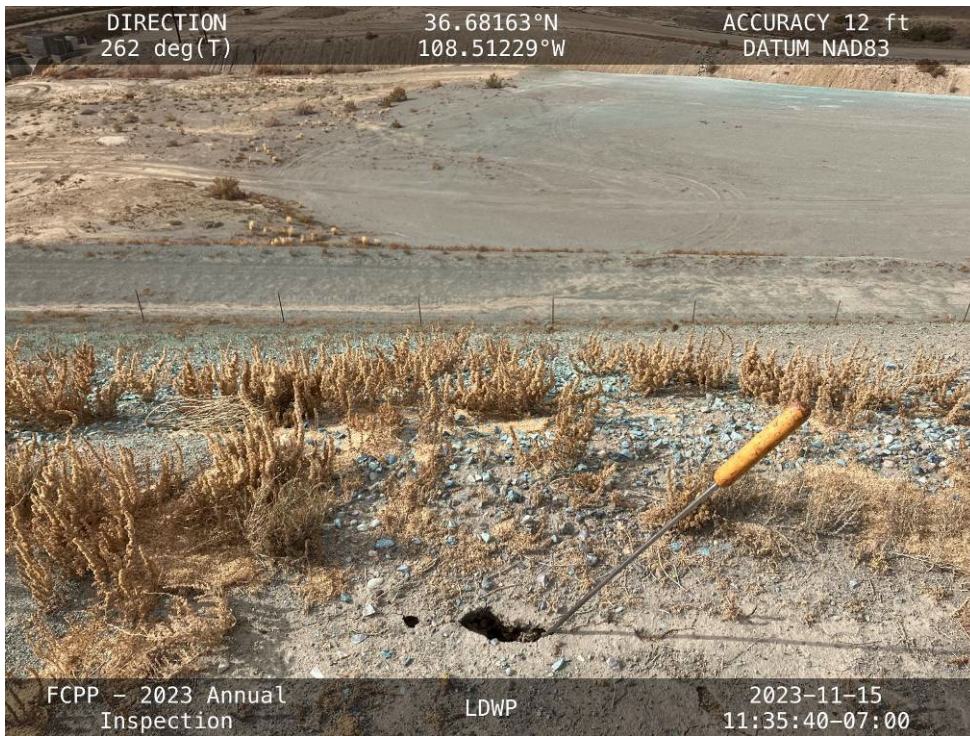
**20231115 – IMG\_2737**

An erosion hole on the downstream shoulder of the West Embankment crest, facing west.

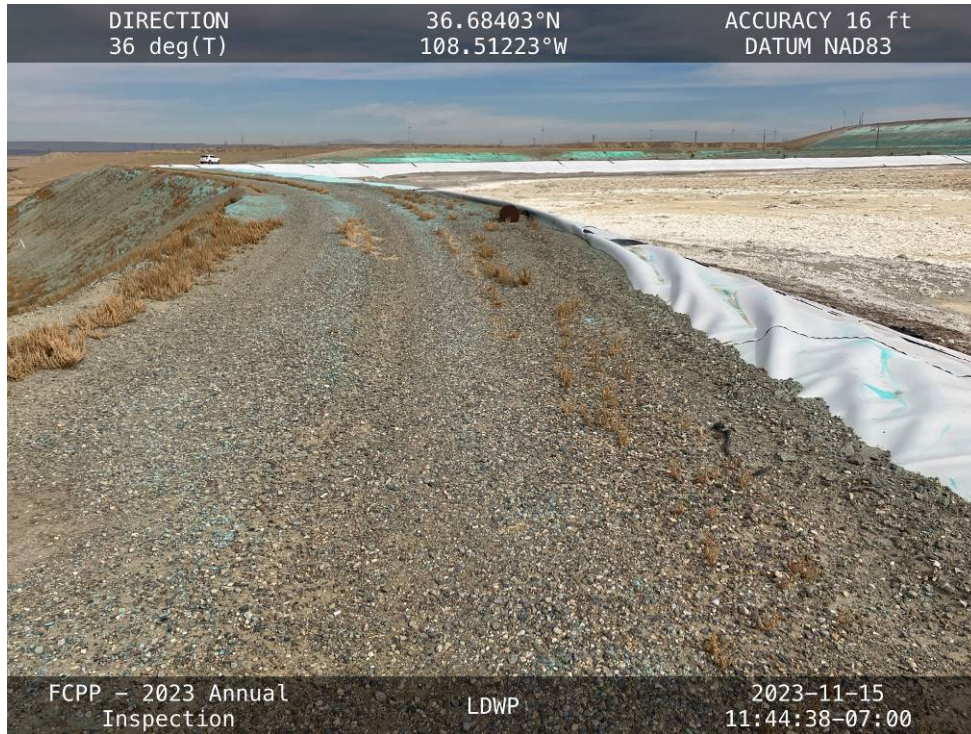
**20231115 – IMG\_2749**

The liner pulling out of the anchor trench in the northern portion of the West Embankment.

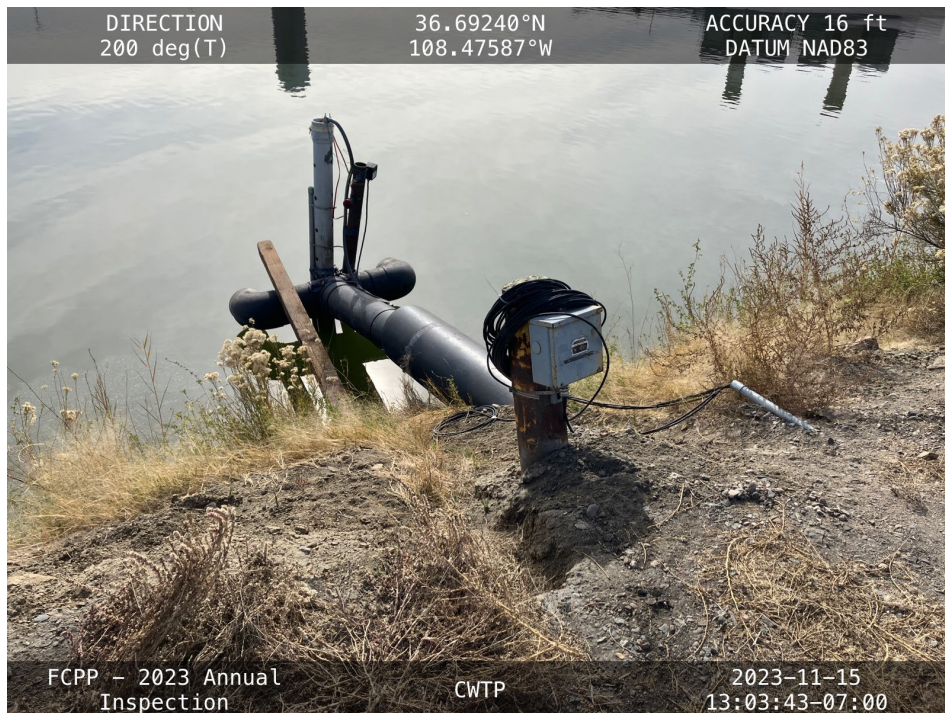
**20231115 – IMG\_2800**

Erosion around the water level transducer and the 18-inch pipe that transfers water from the canal to the CWTP.

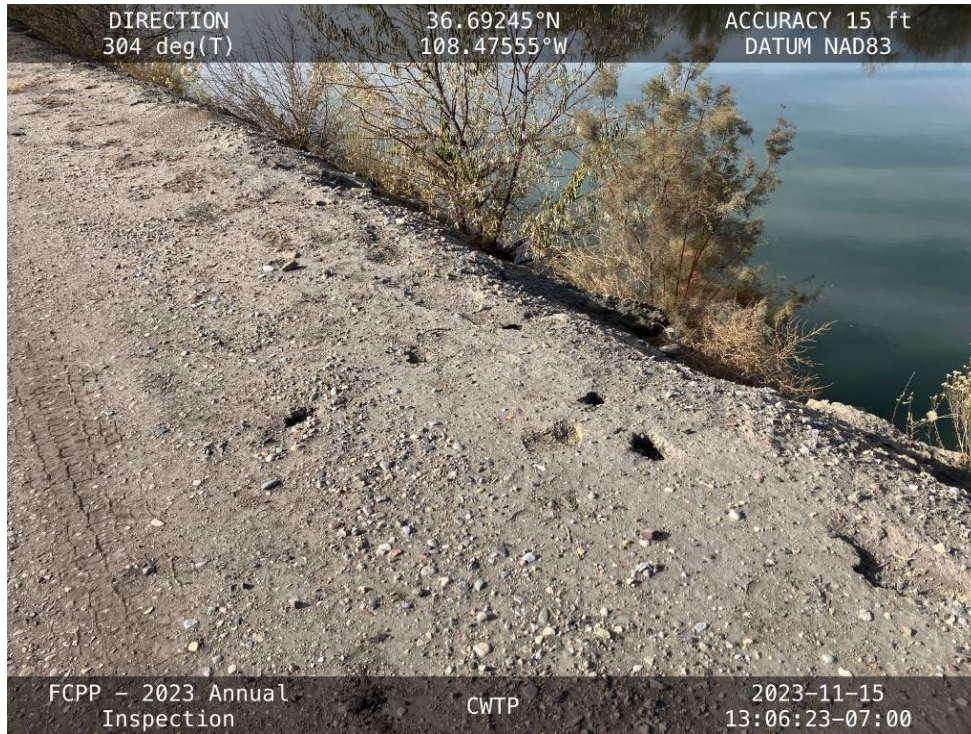
**20231115 – IMG\_2813**

A series of shallow holes on the downstream shoulder of the North Embankment.

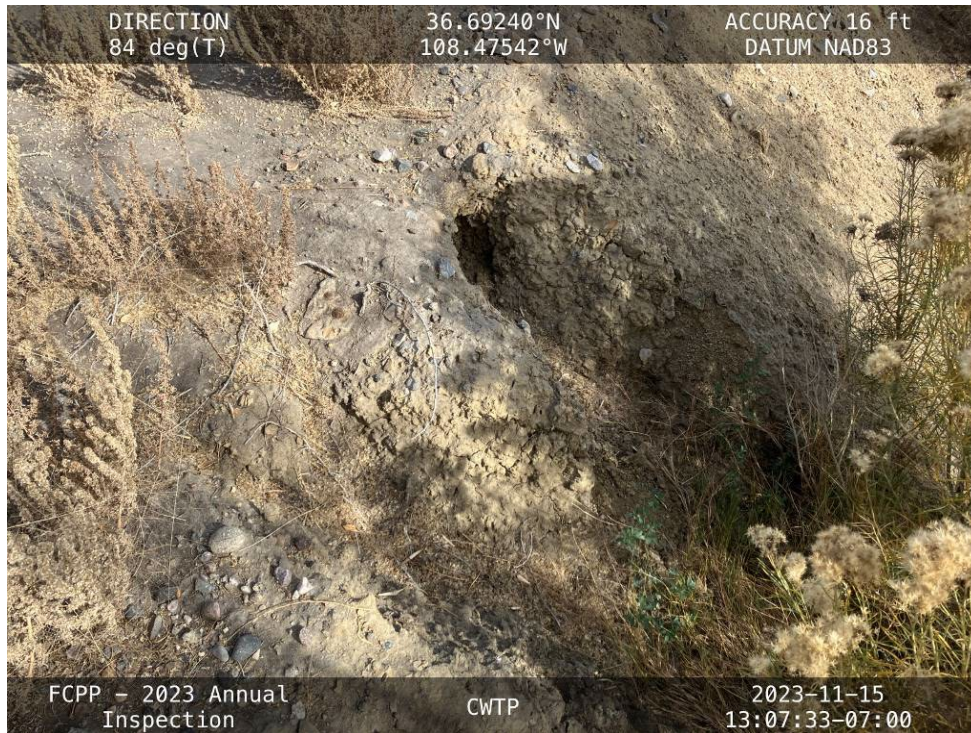
**20231115 – IMG\_2818**

A wide, but shallow hole on the upstream slope of the North Embankment.

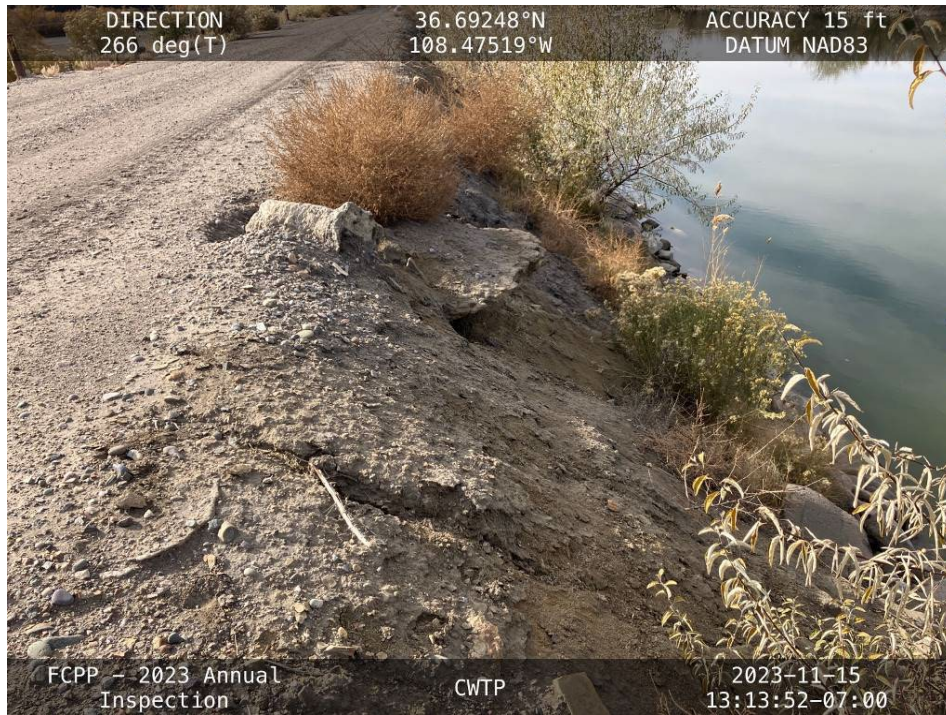
**20231115 – IMG\_2820**

Erosion around an old concrete post and undermining a riprap boulder on the downstream slope of the North Embankment.
