**FOUR CORNERS POWER PLANT  
Lined Ash Impoundment,  
Lined Decant Water Pond,  
Combined Waste Treatment Pond,  
Dry Fly Ash Disposal Area,  
and Return Water Pond**

**Annual  
CCR Impoundment and  
Landfill Inspection Report  
2023**

**GENERATION ENGINEERING  
Design Engineering  
P.O. BOX 53999  
PHOENIX, ARIZONA 85072**

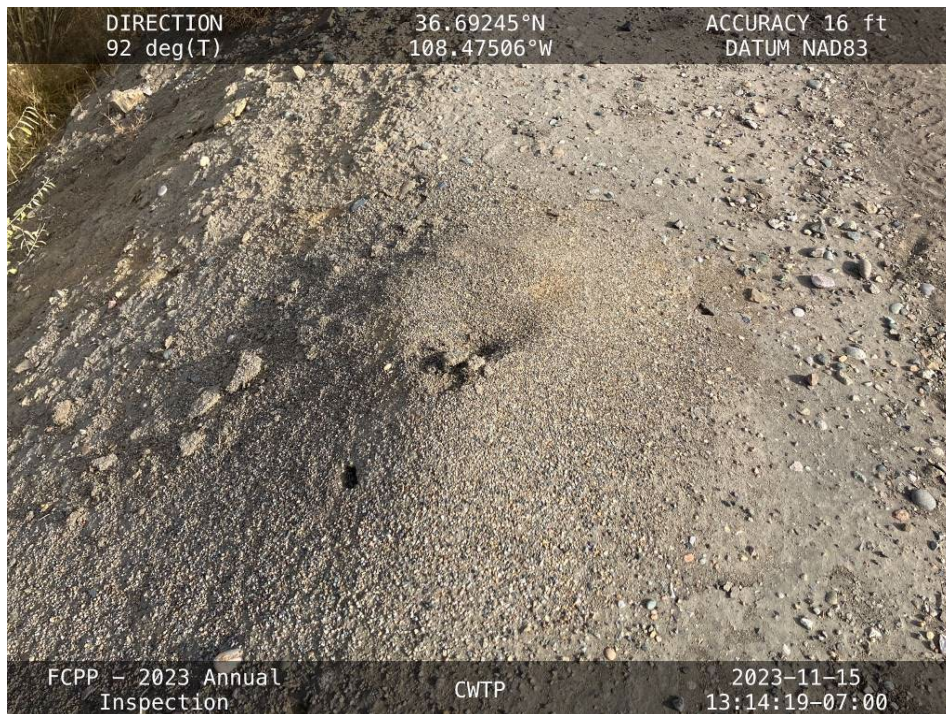
**20231115 – IMG\_2823**

An ant hill on the downstream shoulder of the embankment.

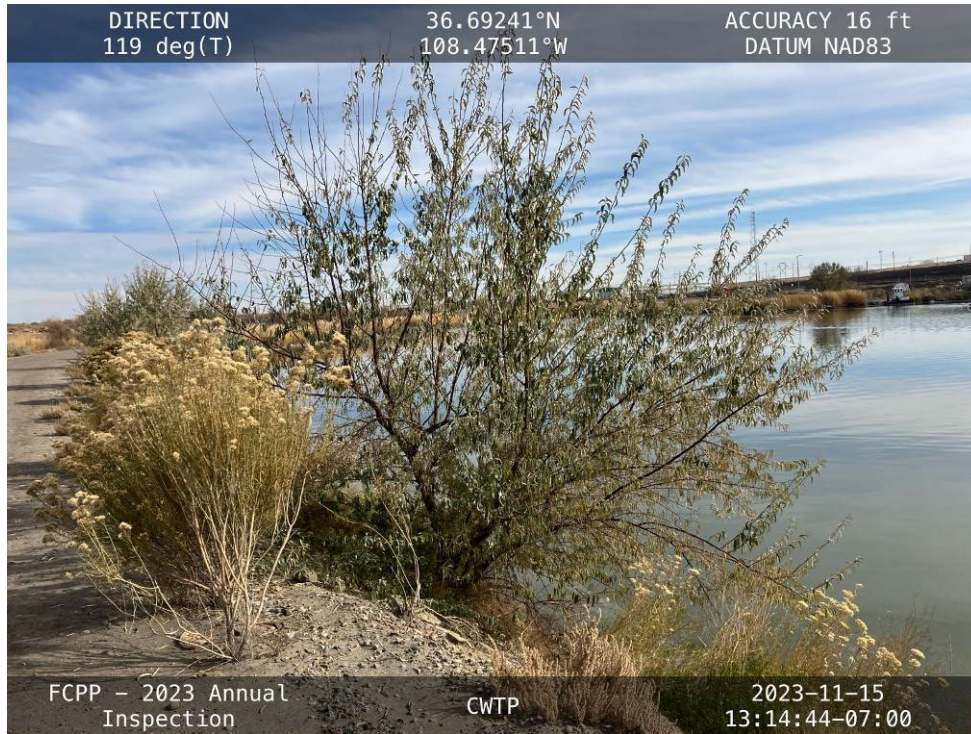
**20231115 – IMG\_2826**

Vegetation to be removed from the East Embankment upstream slope.

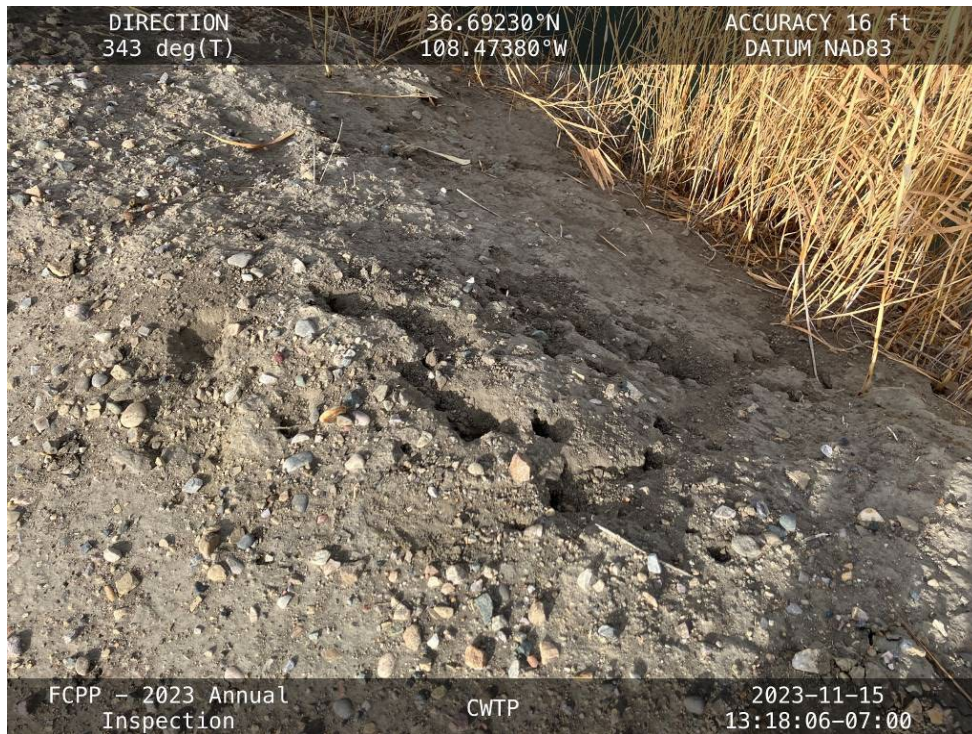
**20231115 – IMG\_2842**

Erosion undermining a riprap boulder on the downstream slope of the North Embankment.

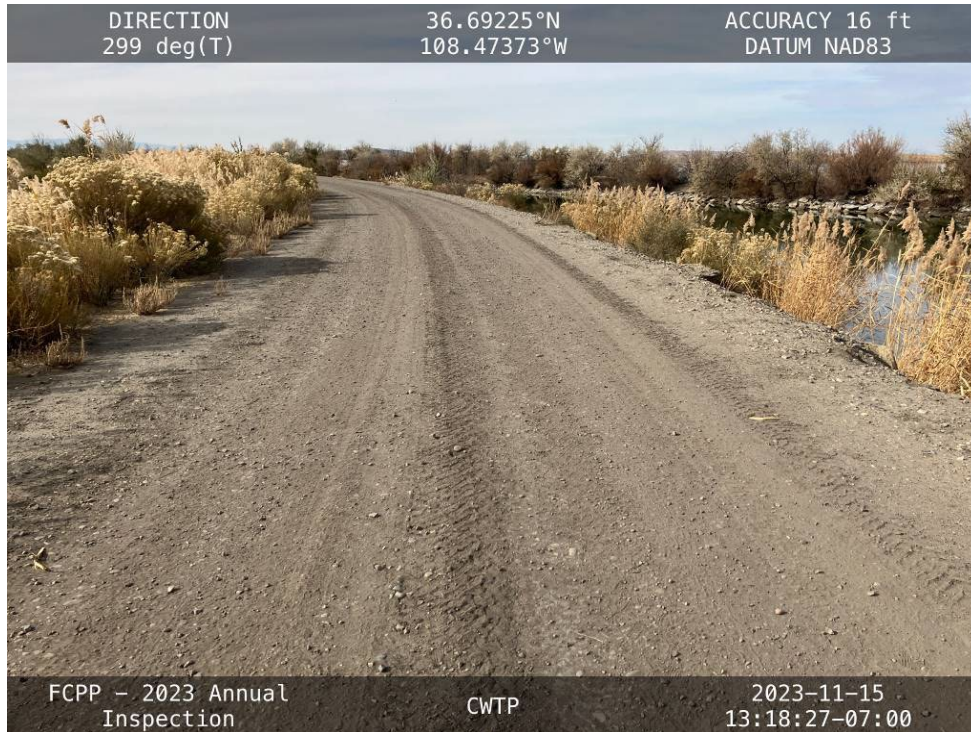
**20231115 – IMG\_2843**

Shallow holes and incipient erosion on the downstream slope of the North Embankment.

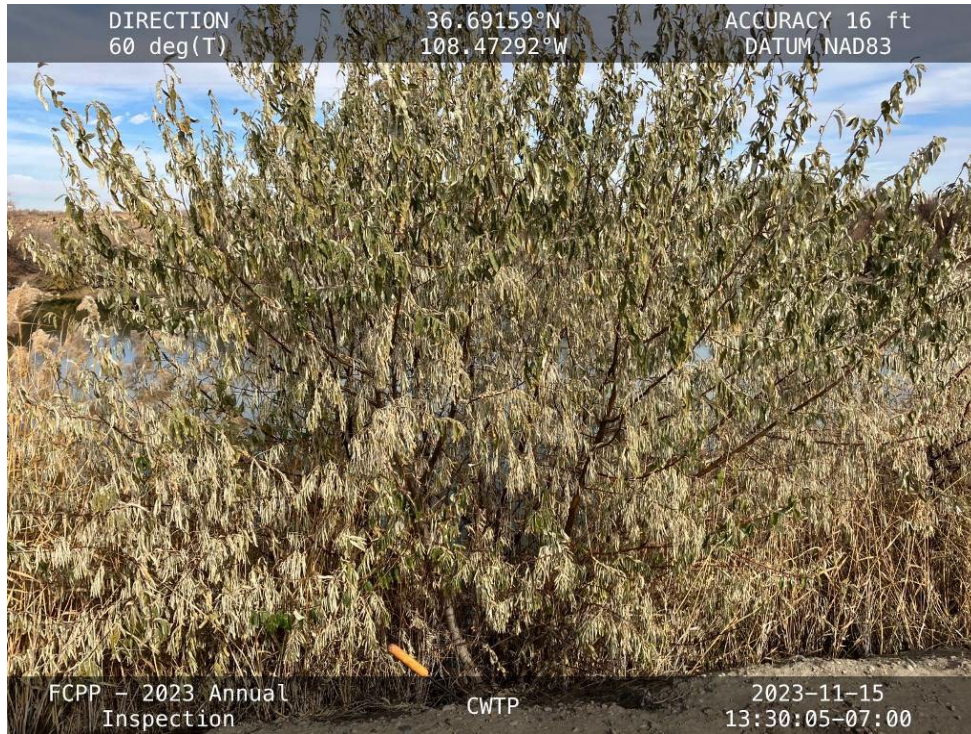
**20231115 – IMG\_2870**

Erosion around reeds growing on the downstream slope of the East Embankment.

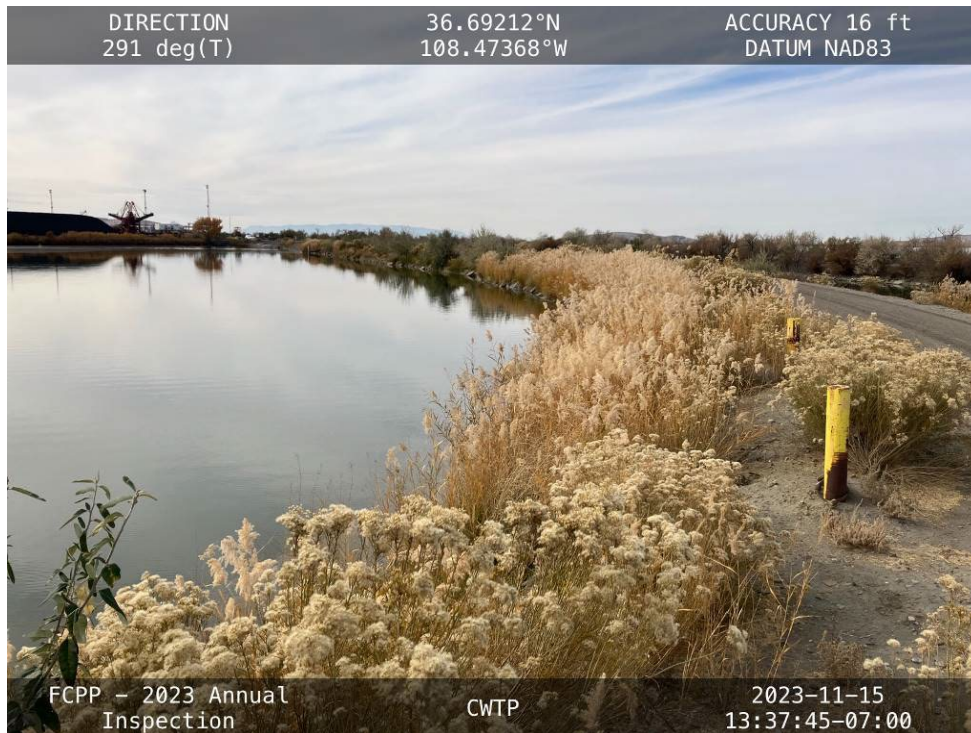
**20231115 – IMG\_2872**

Vegetation to be removed from the East Embankment downstream slope, with a hole adjacent to the tree.

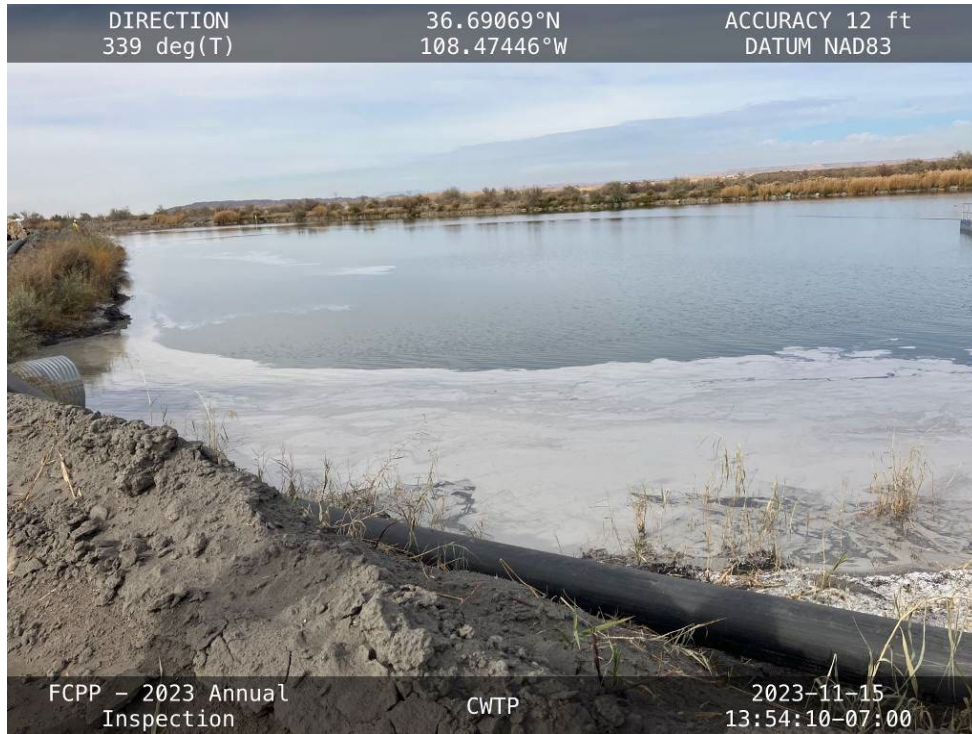
**20231115 – IMG\_2924**

The west side of the CWTP reservoir with the decant cells removed, facing north from the south end.

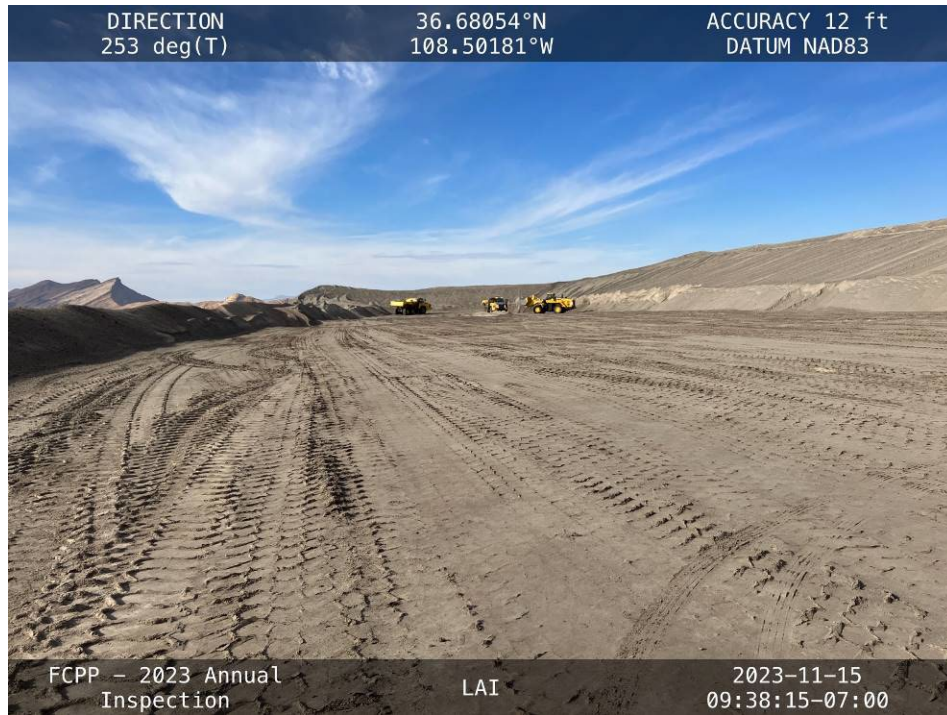
**20231115 – IMG\_2503**

Haul trucks and a loader on top of Cell 3 moving bottom ash stockpiled for access road construction at the LAI.

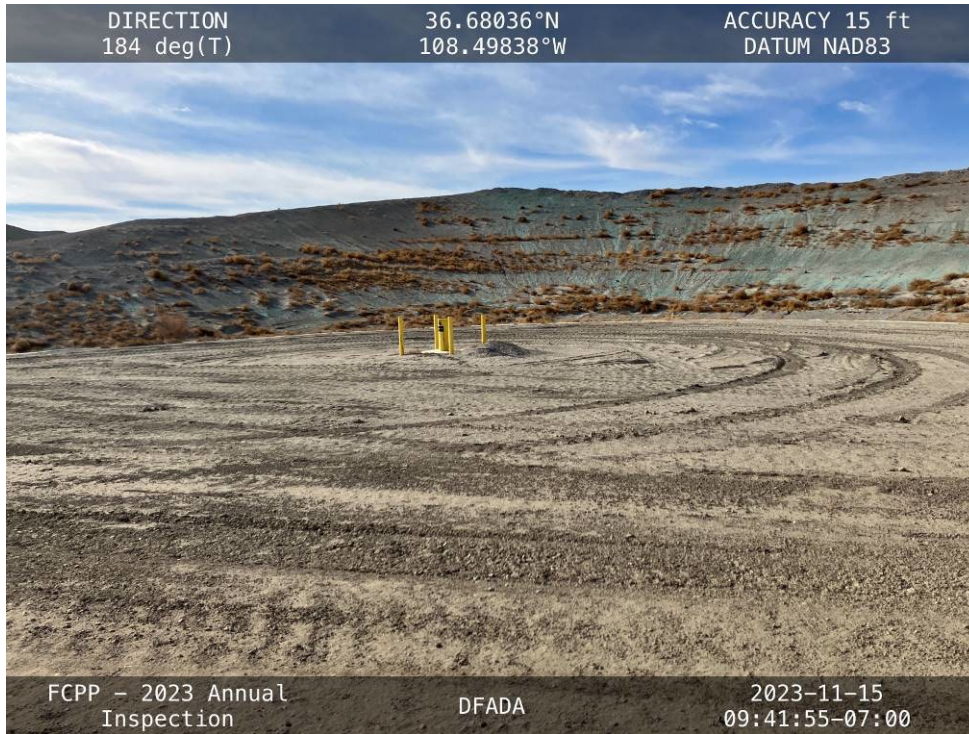
**20231115 – IMG\_2516**

MW-55R and the east side of Cell 2, facing south from the northeast side.

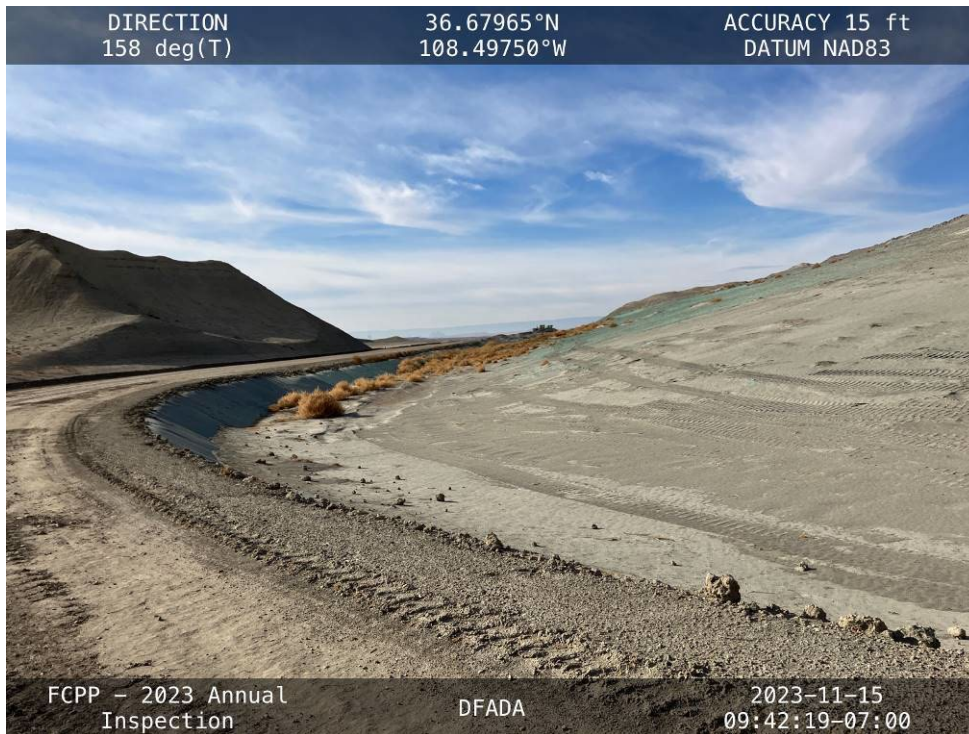
**20231115 – IMG\_2519**

The slope on the east side of Cell 2, viewed from the east side.

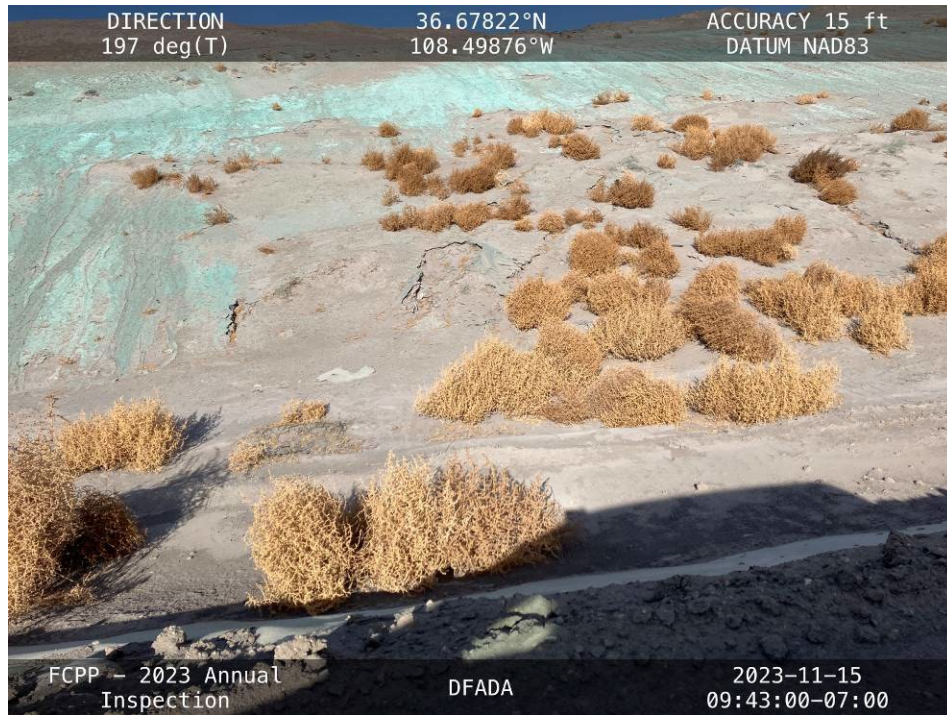
**20231115 – IMG\_2522**

Shallow erosion features on the southeast slope of Cell 2.

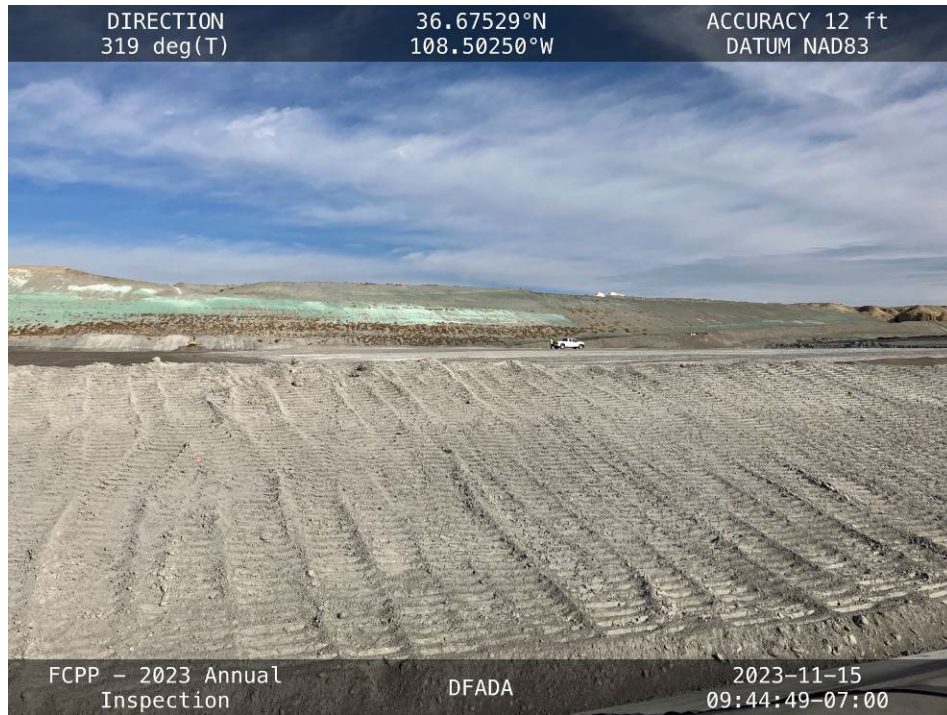
**20231115 – IMG\_2530**

The surface of Cell 4 with the downstream slope of Cell 2 in the background, facing northwest from the south side of Cell 4.

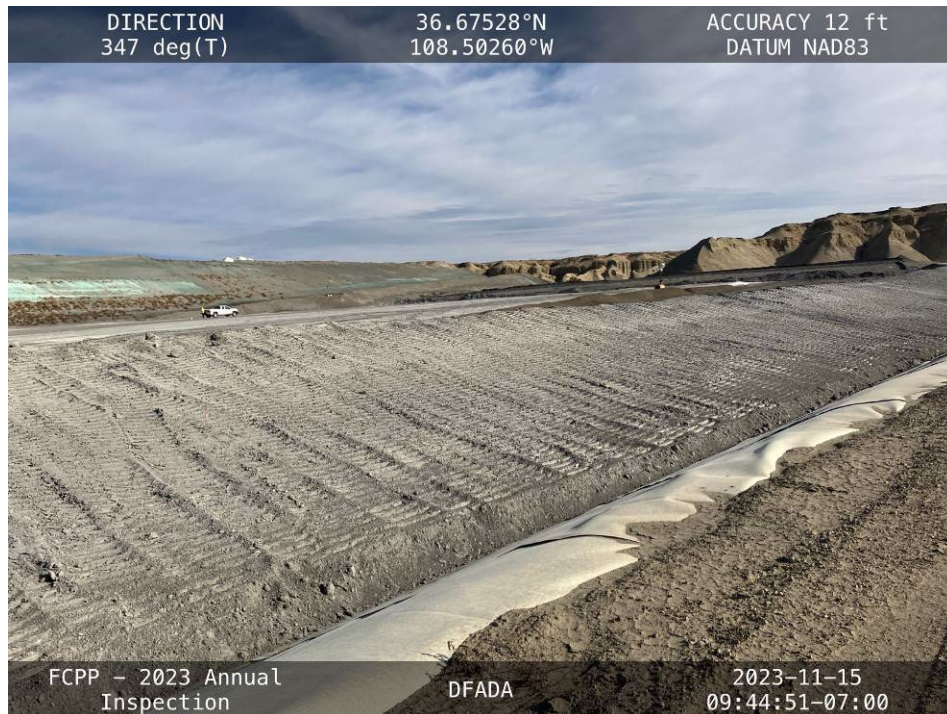
**20231115 – IMG\_2531**

Ash placed in Cell 4, facing north.

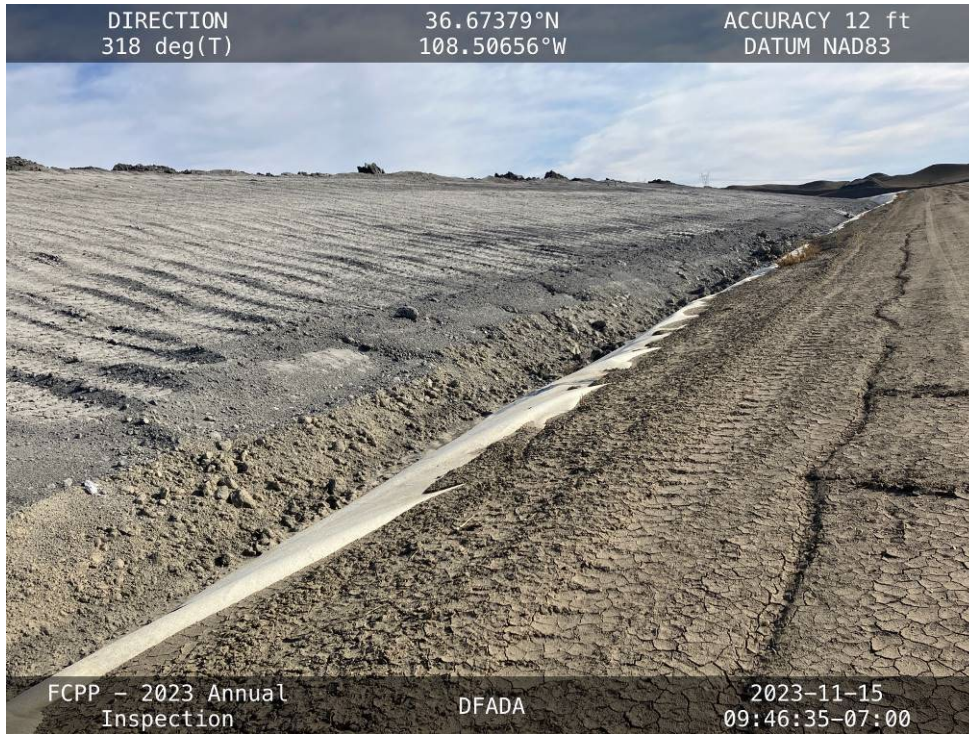
**20231115 – IMG\_2536**

The southern toe of Cell 4, facing east from the south end.

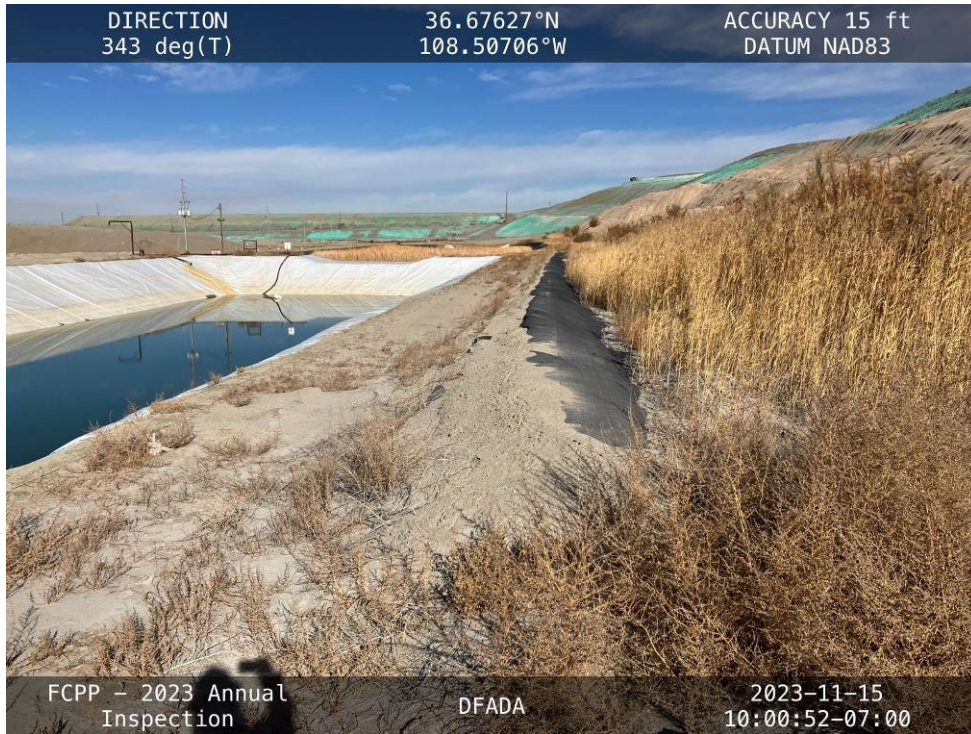
**20231115 – IMG\_2553**

Reeds along the western toe of Cell 1, facing north from the southwest corner of Cell 1.

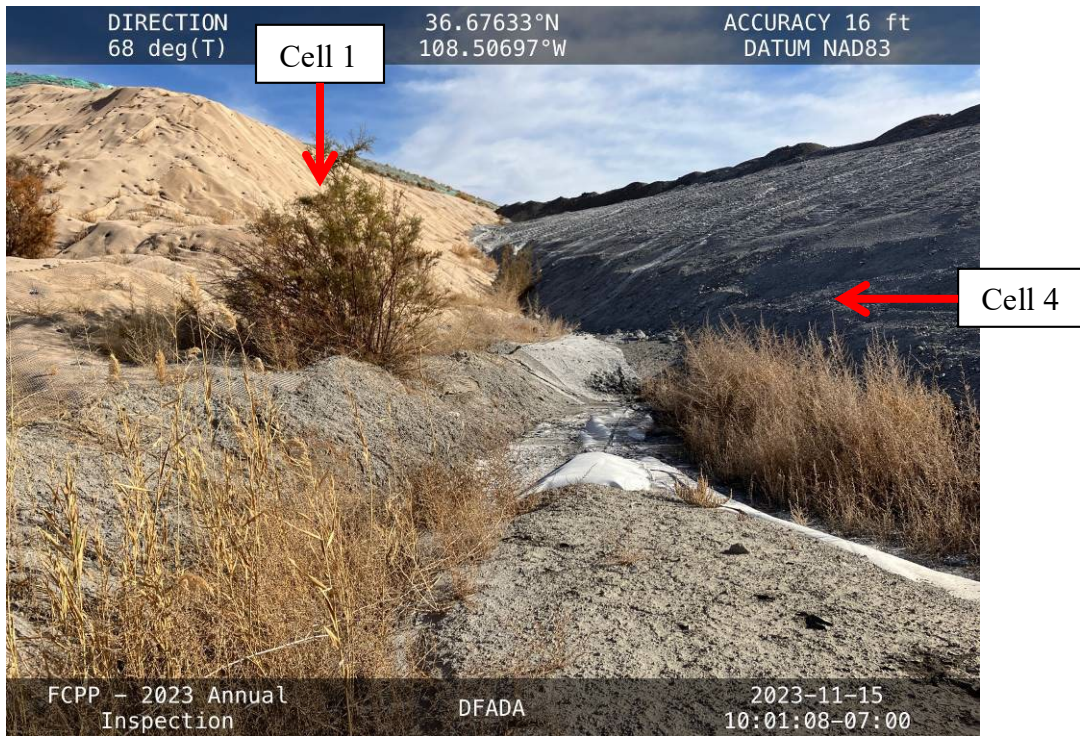
**20231115 – IMG\_2554**

The junction of Cell 1 and Cell 4, facing northeast from the western toe.

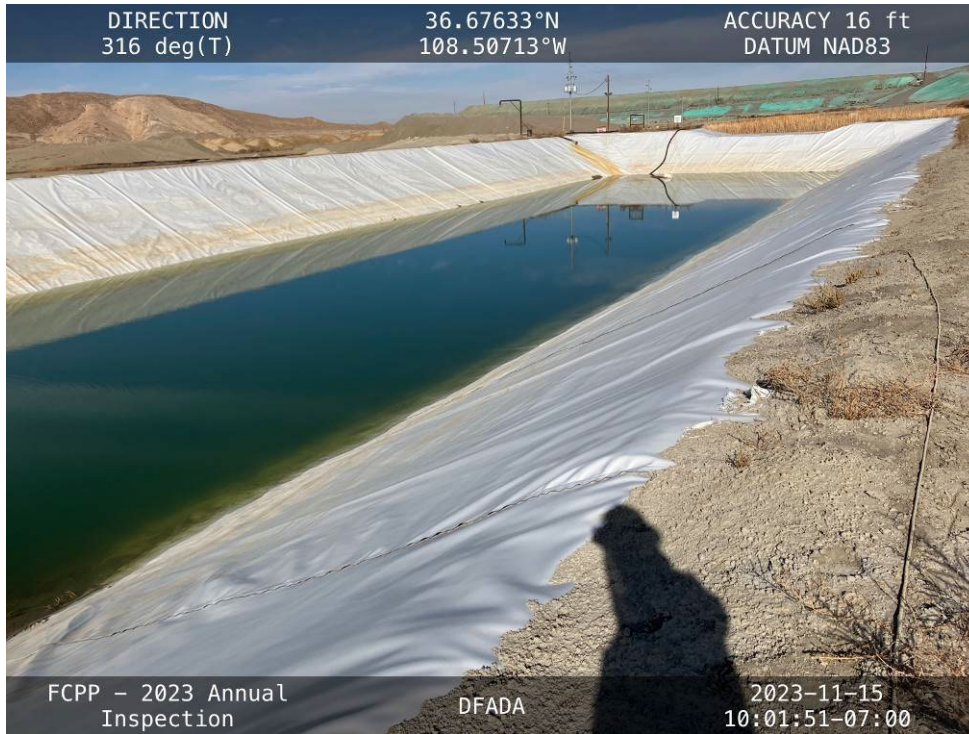
**20231115 – IMG\_2555**

The DFADA Cell 2 leachate collection pond, facing north from its southeast corner.

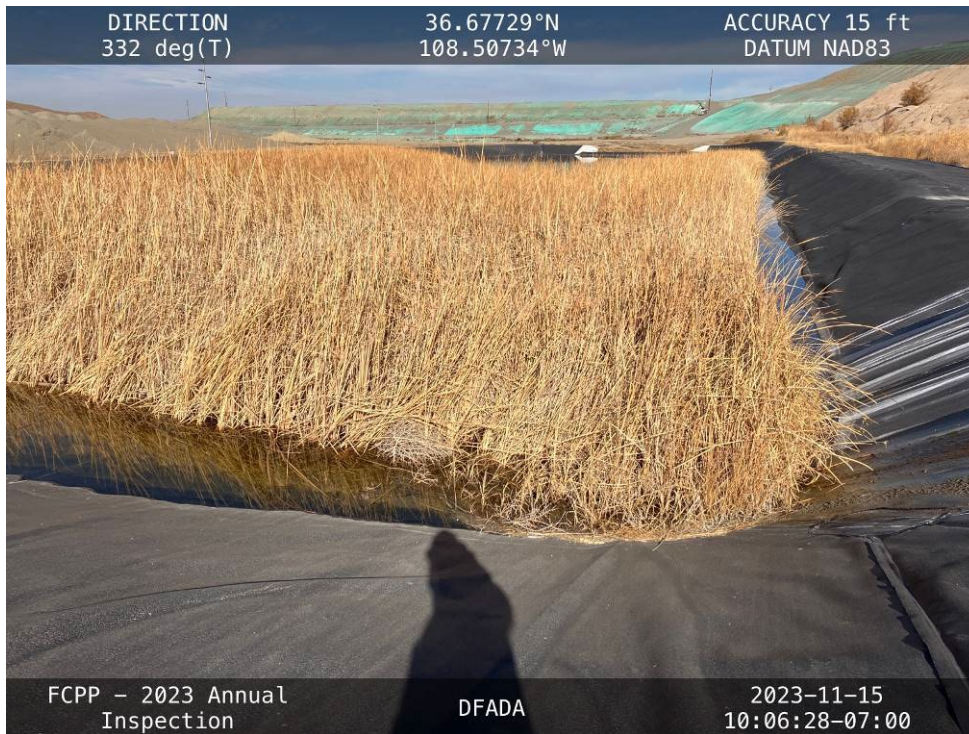
**20231115 – IMG\_2560**

The DFADA Cell 1 leachate collection pond, facing north from the western toe of Cell 1.

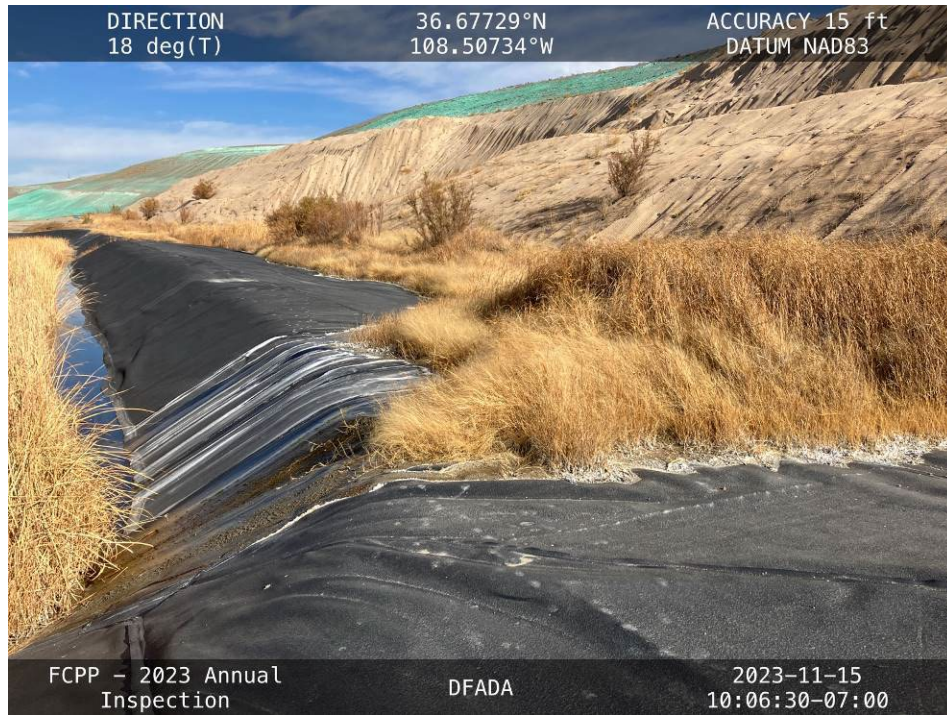
**20231115 – IMG\_2561**

Vegetation to be removed and water draining from Cell 1, seeping directly over the liner into the leachate collection pond.

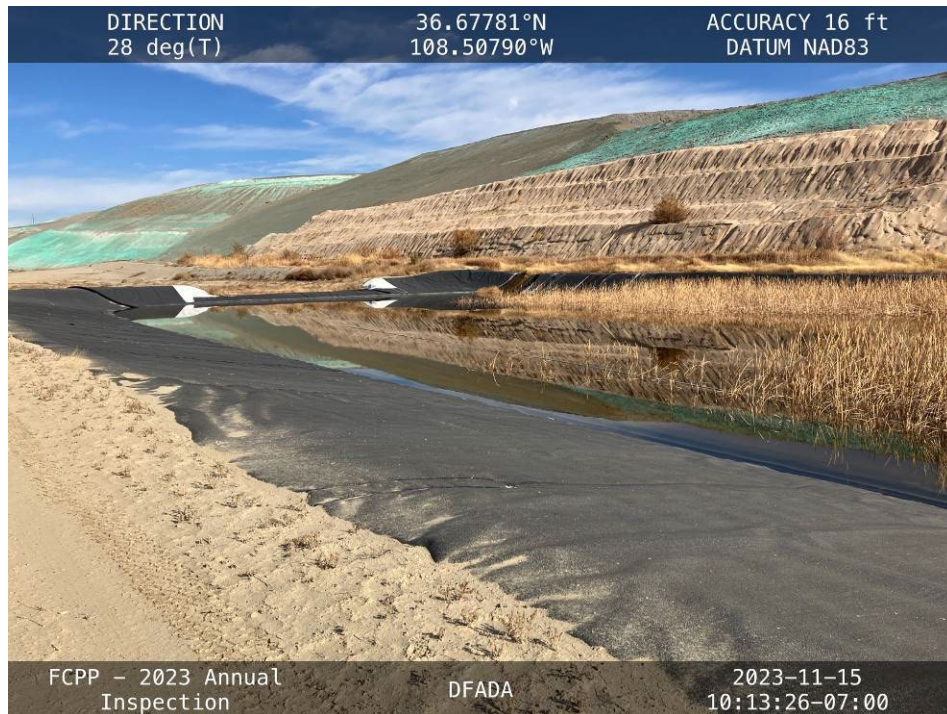
**20231115 – IMG\_2575**

The Cell 1 leachate collection pond and northern portion of the western slope.

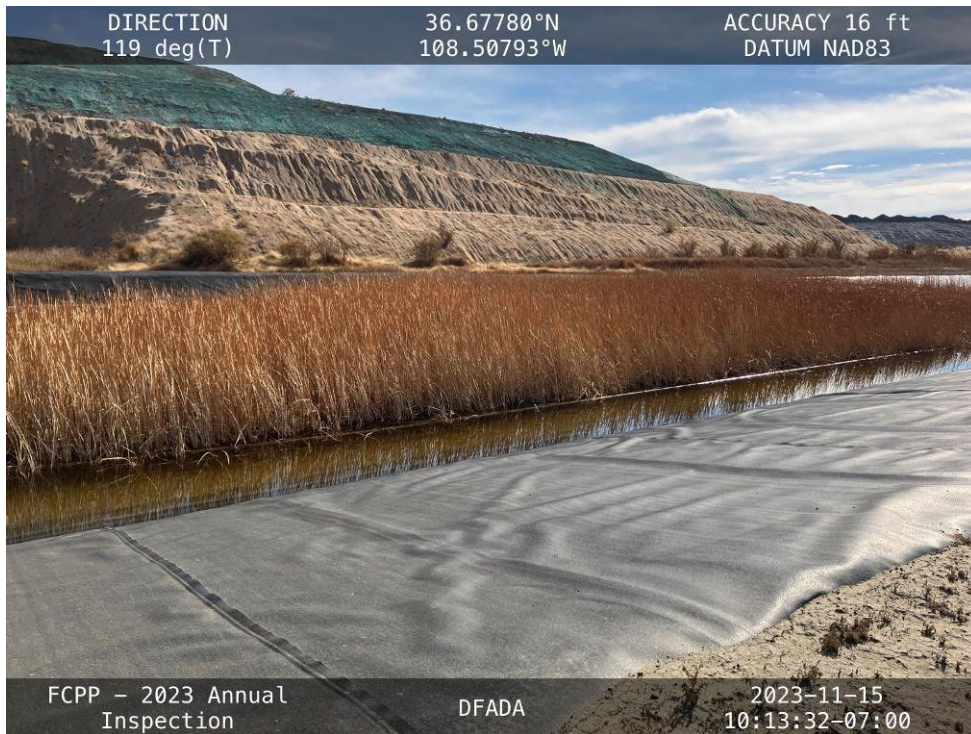
**20231115 – IMG\_2578**

The Cell 1 leachate collection pond and southern portion of the western slope.

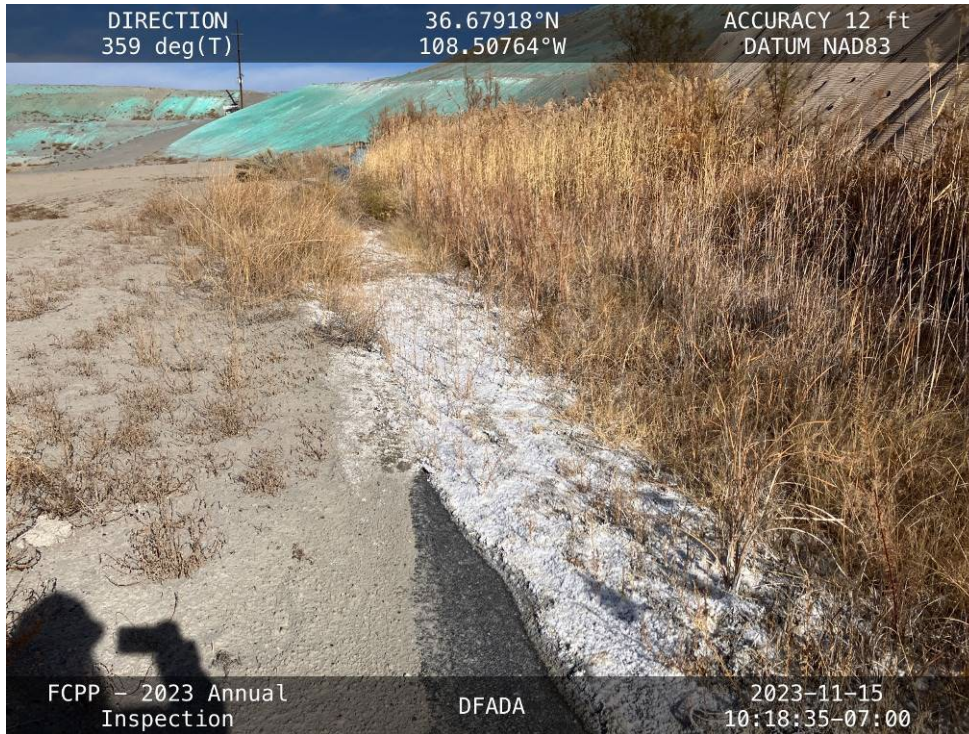
**20231115 – IMG\_2581**

Reeds and sediment filling the drainage ditch at the western toe of the Cell 3 slope.

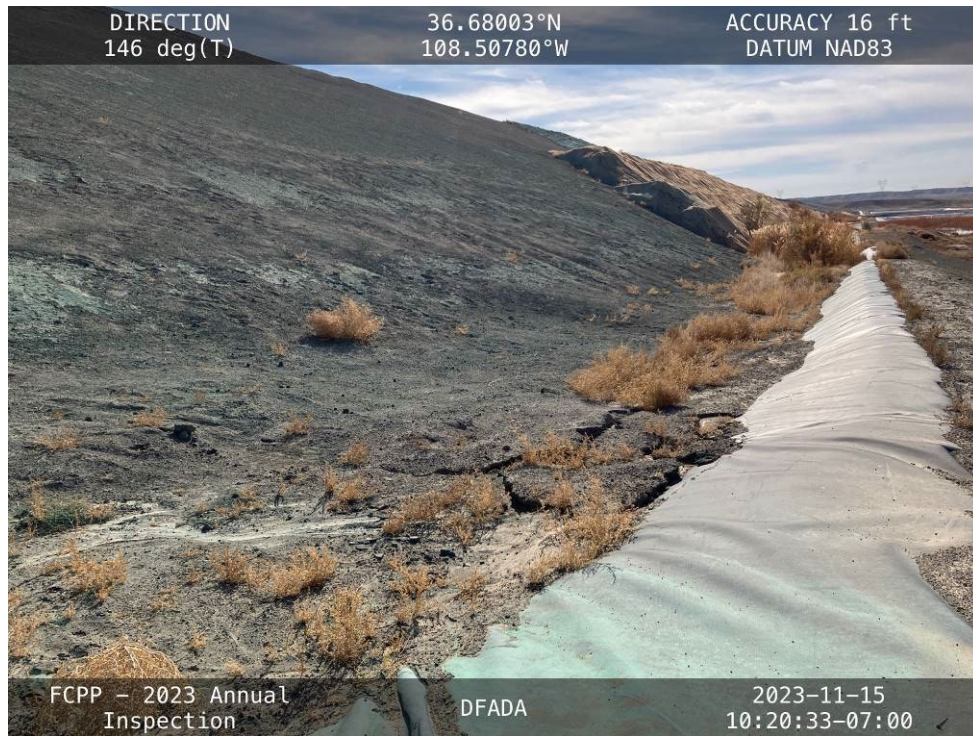
**20231115 – IMG\_2589**

The downstream toe of the Cell 3 West Embankment, facing south.

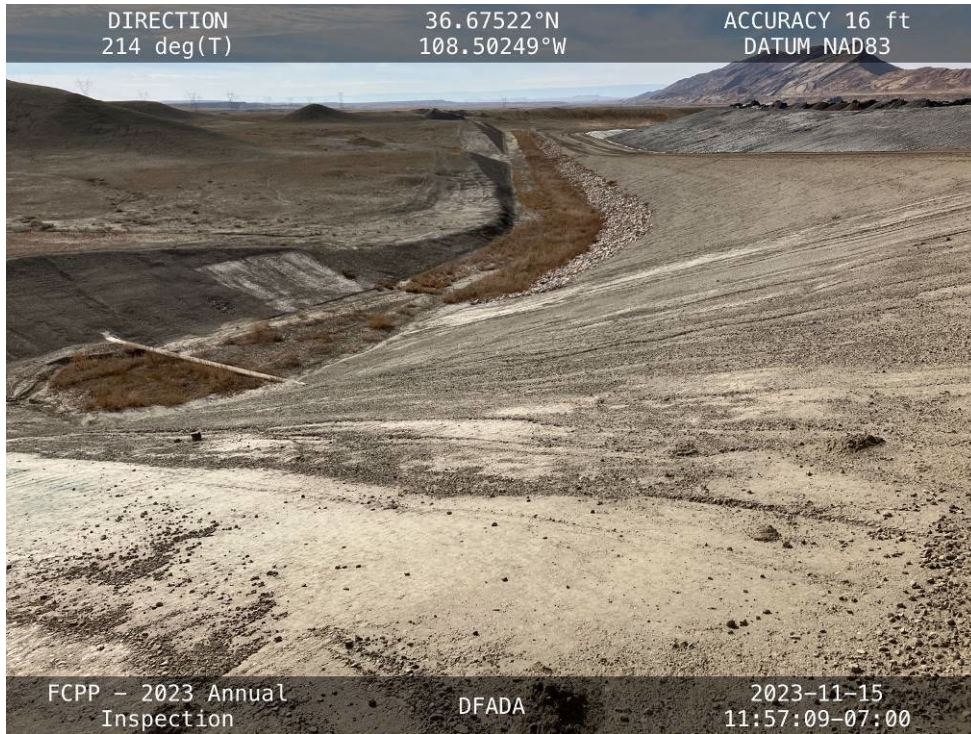
**20231115 – IMG\_2766**

The Stormwater Diversion Channel south of Cell 4 downstream of the stilling basin, facing southwest.

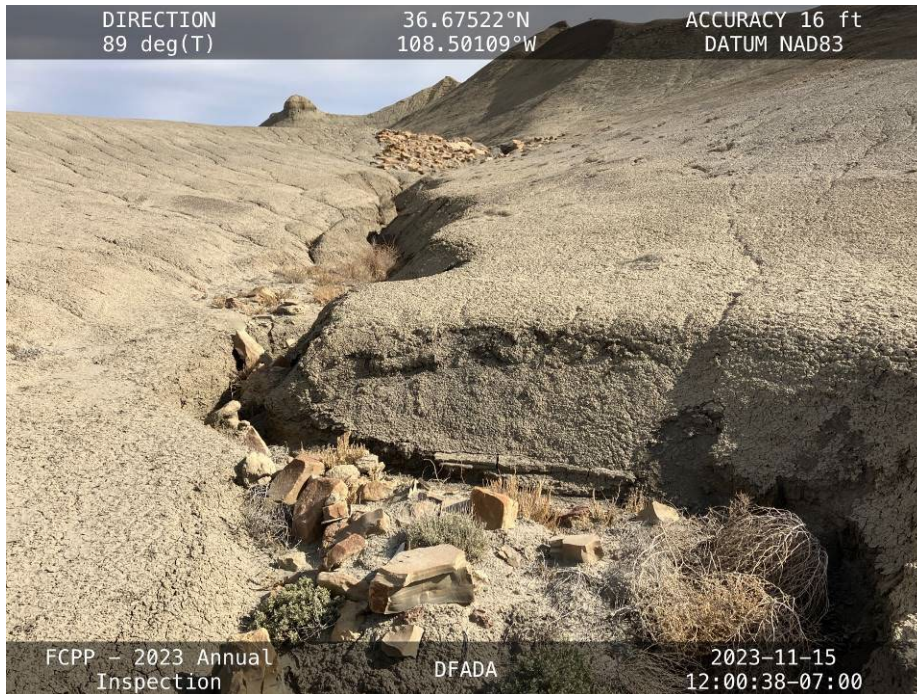
**20231115 – IMG\_2772**

Action Item	Action Status
1) There is erosion at the Stormwater Diversion Channel inlet and outlet, as well as along the extension constructed as part of the Cell 4 expansion where the previous alignment terminated.	Monitor erosion and repair the area. Alternately, place additional sandstone riprap in the eroded area.

Several feet of erosion where the Stormwater Diversion Channel previously terminated, immediately upstream of the section lined with cement-treated base.

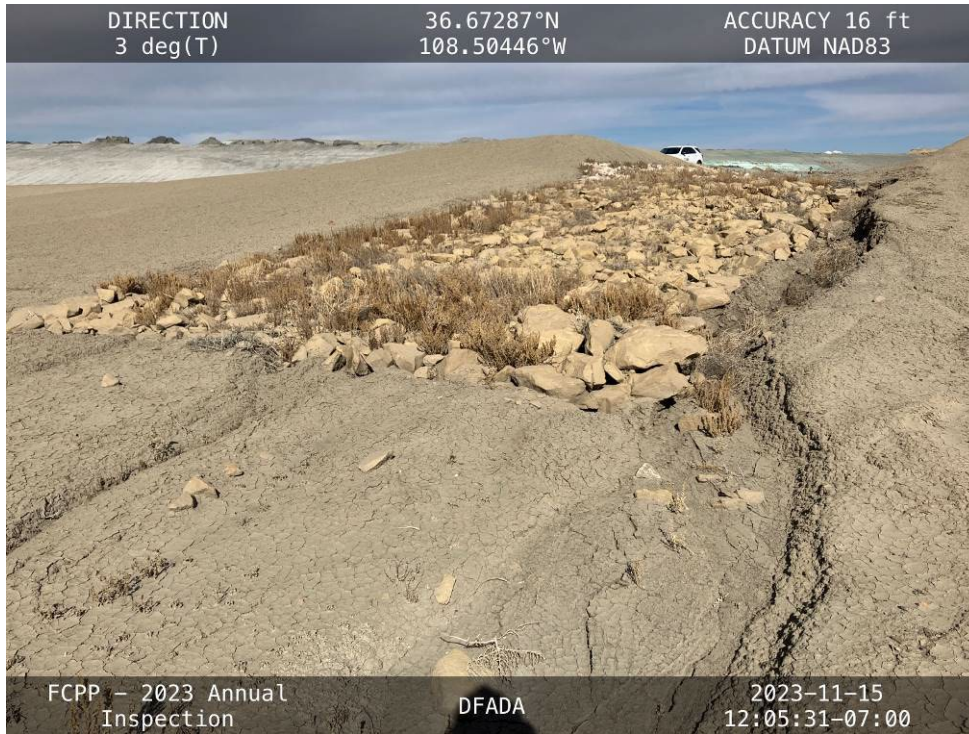
**20231115 – IMG\_2782**

Erosion around the new outlet for the Stormwater Diversion Channel.

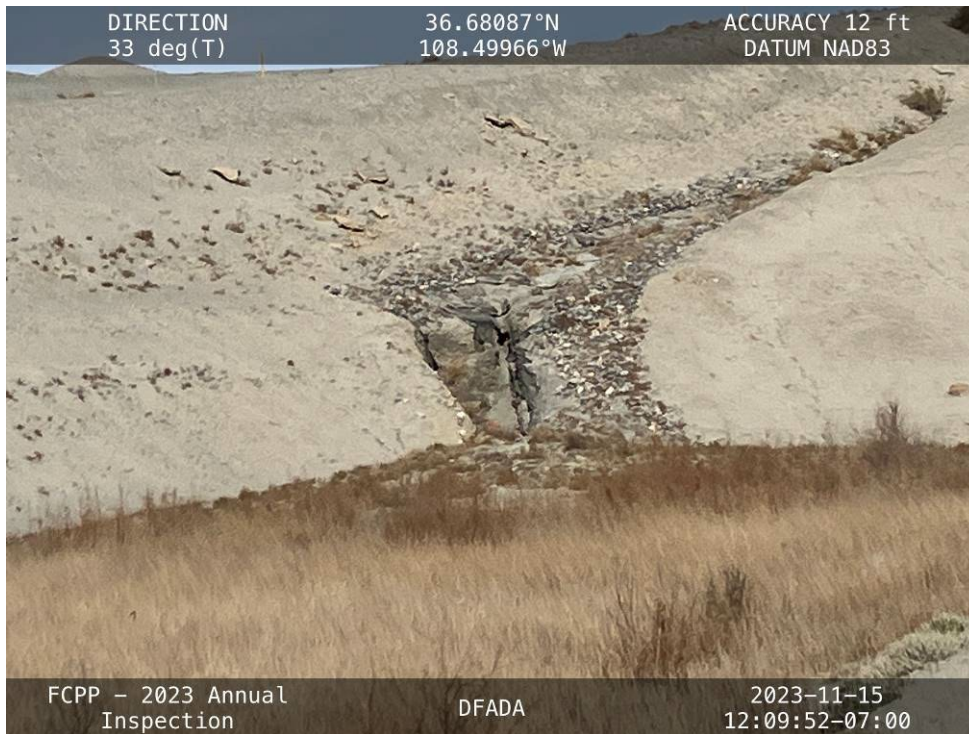
**20231115 – IMG\_2785**

The inlet to the Stormwater Diversion Channel, facing north from the ash haul road.

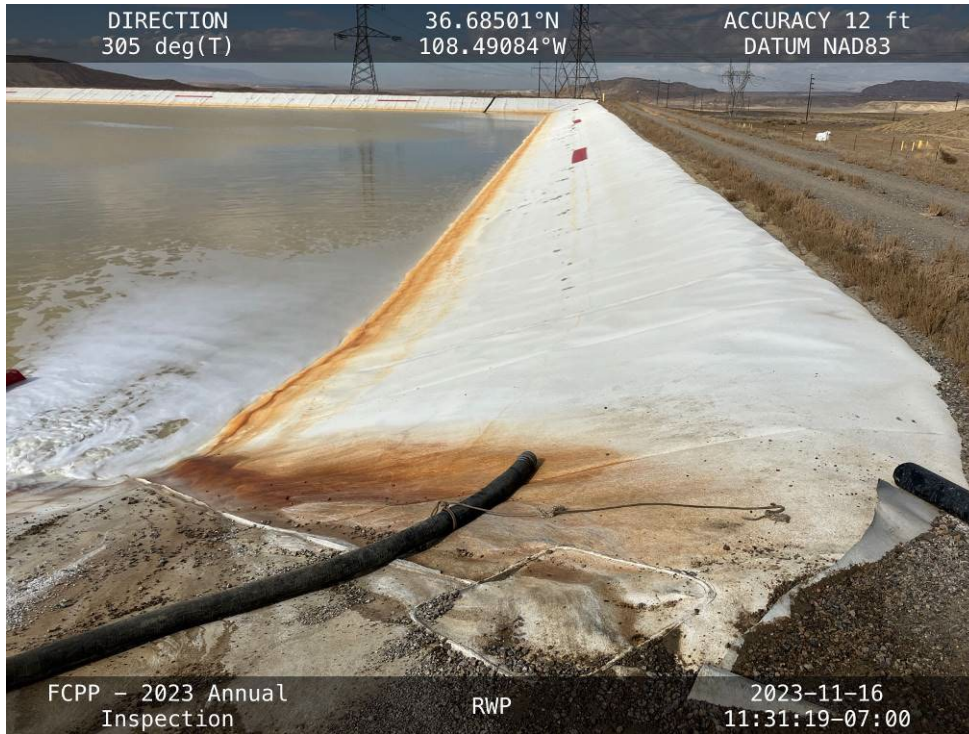
**20231116 – IMG\_3114**

The upstream slope of the Northeast Embankment, facing northwest from the eastern corner.

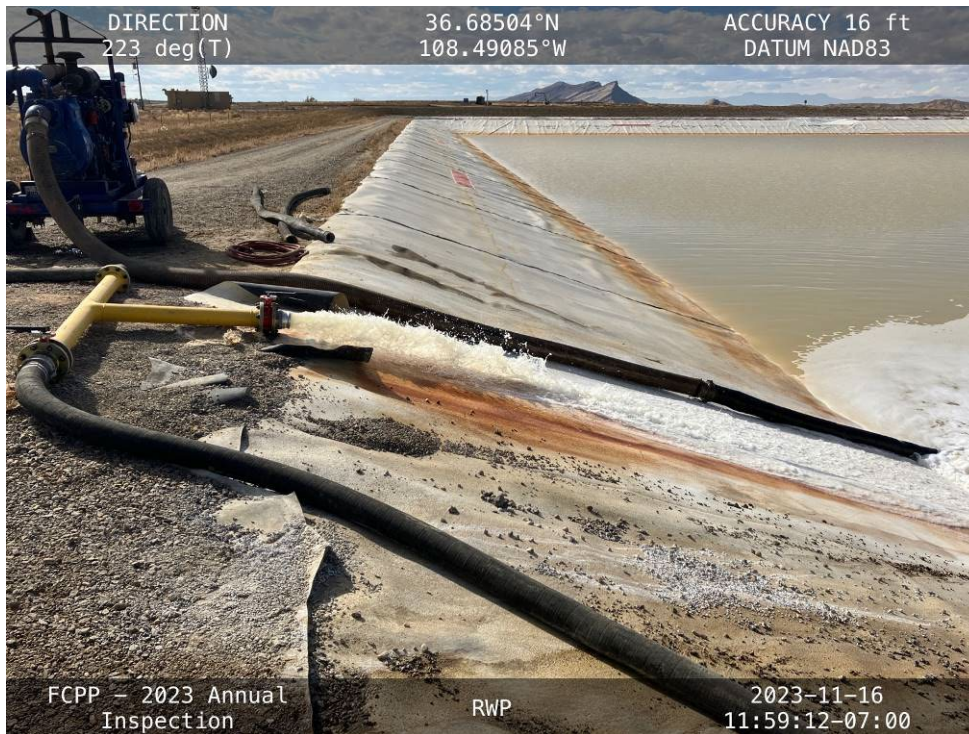
**20231116 – IMG\_3115**

The upstream slope of the Southeast Embankment, facing southwest from the eastern corner.

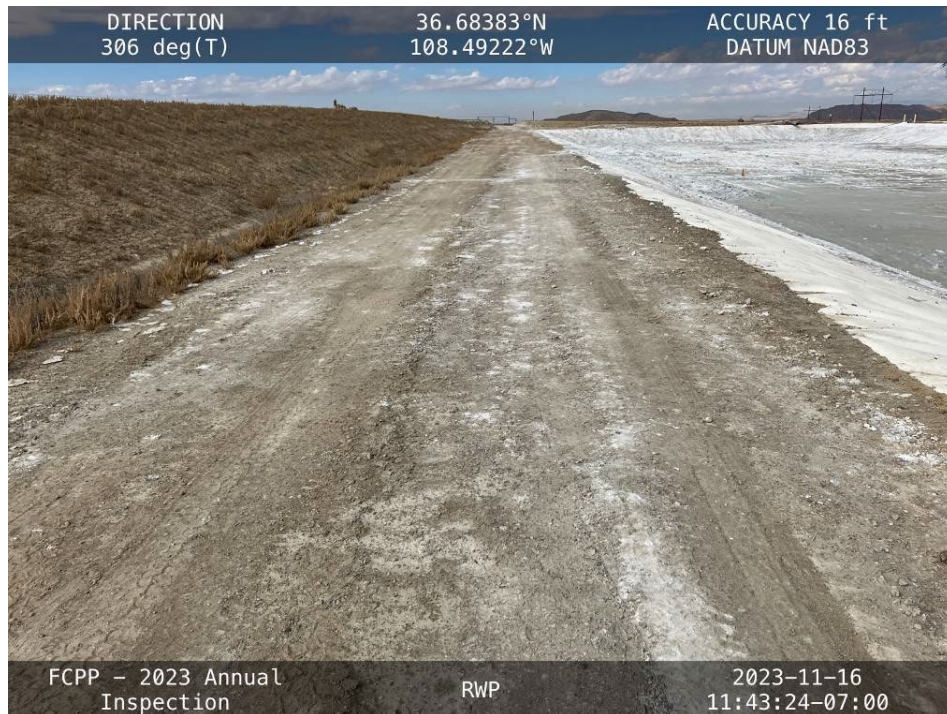
**20231116 – IMG\_3148**

The upstream slope of the FGD Pond Southwest Embankment with two repaired areas in the foreground, facing northwest.

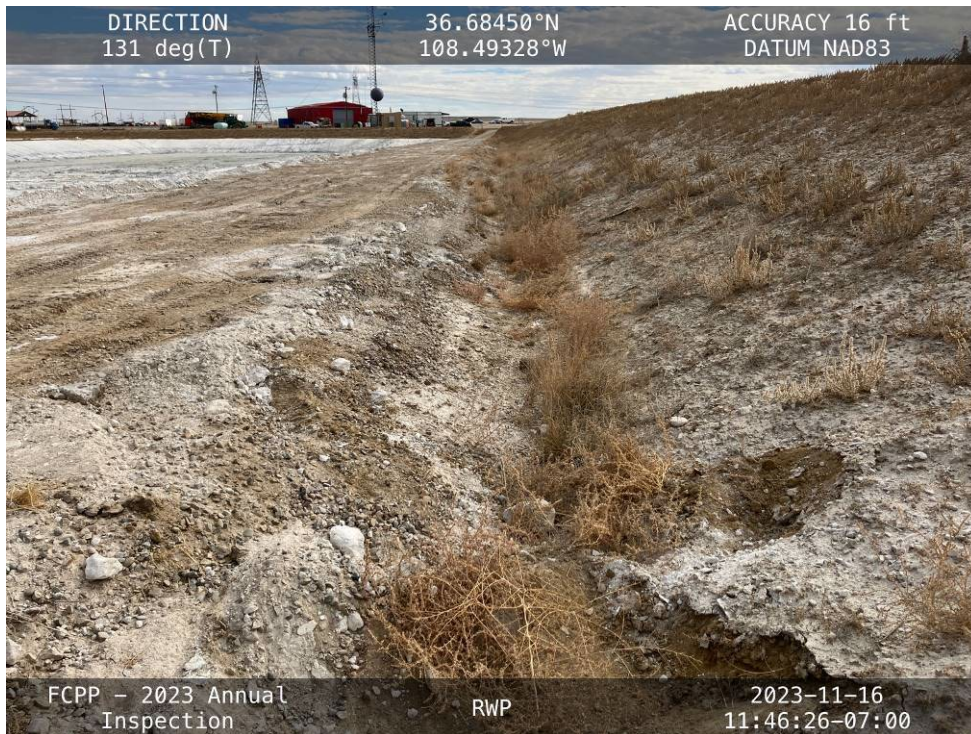
**20231116 – IMG\_3155**

Sediment filling the drainage ditch on the western corner of the FGD Pond.
