**FOUR CORNERS POWER PLANT  
Lined Ash Impoundment,  
Lined Decant Water Pond,  
Combined Waste Treatment Pond,  
Dry Fly Ash Disposal Area,  
and Return Water Pond**

**Annual  
CCR Impoundment and  
Landfill Inspection Report  
2023**

**GENERATION ENGINEERING  
Design Engineering  
P.O. BOX 53999  
PHOENIX, ARIZONA 85072**

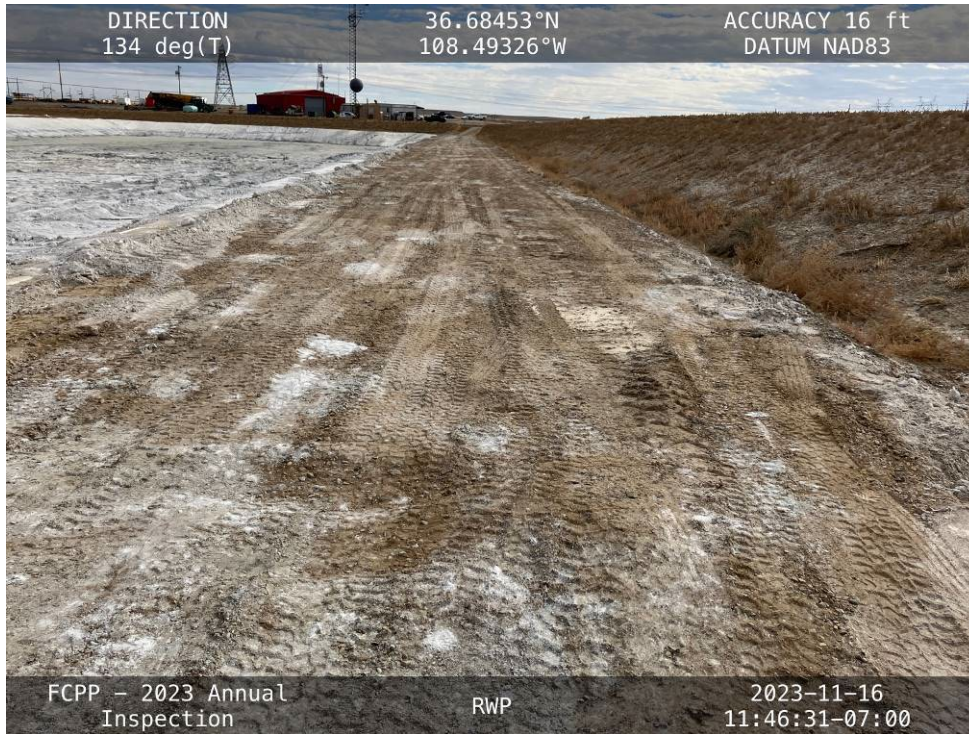
**20231116 – IMG\_3156**

2) Tension cracks were observed on the slope of the incised drainage ditch along the western corner of the pond, downstream of the FGD cell.	This area should be monitored for sloughs that could impede the drainage characteristics in the western corner.

The drainage ditch on the western corner of the FGD Pond, facing southeast from the western corner.

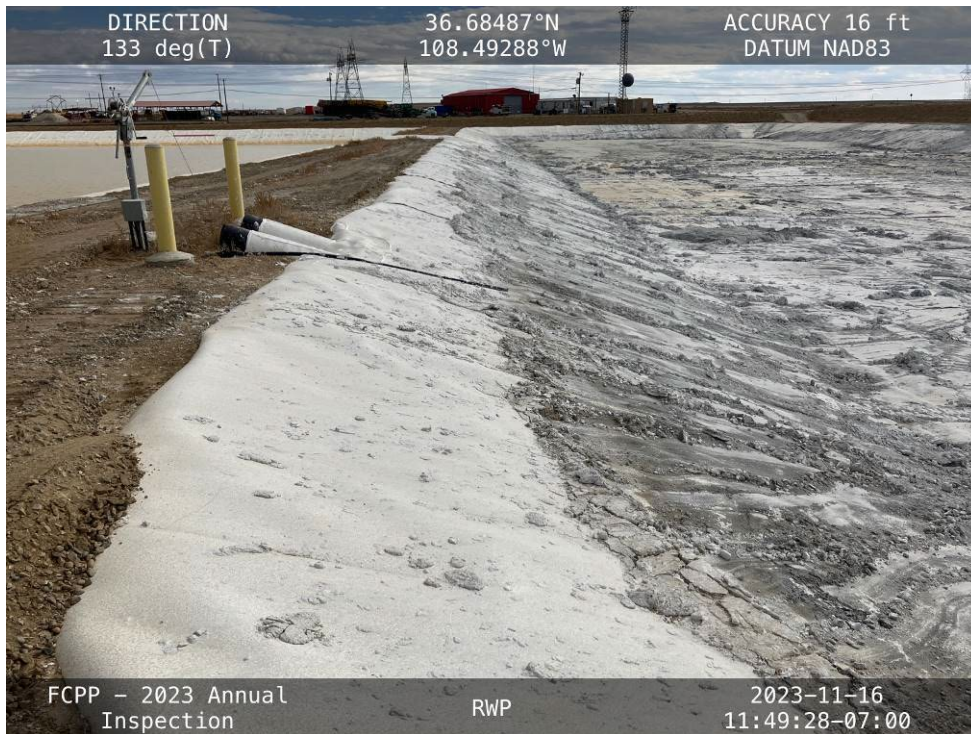
**20231116 – IMG\_3165**

Sediment (to be removed) blocking the drain pipe on the western corner of the RWP.

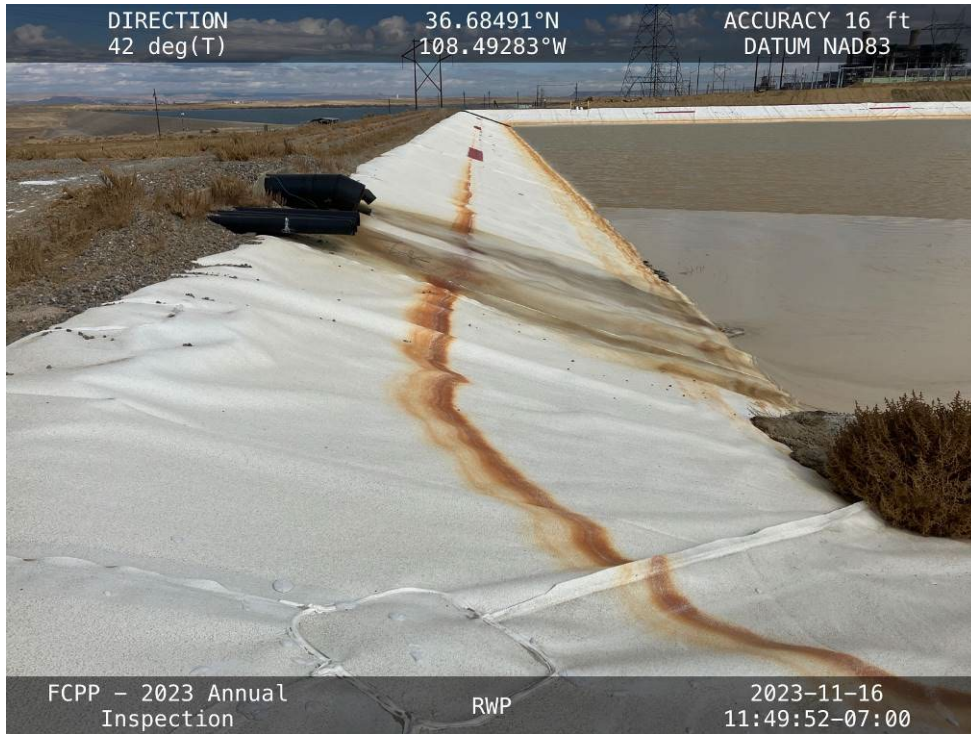
**20231116 – IMG\_3178**

The upstream slope of the RWP Internal Embankment with loose liner where previous construction activity took place (arrow), facing southeast.

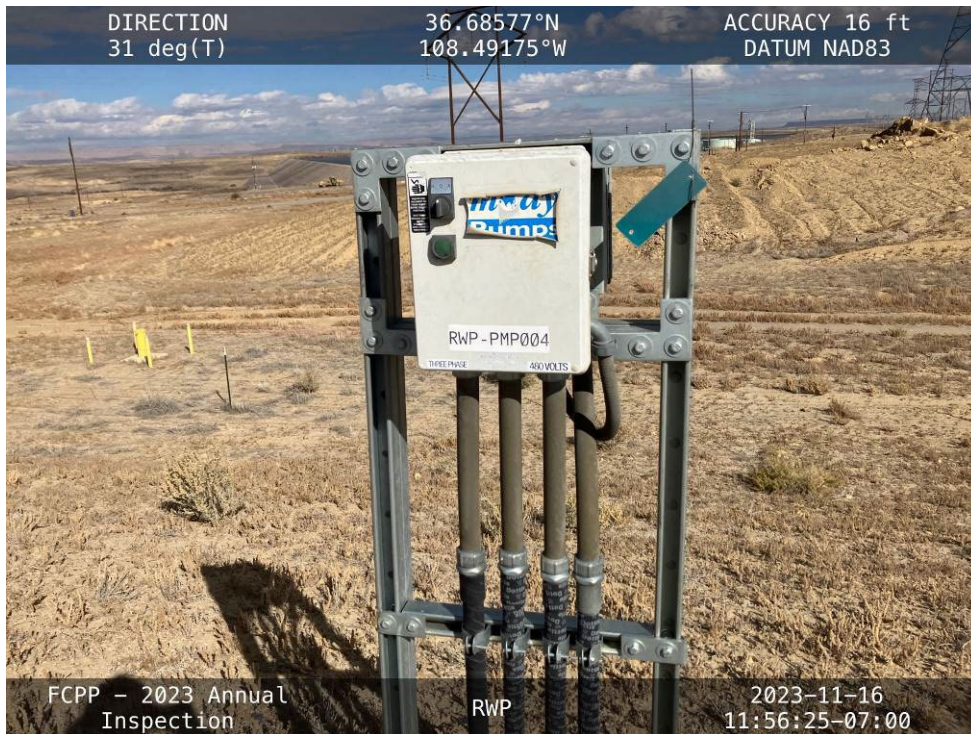
**20231116 – IMG\_3211**

The LCRS pump control for RWP Pump 004 on the north side of the RWP.

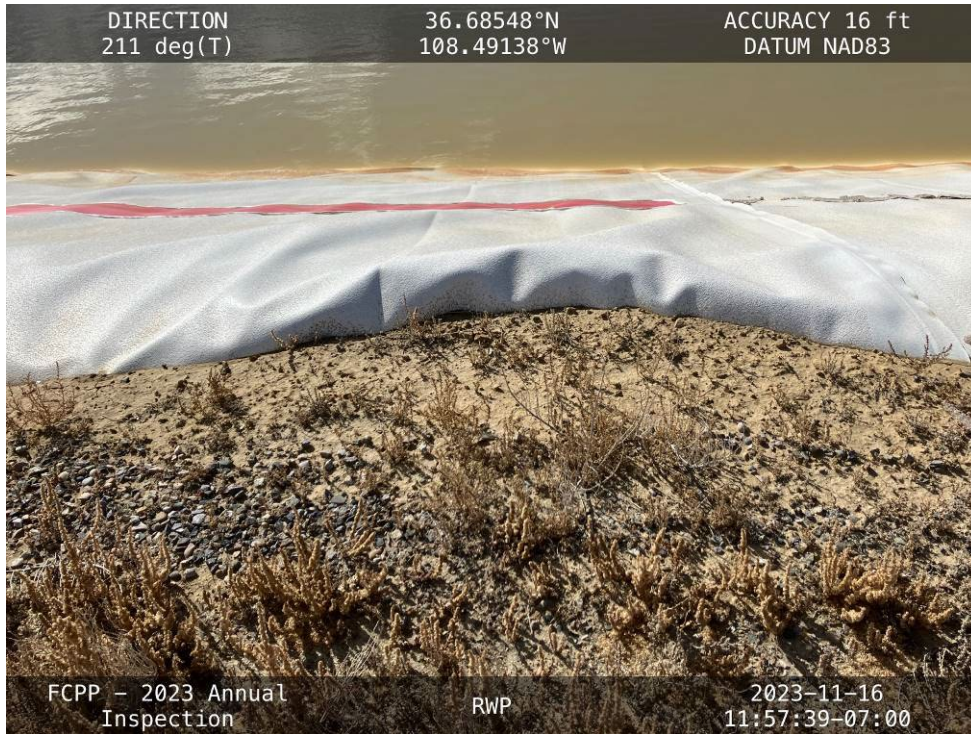
**20231116 – IMG\_3218**

The liner pulling out of the anchor trench along the Northeast Embankment.

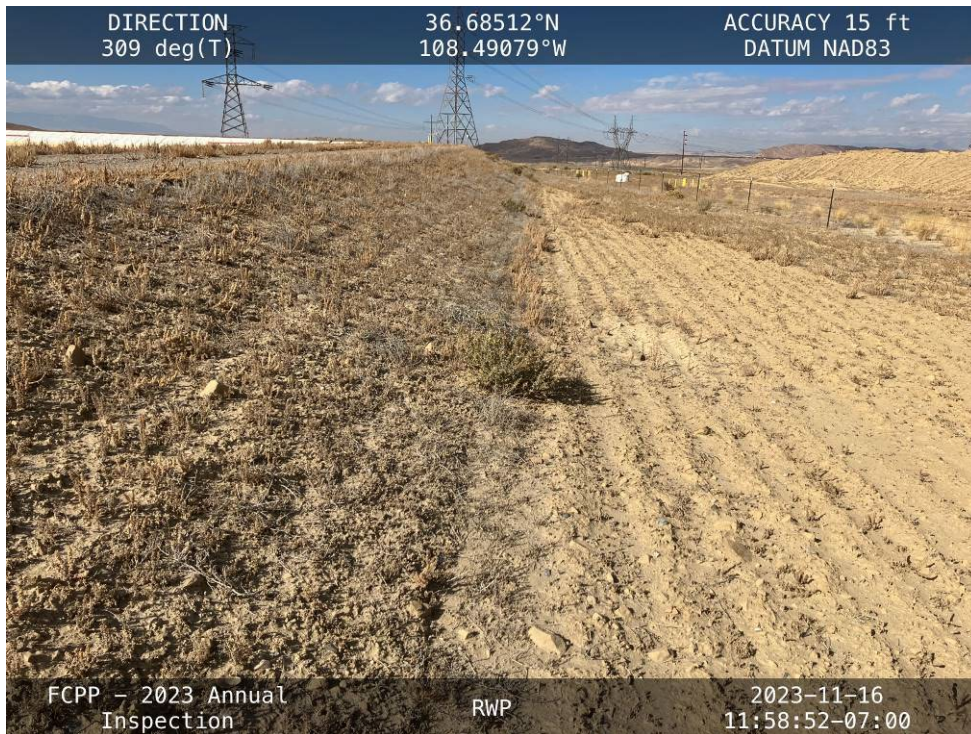
**20231116 – IMG\_3220**

The downstream slope of the RWP cell Northeast Embankment, facing northwest from the eastern corner.

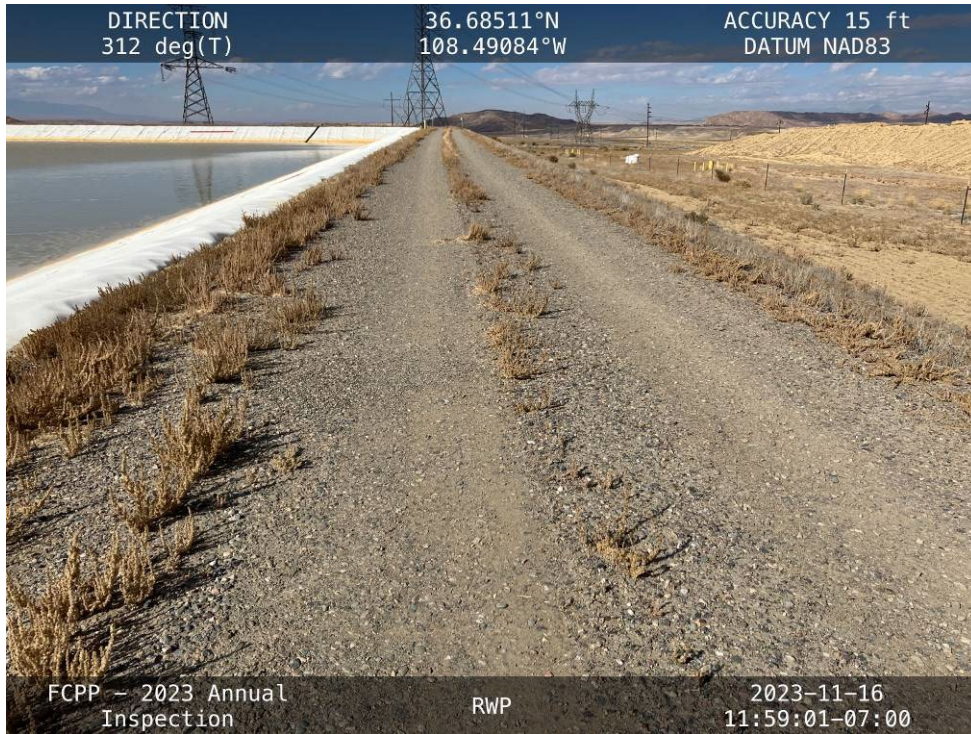
**20231116 – IMG\_3221**

The crest of the RWP cell Northeast Embankment, facing northwest from the eastern corner.
