FOUR CORNERS POWER PLANT
Lined Ash Impoundment,
Lined Decant Water Pond,
Combined Waste Treatment Pond,
Dry Fly Ash Disposal Area,
and Return Water Pond

Annual
CCR Impoundment and
Landfill Inspection Report
2024

GENERATION ENGINEERING
Design Engineering
P.O. BOX 53999
PHOENIX, ARIZONA 85072

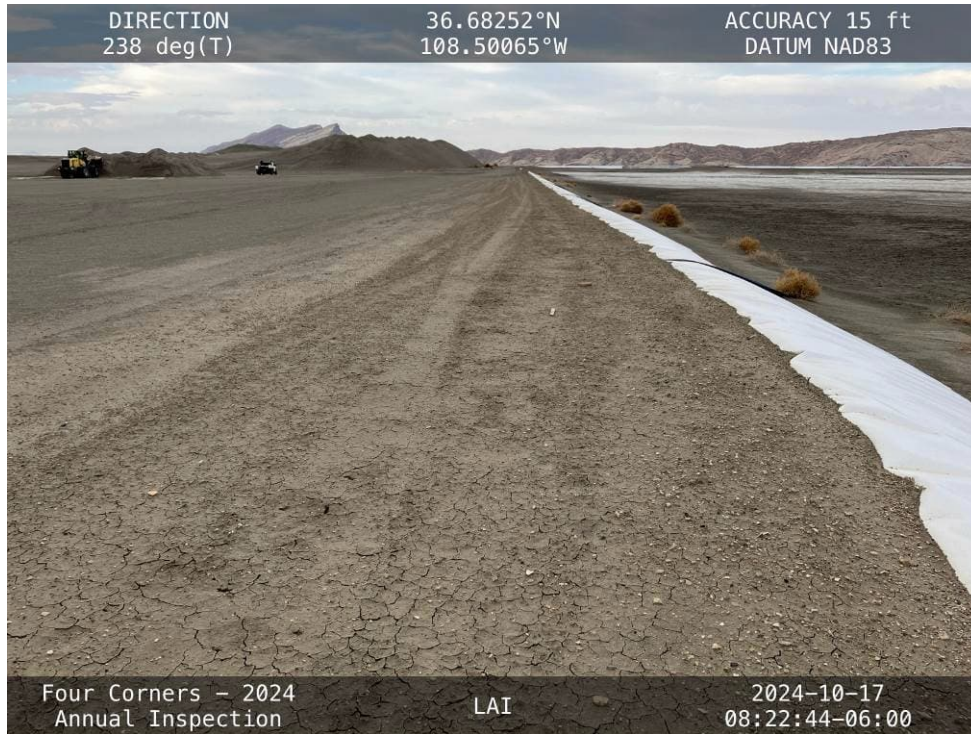
20241017 - IMG_7159

The South Embankment crest and upstream slope, facing southwest from the eastern end.

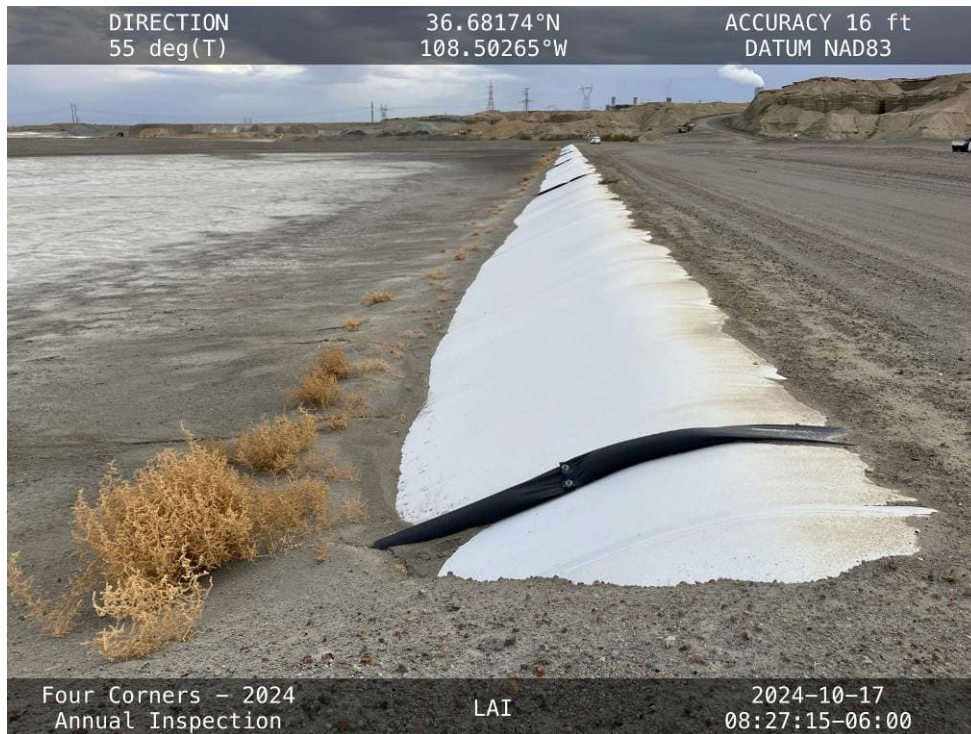
20241017 - IMG_7167

The South Embankment upstream slope, facing northeast from the middle of the embankment.

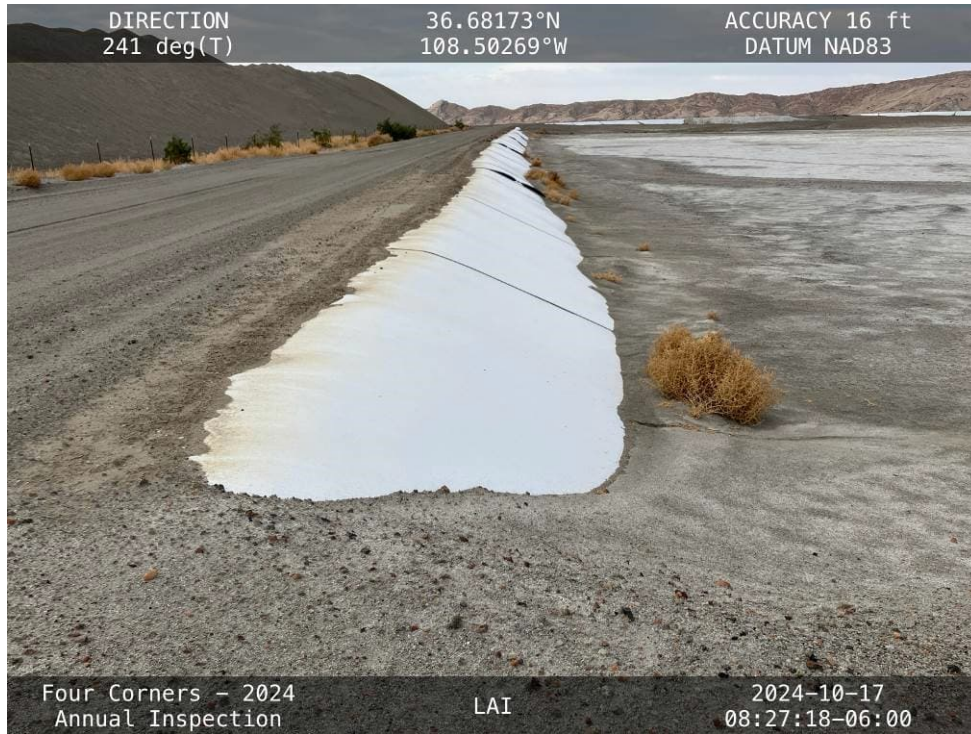
20241017 – IMG_7168

The South Embankment upstream slope, facing southwest from the middle of the embankment.

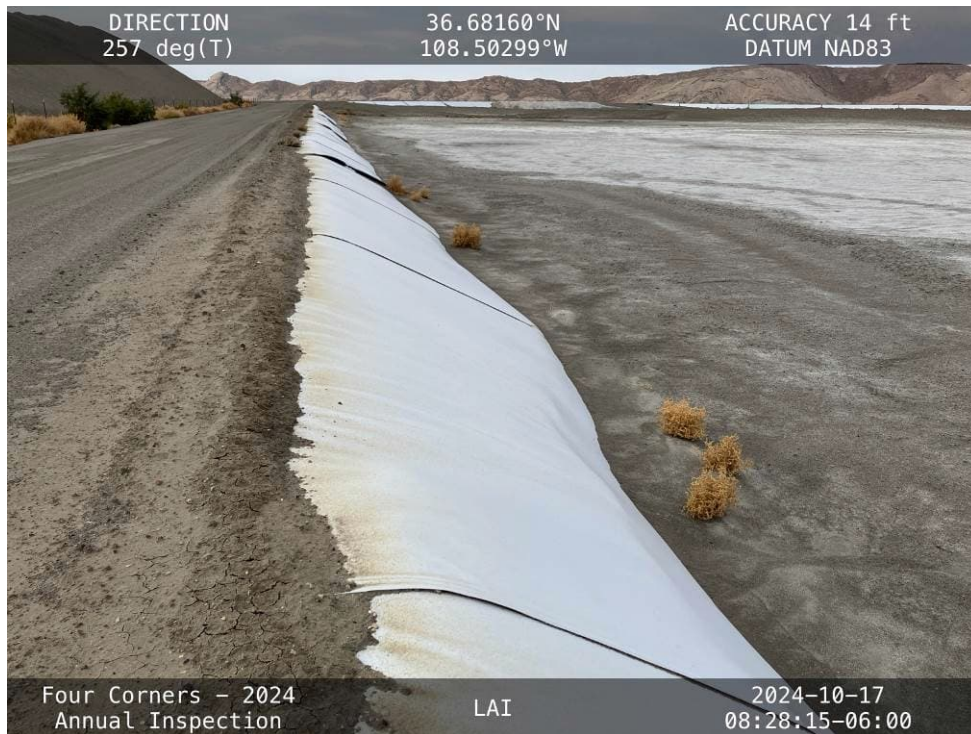
20241017 – IMG_7169

The South Embankment upstream slope with a very tight liner and irregular, steeper areas.

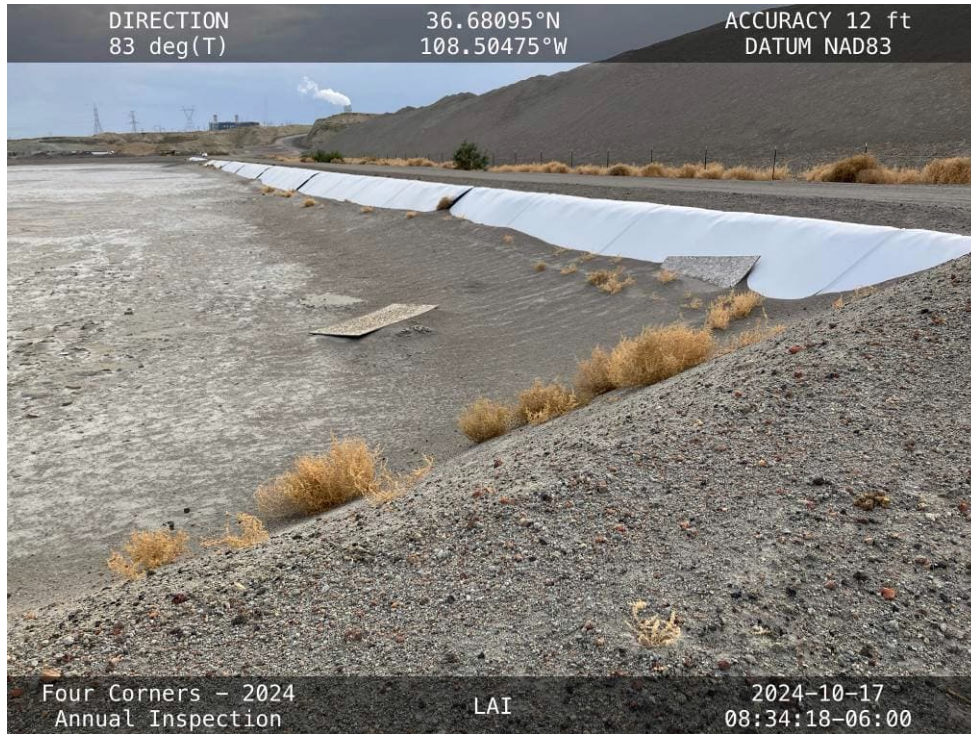
20241017 – IMG_7173

A piece of plywood along the liner, separated by a thin layer of ash.

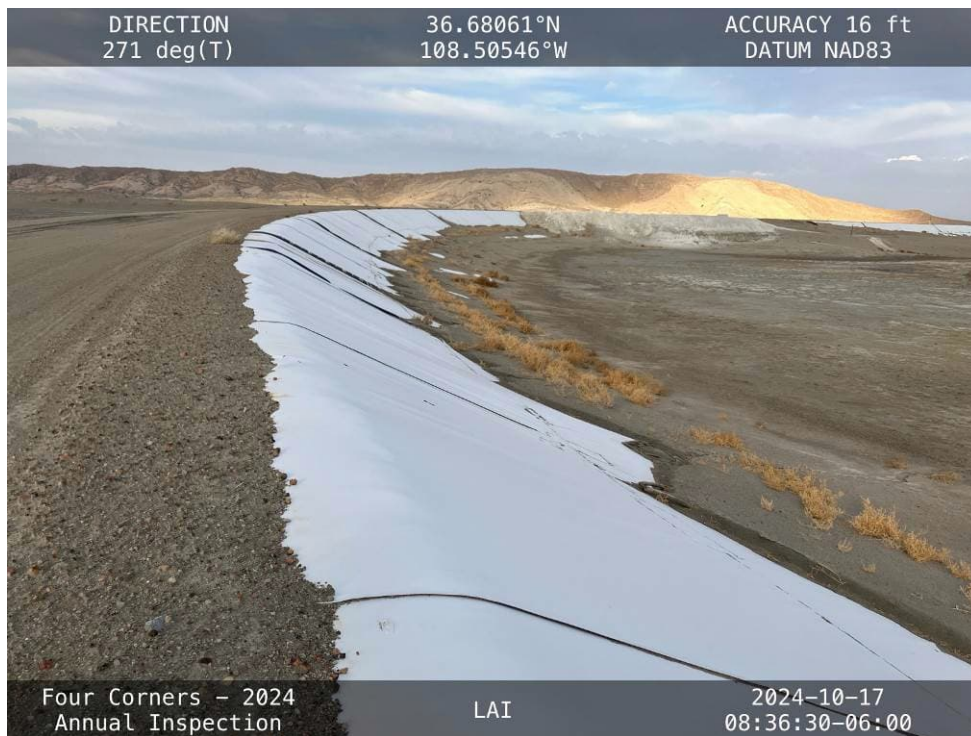
20241017 – IMG_7185

The upstream slope of the South Embankment, facing west toward the Southwest Corner.

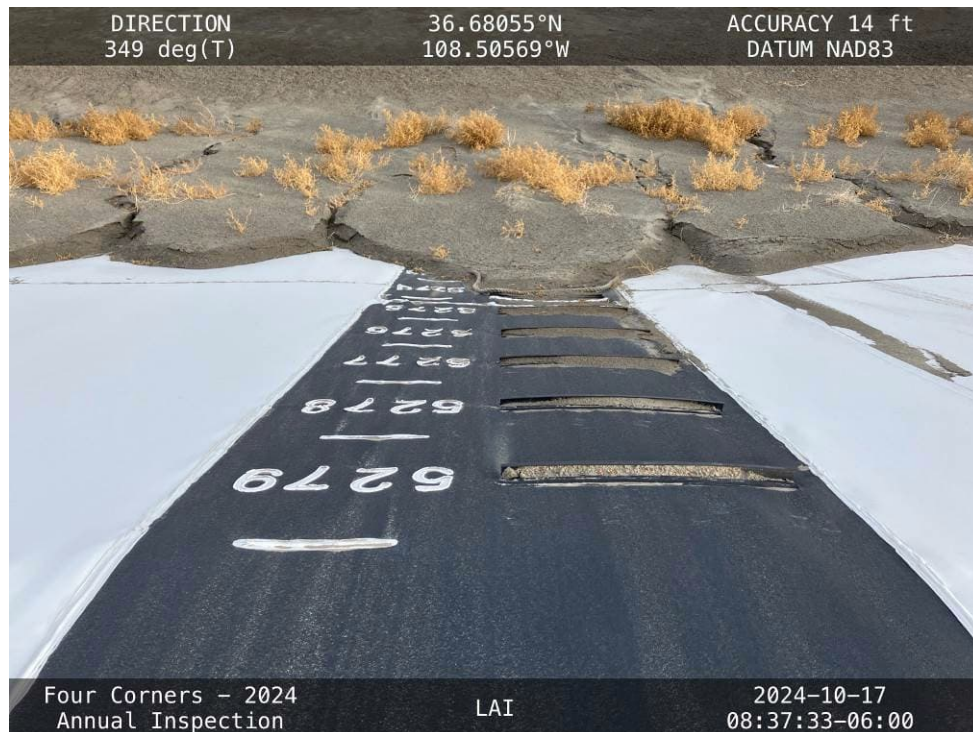
20241017 – IMG_7187

The LAI staff gage at STA 36+00 at the time of the inspection.

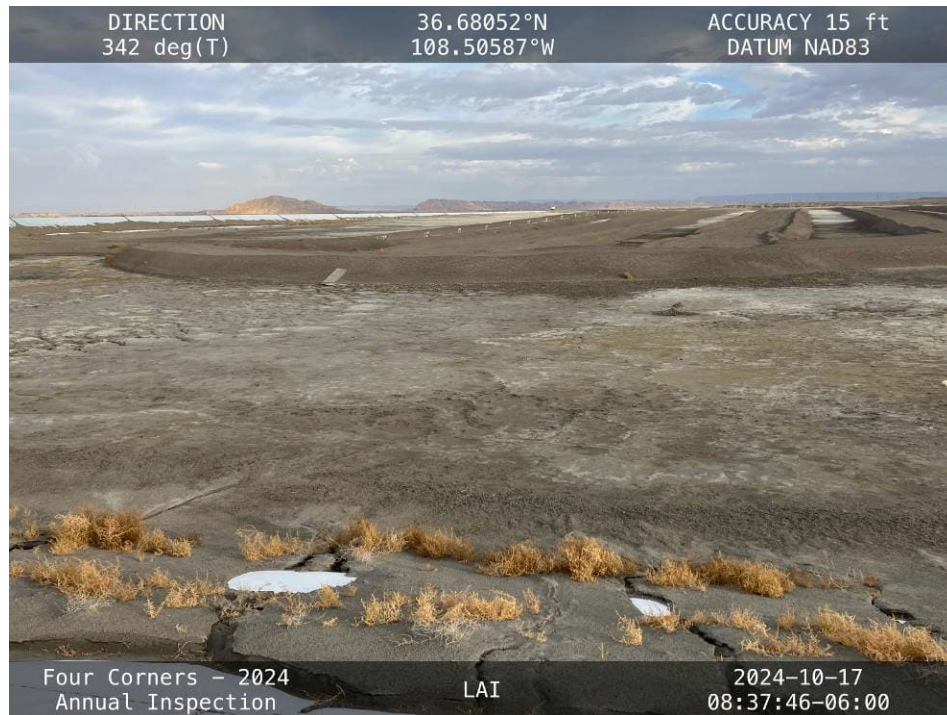
20241017 – IMG_7189

Access roads and dewatering wells in the reservoir, facing north from the Southwest Corner.

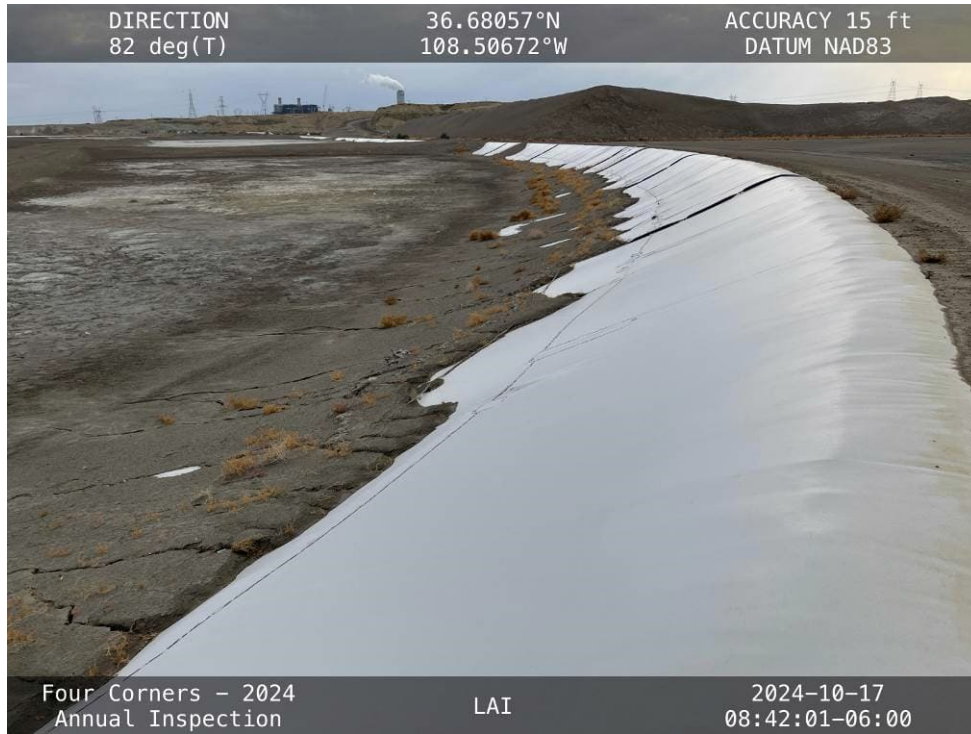
20241017 – IMG_7198

The upstream slope of the South Embankment, facing east from the Southwest Corner.

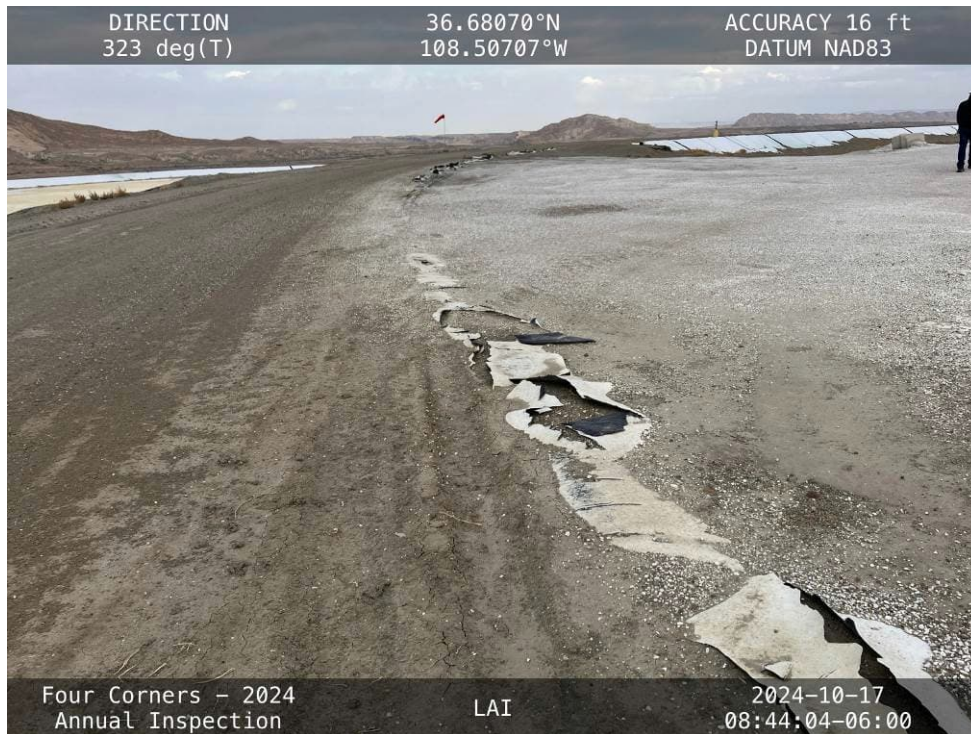
20241017 – IMG_7204

Torn liner in the cenosphere mining area in the Southwest Corner, facing north.

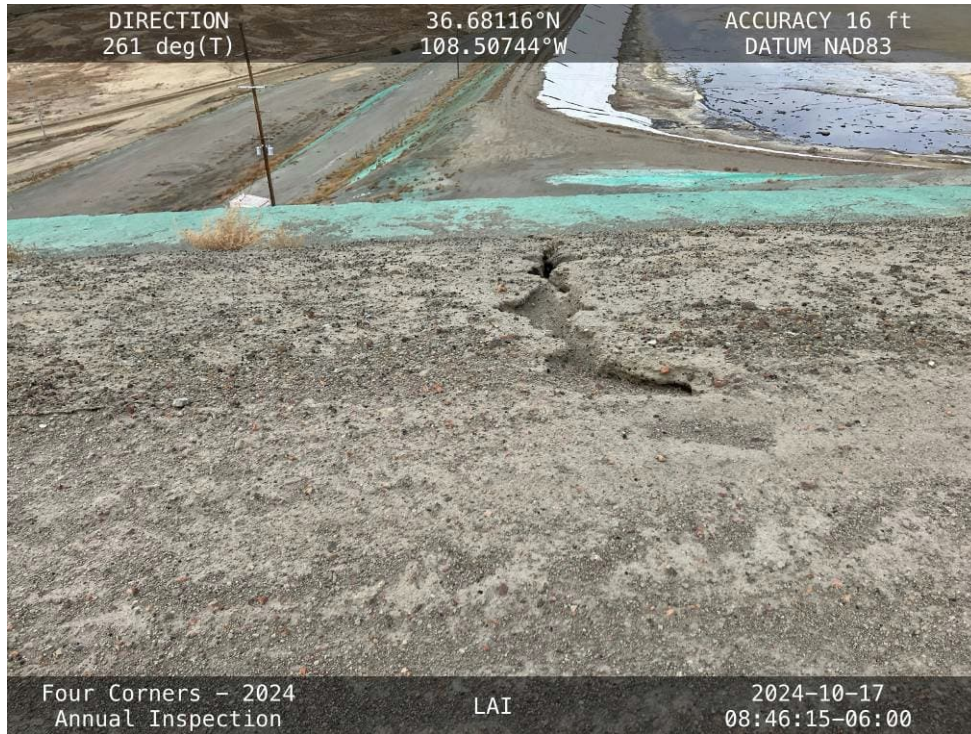
20241017 – IMG_7211

DAM EMBANKMENT CHECKLIST									
3	DAM CREST								
a	Settlements, slides, depressions? See comment iv.			X	X				
b	Misalignment?			X					
c	Longitudinal/Transverse cracking? The shallow holes observed along the downstream shoulder and the anchor trench on the East Embankment crest during the 2023 inspection were not observed during this inspection.			X					
d	Animal burrows?			X					
e	Adverse vegetation?			X					
f	Erosion? A shallow erosion rill was observed on the downstream shoulder at the Southwest Corner (IMG 7211)				X	X

A shallow erosion rill on the downstream shoulder at the Southwest Corner, facing west.

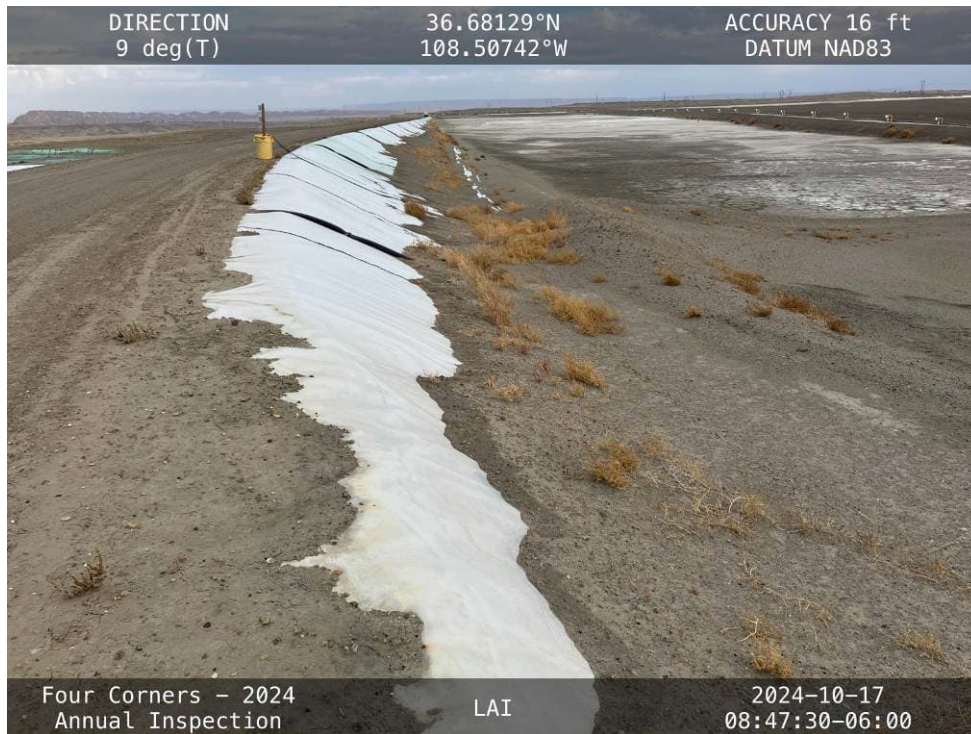
20241017 – IMG_7212

The upstream slope of the West Embankment, facing north from the Southwest Corner.

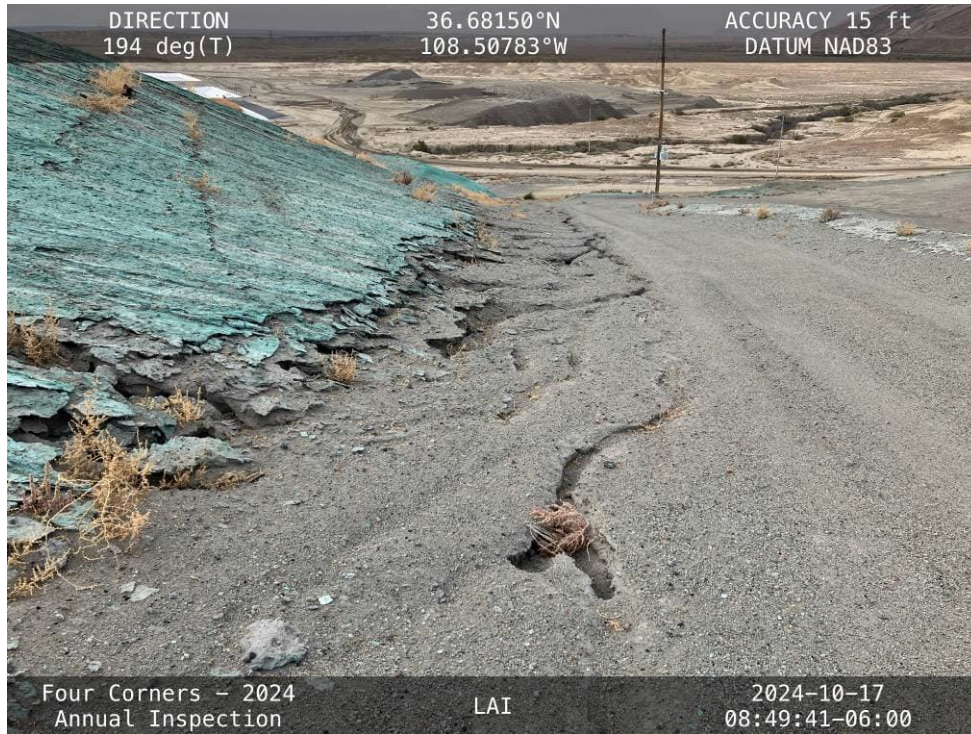
20241017 – IMG_7220

2.5 feet of erosion along the LAI access ramp on the south end of the West Embankment.

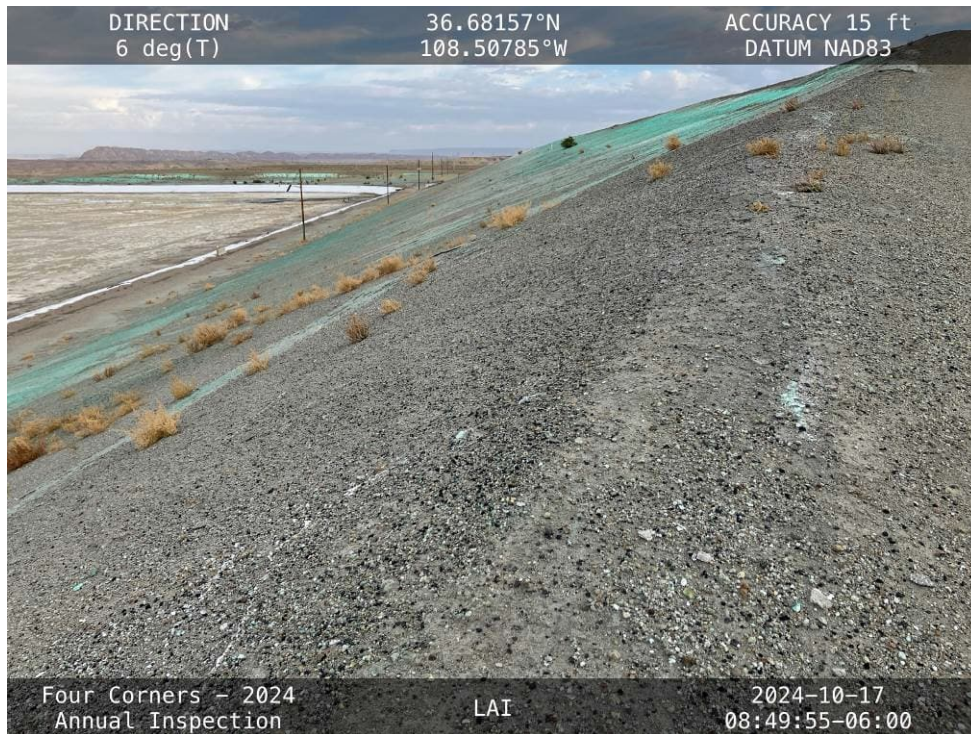
20241017 – IMG_7221

The downstream slope of the West Embankment, facing north from the access ramp.

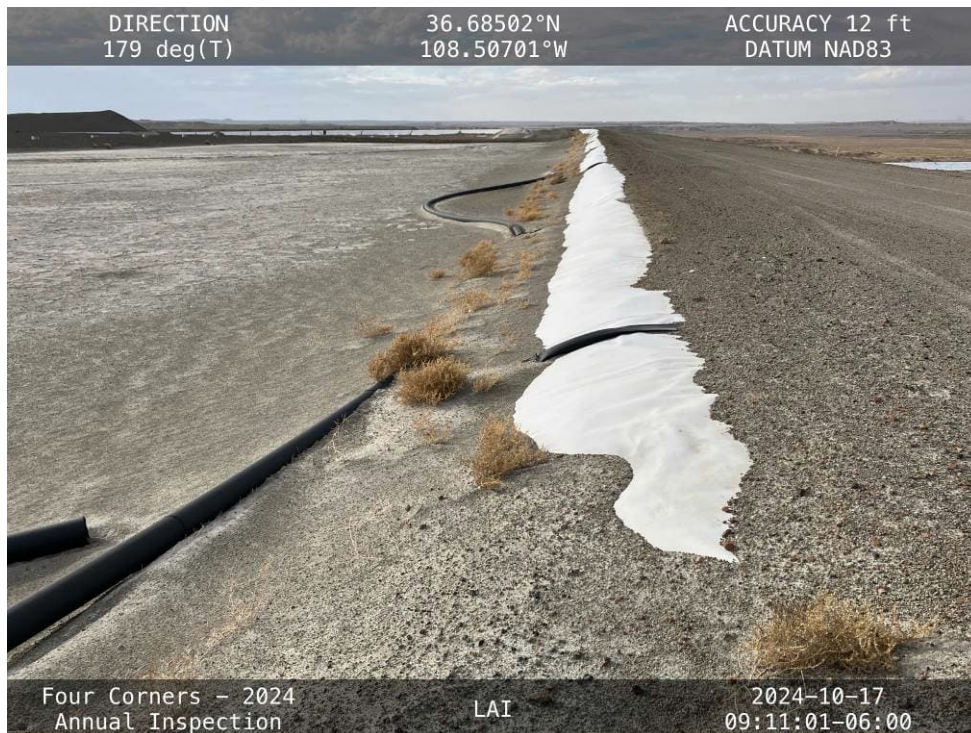
20241017 – IMG_7225

The upstream slope of the West Embankment, facing south from the Drop Inlet Structure ramp.

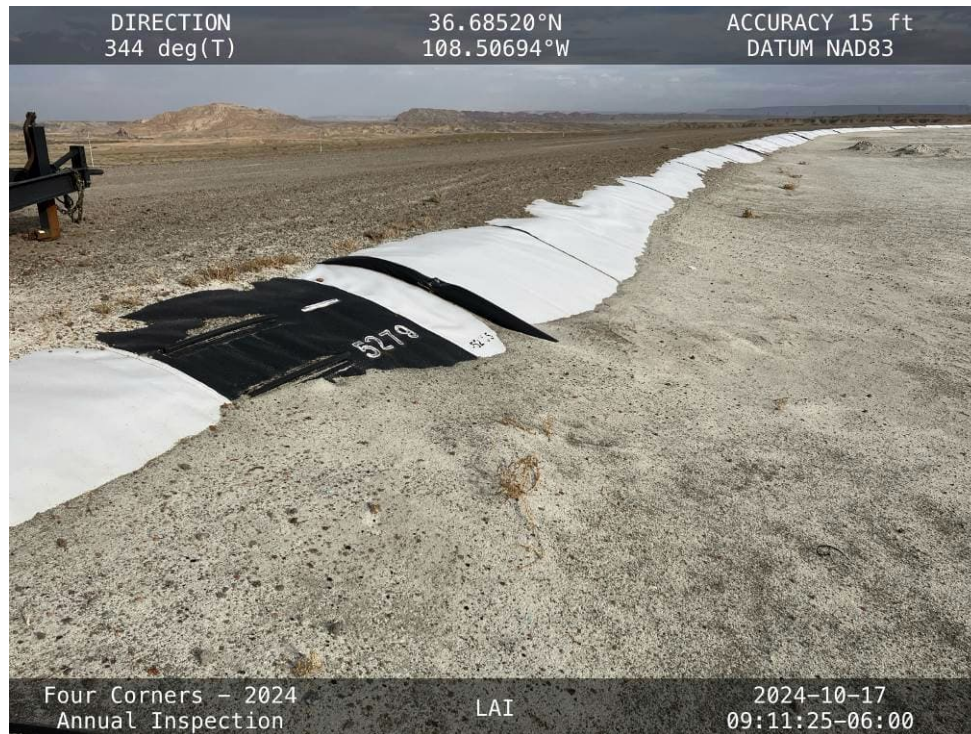
20241017 – IMG_7227

The upstream slope of the West Embankment, facing north from the Drop Inlet Structure ramp.

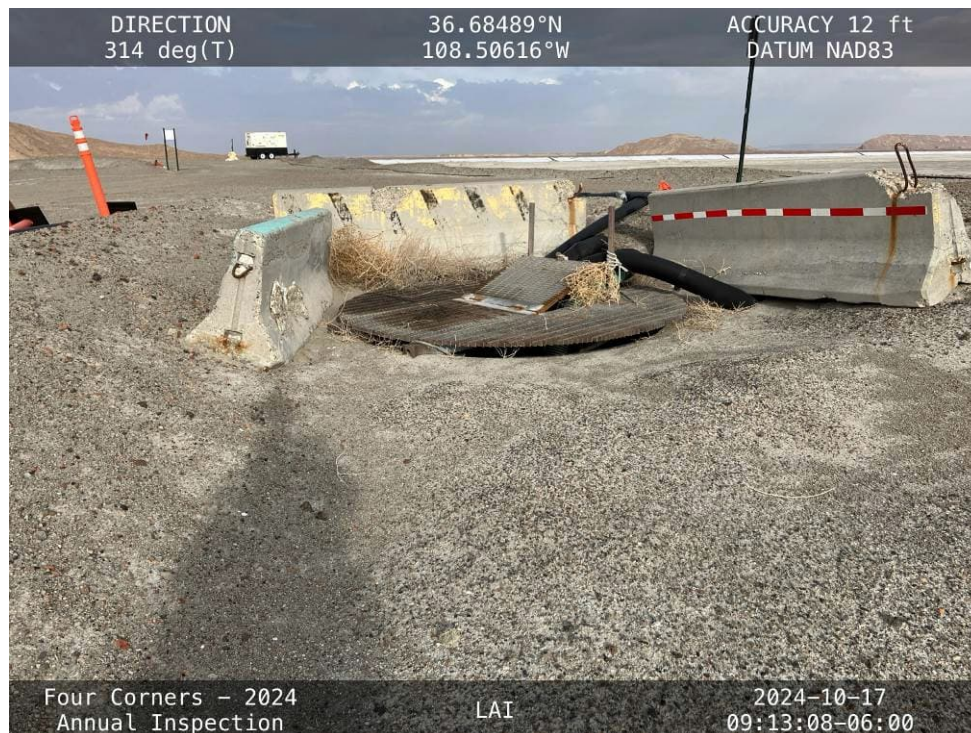
20241017 – IMG_7228

The Drop Inlet Structure, facing west from inside the LAI reservoir.

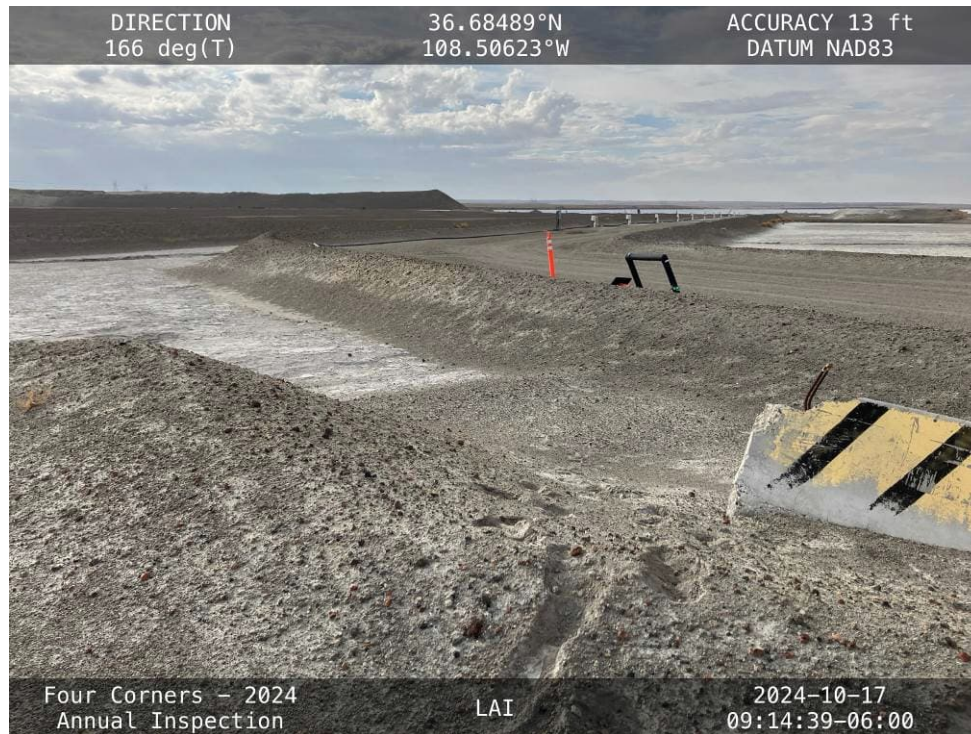
20241017 – IMG_7230

A road with wells installed to remove interstitial water inside the reservoir.

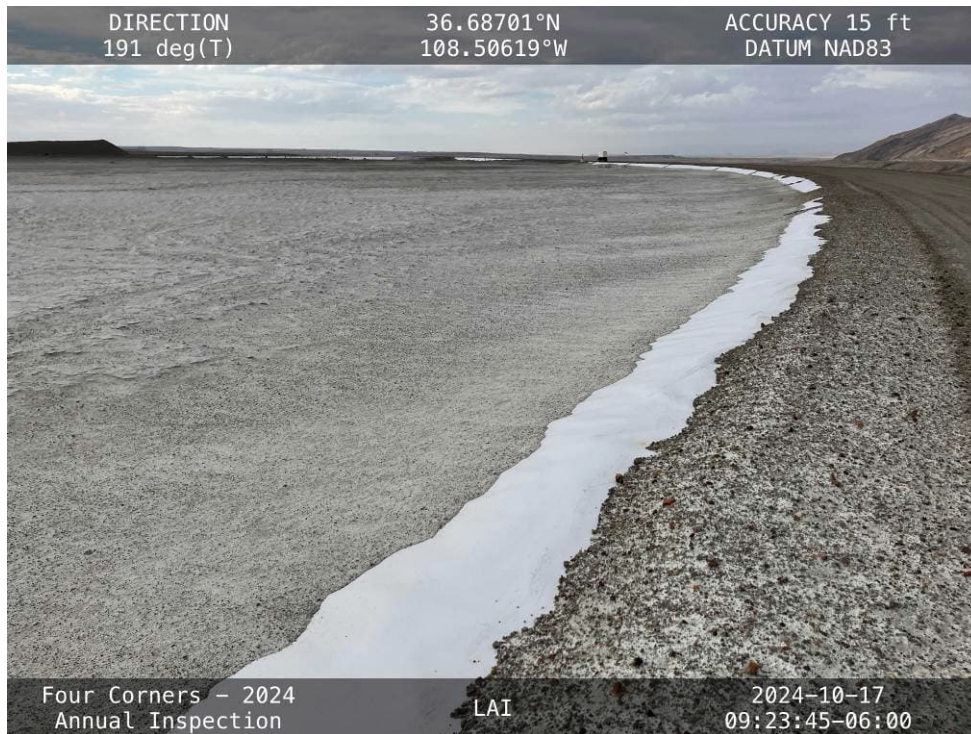
20241017 – IMG_7243

The impounded ash level along the north side of the West Embankment, facing south.

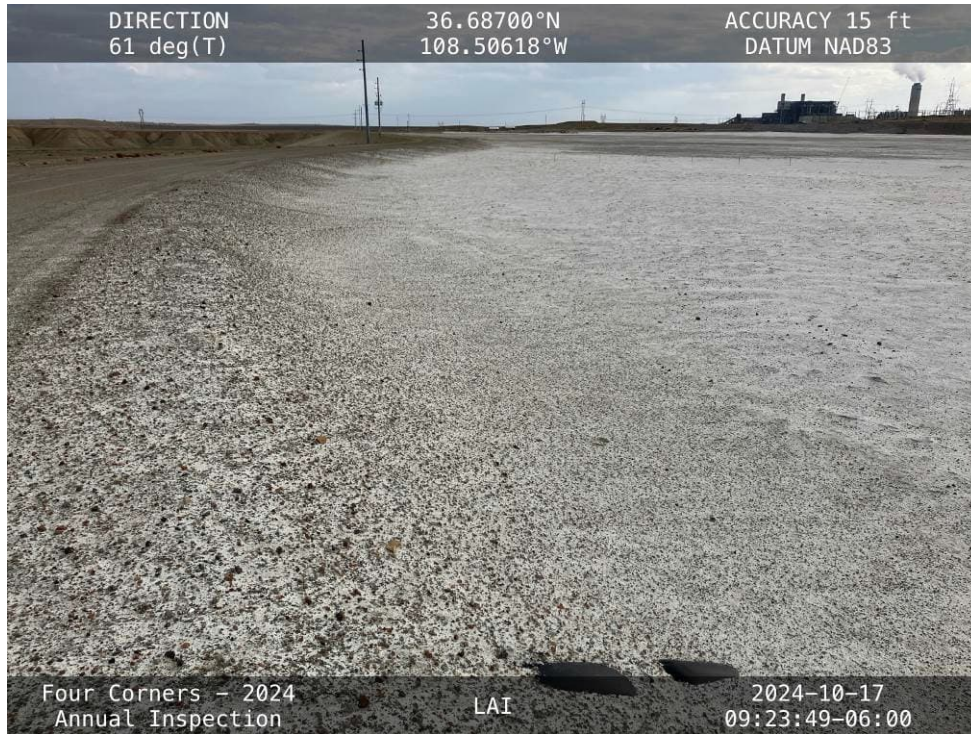
20241017 – IMG_7244

The impounded ash level at the crest of the Northwest Embankment covered with FGD, facing northeast.

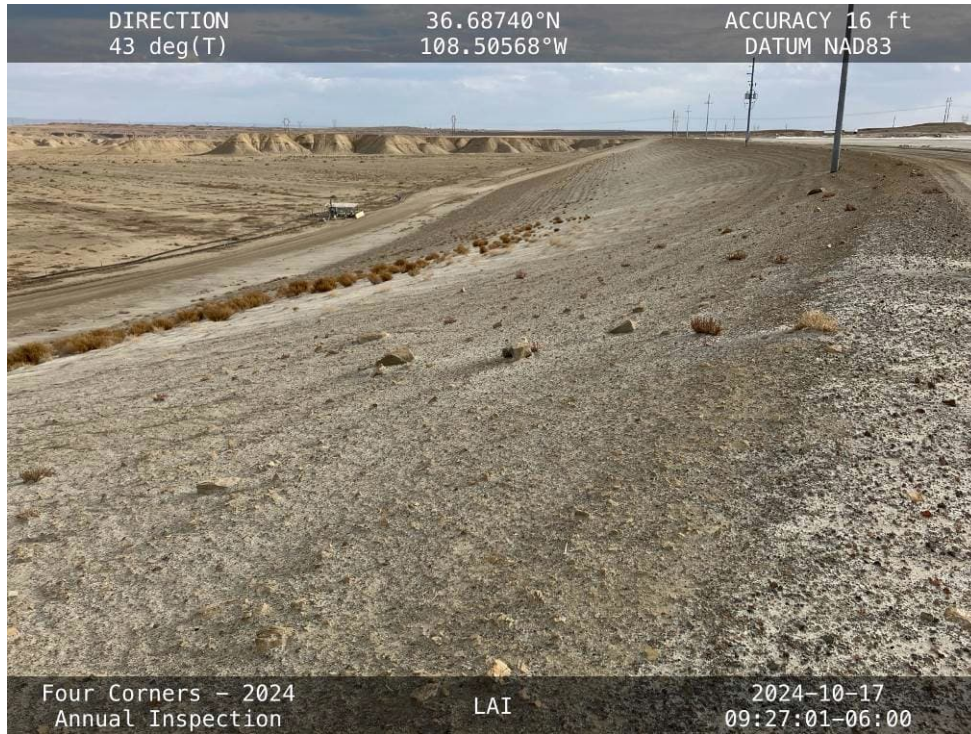
20241017 – IMG_7251

The downstream slope of the Northwest Embankment covered with FGD, facing northeast.

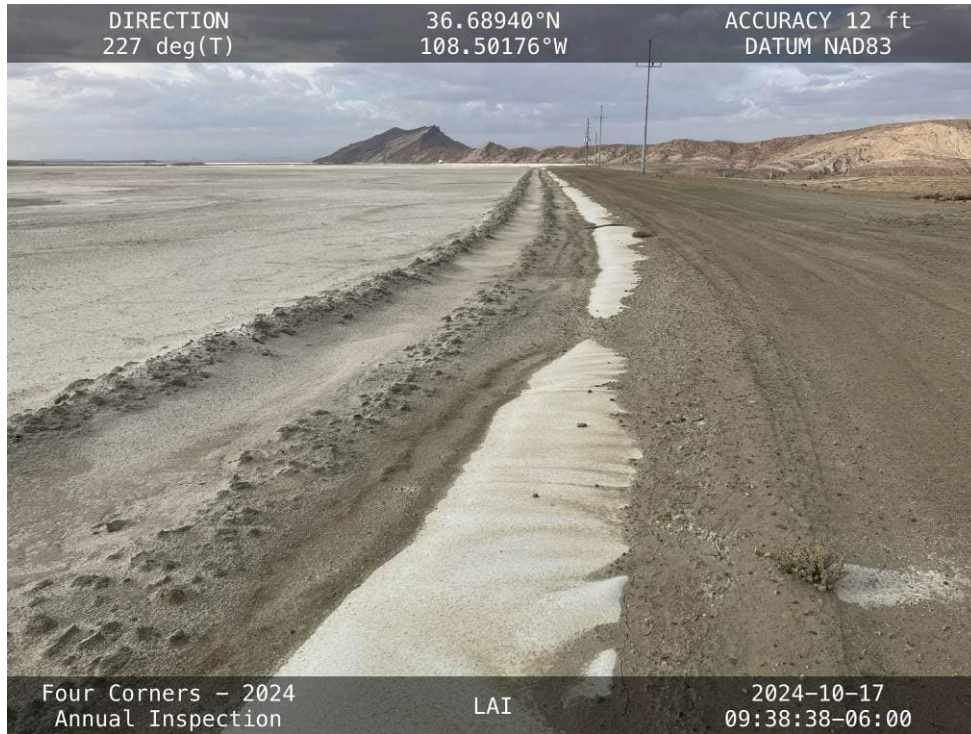
20241017 – IMG_7257

The upstream slope of the Northwest Embankment, facing southwest.

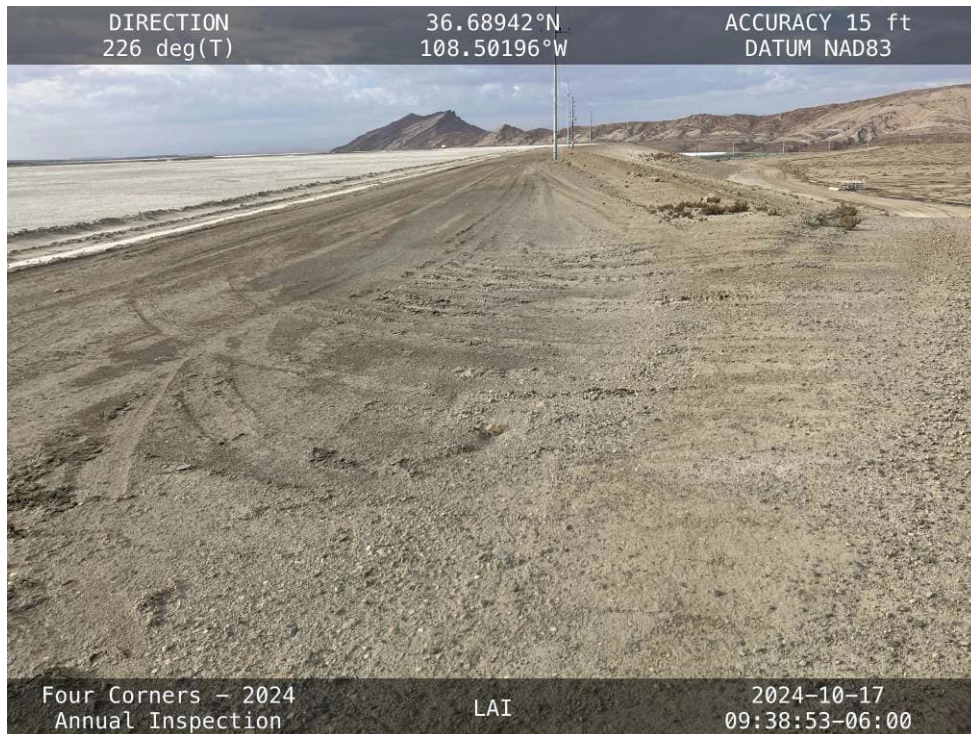
20241017 – IMG_7259

Tire tracks at the Northwest Embankment access ramp.

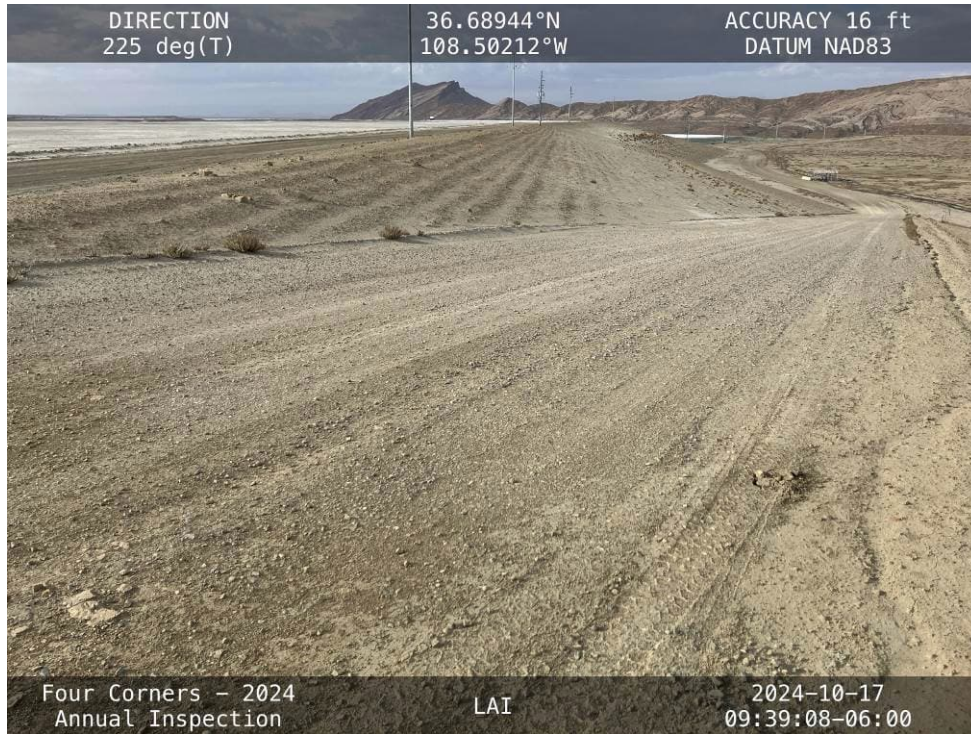
20241017 – IMG_7260

The downstream slope of the Northwest Embankment, facing southwest.

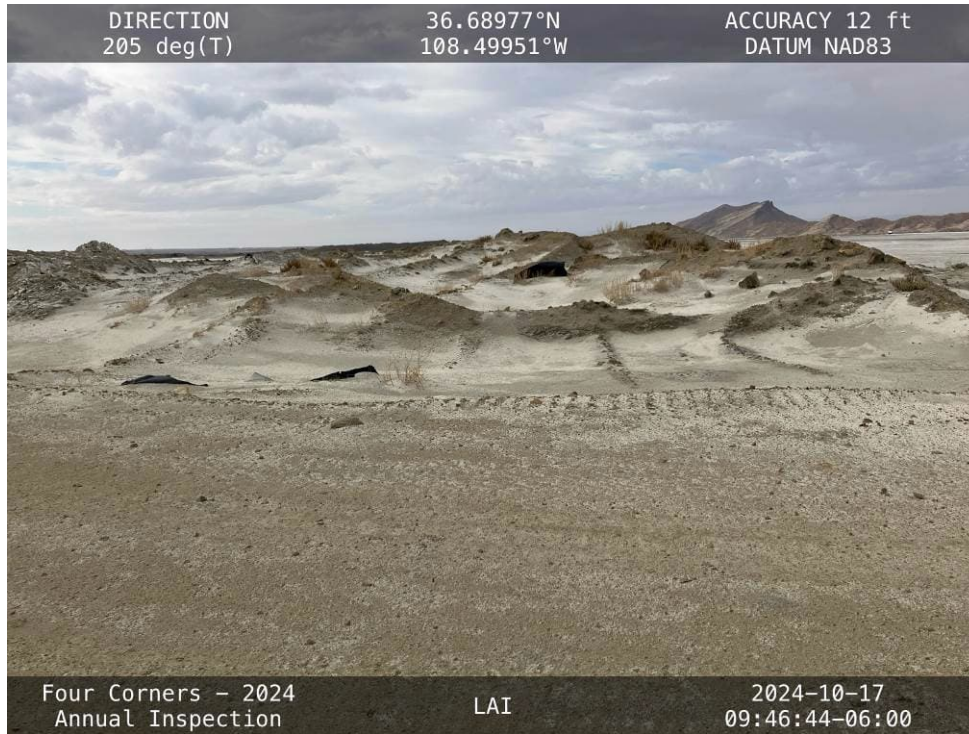
20241017 – IMG_7264

The upstream slope of the Northwest Embankment near the north V-ditch, facing northeast.

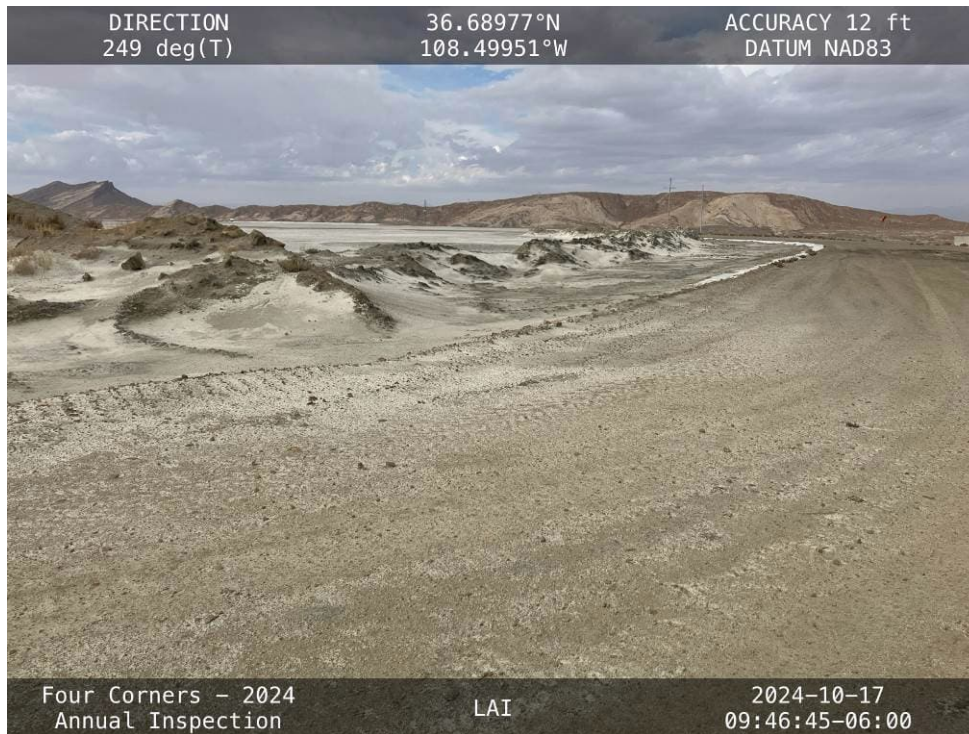
20241017 – IMG_7274

The CCR berm constructed to keep stormwater off the crest at the north V-ditch, facing south.

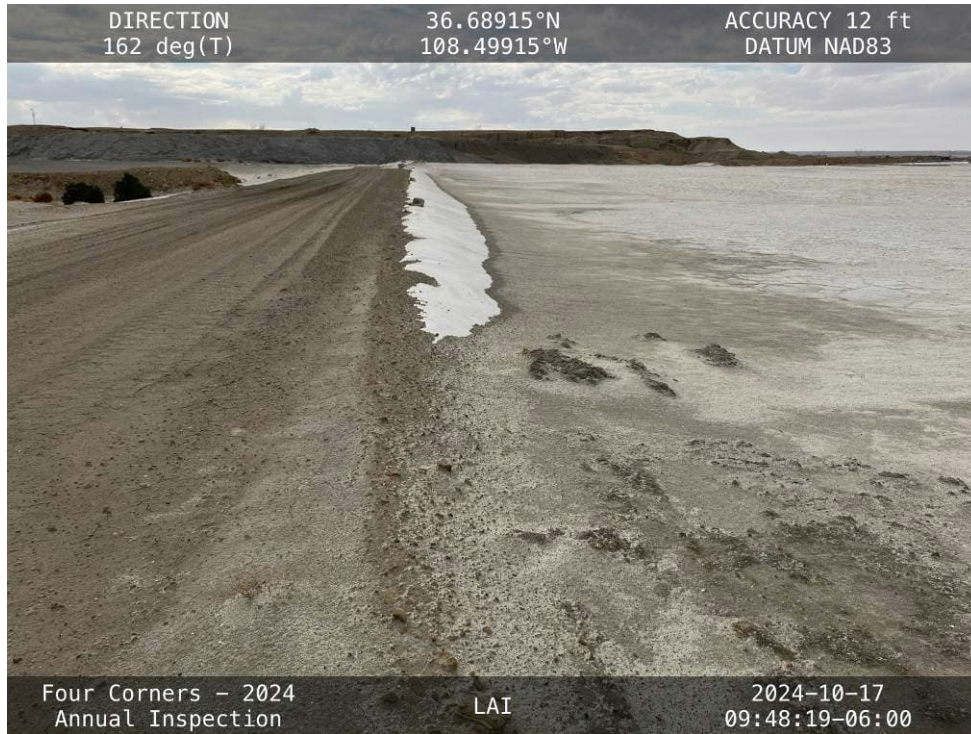
20241017 – IMG_7275

The CCR berm constructed to keep stormwater off the crest at the north V-ditch, facing west.

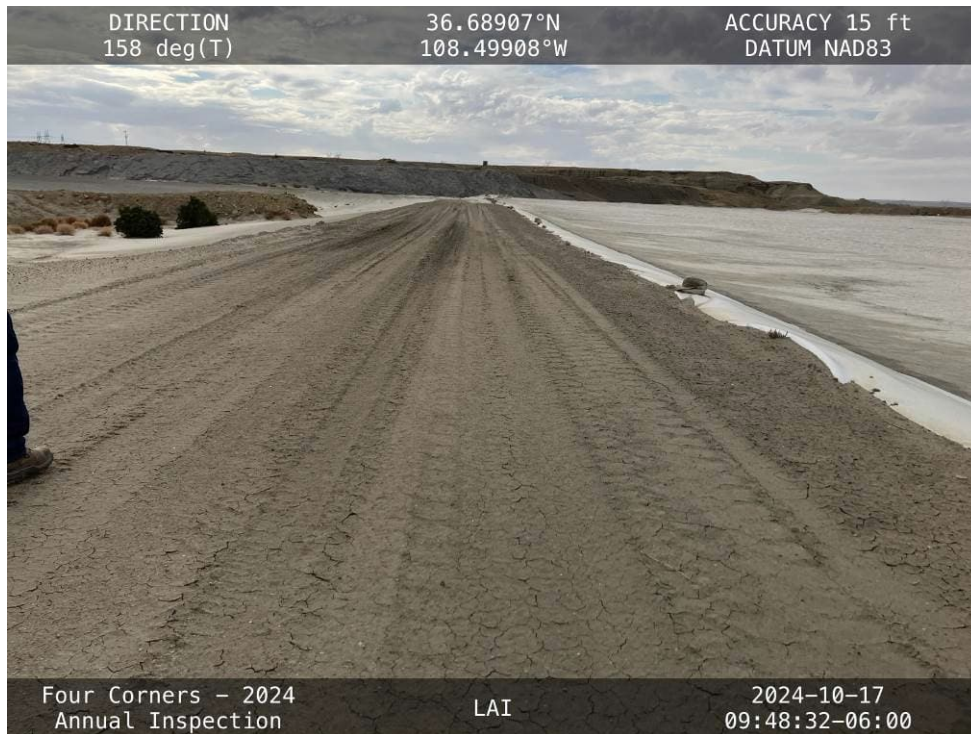
20241017 – IMG_7277

The upstream slope of the East Embankment, facing south near the north V-ditch.

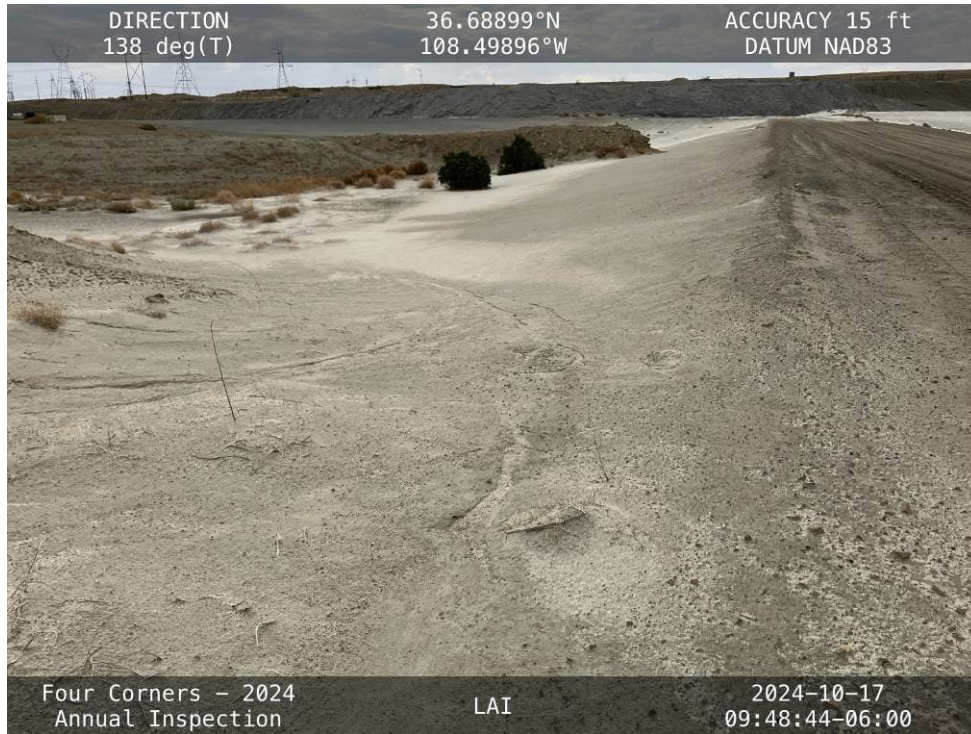
20241017 – IMG_7278

The crest of the East Embankment, facing south near the north V-ditch.

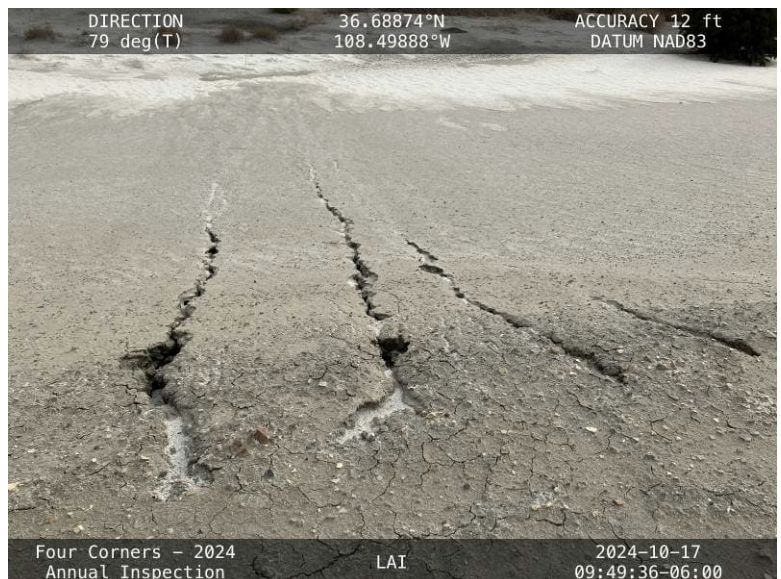
20241017 – IMG_7280

3) There was a series of holes up to 1 foot deep and a separate hole approximately 1 foot deep on the downstream shoulder of the East Embankment.	Monitor the erosion holes and repair them if they are observed to expand.

Erosion rills 7-10 inches deep on the downstream shoulder and slope of the East Embankment.

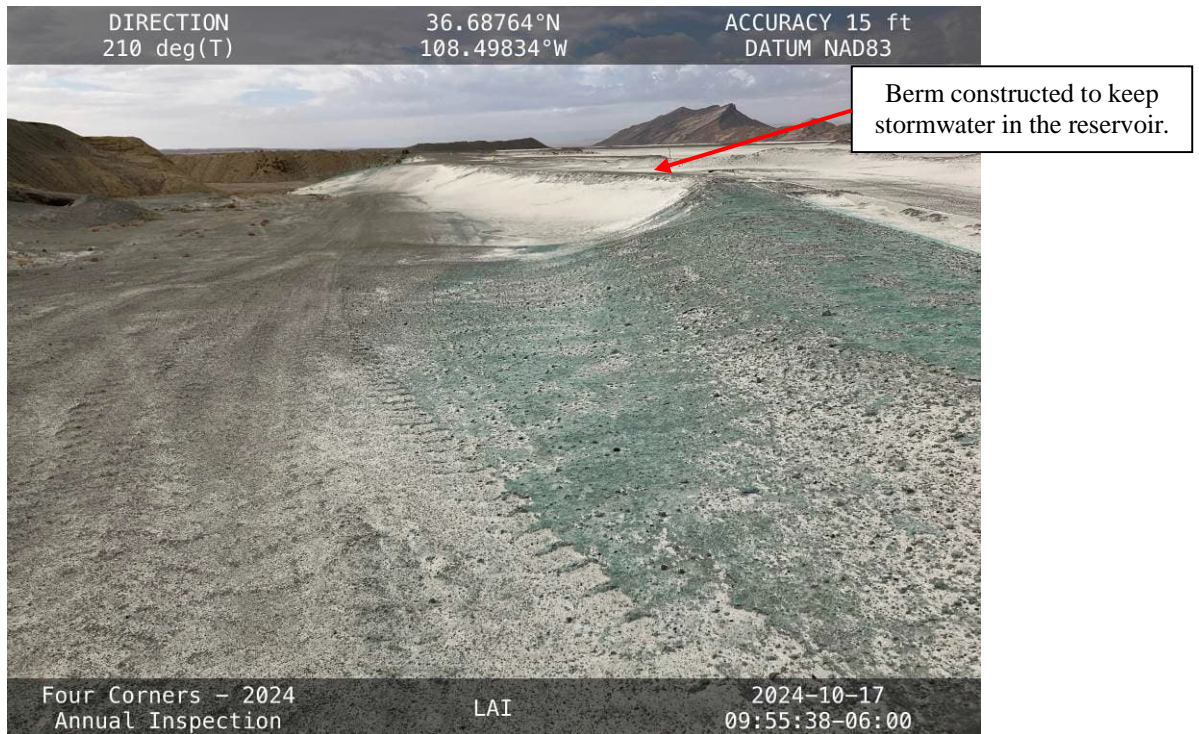
20241017 – IMG_7285

The downstream slope and toe of the East Embankment.
