FOUR CORNERS POWER PLANT
Lined Ash Impoundment,
Lined Decant Water Pond,
Combined Waste Treatment Pond,
Dry Fly Ash Disposal Area,
and Return Water Pond

Annual
CCR Impoundment and
Landfill Inspection Report
2024

GENERATION ENGINEERING
Design Engineering
P.O. BOX 53999
PHOENIX, ARIZONA 85072

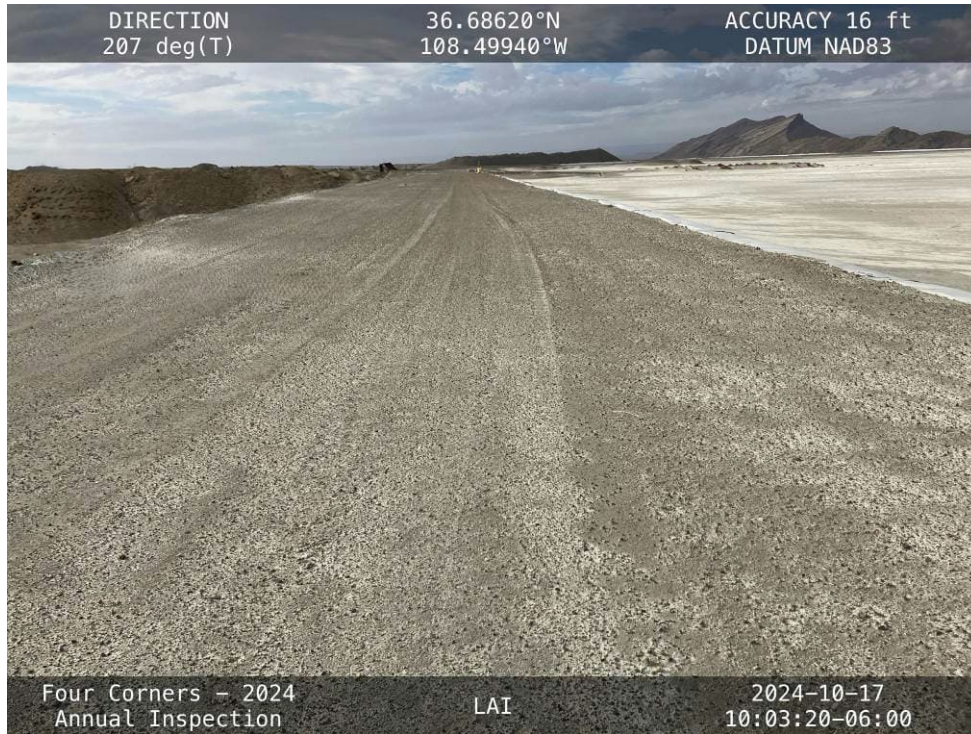
20241017 – IMG_7289

The containment berm on the East Embankment near the old V-ditch, facing south.

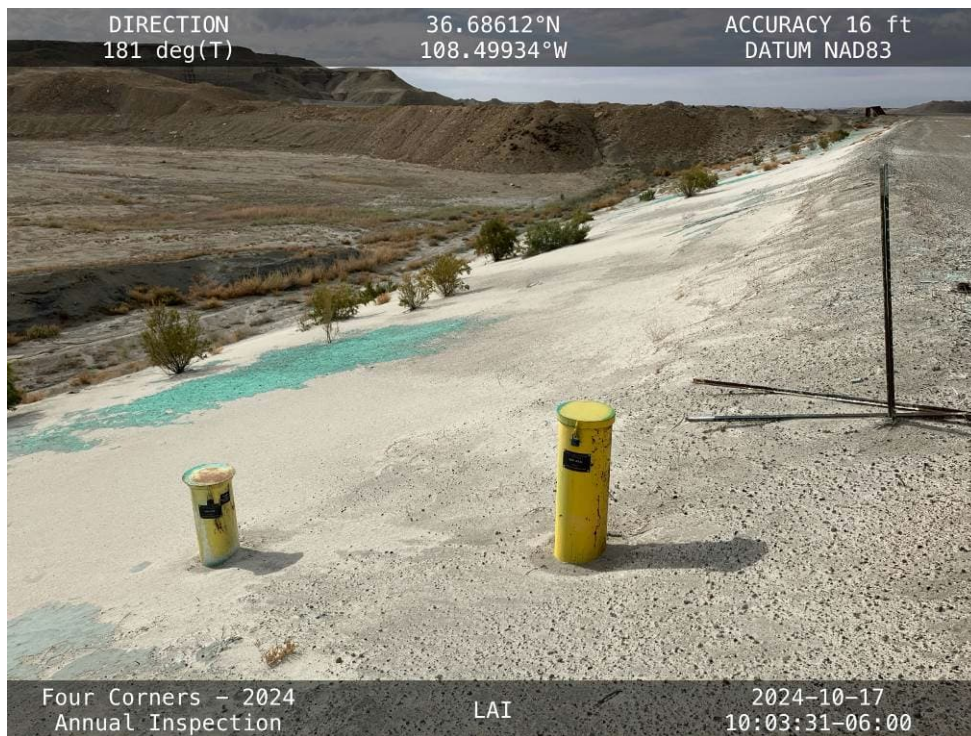
20241017 – IMG_7302
The crest of the East Embankment, facing south.

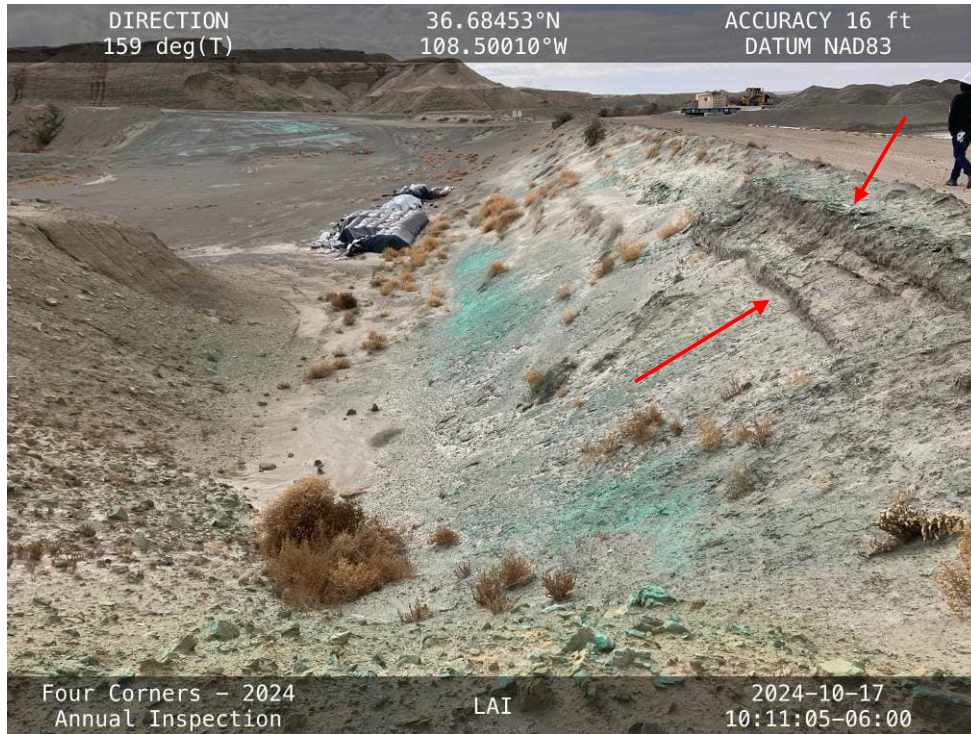
20241017 – IMG_7313
Approximately 18 inches of erosion on the downstream slope of the East Embankment shown in IMG_7319.

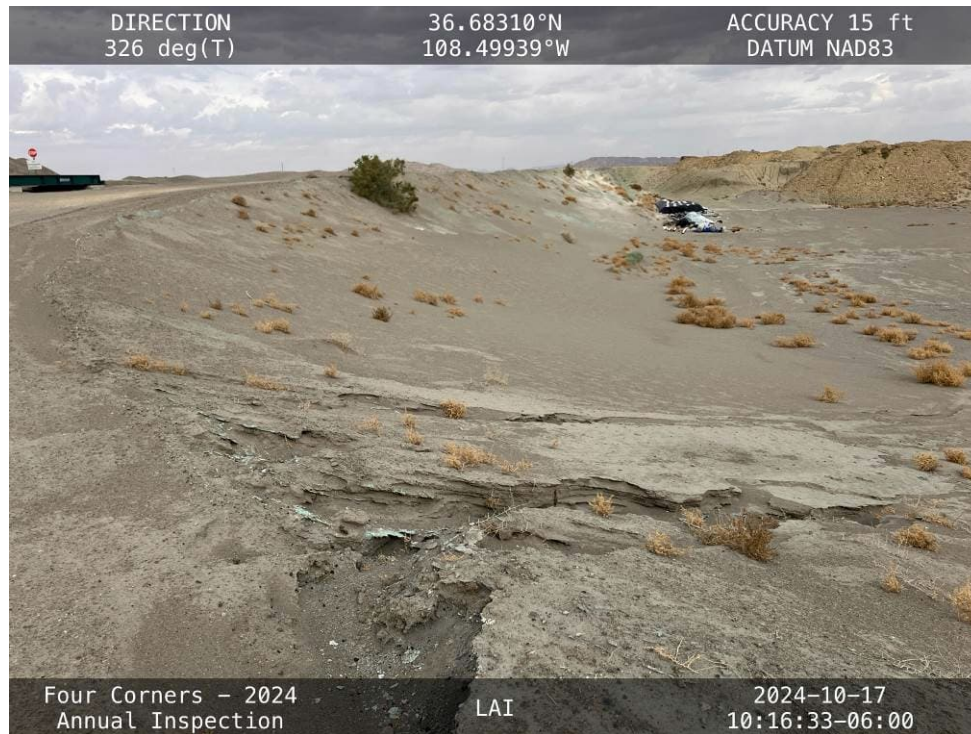
20241017 – IMG_7319

The downstream slope of the East Embankment facing north.

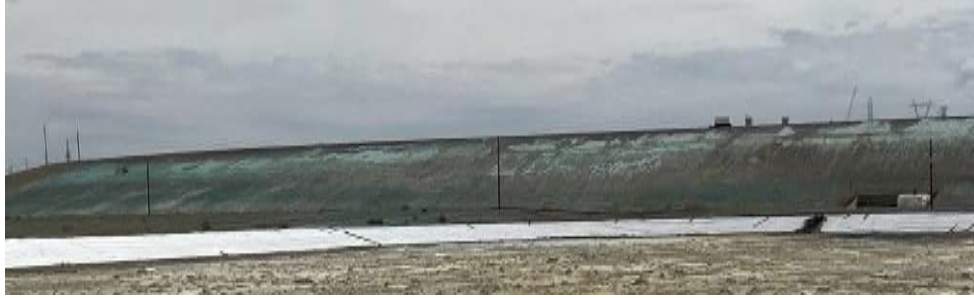
20241017 – IMG_7338

The downstream slope of the West Embankment, facing northeast.

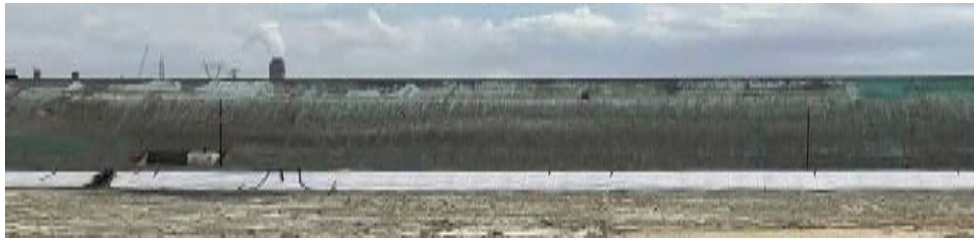
20241017 – IMG_7395

The downstream slope of the West Embankment, facing east from the LDWP.

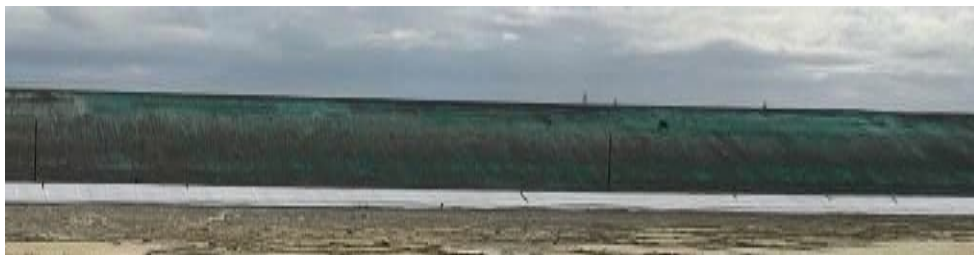
20241017 – IMG_7396

The downstream slope of the West Embankment, facing east from the LDWP.

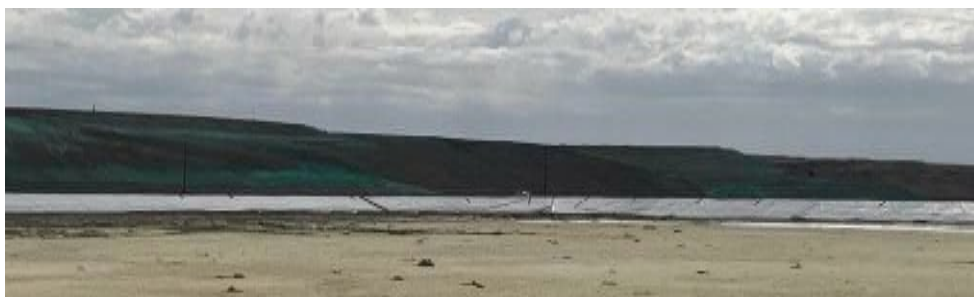
20241017 – IMG_7397

The downstream slope of the West Embankment, facing east from the LDWP.

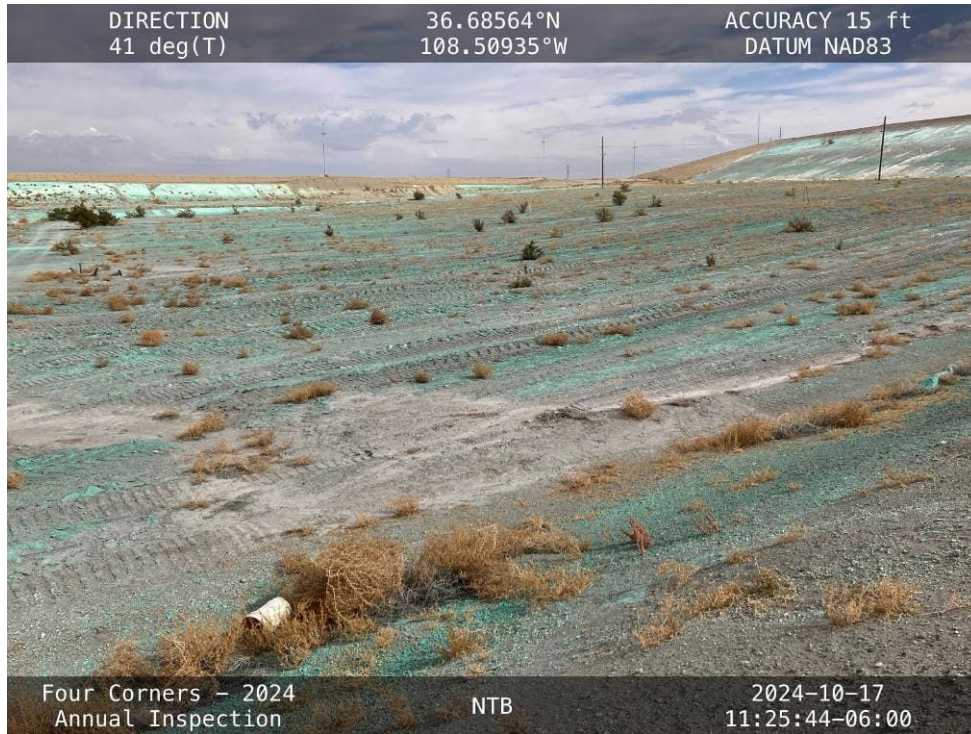
20241017 – IMG_7398

The downstream slope of the West Embankment, facing east from the LDWP.

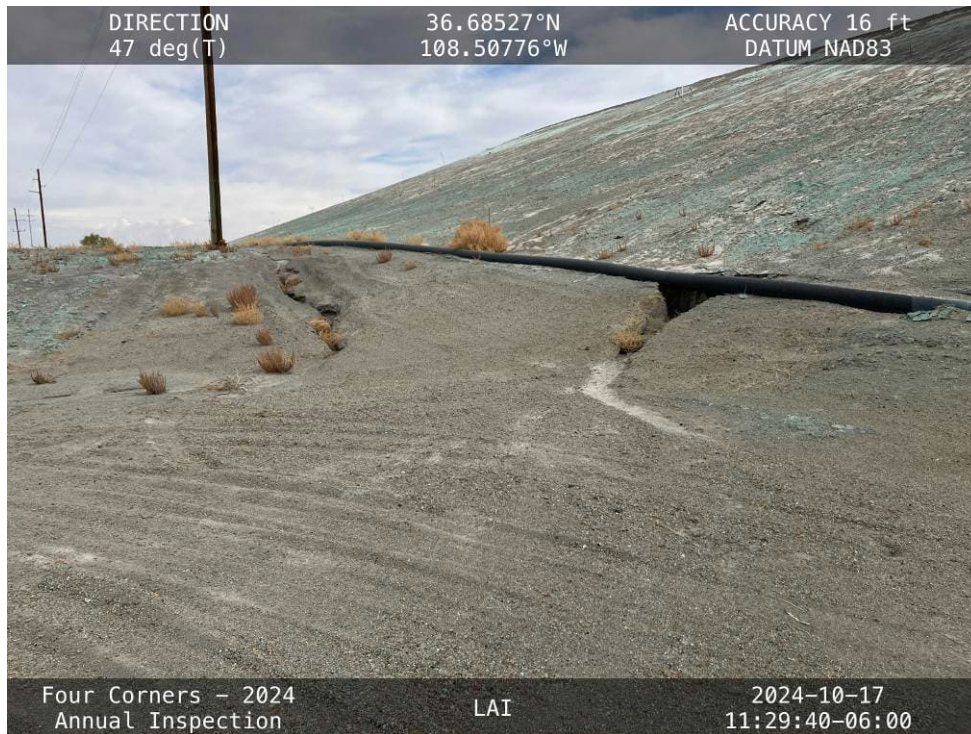
20241017 – IMG_7432

The western half of the North Toe Buttress, facing north from the LDWP crest.

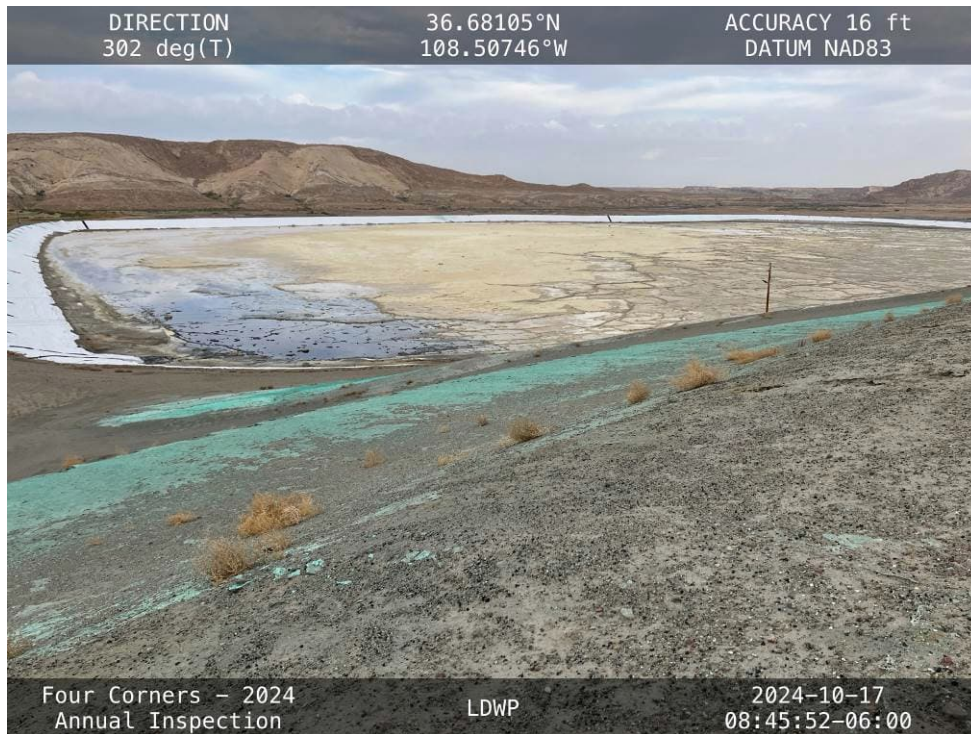
20241017 – IMG_7207

The downstream slope of the LDWP South Embankment, facing west from the LAI crest.

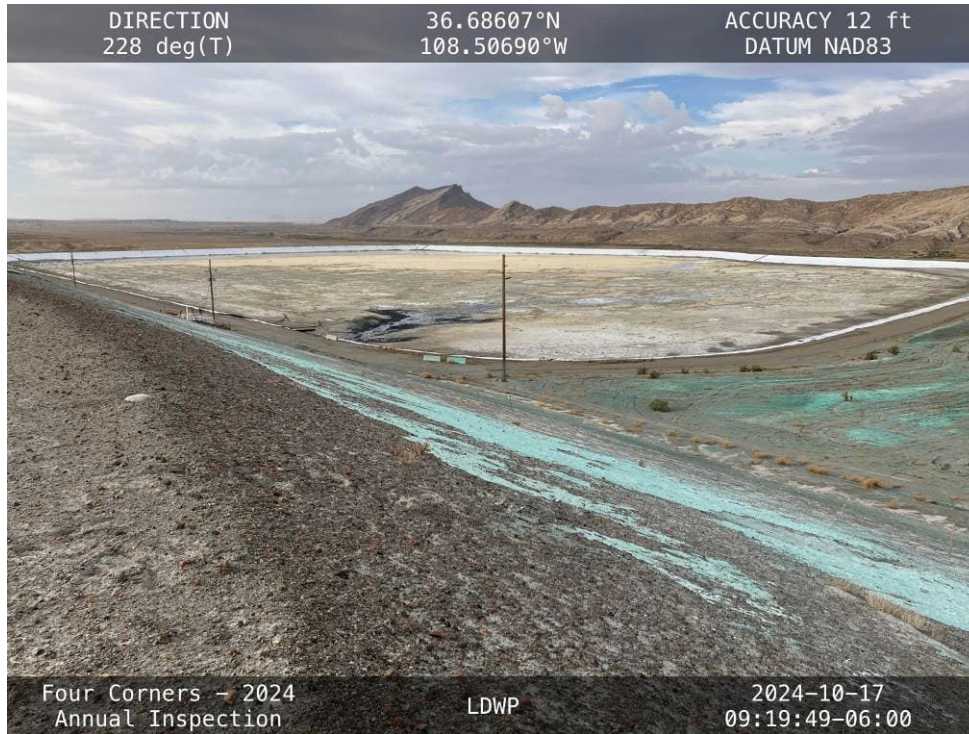
20241017 – IMG_7209

The south end of the LDWP reservoir, facing west from the LAI crest.

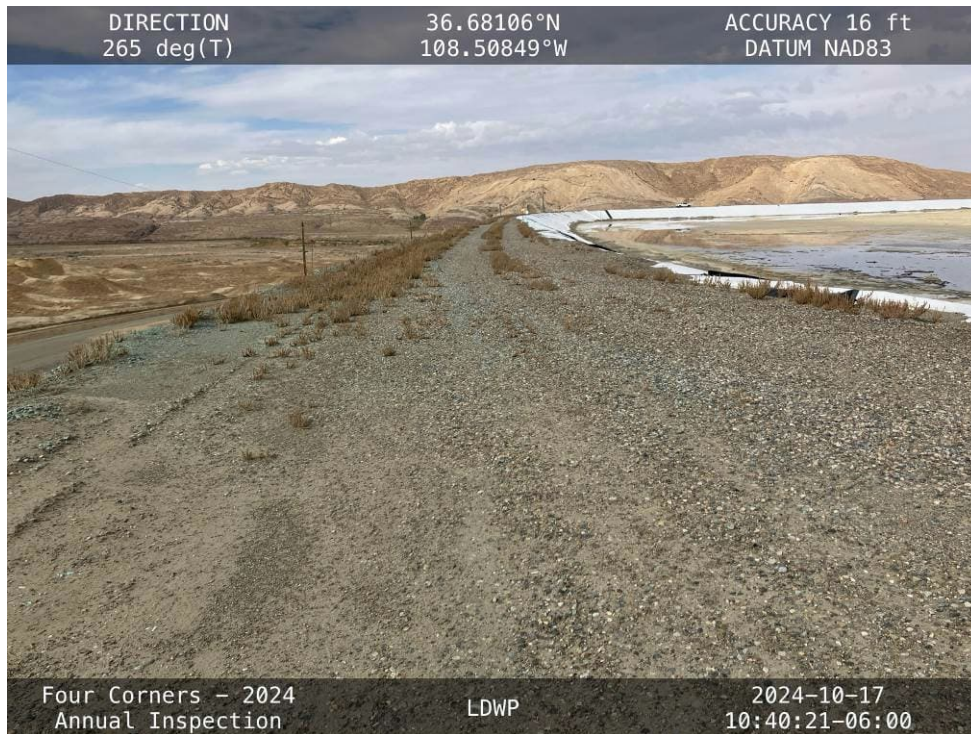
20241017 – IMG_7331

The downstream slope of the South Embankment, facing west from the southeast corner.

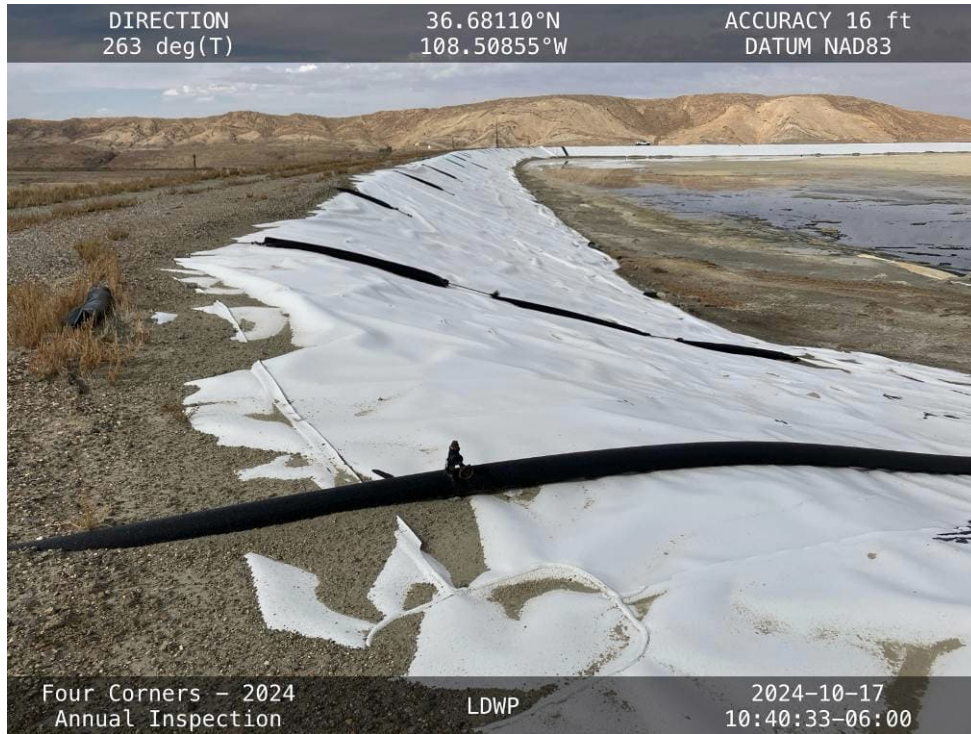
20241017 – IMG_7333

The crest of the South Embankment, facing west from the southeast corner.

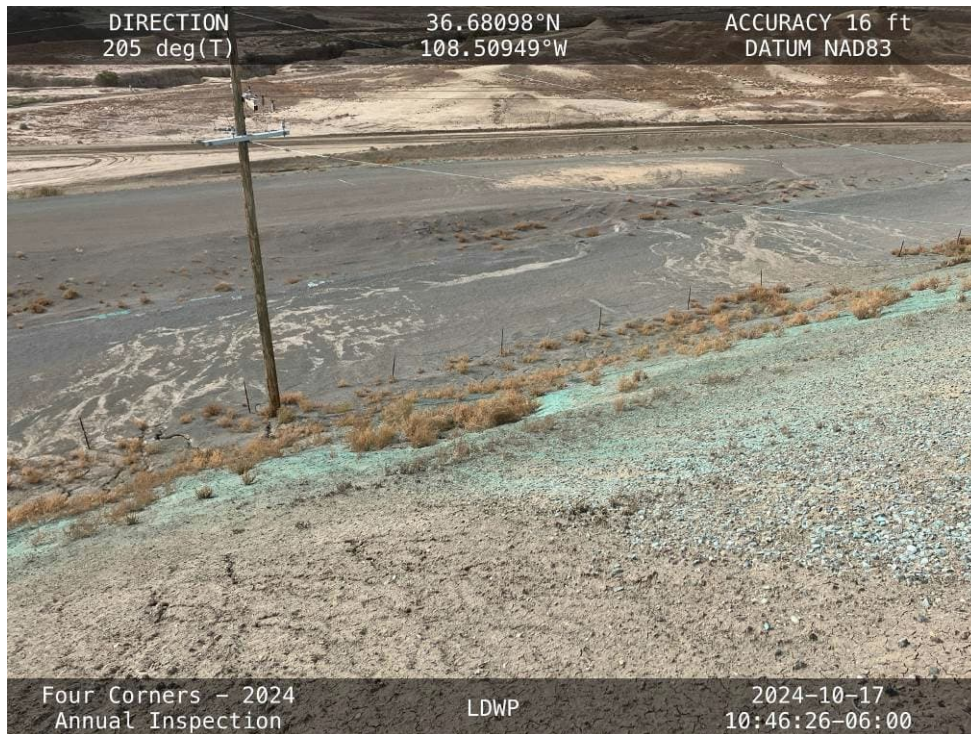
20241017 – IMG_7345

An ant hill on the downstream shoulder of the South Embankment.

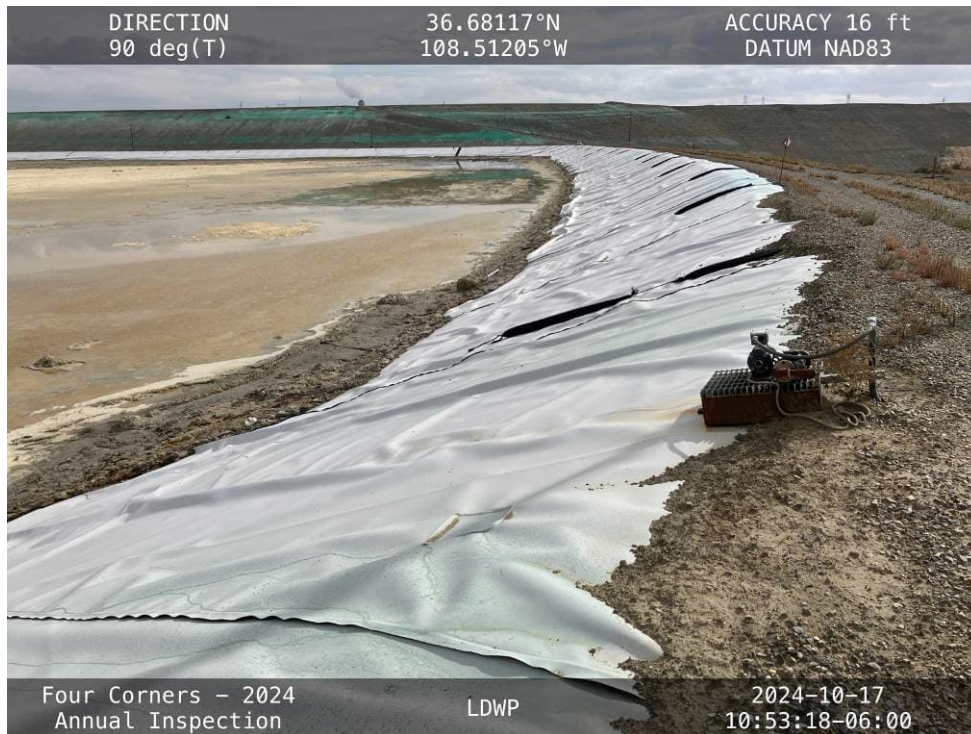
20241017 – IMG_7355

The upstream slope of the LDWP West Embankment, facing north from the southwest corner.

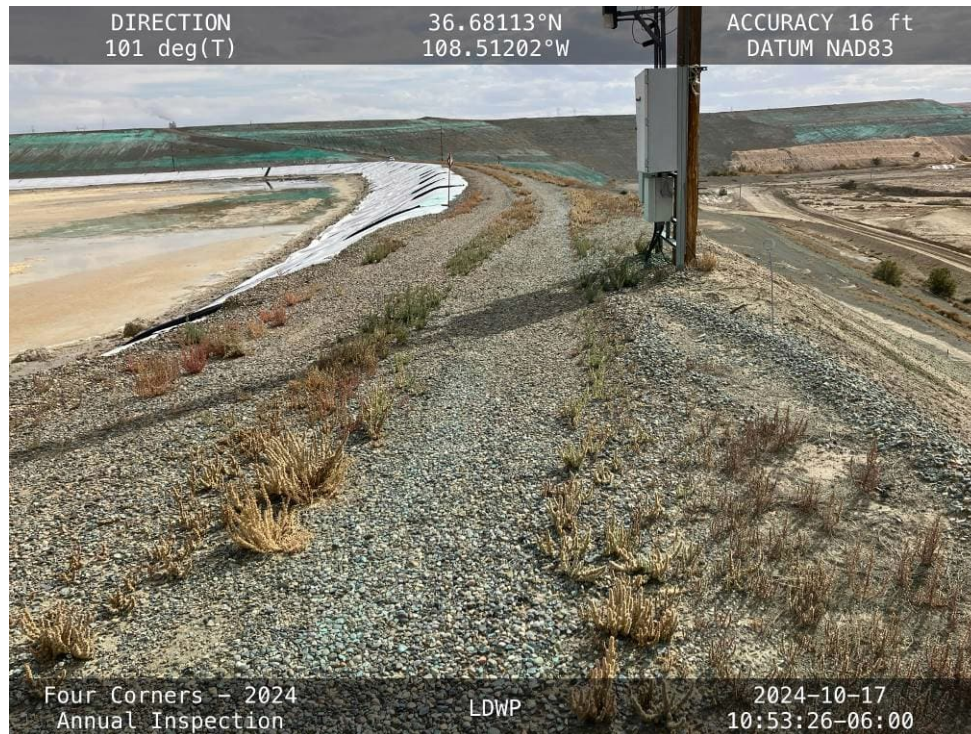
20241017 – IMG_7358

The upstream slope of the LDWP South Embankment, facing east from the southwest corner.

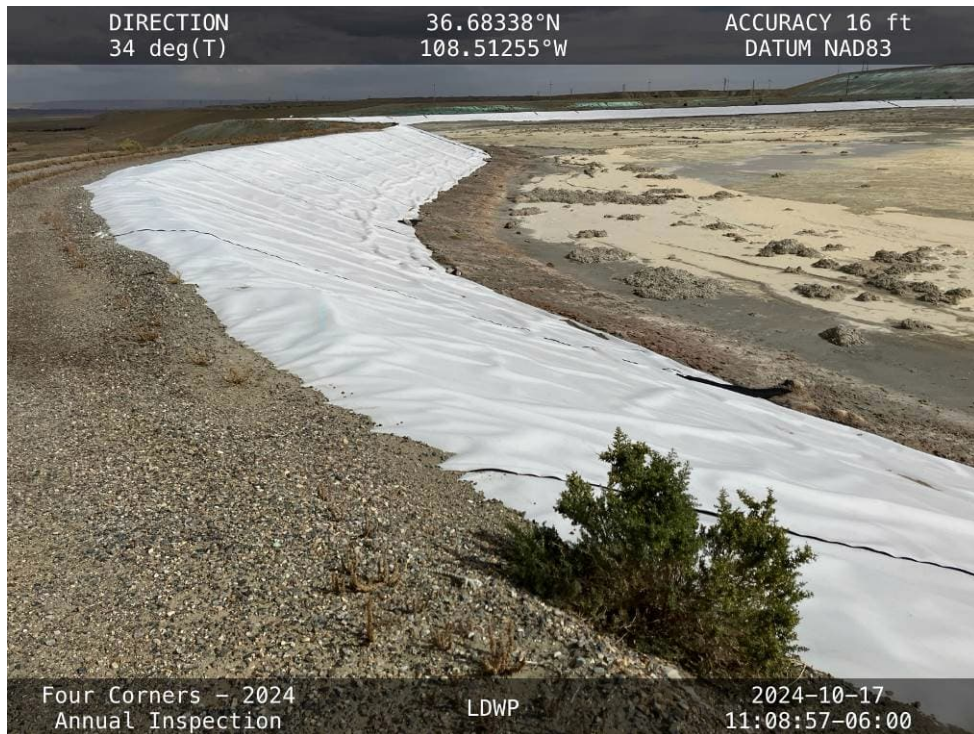
20241017 – IMG_7371

A 10-inch deep erosion rill on the downstream slope of the West Embankment.

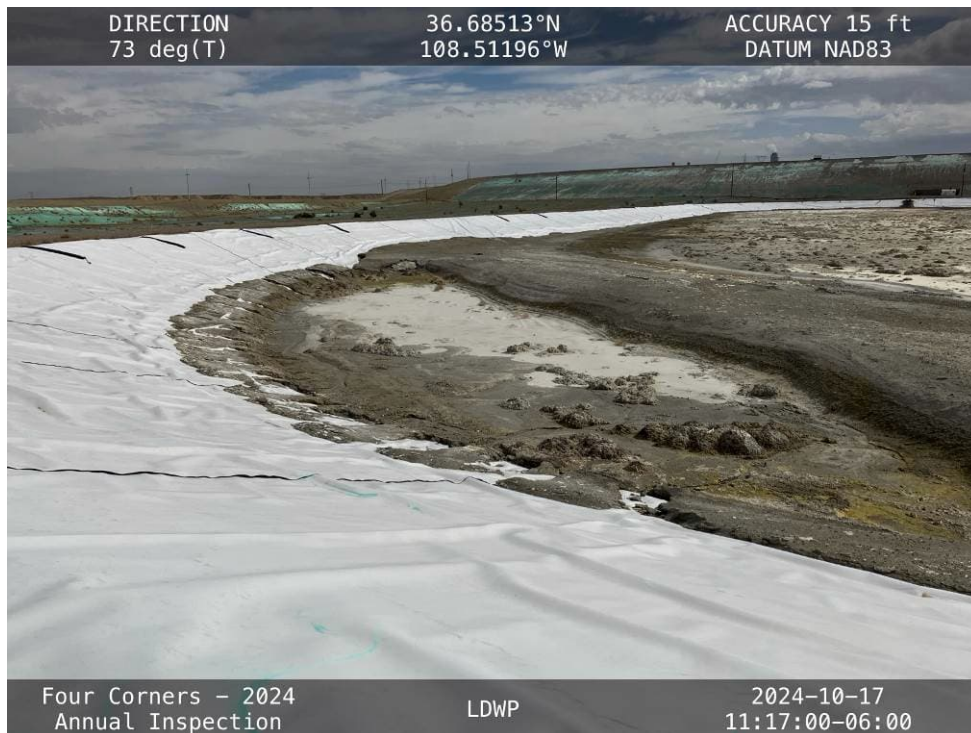
20241017 – IMG_7404

An erosion gully forming on the downstream slope in the northern portion of the West Embankment.

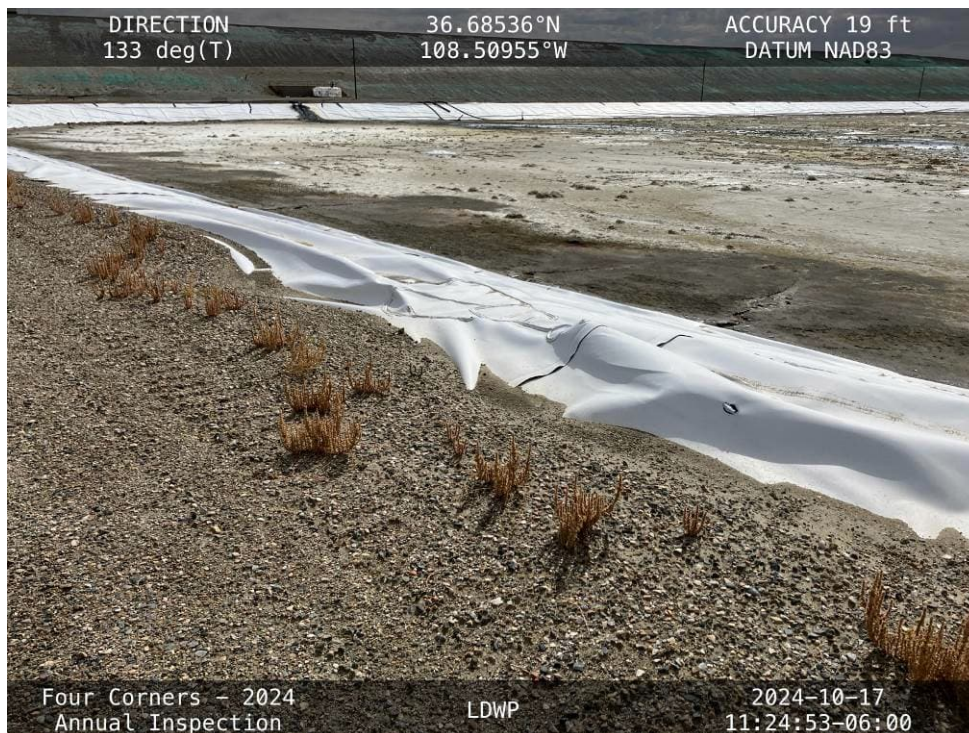
20241017 – IMG_7423

A hole in the liner along the North Embankment marked with a pin flag.

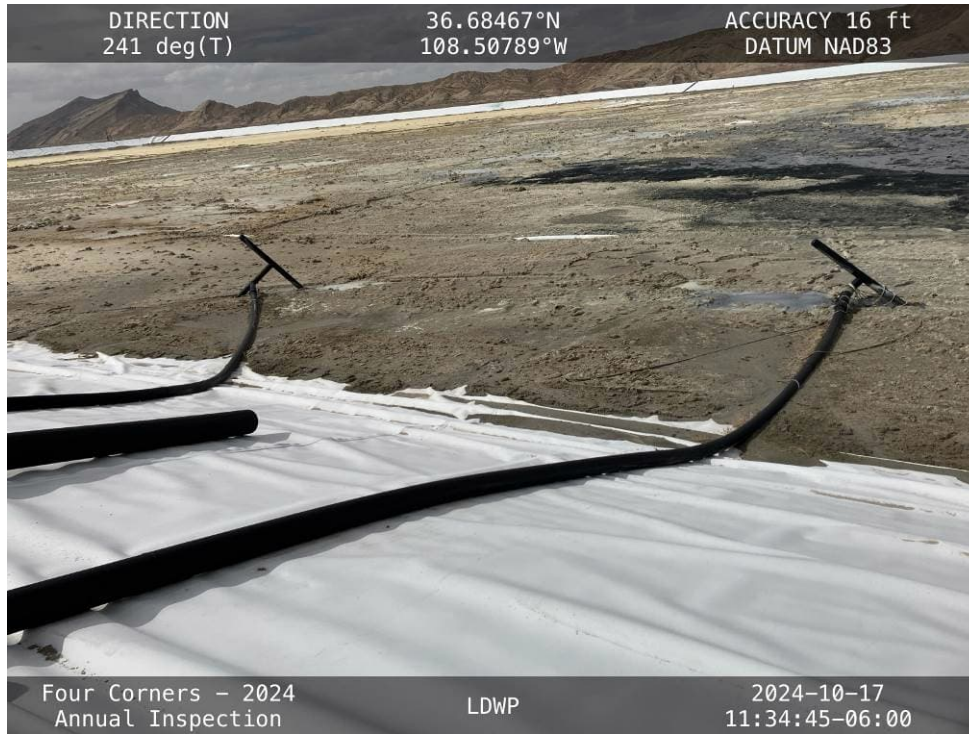
20241017 – IMG_7460
Portions of the outer pipes for the suction intake lines exposed across the East Embankment crest.

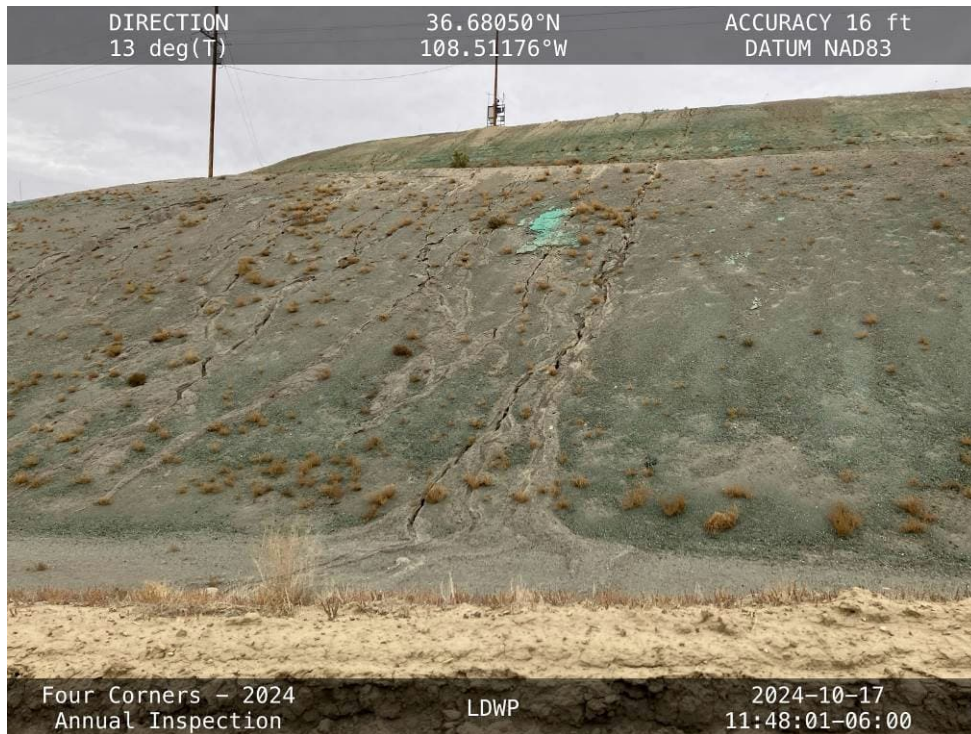
20241017 – IMG_7478

Erosion on the South Embankment downstream slope, facing north from the toe.

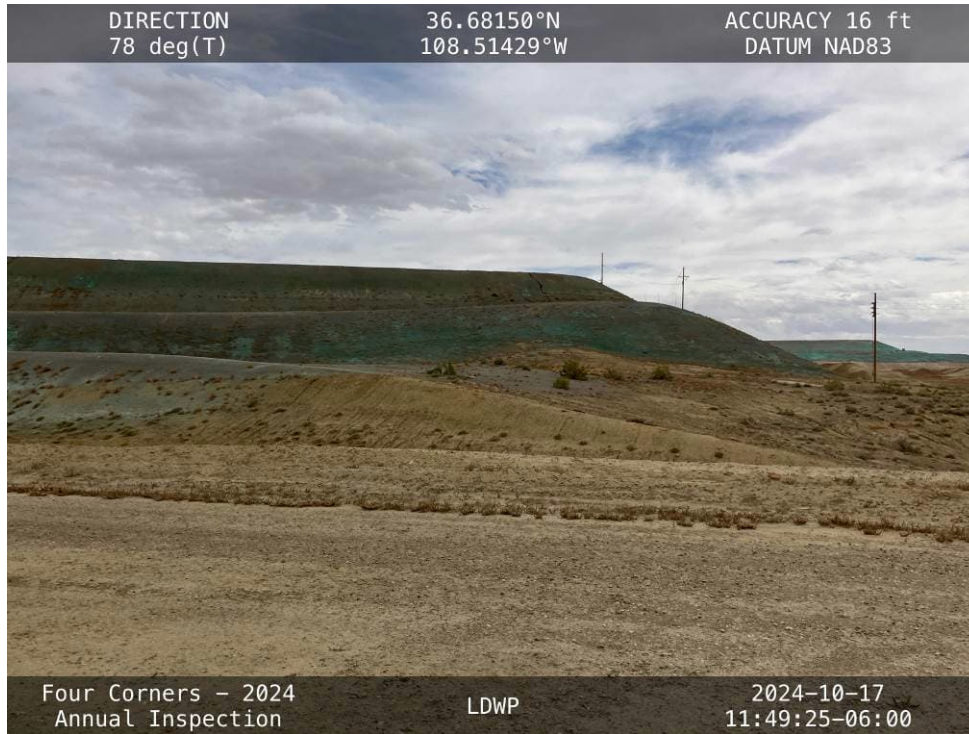
20241017 – IMG_7479

Erosion on the western half of the South Embankment downstream slope, facing north from the toe.

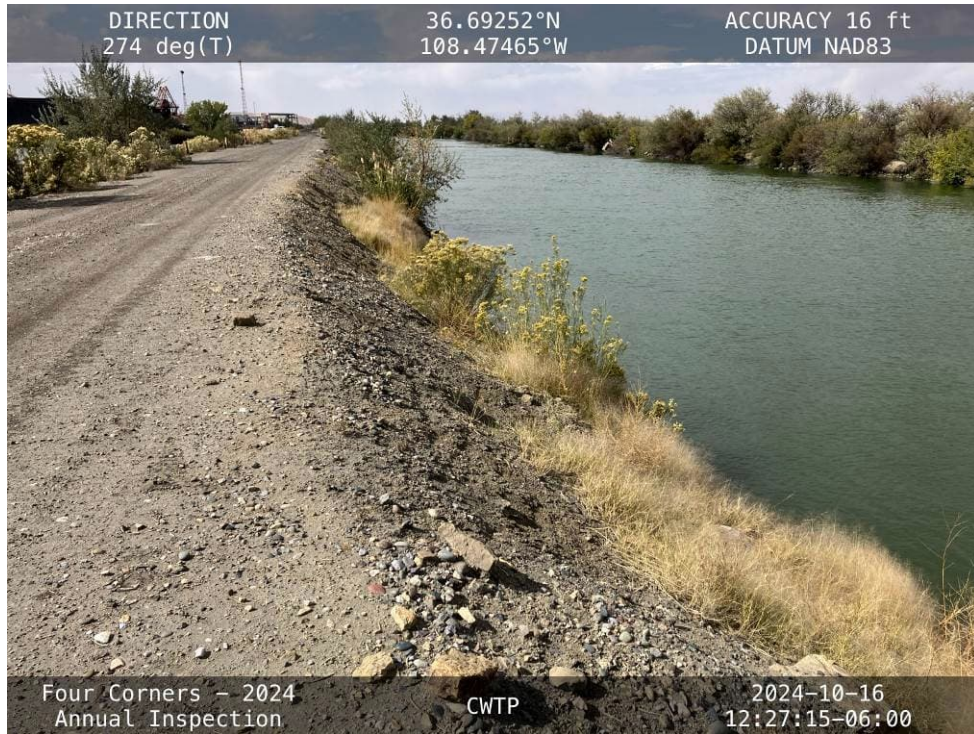
20241016 – IMG_7093

Erosion on the upstream slope of the North Embankment.

8) Erosion along the slopes resulting in an irregular face.	Continue to monitor the area repair the area if required to bring it to the design slope (2H:1V).

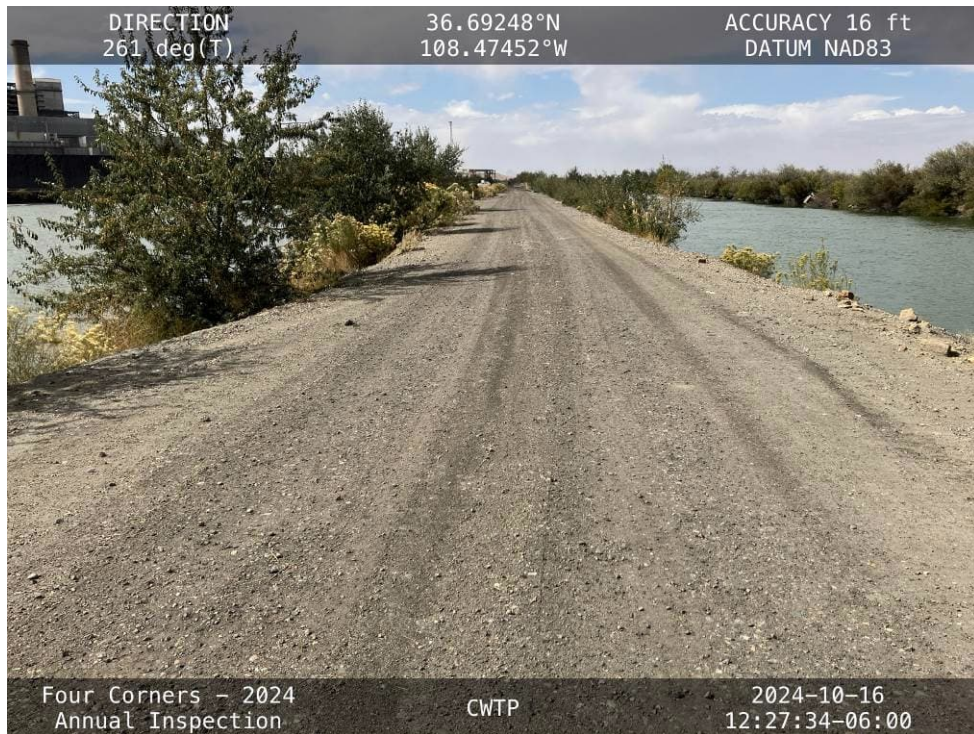
20241016 – IMG_7094

The downstream slope along the North Embankment, facing west.

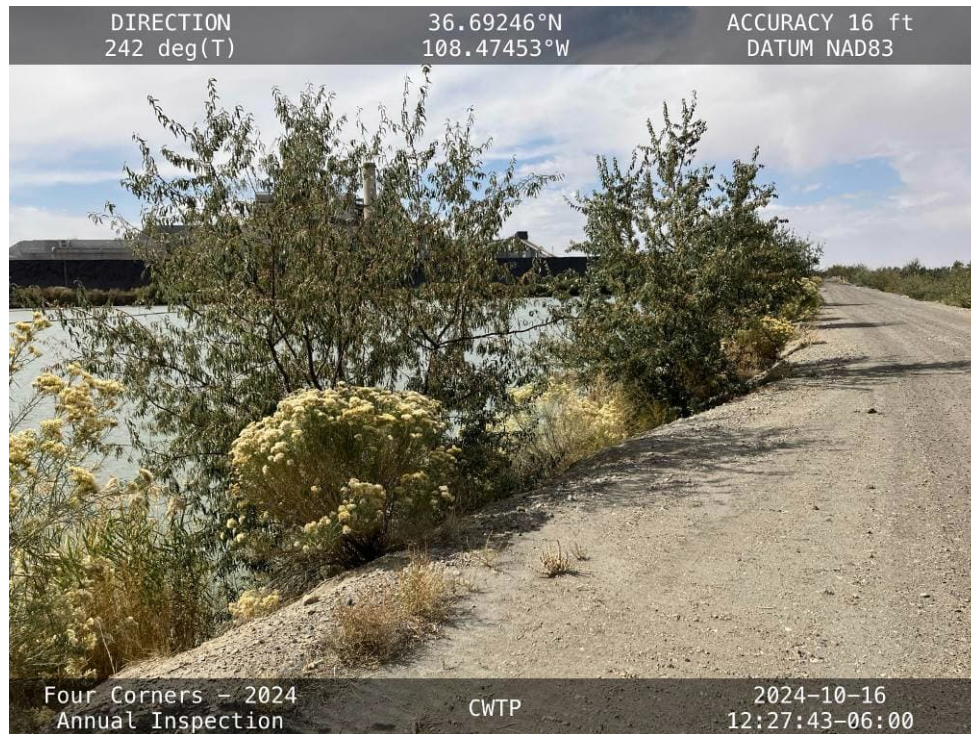
20241016 – IMG_7095

The crest of the North Embankment, facing west.

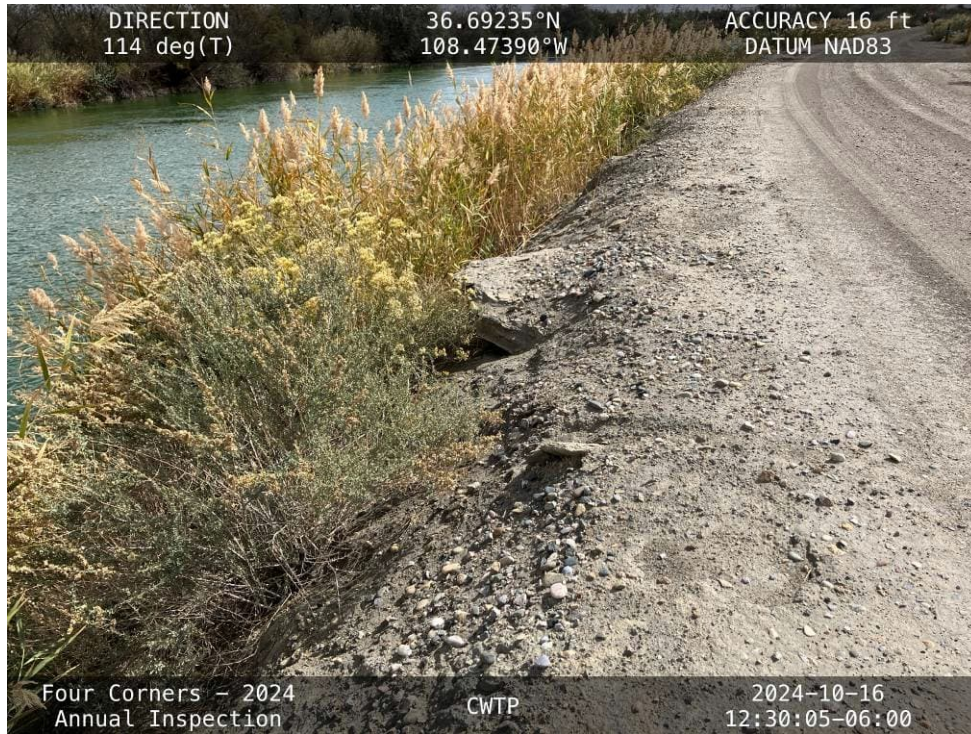
20241016 – IMG_7098
The upstream slope at the transition from the North Embankment to the East Embankment.

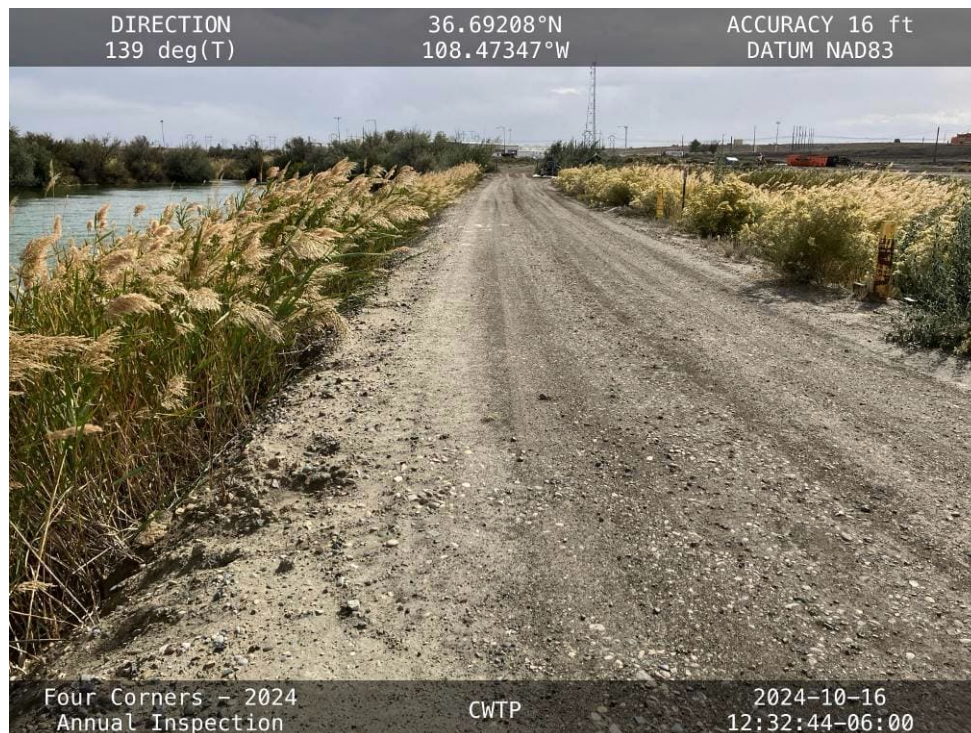
20241016 – IMG_7116
The crest of the East Embankment, facing northwest toward the curve.

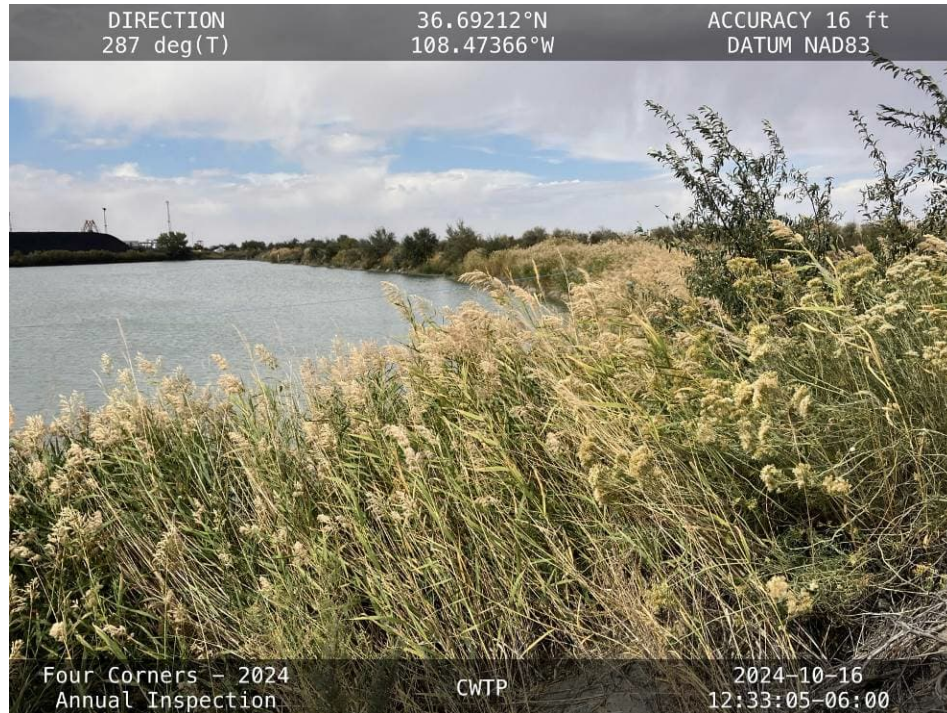
20241016 – IMG_7117
The crest of the East Embankment, facing southeast.

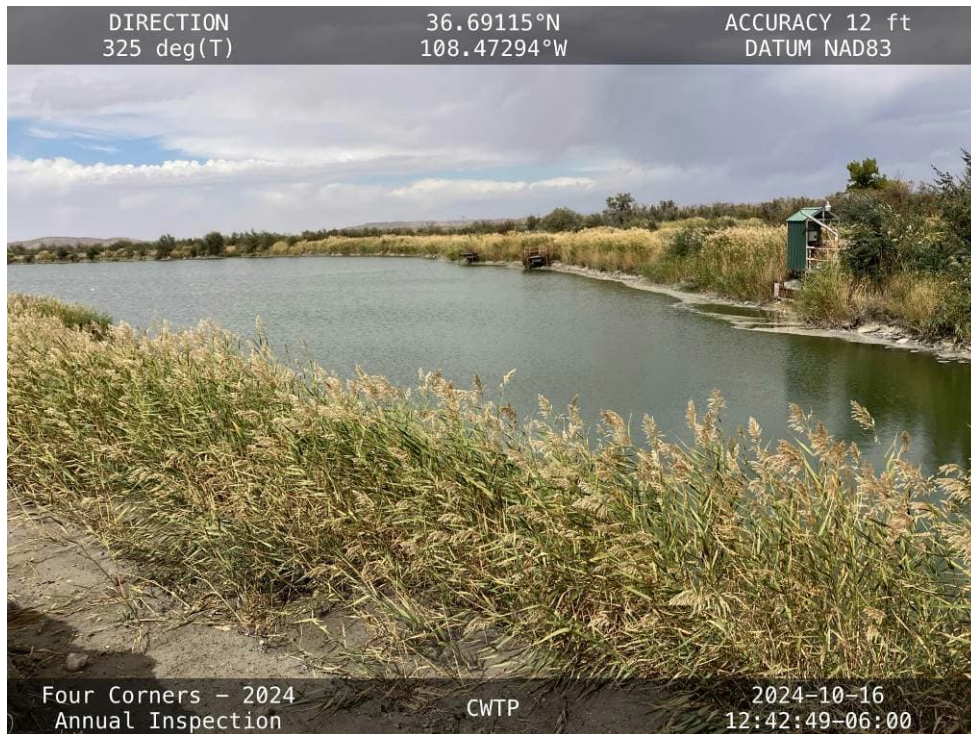
20241016 – IMG_7142

The East Embankment crest, facing northwest near the abutment.

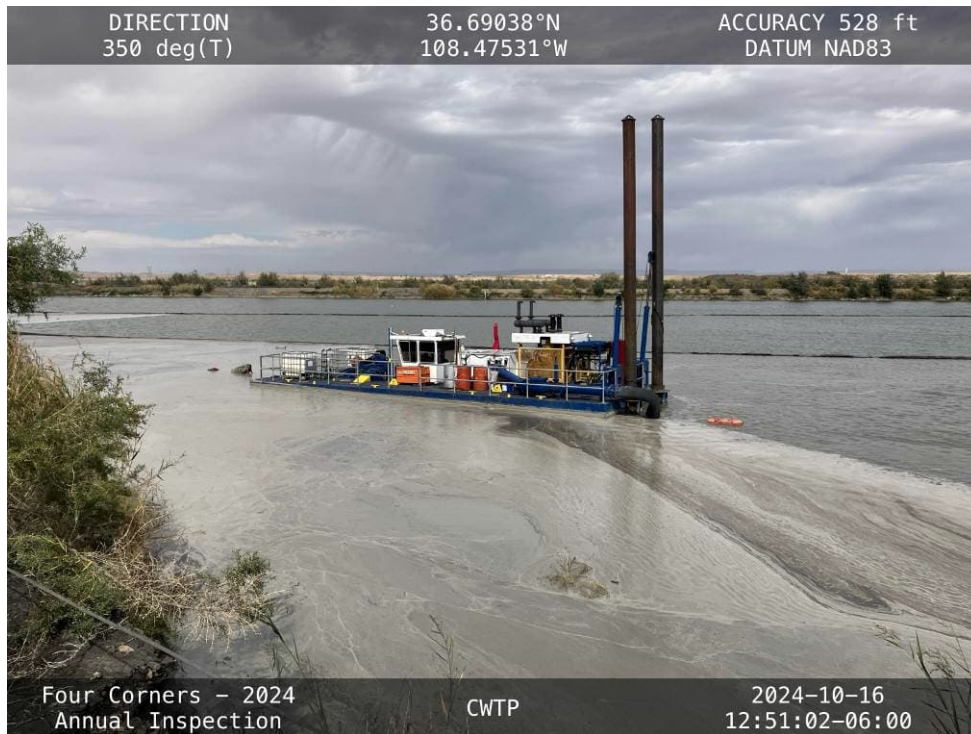
20241016 – IMG_7149

The settling pond for the dredging subcontractor on the south side of the CWTP.

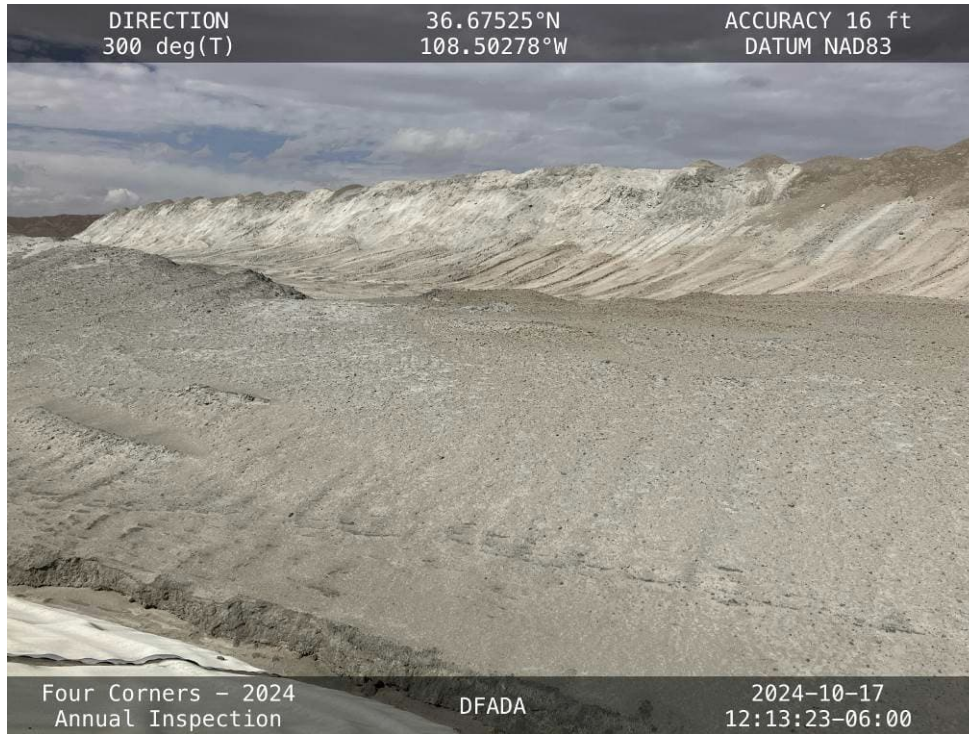
20241017 – IMG_7514

Several feet of erosion where the Stormwater Diversion Channel previously terminated.

Action Item	Action Status
1) There is erosion at the Stormwater Diversion Channel inlet and outlet, as well as along the extension constructed as part of the Cell 4 expansion where the previous alignment terminated.	Monitor erosion and repair the erosion gullies when they exceed 1 foot in depth. Alternately, place additional sandstone riprap in the eroded area.

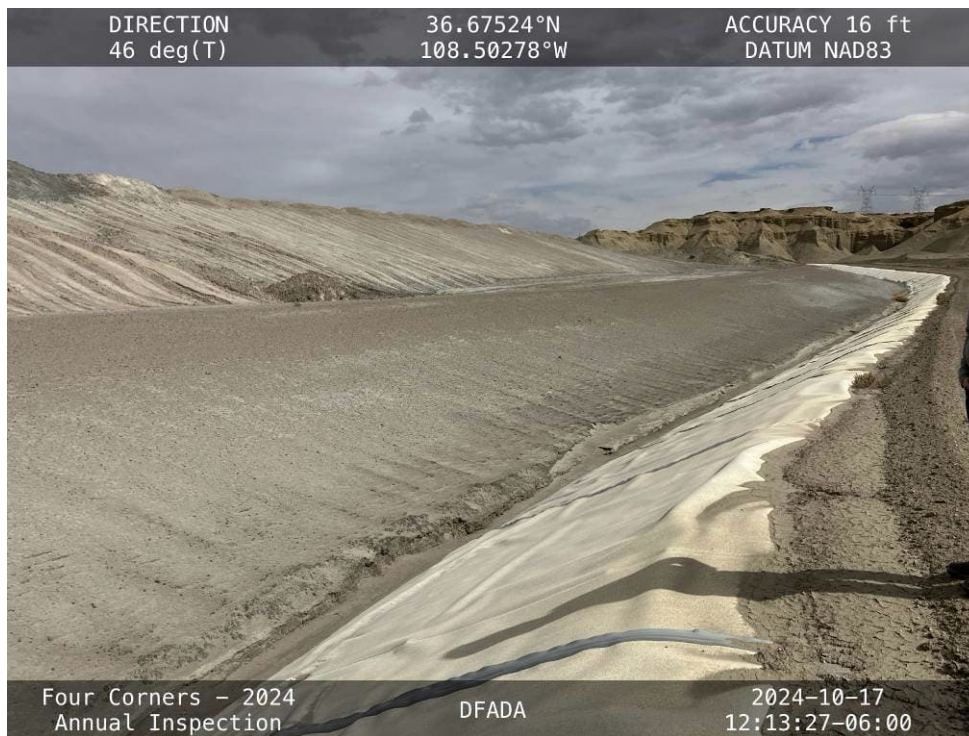
20241017 – IMG_7518
Cell 4, facing northwest from the south side of the DFADA.
