FOUR CORNERS POWER PLANT
Lined Ash Impoundment,
Lined Decant Water Pond,
Combined Waste Treatment Pond,
Dry Fly Ash Disposal Area,
and Return Water Pond

Annual
CCR Impoundment and
Landfill Inspection Report
2024

GENERATION ENGINEERING
Design Engineering
P.O. BOX 53999
PHOENIX, ARIZONA 85072

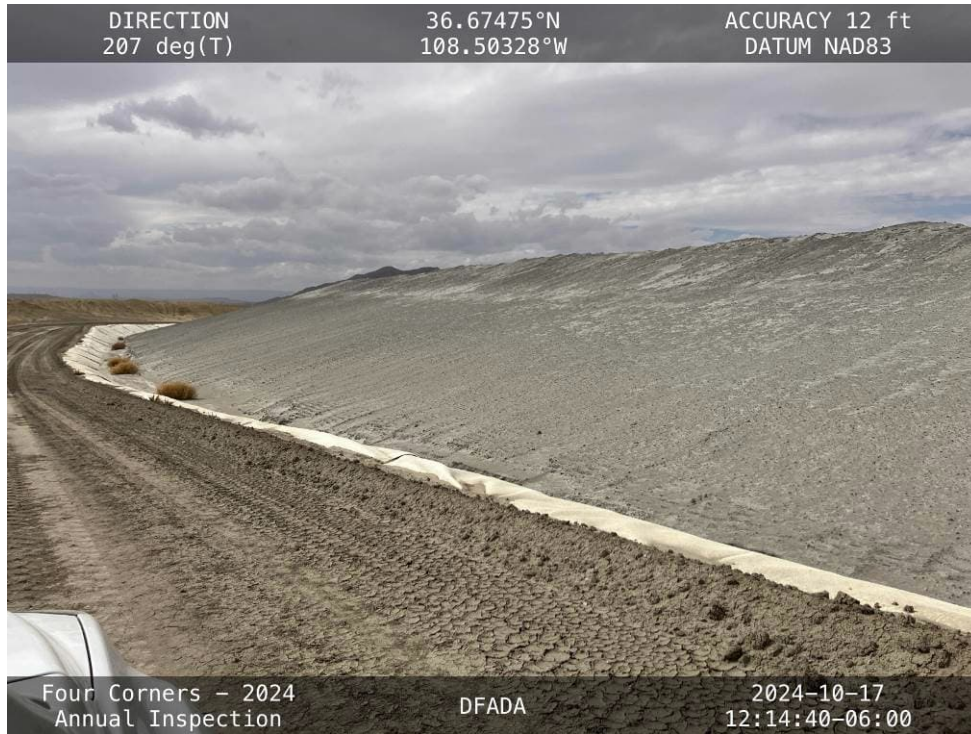
20241017 – IMG_7521
Cell 4, facing northeast from the south side of the DFADA.

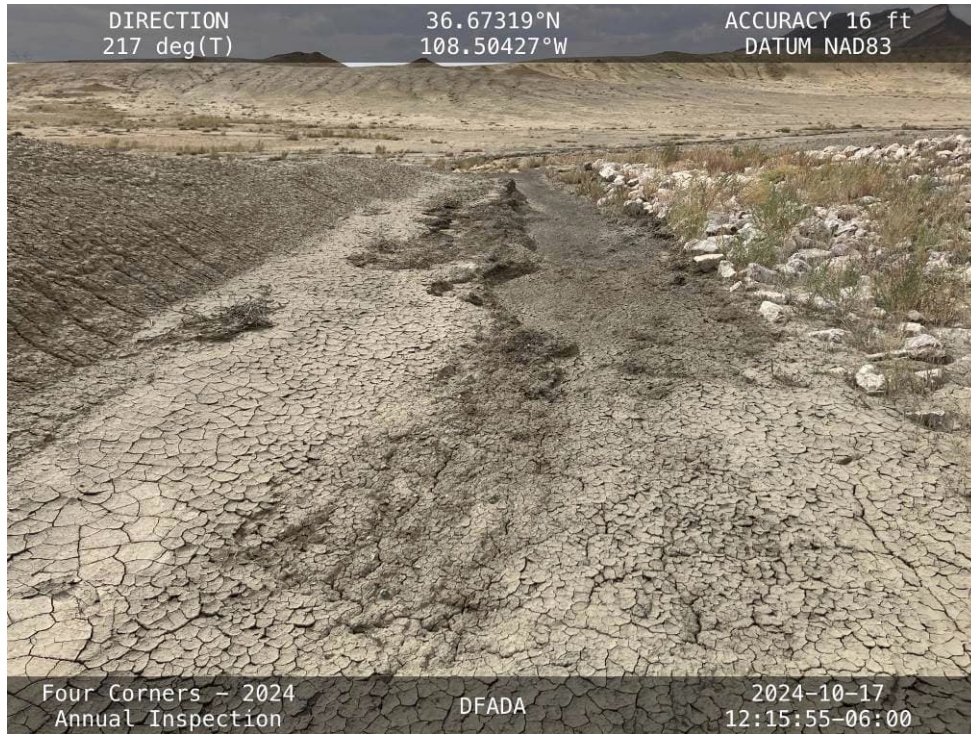
20241017 – IMG_7524

The headwall at the end of the Stormwater Diversion Channel with sediment on both sides.

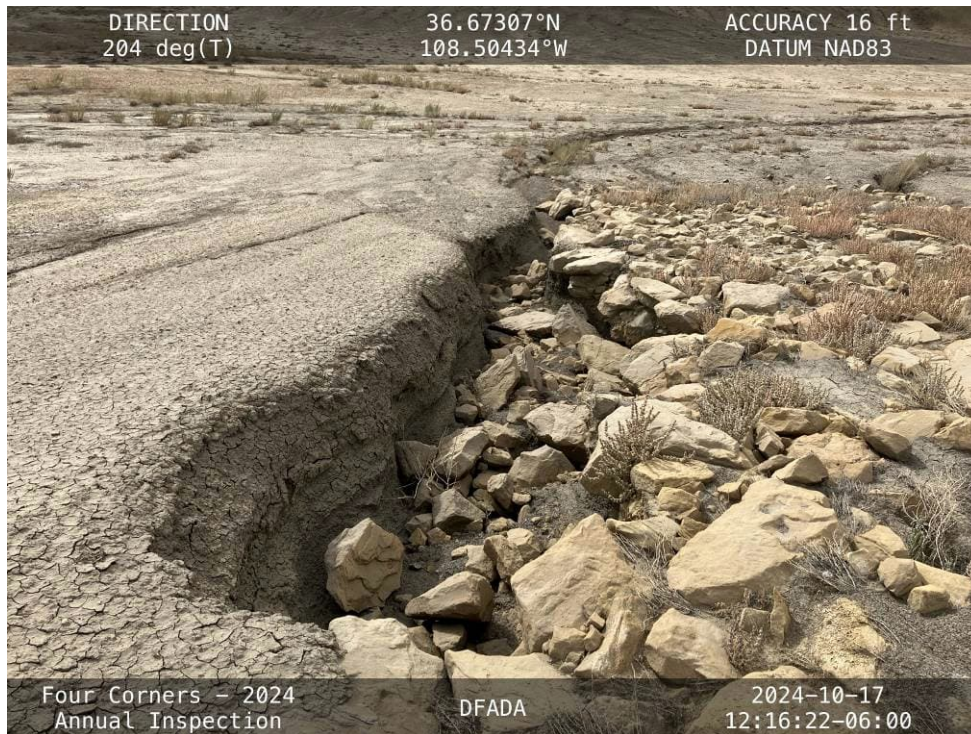
20241017 – IMG_7526

The end of the Stormwater Diversion Channel, facing south.

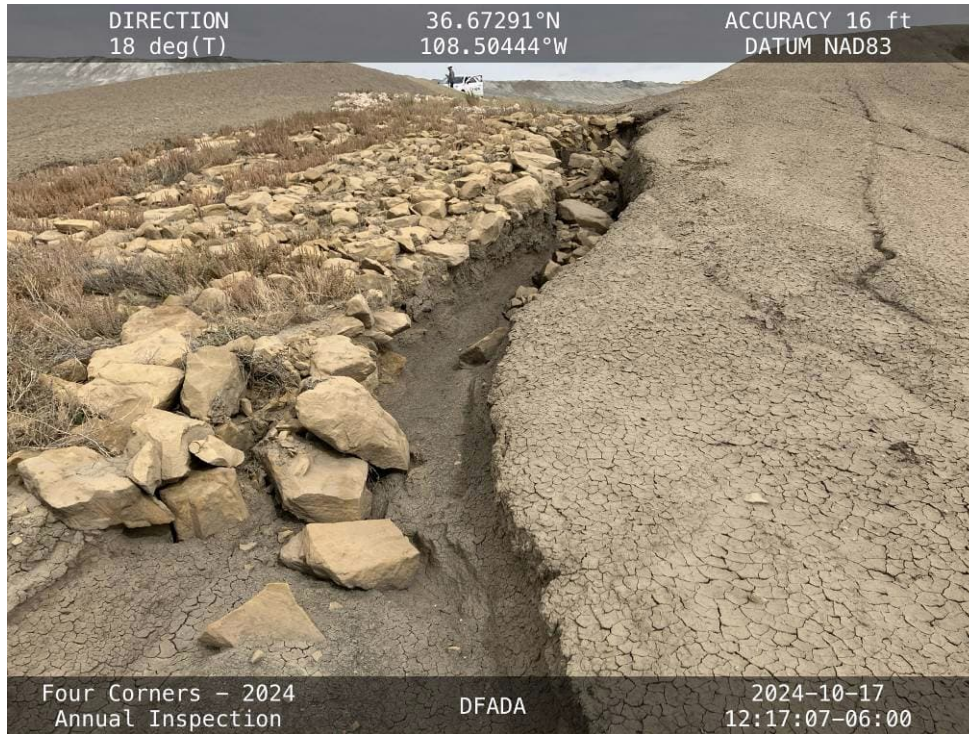
20241017 – IMG_7527

More than 3.5 feet of erosion at the outlet for the Stormwater Diversion Channel.

Action Item	Action Status
1) There is erosion at the Stormwater Diversion Channel inlet and outlet, as well as along the extension constructed as part of the Cell 4 expansion where the previous alignment terminated.	Monitor erosion and repair the erosion gullies when they exceed 1 foot in depth. Alternately, place additional sandstone riprap in the eroded area.

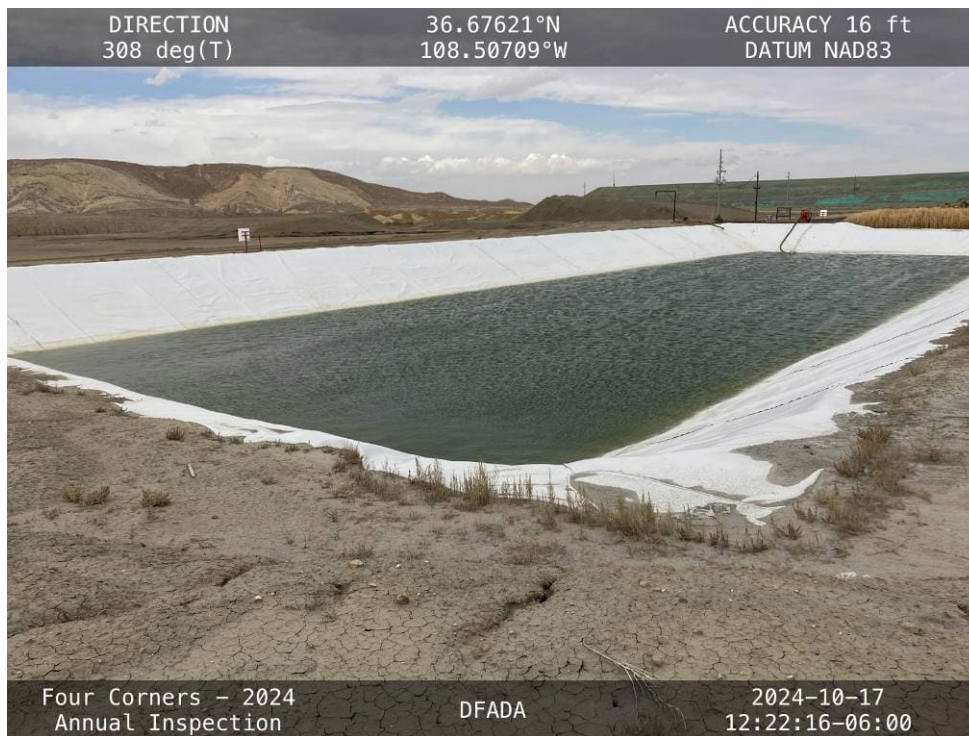
20241017 – IMG_7533
Moisture along the lower portion of the Cell 4 western slope.

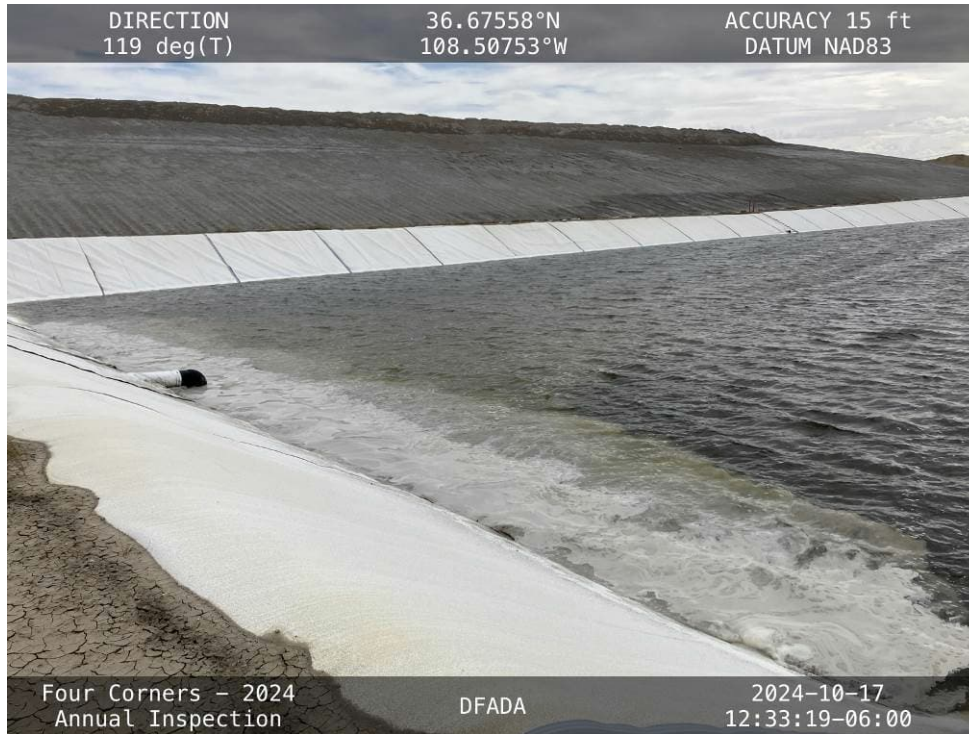
20241017 – IMG_7545

Vegetation to be removed and water draining from Cell 1, seeping directly over the liner into the leachate collection pond.

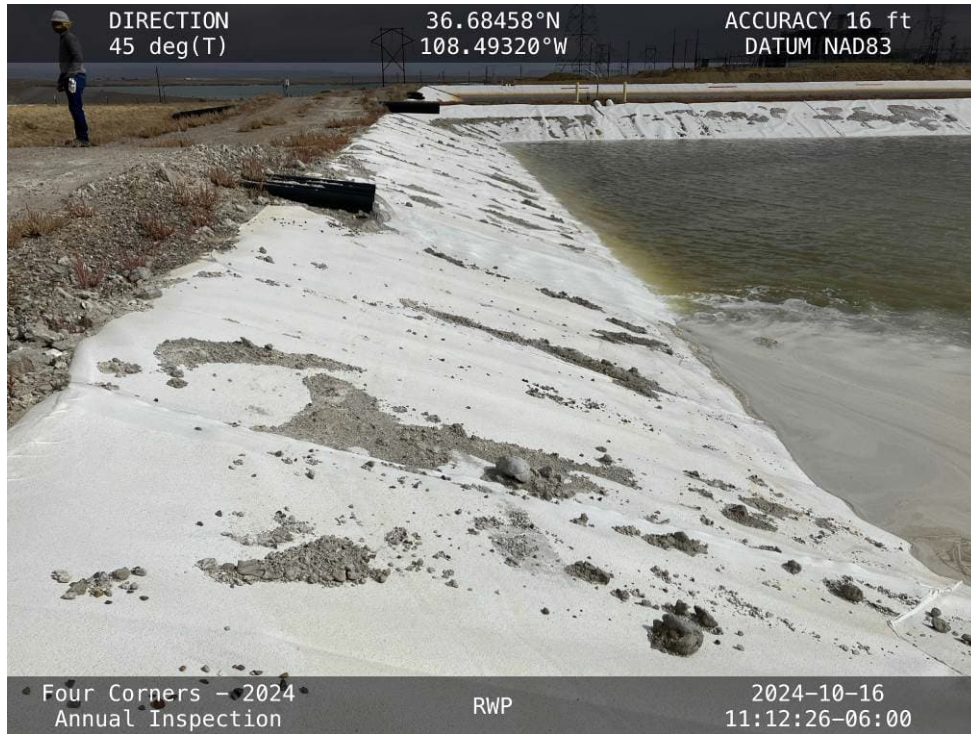
20241016 – IMG_7016

A tear in the liner along the crest of the FGD cell Northwest Embankment.

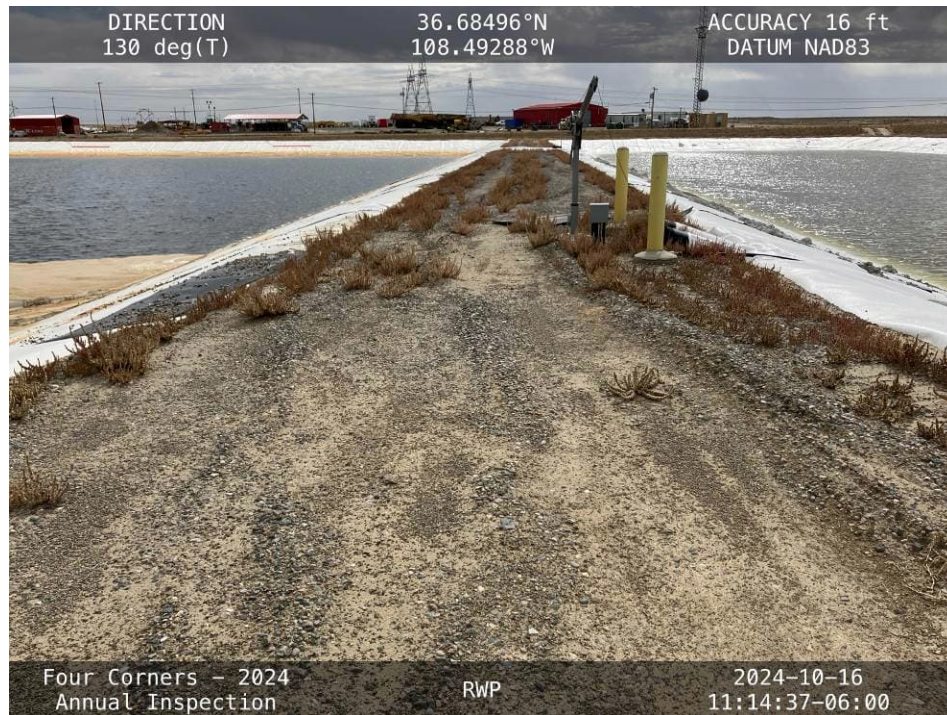
20241016 – IMG_7030

The upstream slope of the Internal Embankment with loose liner where previous construction activity took place (arrow), facing southeast with the RWP cell on the left.
