**FOUR CORNERS POWER PLANT
Lined Ash Impoundment,
Lined Decant Water Pond,
Combined Waste Treatment Pond,
Dry Fly Ash Disposal Area,
and Return Water Pond**

**Annual
CCR Impoundment and
Landfill Inspection Report
2020**

**GENERATION ENGINEERING
Design Engineering
P.O. BOX 53999
PHOENIX, ARIZONA 85072**

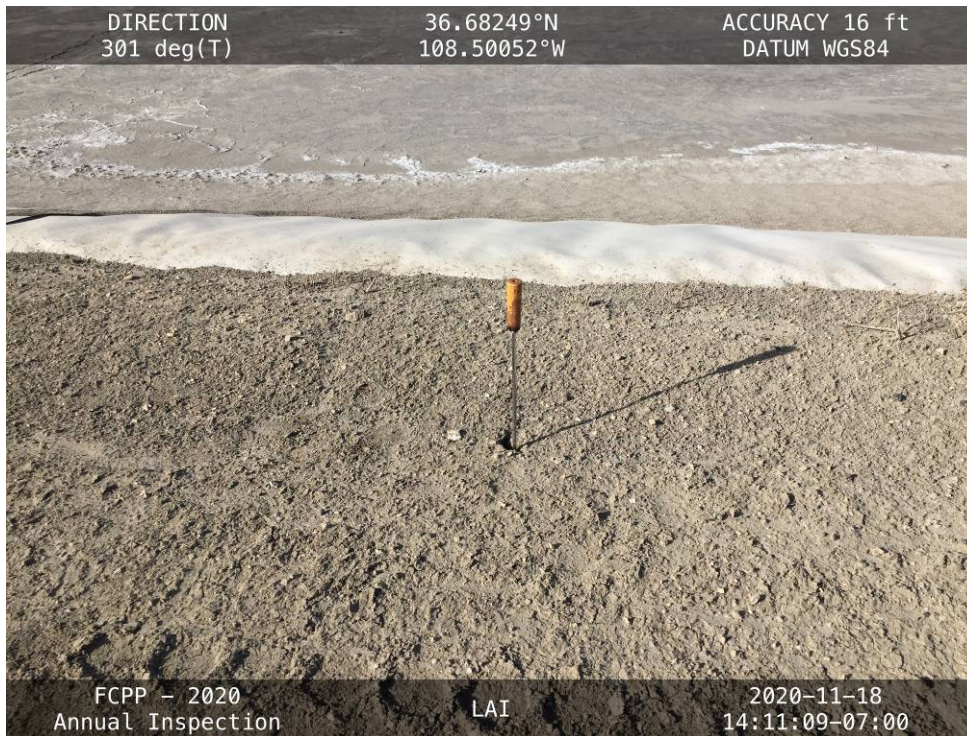
20201118 – IMG_3375

- i. Holes were observed along portions of the geomembrane liner anchor trench in the South and East Embankment (see Photos IMG_3375 and IMG_3384). Mud cracks were observed on the East Embankment crest (see Photo IMG_3388). The holes and cracks all appeared to be superficial. The holes did not extend past the bottom of the anchor trench and the mud cracks were less than 1 inch deep. The holes and mud cracks should be monitored and repaired if they are observed to extend deeper than 1 foot.

A hole at the edge of the anchor trench along the upstream side of the South Embankment.

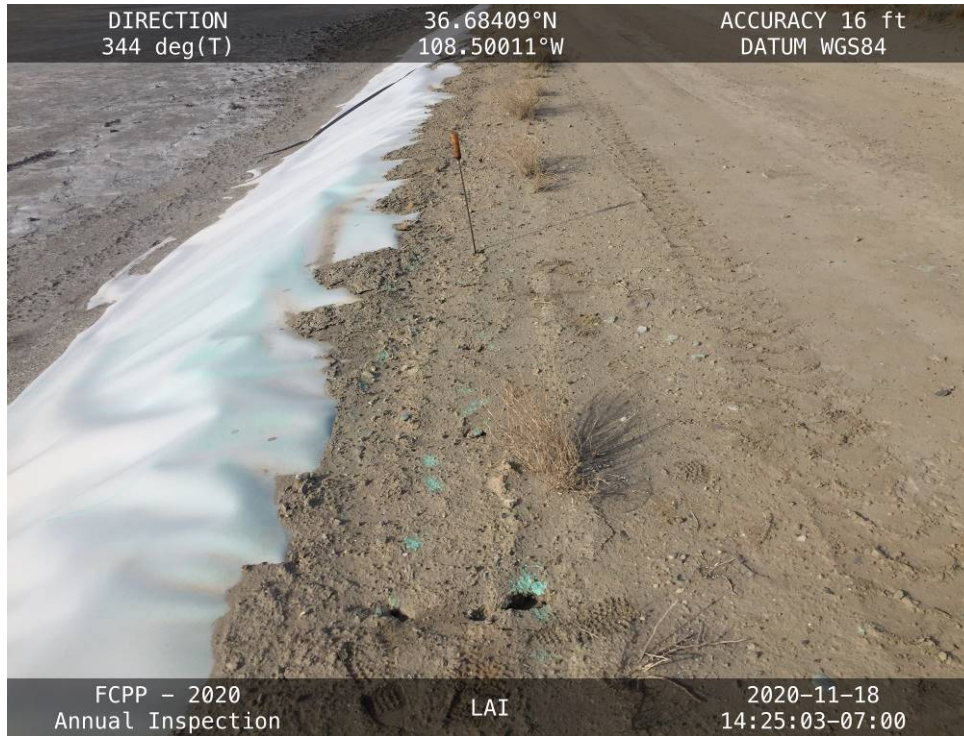
20201118 – IMG_3384

Holes at the edge of the anchor trench along the upstream side of the East Embankment.

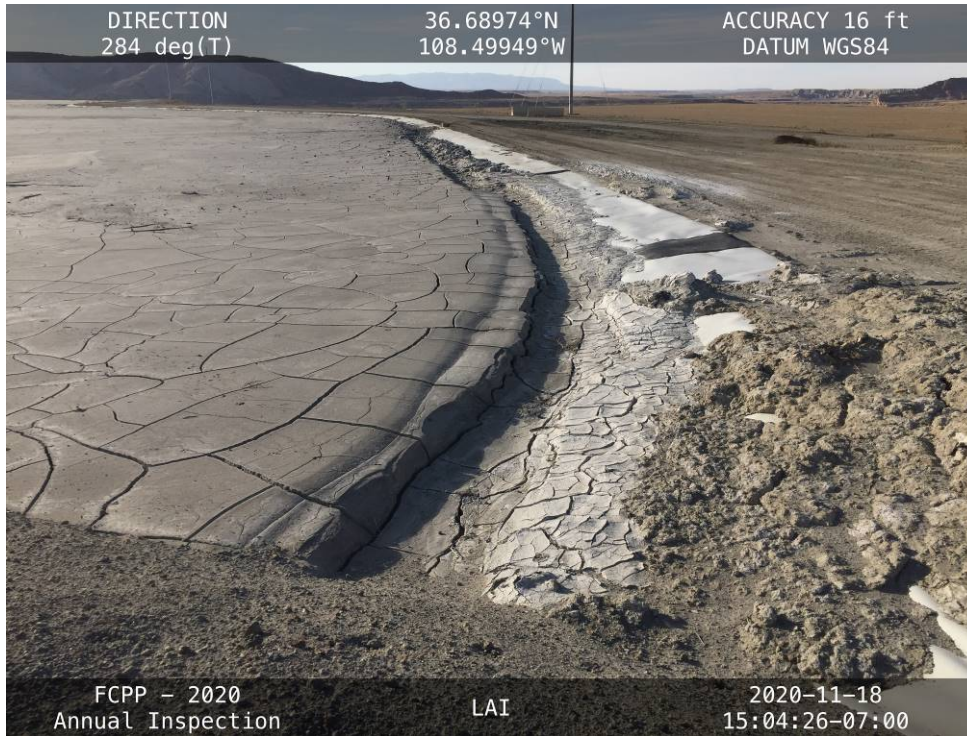
20201118 – IMG_3411

Ash at the north side of the LAI within inches of the crest elevation, facing west.

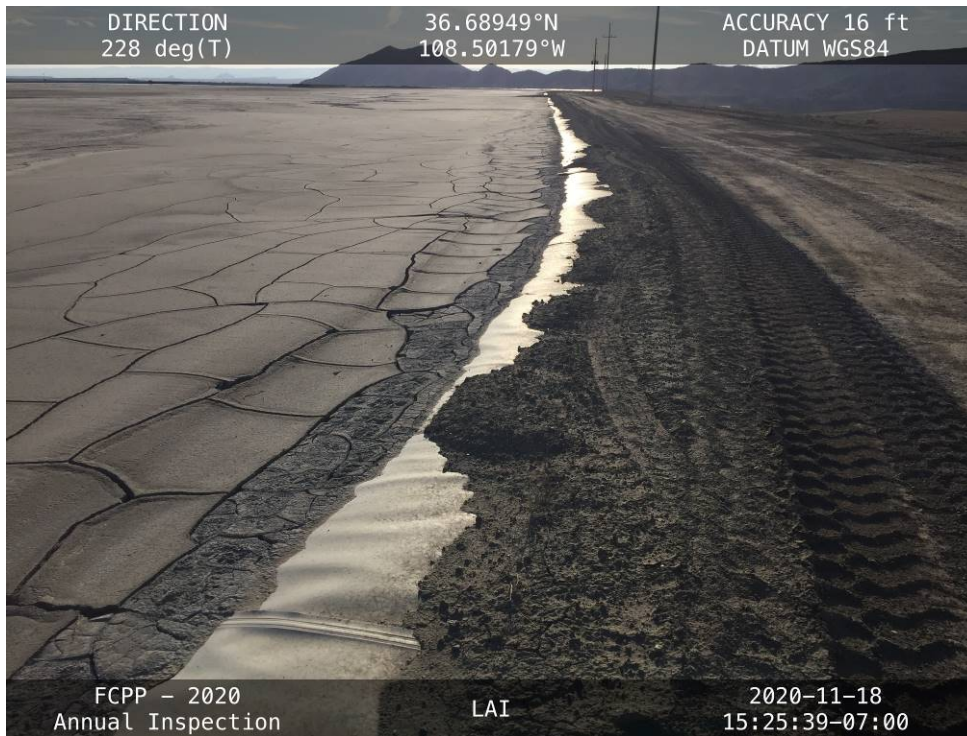
20201118 – IMG_3434

Ash at the north side of the LAI within inches of the crest elevation, facing west.

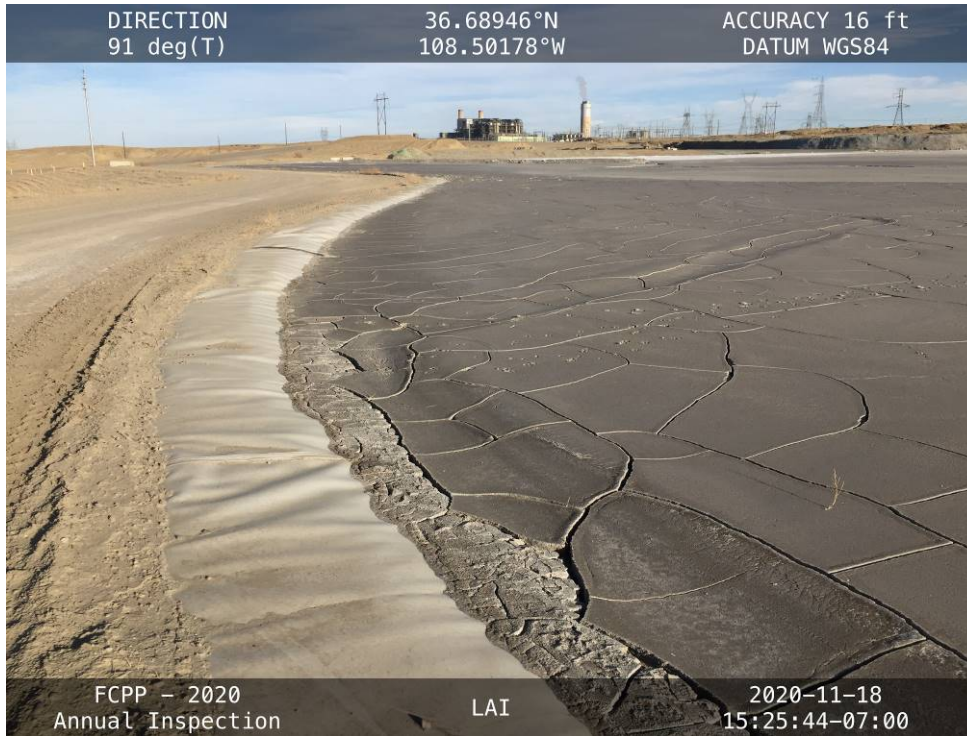
20201118 – IMG_3435

Ash at the north side of the LAI within inches of the crest elevation, facing east.

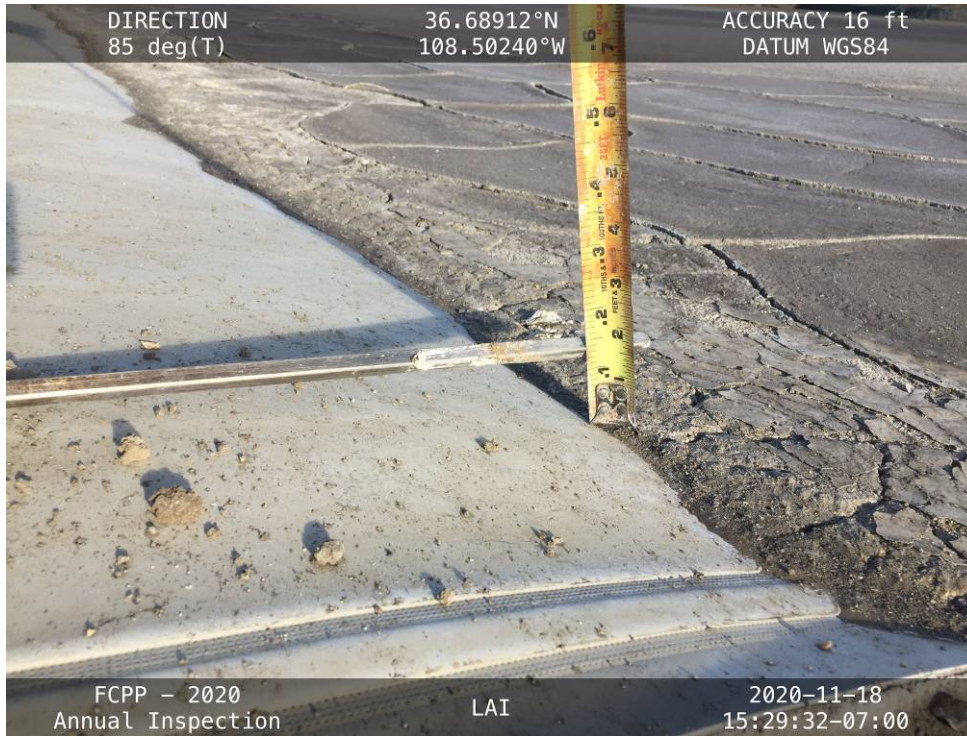
20201118 – IMG_3445

Ash at the north side of the LAI within 1.25 inches of the crest elevation.

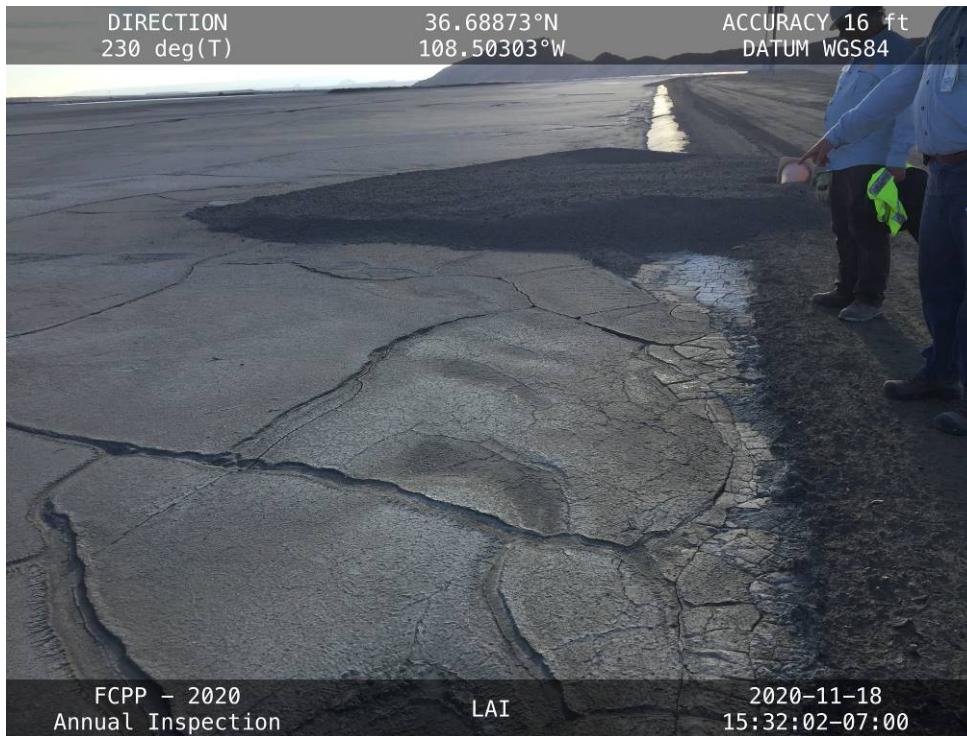
20201118 – IMG_3447

A short berm constructed to divert inflows away from the Northwest Embankment crest.

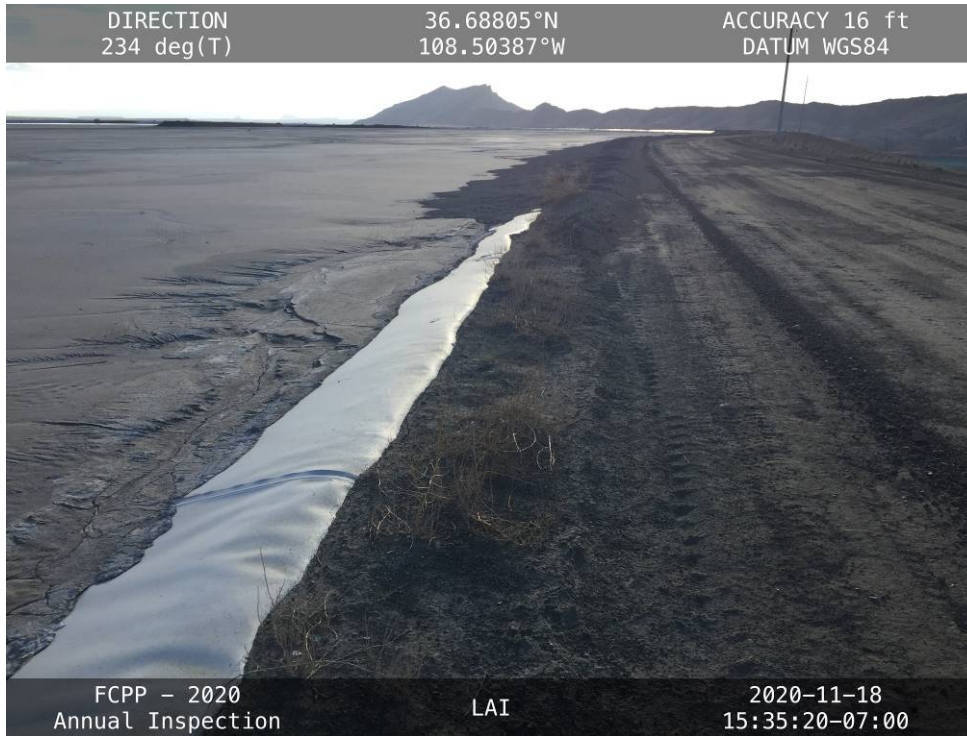
20201118 – IMG_3450

A second berm constructed to divert inflows away from the Northwest Embankment crest.

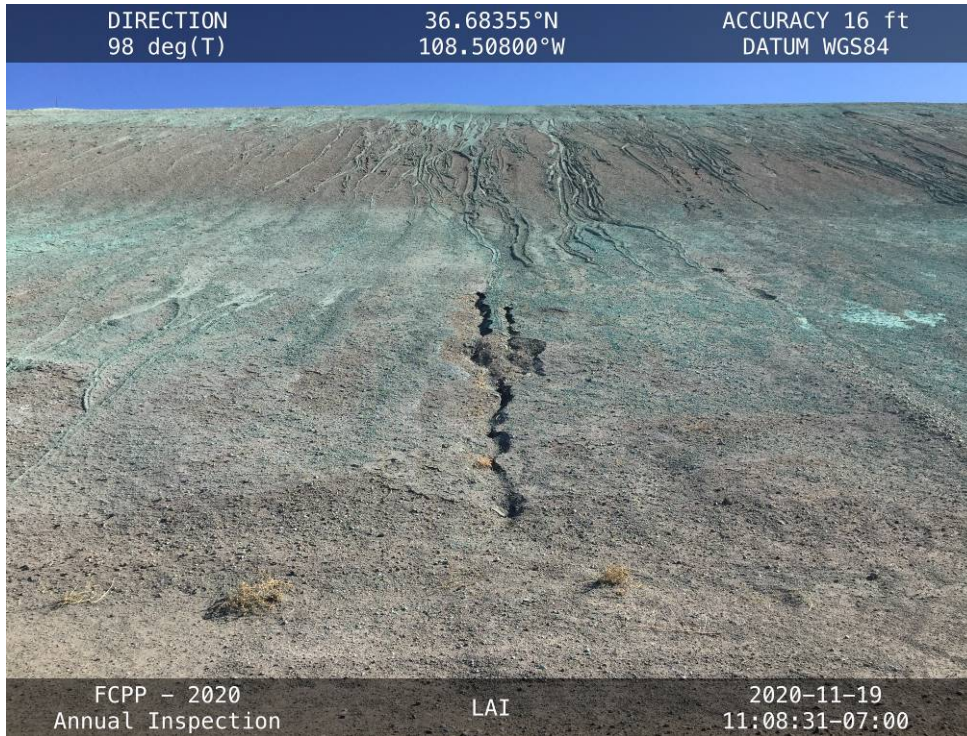
20201119 – IMG_3649

- b. The August 3, 2020 inspection noted that the downstream slope had signs of erosion, likely due to recent rainfall, that required monitoring.
- c. The inlet flows to the LAI were first noted as requiring monitoring in the August 3, 2020 inspection. The inlet flow was also referenced on two subsequent weekly reports. Based on the conditions observed at the inlet during the annual inspection, Plant personnel should continue to monitor the inlet flows during periods of deposition so that future deposition events do not cause the inflow to overtop the embankment and lead to an operational disruption of the LAI.

Erosion rills in the lower half of the West Embankment downstream slope, facing east.

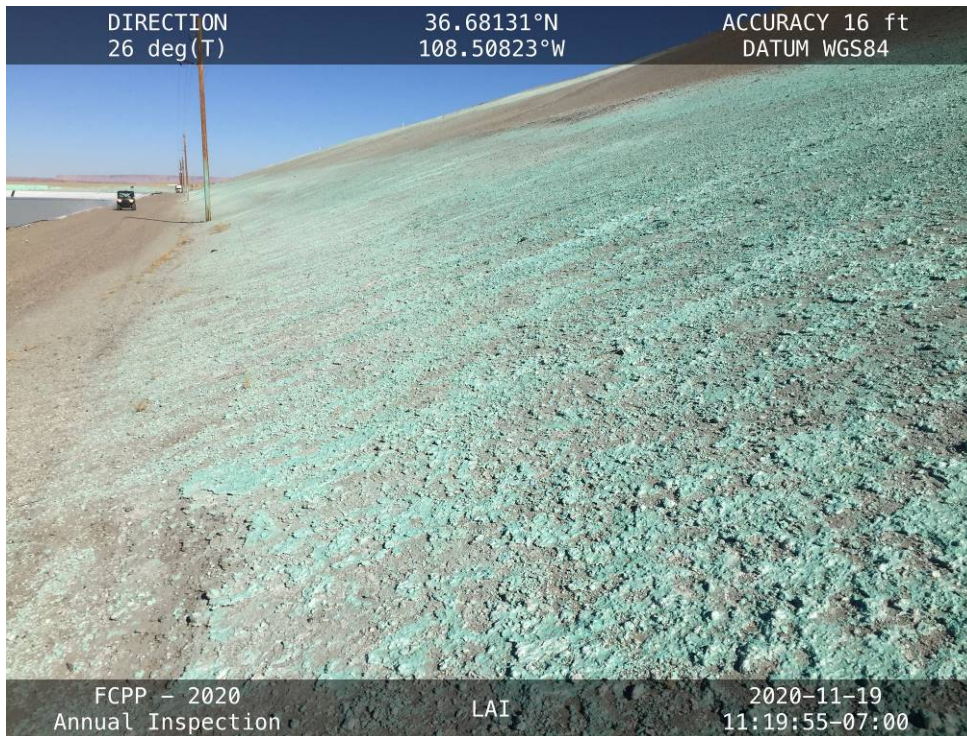
20201119 – IMG_3654

The downstream toe of the West Embankment, facing north.

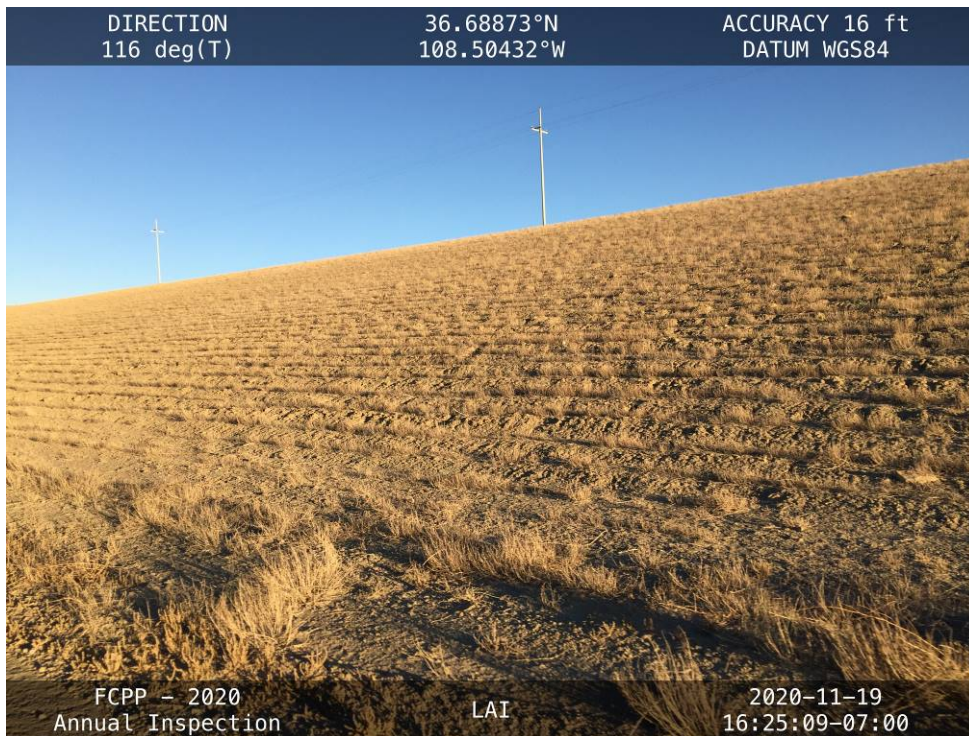
20201119 – IMG_3943

The downstream slope of the Northwest Embankment.

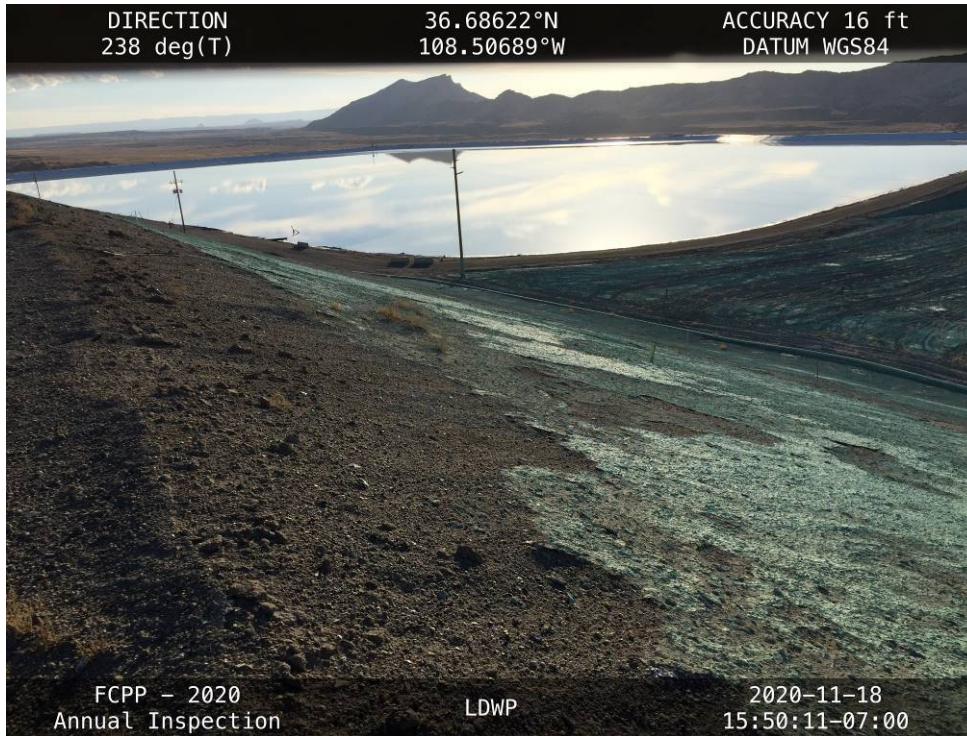
20201118 – IMG_3467

The North Embankment of the LDWP, facing west from the crest of the LAI.

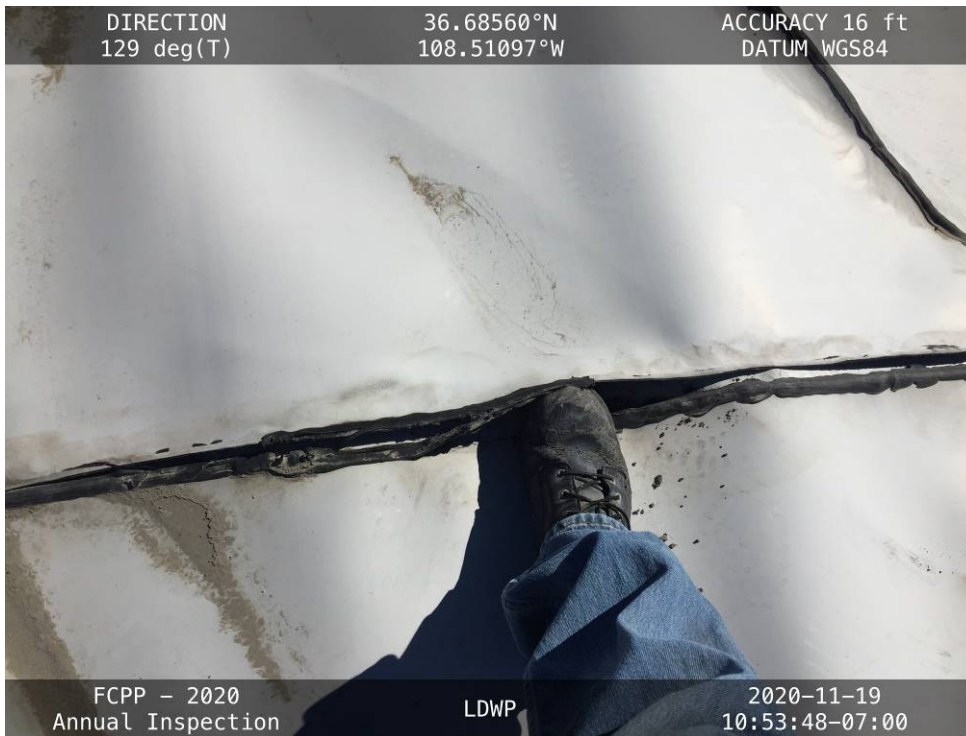
20201119 – IMG_3619

Two sheets of liner separating at the North Embankment.

3) There is a small hole in the liner at the crest elevation along the North Embankment.	Repair the hole.
4) The seam connecting two adjacent sheets of liner has failed along approximately 10 inches at the North Embankment.	Repair the liner.

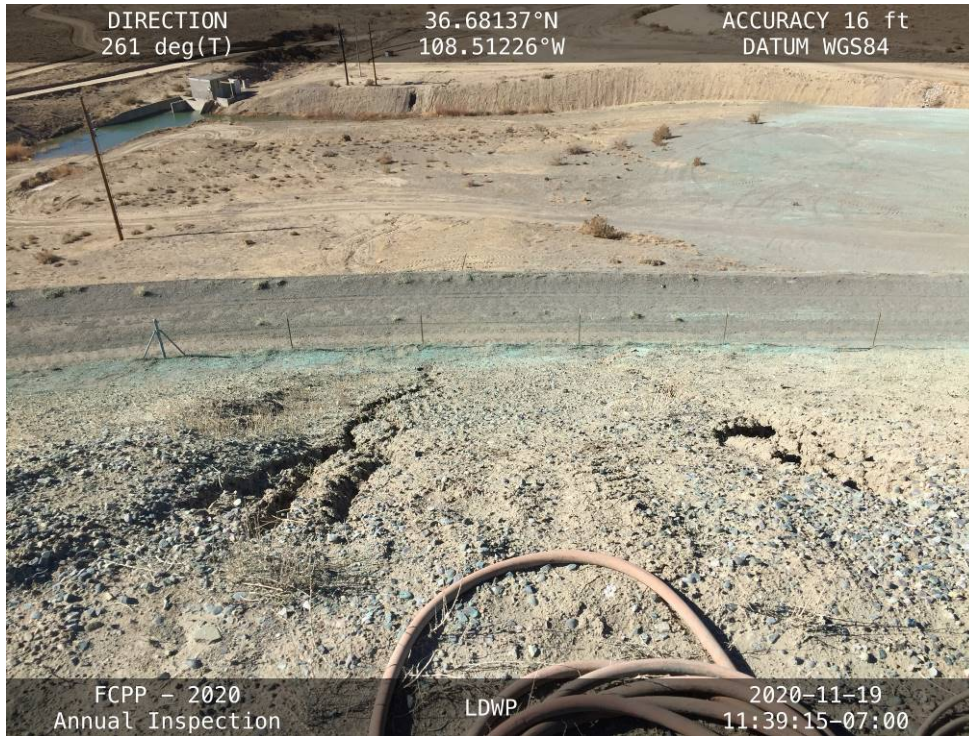
Incipient erosion rills on the downstream slope of the West Embankment, seen from the crest.

2) Minor erosion rilling was observed on the West and South downstream slopes of the LDWP at the time of the inspection.	Continue ongoing repair program for repairing rills if the erosion depth exceeds 1 foot.

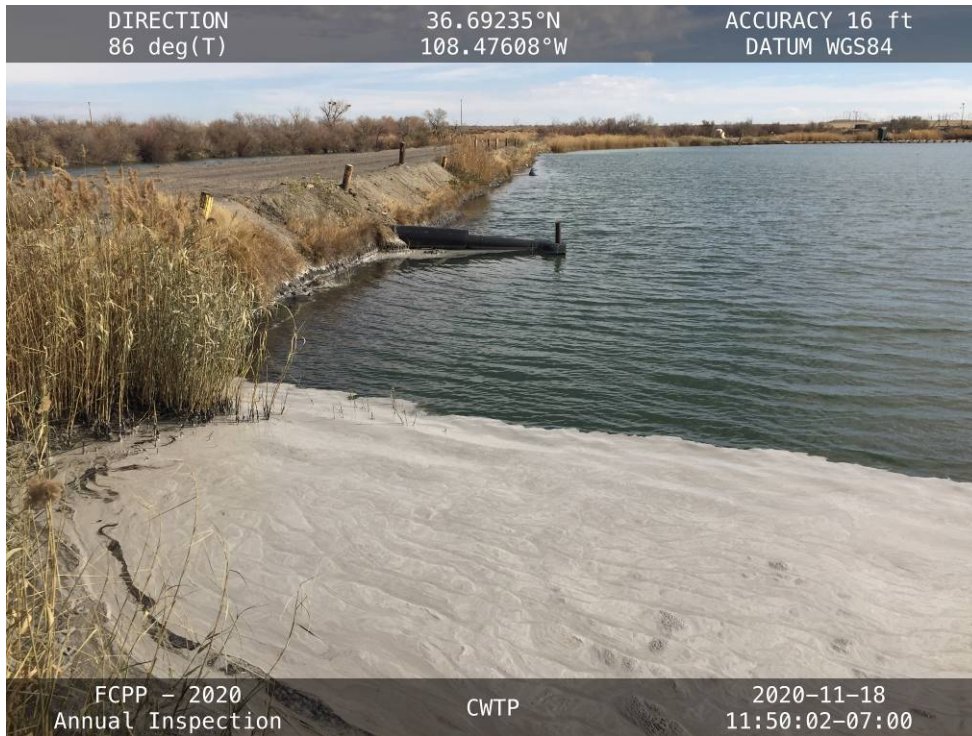
20201118 – IMG_3236

The upstream slope along the northern embankment, facing east from the West Abutment.

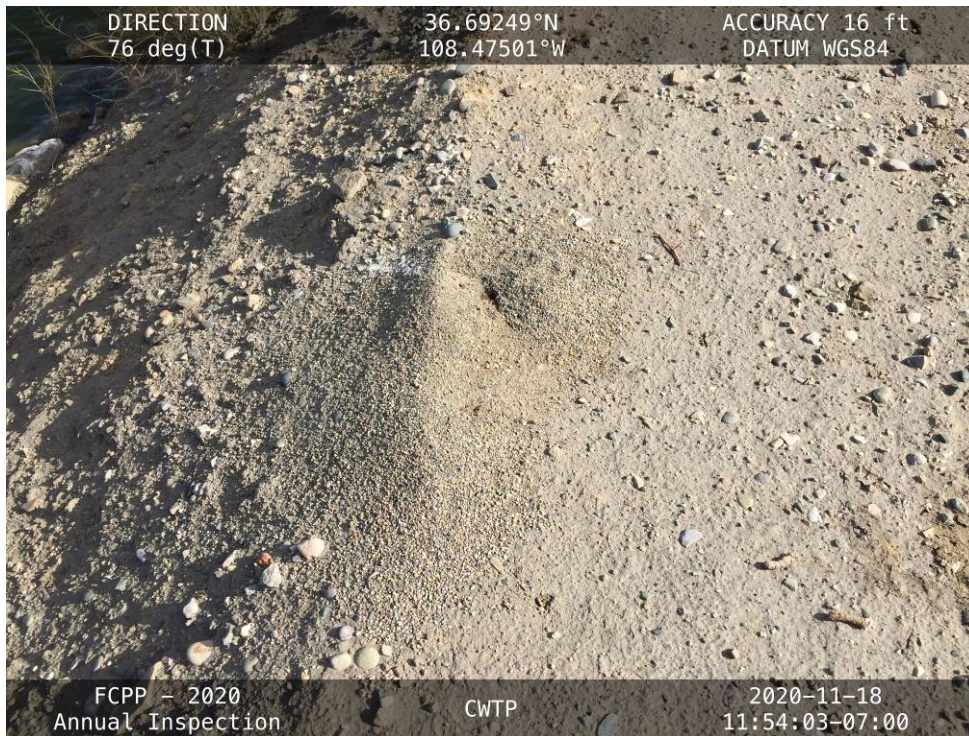
20201118 – IMG_3245

An ant hill on the downstream shoulder of the embankment.

7) Ant hills were observed along the embankment crest and animals have been known to burrow in the area.	This is an ongoing maintenance requirement. Repair ant hills and animal burrows as needed.

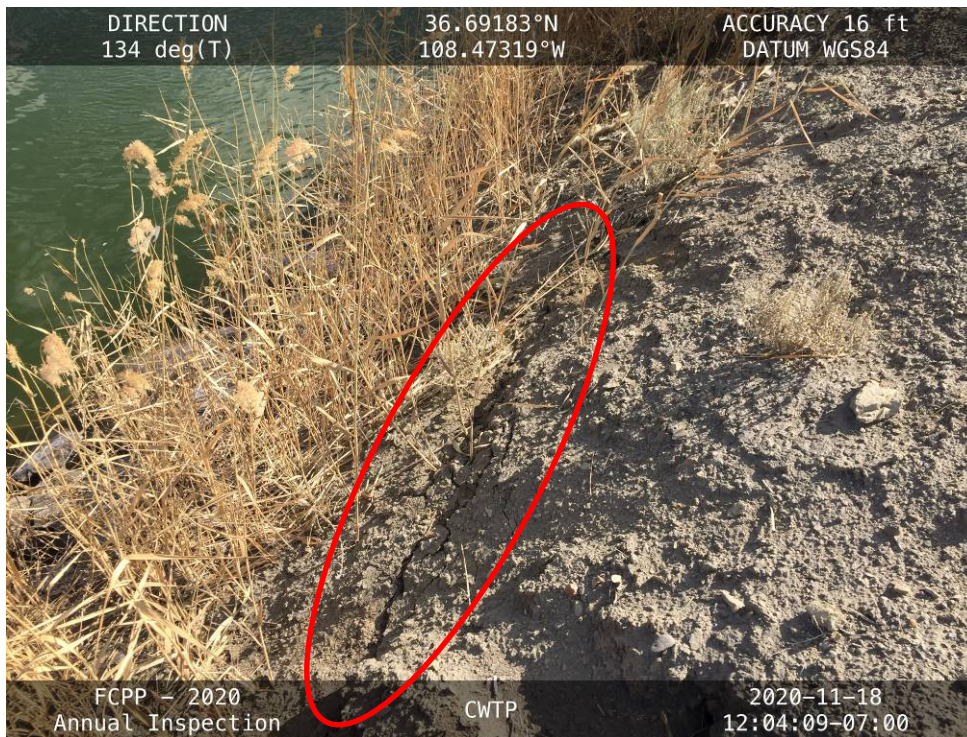
20201118 – IMG_3272

4) An 11.5-foot long longitudinal crack was observed on the downstream slope near the weak crest soil in Condition 3 (above).	Investigate the cause of the crack and repair the slope.

An 11.5-foot long tension crack forming on the downstream slope of the eastern part of the embankment. This is the same location observed in photo IMG_0933 during the 2018 inspection.

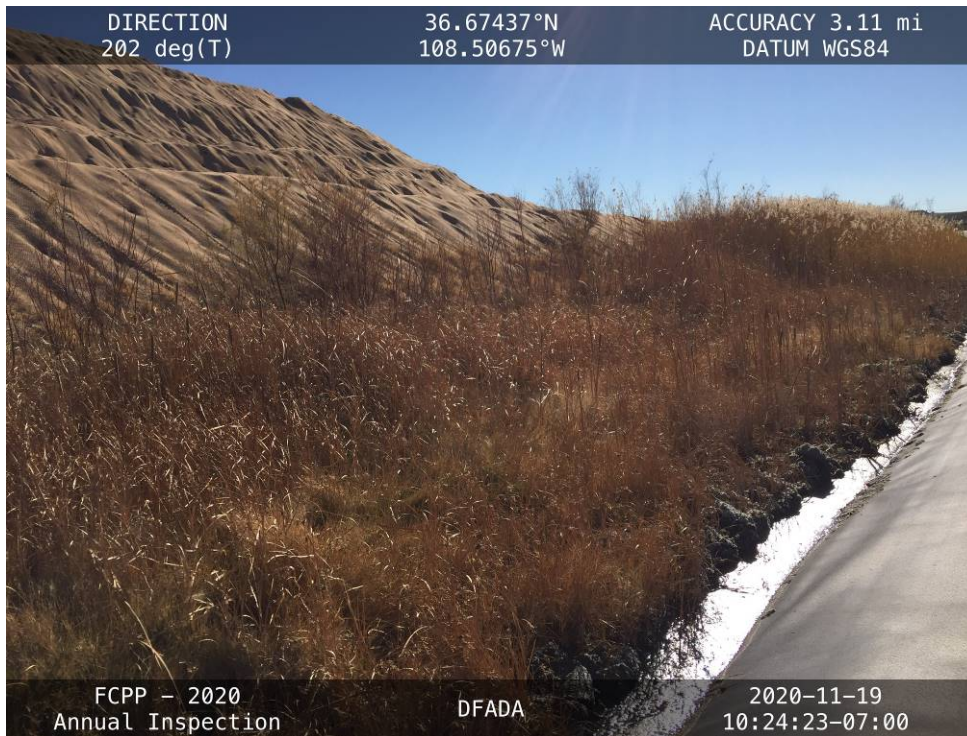
20201119 – IMG_3598

Vegetation growing along the toe of the western slope of Cell 1.

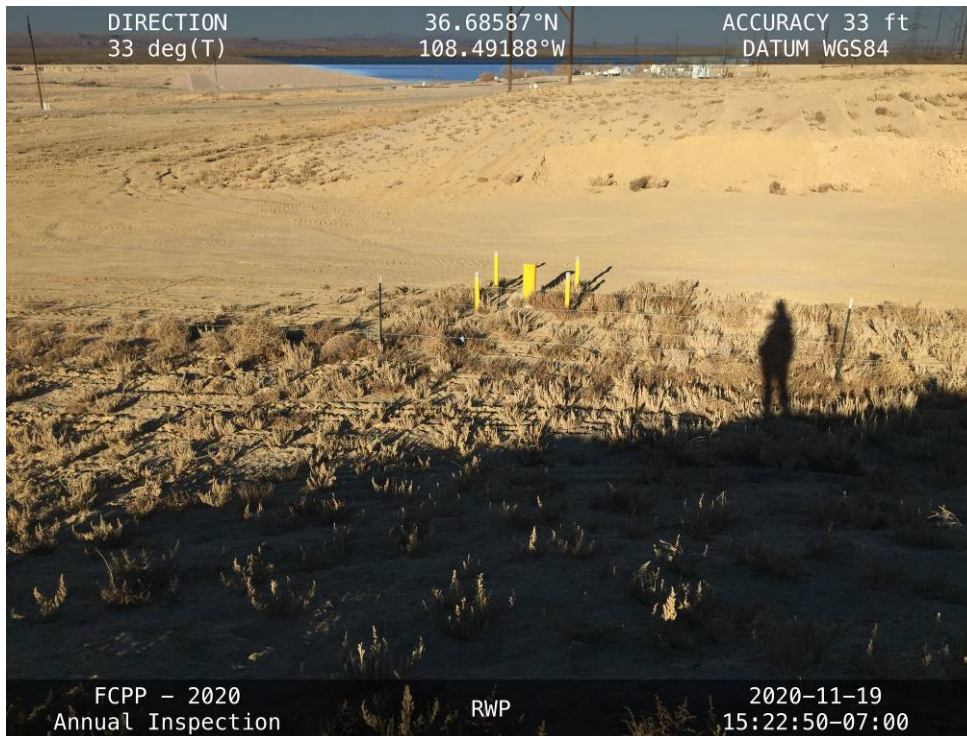
20201119 – IMG_3855

The downstream slope of the Northeast Embankment, facing southeast from the north corner.

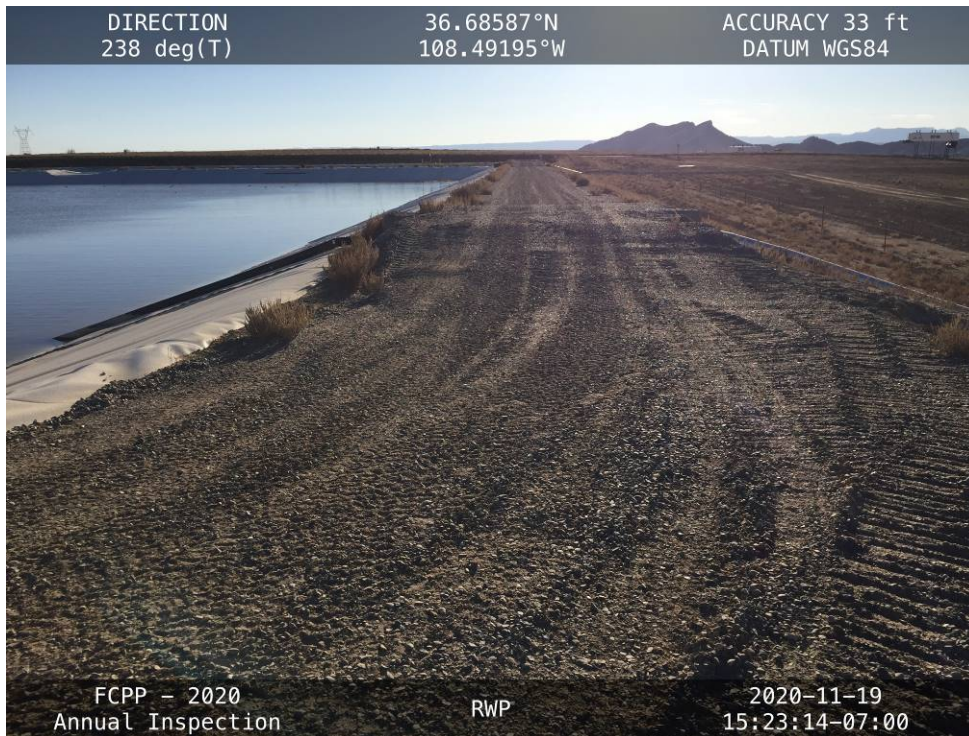
20201119 – IMG_3857

The upstream slope of the Northwest Embankment, facing southwest from the north corner.

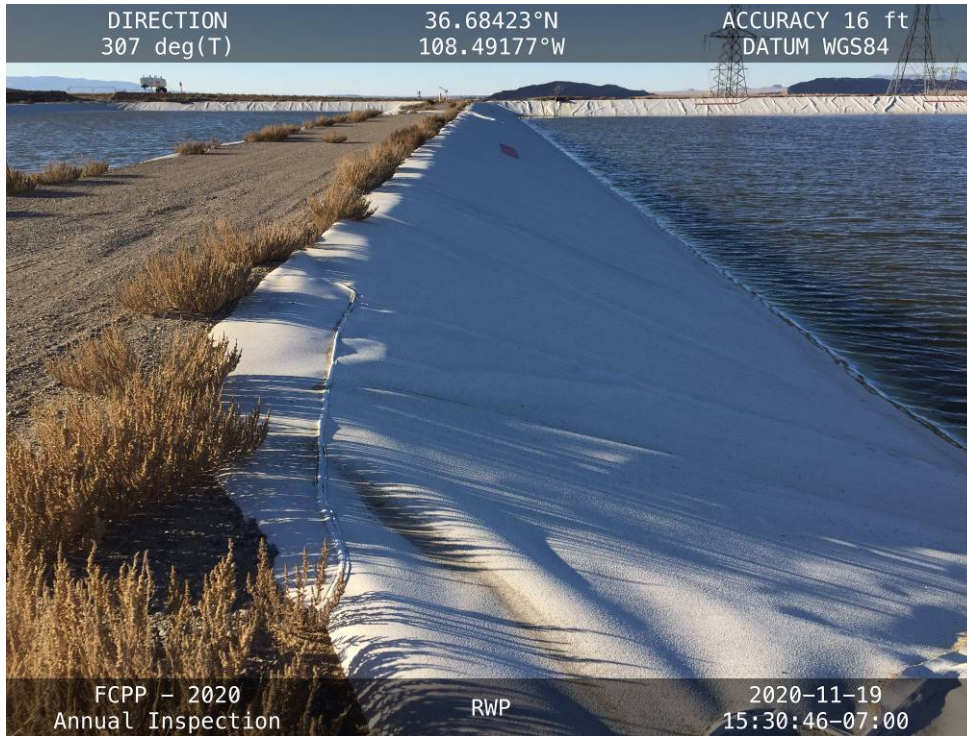
20201119 – IMG_3874

The crest of the FGD Pond cell Internal Embankment, facing northwest.

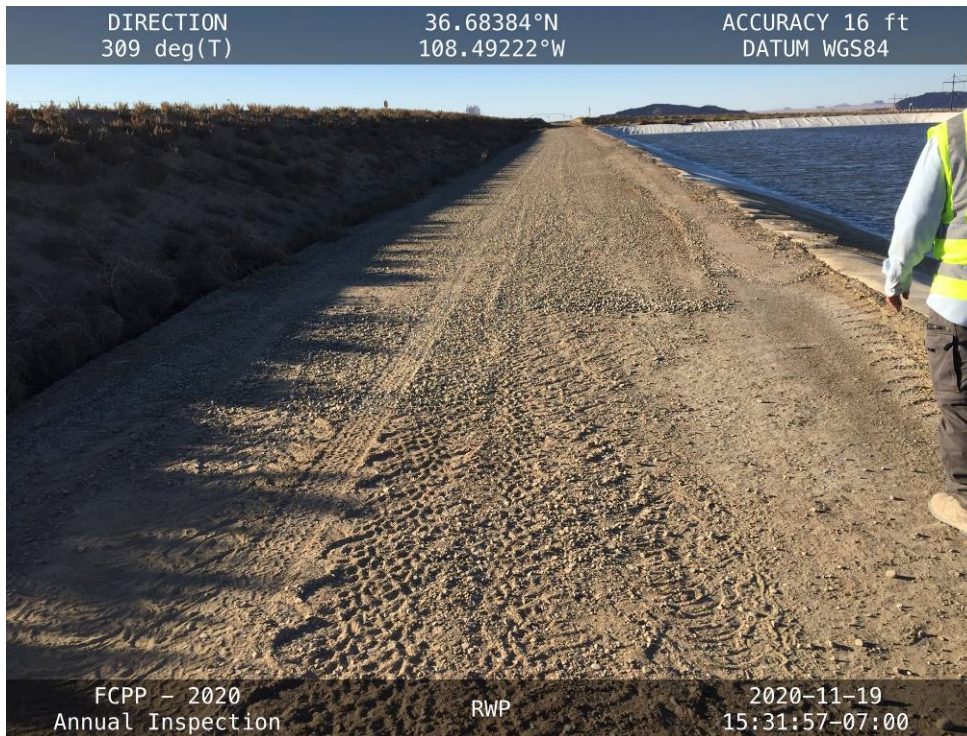
20201119 – IMG_3875

The upstream slope of the RWP Internal Embankment, facing northwest.

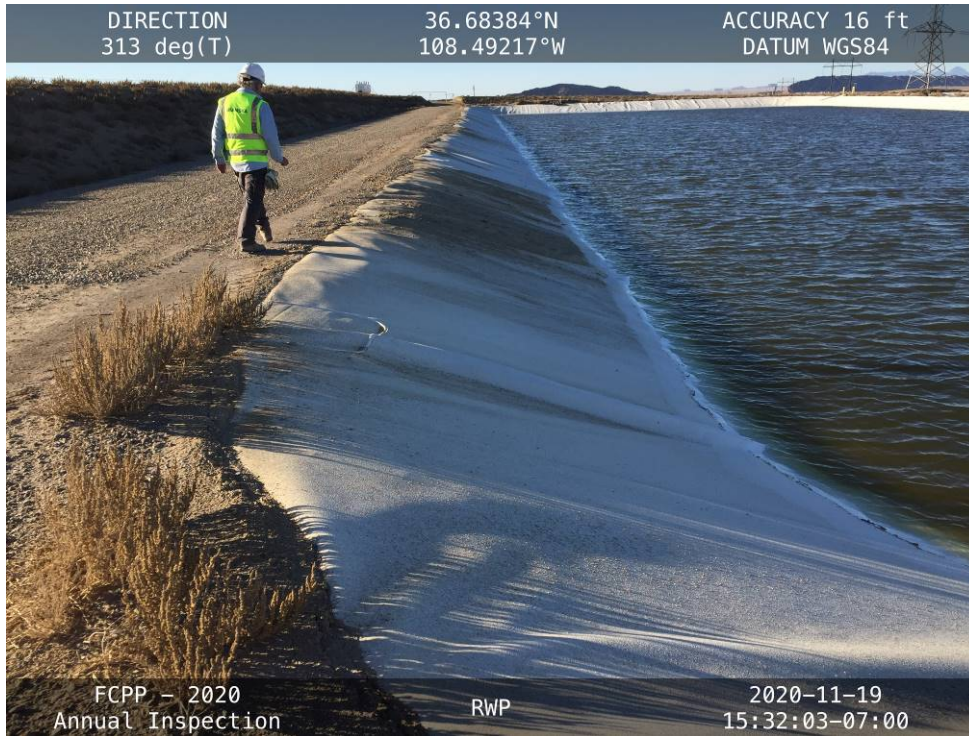
20201119 – IMG_3879

The crest of the FGD Pond cell South Embankment, facing northwest.

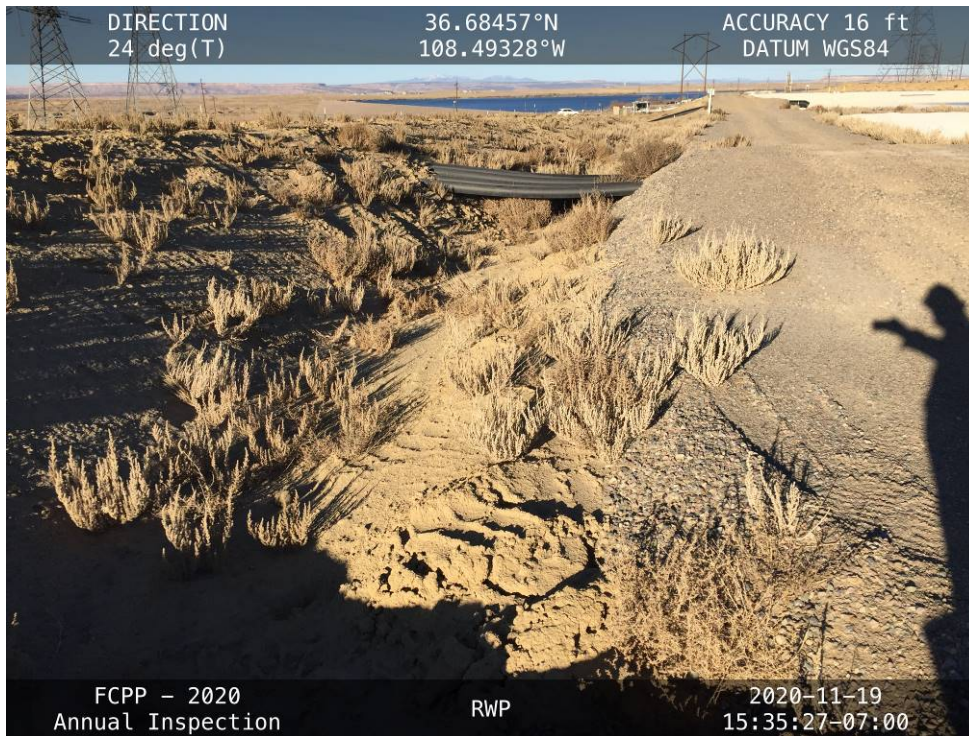
20201119 – IMG_3880

The upstream slope of the FGD Pond cell South Embankment, facing northwest.

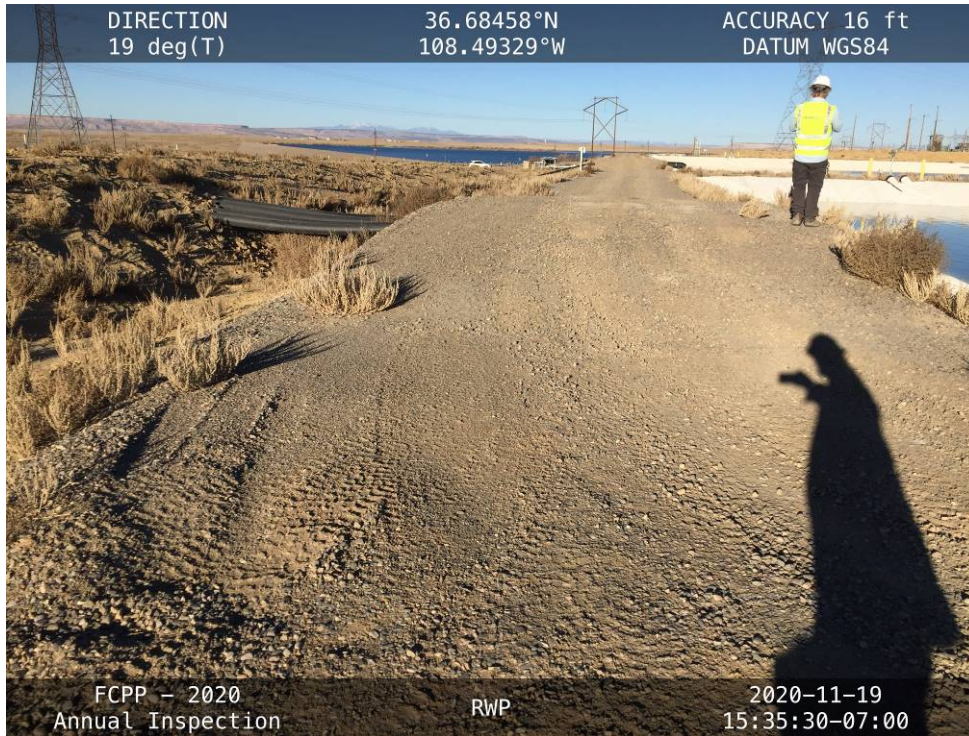
20201119 – IMG_3884

The downstream slope of the FGD Pond cell Northwest Embankment, facing northeast.

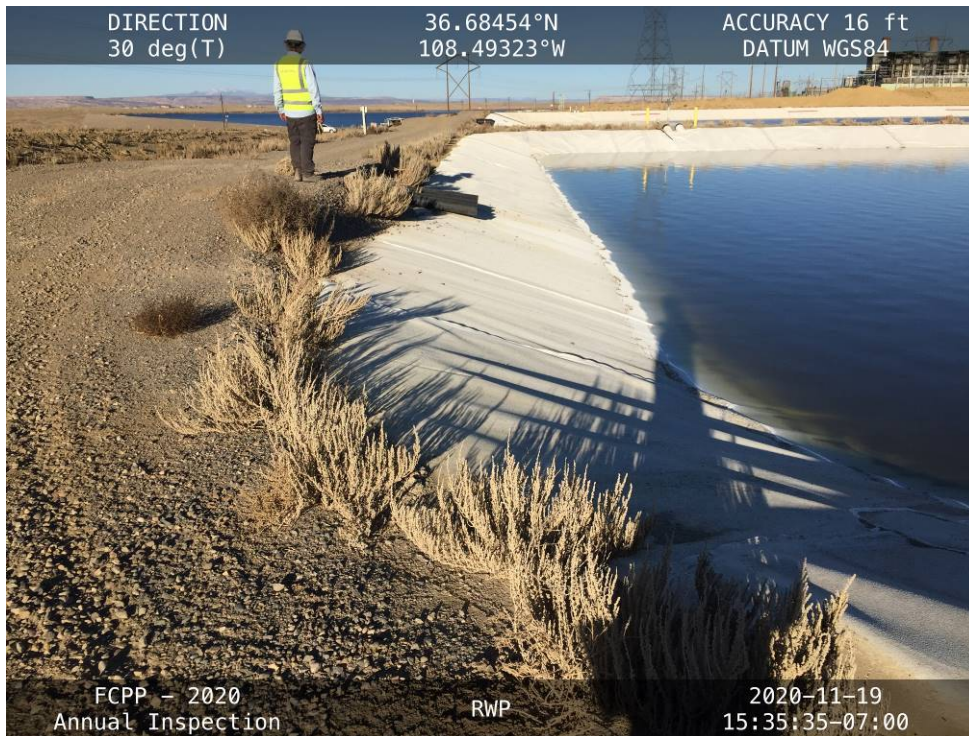
20201119 – IMG_3885

The crest of the FGD Pond cell Northwest Embankment, facing northeast.

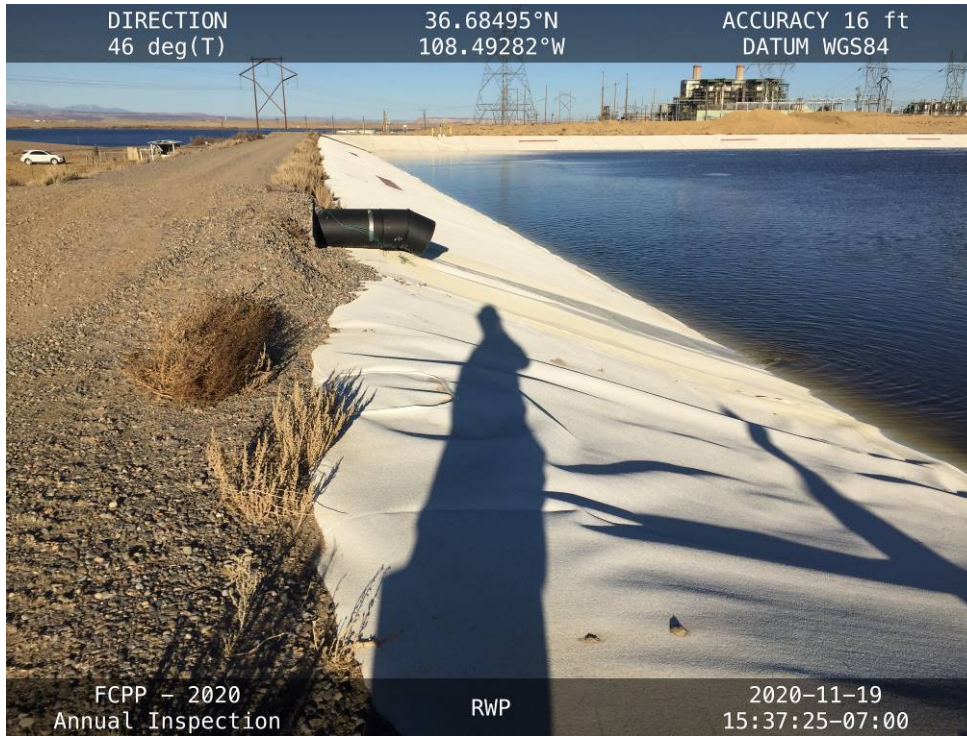
20201119 – IMG_3897
The crest of the Internal Embankment, facing southeast.

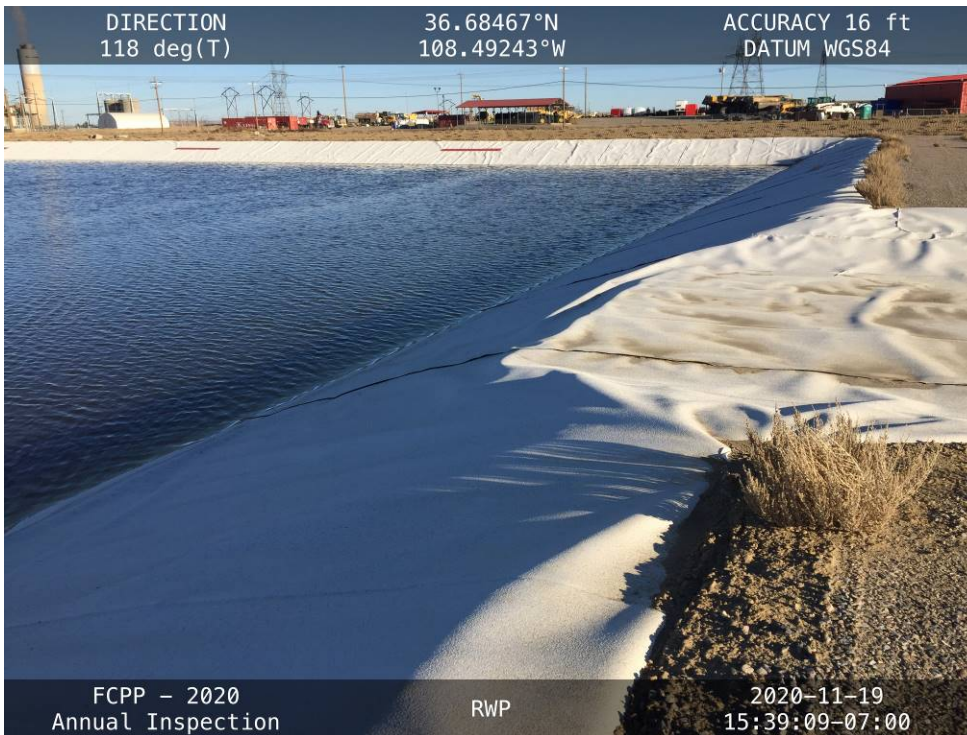
20201119 – IMG_3900

The Return Water Pond cell Inlet along the upstream slope of the Northwest Embankment, facing northeast.

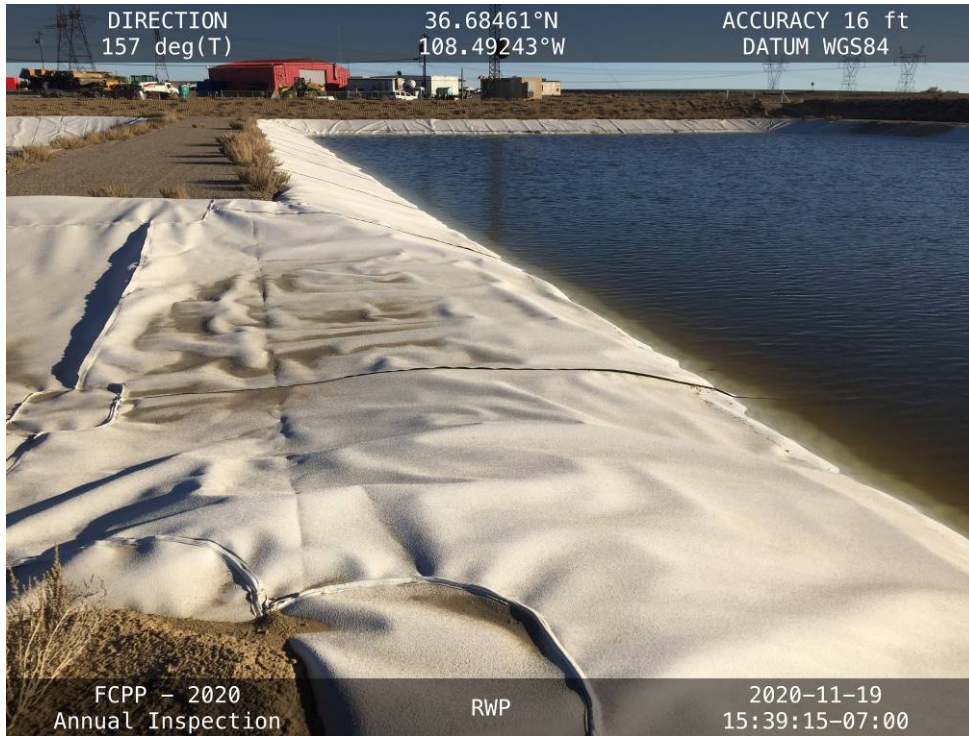
20201119 – IMG_3906

The Return Water Pond cell reservoir below the elevation of the overflow weir in the Internal Embankment.

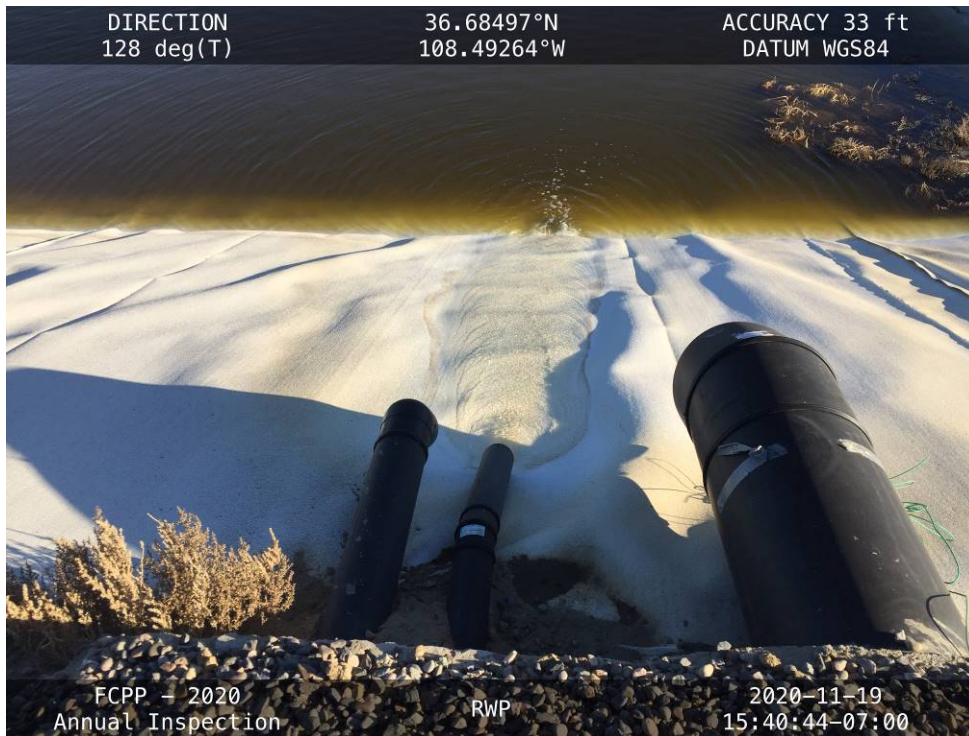
20201119 – IMG_3907

The FGD Pond cell below the elevation of the overflow weir in the Internal Embankment.
